# **Houspect**

### **Pre purchase inspection**

**Job ID:** 92810

**Address:** 1 Straker Rd, Millars Well WA 6714

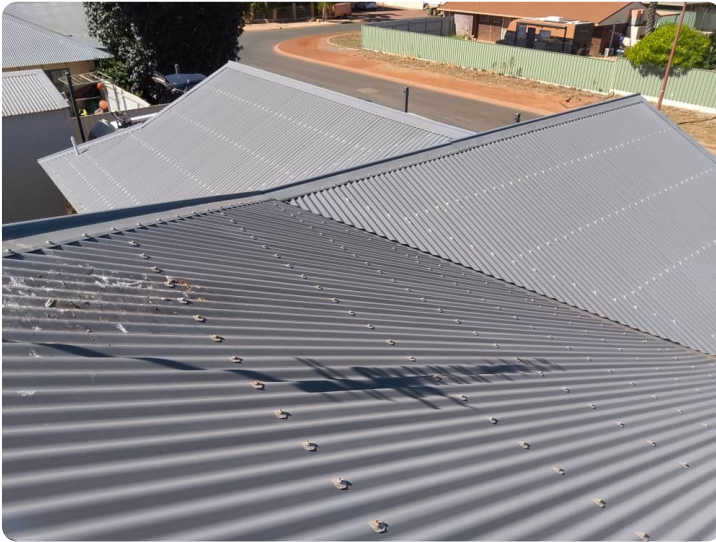
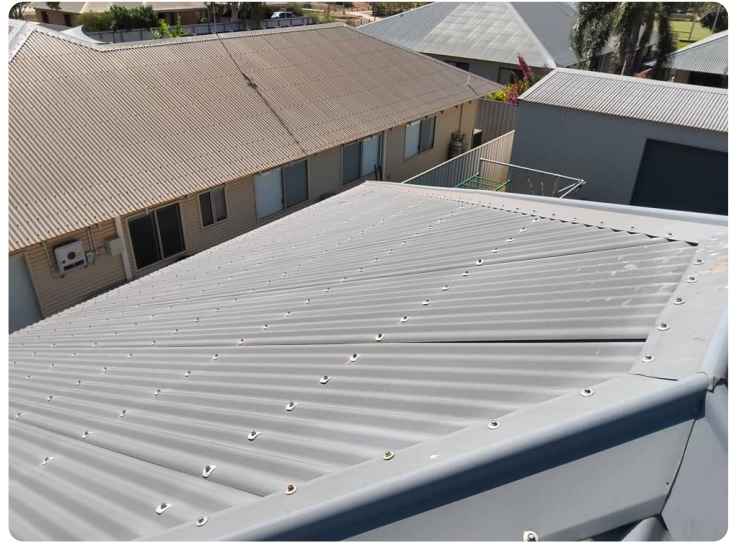
## 1. Roof covering

The roof covering is constructed of colorbond. The condition of the roof covering is satisfactory in relation to its age and will require normal ongoing maintenance.

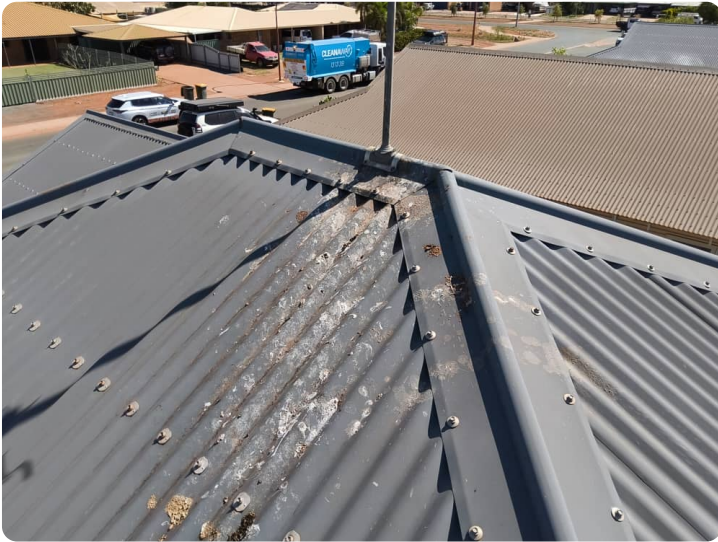
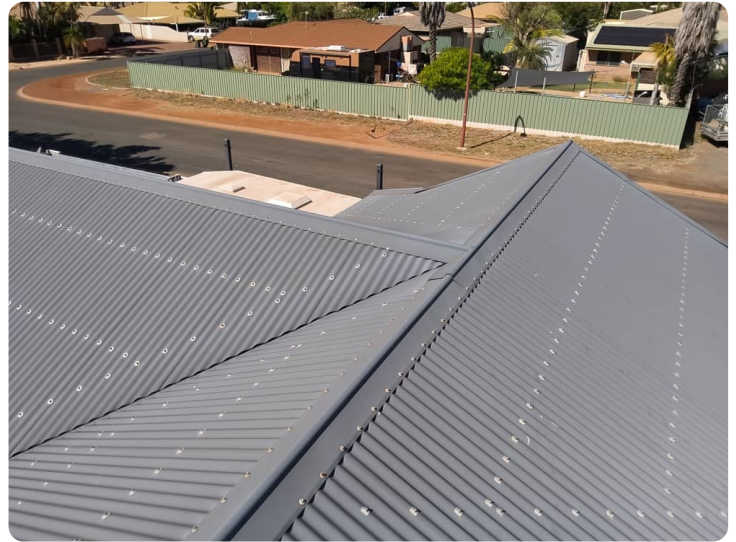
## 2. Ridges

The ridges and capping are satisfactory in relation to its age and will require normal ongoing maintenance.

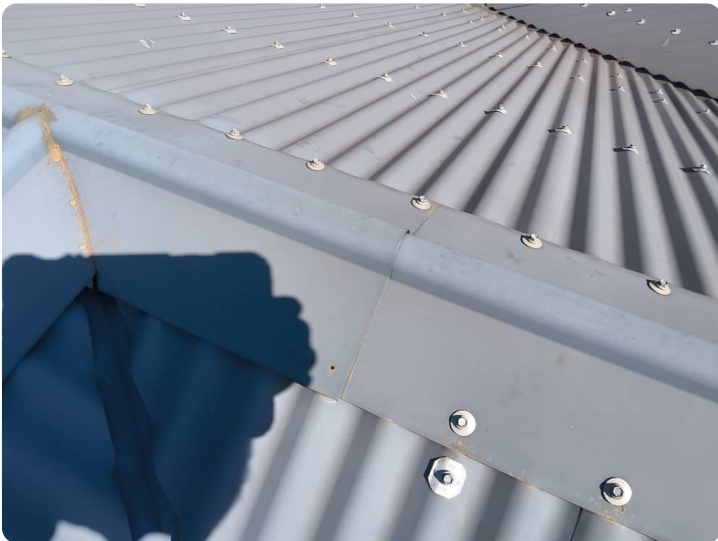
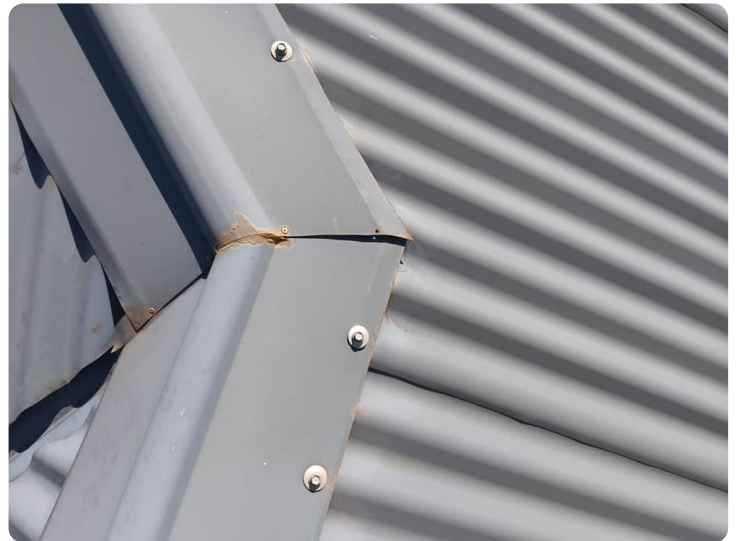
### 2.1 Metal ridge tek screws insufficient

There are insufficient fixings located in the correct areas. Remediation is recommended.

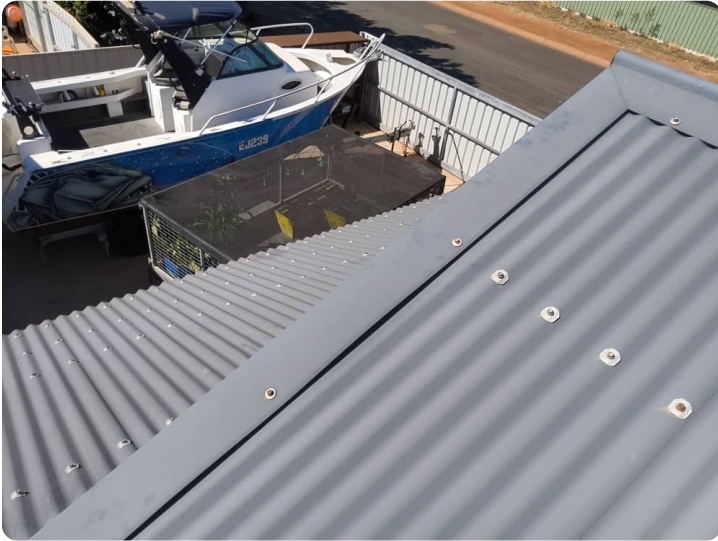
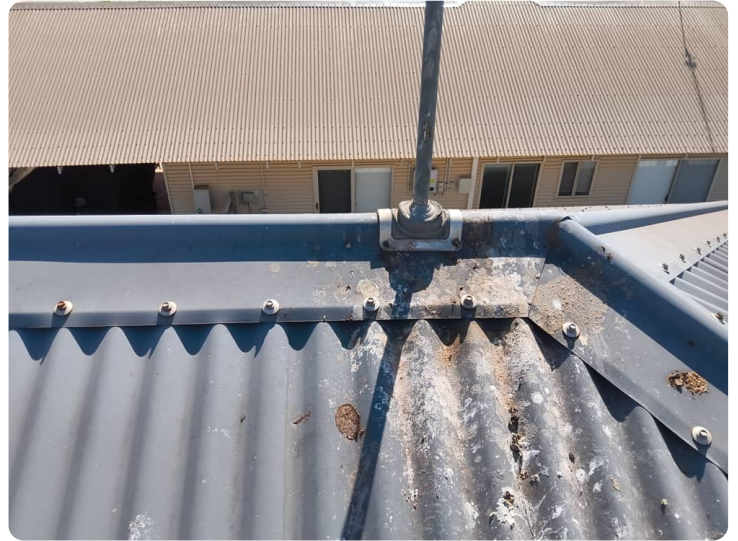
### 3. Flashings

The flashings are covered with a variety of finishes and are constructed of a mixture of materials. The condition of the flashings is satisfactory in relation to their age and will require normal ongoing maintenance.

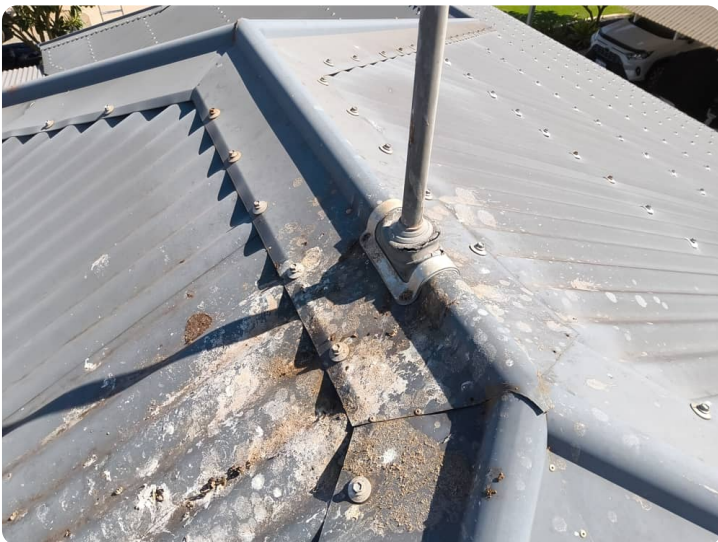
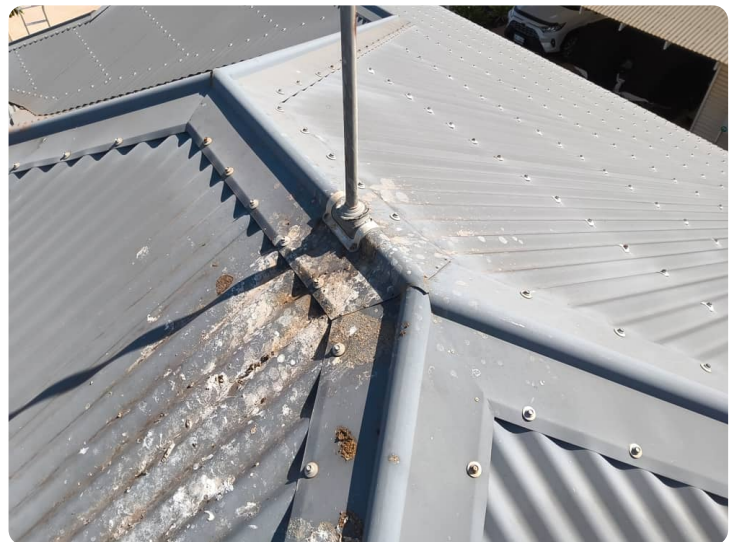
#### 3.1 Dektite damaged or perished

The dektite has been damaged or has perished and needs to be replaced.

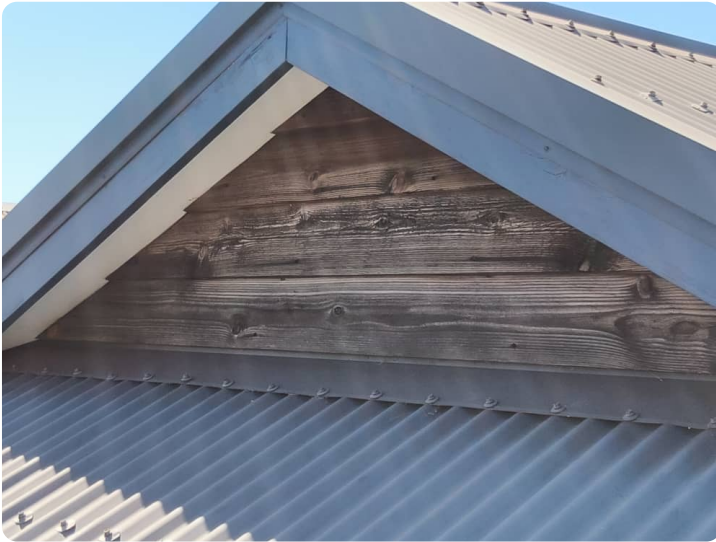
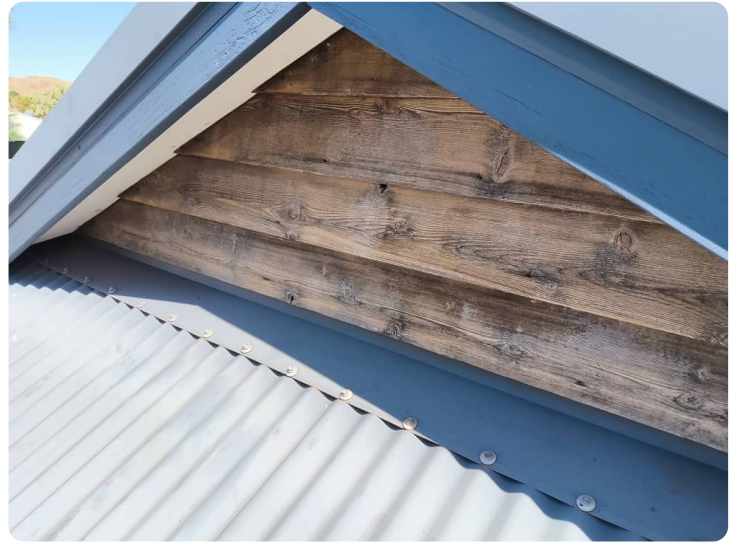
#### 4. Gables

The gables are weathered and constructed of timber. The condition of the gables is fair in relation to its age and will require ongoing maintenance.

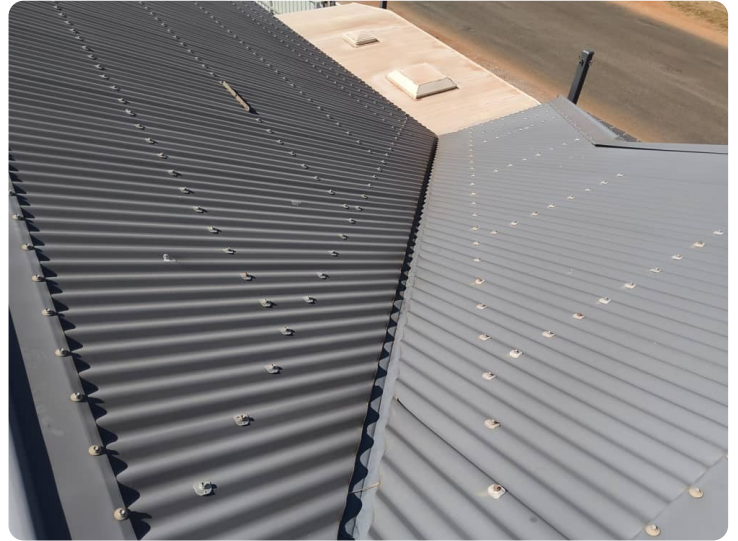
## 5. Valleys

The valleys are constructed of metal and have a colorbond covering. The condition of the valleys is satisfactory in relation to their age and will require normal ongoing maintenance. The valleys appear to be relatively free of debris.

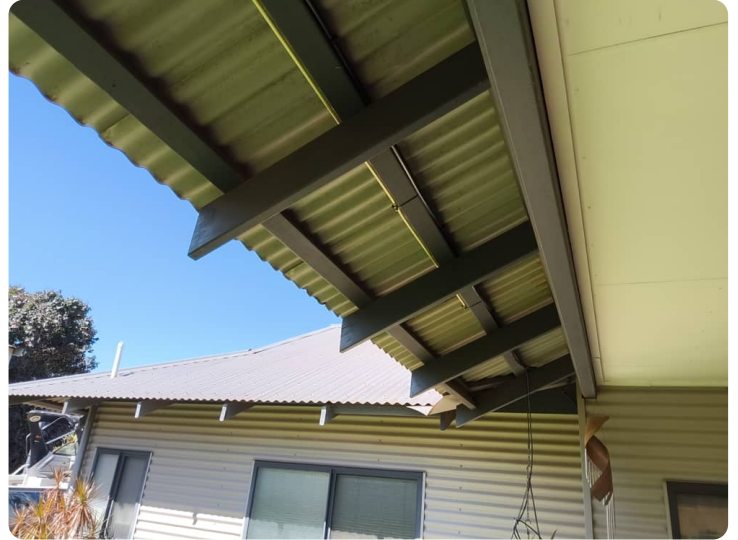
## 6. Eaves

The eaves are exposed and constructed of exposed rafters. The condition of the eaves is satisfactory in relation to their age and will require normal ongoing maintenance.

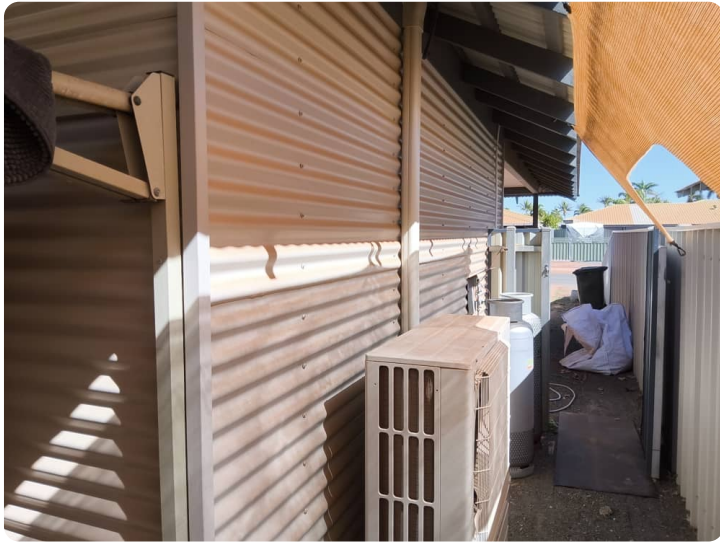
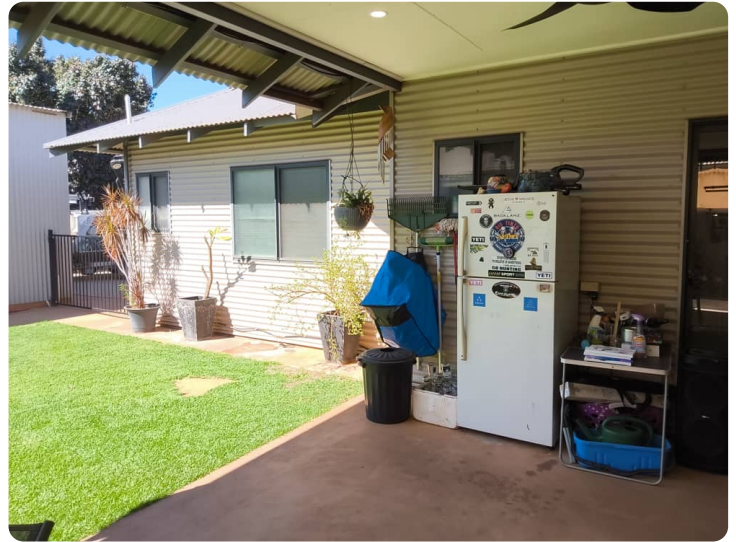
## 7. External walls

The external walls are constructed of a framed structure with cladding. The condition of the walls generally is satisfactory in relation to their age and will require normal ongoing maintenance.

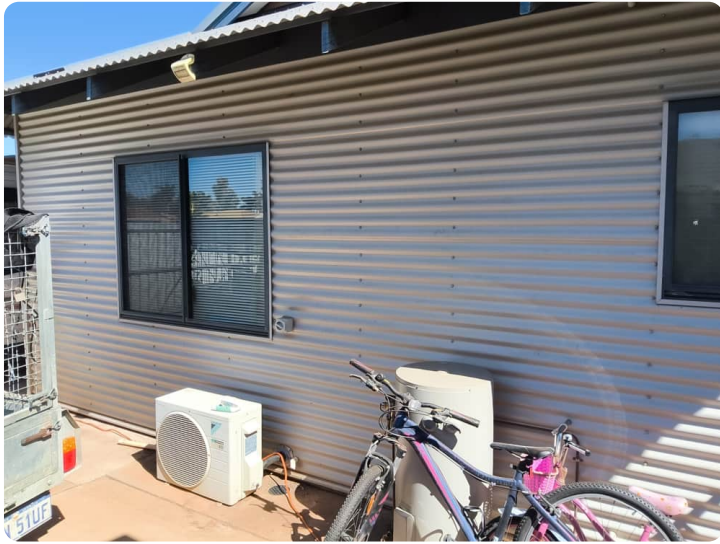
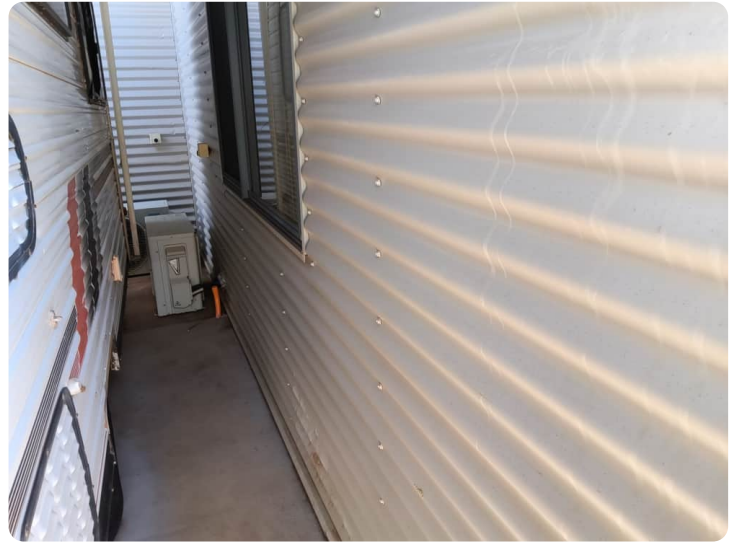
## 8. Wall cladding

The external walls are (or partially are) clad with metal. The condition of the cladding is generally satisfactory in relation to its age and will require normal ongoing maintenance.

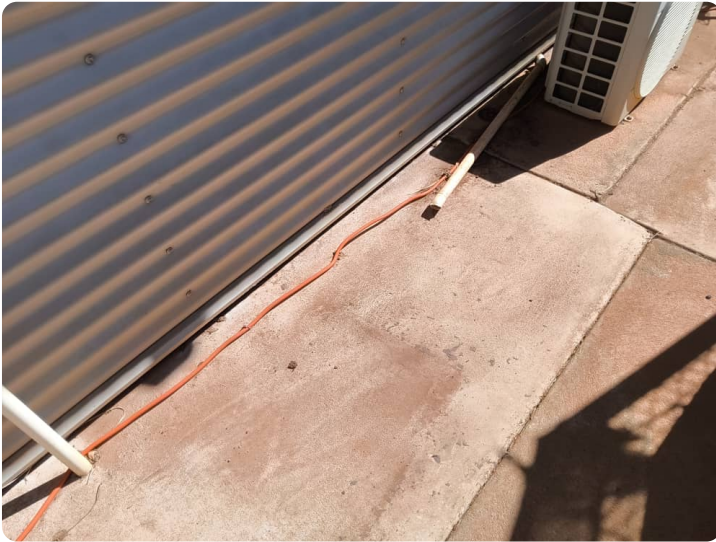
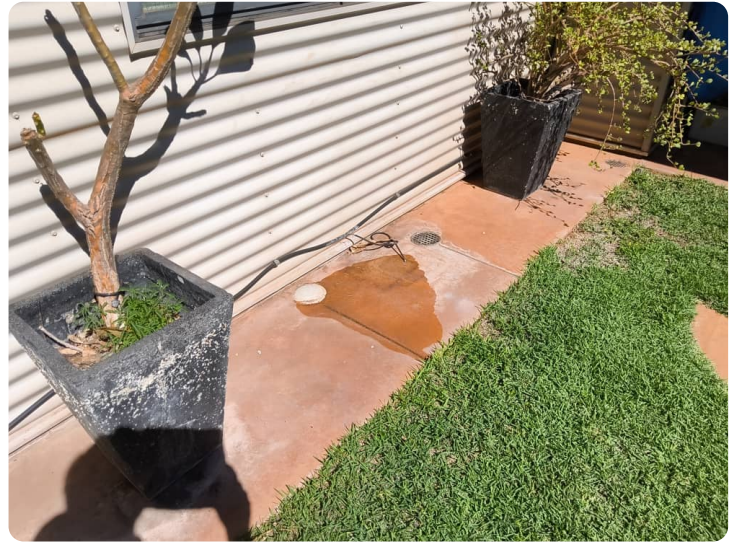
## 9. Footings

The footings are below ground and cannot be seen. The condition of the footings cannot be determined.

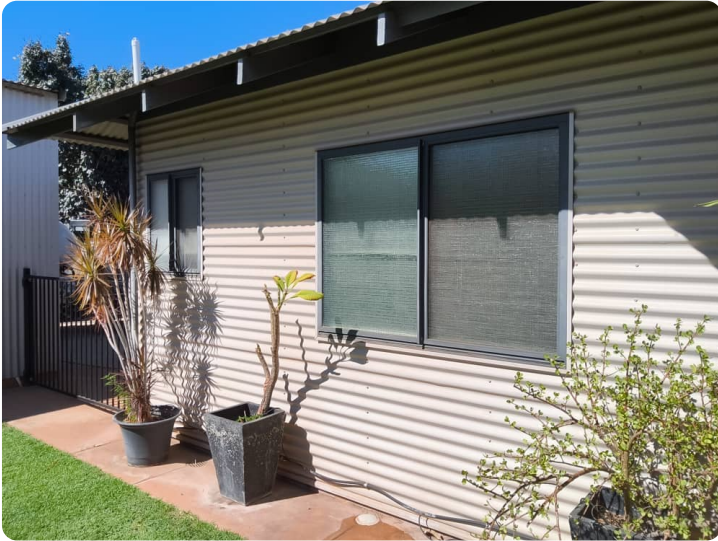
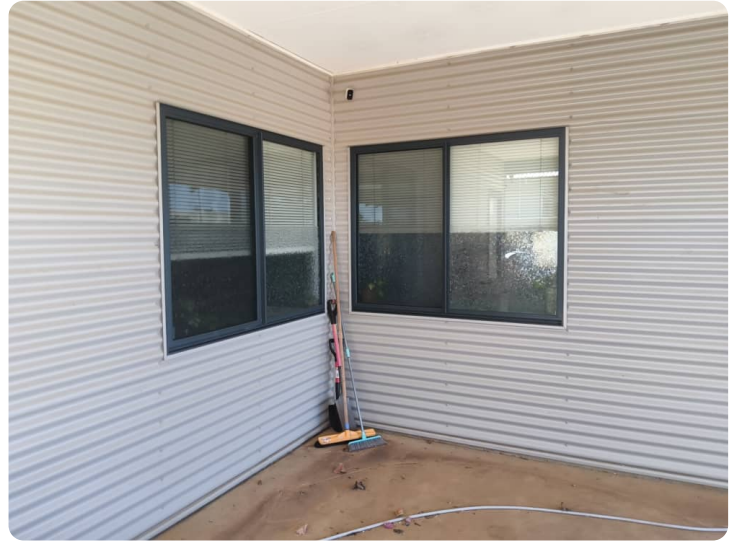
## 10. Windows and window frames

The window and window frames are primarily constructed of aluminium. The condition of the window and window frames is generally satisfactory in relation to its age and will require normal ongoing maintenance.

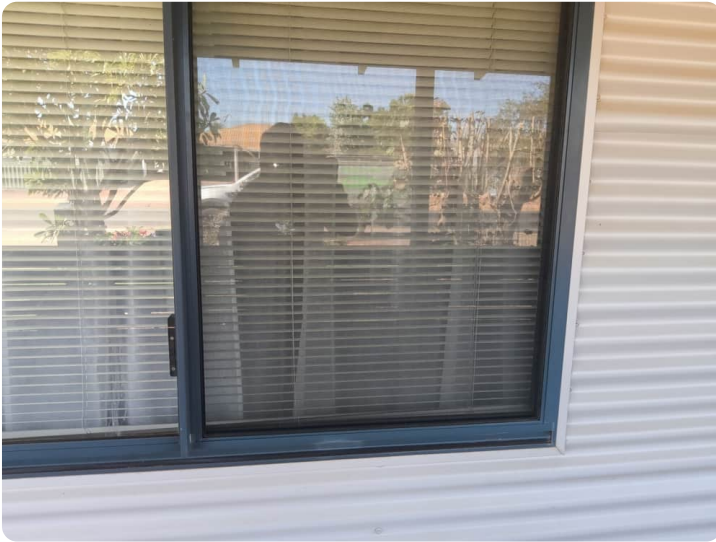
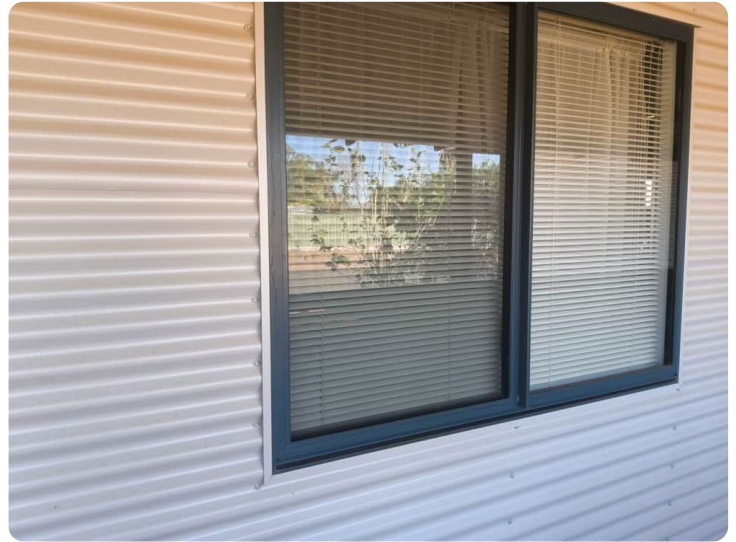
## 11. Window fly screens

Fly screens have been installed to all of the windows. The condition of the window fly screens is generally satisfactory in relation to its age and will require normal ongoing maintenance.

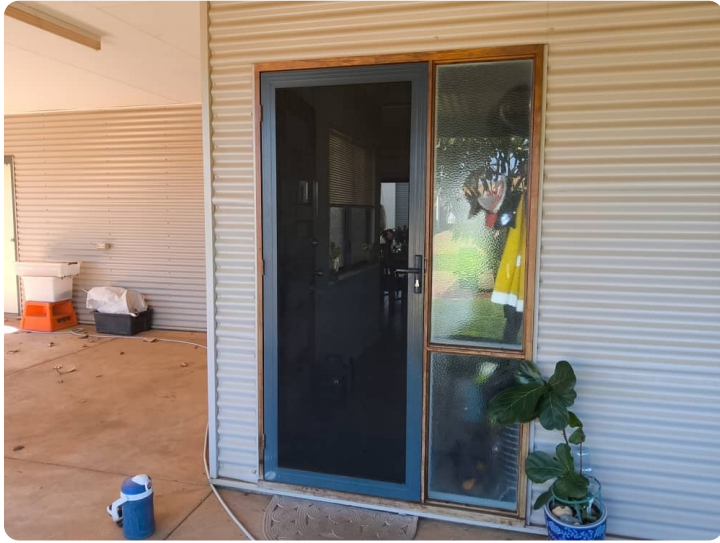
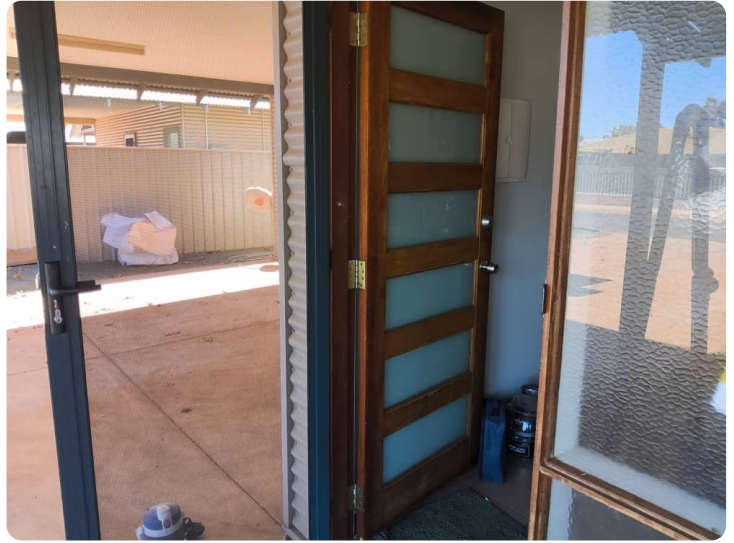
## 12. Front door

The front door is constructed of timber and glass. The condition of the front door is satisfactory in relation to its age and will require normal ongoing maintenance. Deadlocks have been installed. A security screen door has not been fitted.

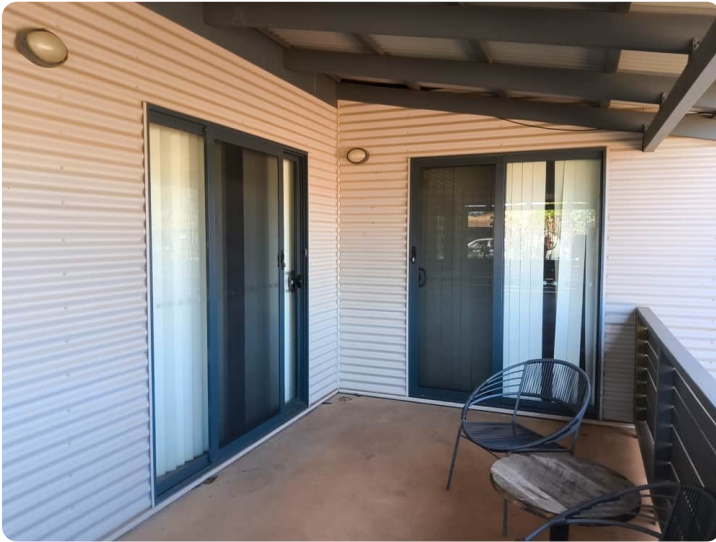
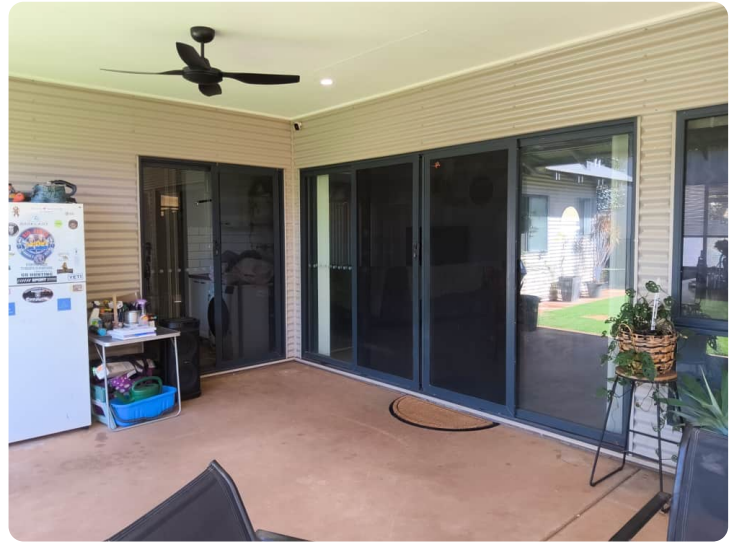
### 13. Other external doors

Other external doors are constructed of aluminium. The condition of the other external doors is satisfactory in relation to its age and will require normal ongoing maintenance.

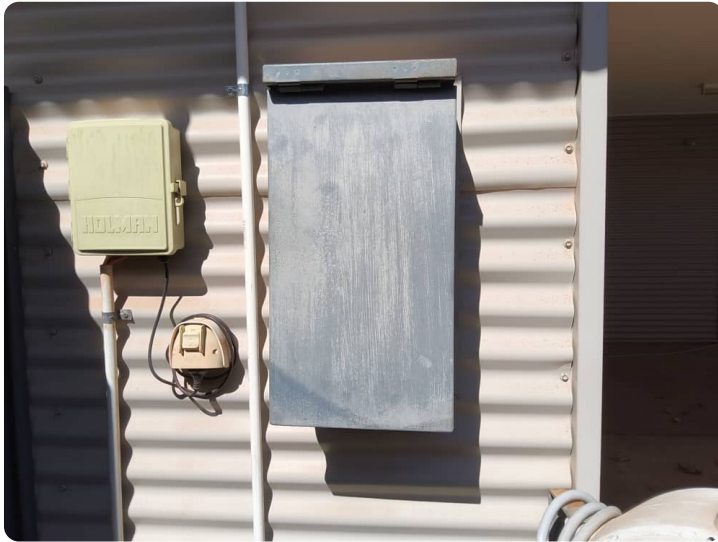
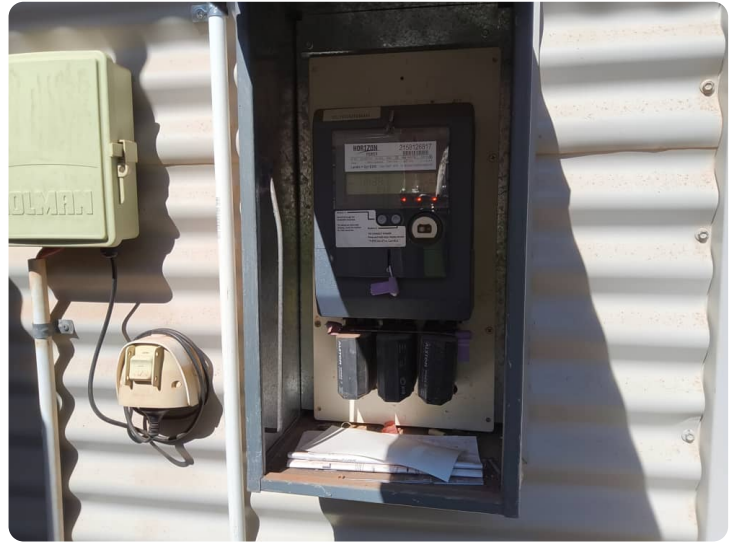
#### 14. Meter box and power

Access to the meter box or sub board was available. The meter box or sub board is not lockable. Power phase type to the site is three phase.

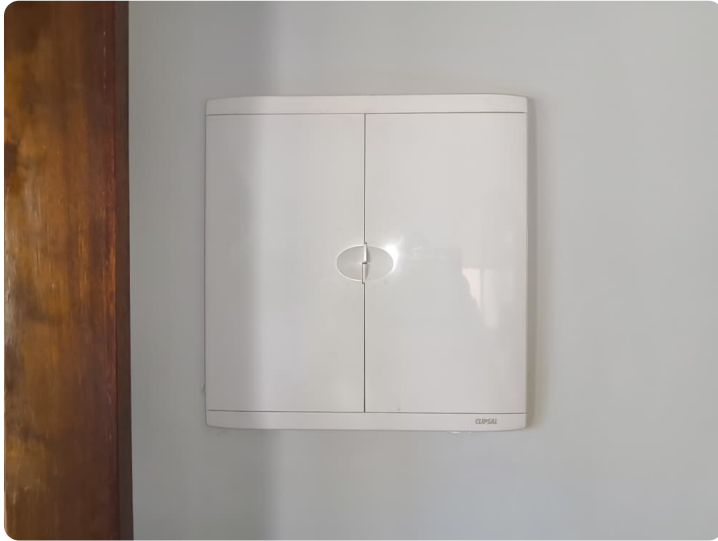
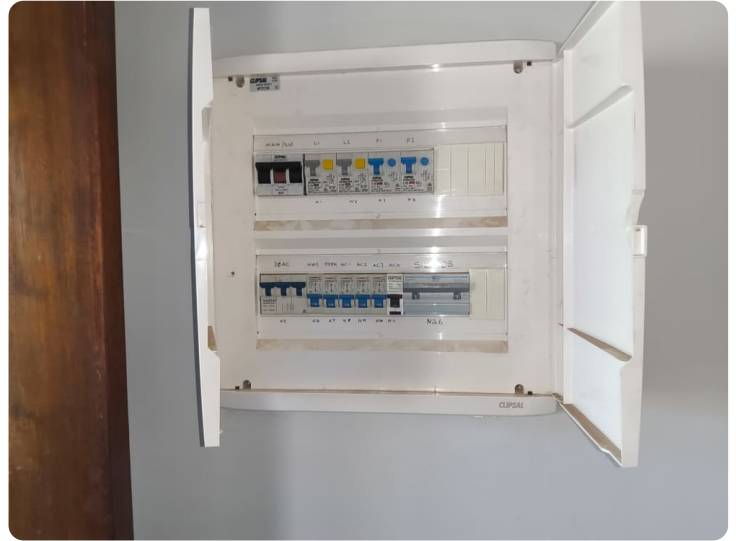
## 15. Residual Current Devices

There were multiple Residual Current Devices (RCD)(s) noted in the meter box or sub meter box. The RCD(s) were not tested. It is suggested that an Electrical Compliance Certificate be obtained in relation to the RCD(s).

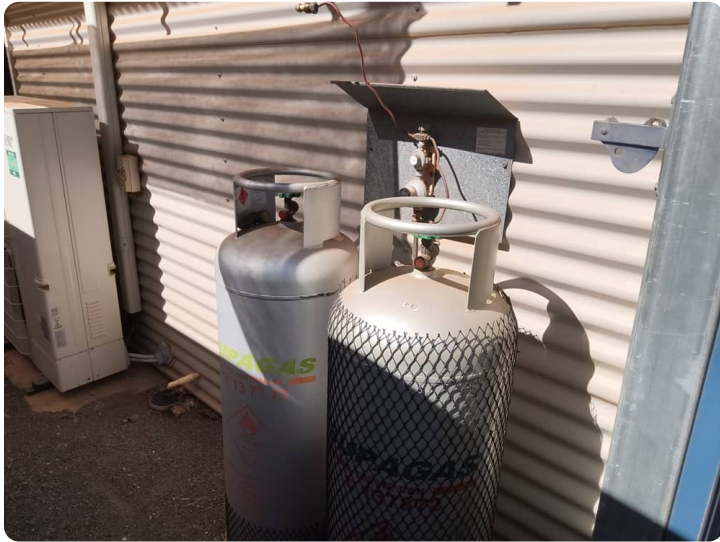
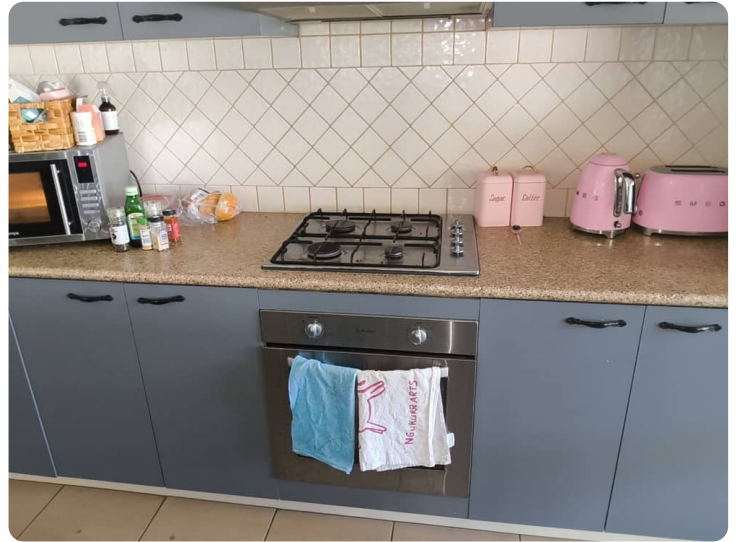
## 16. Gas Supply

Gas supply to the property is via LPG bottles. While on site the inspector could not smell detectable gas leaks.

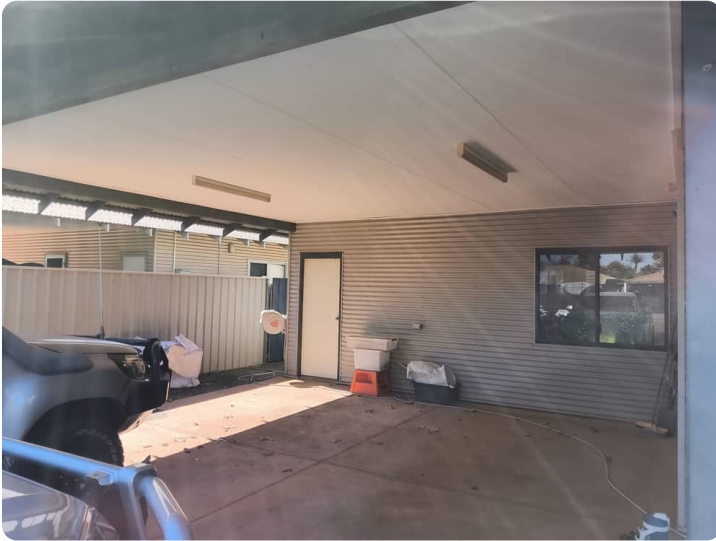
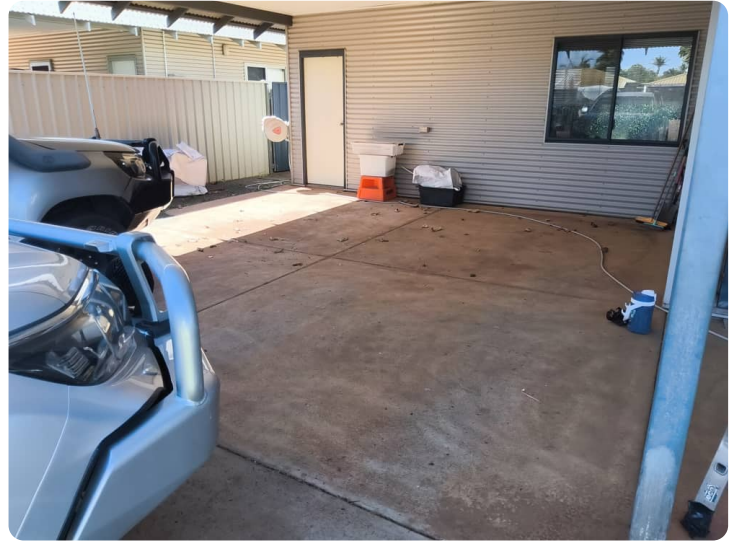
### 17. Carport or Garage (Primary)

There is a primary carport on the property constructed of same materials as the primary structure. The condition of the carport or garage is satisfactory in relation to its age and will require normal ongoing maintenance.

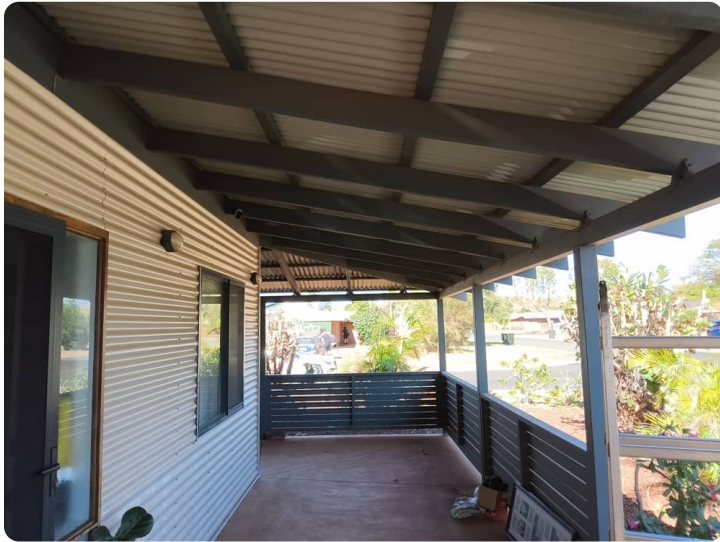
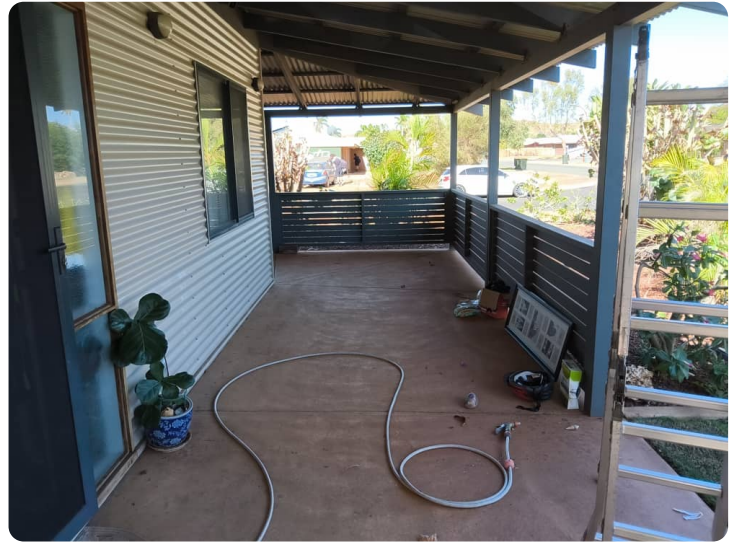
### 18. Veranda (Primary)

The primary veranda is constructed of same materials as the primary structure. The condition of the veranda is satisfactory in relation to its age and will require normal ongoing maintenance.

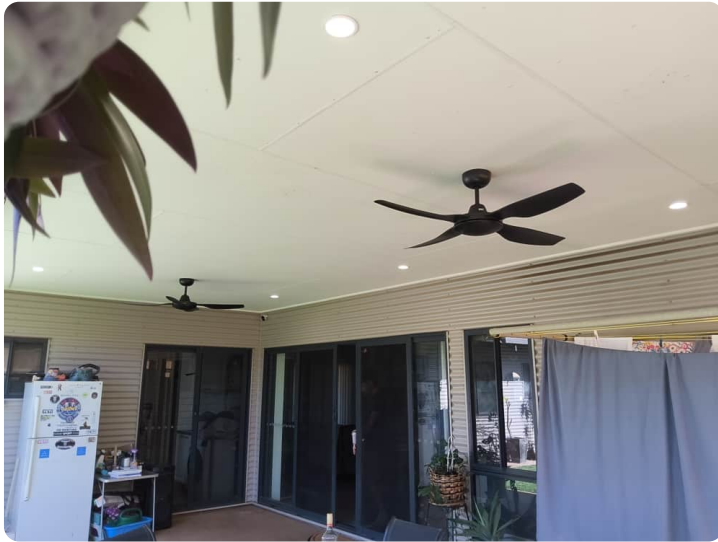
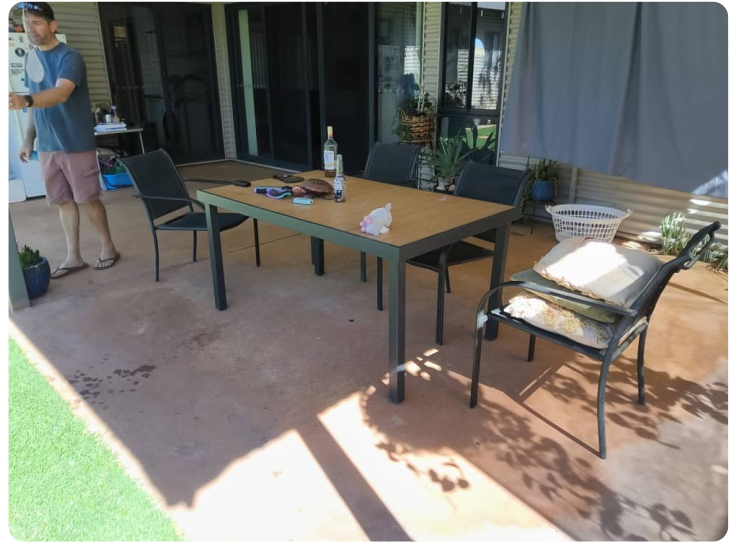
### 19. Alfresco (under main roof)

The alfresco under the main roof is constructed of same materials as the building. The condition of the alfresco is satisfactory in relation to its age and will require normal ongoing maintenance.

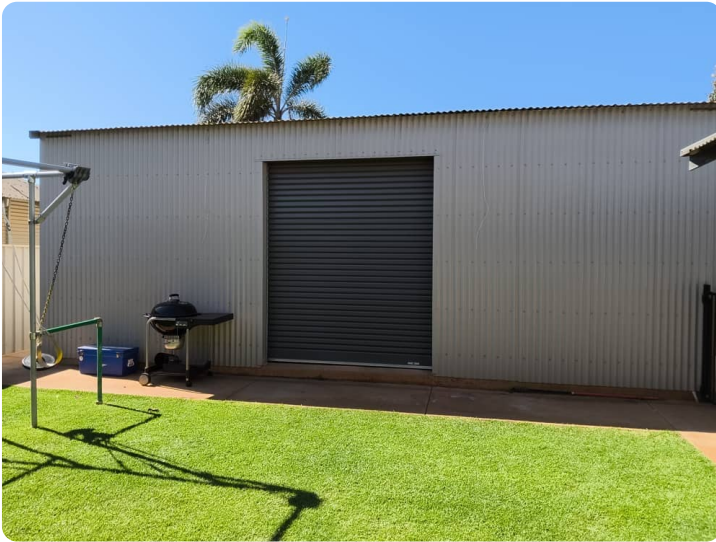
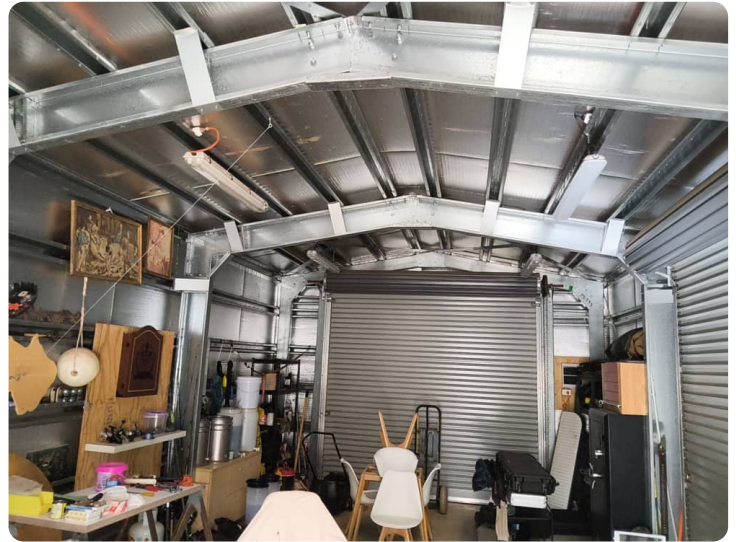
## 20. Large shed

The large shed is constructed of metal. The condition of the large shed is satisfactory in relation to its age and will require normal ongoing maintenance.

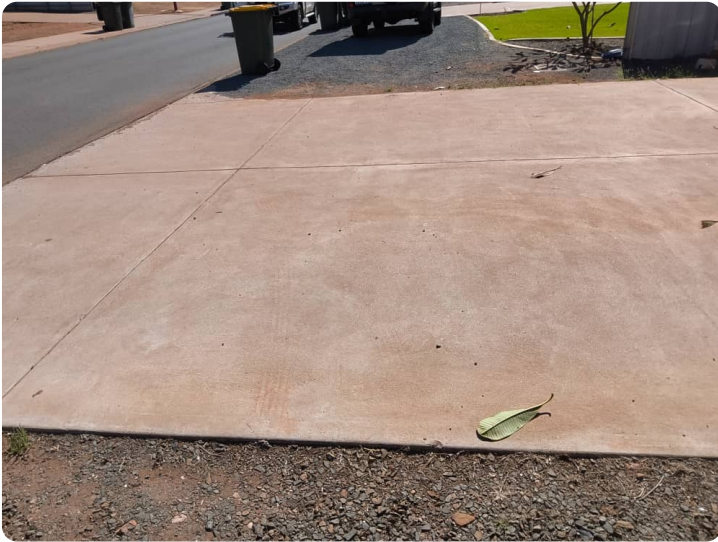
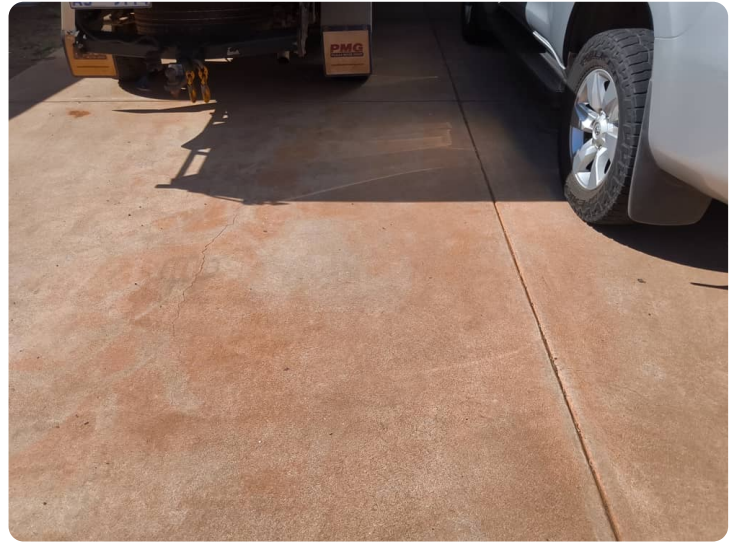
## 21. Driveway

The driveway and cross over is constructed of concrete. The condition of the driveway is satisfactory in relation to its age and will require normal ongoing maintenance.

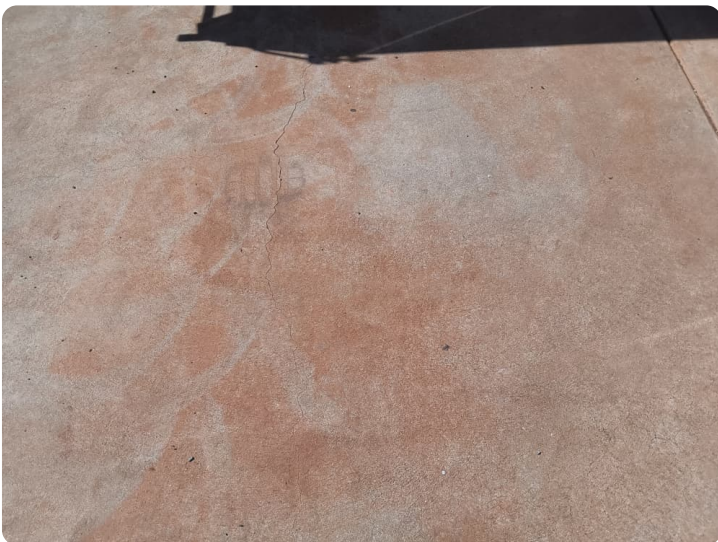
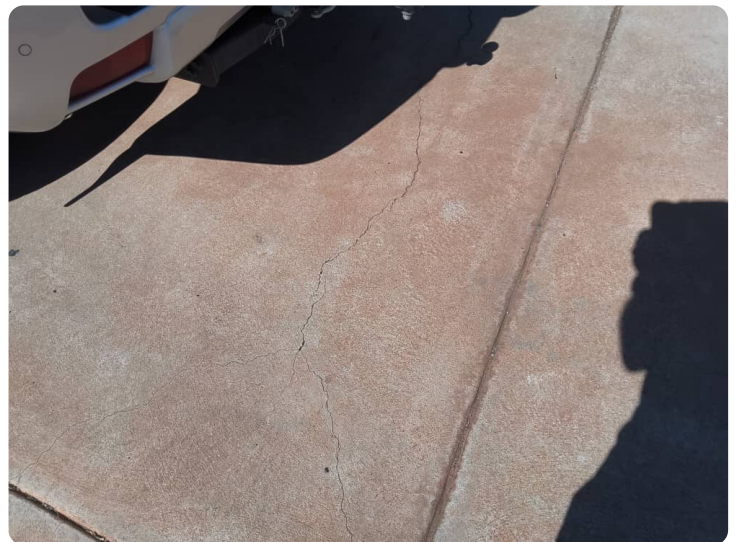
### 21.1 Concrete cracking - minor

Cracking was noted to the concrete driveway. This is not of a structural concern. Cracks should be filled to avoid further deterioration.

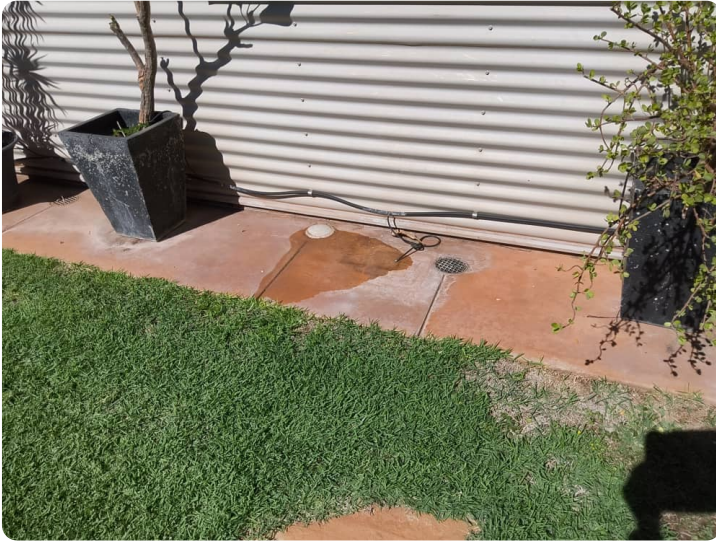
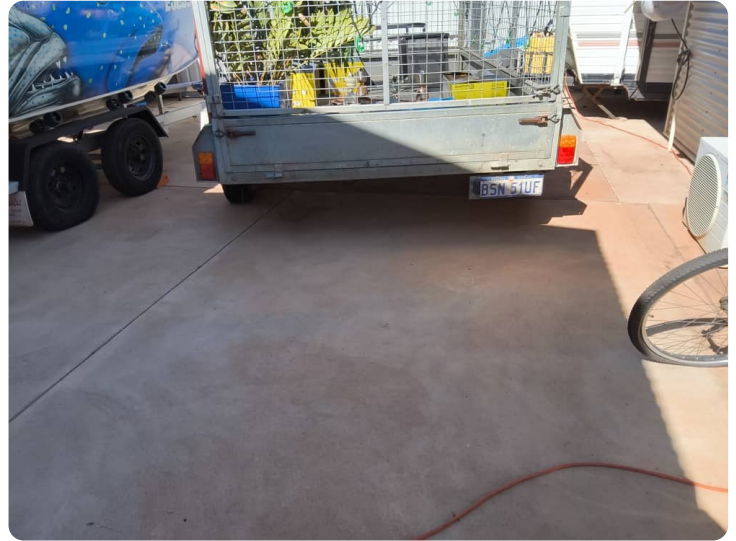
## 22. External walkways and paved areas

The external walkways and paved areas are constructed of concrete. The condition of the external walkways and paved areas is satisfactory in relation to its age and will require normal ongoing maintenance.

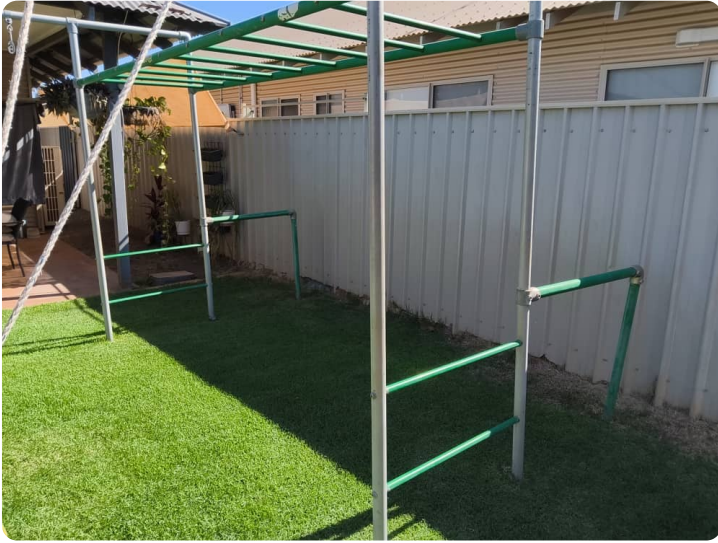
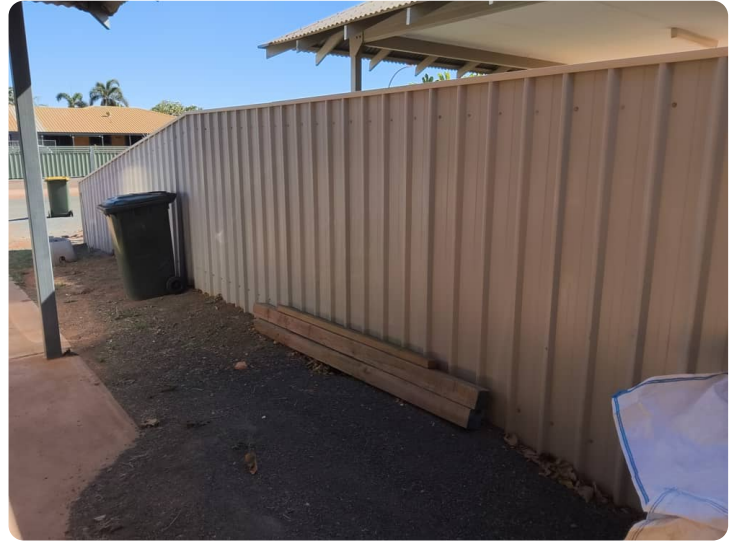
### 23. Fences - boundary

The boundary fences are constructed of metal. The condition of the boundary fence is satisfactory in relation to its age and will require normal ongoing maintenance. Some of the fences could not be viewed due to vegetation, stored items or secondary structures.

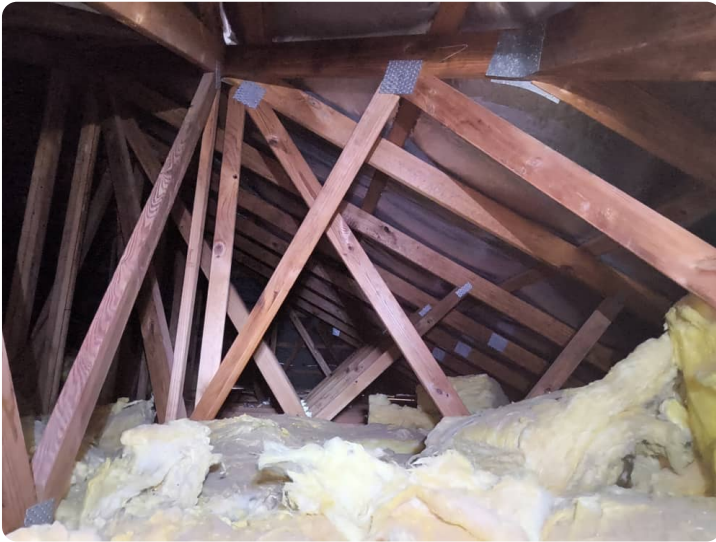
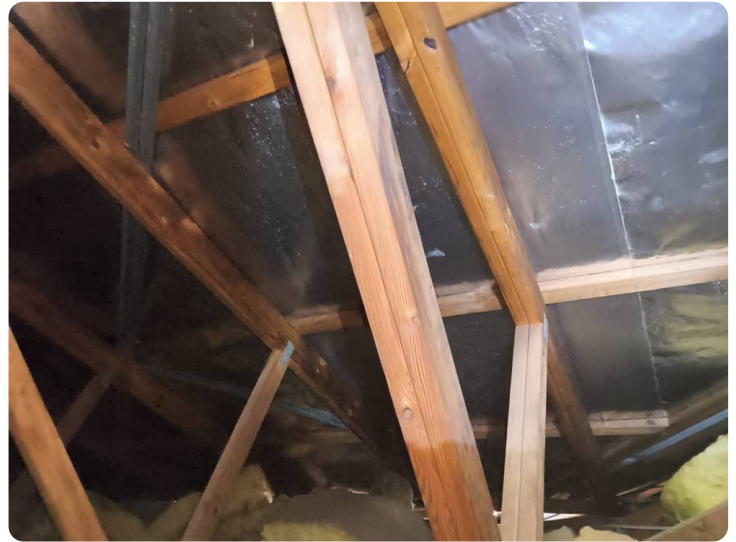
## 24. Under side of roof cover

The condition of the underside of the roof cover could not be determined as sarking had been installed.

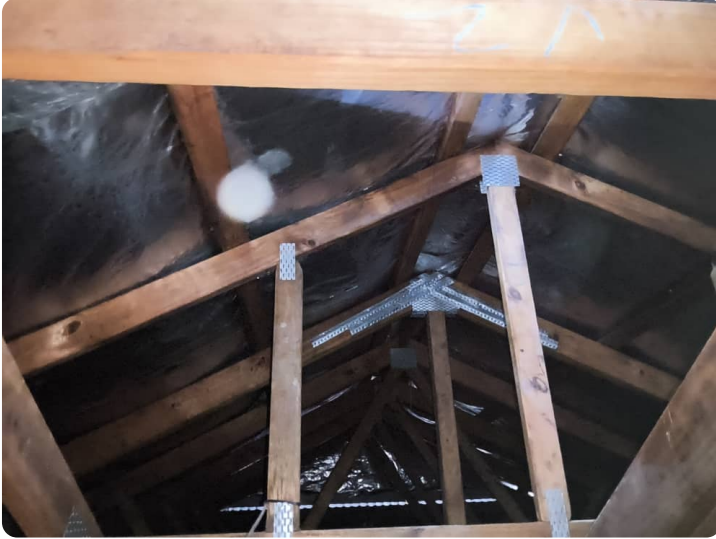
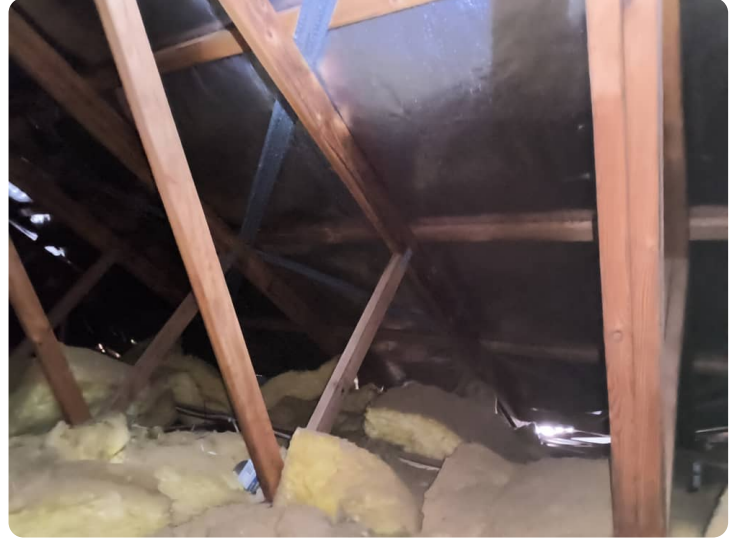
## 25. Sarking

Sarking to the underside of the roof was installed and was considered effective.
