# **Houspect**

### **Pre purchase inspection**

**Job ID:** 92810

**Address:** 1 Straker Rd, Millars Well WA 6714

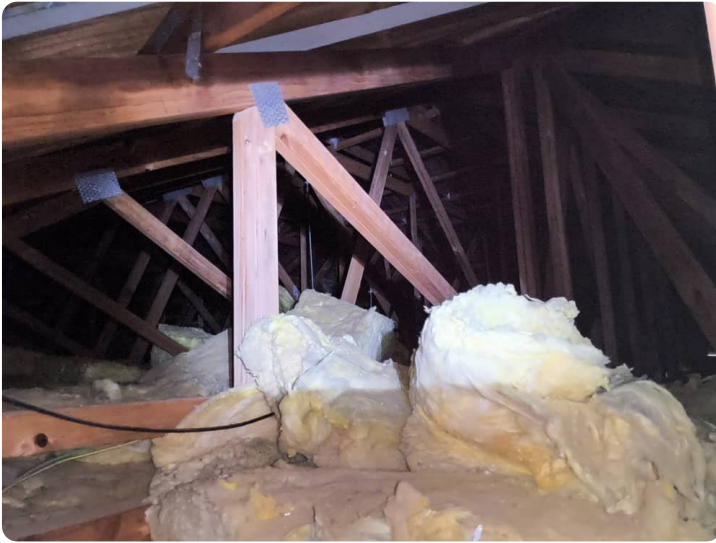
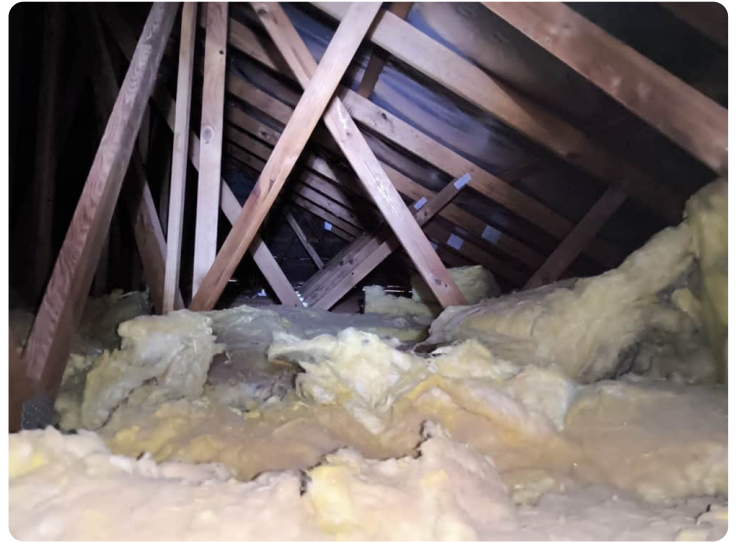
## 26. Roof frame

The roof frame type is a timber truss. The condition of the roof frame is satisfactory in relation to its age and will require normal ongoing maintenance. Access to the roof space was restricted by the pitch of the roof, insulation, ducting or other items. The inspector estimates that visibility was available to more than 75% of the area.

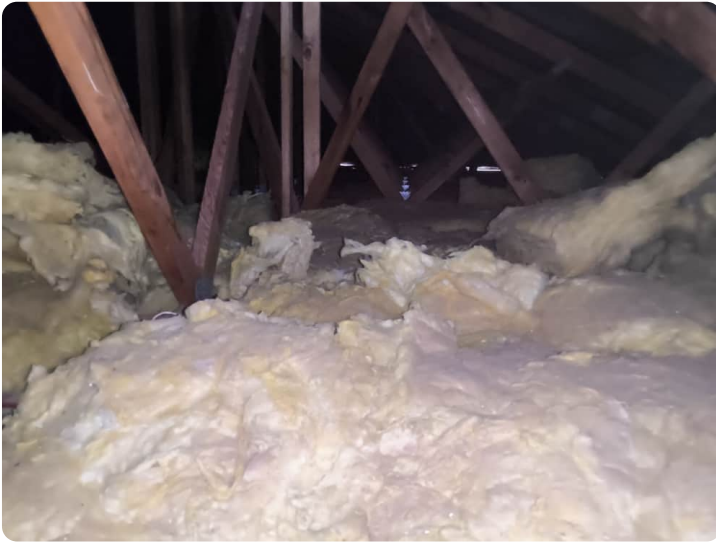
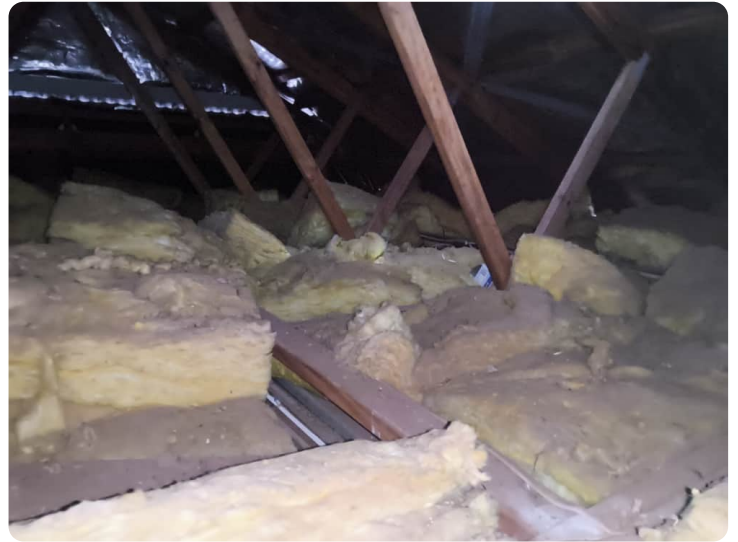
## 27. Insulation

Insulation was installed. Where insulation was installed it was considered effective. The insulation type was predominately batt or rolled type insulation.

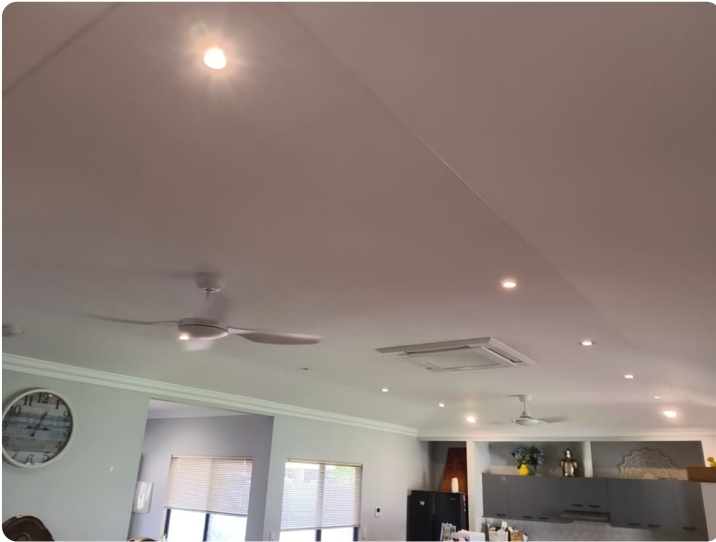
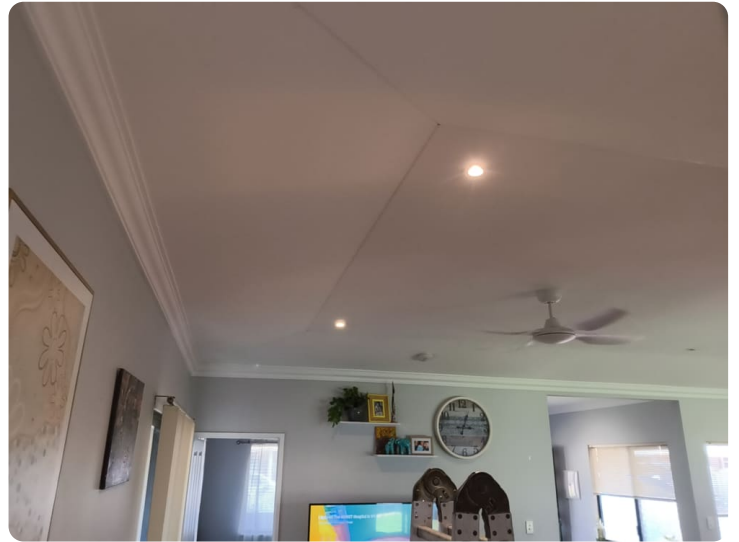
## 28. Ceilings

The ceilings are constructed of plasterboard with cornices constructed of plasterboard. The condition of the ceilings is satisfactory in relation to its age and will require normal ongoing maintenance.

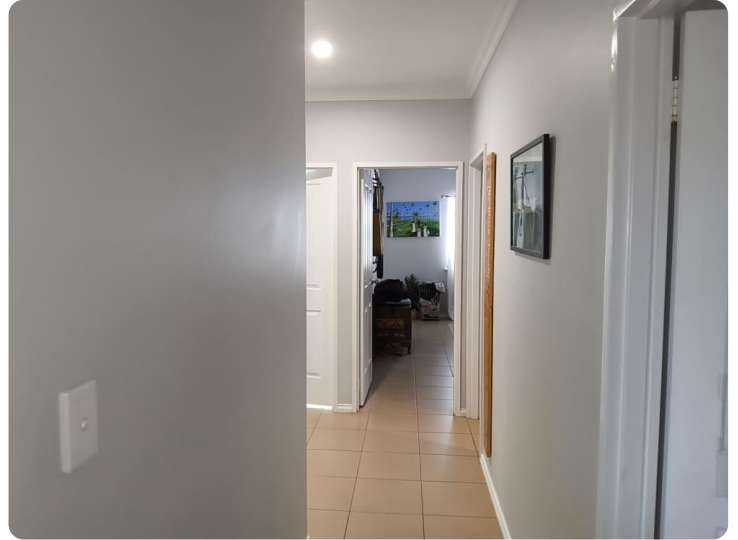
## 29. Internal walls

The internal walls are constructed of a frame with plaster board cladding. The condition of the internal walls is satisfactory in relation to its age and will require normal ongoing maintenance.

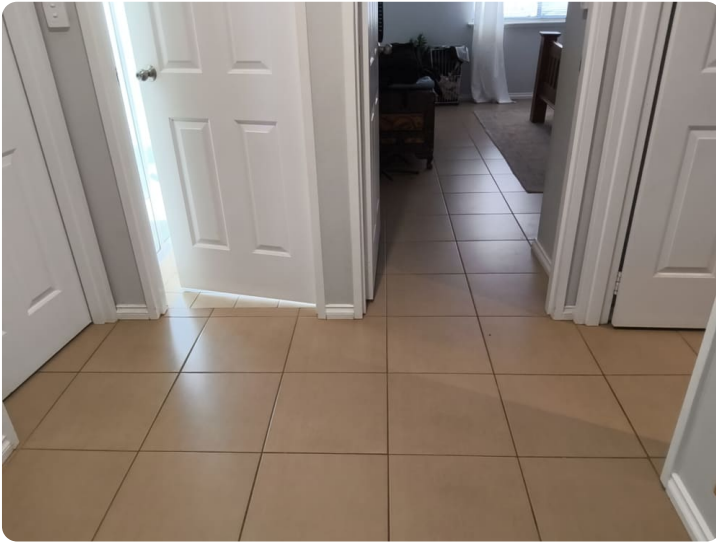
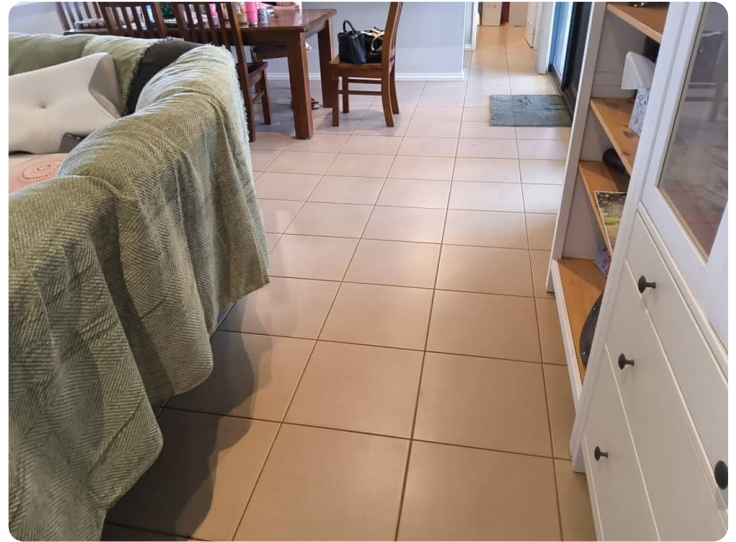
### 30. Internal floors

The internal floors are constructed of concrete and are covered in ceramic tiles. The condition of the internal floors is unable to be determined as they could not be seen due to coverings.

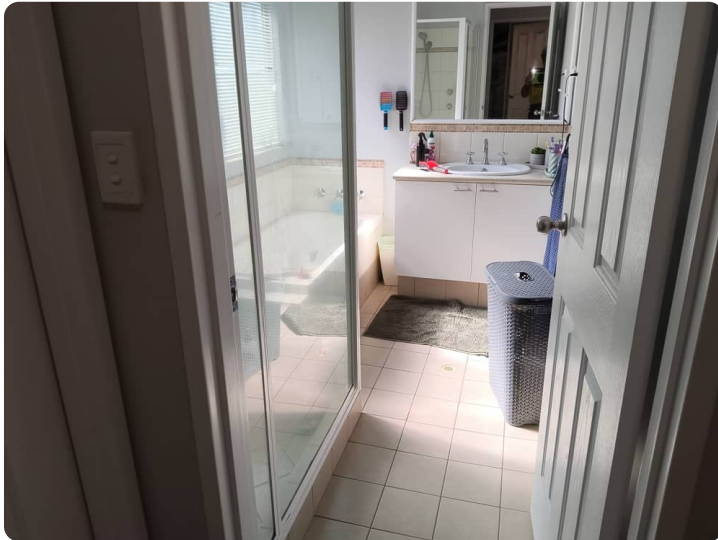
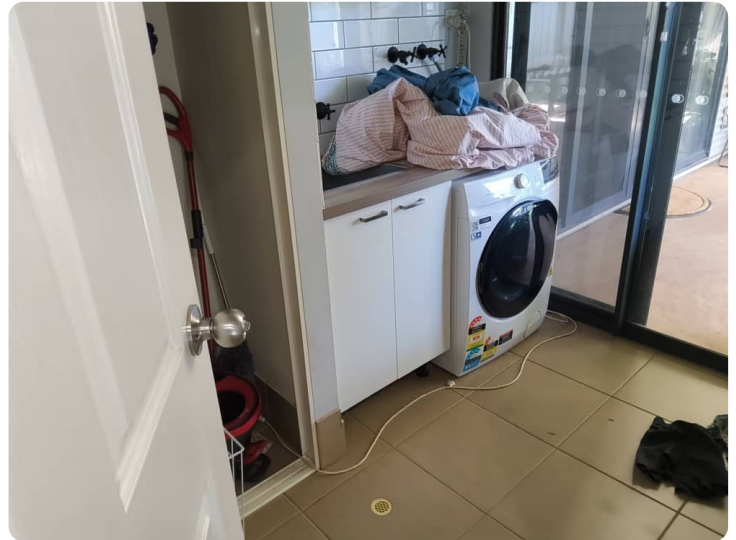
### 31. Tiled floors and walls

There are areas of internal floors and walls which are covered with a tile covering. The condition of the tiles is satisfactory in relation to its age and will require normal ongoing maintenance.

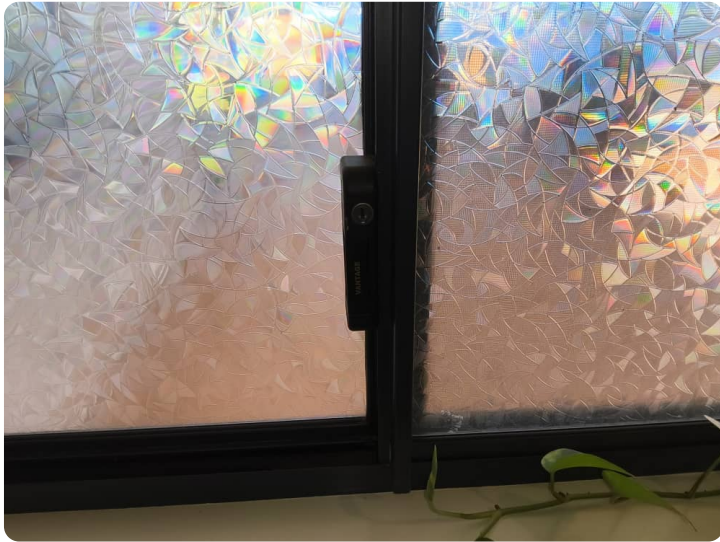
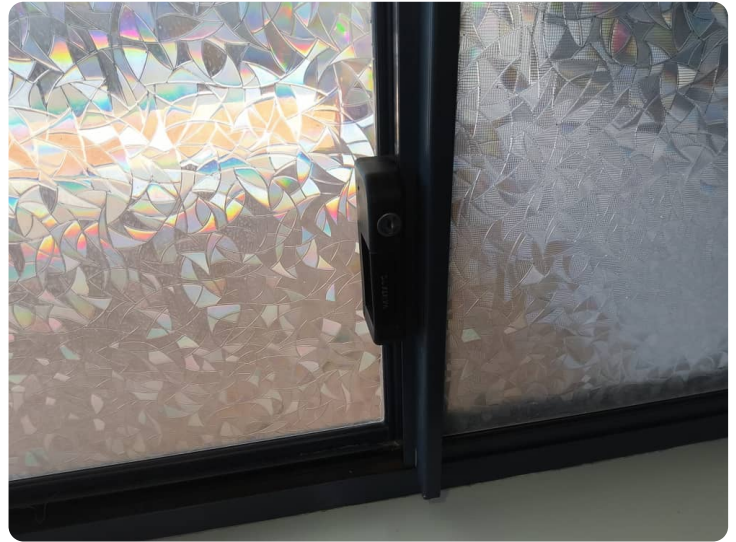
### 32. Windows (internal)

The condition of the windows, as viewed from within the property, is satisfactory in relation to its age and will require normal ongoing maintenance. Window locks have been installed to all of the windows.

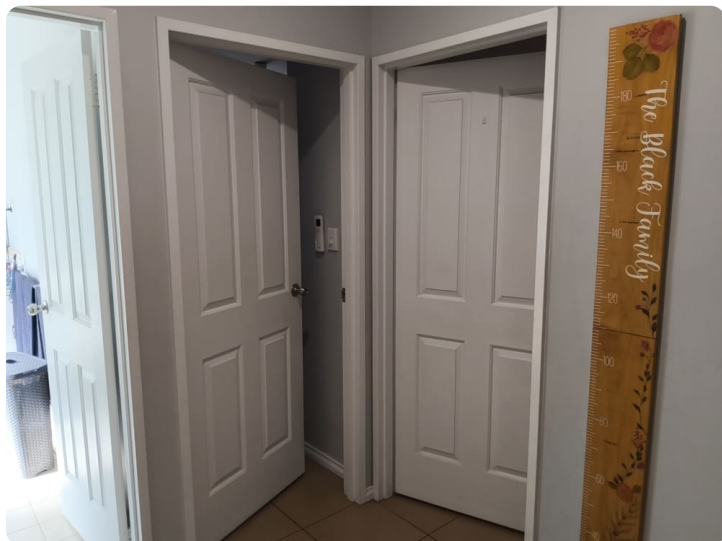
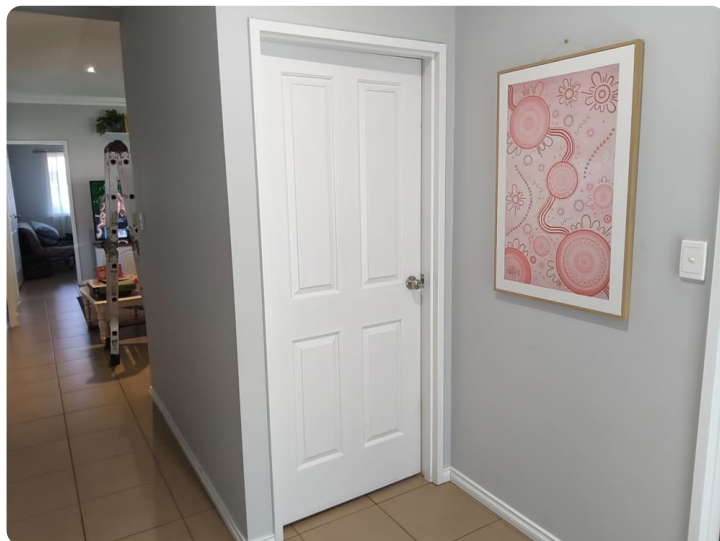
### 33. Internal doors

The internal doors were mainly constructed of timber hollow core. The condition of the internal doors is satisfactory in relation to its age and will require normal ongoing maintenance.

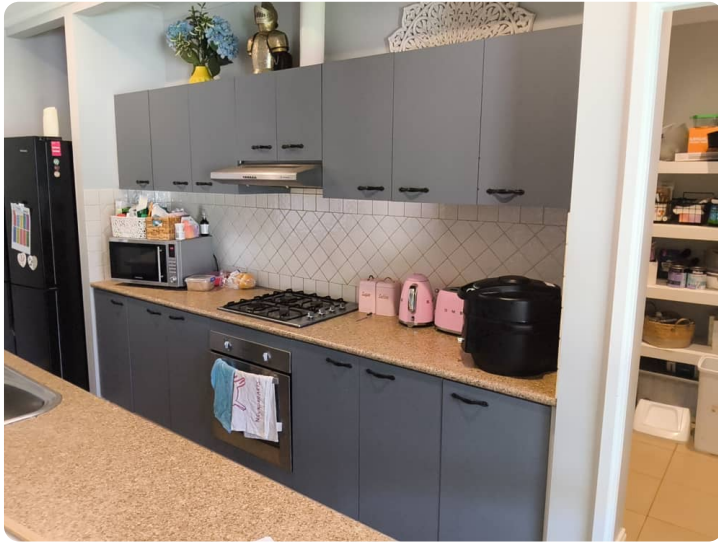
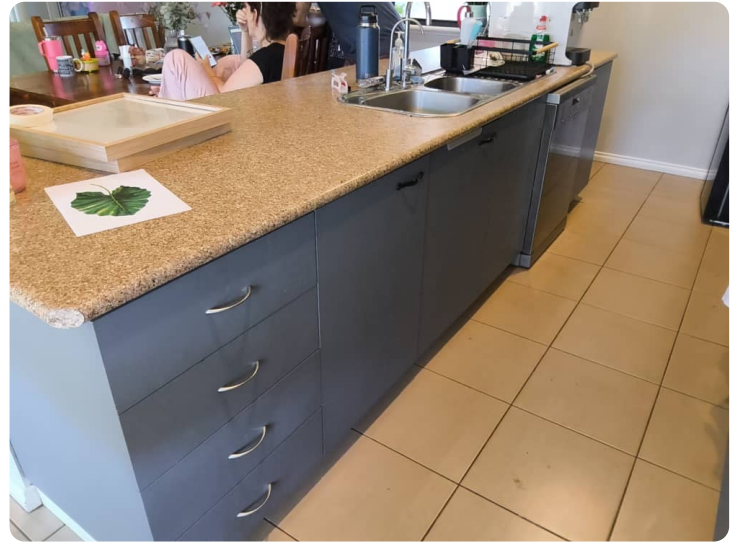
### 34. Kitchen cabinets

The condition of the kitchen cabinets in general is satisfactory in relation to their age and require normal maintenance.

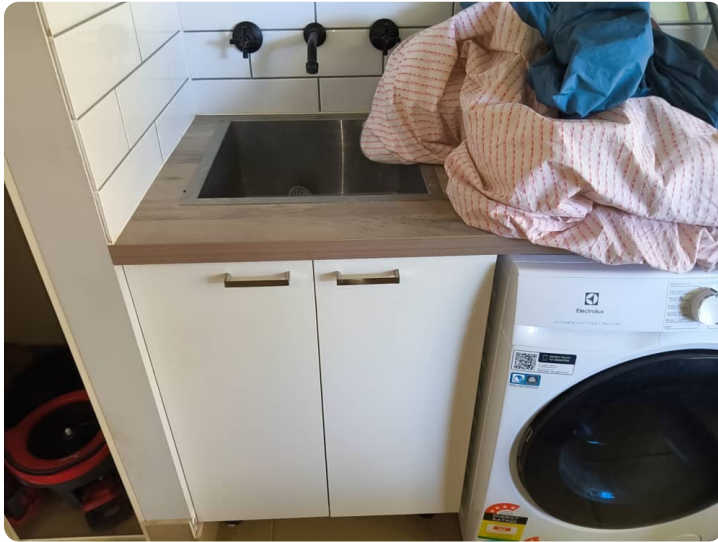
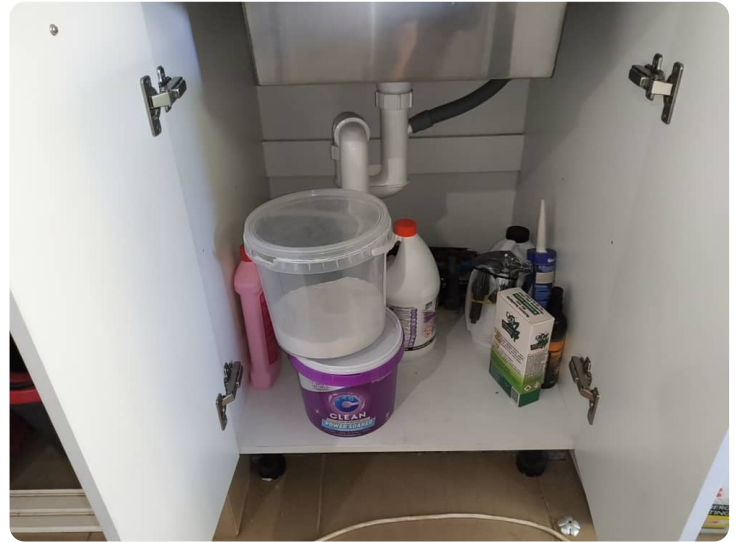
### 35. Laundry cabinets

The condition of the laundry cabinets is satisfactory in relation to their age and require normal maintenance.

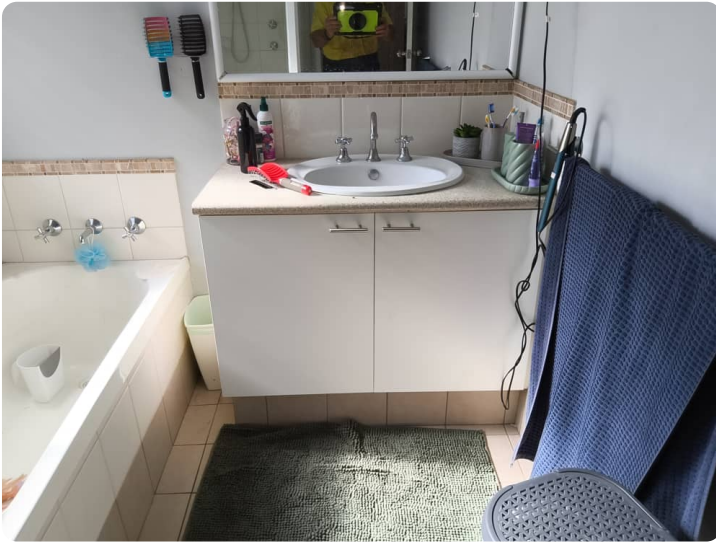
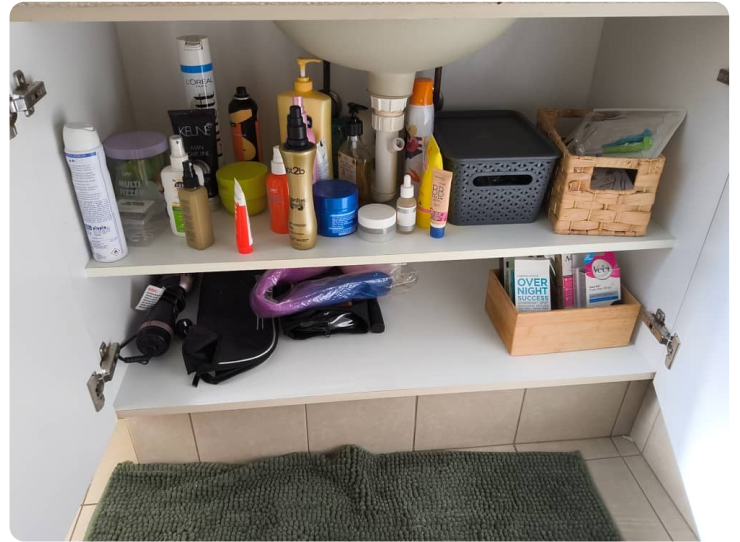
### 36. Bathroom cabinets

The condition of the bathroom cabinets is satisfactory in relation to their age and require normal maintenance.

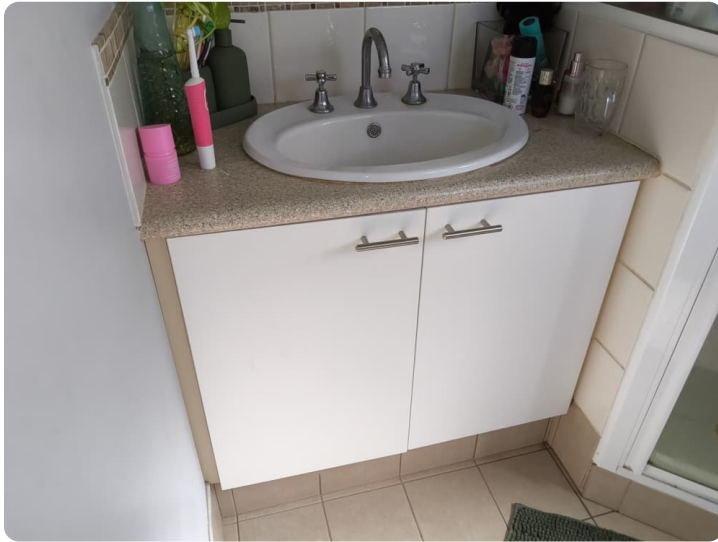
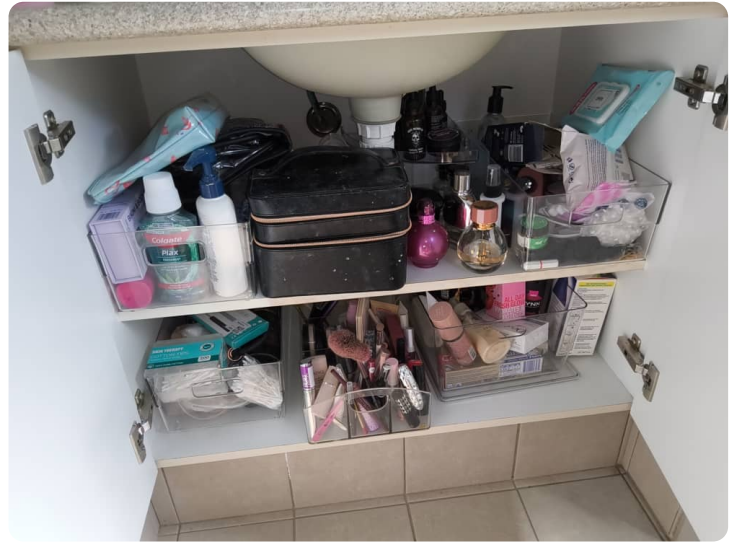
### 37. Ensuite cabinets

The condition of the ensuite cabinets is satisfactory in relation to their age and require normal maintenance.

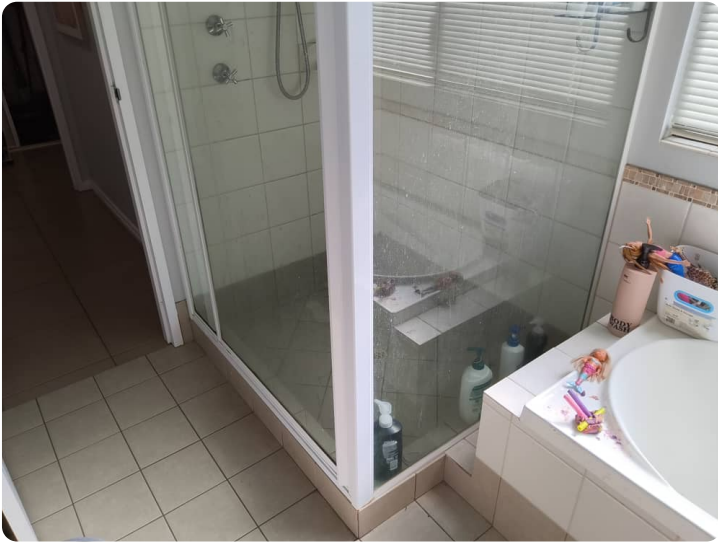
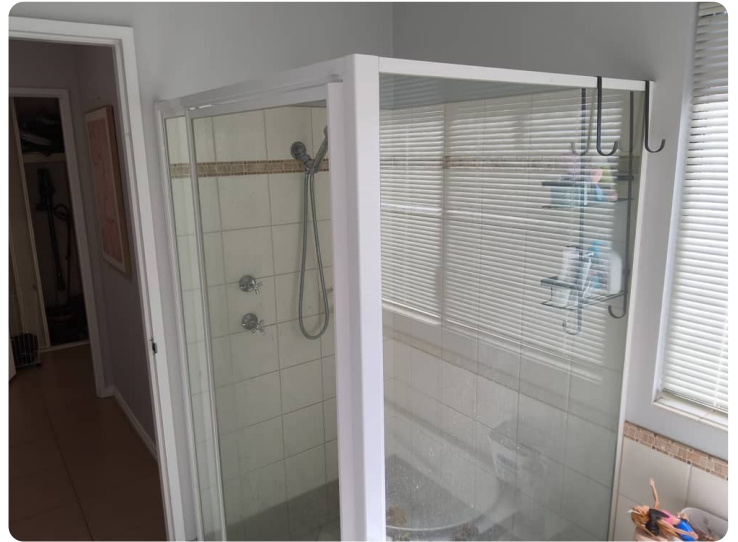
### 38. Shower screens

The condition of the shower screens is satisfactory in relation to their age and require normal maintenance.

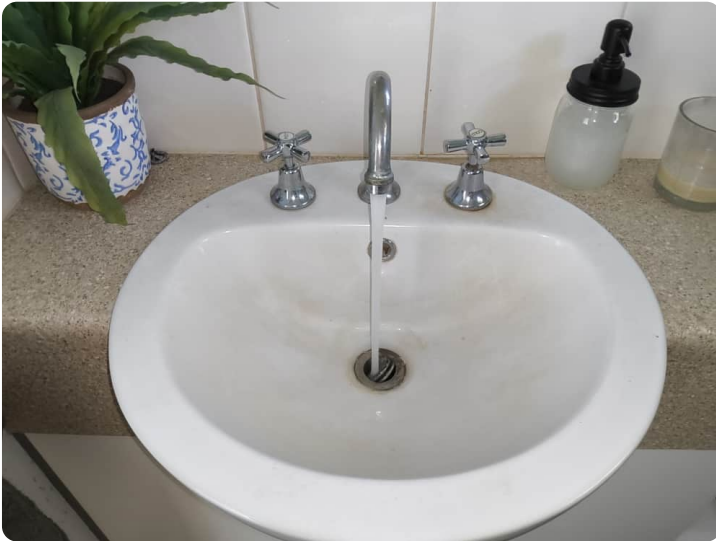
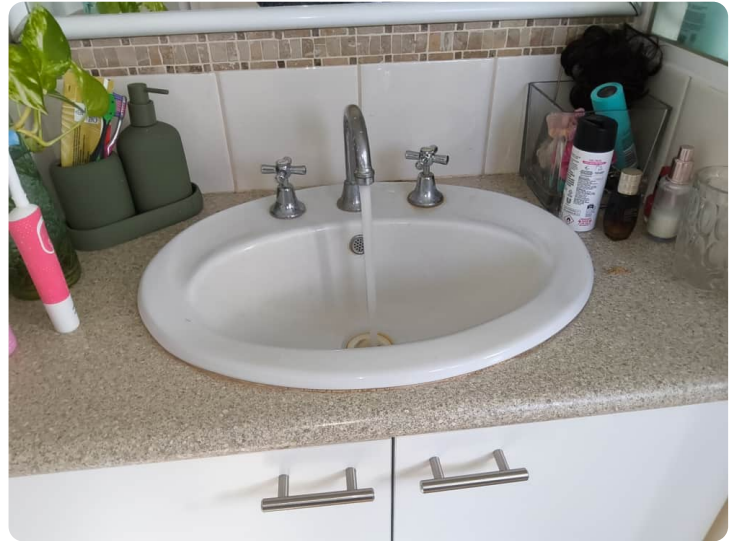
### 39. Plumbing

The taps to multiple areas were turned on and the water flow appeared to be reasonable. Water draining to several sinks and toilets appeared to be reasonable. The Building Inspector is not a Plumbing Contractor and is not permitted to test Plumbing items under WA Law. Where appropriate a Plumbing Contractor should be engaged to test the plumbing in the property.

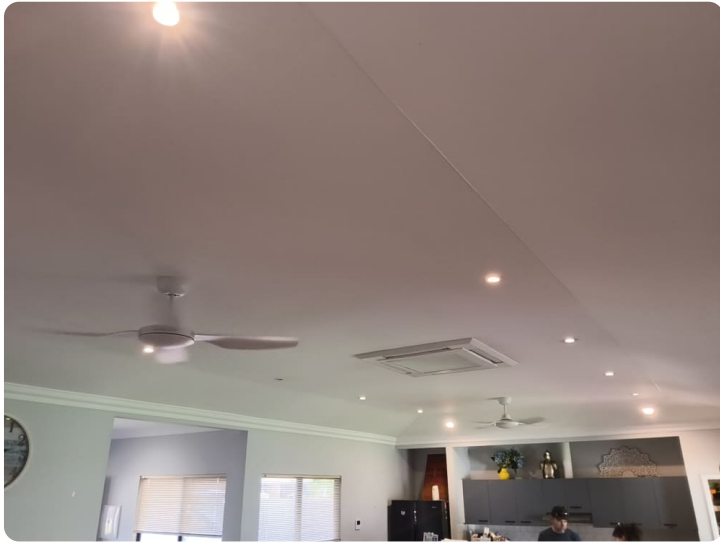
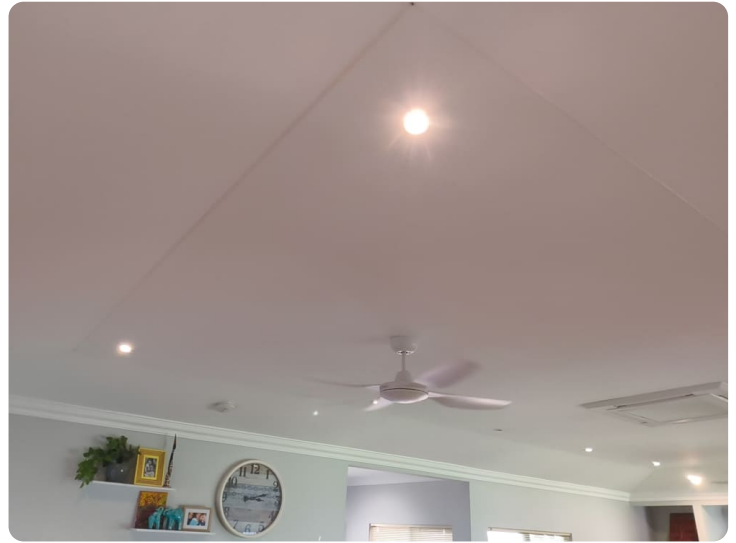
#### 40. Lights and power points

Several lights were turned on during the inspection and the lights appeared to be operational. The Building Inspector is not an Electrical Contractor and is not permitted to test Electrical items under WA Law. Where appropriate an Electrical Contractor should be engaged to test the electrical items in the property.

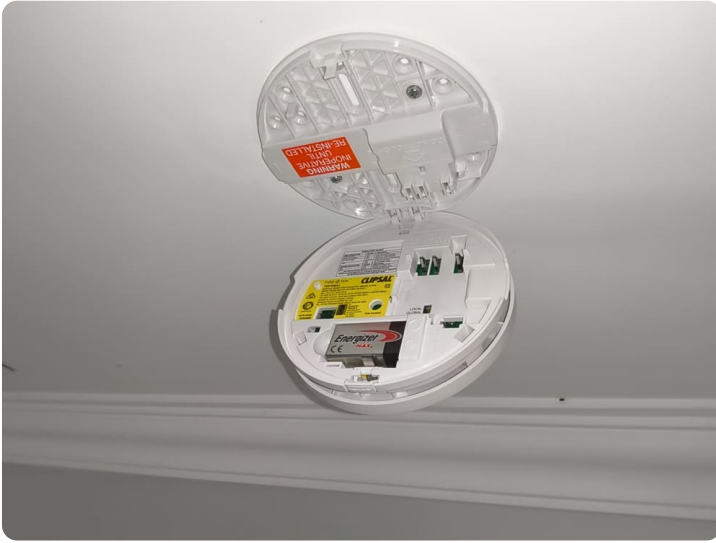
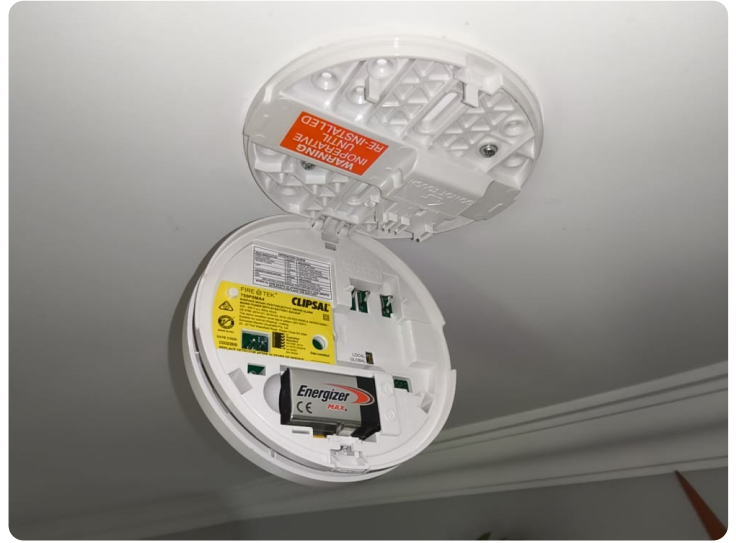
#### 41. Smoke Alarms

There were two hardwired smoke alarms on site. There were no battery smoke alarms on site. The location, number and type of smoke alarms appeared to be consistent with Legislative requirements. It is suggested that an Electrical Compliance Certificate be obtained in relation to the smoke alarms.
