KARRATHA BUILDING INSPECTIONS

# Pre-Purchase Building Inspection Report

In accordance with AS 4349.1 - 2007

8B Comrie Court Baynton 6714 Western Australia Australia

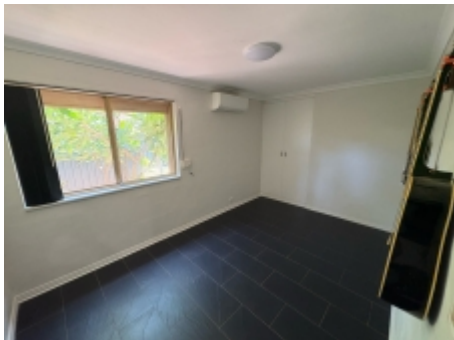
Bed 4

Defect Severity	Minor Defect
Defect Classification	A - Damage
Defective Item	Ceilings
Defect	Surface Defects
Comment	Inconsistencies in paint and finishes, signs of peeling or flaking, or surface damage.

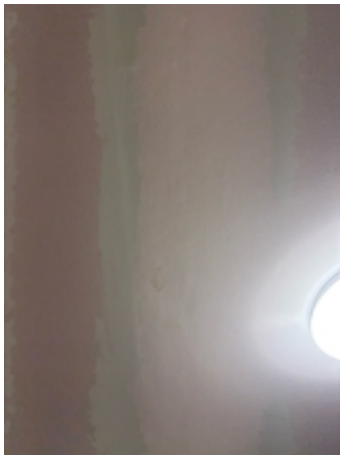
Bed 3

Defect Severity	Minor Defect
Defect Classification	C - Water Penetration, Damp Related
Defective Item	Ceilings
Defect	Minor Water Damage
Comment	Visible signs of minor water damage to ceiling, indicating possible leaks or condensation

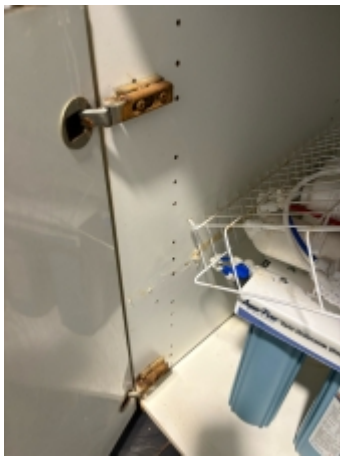
Defect Severity	Minor Defect
Defect Classification	D - Material deterioration (rusting, rotting, corrosion, decay)
Defective Item	Kitchen Cupboards
Defect	Visible Damage
Comment	Visible signs of corrosion and rust to cupboard hinges

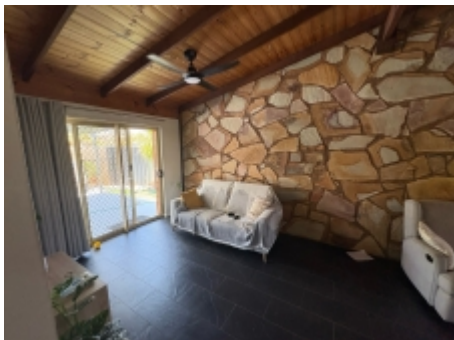
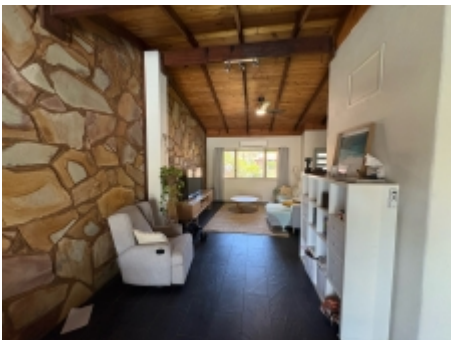
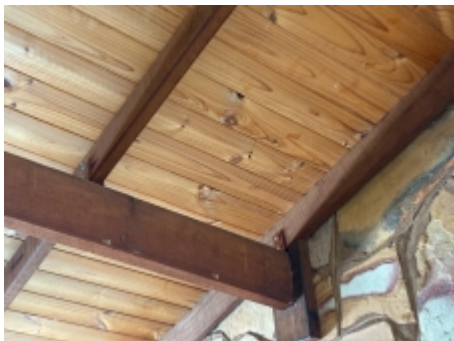
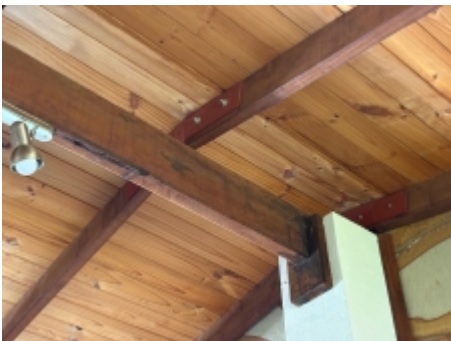
## Lounge

Comments	Raked ceilings with sufficient brackets and bolts in good order to rafters. No defects to note
----------	--

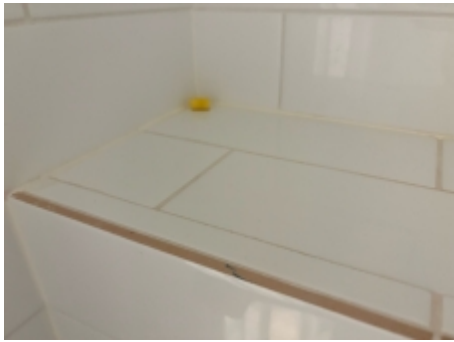
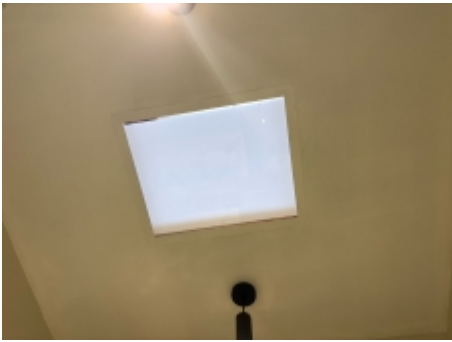
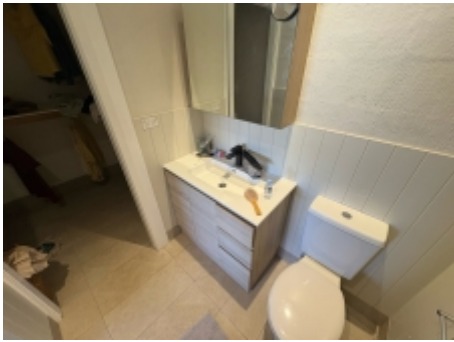
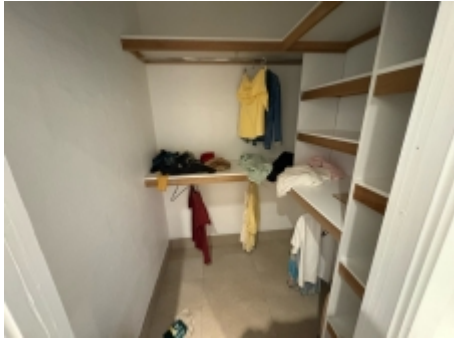
**Ensuite**

Comments	Renovated ensuite with no defects to note at time of inspection.
----------	--

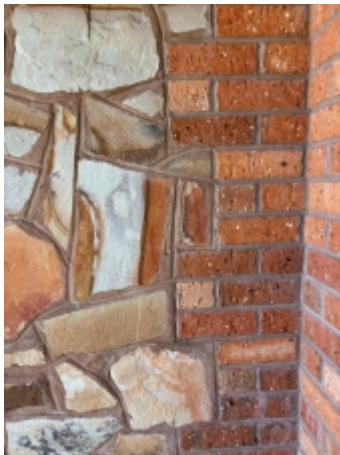
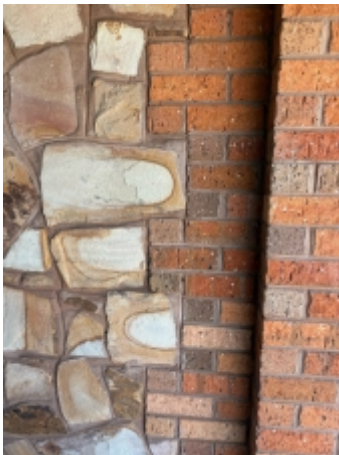
Front Elevation

Defect Severity	Minor Defect
Defect Classification	B - Distortion, Warping, Twisting
Defective Item	Walls
Defect	Cracks to stone

Comment	Signs of cracks or damage observed in the exterior walls, no affecting structural integrity
---------	---

Property has had improvements completed to acceptable standard. Roof repairs are bandaied fixes and not a permanent solution to roof leaks. Minor cracking to karratha stone evident however deemed minor as this is not a structural component of the home.

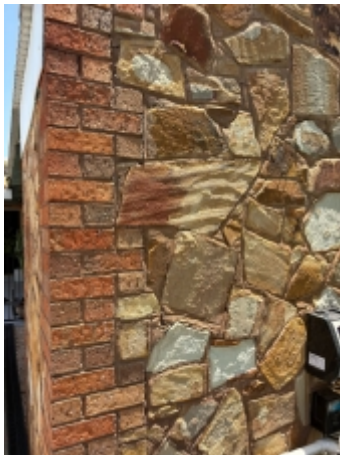
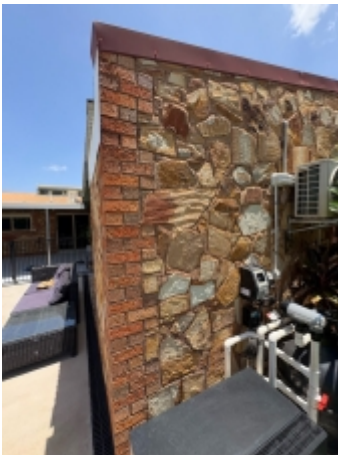
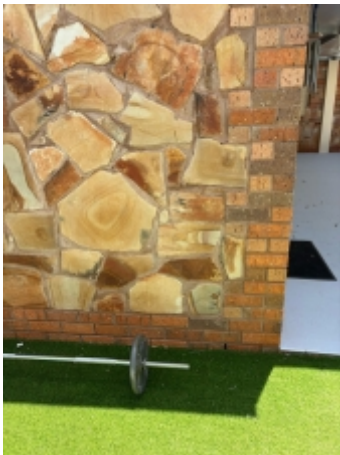
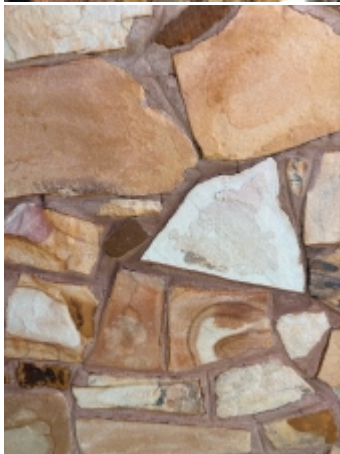
Rear Elevation

Defect Severity	Minor Defect
Defect Classification	B - Distortion, Warping, Twisting
Defective Item	Walls
Defect	Cracks

Comment	Signs of cracks observed in the exterior walls, not affecting their structural integrity and overall performance.
---------	---

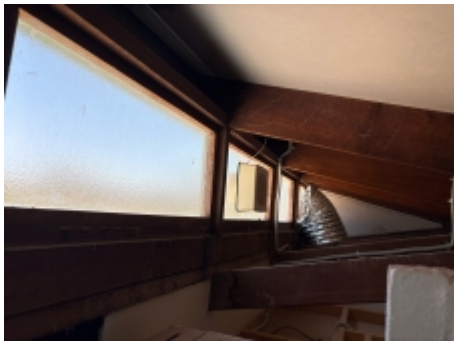
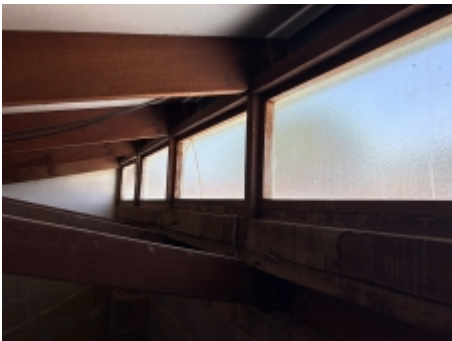
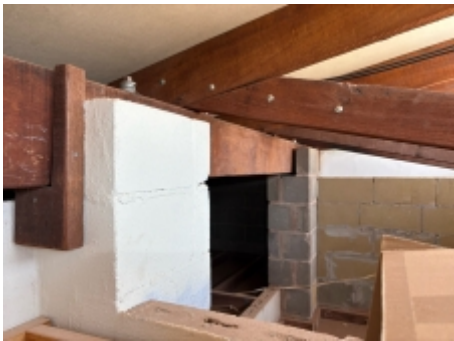
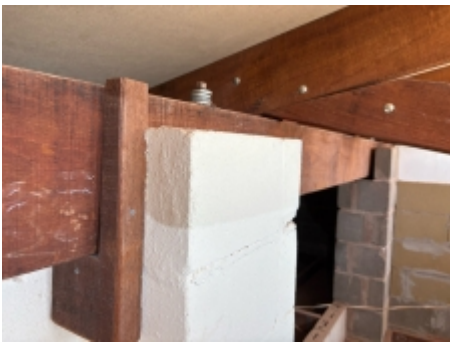
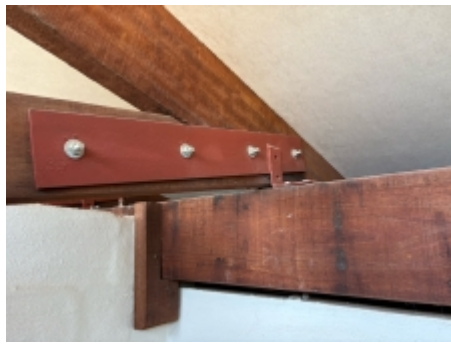
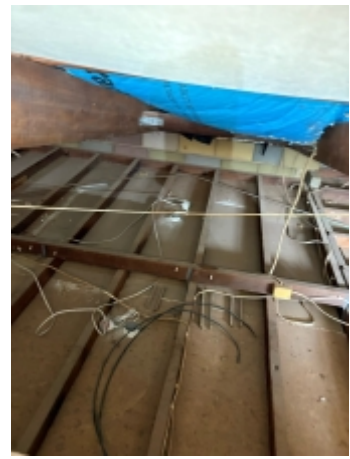
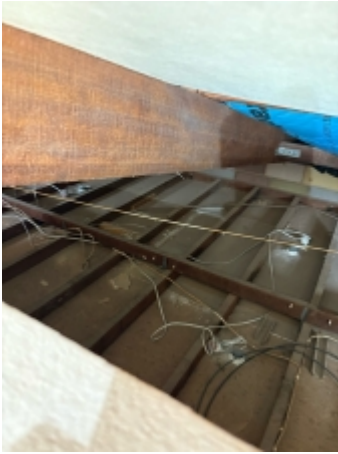
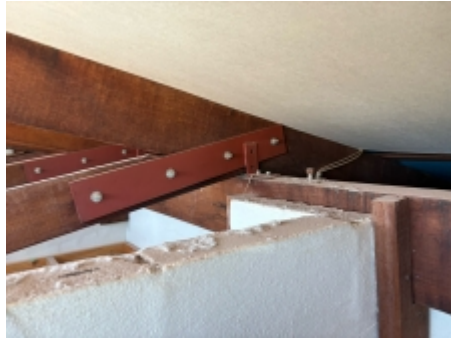
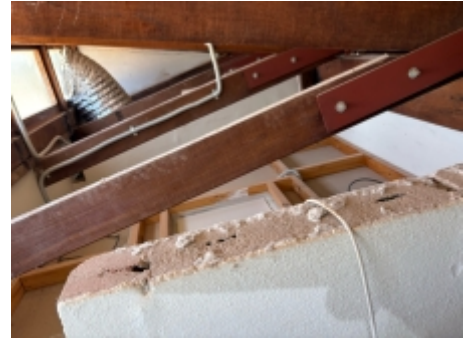
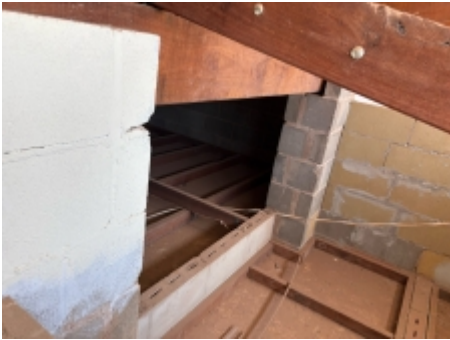
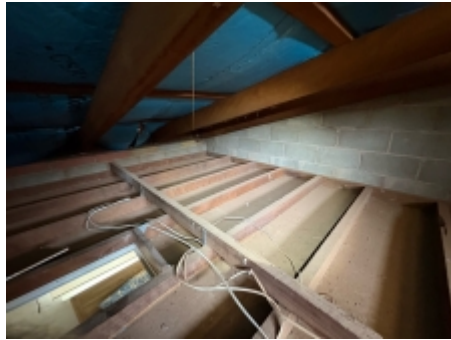
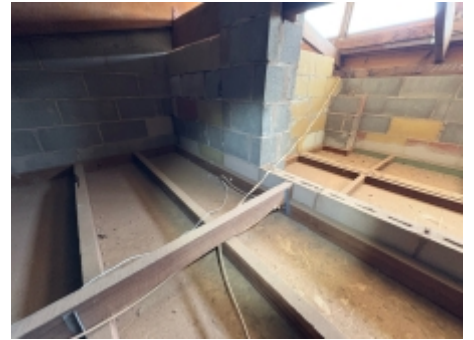
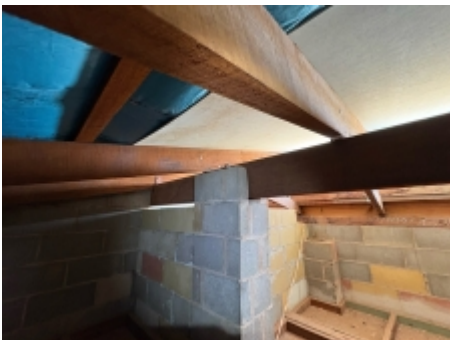
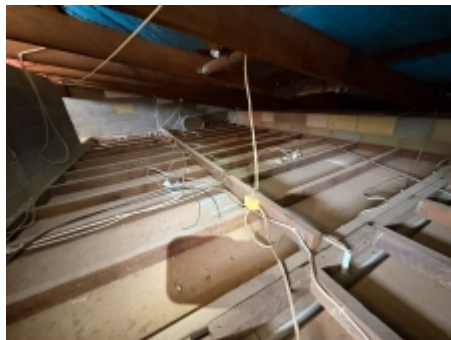
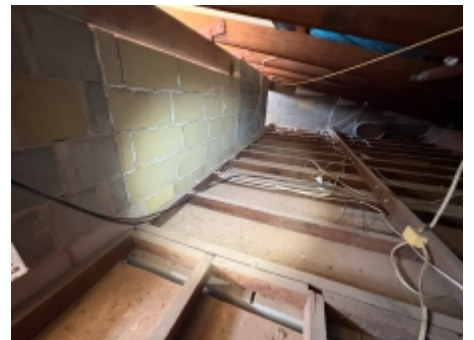
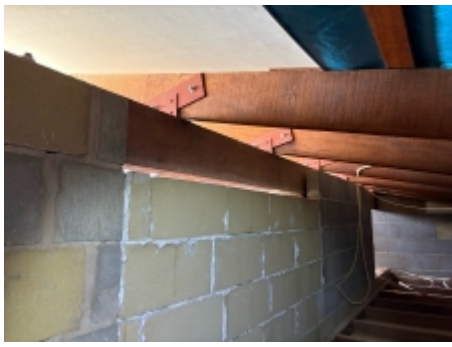
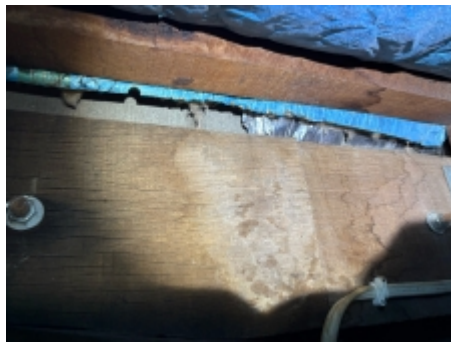
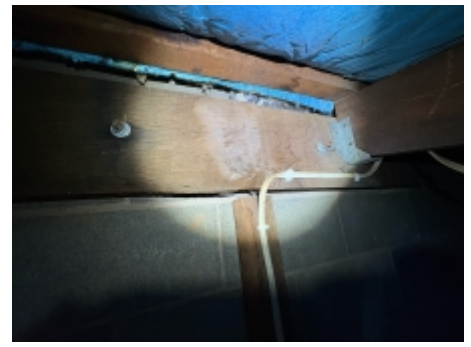
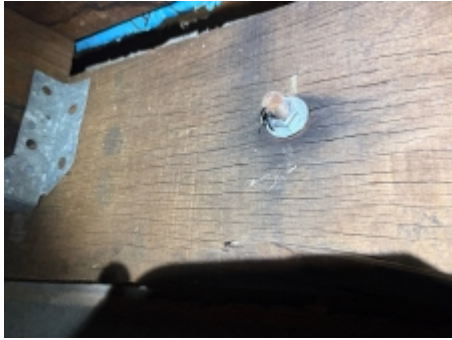
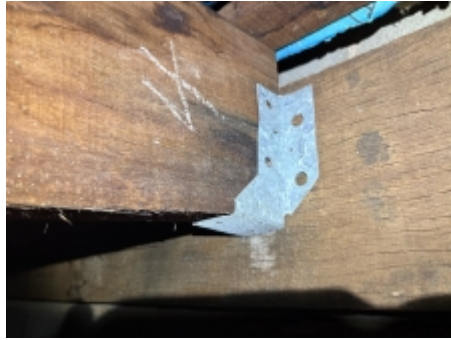
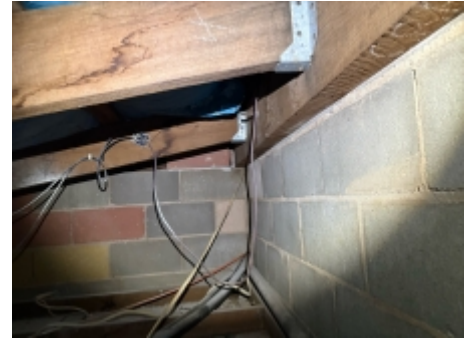
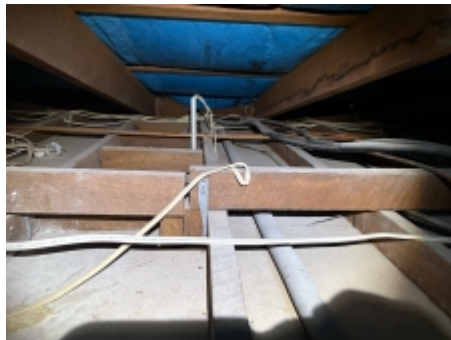
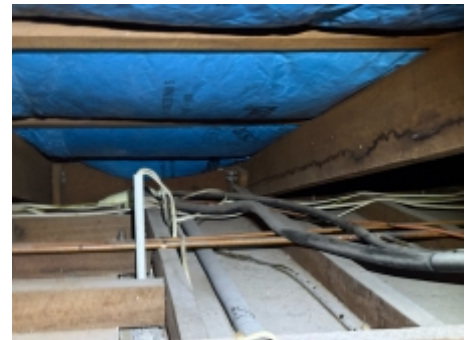
Roof Space

No defects found in the roof space at the time of the inspection

Timber stick roof with insulation beneath roof sheeting. No insulation to top of ceilings reducing overall insulation values of home. Sufficient tie down straps, bolts and brackets installed and no structural defects to note at time of inspection

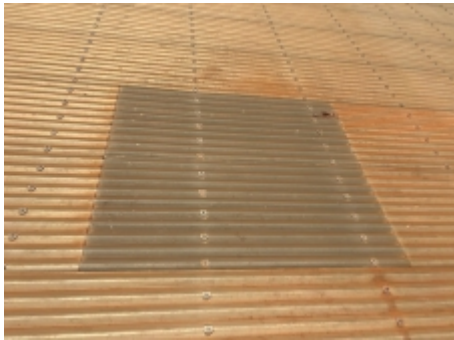
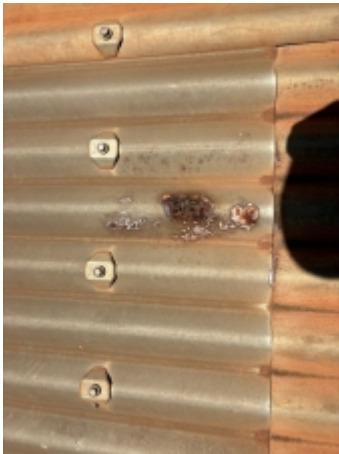
Defect Severity	Minor Defect
Defect Classification	D - Material deterioration (rusting, rotting, corrosion, decay)
Defect	Rusted cover sheets
Comment	Cover sheets installed above master bedroom, rust evident to patch which generally will spread on a steel roof and create leak points

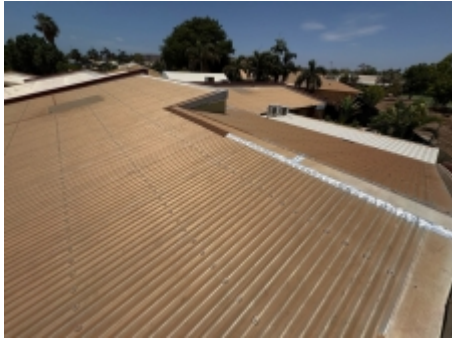
Defect Severity	Minor Defect
Defect Classification	F - Installations (including omissions)
Defective Item	Barges

Defect	Flash Tape
Comment	Significant amounts of flash tape installed across all ridge and barge flashings. Deemed a short term fix or bandage fix that will deteriorated and generate further leaks.

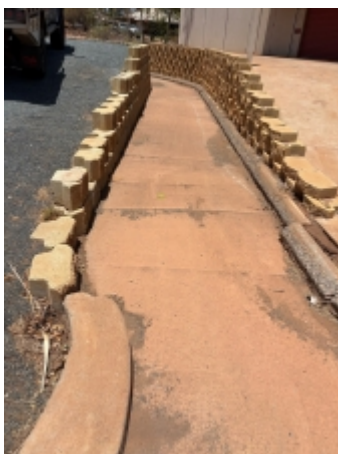
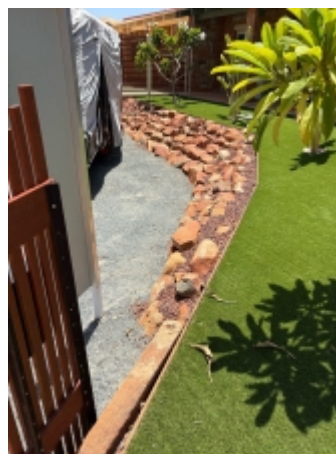
### Retaining Walls

Defect Classification	A - Damage
Defective Item	Retaining Walls
Defect	Leaning or Movement
Comment	Signs of leaning or movement observed in the retaining walls, potentially indicating a failure of the wall or the soil behind it.

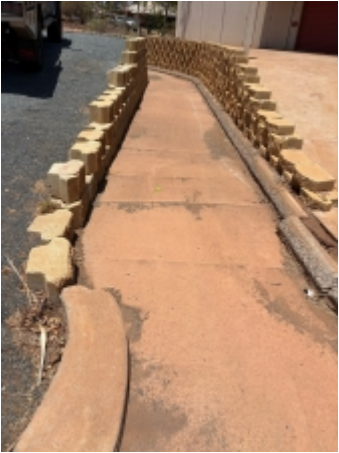
Defect Severity	Minor Defect
-----------------	--------------
