Houspect

Building inspection

Job ID: 91385

Address: 12 Jankurna Street, Baynton WA

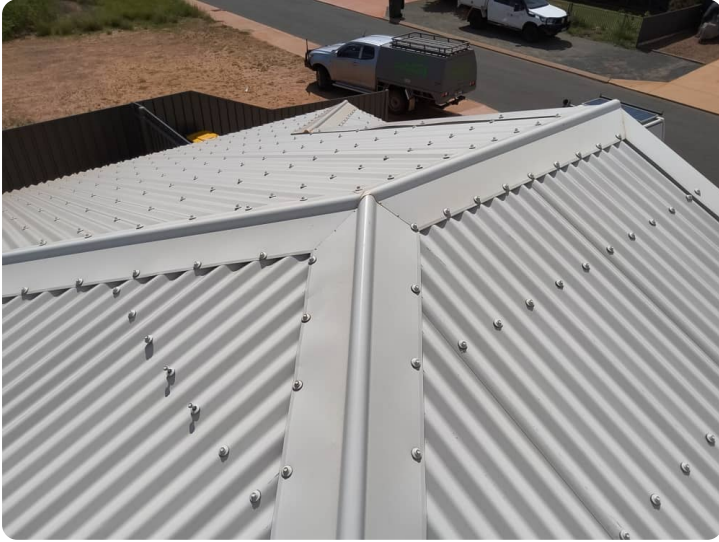
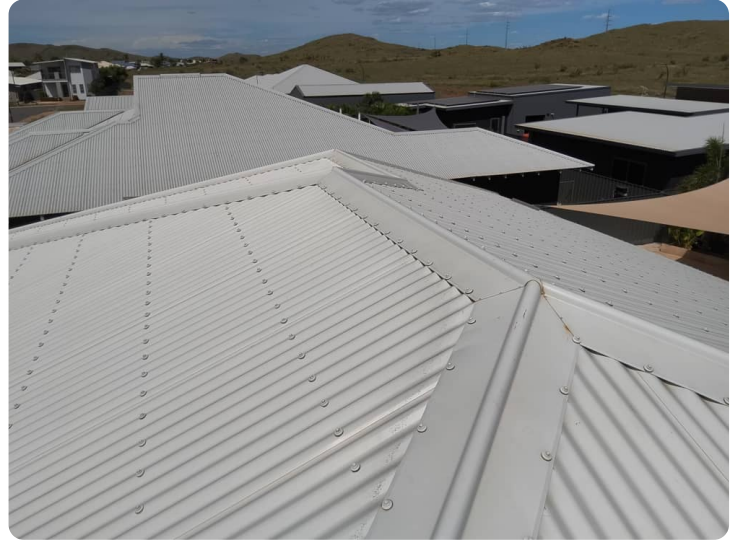
2. Ridges

The ridges and capping are satisfactory in relation to its age and will require normal ongoing maintenance.

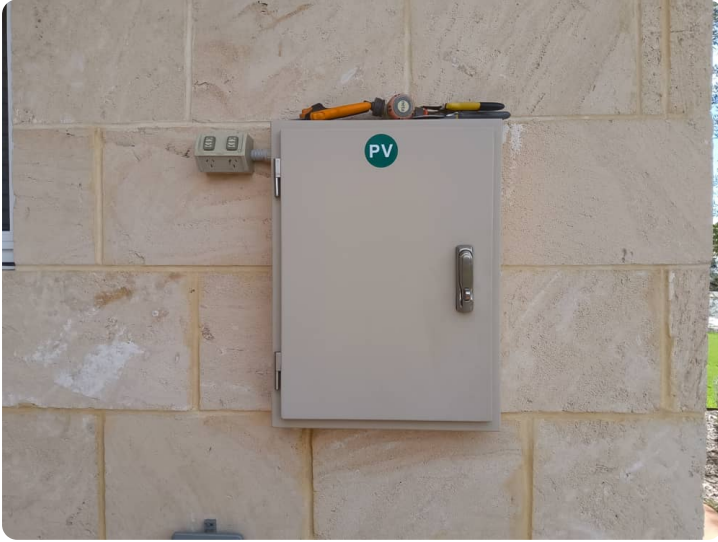
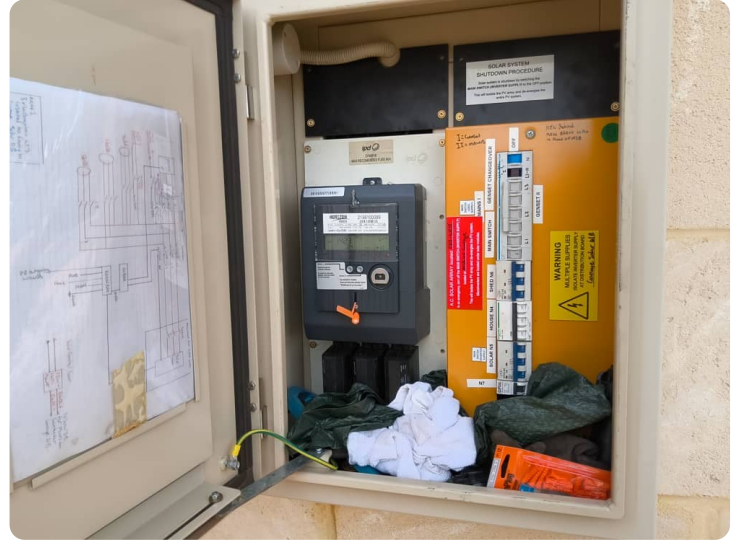
15. Meter box and power

Access to the meter box or sub board was available. The meter box or sub board is lockable. Power phase type to the site is three phase.

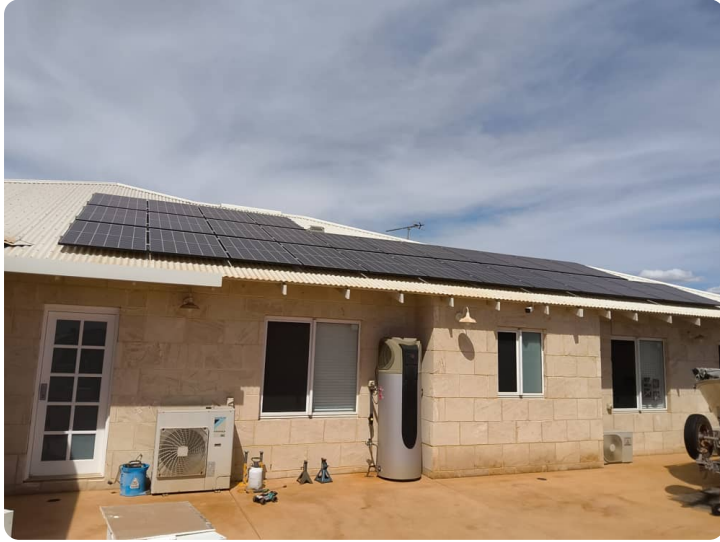
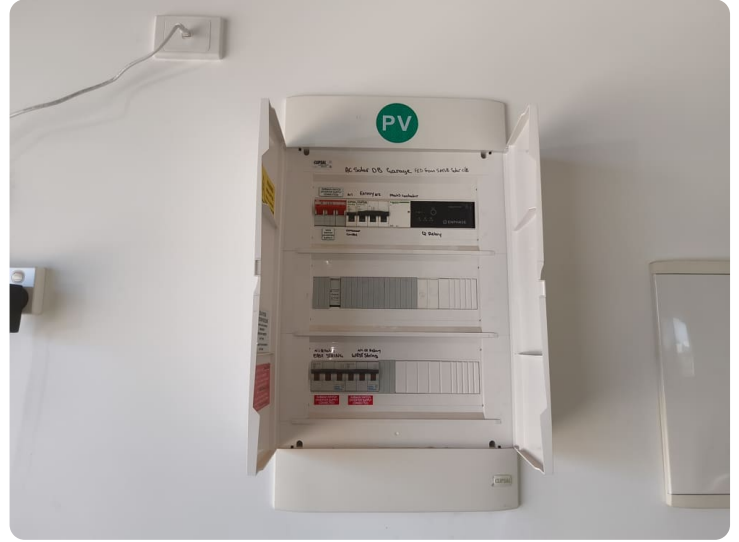
17. Solar photovoltaic panels

Solar photovoltaic panels were installed on the property. It is suggested that a Licenced Electrician review the operation of the solar photovoltaic panels and associated inverter.

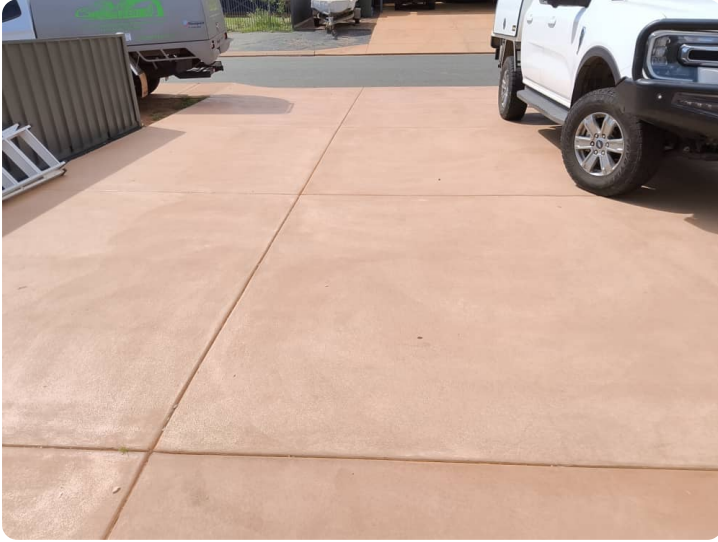
24. Driveway

The driveway and cross over is constructed of concrete. The condition of the driveway is satisfactory in relation to its age and will require normal ongoing maintenance.

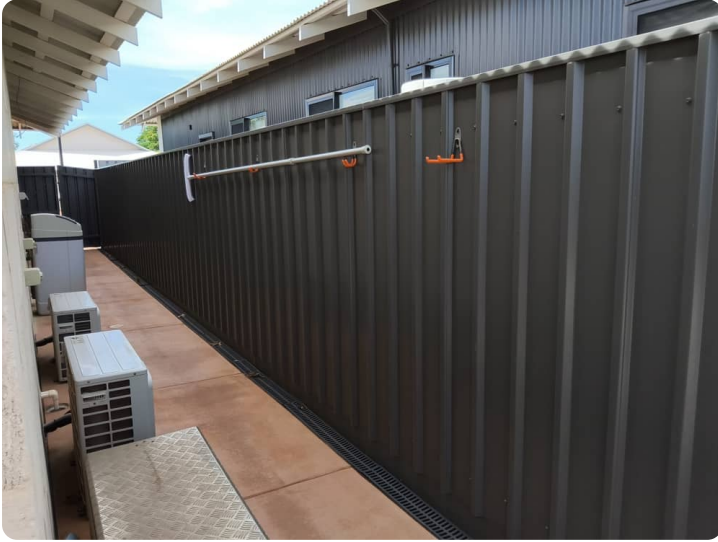
26. Fences - boundary

The boundary fences are constructed of metal. The condition of the boundary fence is satisfactory in relation to its age and will require normal ongoing maintenance.

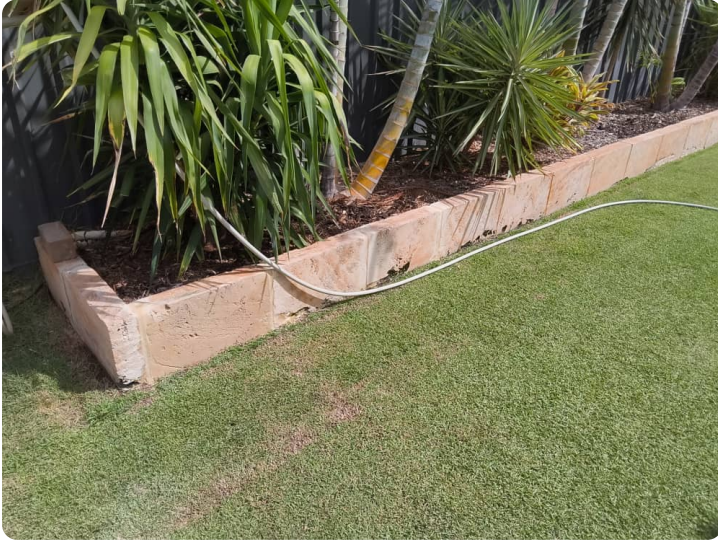
27. Retaining walls

The retaining walls are constructed of limestone or concrete blocks. The condition of the retaining wall is satisfactory in relation to its age and will require normal ongoing maintenance.

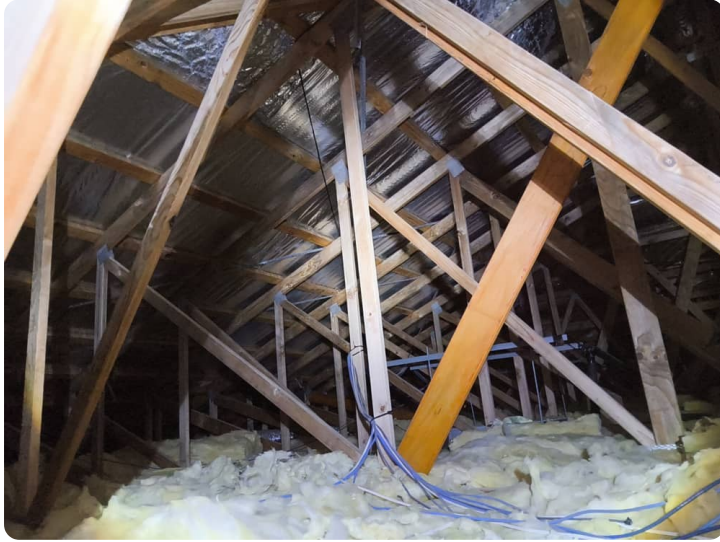
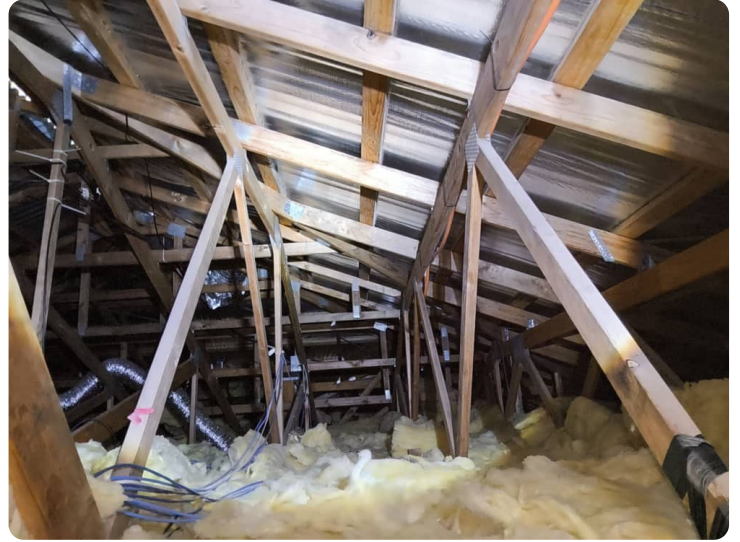
30. Sarking

Sarking to the underside of the roof was installed and was considered effective.

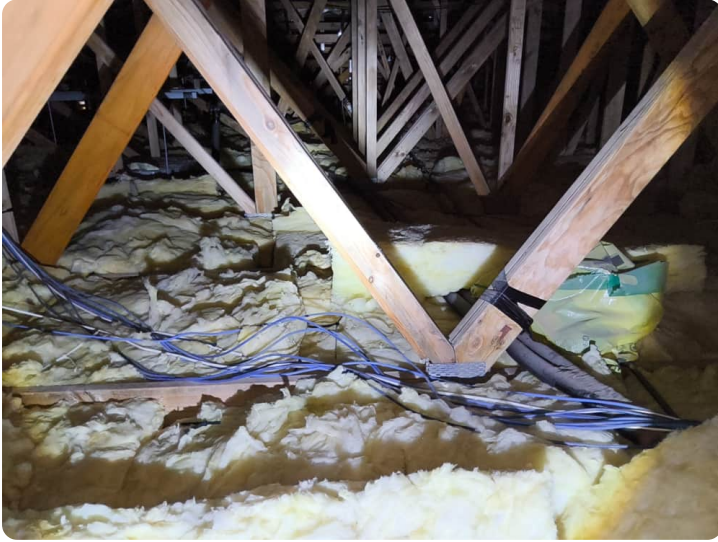
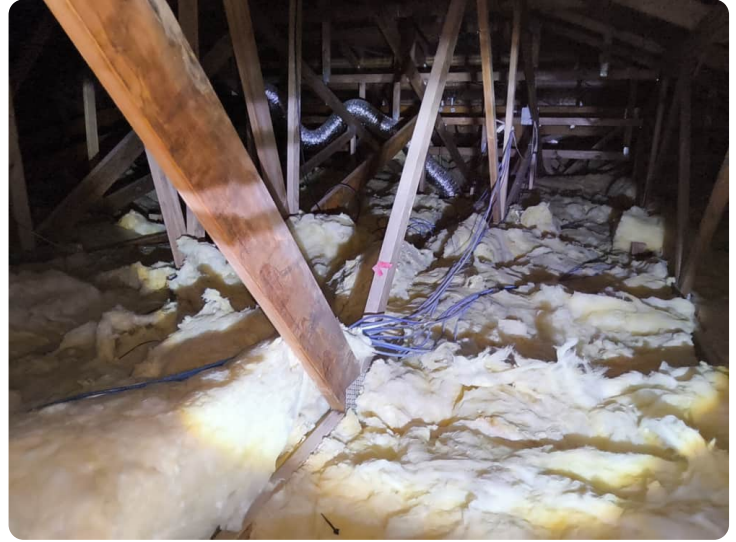
32. Insulation

Insulation was installed. Where insulation was installed it was considered effective. The insulation type was predominately batt or rolled type insulation.

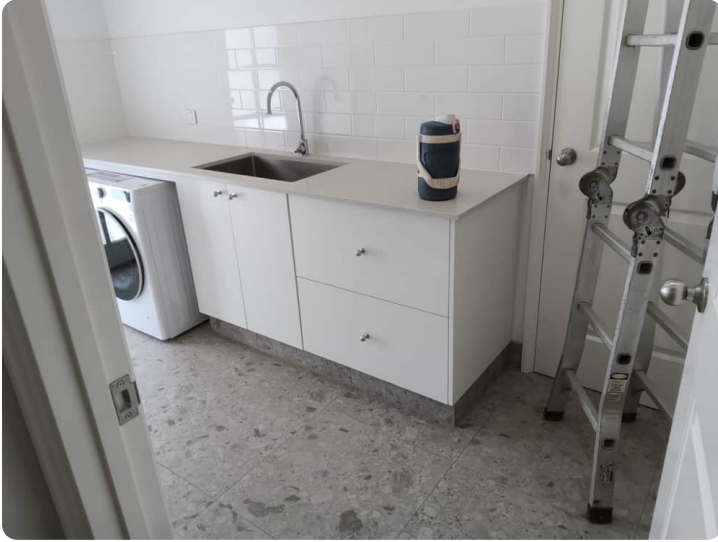
36. Tiled floors and walls

There are areas of internal floors and walls which are covered with a tile covering. The condition of the tiles is satisfactory in relation to its age and will require normal ongoing maintenance.

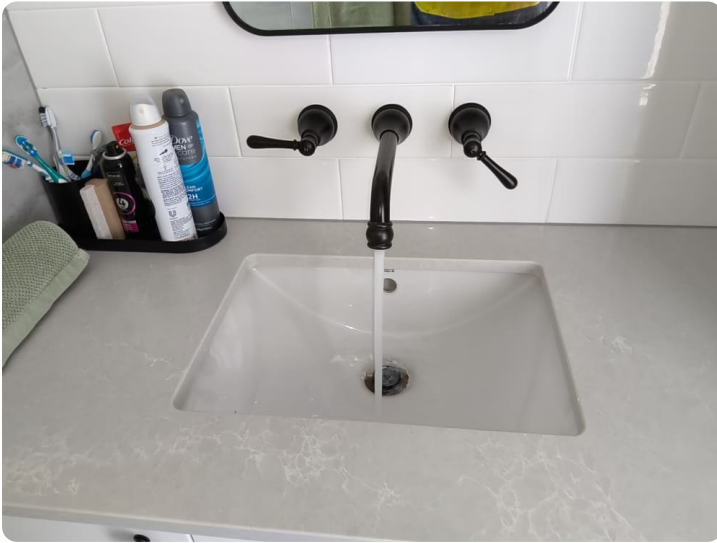
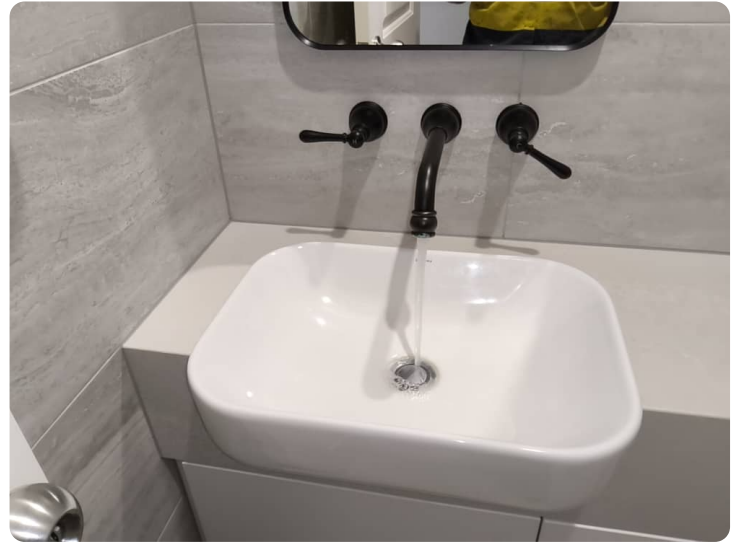
43. Plumbing

The taps to multiple areas were turned on and the water flow appeared to be reasonable. Water draining to several sinks and toilets appeared to be reasonable. The Building Inspector is not a Plumbing Contractor and is not permitted to test Plumbing items under WA Law. Where appropriate a Plumbing Contractor should be engaged to test the plumbing in the property.

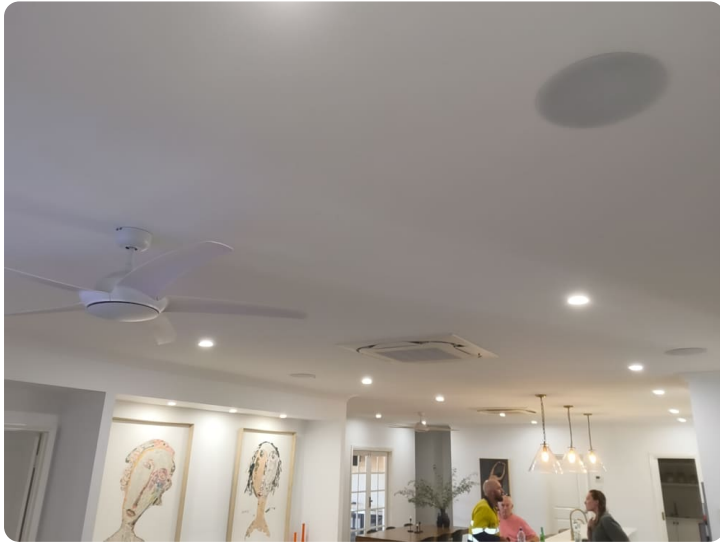
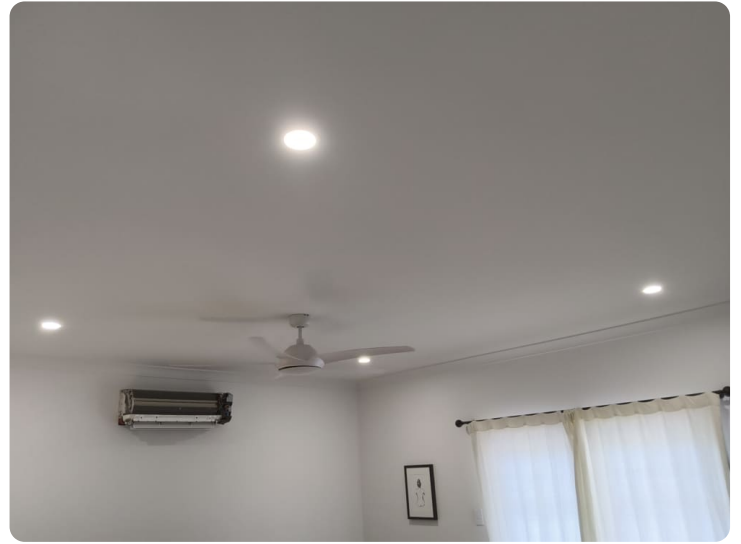
44. Lights and power points

Several lights were turned on during the inspection and the lights appeared to be operational. The Building Inspector is not an Electrical Contractor and is not permitted to test Electrical items under WA Law. Where appropriate an Electrical Contractor should be engaged to test the electrical items in the property.

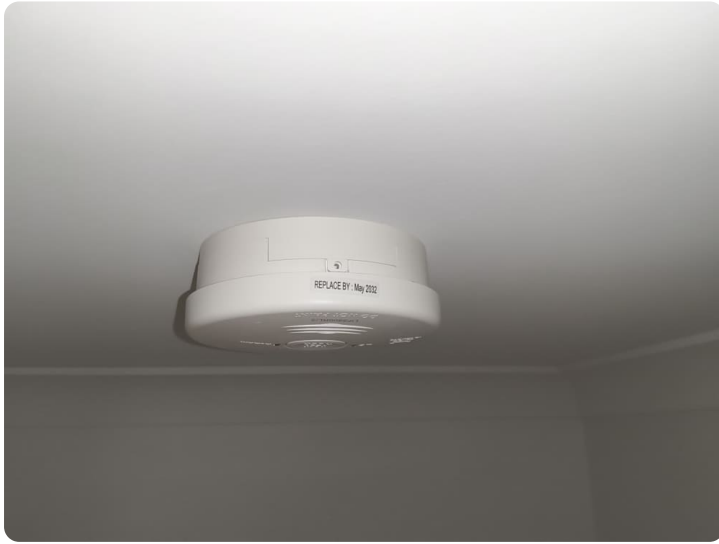
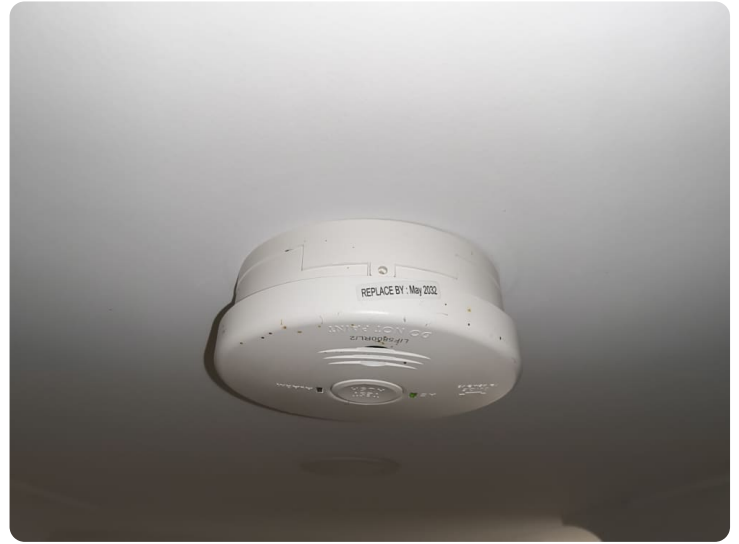
45. Smoke Alarms

There were two hardwired smoke alarms on site. There were no battery smoke alarms on site. The location, number and type of smoke alarms appeared to be consistent with Legislative requirements. It is suggested that an Electrical Compliance Certificate be obtained in relation to the smoke alarms.
