# **Houspect**

**Building inspection**

**Job ID:** 91887

**Address:** 10 Matebore Street, Nickol WA

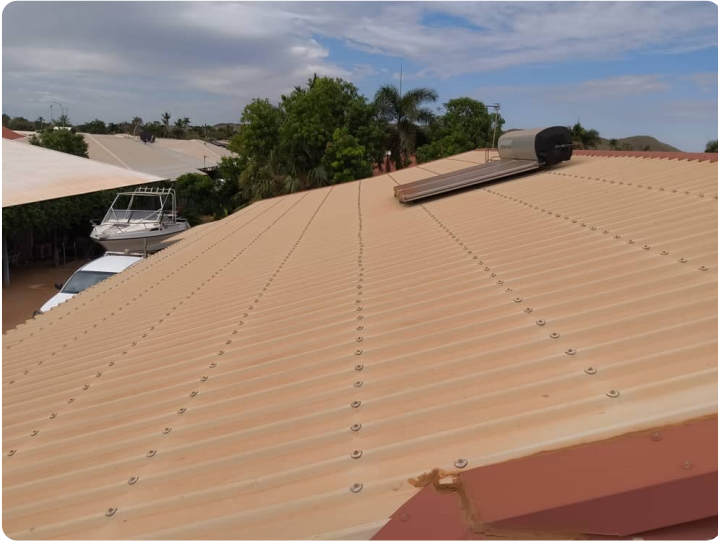
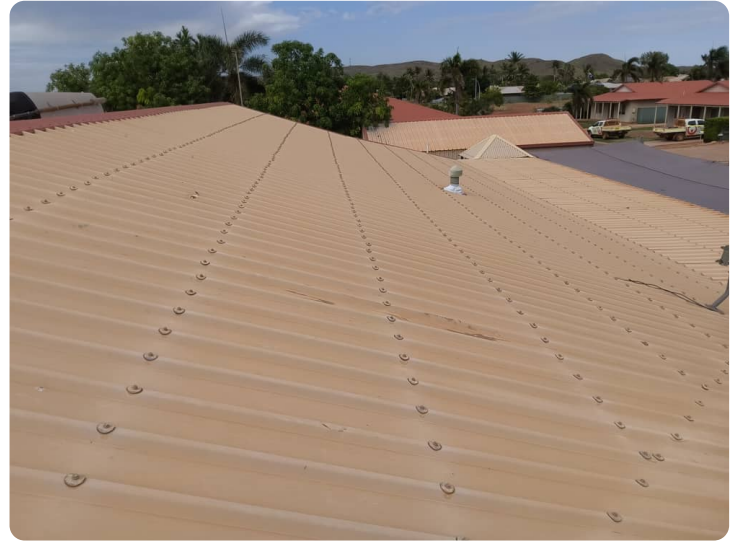
## 1. Roof covering

The roof covering is constructed of colorbond. The condition of the roof covering is satisfactory in relation to its age and will require normal ongoing maintenance.

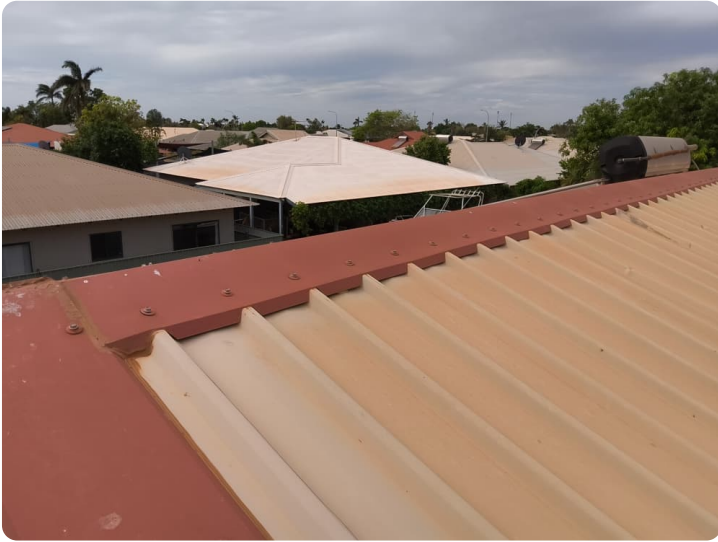
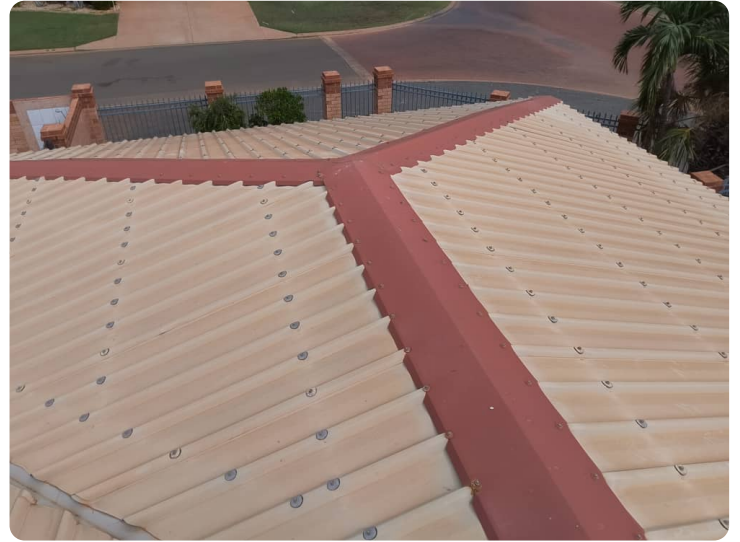
## 2. Ridges

The ridges and capping are satisfactory in relation to its age and will require normal ongoing maintenance.

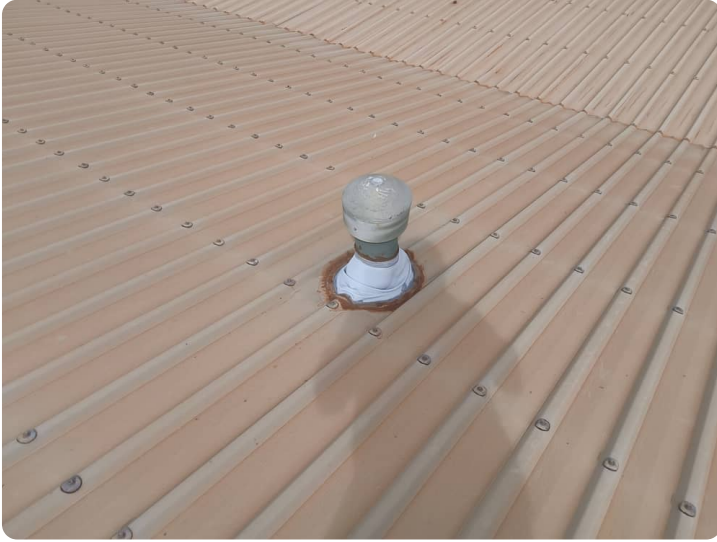
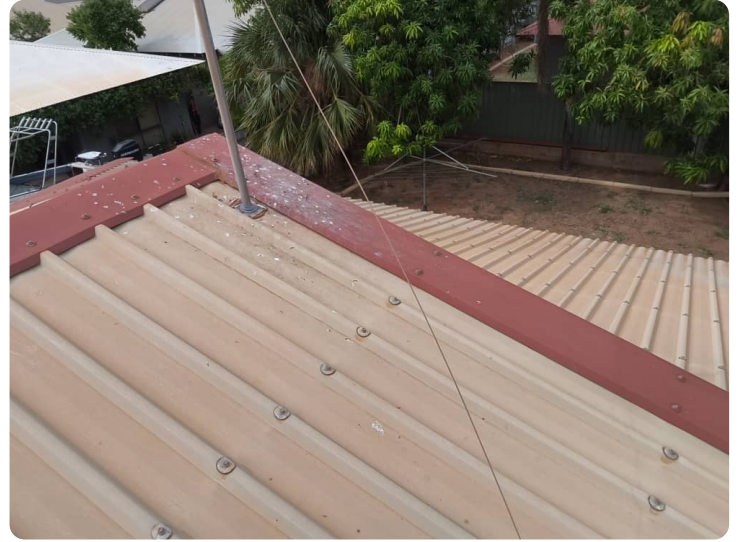
### 3. Flashings

The flashings are covered with a variety of finishes and are constructed of a mixture of materials. The condition of the flashings is satisfactory in relation to their age and will require normal ongoing maintenance.

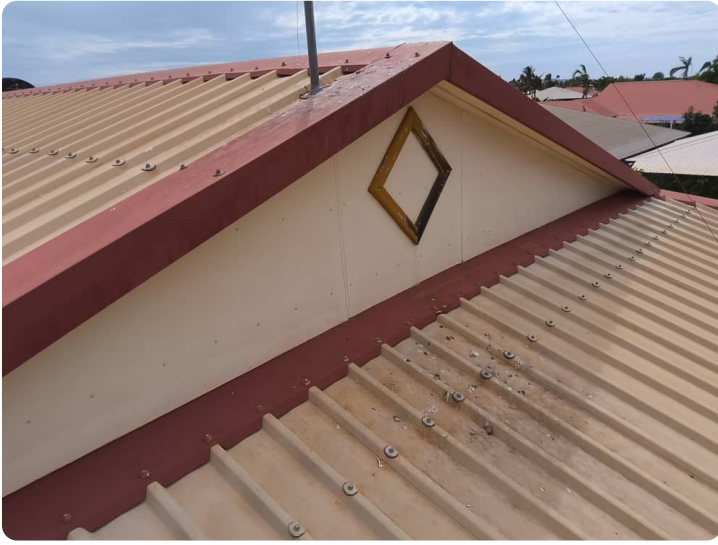
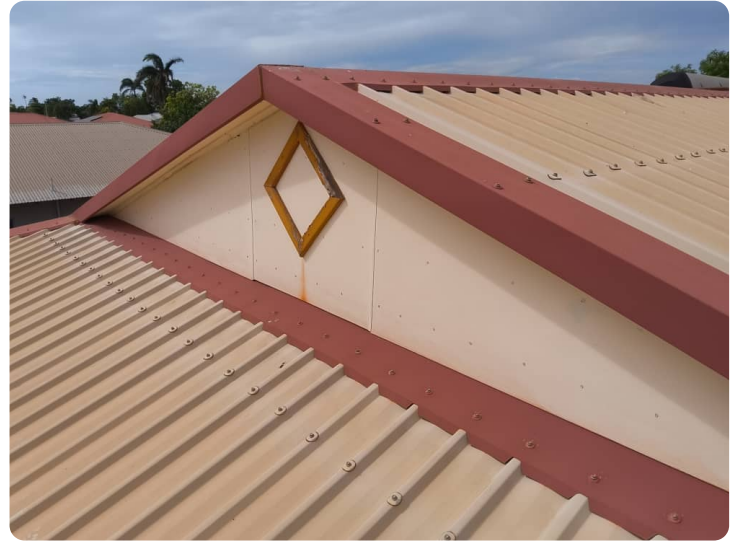
#### 4. Gables

The gables are painted and constructed of fibre cement. The condition of the gables is satisfactory in relation to their age and will require normal ongoing maintenance.

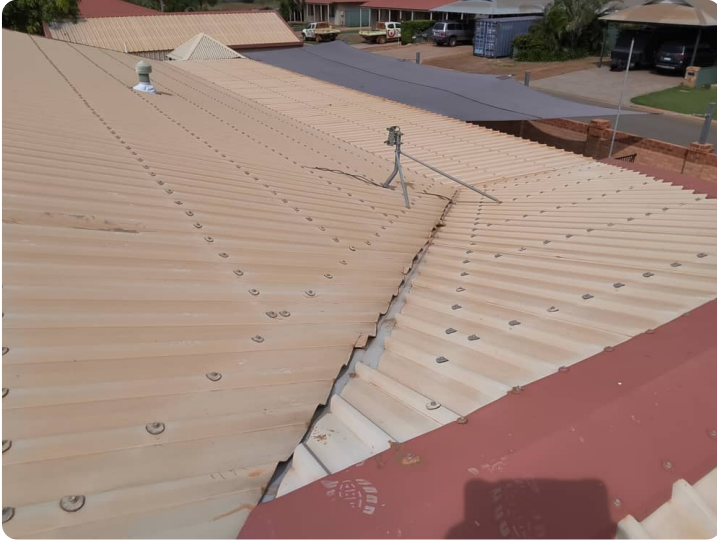
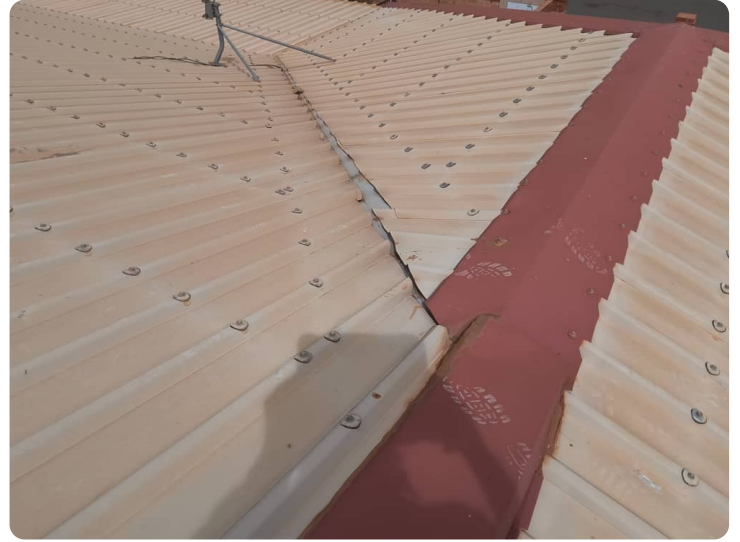
## 5. Valleys

The valleys are constructed of metal and have a colorbond covering. The condition of the valleys is satisfactory in relation to their age and will require normal ongoing maintenance. The valleys appear to be relatively free of debris.

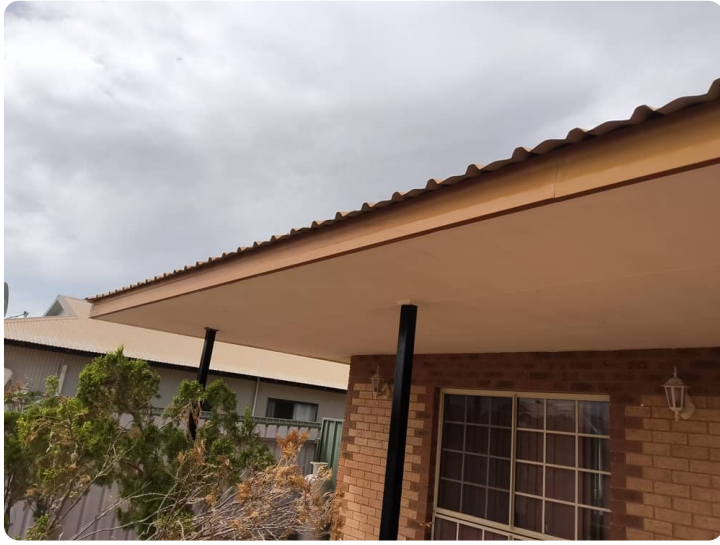
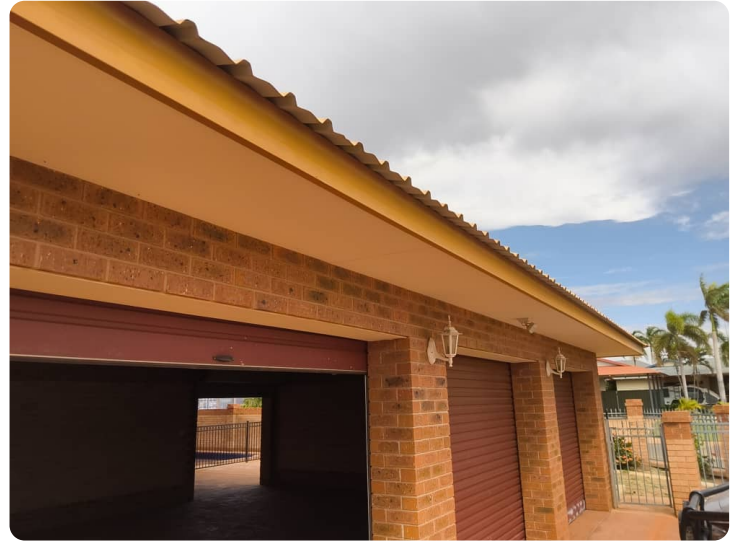
## 6. Fascia

The fascia are constructed of metal and they are painted. The condition of the fascia is satisfactory in relation to their age and will require normal ongoing maintenance.

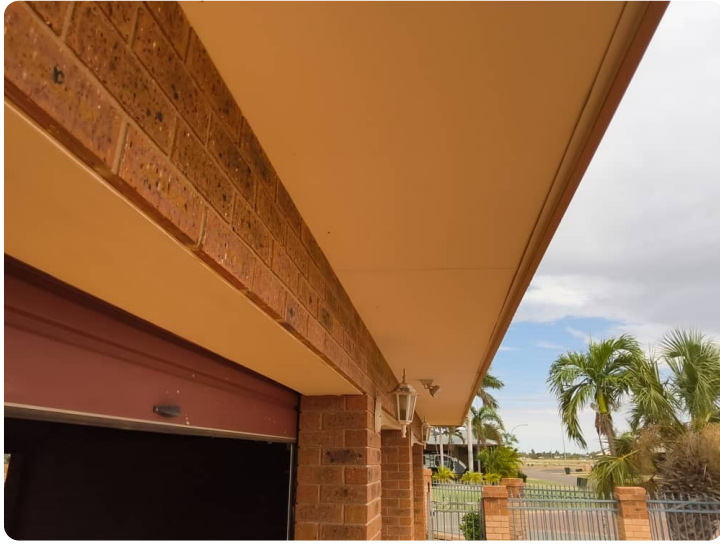
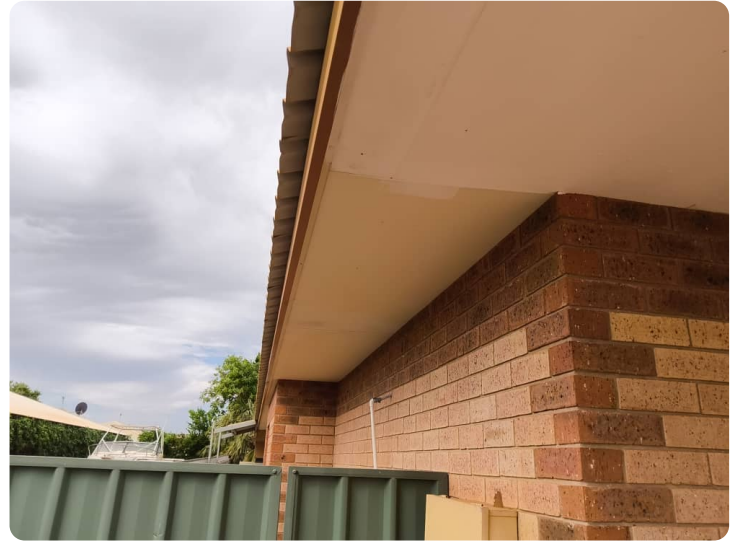
## 7. Eaves

The eaves are boxed and constructed of painted fibre cement. The condition of the eaves is satisfactory in relation to their age and will require normal ongoing maintenance.

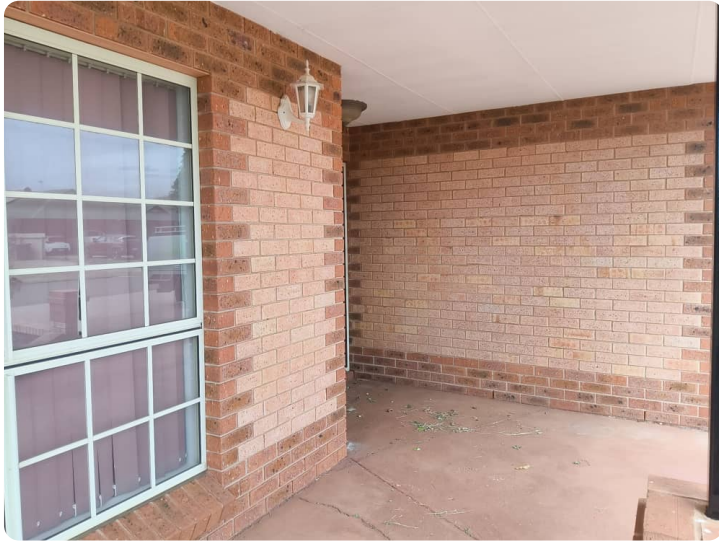
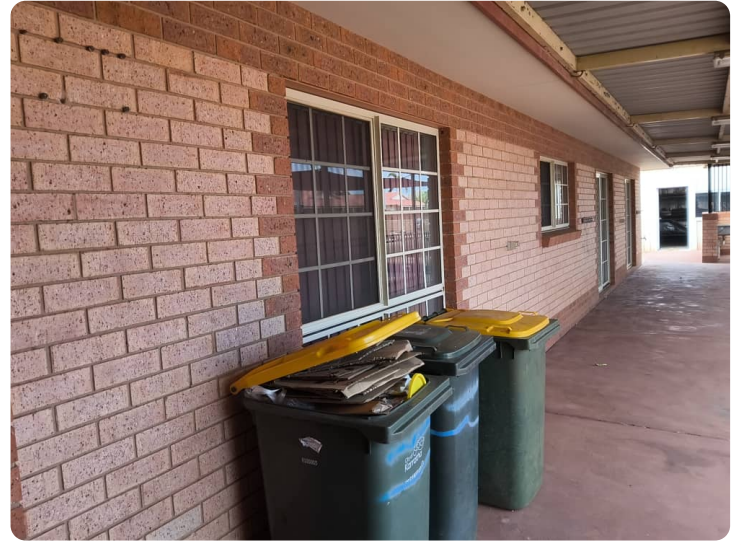
## 8. External walls

The external walls are constructed of brick. The condition of the walls generally is satisfactory in relation to their age and will require normal ongoing maintenance.

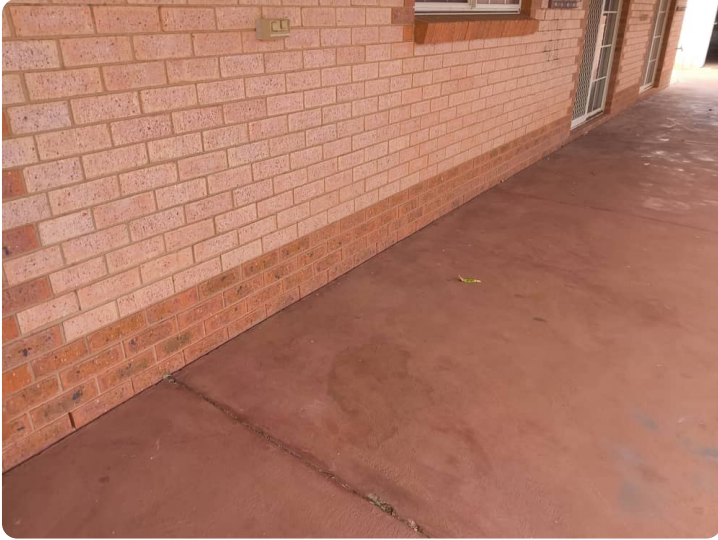
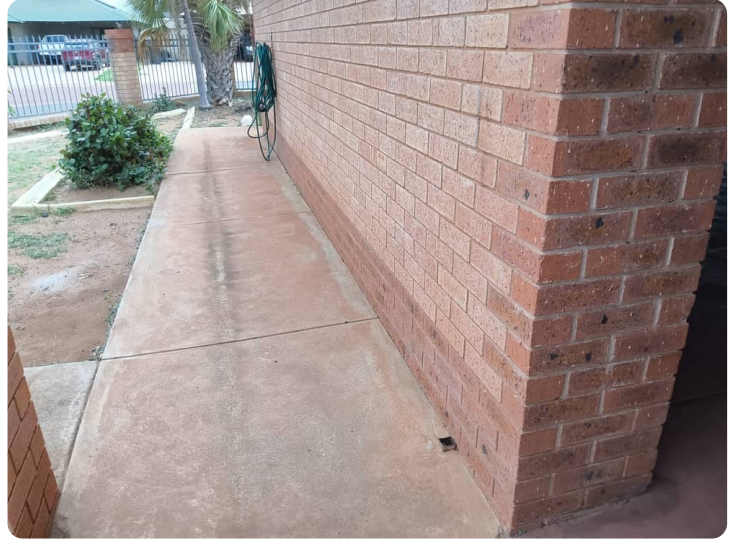
## 9. Footings

The footings are below ground and cannot be seen. The condition of the footings cannot be determined.

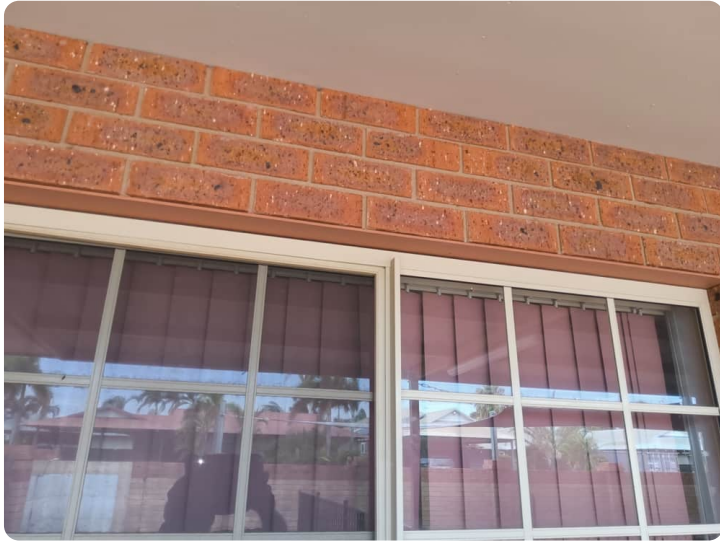
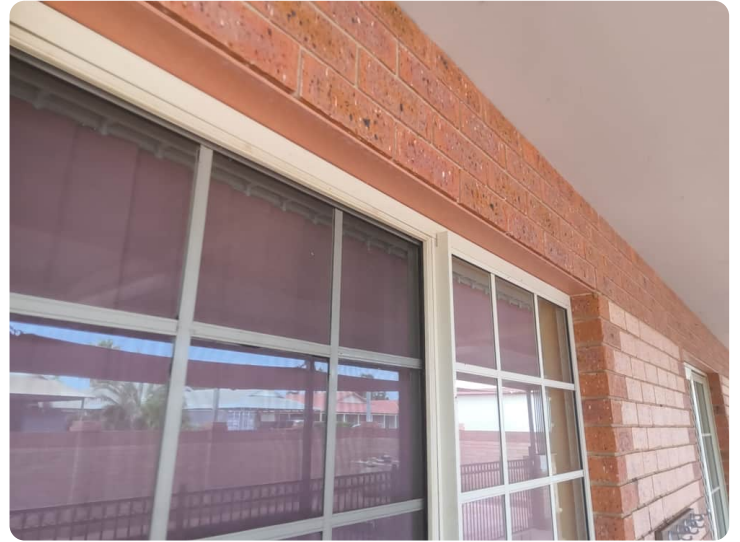
## 10. Lintels

The external lintels are (or partially are) constructed of steel. The condition of the lintels is satisfactory in relation to its age and will require normal ongoing maintenance.

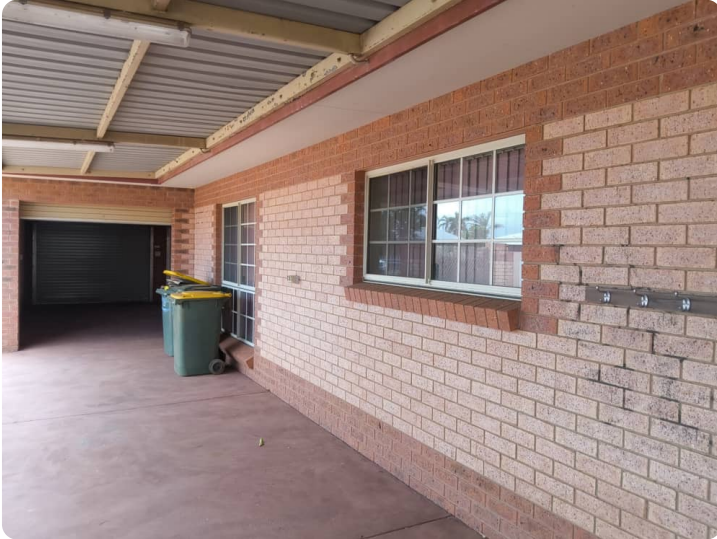
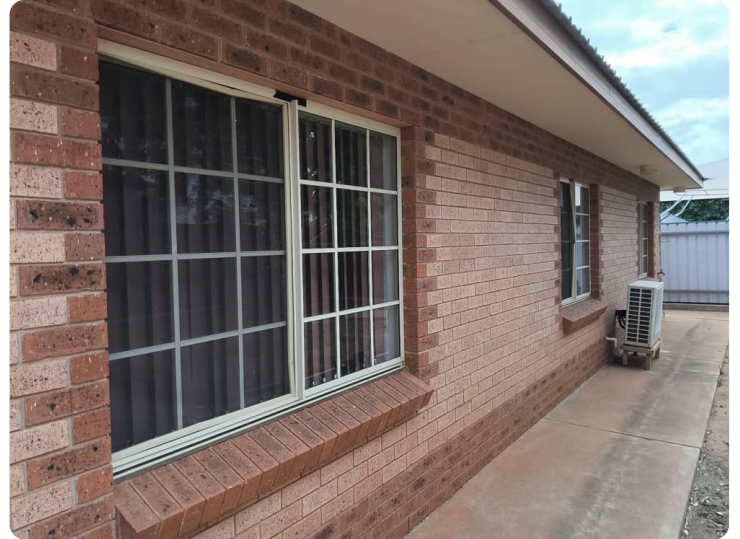
## 11. Windows and window frames

The window and window frames are primarily constructed of aluminium. The condition of the window and window frames is generally satisfactory in relation to its age and will require normal ongoing maintenance.

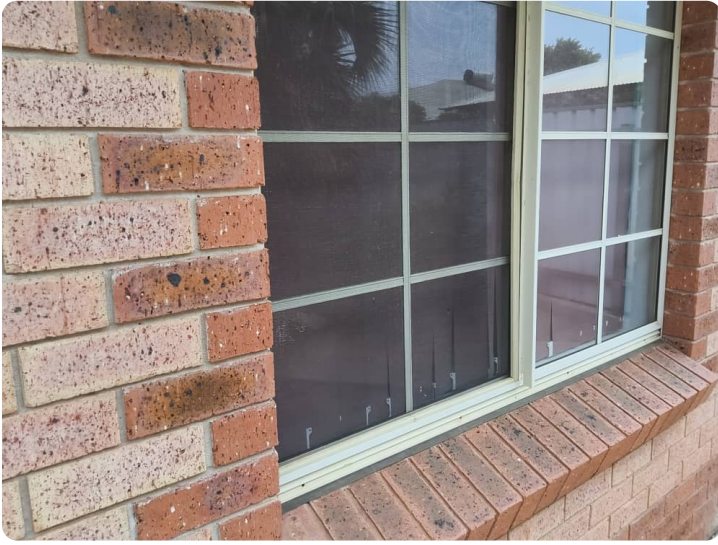
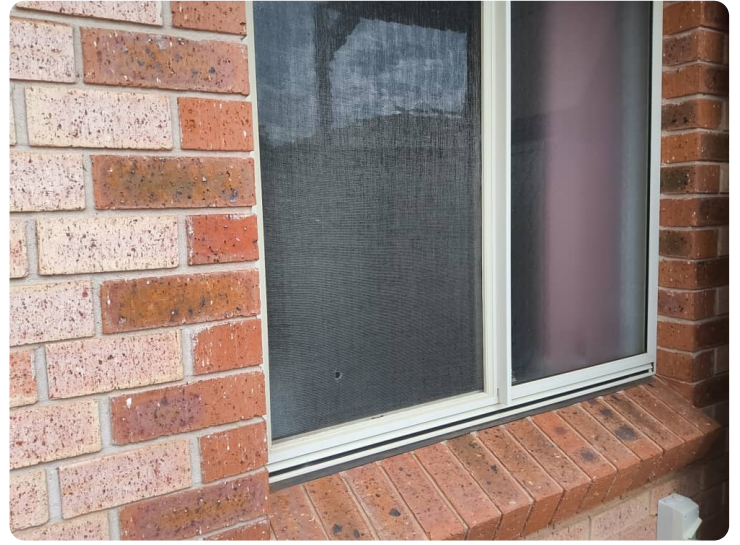
## 12. Window fly screens

Fly screens have been installed to all of the windows. The condition of the window fly screens is generally fair in relation to its age and will require ongoing maintenance.

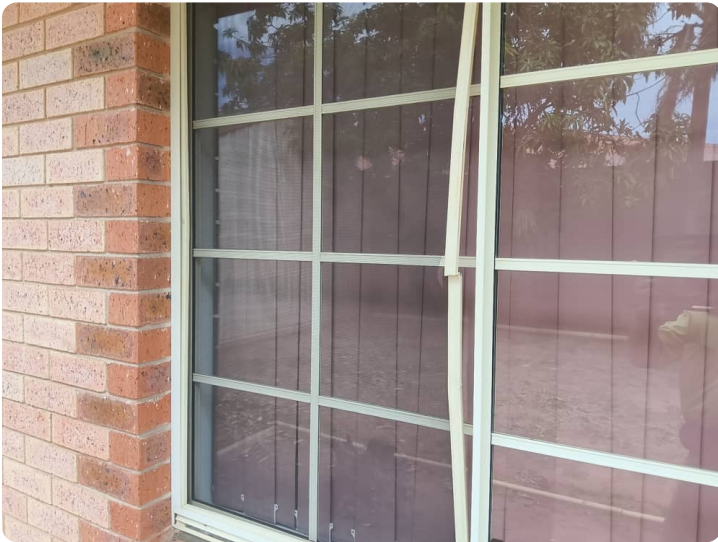
### 12.1 Screens damage - replacement

As per the images, the fly screens are damaged and require replacement.

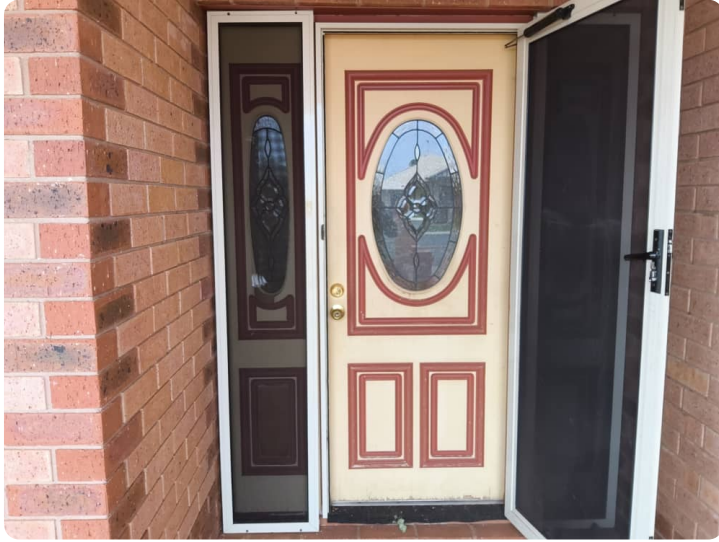
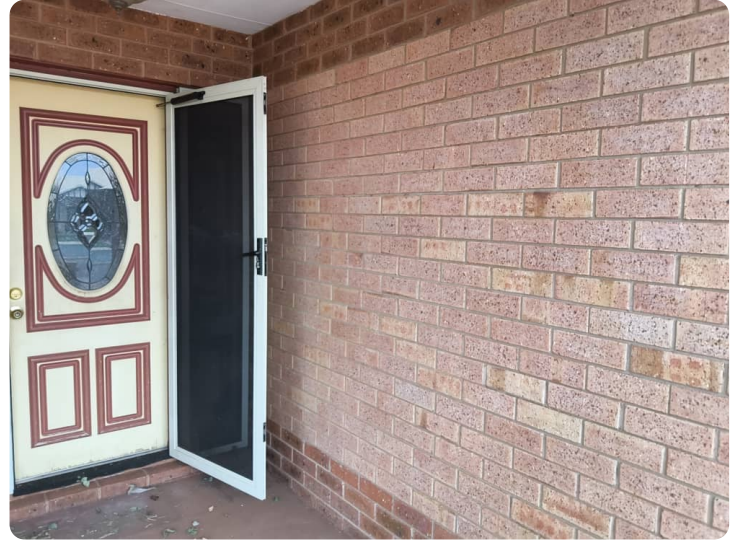
### 13. Front door

The front door is constructed of timber and glass. The condition of the front door is satisfactory in relation to its age and will require normal ongoing maintenance. Deadlocks have been installed. A security screen door has been fitted.

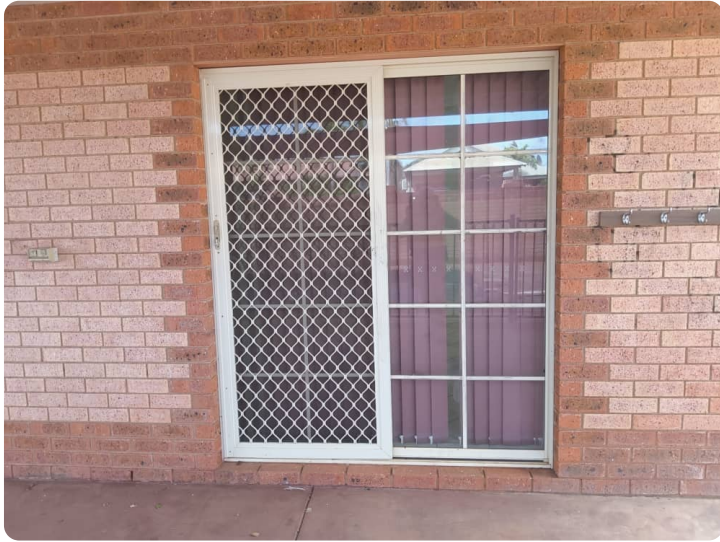
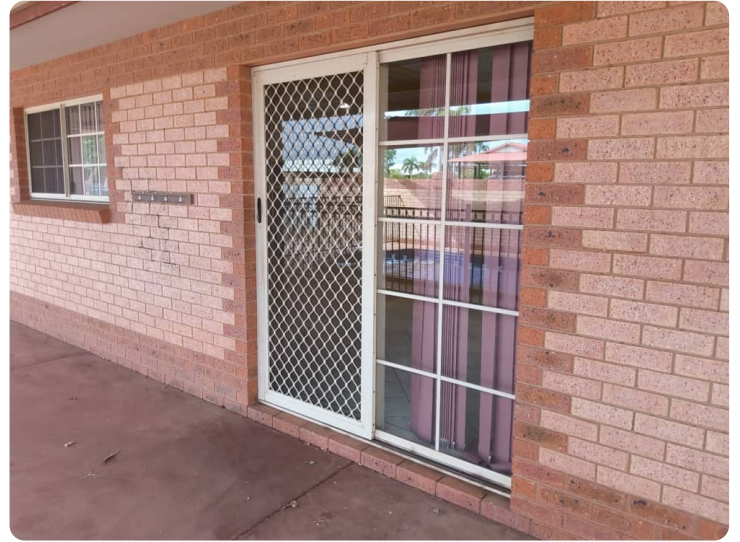
#### 14. Other external doors

Other external doors are constructed of aluminium. The condition of the other external doors is satisfactory in relation to its age and will require normal ongoing maintenance.

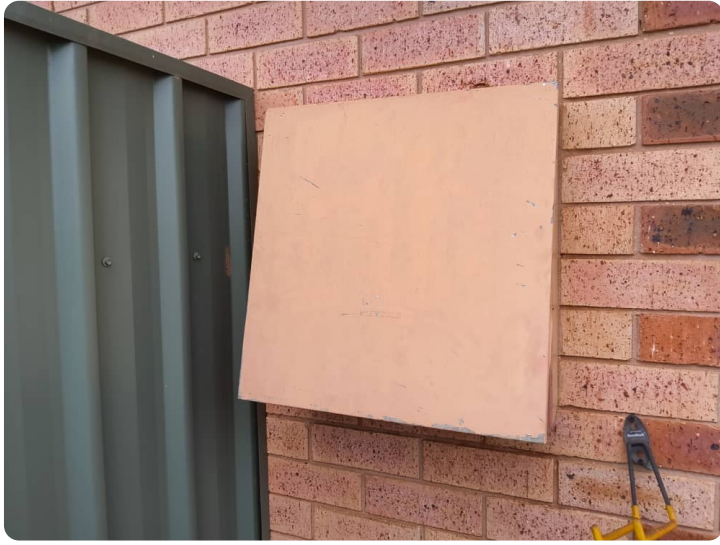
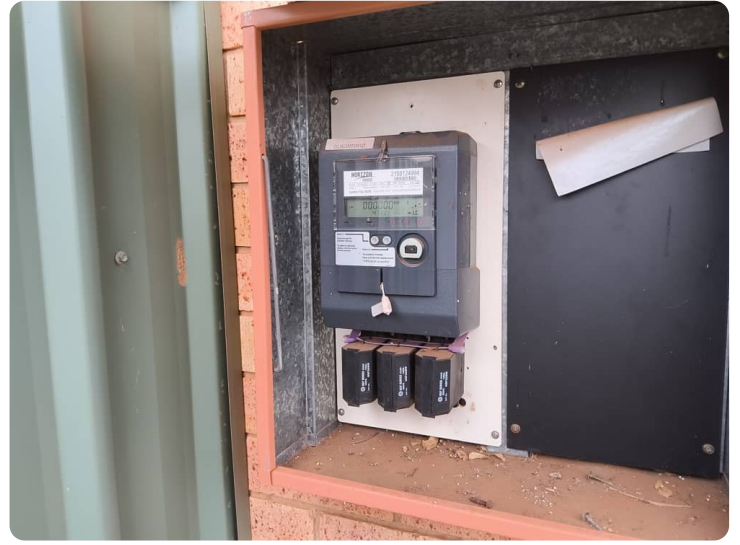
### 15. Meter box and power

Access to the meter box or sub board was available. The meter box or sub board is not lockable. Power phase type to the site is three phase.

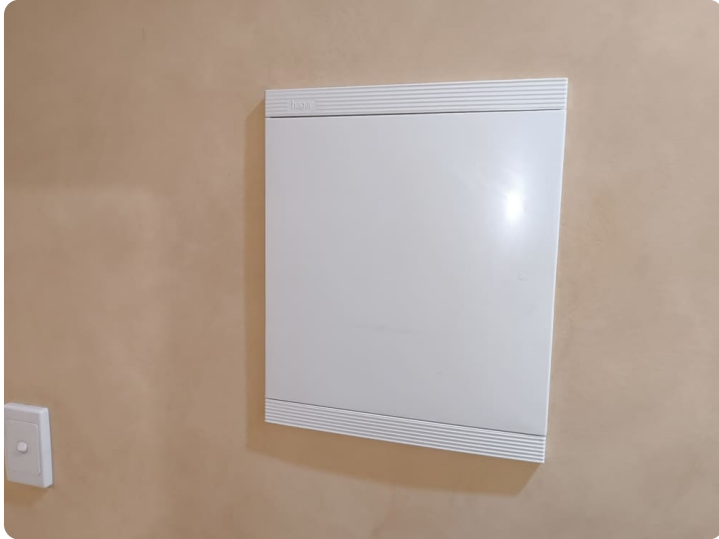
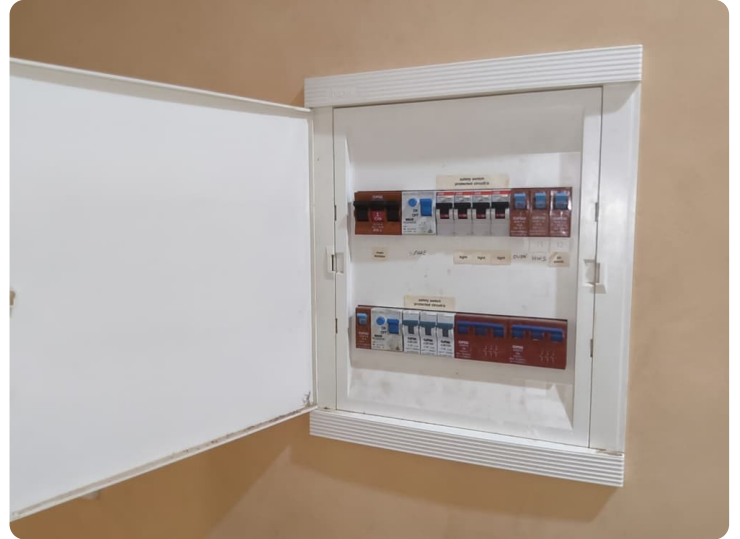
## 16. Residual Current Devices

There were two Residual Current Devices (RCD)(s) noted in the meter box or sub meter box. The RCD(s) were not tested. It is suggested that an Electrical Compliance Certificate be obtained in relation to the RCD(s).

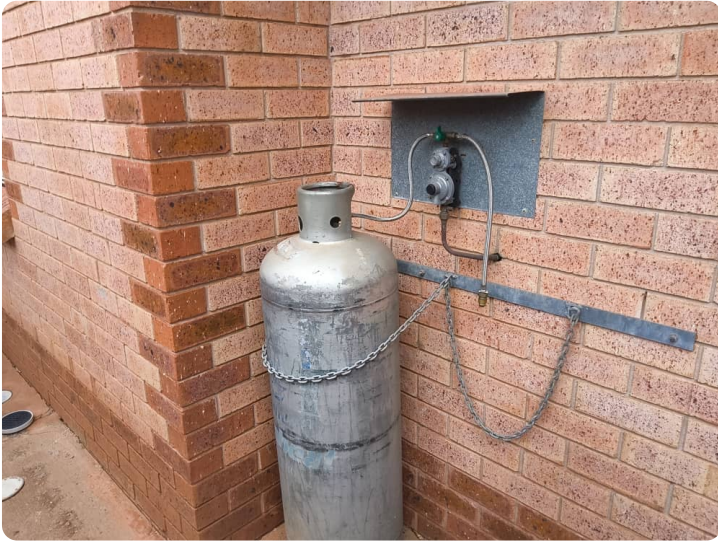
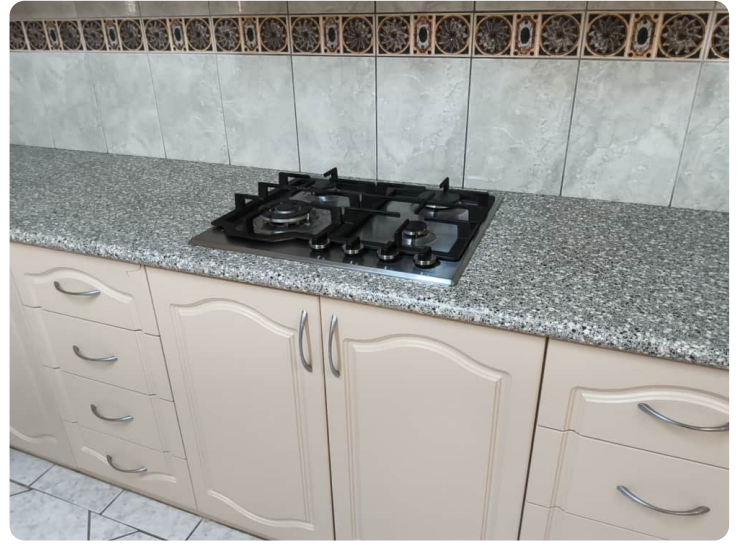
### 17. Gas Supply

Gas supply to the property is via LPG bottles. While on site the inspector could not smell detectable gas leaks.

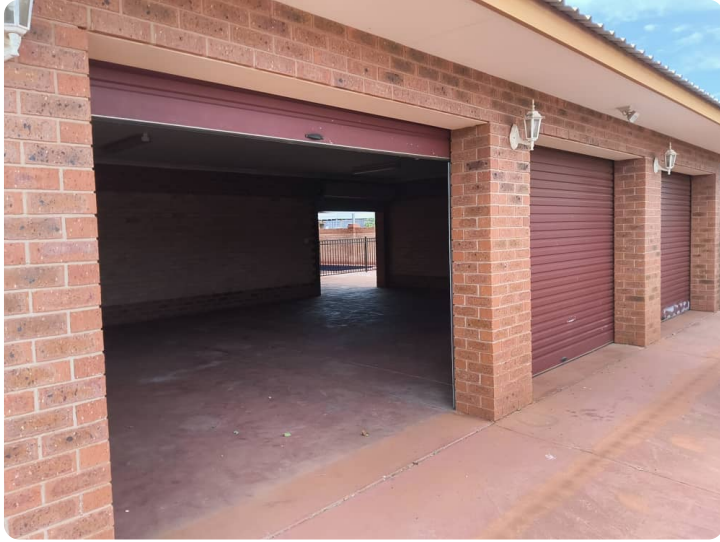
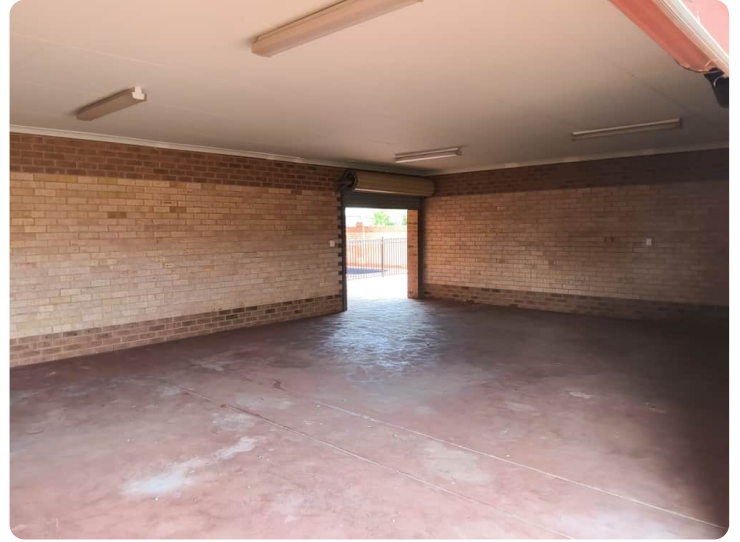
### 18. Carport or Garage (Primary)

There is a primary garage on the property constructed of same materials as the primary structure. The condition of the carport or garage is satisfactory in relation to its age and will require normal ongoing maintenance.

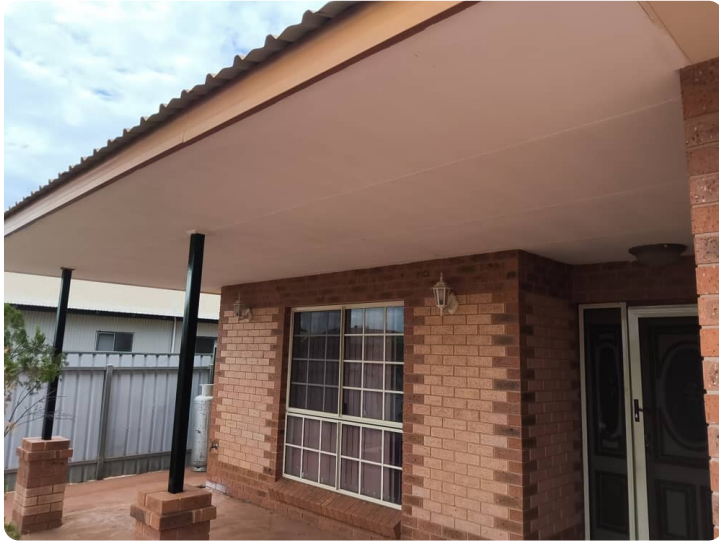
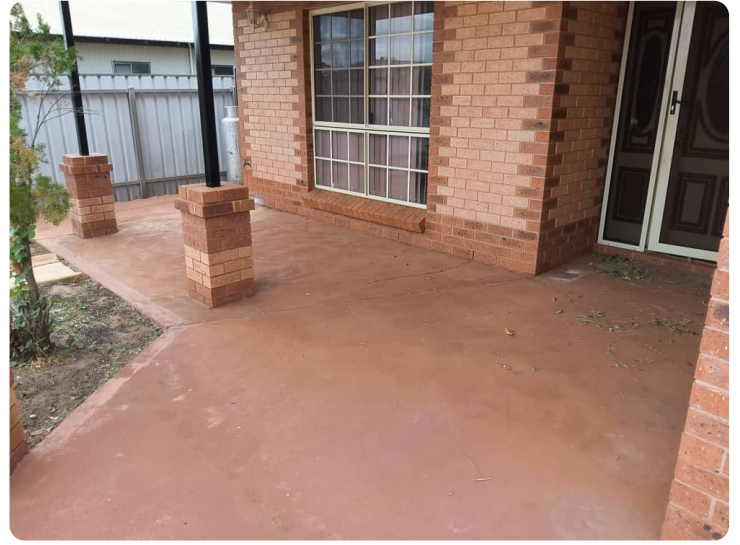
### 19. Veranda (Primary)

The primary veranda is constructed of same materials as the primary structure. The condition of the veranda is satisfactory in relation to its age and will require normal ongoing maintenance.

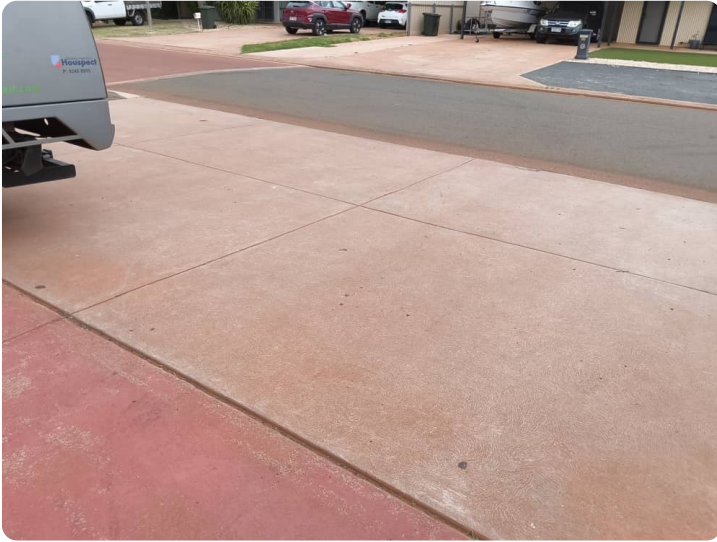
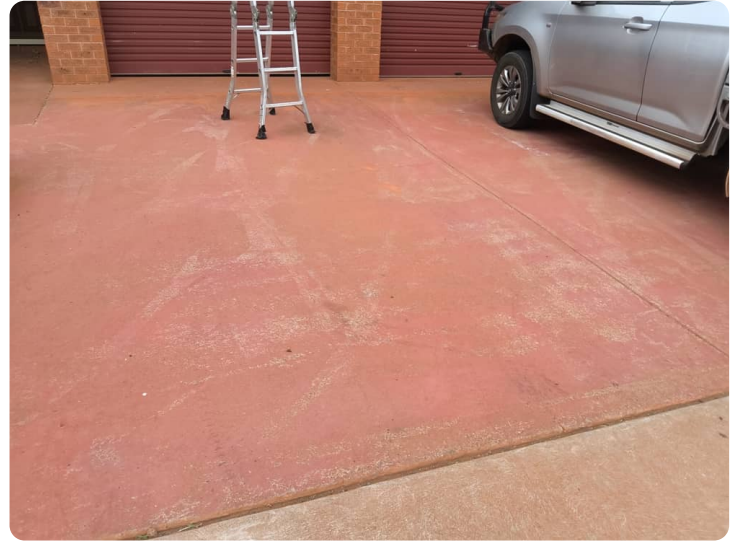
### 23. Driveway

The driveway and cross over is constructed of concrete. The condition of the driveway is satisfactory in relation to its age and will require normal ongoing maintenance.

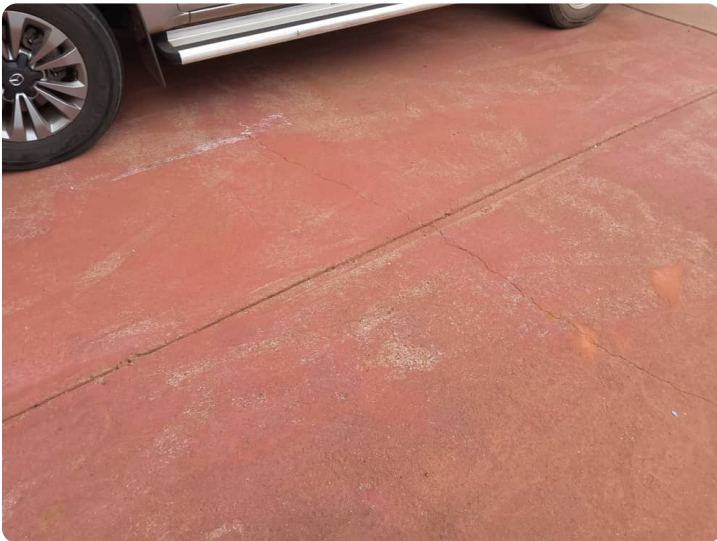
#### 23.1 Concrete cracking - minor

Cracking was noted to the concrete driveway. This is not of a structural concern. Cracks should be filled to avoid further deterioration.

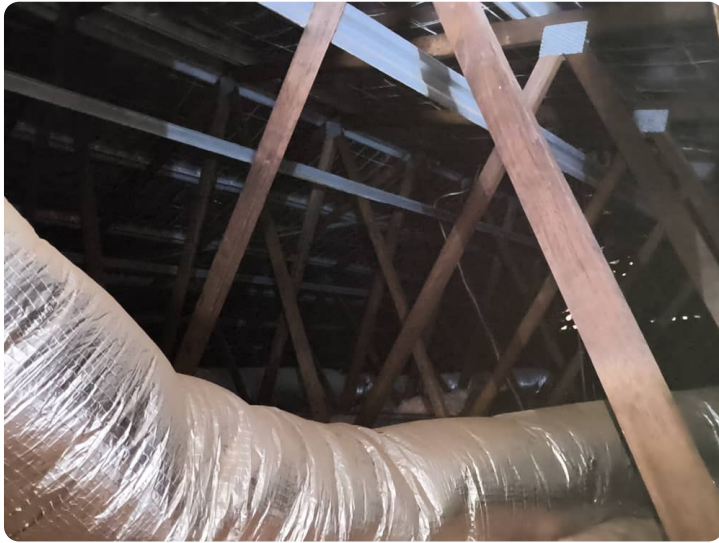
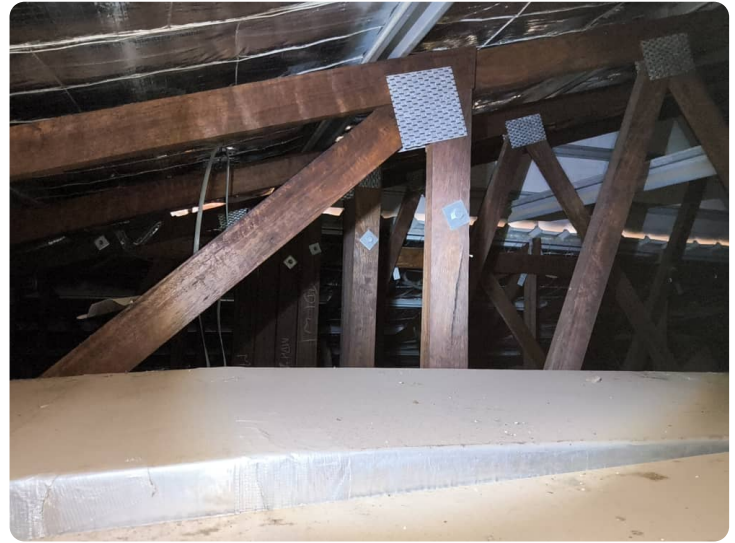
### 30. Roof frame

The roof frame type is a timber truss. The condition of the roof frame is satisfactory in relation to its age and will require normal ongoing maintenance. Access to the roof space was restricted by the pitch of the roof, insulation, ducting or other items. The inspector estimates that visibility was available to more than 75% of the area.

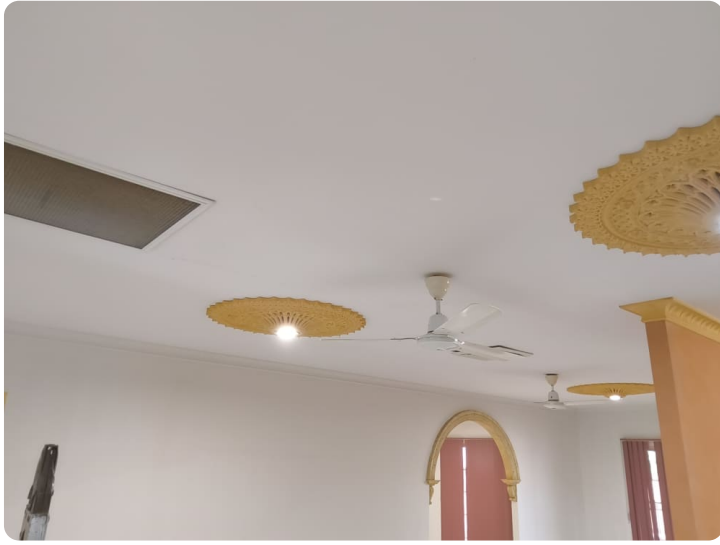
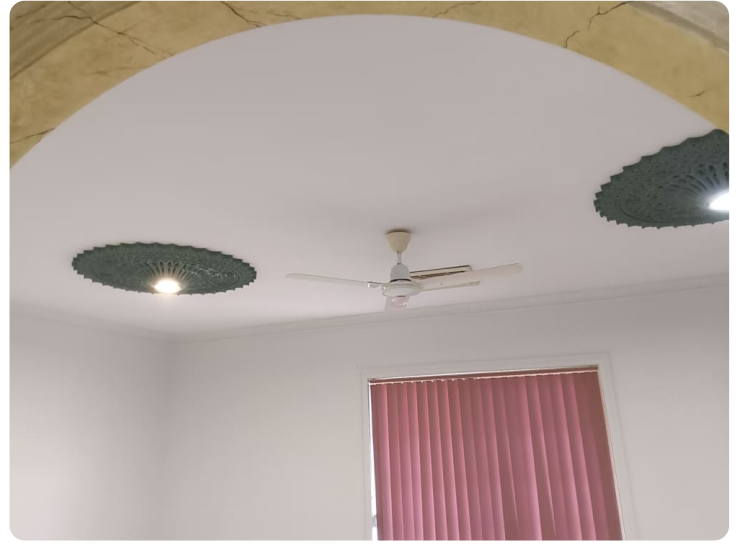
## 32. Ceilings

The ceilings are constructed of plasterboard with cornices constructed of plasterboard. The condition of the ceilings is satisfactory in relation to its age and will require normal ongoing maintenance.

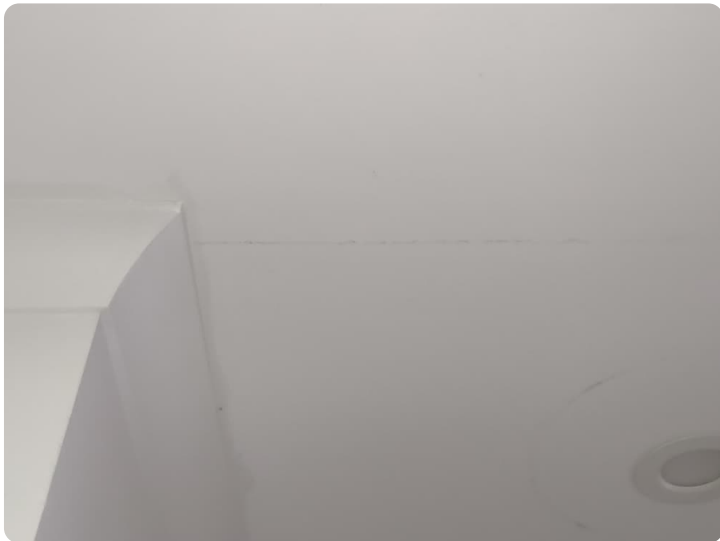
### 32.1 Cracking - minor

The ceilings in the images contain multiple cracks, likely caused by thermal expansion and contraction. This is not a structural issue but repairs are required.

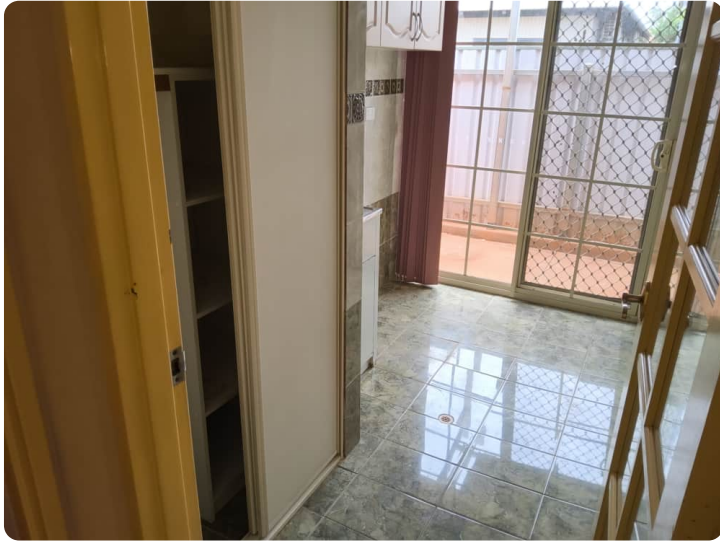
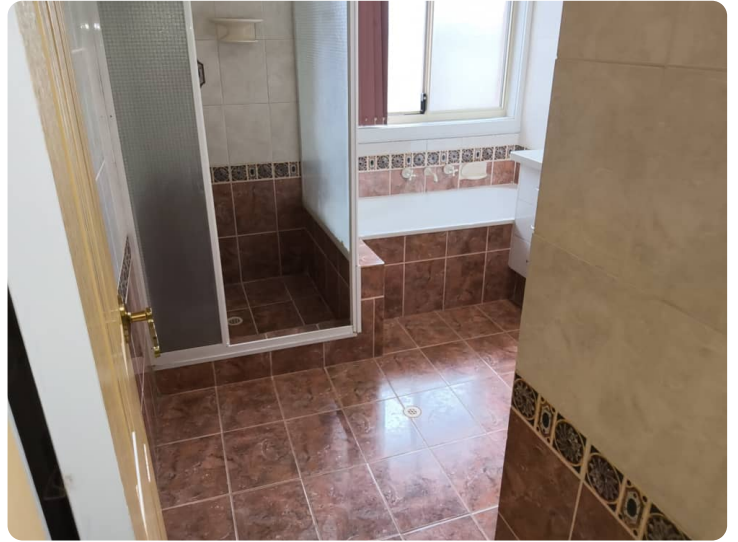
### 35. Tiled floors and walls

There are areas of internal floors and walls which are covered with a tile covering. The condition of the tiles is satisfactory in relation to its age and will require normal ongoing maintenance.

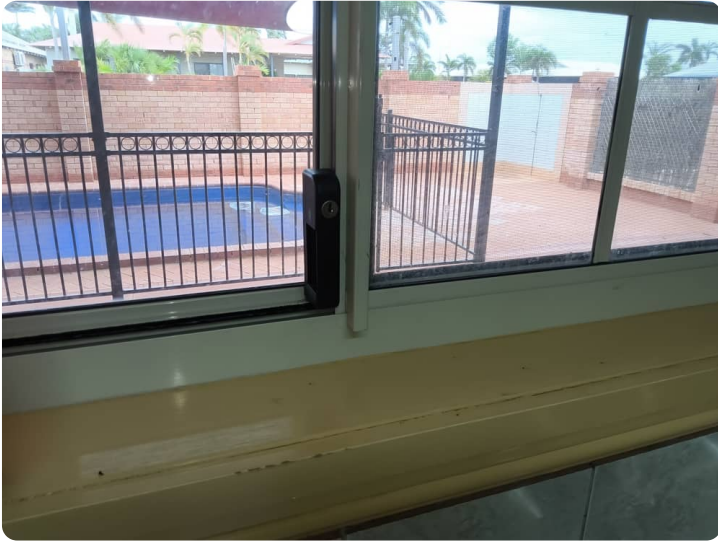
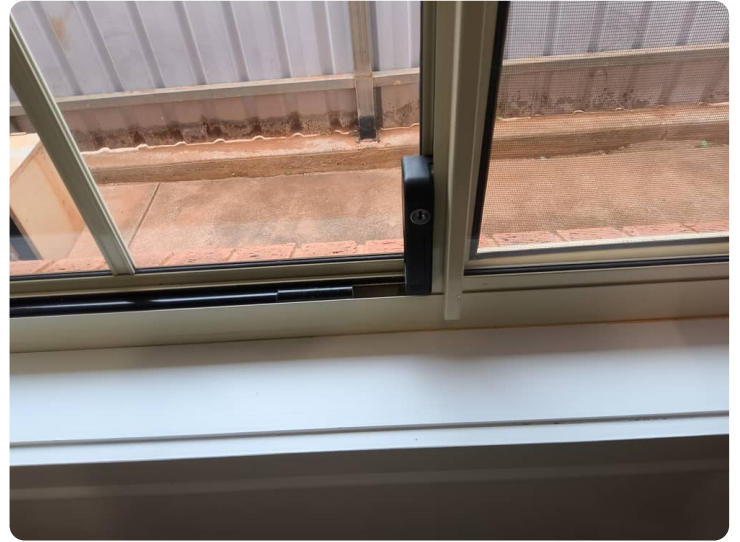
### 36. Windows (internal)

The condition of the windows, as viewed from within the property, is satisfactory in relation to its age and will require normal ongoing maintenance. Window locks have been installed to all of the windows.

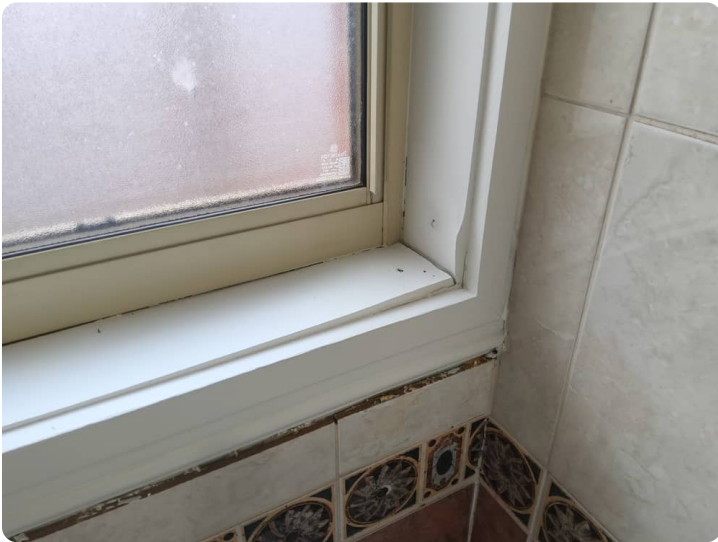
#### 36.1 Sill water damaged

The window sill is water damaged. Windows require new sill to remediate.

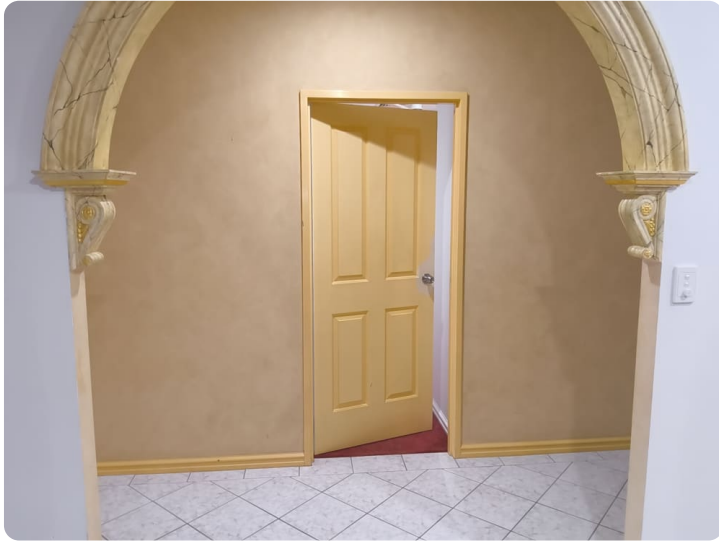
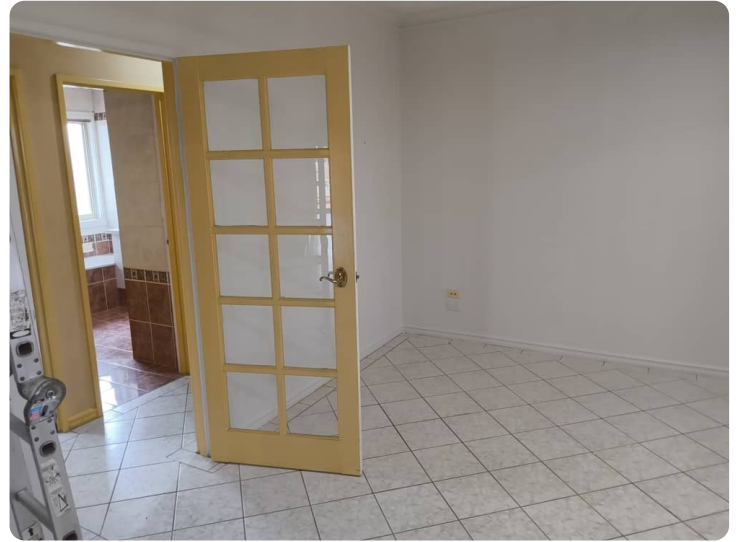
### 37. Internal doors

The internal doors were mainly constructed of a variety of materials. The condition of the internal doors is satisfactory in relation to its age and will require normal ongoing maintenance.
