# **Houspect**

**Building inspection**

**Job ID:** 91887

**Address:** 10 Matebore Street, Nickol WA

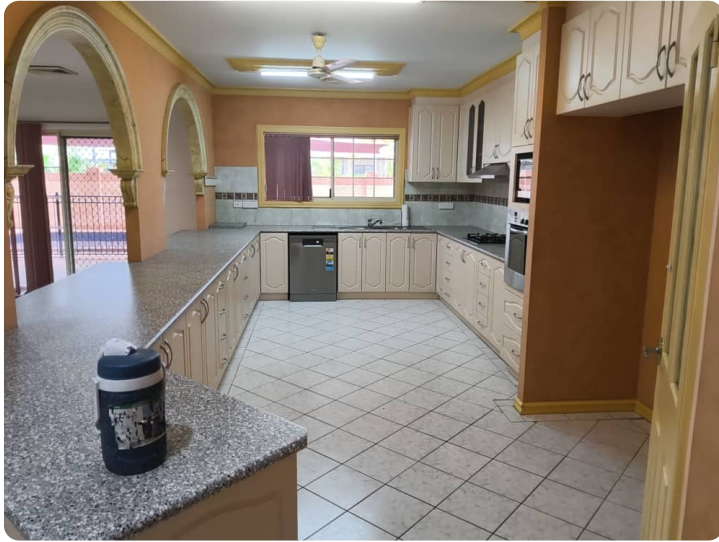
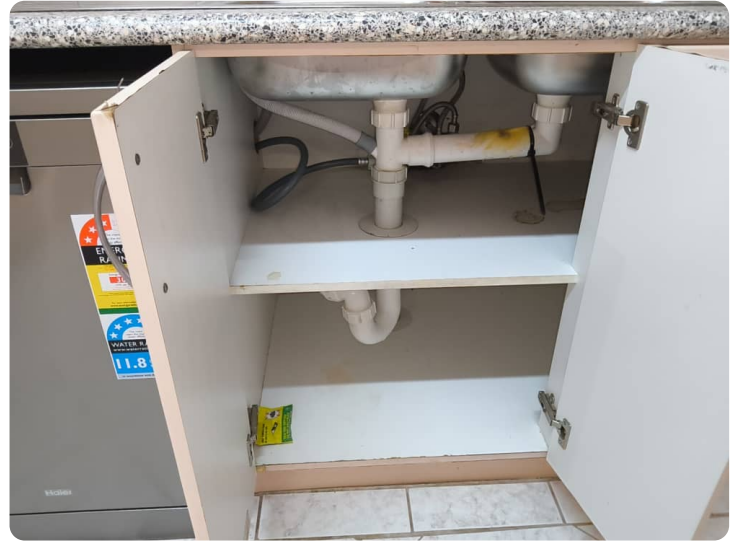
### 38. Kitchen cabinets

The condition of the kitchen cabinets in general is satisfactory in relation to their age and require normal maintenance.

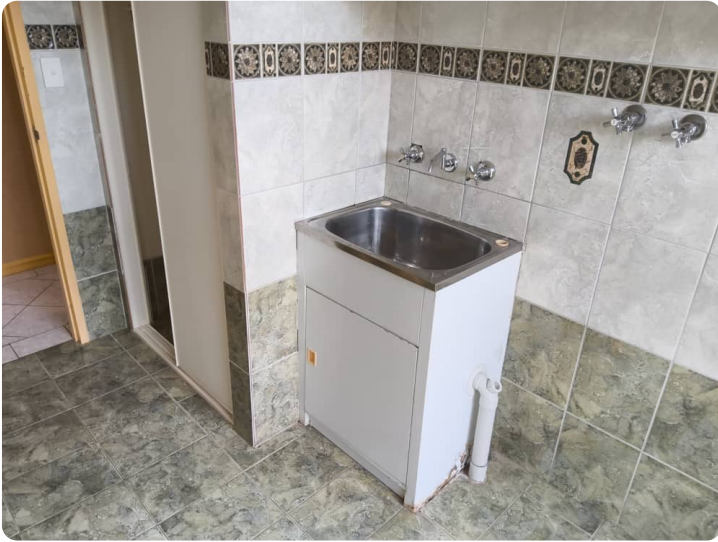
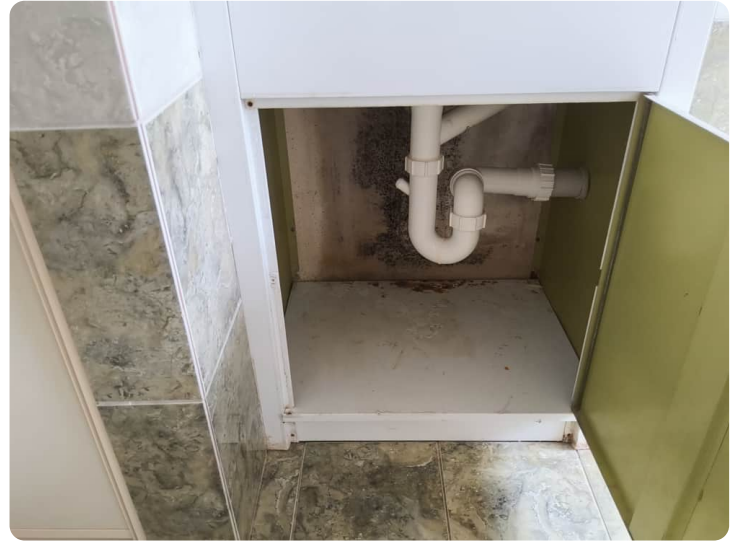
### 39. Laundry cabinets

The condition of the laundry cabinets is satisfactory in relation to their age and require normal maintenance.

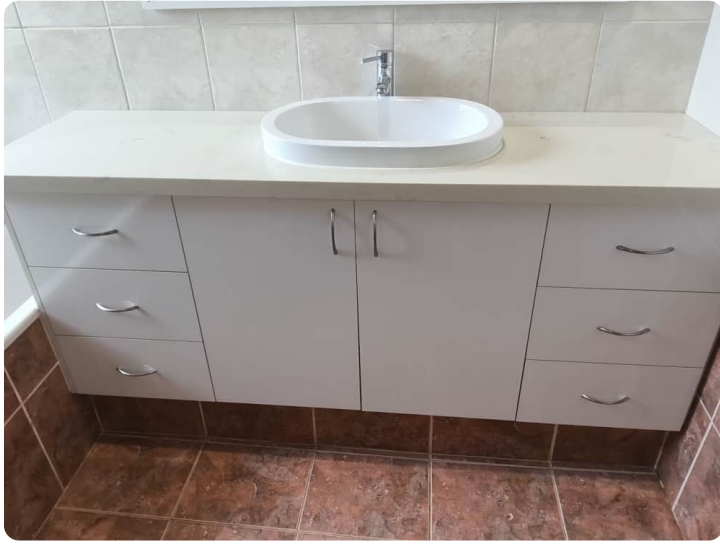
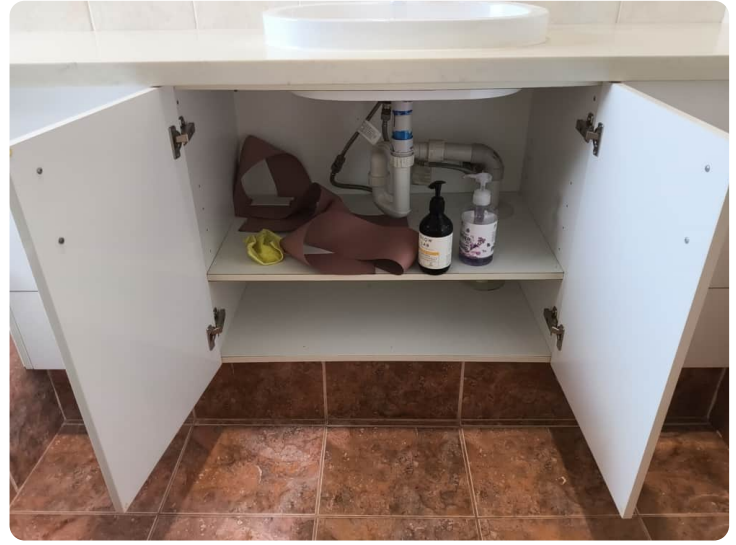
#### 40. Bathroom cabinets

The condition of the bathroom cabinets is satisfactory in relation to their age and require normal maintenance.

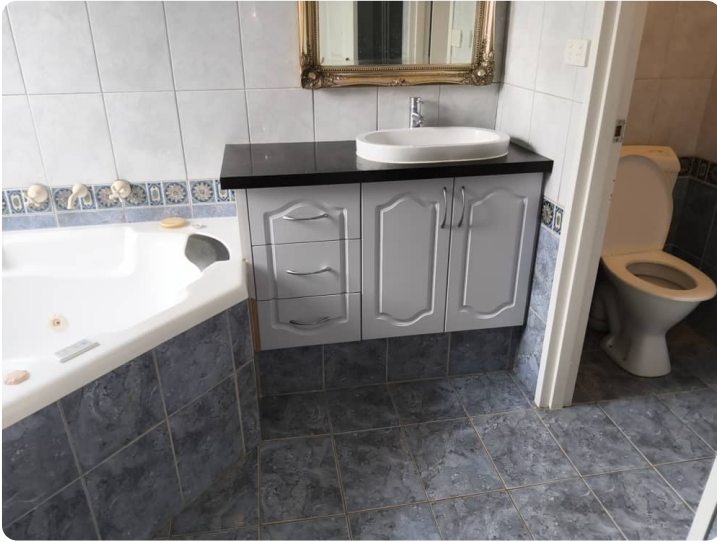
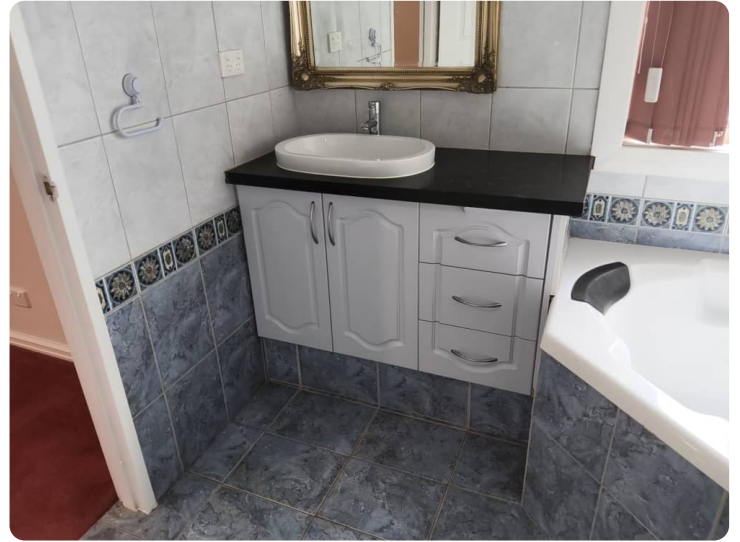
### 41. Ensuite cabinets

The condition of the ensuite cabinets is satisfactory in relation to their age and require normal maintenance.

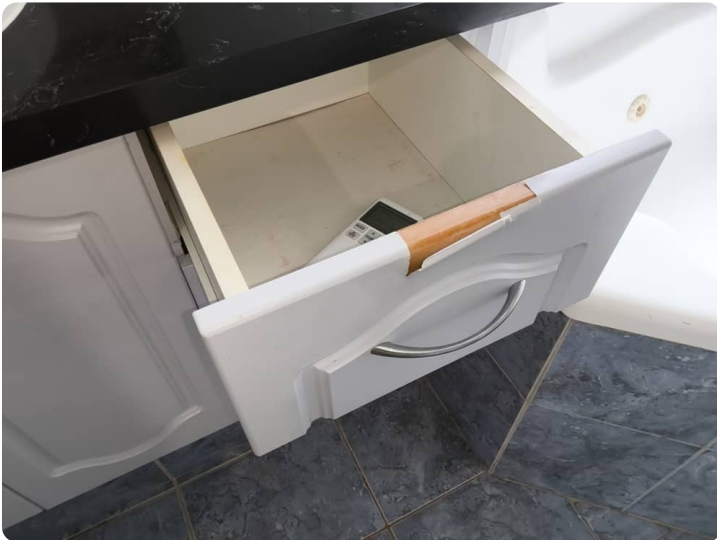
#### 41.1 Cabinet drawer vinyl damage

As per the images some cabinet drawers are damaged requiring repairs.

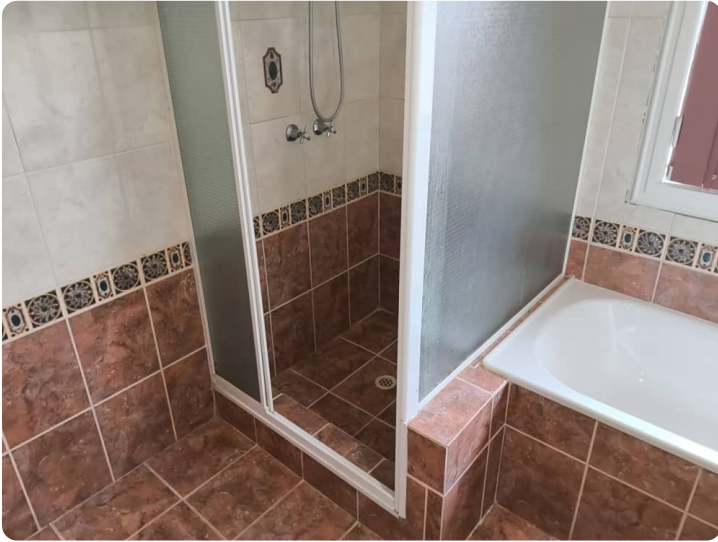
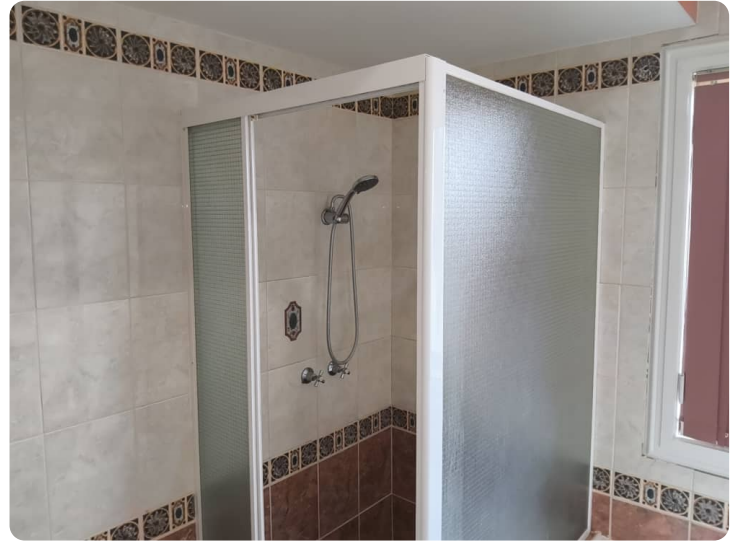
## 42. Shower screens

The condition of the shower screens is fair in relation to its age and will require ongoing maintenance.

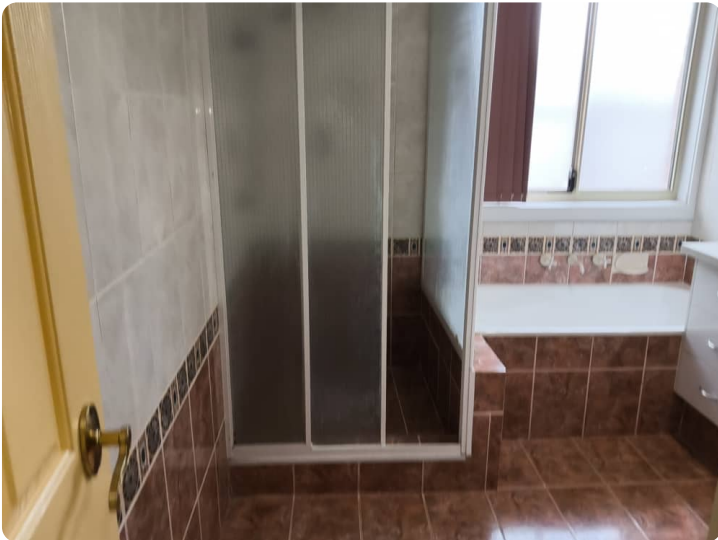
### 42.1 Bathroom shower screen door missing

As per the images the shower screen in the bathroom is missing a section of door. Screen should be replaced.

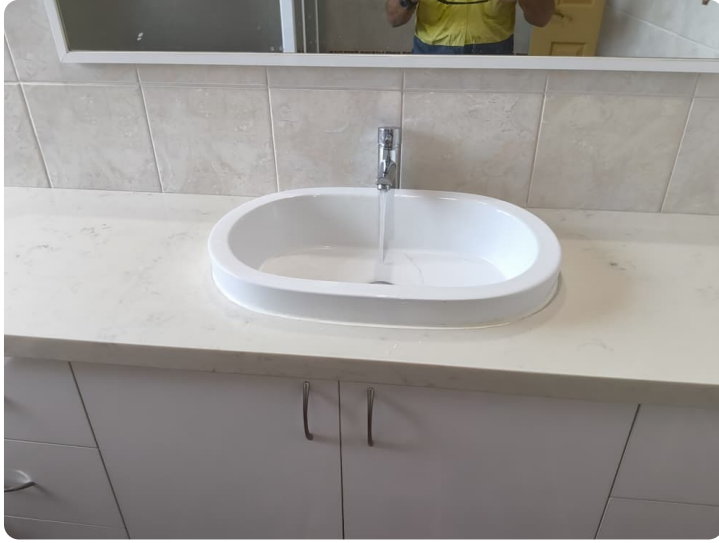
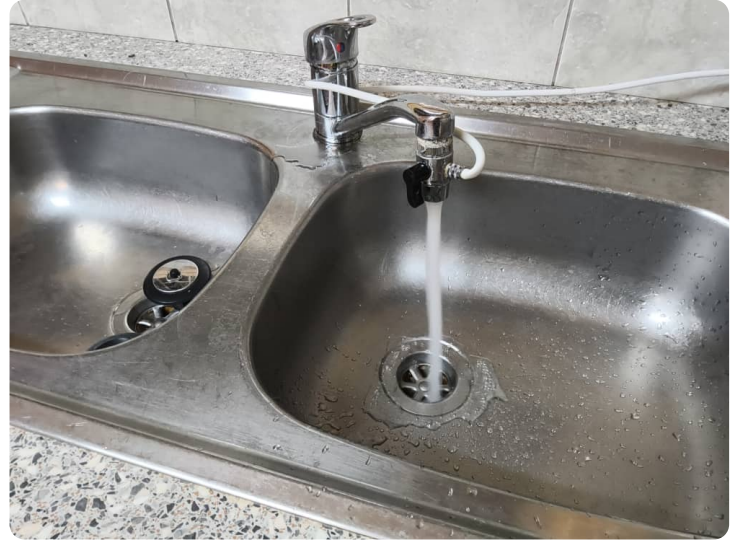
### 43. Plumbing

The taps to multiple areas were turned on and the water flow appeared to be reasonable. Water draining to several sinks and toilets appeared to be reasonable. The Building Inspector is not a Plumbing Contractor and is not permitted to test Plumbing items under WA Law. Where appropriate a Plumbing Contractor should be engaged to test the plumbing in the property.

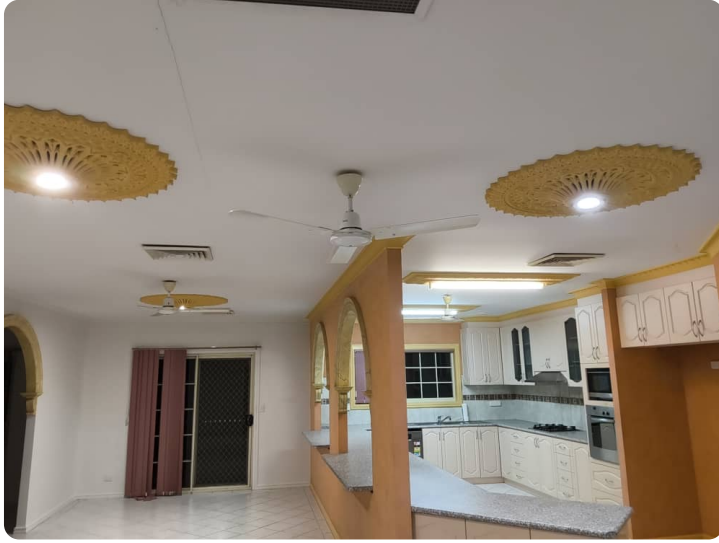
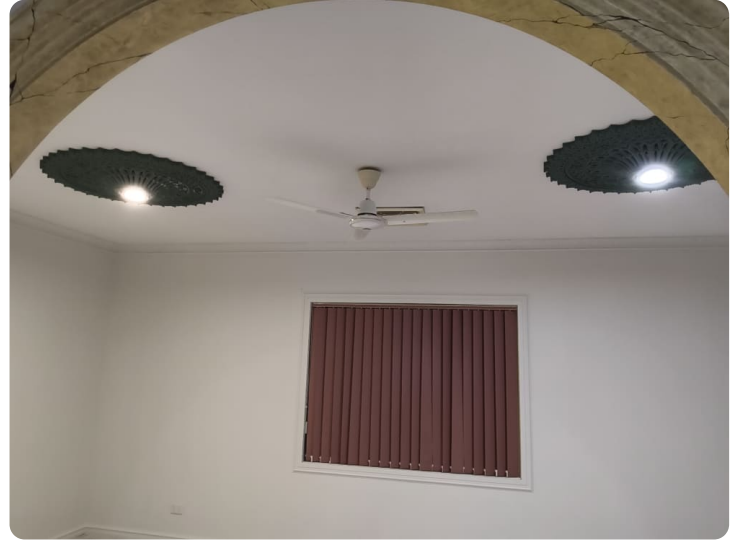
#### 44. Lights and power points

Several lights were turned on during the inspection and the lights appeared to be operational. The Building Inspector is not an Electrical Contractor and is not permitted to test Electrical items under WA Law. Where appropriate an Electrical Contractor should be engaged to test the electrical items in the property.

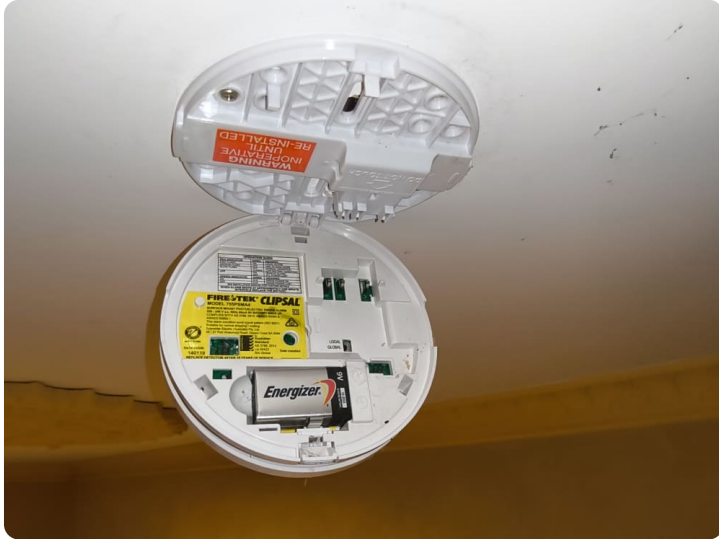
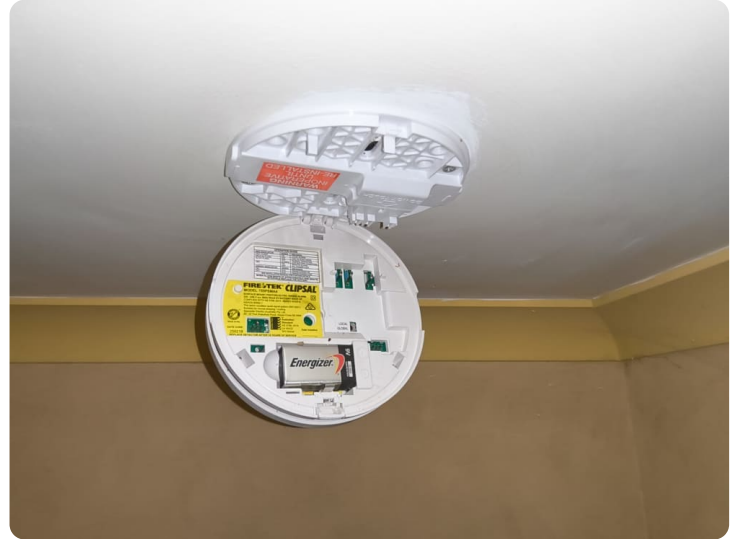
#### 45. Smoke Alarms

There were two hardwired smoke alarms on site. There were no battery smoke alarms on site. The location, number and type of smoke alarms appeared to be consistent with Legislative requirements. It is suggested that an Electrical Compliance Certificate be obtained in relation to the smoke alarms.
