**Building inspection**

**Job ID:** 89831

**Address:** 9 Blackwood Crescent, Dampier WA

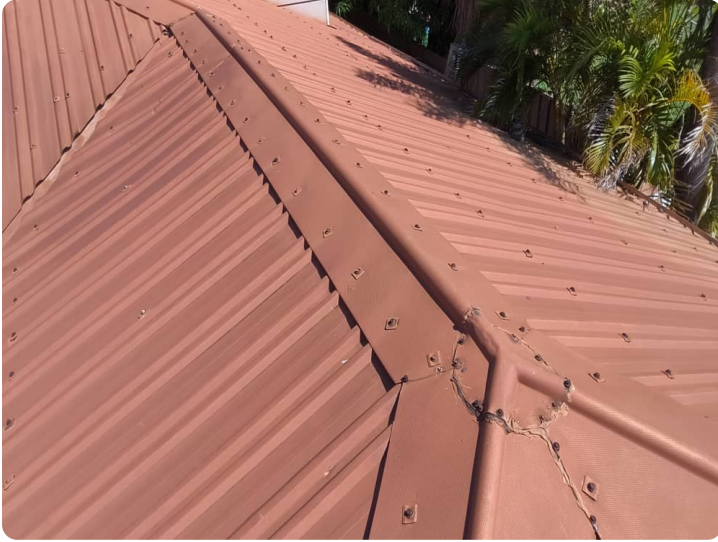
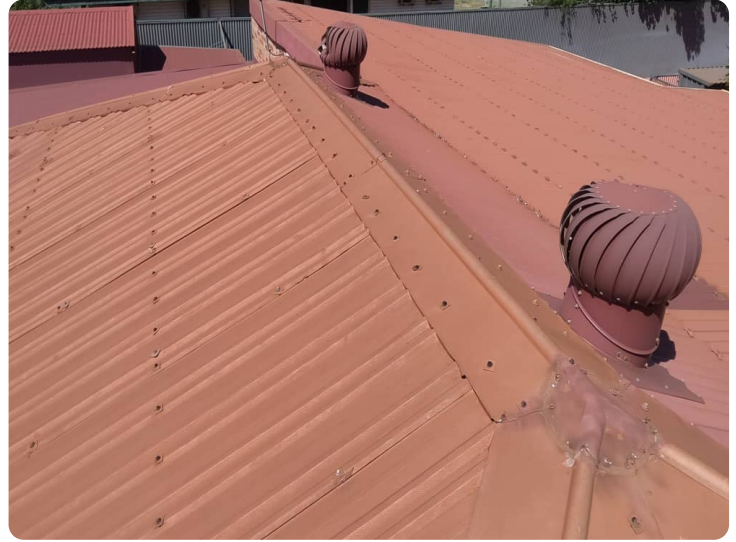
## 2. Ridges

The ridges and capping are fair in relation to their age and will require ongoing maintenance.

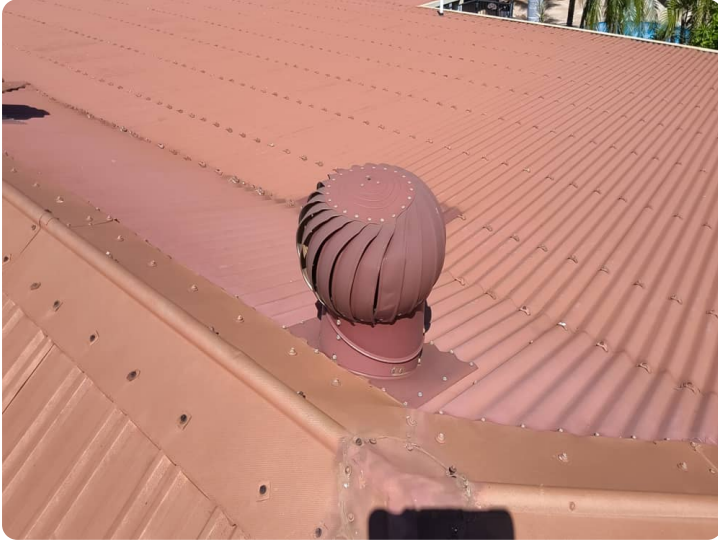
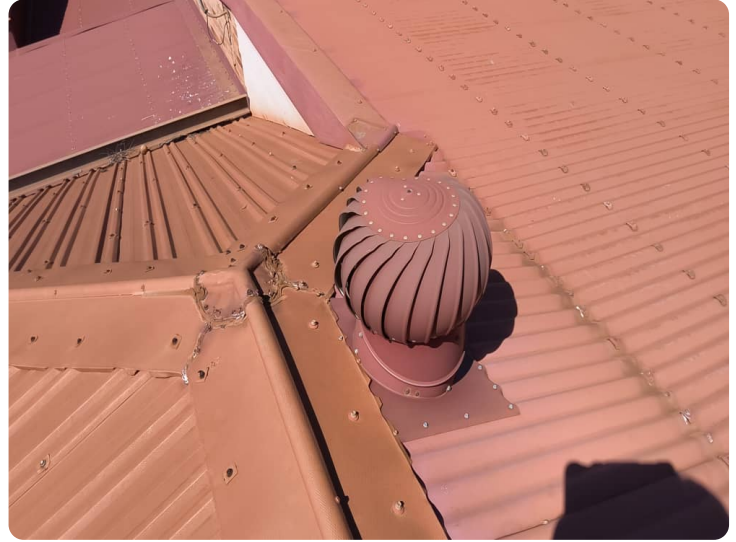
### 3. Roof vents

The roof vents are painted and constructed of metal. The condition of the vents is satisfactory in relation to their age and will require normal ongoing maintenance.

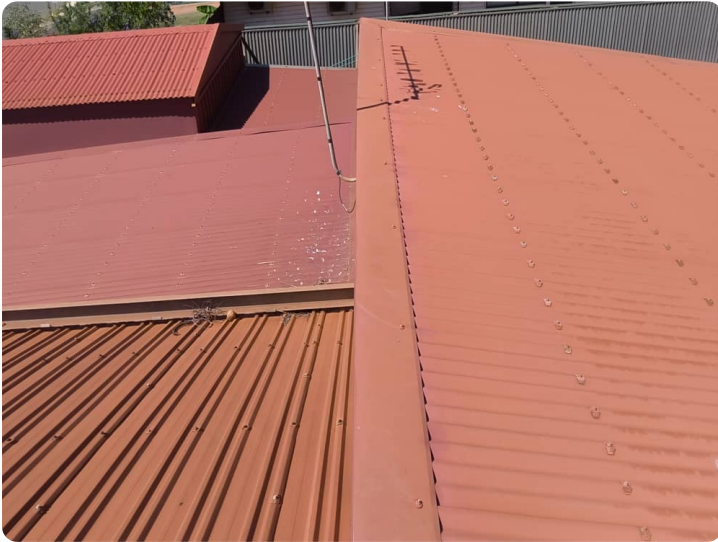
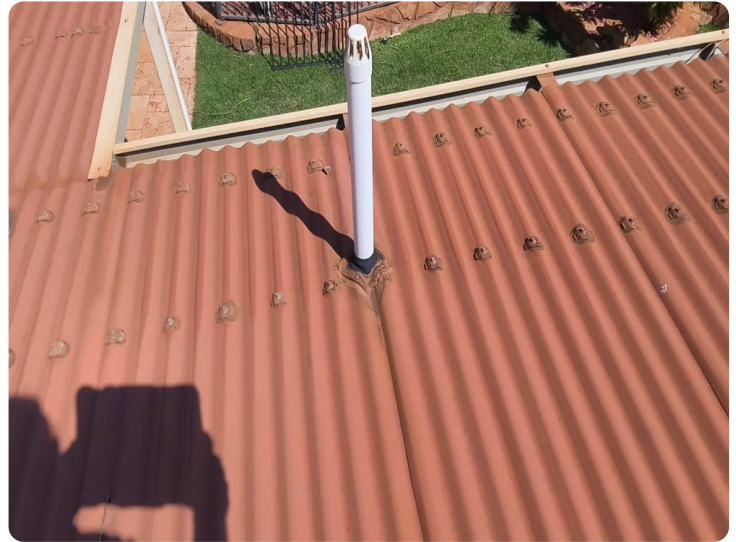
#### 4. Flashings

The flashings are covered with a variety of finishes and are constructed of a mixture of materials. The condition of the flashings is satisfactory in relation to their age and will require normal ongoing maintenance.

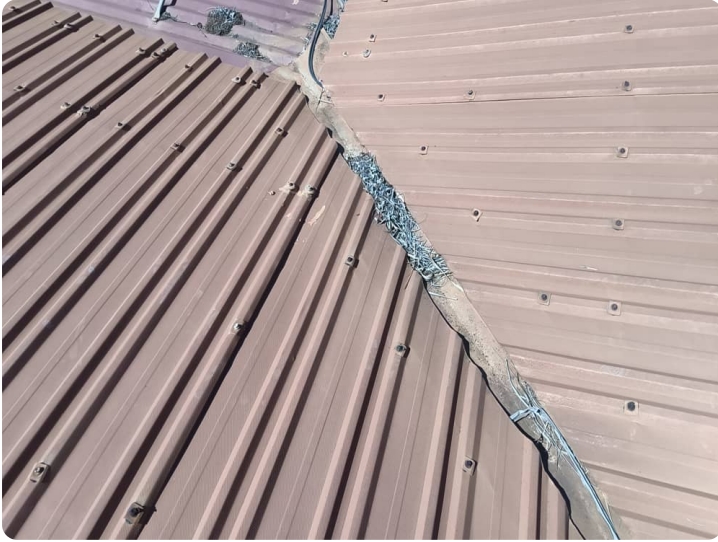
## 5. Valleys

The valleys are constructed of metal and are unpainted. The condition of the valleys is satisfactory in relation to their age and will require normal ongoing maintenance. The valleys need to be cleared of debris.

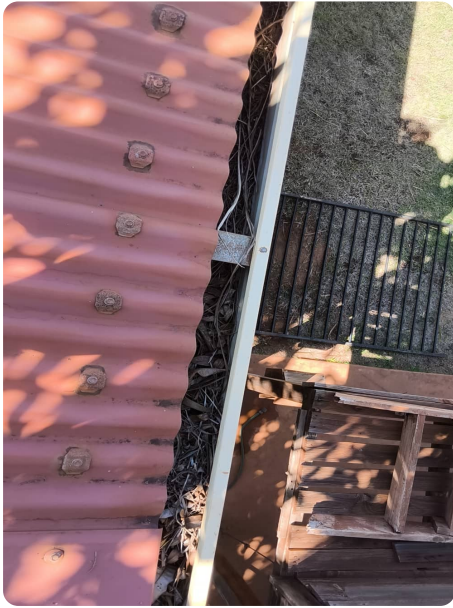
## 6. Gutters

The gutters are constructed of metal and they have a colorbond covering. The condition of the gutters is satisfactory in relation to their age and will require normal ongoing maintenance. The gutters need to be cleared of debris.

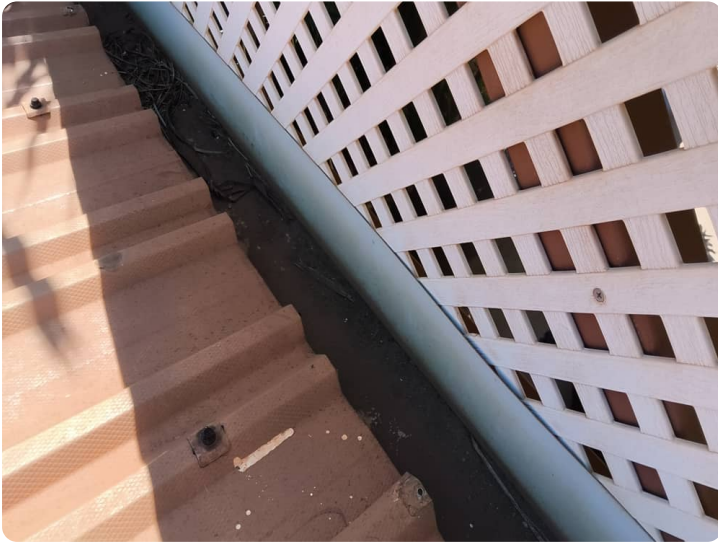
## 7. Box gutters

The box gutters are constructed of metal and they have a colorbond covering. The condition of the box gutters is satisfactory in relation to their age and will require normal ongoing maintenance. The box gutters need to be cleared of debris.

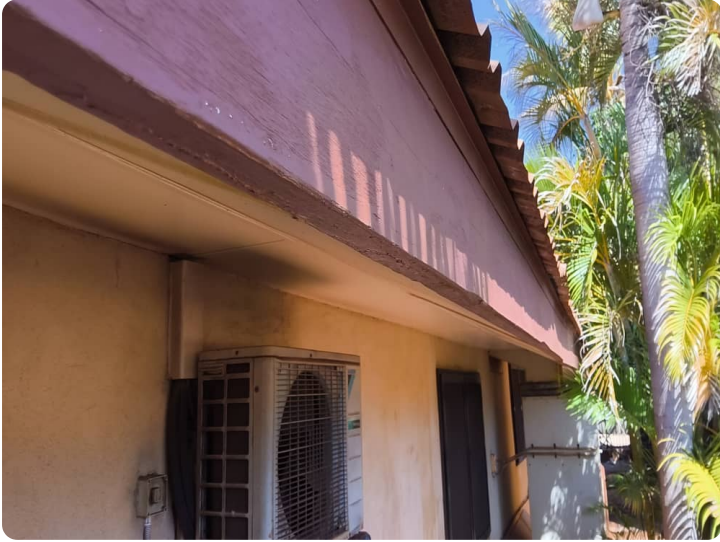
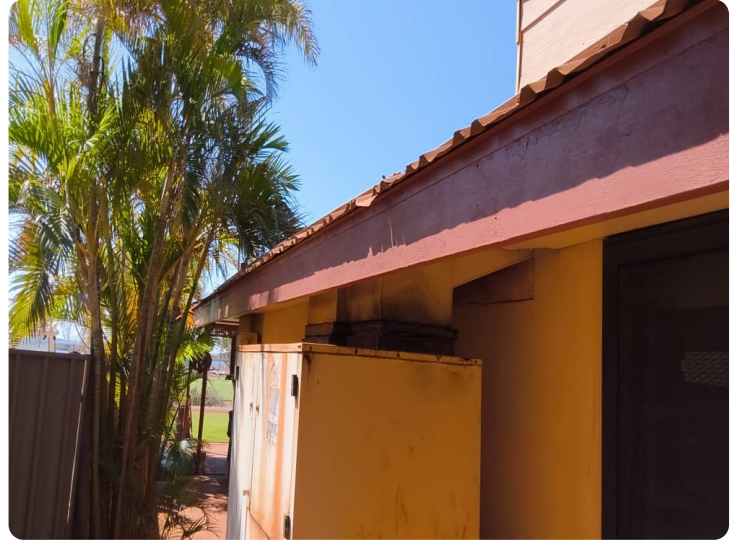
## 8. Fascia

The fascia are constructed of timber and they are painted. The condition of the fascia is satisfactory in relation to their age and will require normal ongoing maintenance.

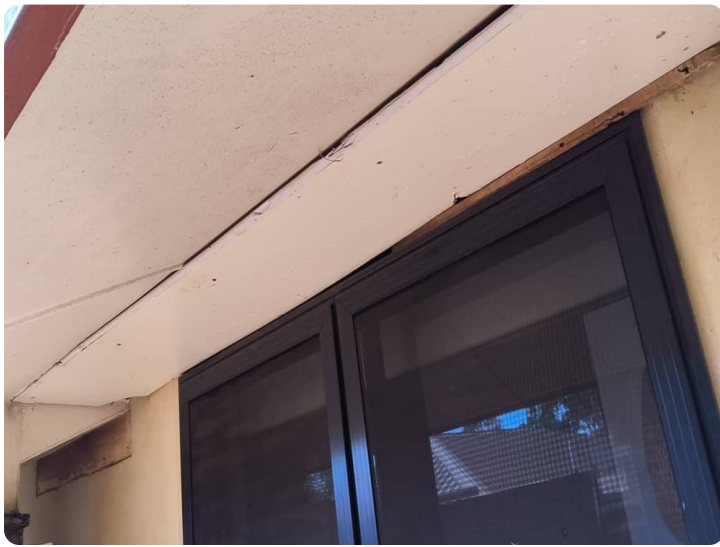
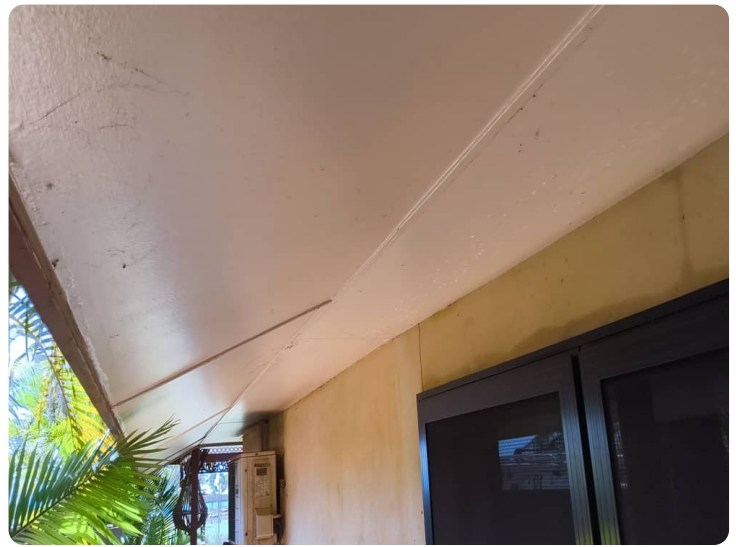
## 9. Eaves

The eaves are boxed and constructed of painted fibre cement. The condition of the eaves is satisfactory in relation to their age and will require normal ongoing maintenance. Please note that some of the building material utilised on or within the building may or may not contain asbestos. The Australian Government has indicated that asbestos can only be correctly identified through laboratory testing. The material on this building site may not pose a concern in the current static state if maintained but for any future works the material should be tested and appropriate measures used for asbestos handling if the material is subsequently found to contain asbestos.

### 9.1 Eaves damaged

The eave is damaged and requires repairs or replacement. The material should be tested where required and then a remediation plan established.

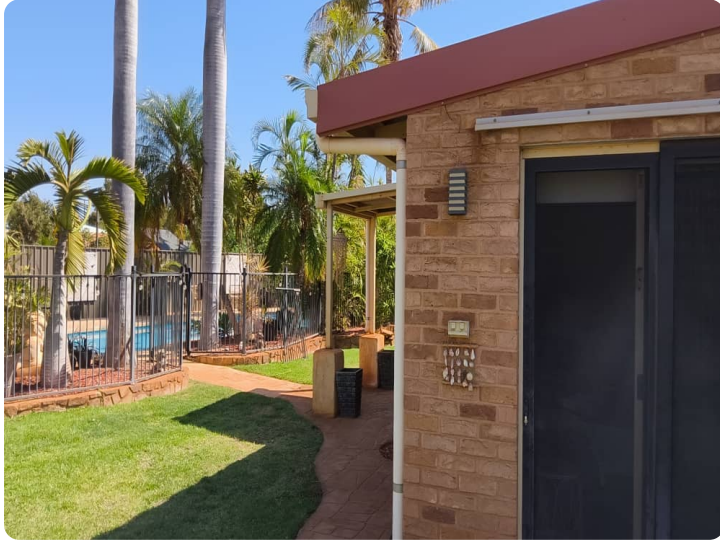
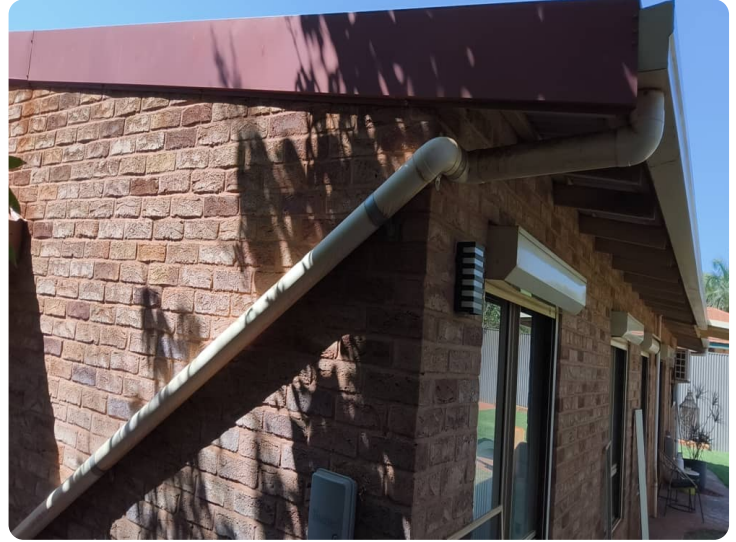
## 10. Downpipes

The downpipes are constructed of pvc or similar and they are unpainted. The condition of the downpipes is satisfactory in relation to their age and will require normal ongoing maintenance. The downpipes are

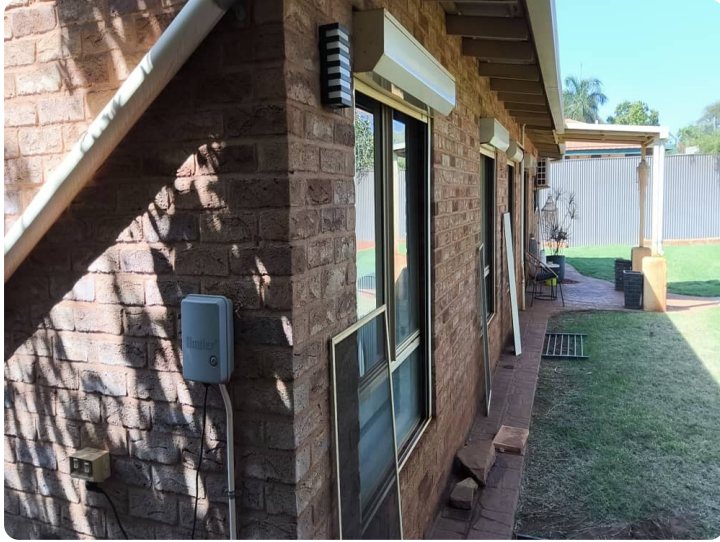
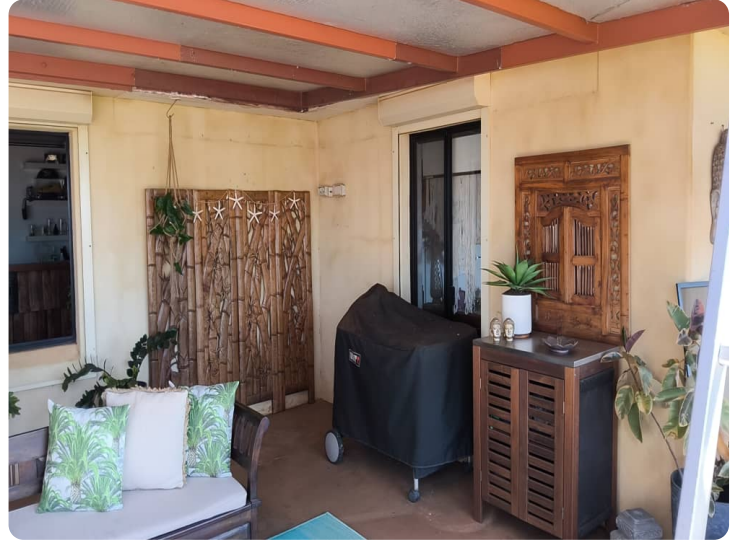
## 11. External walls

The external walls are constructed of face brick and painted rendered brick. The condition of the walls generally is satisfactory in relation to their age and will require normal ongoing maintenance.

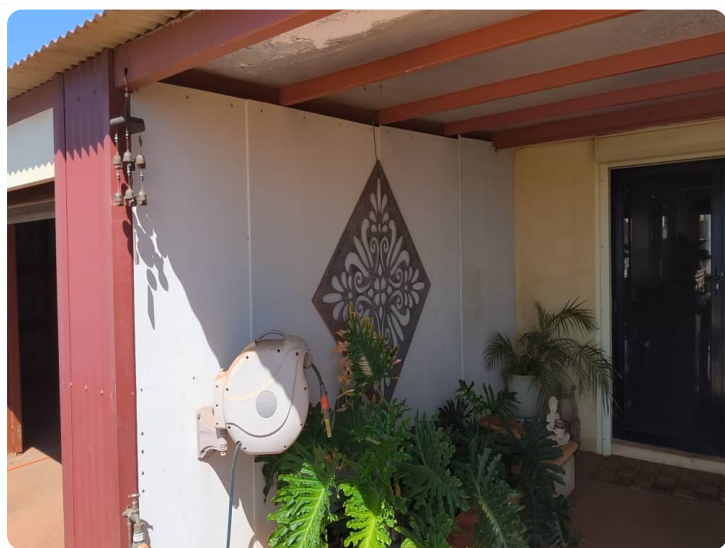
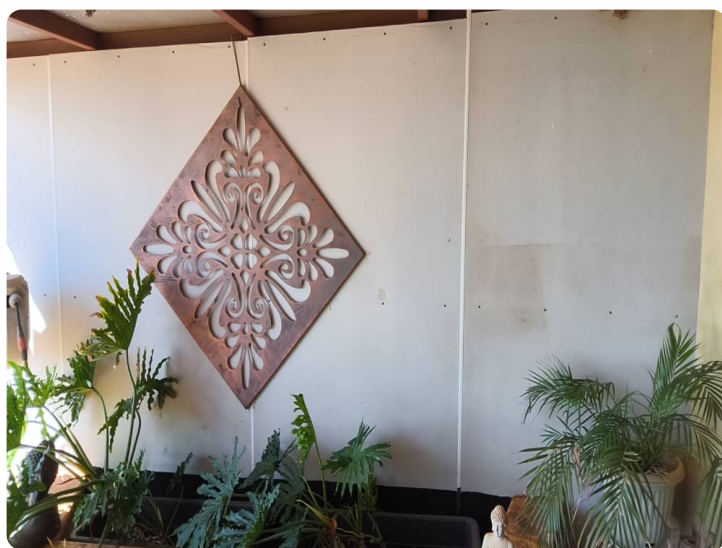
## 12. Wall cladding

The external walls are (or partially are) clad with fibre cement. The condition of the cladding is generally satisfactory in relation to its age and will require normal ongoing maintenance. Please note that some of the building material utilised on or within the building may or may not contain asbestos. The Australian Government has indicated that asbestos can only be correctly identified through laboratory testing. The material on this building site may not pose a concern in the current static state if maintained but for any future works the material should be tested and appropriate measures used for asbestos handling if the material is subsequently found to contain asbestos.

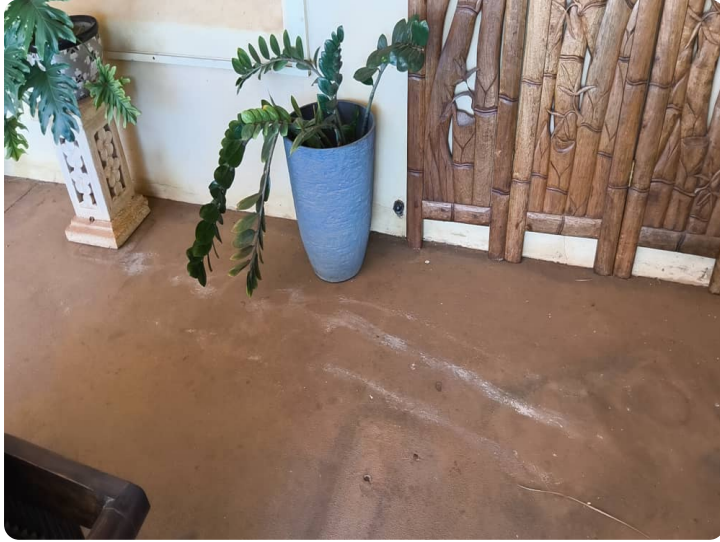
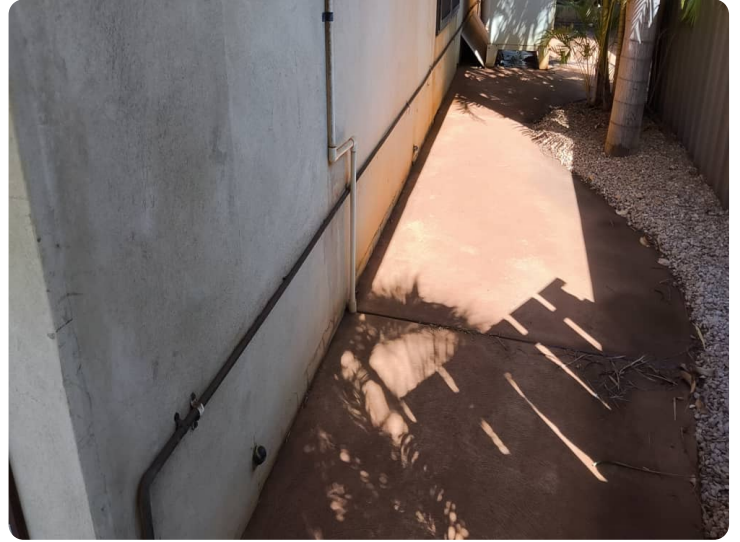
### 13. Footings

The footings are below ground and cannot be seen. The condition of the footings cannot be determined.

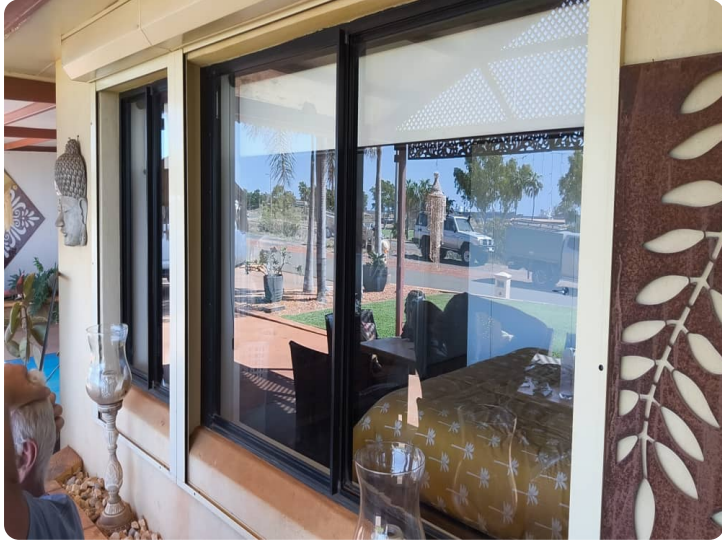
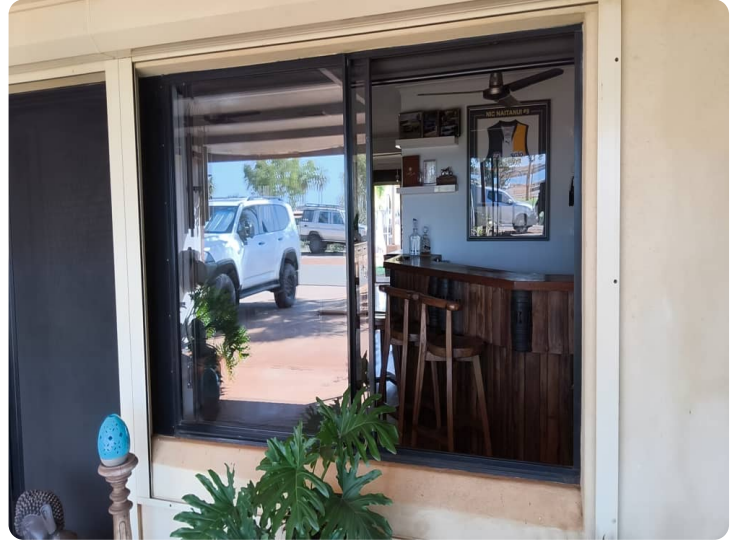
#### 14. Windows and window frames

The window and window frames are primarily constructed of aluminium. The condition of the window and window frames is generally satisfactory in relation to its age and will require normal ongoing maintenance.

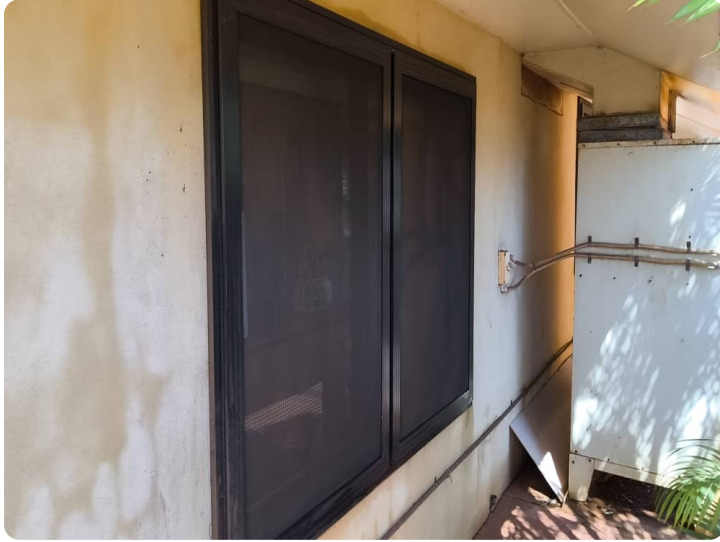
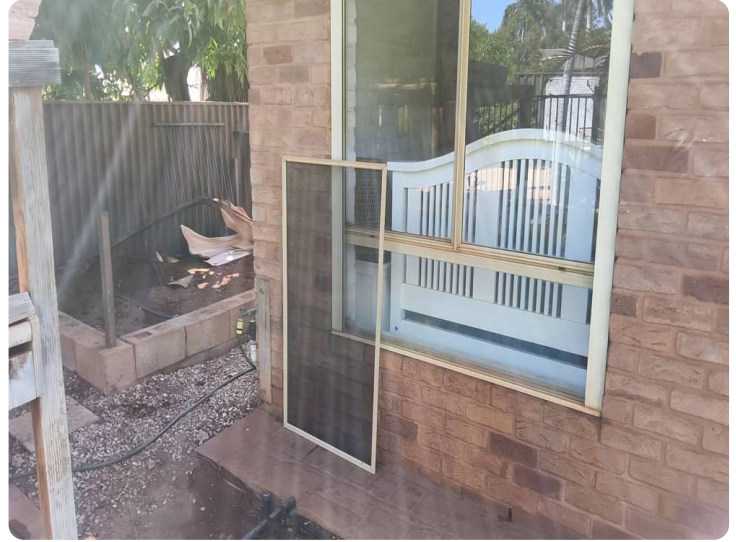
### 15. Window fly screens

Fly screens have been installed to all of the windows. The condition of the window fly screens is generally satisfactory in relation to its age and will require normal ongoing maintenance.

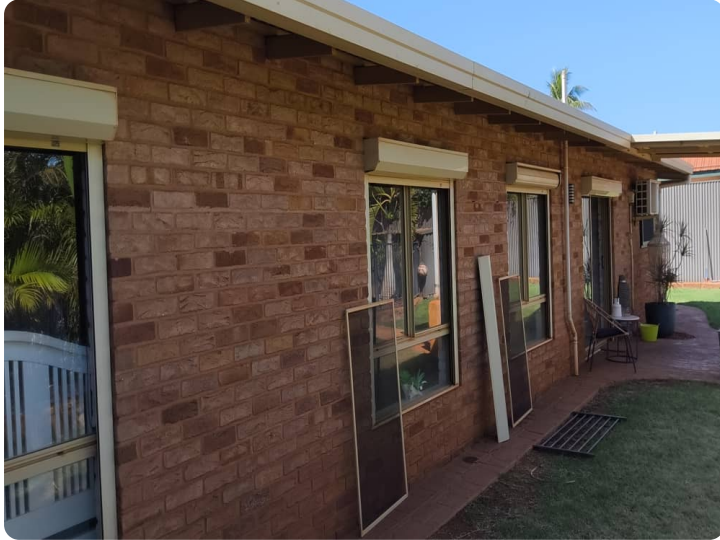
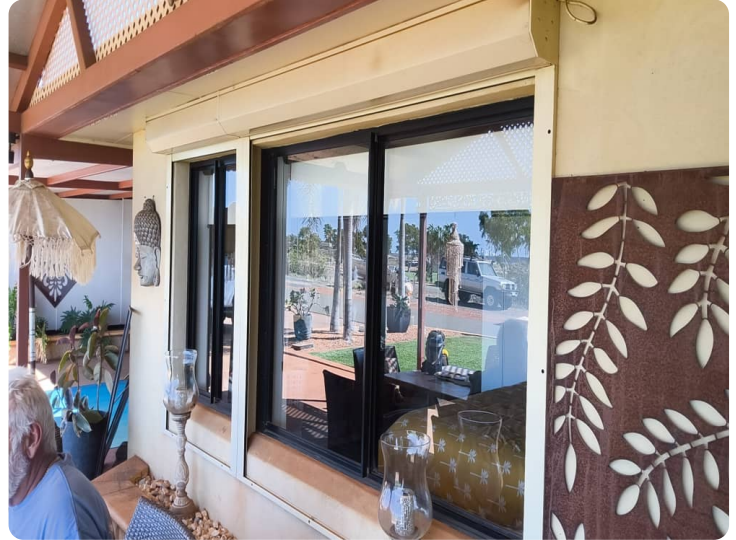
## 16. Roller shutters

Roller shutters have been installed to some of the windows. The condition of the roller shutters is satisfactory in relation to its age and will require normal ongoing maintenance.

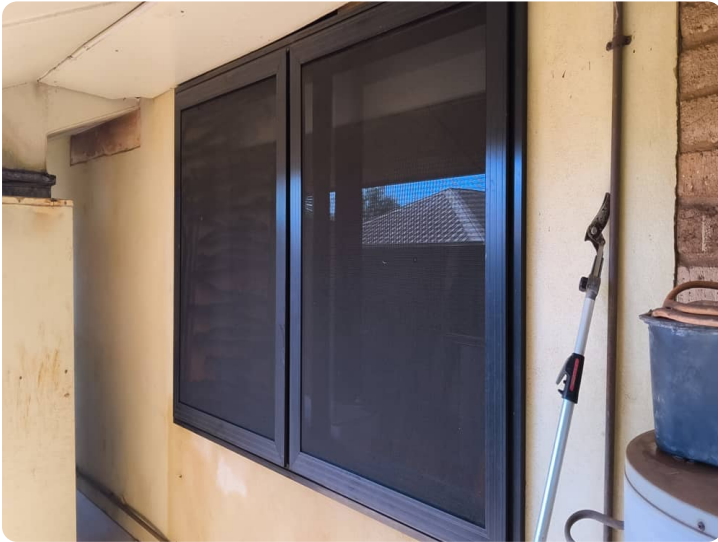
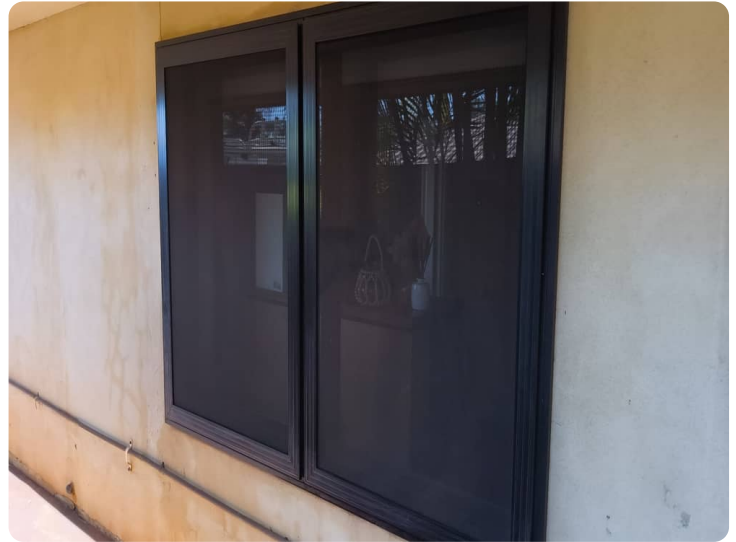
### 17. Cyclone screens

Cyclone screens have been installed to all of the windows. The condition of the cyclone screens is satisfactory in relation to its age and will require normal ongoing maintenance. The cyclone screens appear to be compliant with local requirements.

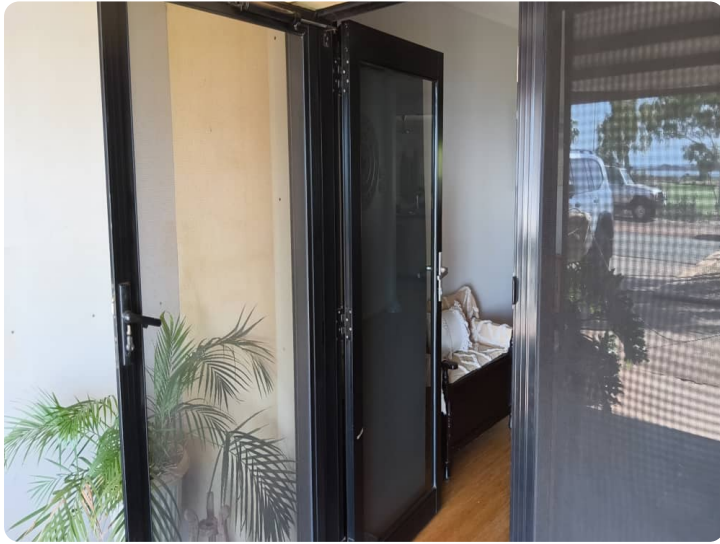
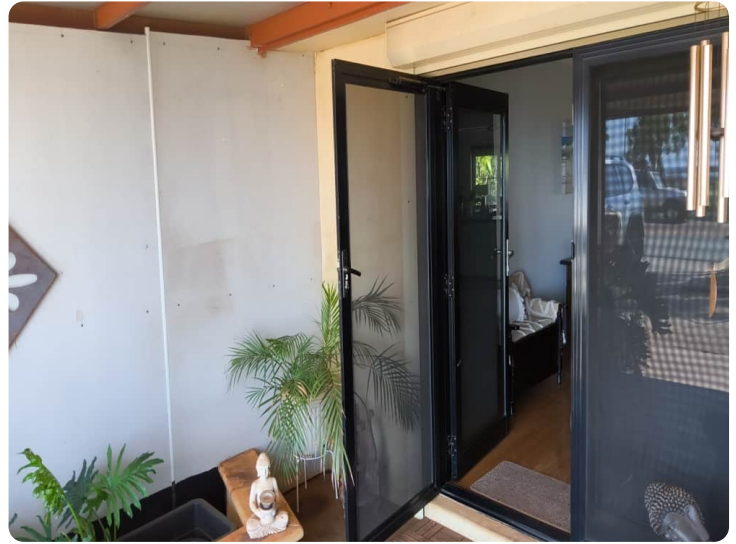
## 18. Front door

The front door is constructed of aluminium and glass . The condition of the front door is satisfactory in relation to its age and will require normal ongoing maintenance. Deadlocks have been installed. A security screen door has been fitted.

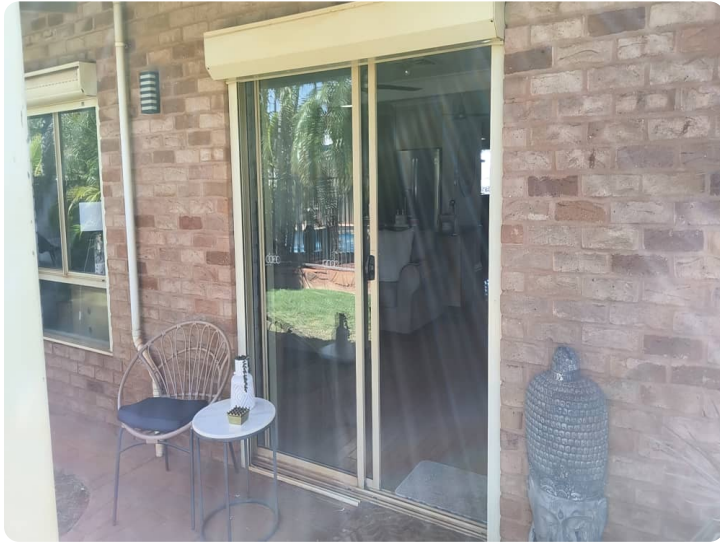
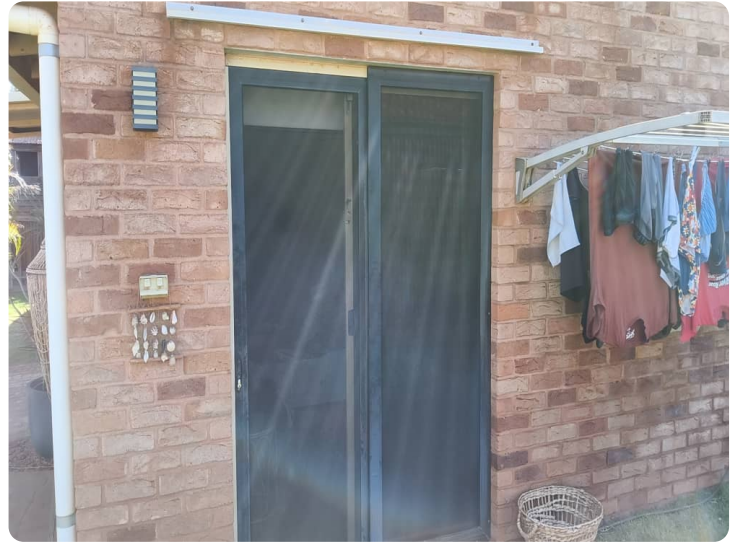
### 19. Other external doors

Other external doors are constructed of aluminium. The condition of the other external doors is satisfactory in relation to its age and will require normal ongoing maintenance.

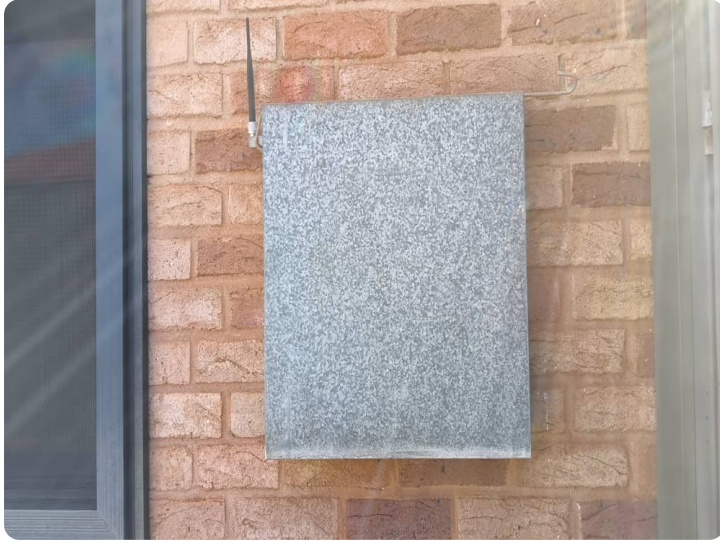
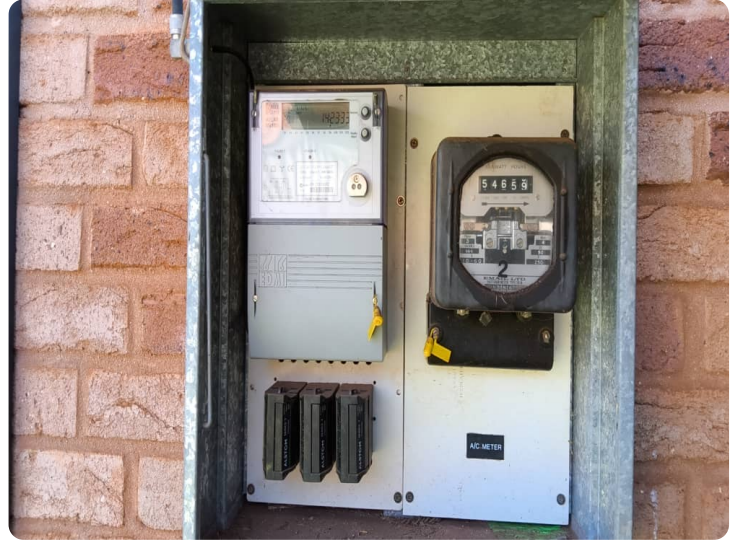
## 20. Meter box and power

Access to the meter box or sub board was available. The meter box or sub board is not lockable. Power phase type to the site is three phase.

There were multiple Residual Current Devices (RCD)(s) noted in the meter box or sub meter box. The RCD(s) were not tested. It is suggested that an Electrical Compliance Certificate be obtained in relation to the RCD(s).

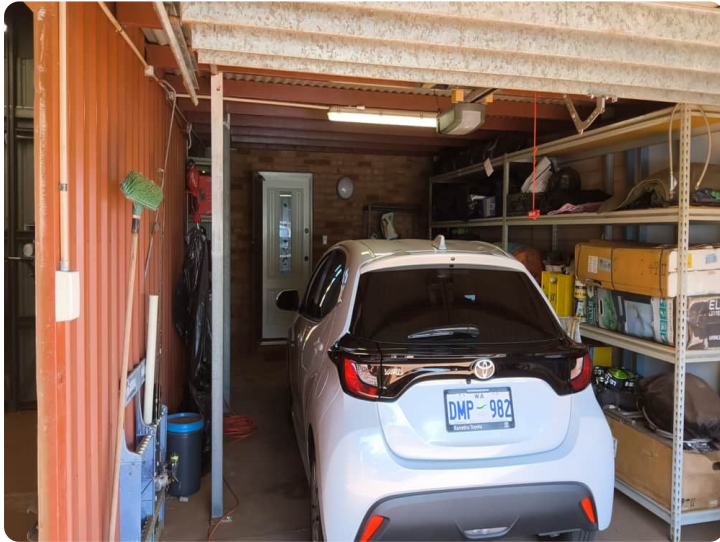
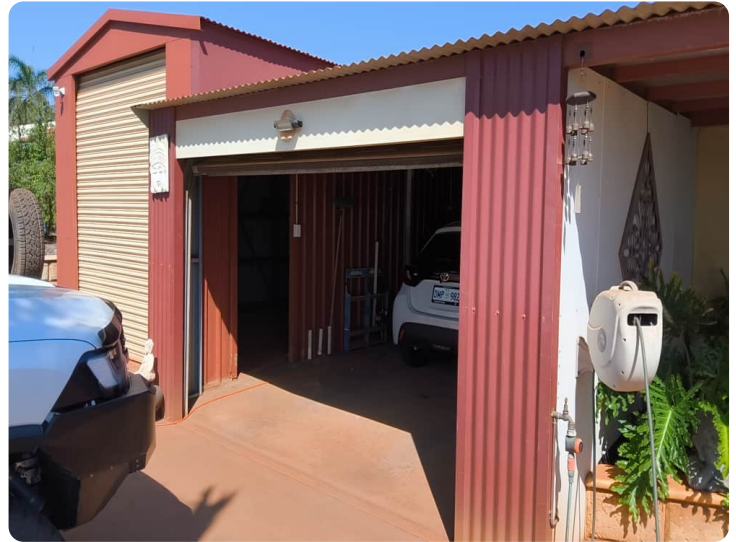
## 22. Carport or Garage (Primary)

There is a primary garage on the property constructed of metal. The condition of the carport or garage is satisfactory in relation to its age and will require normal ongoing maintenance. Access and visibility of the area was restricted by stored items.

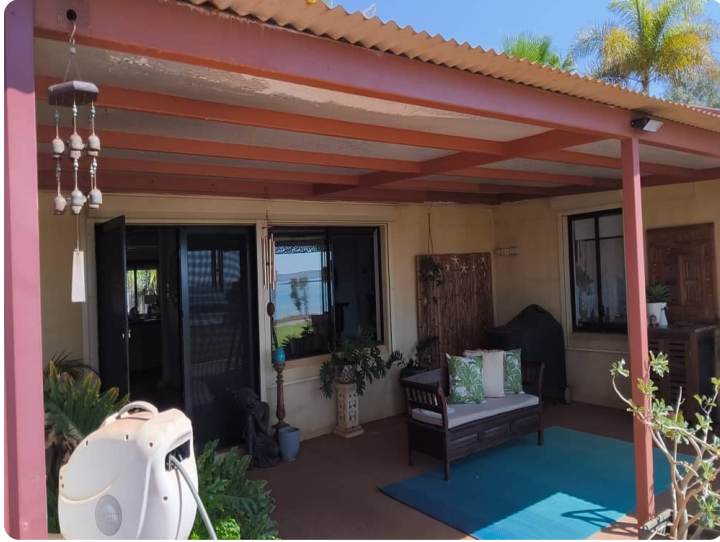
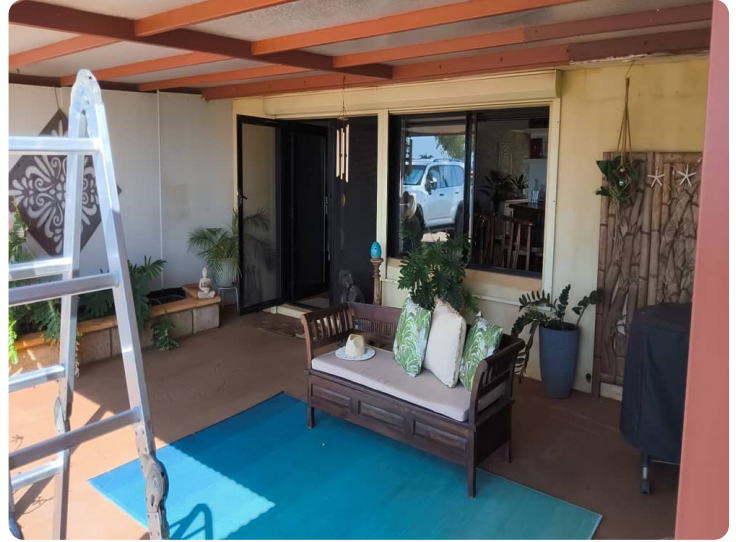
### 23. Veranda (Primary)

The primary veranda is constructed of metal. The condition of the veranda is satisfactory in relation to its age and will require normal ongoing maintenance.

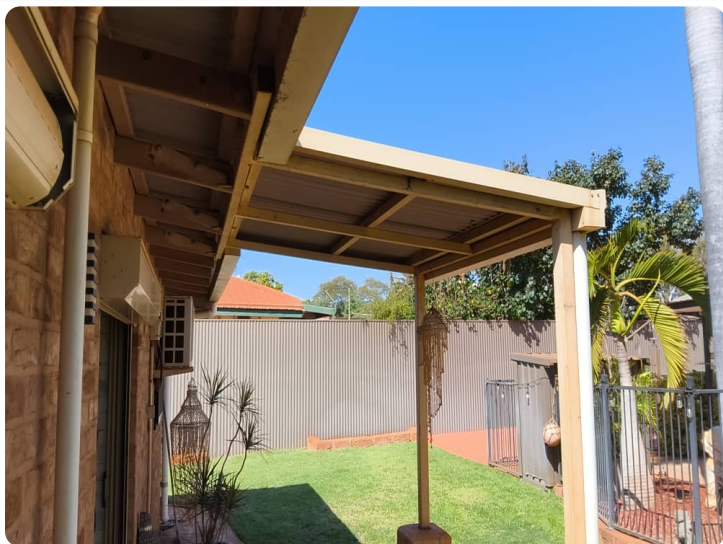
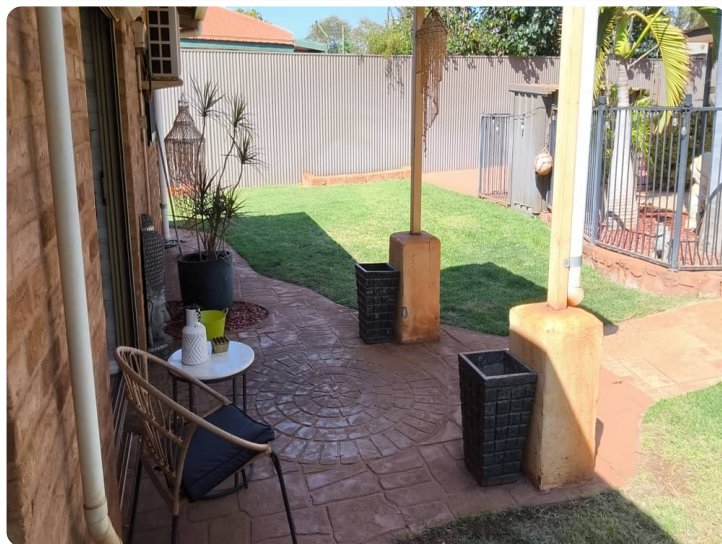
## 24. Veranda (Secondary)

The secondary veranda is constructed of metal. The condition of the veranda is satisfactory in relation to its age and will require normal ongoing maintenance.

### 24.1 Metal posts rusted - minor

Metal support posts are rusted and require maintenance to prolong their life. Photos showing visible cracks, these are not of structural issues, it is only result from poor rendering job, cosmetic only.

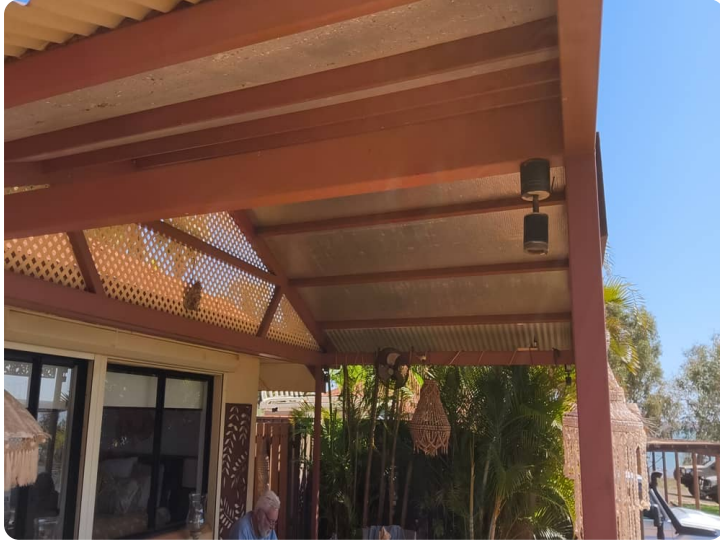
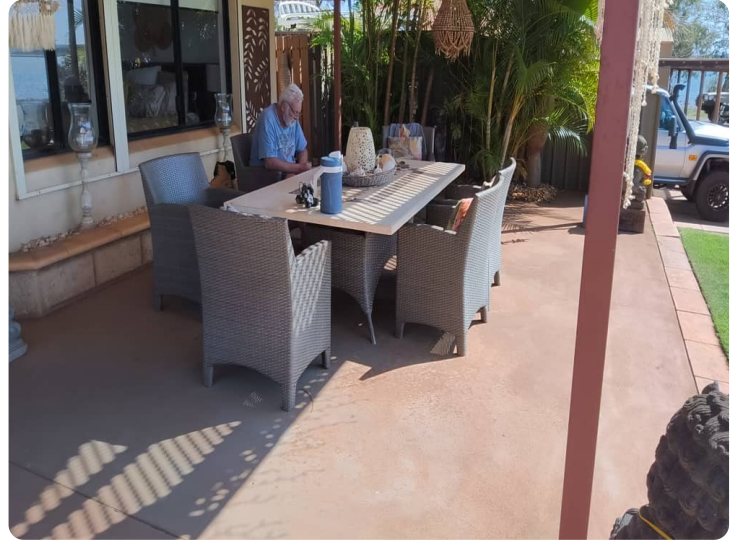
## 25. Patio

The primary patio is constructed of metal. The condition of the patio is satisfactory in relation to its age and will require normal ongoing maintenance.

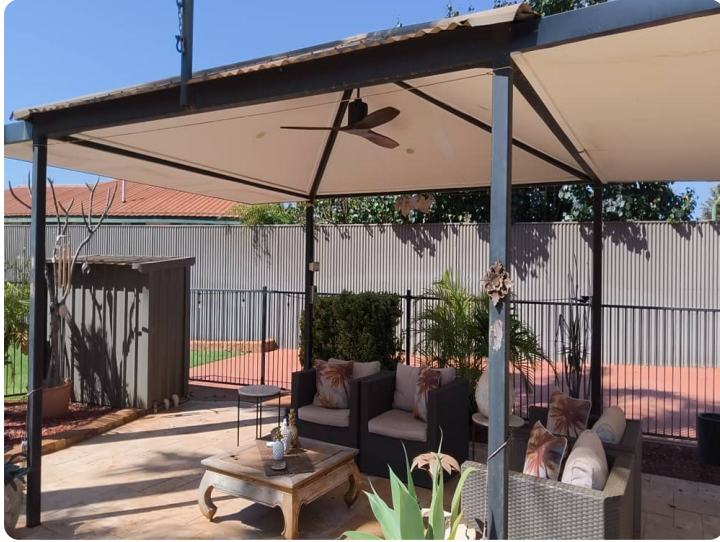
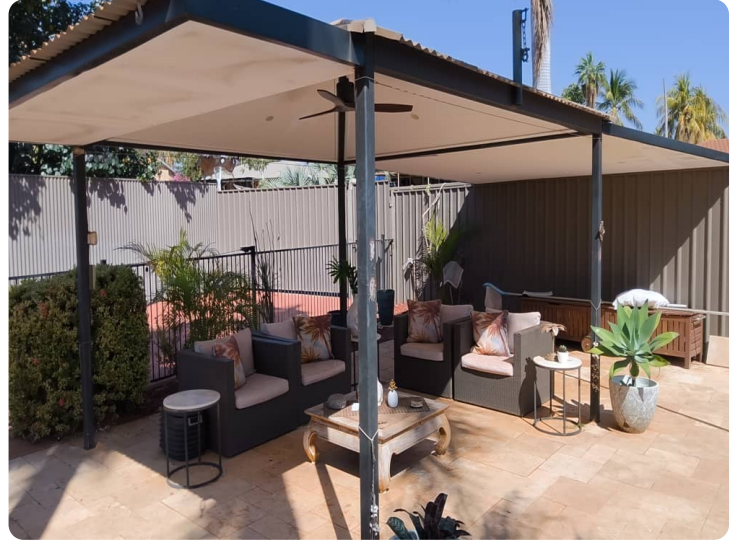
## 26. Gazebo

The gazebo is constructed of metal. The condition of the gazebo is satisfactory in relation to its age and will require normal ongoing maintenance.

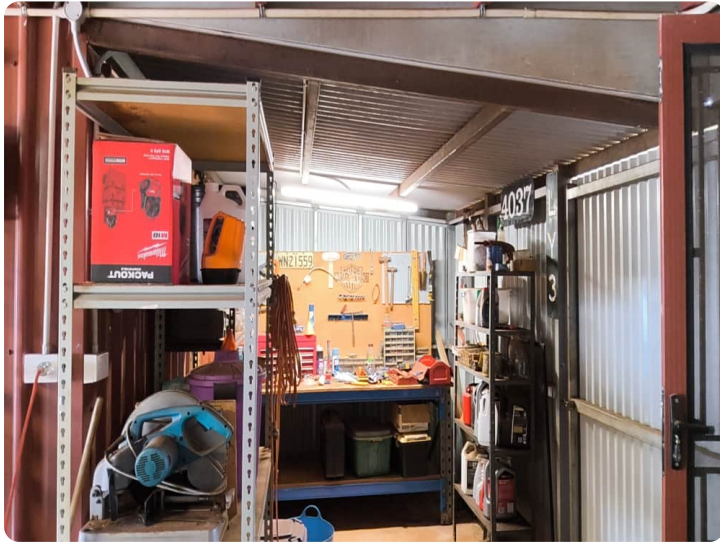
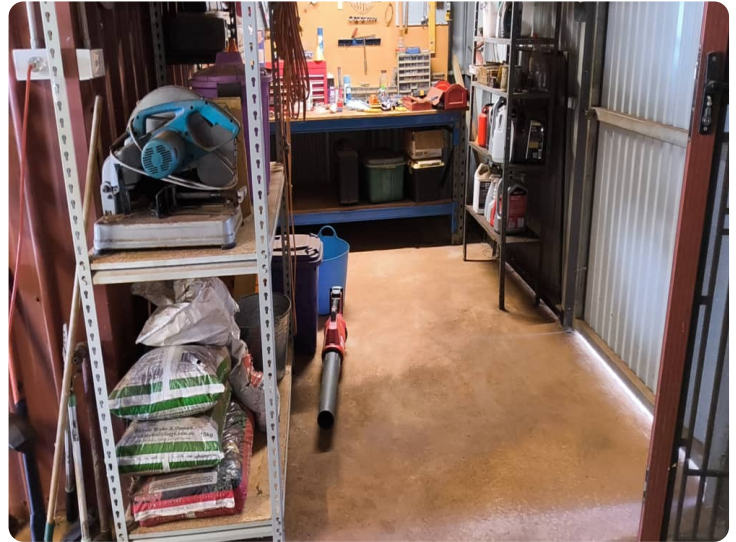
### 27. Garden shed primary

The primary garden shed is constructed of metal. The condition of the garden shed is satisfactory in relation to its age and will require normal ongoing maintenance. Access and visibility of the area was restricted by stored items.

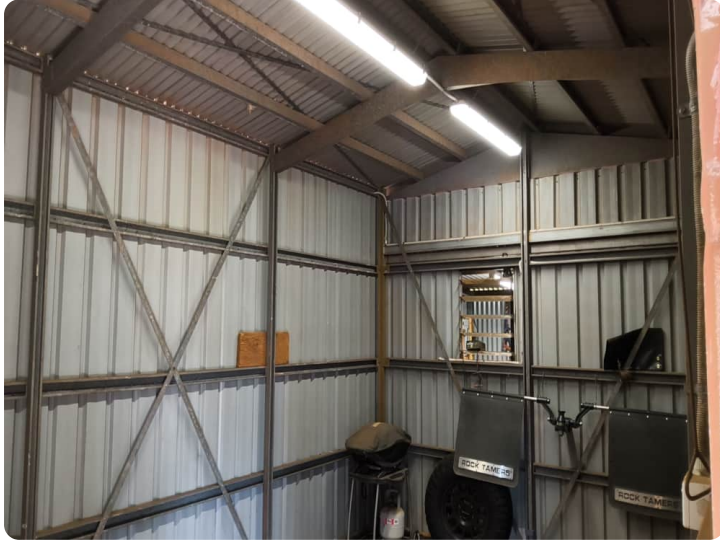
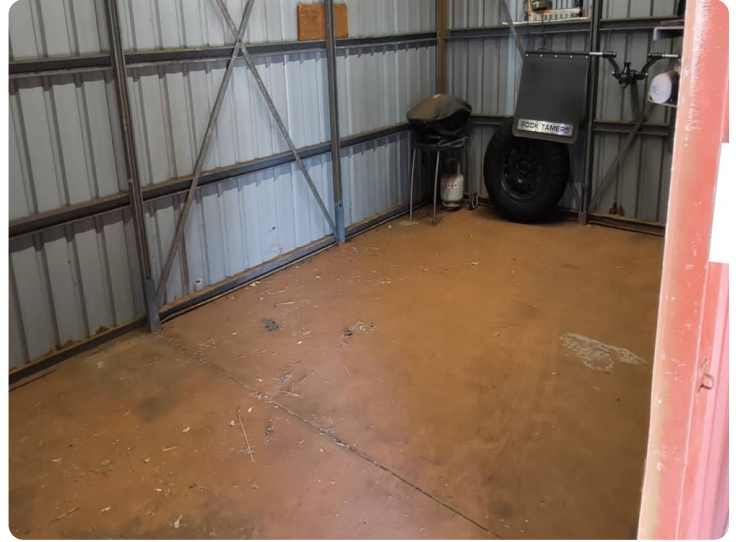
## 28. Large shed

The large shed is constructed of metal. The condition of the large shed is satisfactory in relation to its age and will require normal ongoing maintenance.

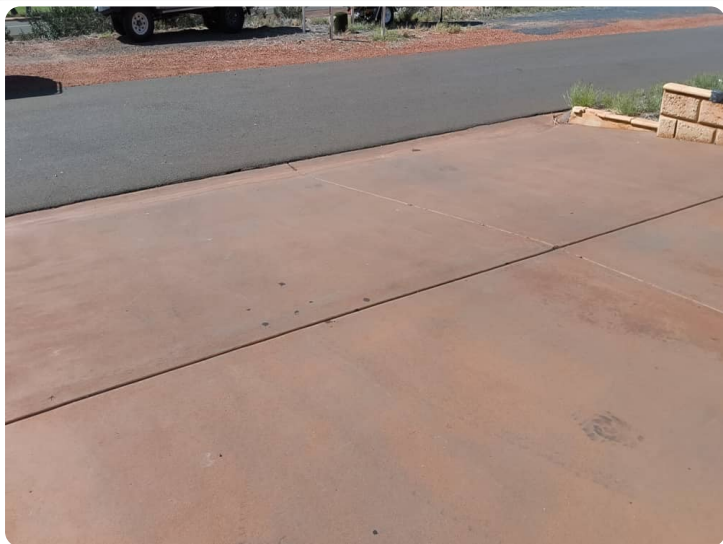
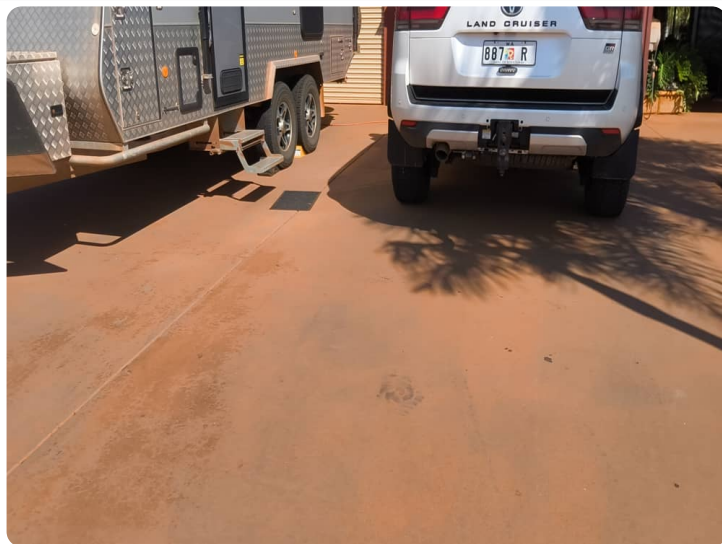
## 29. Driveway

The driveway and cross over is constructed of concrete. The condition of the driveway is satisfactory in relation to its age and will require normal ongoing maintenance.

### 29.1 Concrete cracking - minor

Cracking was noted to the concrete driveway. This is not of a structural concern. Cracks should be filled to avoid further deterioration.

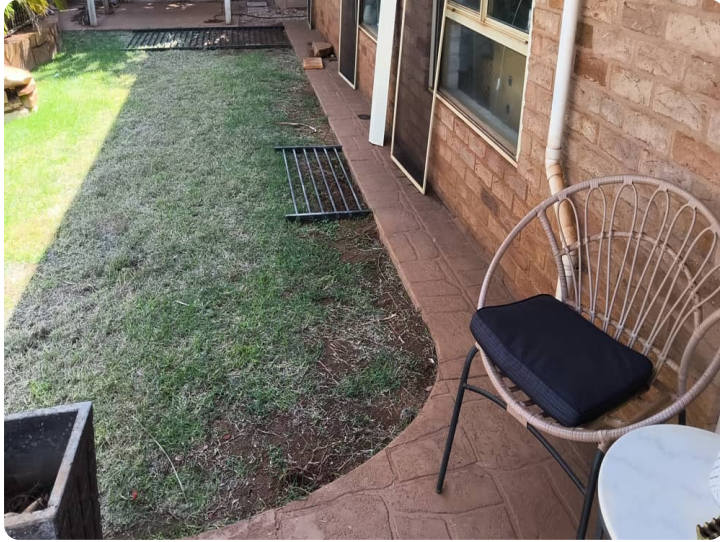
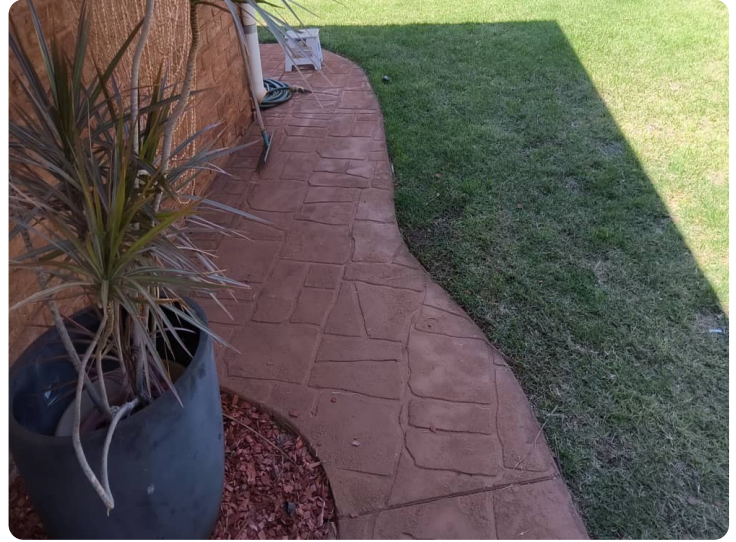
### 30. External walkways and paved areas

The external walkways and paved areas are constructed of concrete. The condition of the external walkways and paved areas is satisfactory in relation to its age and will require normal ongoing maintenance.
