**Building inspection**

**Job ID:** 89831

**Address:** 9 Blackwood Crescent, Dampier WA

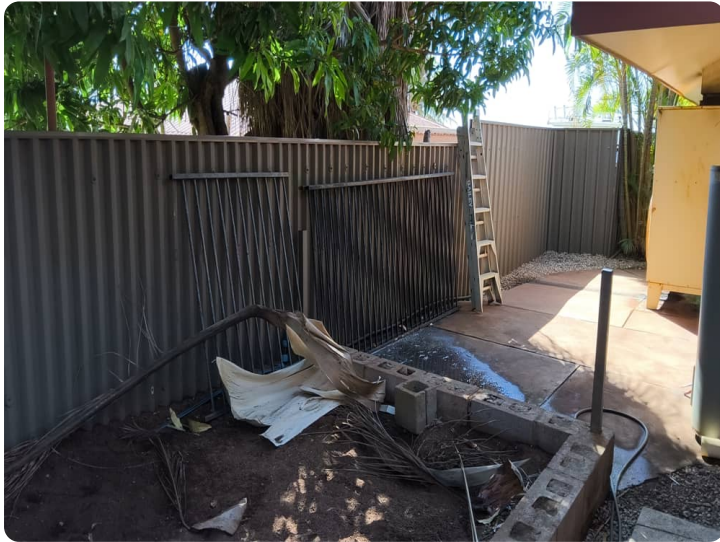
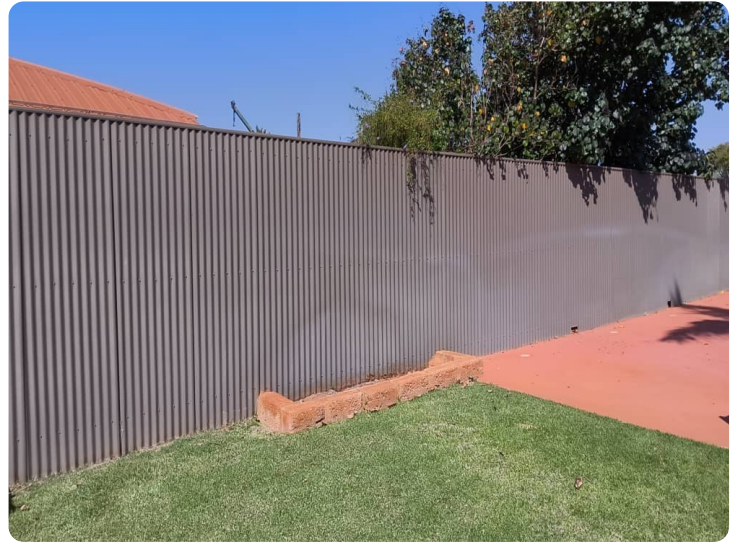
### 31. Fences - boundary

The boundary fences are constructed of metal. The condition of the boundary fence is satisfactory in relation to its age and will require normal ongoing maintenance. Some of the fences could not be viewed due to vegetation, stored items or secondary structures.

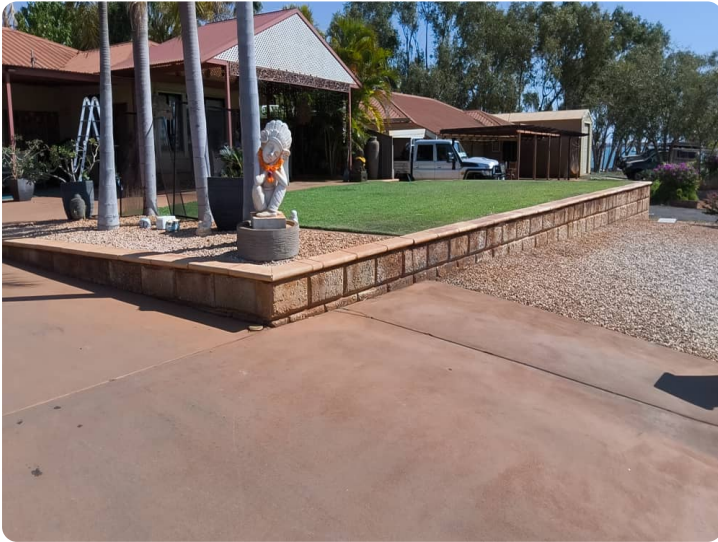
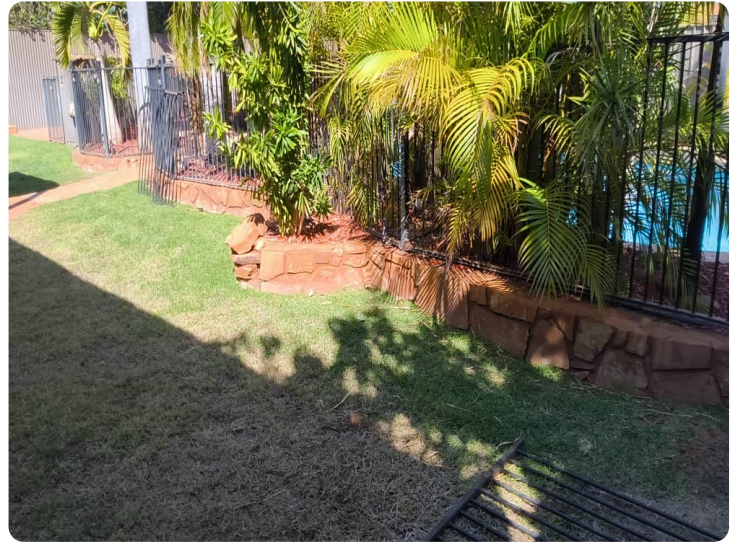
## 32. Retaining walls

The retaining walls are constructed of variety of materials. The condition of the retaining wall is satisfactory in relation to its age and will require normal ongoing maintenance. Some of the fences could not be viewed due to vegetation, stored items or secondary structures.

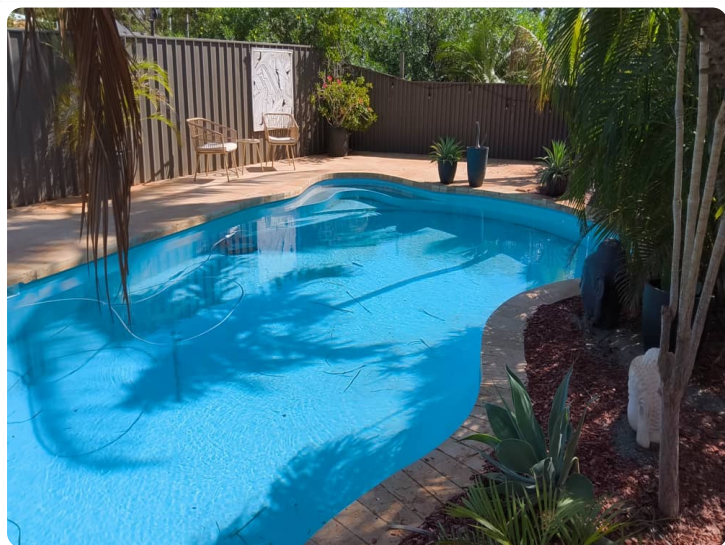
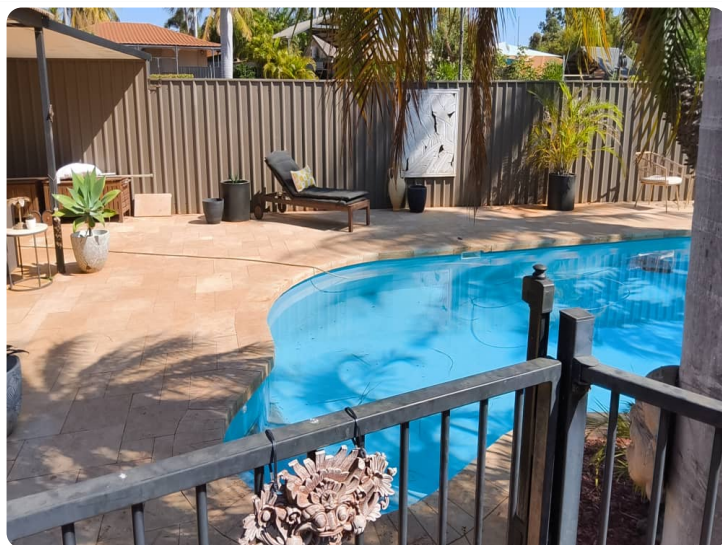
### 33. Pool (isolation fencing)

The pool is situated below ground. The external pool on the property is constructed of concrete. In relation to subsidence to the ground immediately adjacent to the pool, no significant subsidence was noted. There is isolation fencing installed around the pool. The isolation fencing and gates appear to be consistent with current pool fencing requirements. It is recommended that a copy of the previous Council Pool Safety Compliance Certificate is obtained. It is recommended that a pool maintenance contractor review and confirm the operation of all pool equipment.

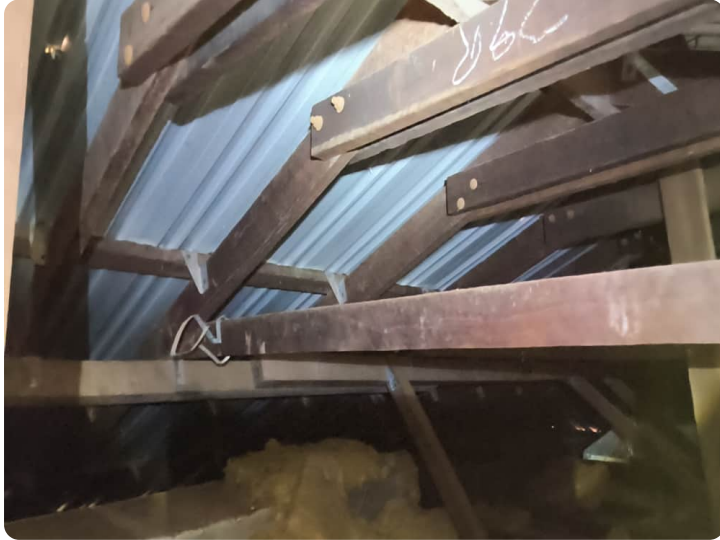
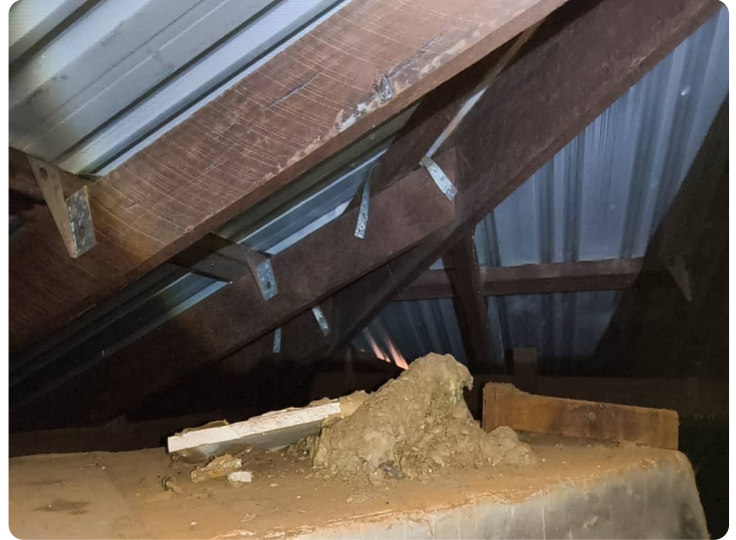
#### 34. Under side of roof cover

The condition of the underside of the roof cover is satisfactory in relation to its age and will require normal ongoing maintenance.

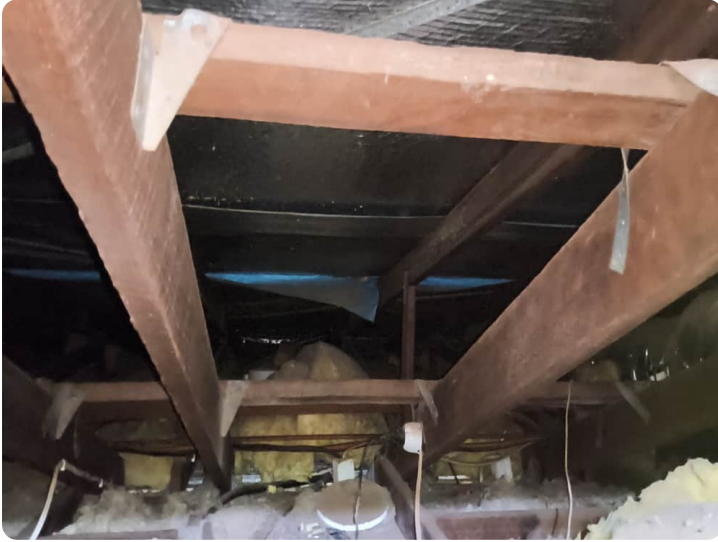
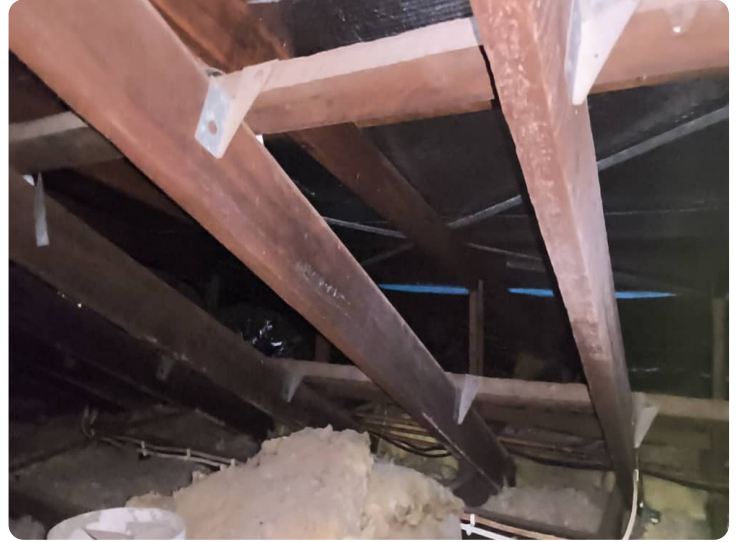
### 35. Sarking

Sarking to the underside of the roof was installed and was considered effective. Extension only.

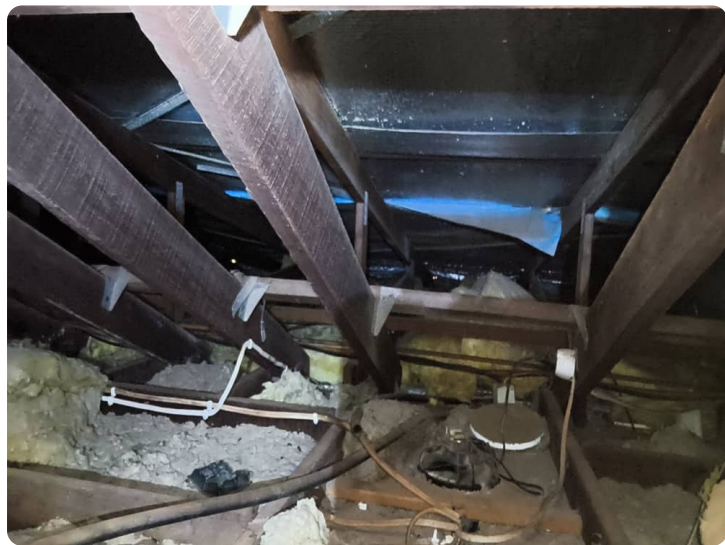
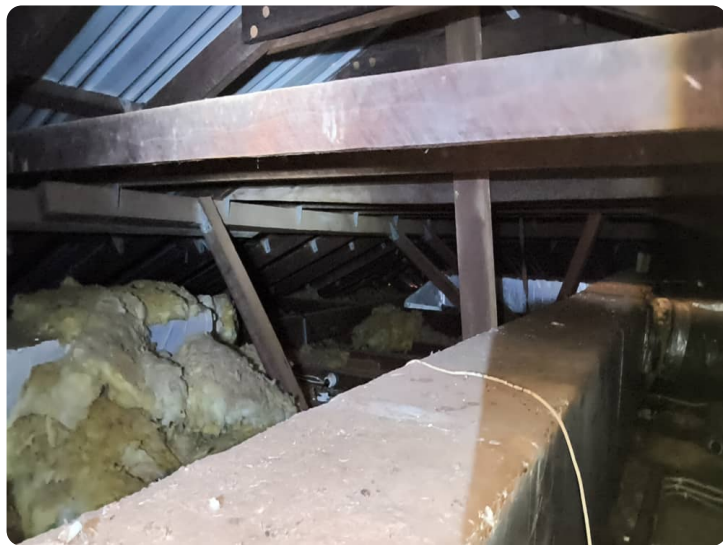
### 36. Roof frame

The roof frame type is both a traditional timber stick frame with timber trusses to the exstention. The condition of the roof frame is satisfactory in relation to its age and will require normal ongoing maintenance. Access to the roof space was restricted by the pitch of the roof, insulation, ducting or other items. The inspector estimates that visibility was available to more than 50% of the area.

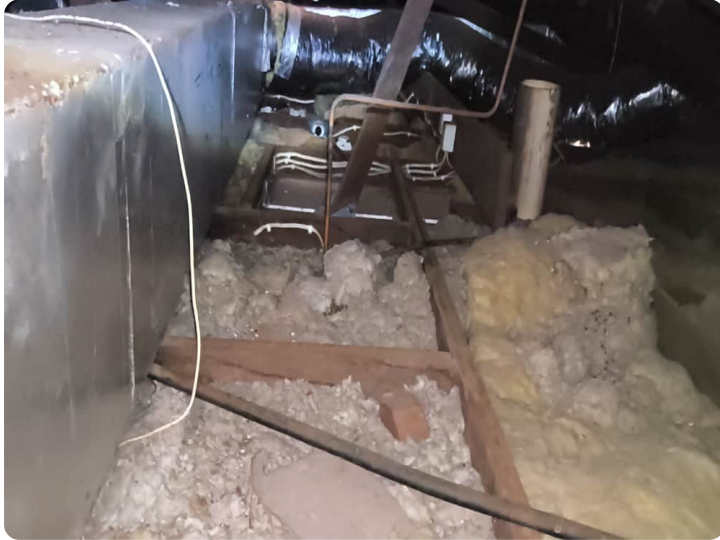
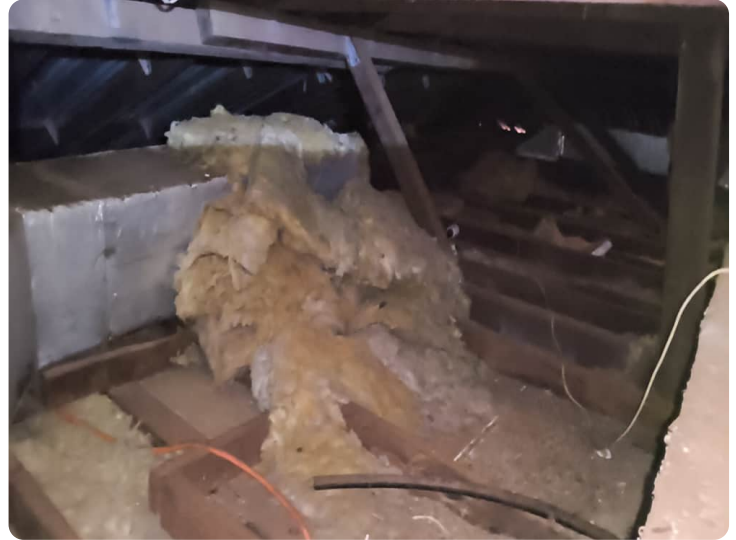
### 37. Insulation

Insulation was installed. Where insulation was installed it was considered effective. The insulation type was predominately batt or rolled type insulation.

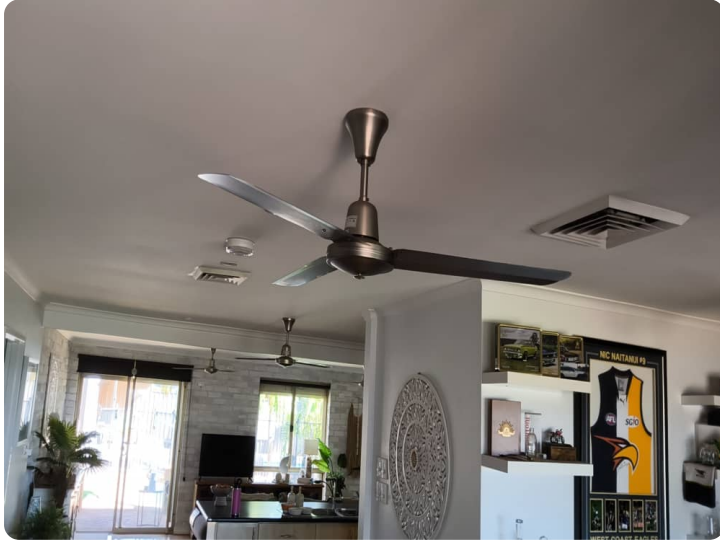
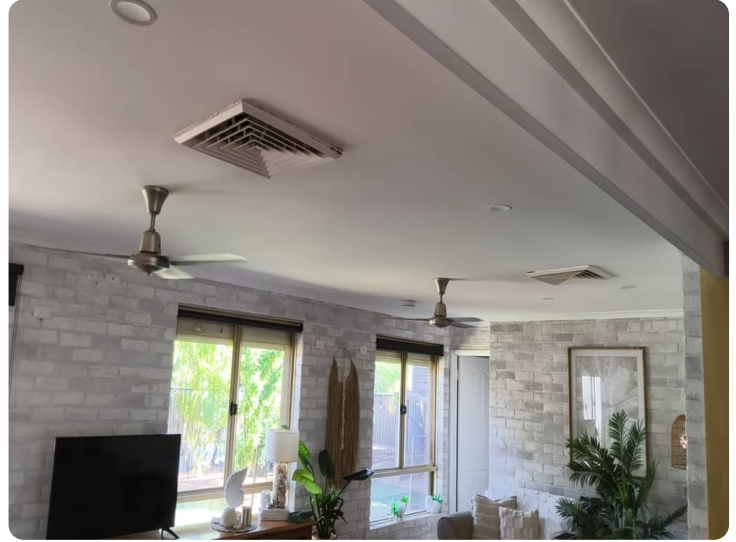
### 38. Ceilings

The ceilings are constructed of plasterboard with cornices constructed of plasterboard. The condition of the ceilings is satisfactory in relation to its age and will require normal ongoing maintenance.

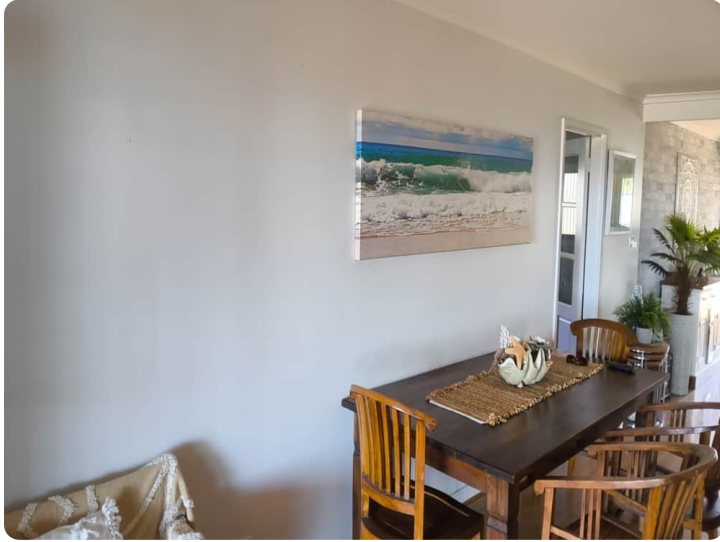
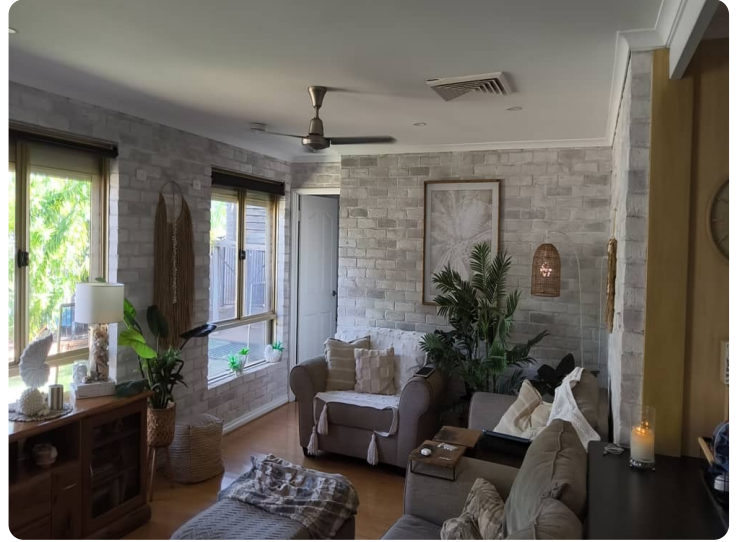
### 39. Internal walls

The internal walls are constructed of a variety of materials. The condition of the internal walls is satisfactory in relation to its age and will require normal ongoing maintenance.

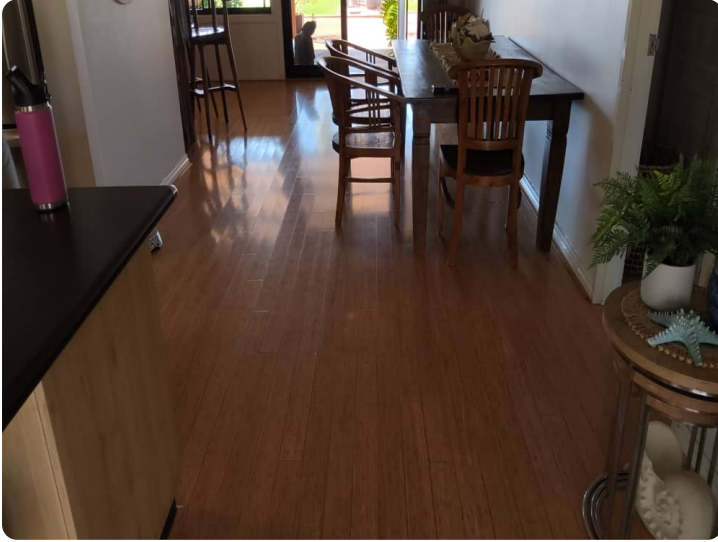
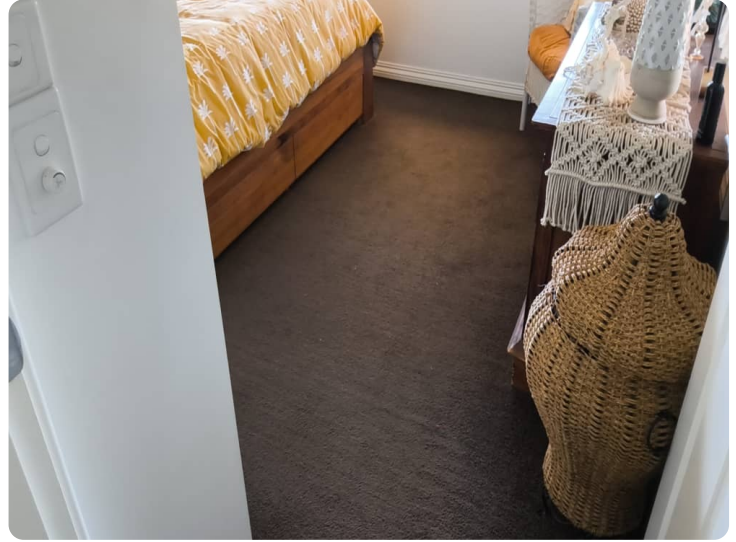
#### 40. Internal floors

The internal floors are constructed of concrete and are covered in a variety of coverings. The condition of the internal floors is unable to be determined as they could not be seen due to coverings.

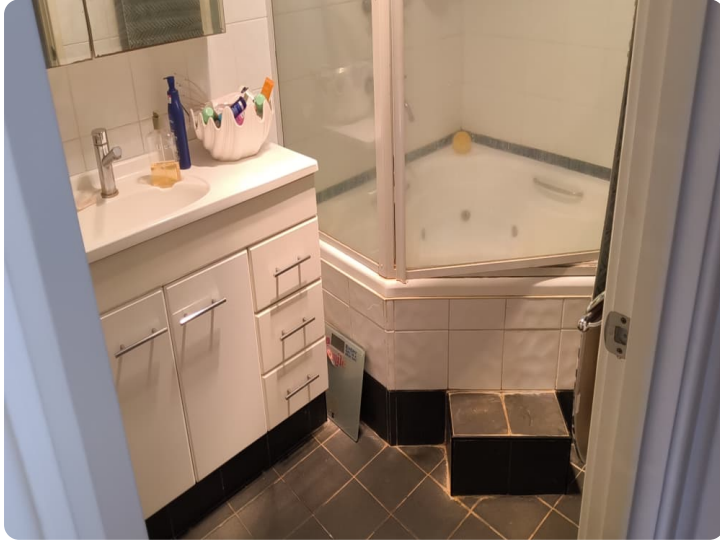
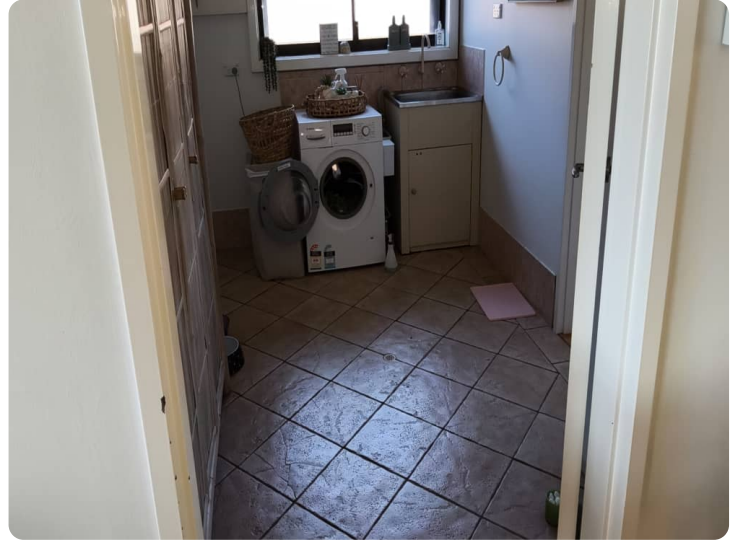
#### 41. Tiled floors and walls

There are areas of internal floors and walls which are covered with a tile covering. The condition of the tiles is satisfactory in relation to its age and will require normal ongoing maintenance.

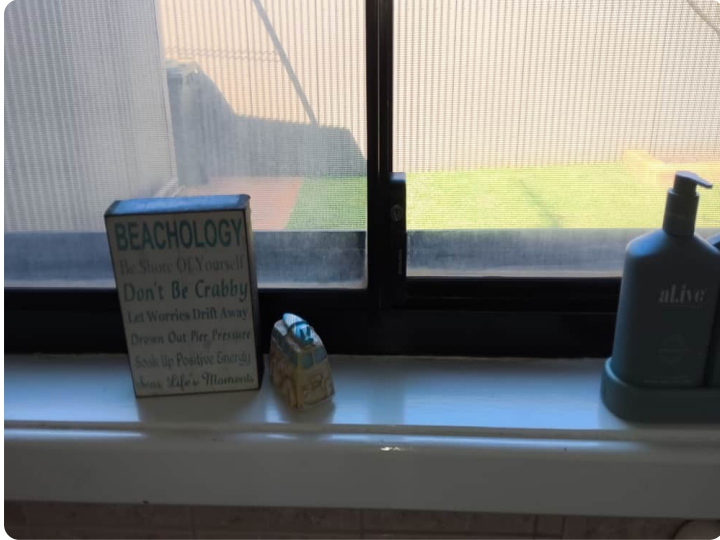
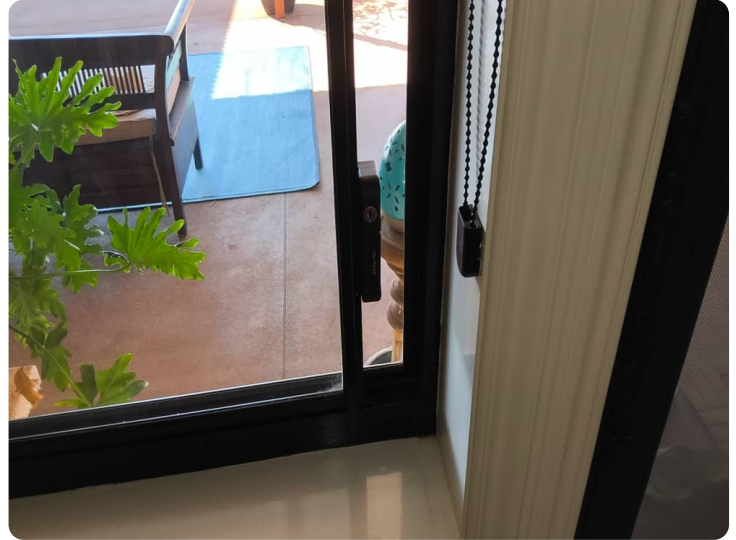
#### 42. Windows (internal)

The condition of the windows, as viewed from within the property, is satisfactory in relation to its age and will require normal ongoing maintenance. Window locks have been installed to all of the windows.

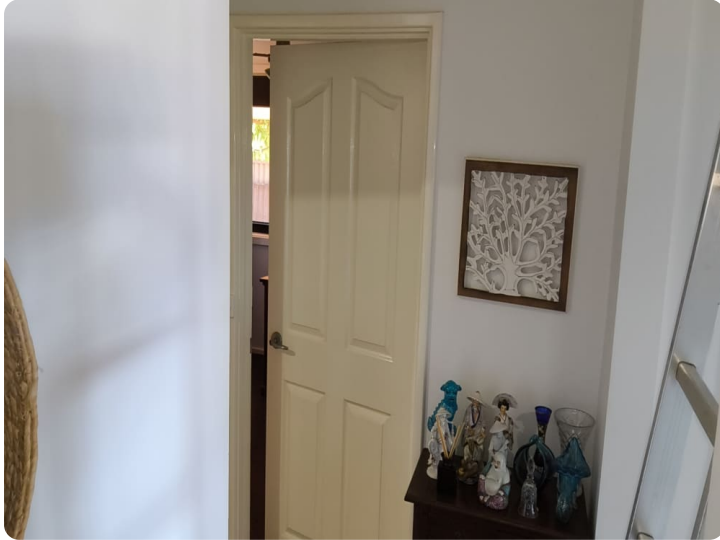
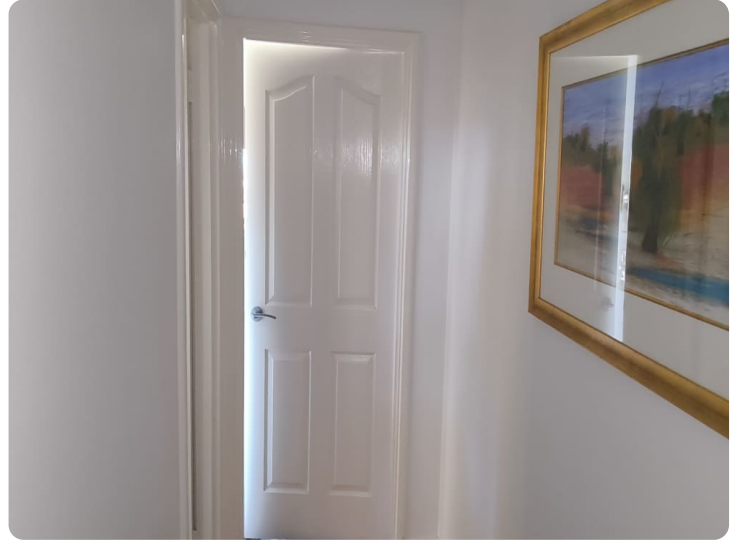
#### 43. Internal doors

The internal doors were mainly constructed of timber hollow core. The condition of the internal doors is satisfactory in relation to its age and will require normal ongoing maintenance.

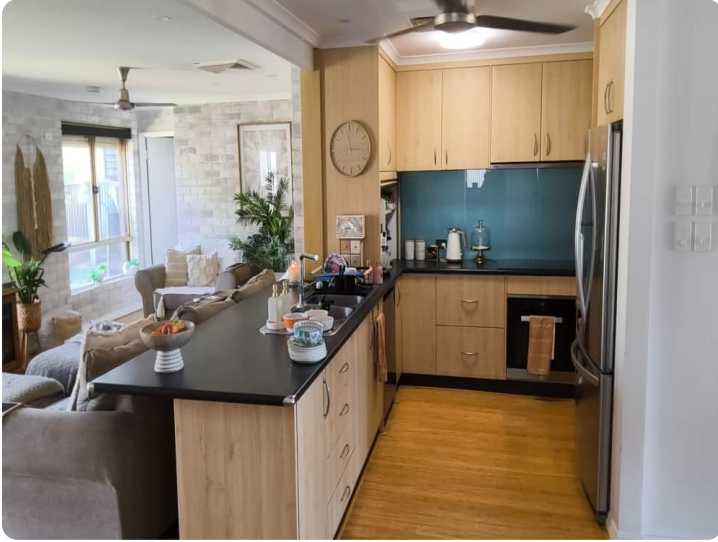
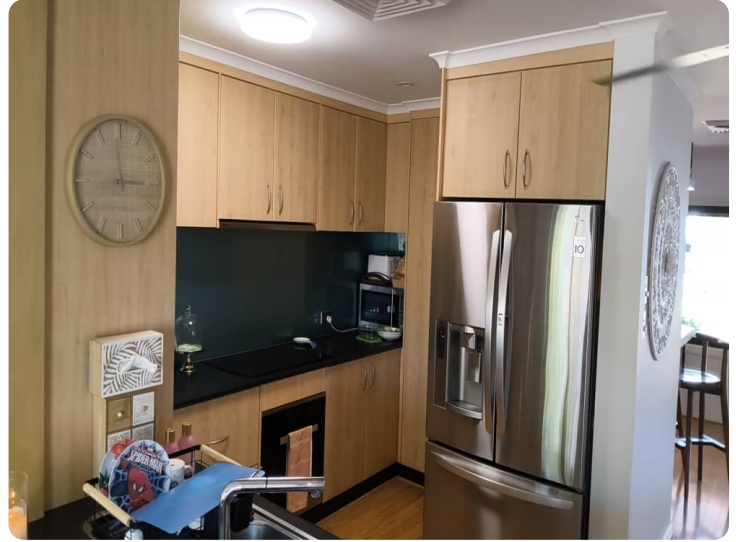
#### 44. Kitchen cabinets

The condition of the kitchen cabinets in general is satisfactory in relation to their age and require normal maintenance.

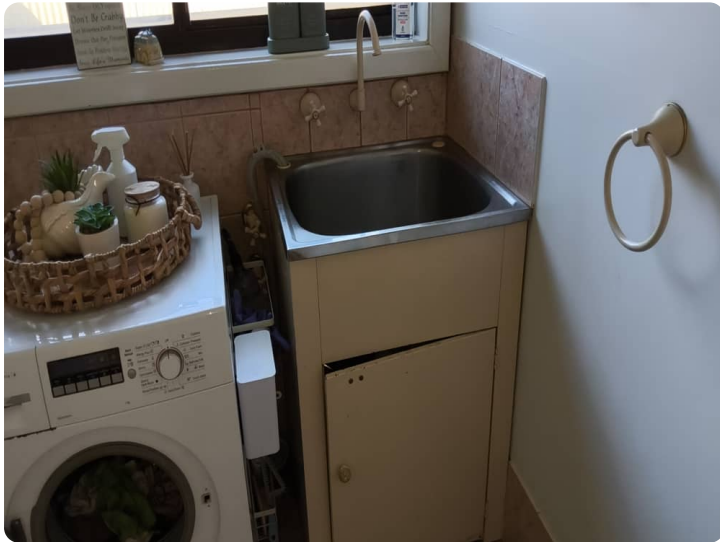
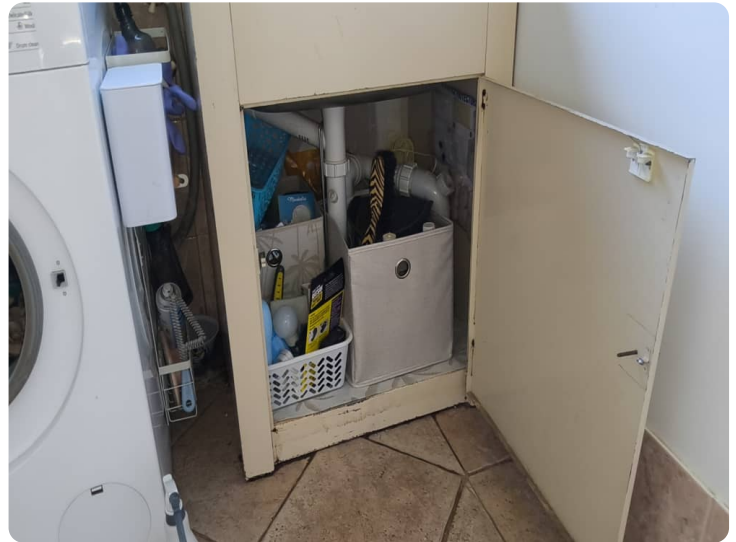
#### 45. Laundry cabinets

The condition of the laundry cabinet is satisfactory in relation to its age and require normal maintenance.

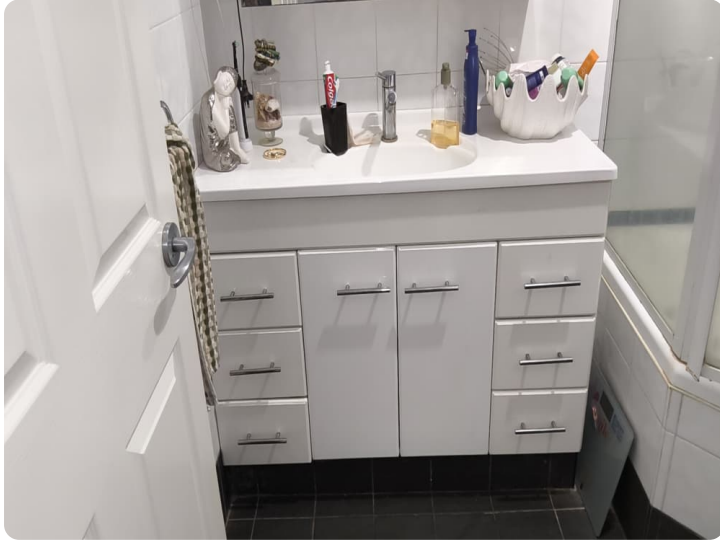
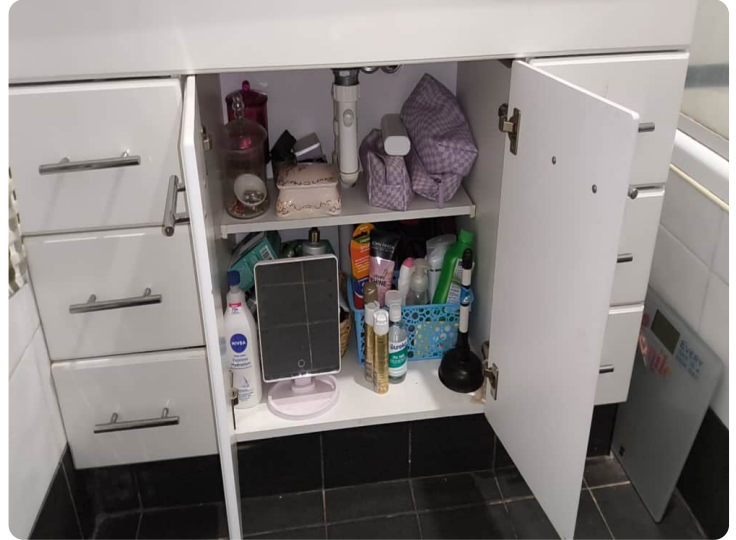
#### 46. Bathroom cabinets

The condition of the bathroom cabinets is satisfactory in relation to their age and require normal maintenance.

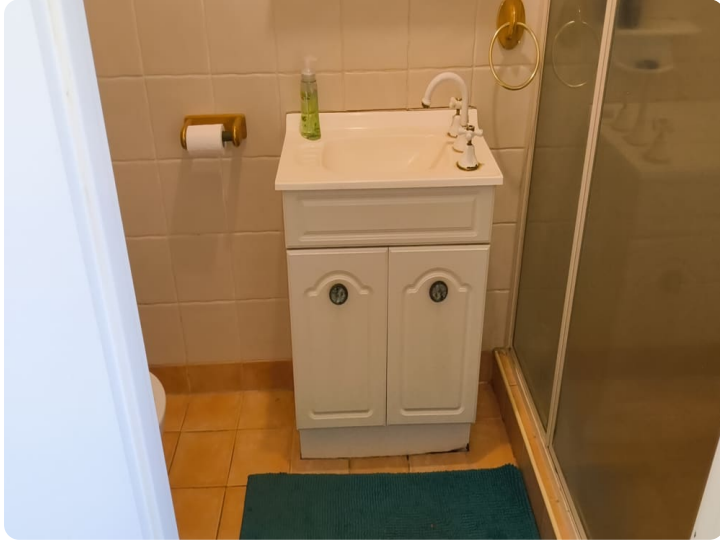
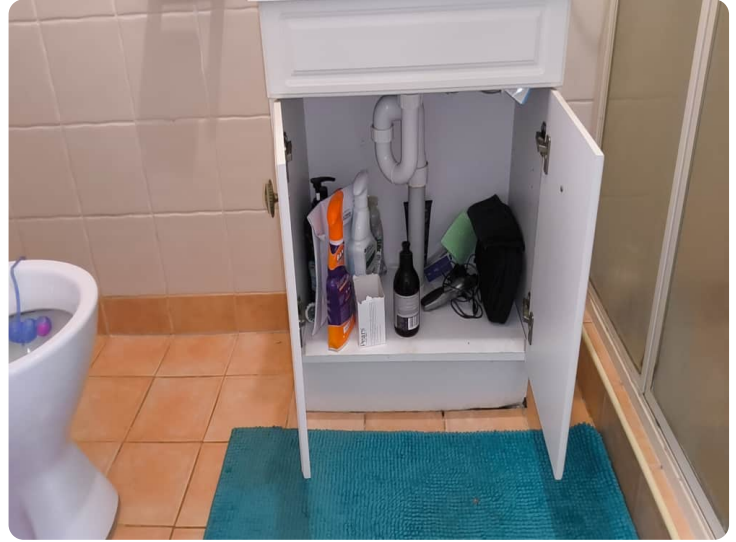
#### 47. Ensuite cabinets

The condition of the ensuite cabinets is satisfactory in relation to their age and require normal maintenance.

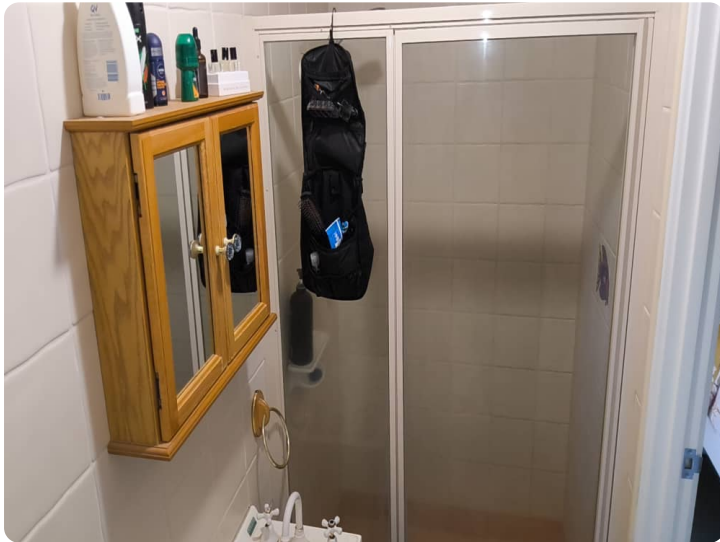
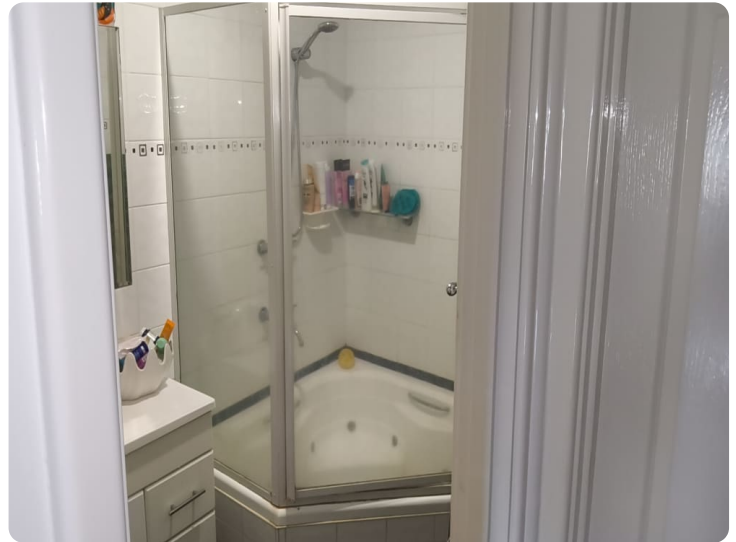
#### 48. Shower screens

The condition of the shower screens is satisfactory in relation to their age and require normal maintenance.

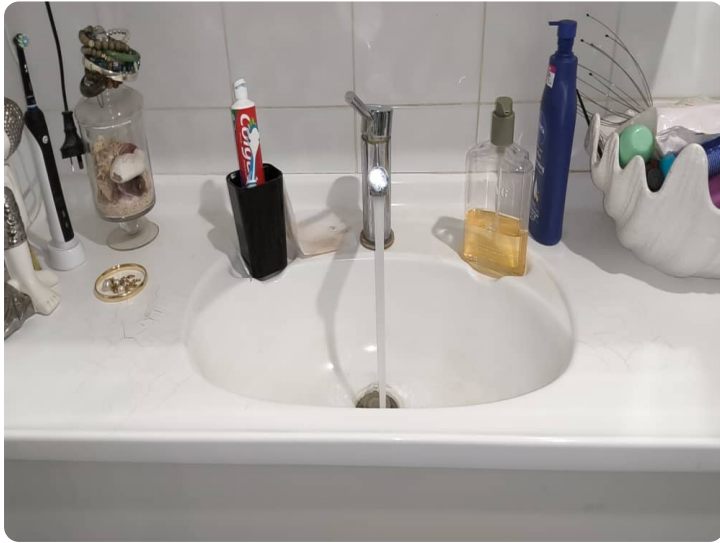
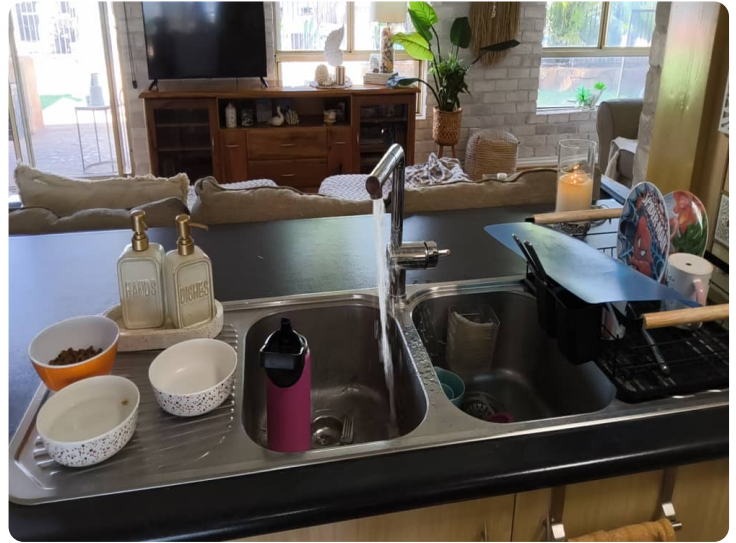
#### 49. Plumbing

The taps to multiple areas were turned on and the water flow appeared to be reasonable. Water draining to several sinks and toilets appeared to be reasonable. The Building Inspector is not a Plumbing Contractor and is not permitted to test Plumbing items under WA Law. Where appropriate a Plumbing Contractor should be engaged to test the plumbing in the property.

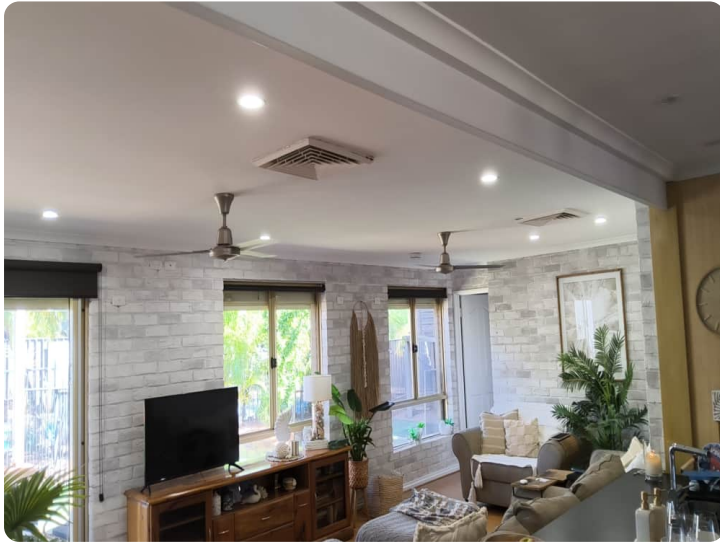
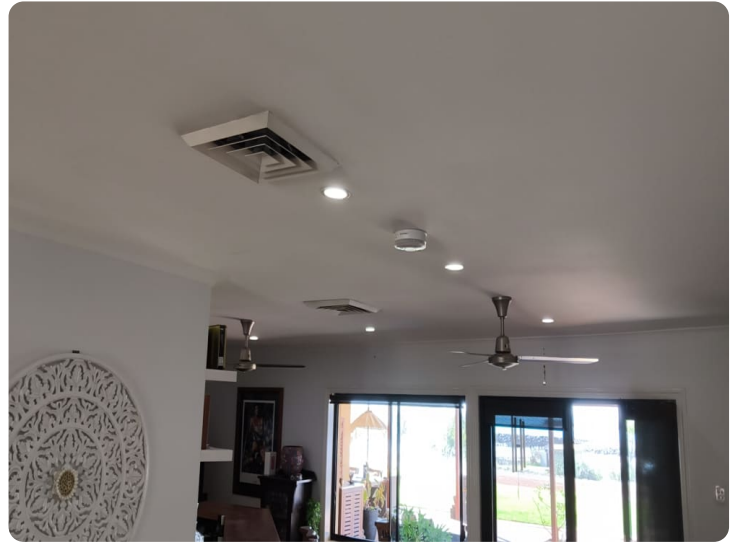
## 50. Lights and power points

Several lights were turned on during the inspection and the lights appeared to be operational. The Building Inspector is not an Electrical Contractor and is not permitted to test Electrical items under WA Law. Where appropriate an Electrical Contractor should be engaged to test the electrical items in the property.

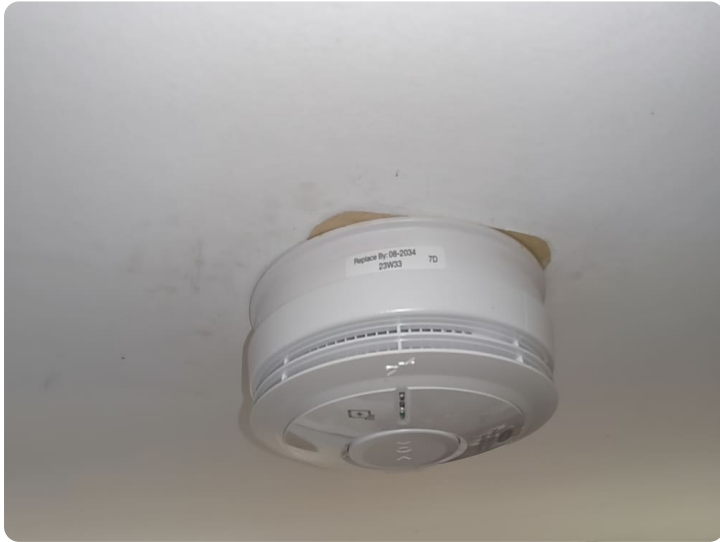
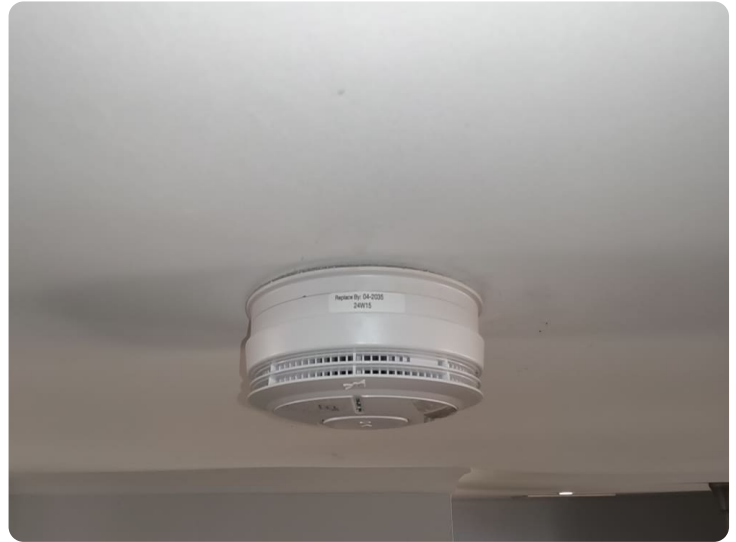
## 51. Smoke Alarms

There were three hardwired smoke alarms on site. There were no battery smoke alarms on site. The location, number and type of smoke alarms appeared to be consistent with Legislative requirements. It is suggested that an Electrical Compliance Certificate be obtained in relation to the smoke alarms.
