Building inspection

Job ID: 91652

Address: 74 Falcon Parade, Nickol WA

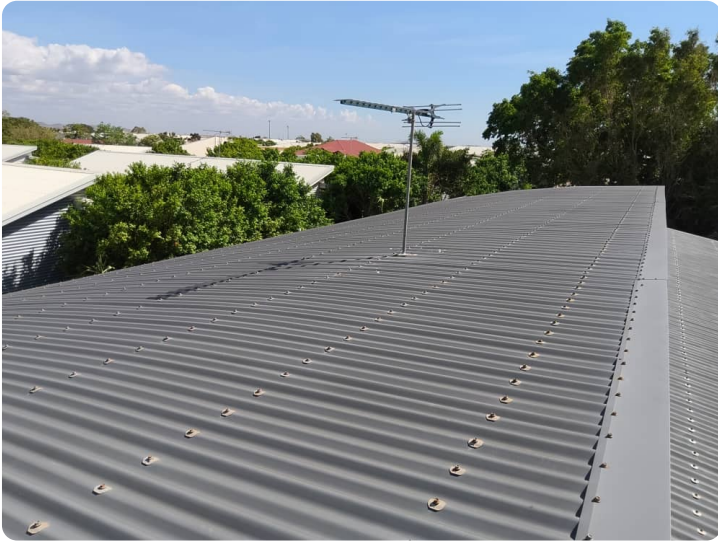
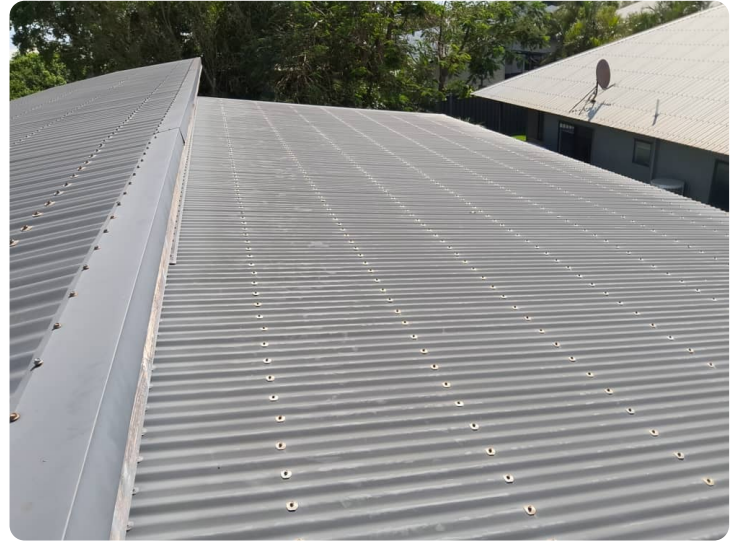
1. Roof covering

The roof covering is constructed of colorbond. The condition of the roof covering is satisfactory in relation to its age and will require normal ongoing maintenance.

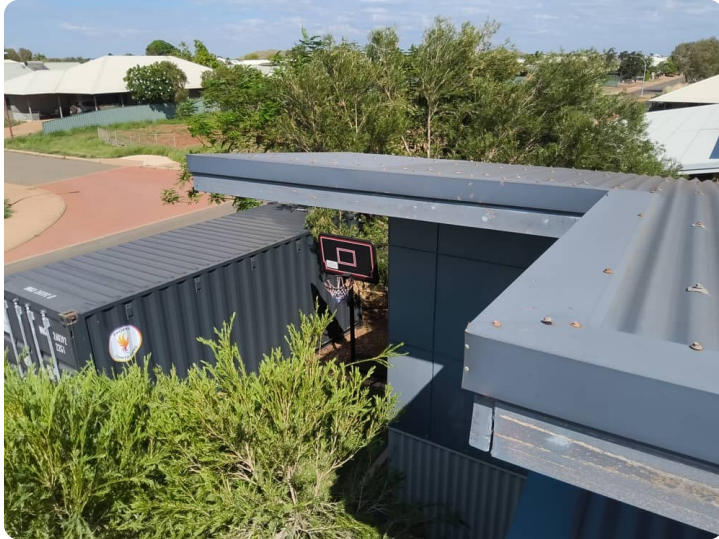
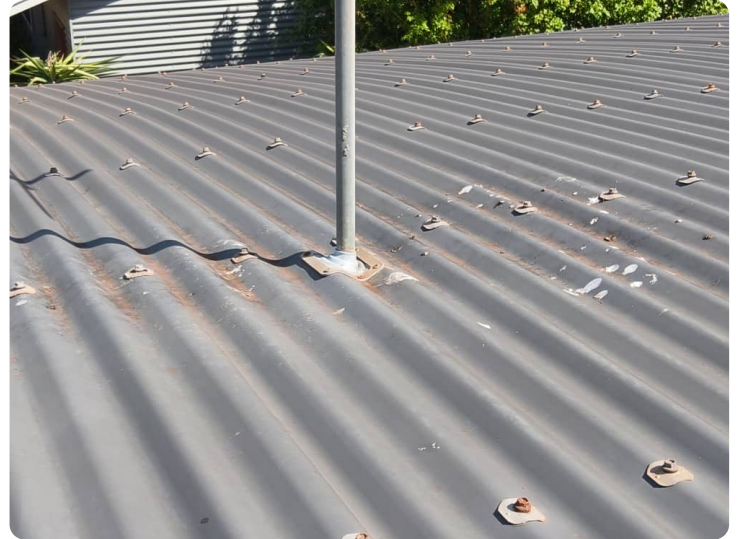
2. Flashings

The flashings are covered with a variety of finishes and are constructed of a mixture of materials. The condition of the flashings is satisfactory in relation to their age and will require normal ongoing maintenance.

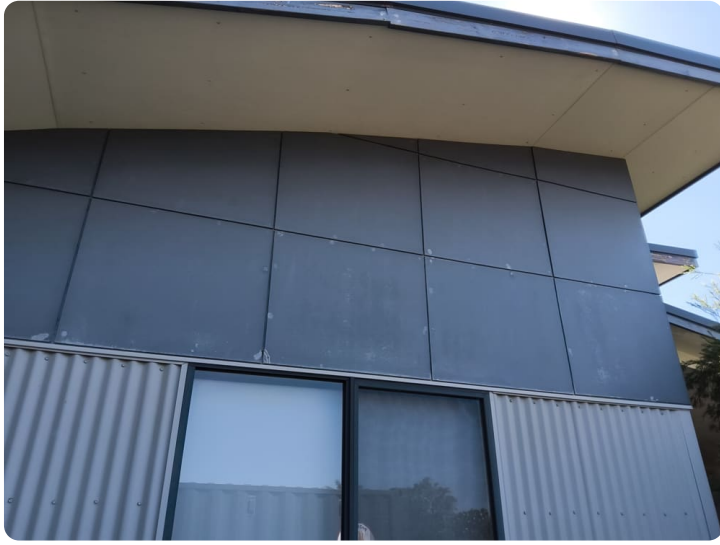
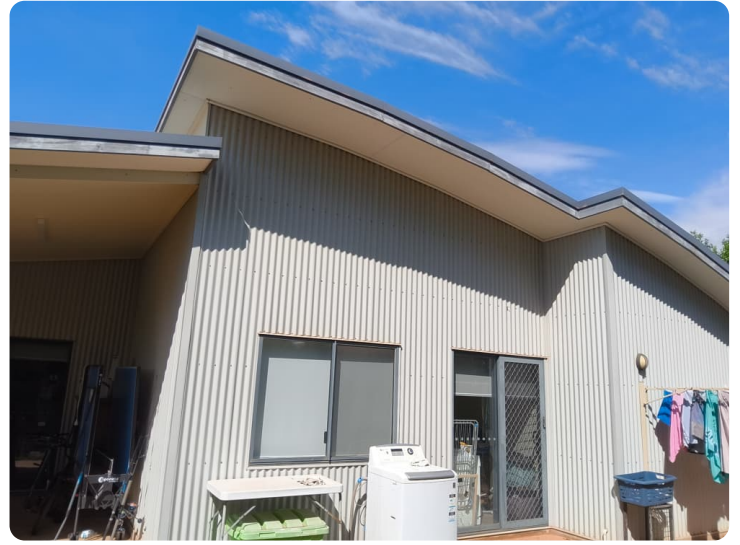
3. Gables

The gables are painted and constructed of fibre cement and Colorbond sheeting. The condition of the gables is satisfactory in relation to their age and will require normal ongoing maintenance.

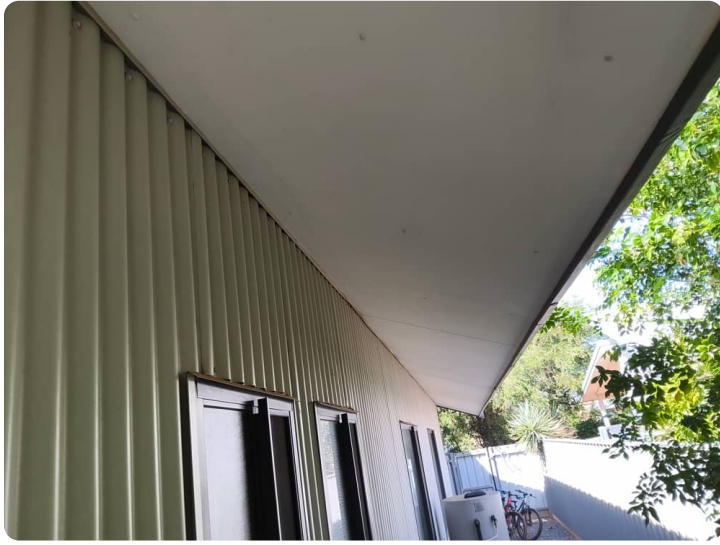
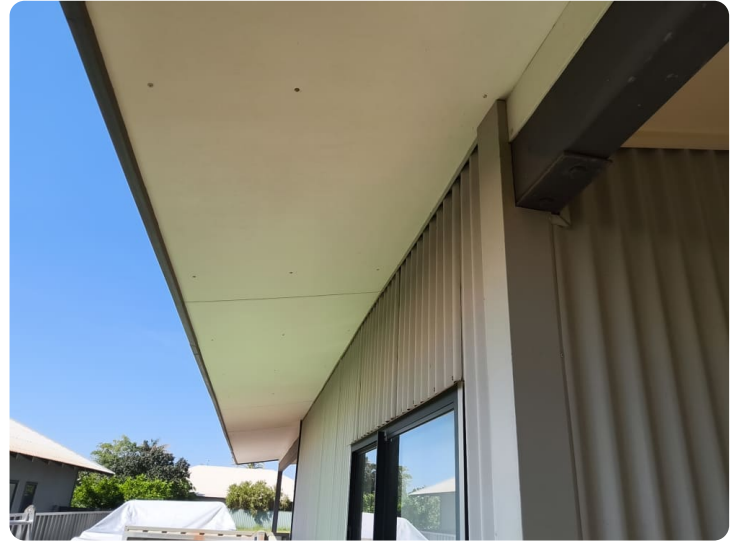
5. Eaves

The eaves are boxed and constructed of painted fibre cement. The condition of the eaves is satisfactory in relation to their age and will require normal ongoing maintenance.

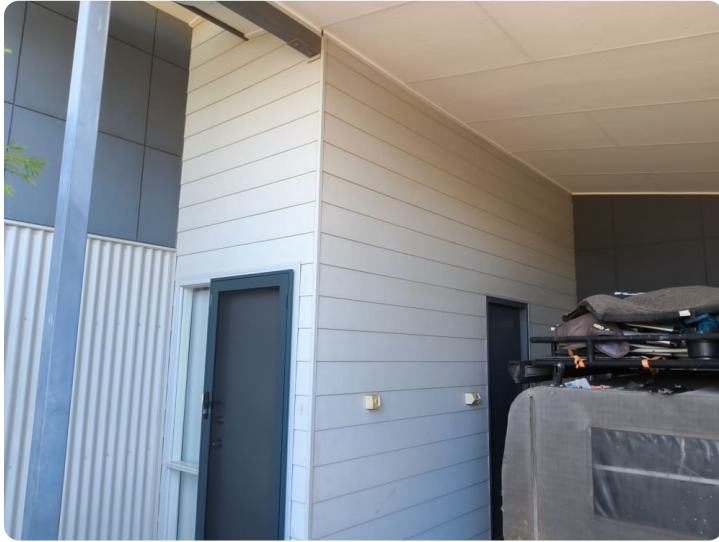
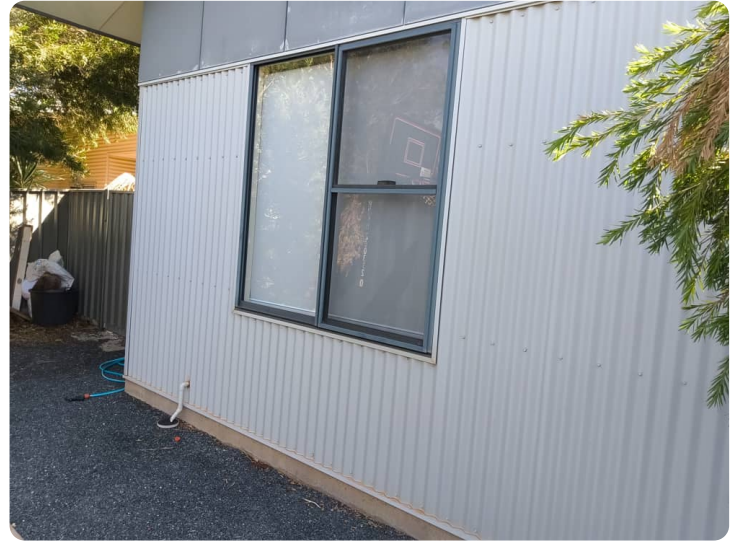
6. External walls

The external walls are constructed of a framed structure with cladding. The condition of the walls generally is satisfactory in relation to their age and will require normal ongoing maintenance.

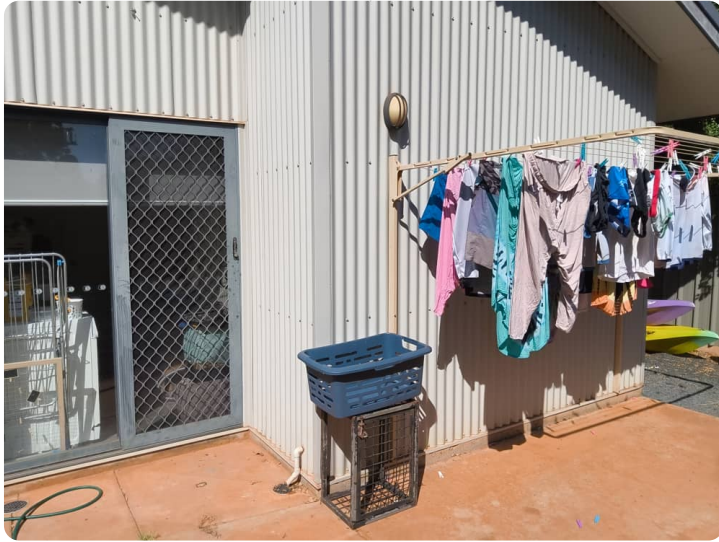
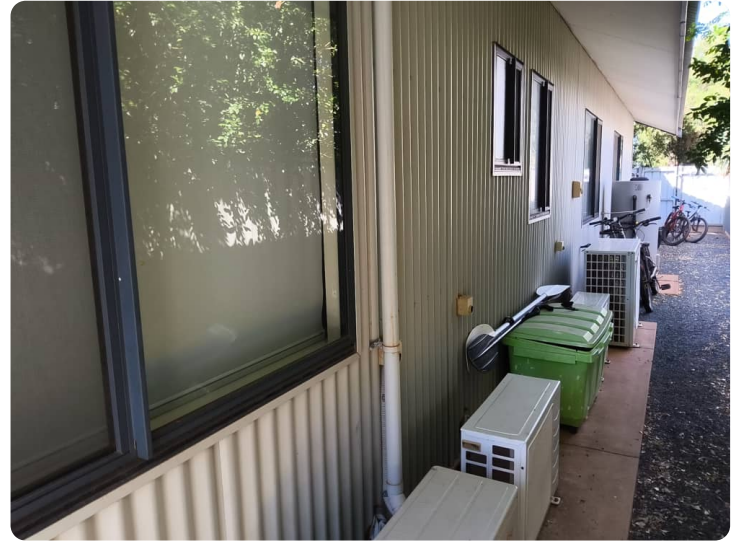
7. Wall cladding

The external walls are (or partially are) clad with fibre cement and colorbondsheeting. The condition of the cladding is generally satisfactory in relation to its age and will require normal ongoing maintenance.

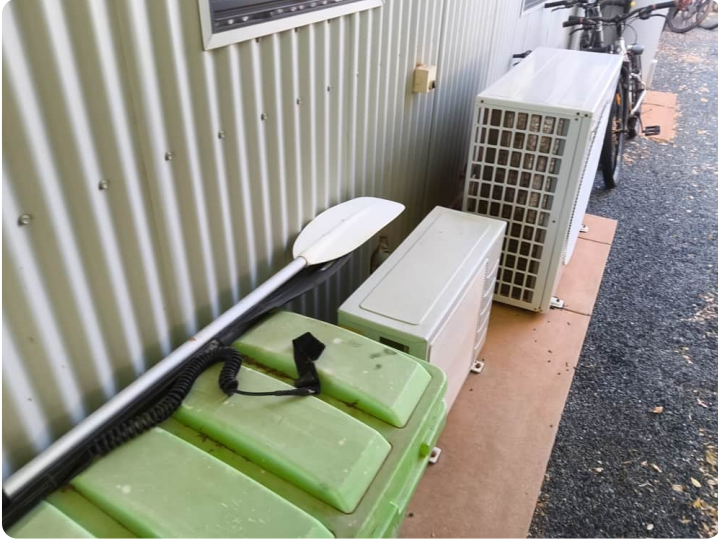
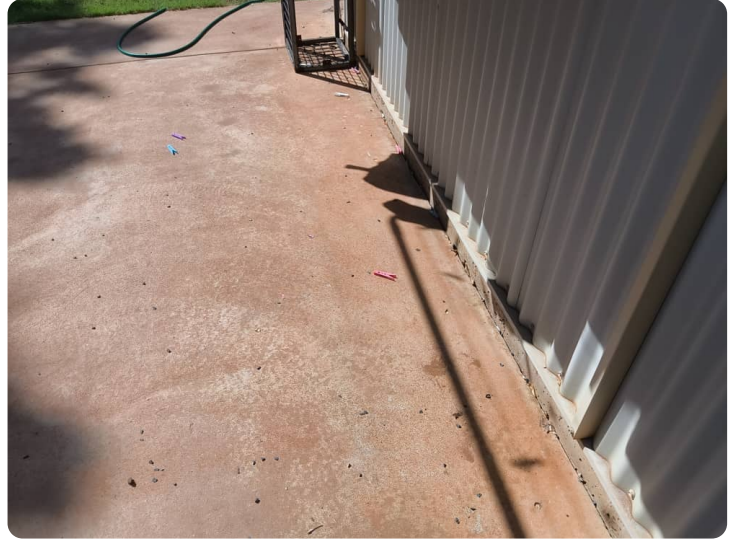
8. Footings

The footings are below ground and cannot be seen. The condition of the footings cannot be determined.

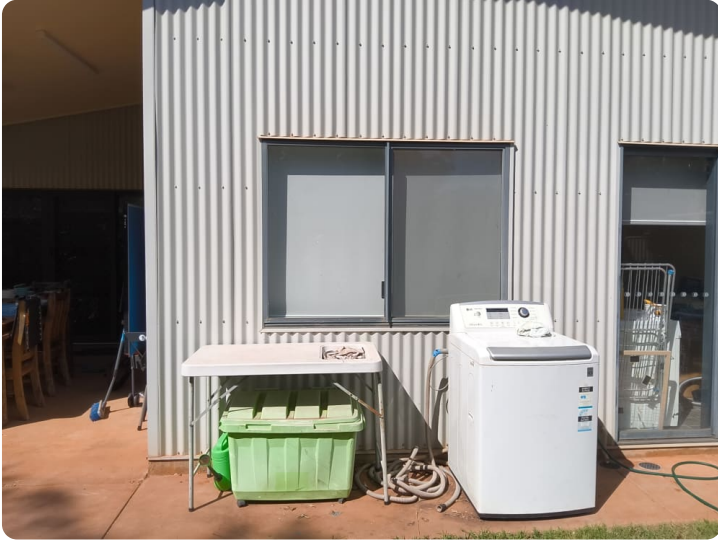
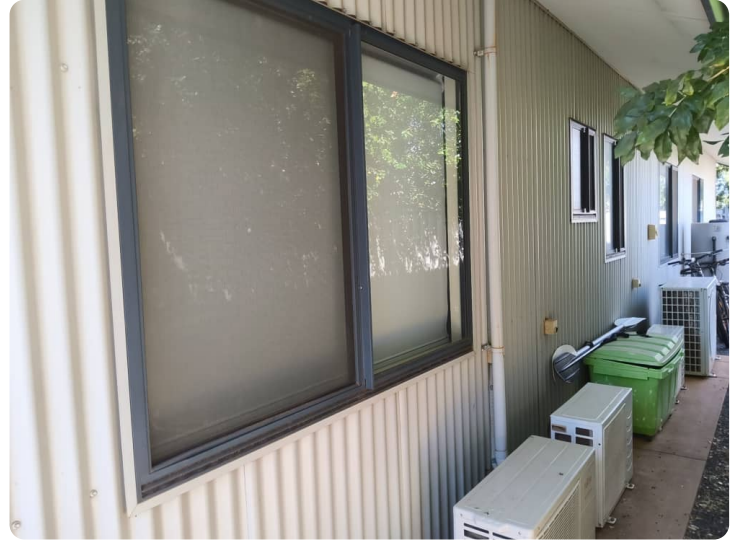
9. Windows and window frames

The window and window frames are primarily constructed of aluminium. The condition of the window and window frames is generally satisfactory in relation to its age and will require normal ongoing maintenance.

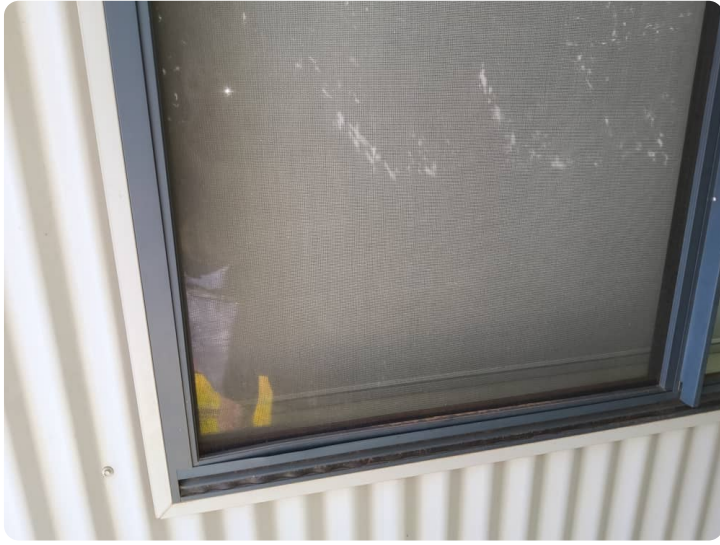
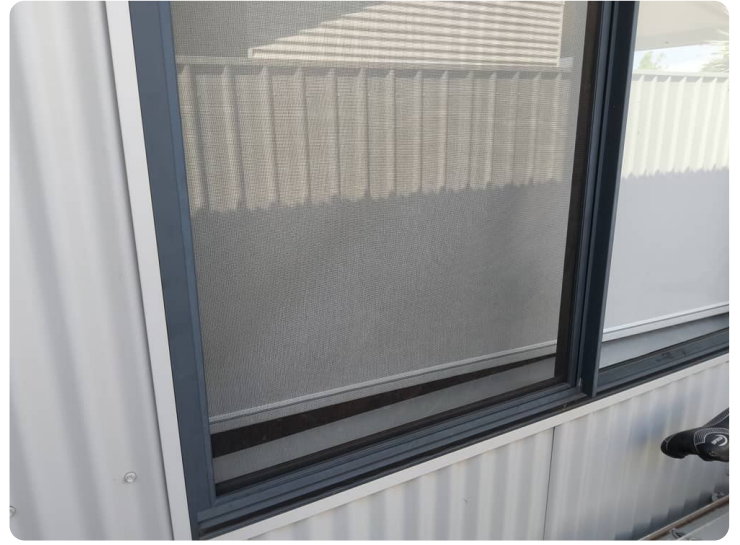
10. Window fly screens

Fly screens have been installed to all of the windows. The condition of the window fly screens is generally satisfactory in relation to its age and will require normal ongoing maintenance.

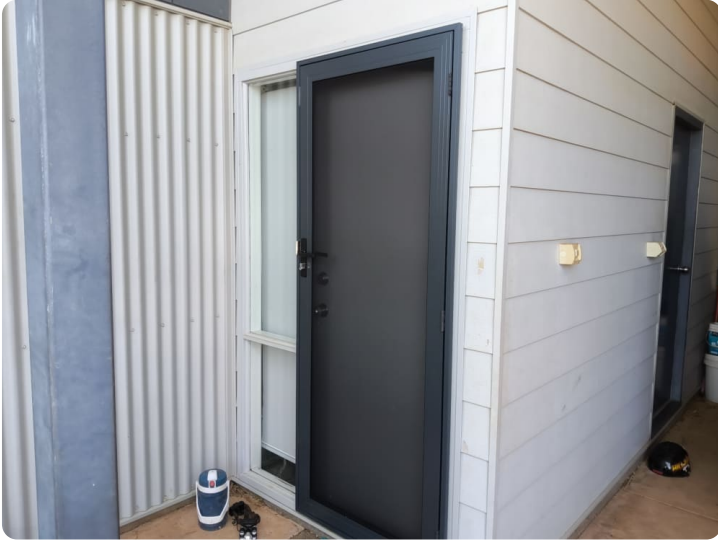
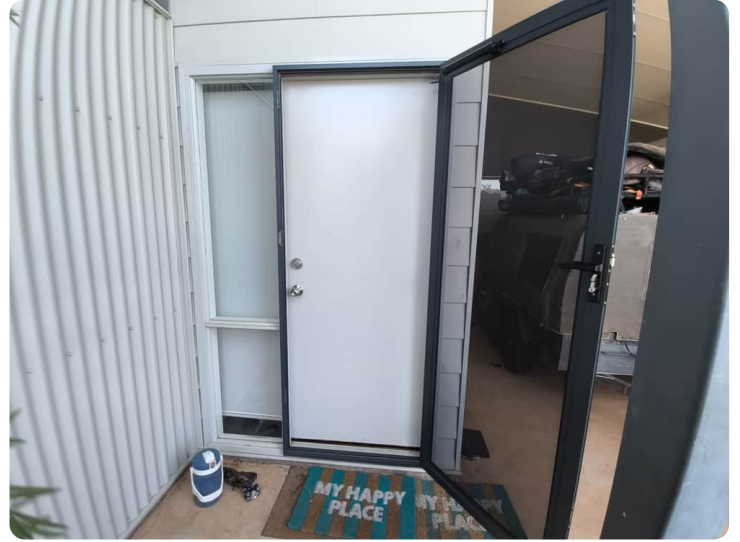
11. Front door

The front door is constructed of solid timber. The condition of the front door is satisfactory in relation to its age and will require normal ongoing maintenance. Deadlocks have been installed. A security screen door has been fitted.

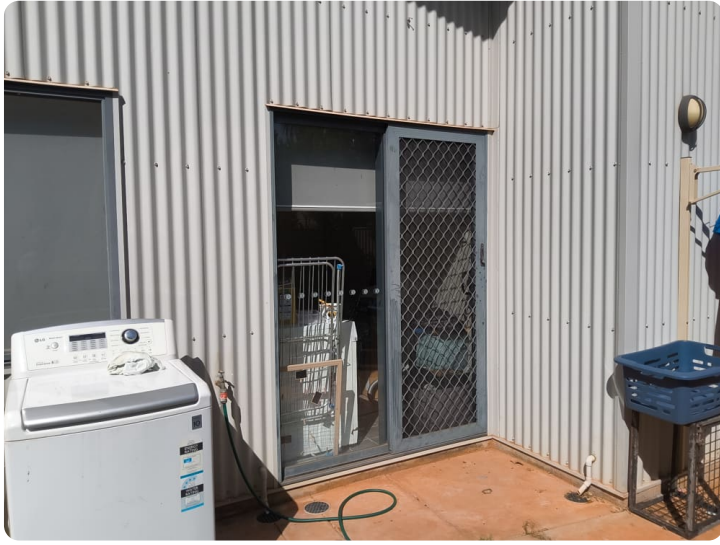
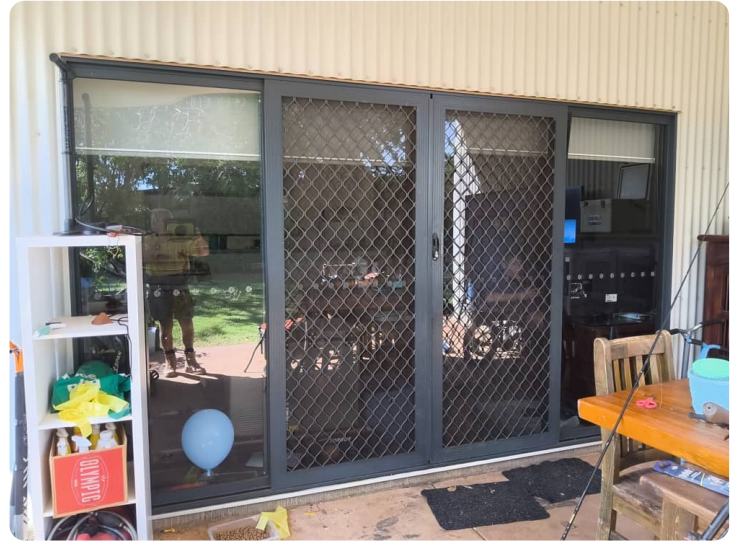
12. Other external doors

Other external doors are constructed of aluminium. The condition of the other external doors is satisfactory in relation to its age and will require normal ongoing maintenance.

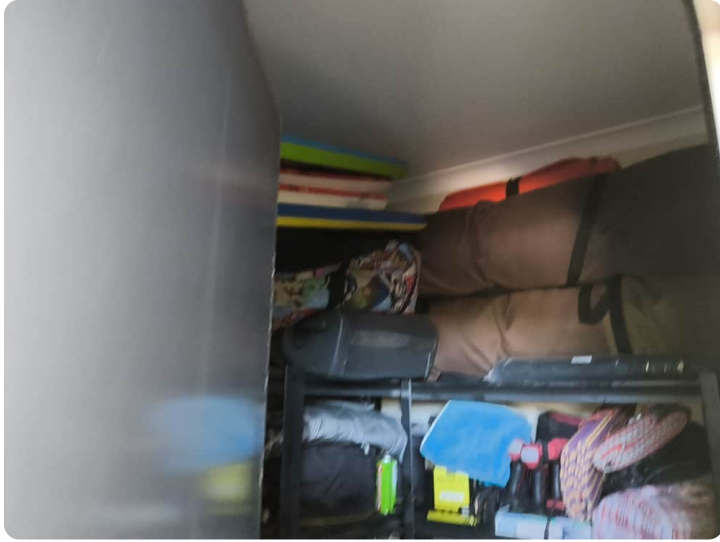
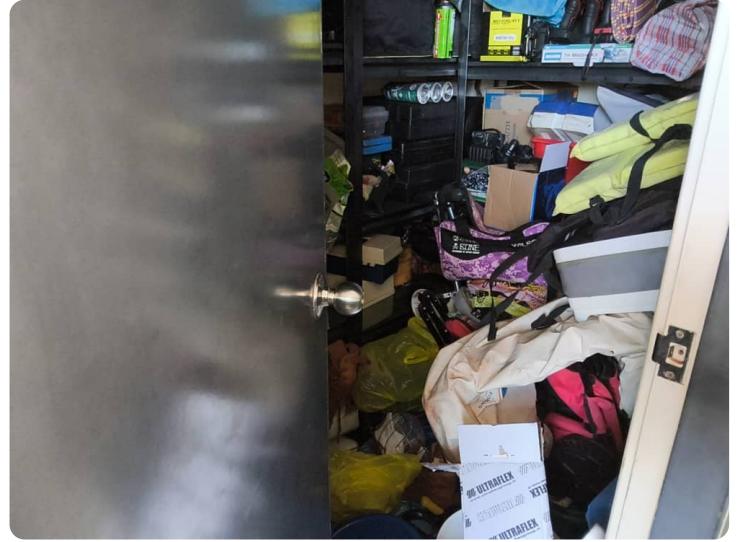
13. Storeroom 1

An external storeroom for the property is located adjacent and under the main roof of the building. The condition of the storeroom is satisfactory in relation to its age and will require normal ongoing maintenance. Access and visibility of the area was restricted by stored items.

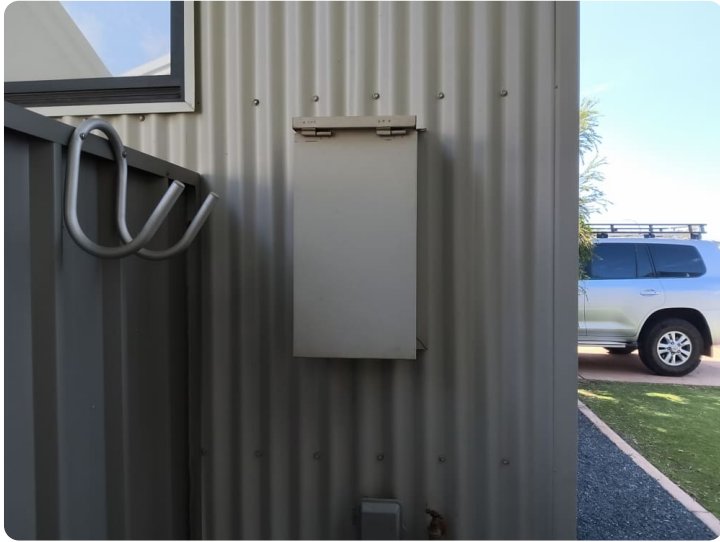
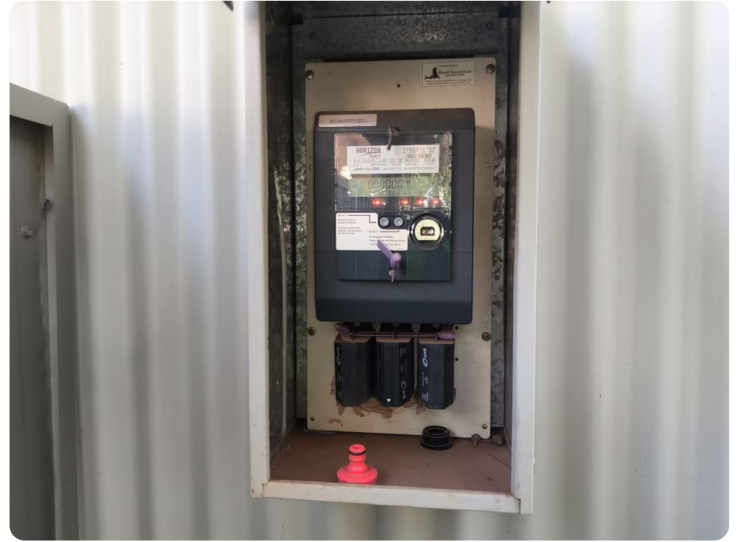
14. Meter box and power

Access to the meter box or sub board was available. The meter box or sub board is not lockable. Power phase type to the site is three phase.

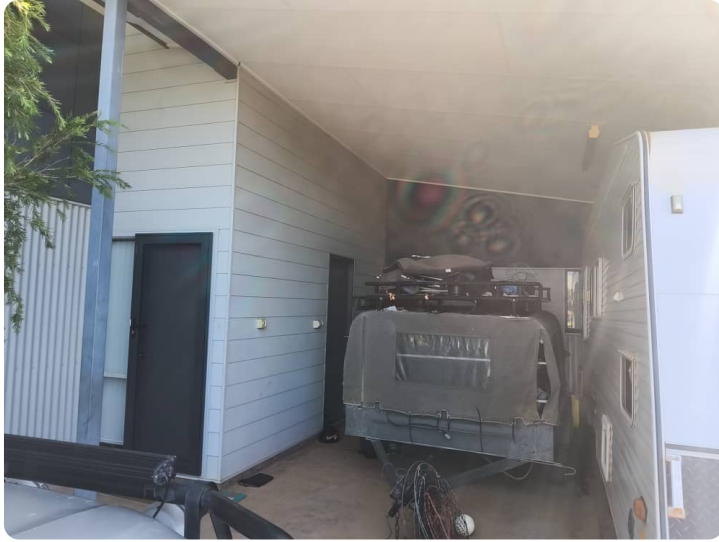
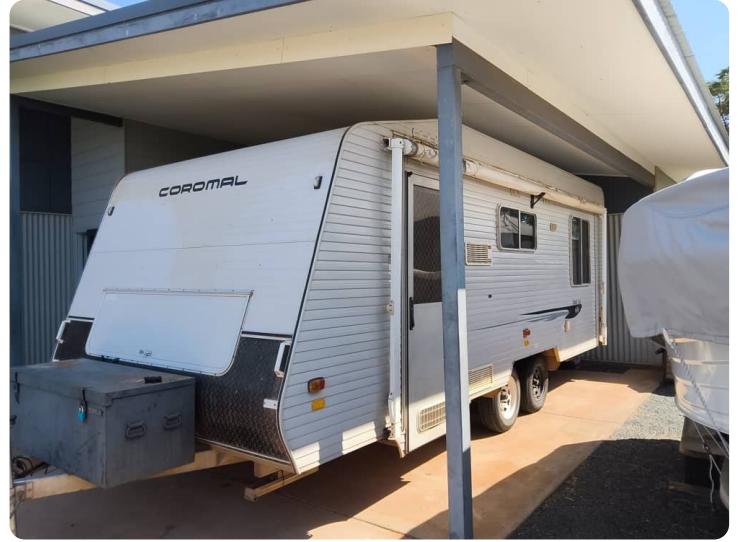
16. Carport or Garage (Primary)

There is a primary carport on the property constructed of same materials as the primary structure. The condition of the carport or garage is satisfactory in relation to its age and will require normal ongoing maintenance.

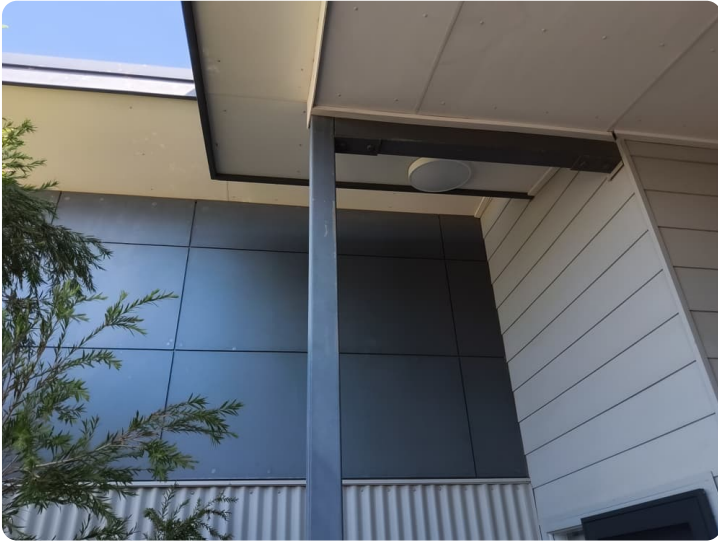
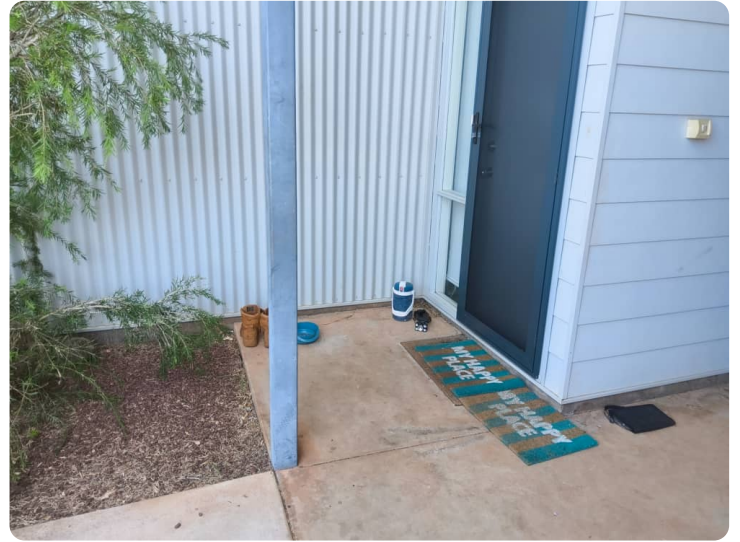
17. Veranda (Primary)

The primary veranda is constructed of same materials as the primary structure. The condition of the veranda is satisfactory in relation to its age and will require normal ongoing maintenance.

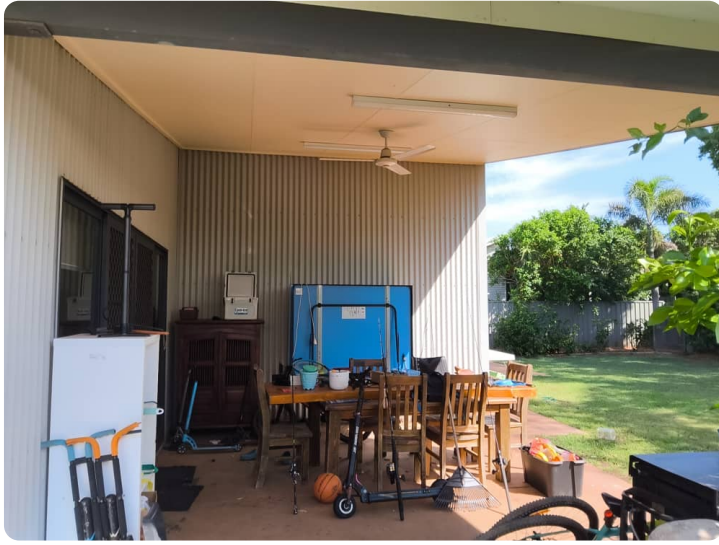
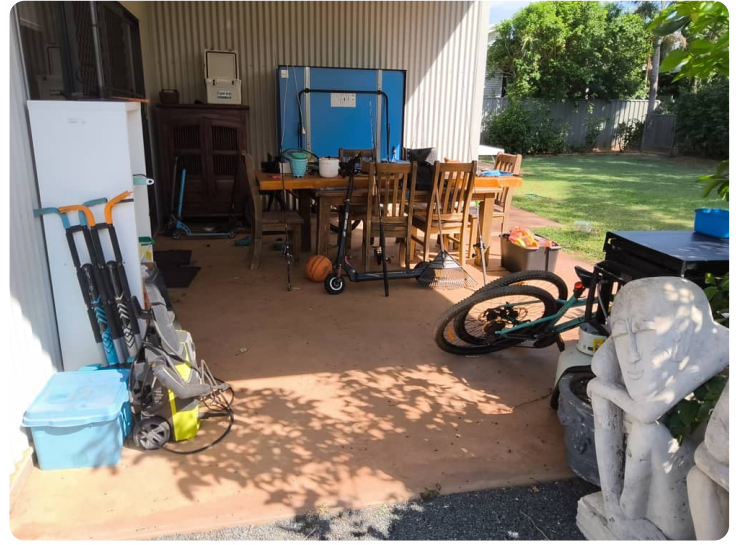
18. Alfresco (under main roof)

The alfresco under the main roof is constructed of same materials as the building. The condition of the alfresco is satisfactory in relation to its age and will require normal ongoing maintenance.

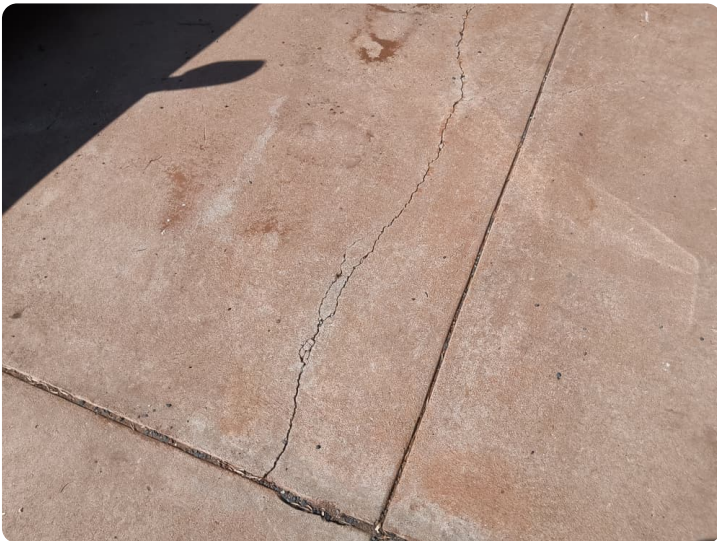
19.1 Concrete cracking - minor

The driveway and cross over is constructed of concrete. The condition of the driveway is fair in relation to its age and will require ongoing maintenance.

Cracking was noted to the concrete driveway. This is not of a structural concern. Cracks should be filled to avoid further deterioration.

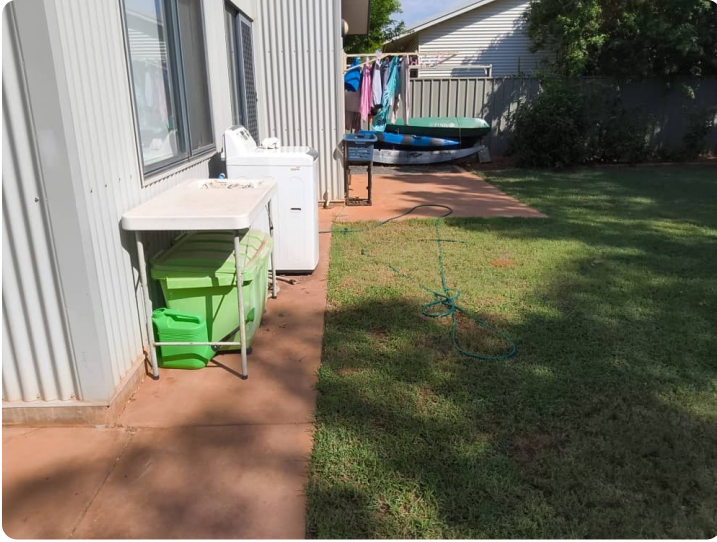
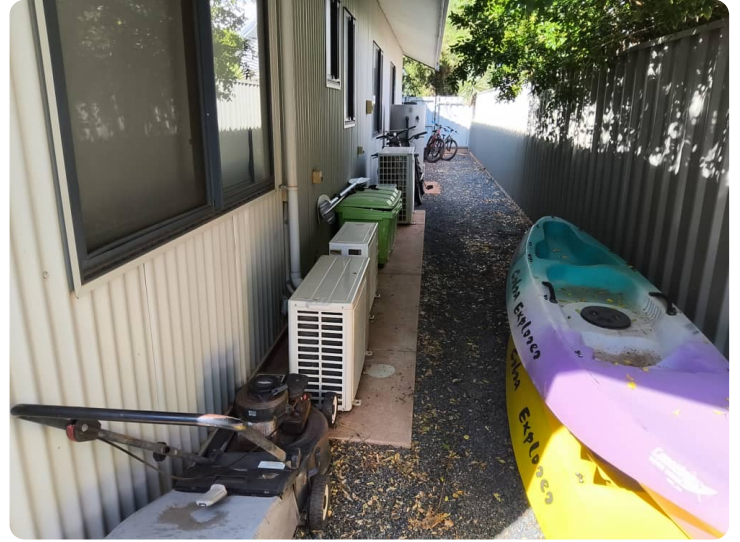
20. External walkways and paved areas

The external walkways and paved areas are constructed of a variety of materials. The condition of the external walkways and paved areas is satisfactory in relation to its age and will require normal ongoing maintenance.

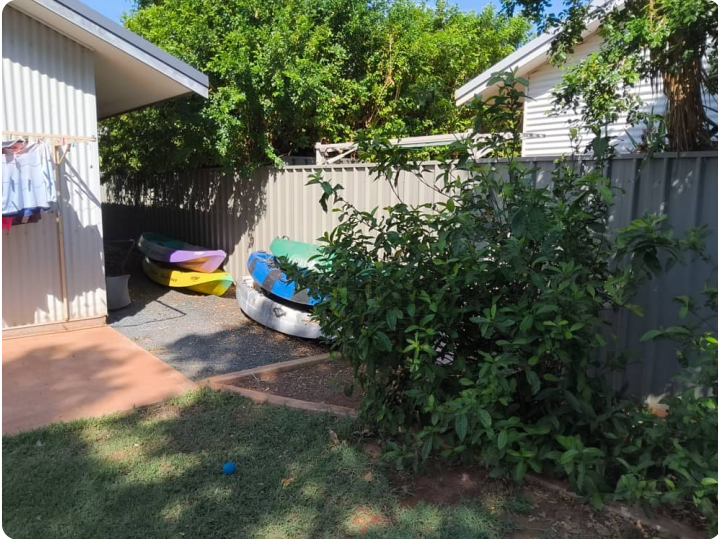
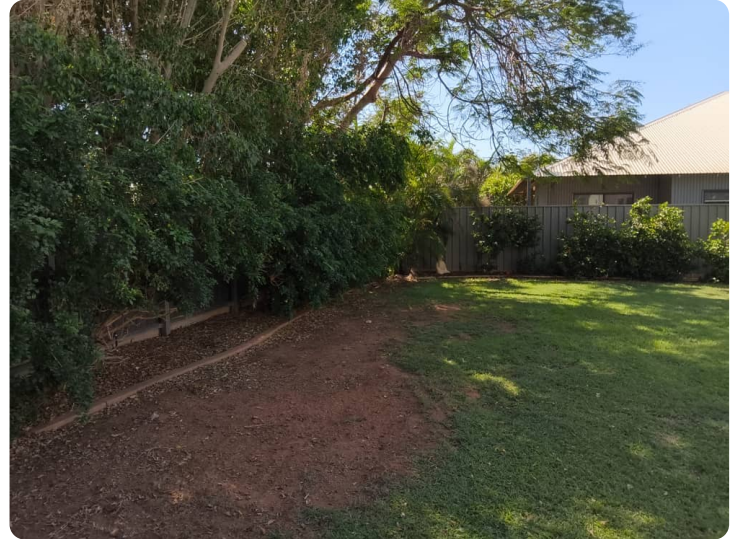
21. Fences - boundary

The boundary fences are constructed of metal. The condition of the boundary fence is satisfactory in relation to its age and will require normal ongoing maintenance. Some of the fences could not be viewed due to vegetation, stored items or secondary structures.

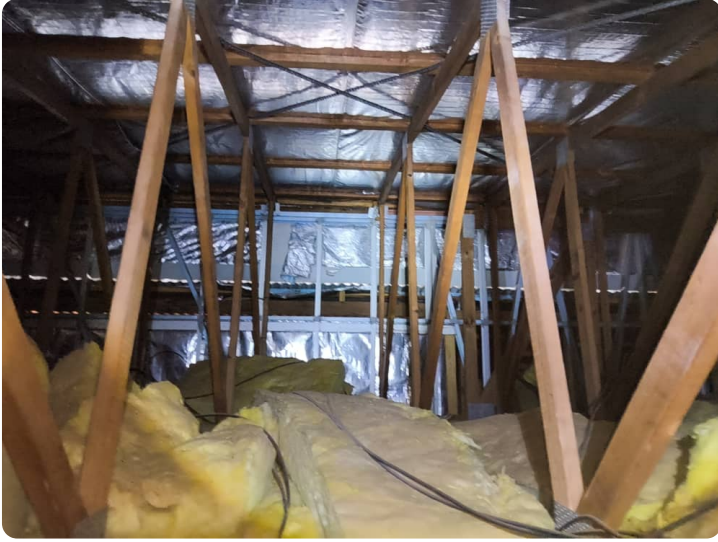
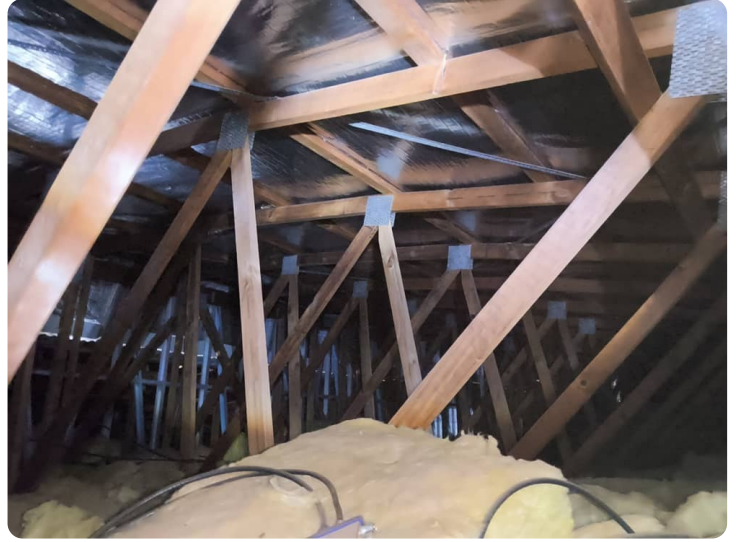
22. Under side of roof cover

The condition of the underside of the roof cover could not be determined as sarking had been installed.

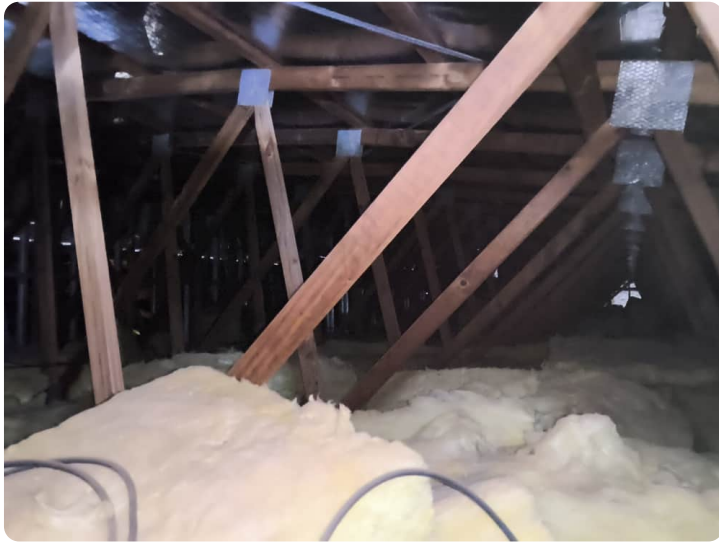
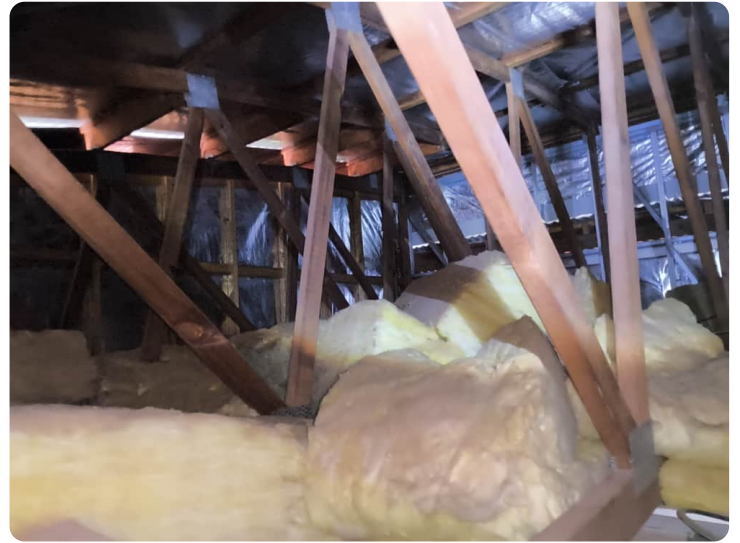
24. Roof frame

The roof frame type is a timber truss. The condition of the roof frame is satisfactory in relation to its age and will require normal ongoing maintenance. Access to the roof space was restricted by the pitch of the roof, insulation, ducting or other items. The inspector estimates that visibility was available to more than 50% of the area.

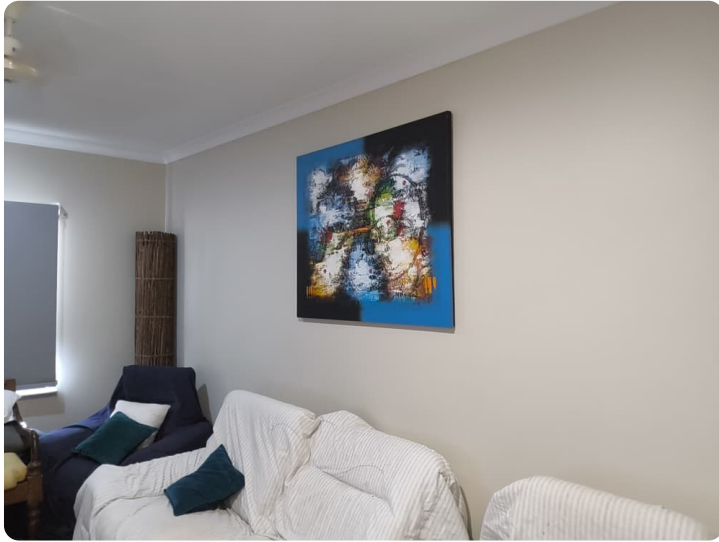
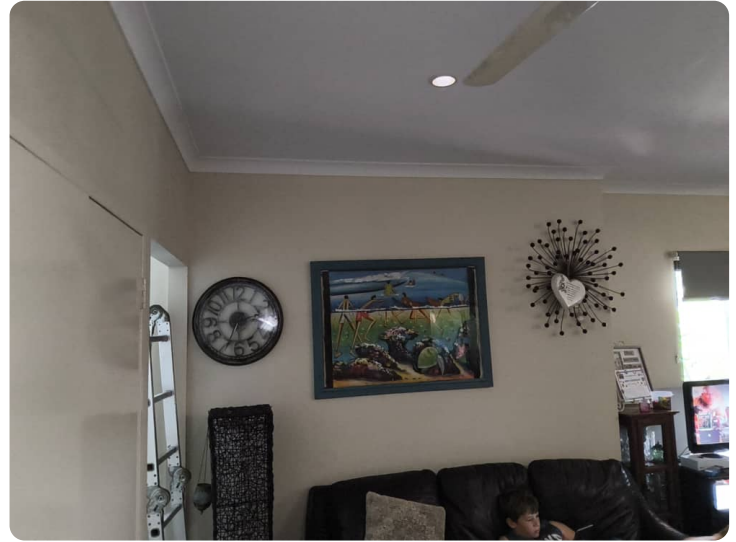
27.1 Ensuite water egress

As per the images provided the internal wall broadly adjacent to the shower recess on the main bathroom has water damage. In the majority of cases this relates to a break down in the grout or silicone seals allowing water to escape into the wall and spread via capillary action. Often this can be resolved by regrouting and sealing the shower. On occasions the issues relates to a plumbing failure or a failure of the waterproofing system. This can only be checked via pressure test conducted by a Plumbing Contractor or an invasive inspection of the waterproofing membrane both of which are outside the scope of our inspection.

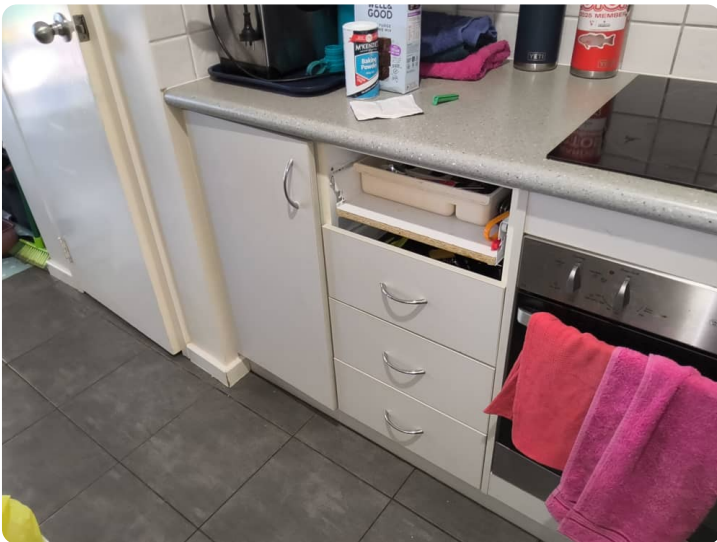
32.1 Cabinet draw front missing

As per the images the cabinet draw front was missing at the time of the inspection.

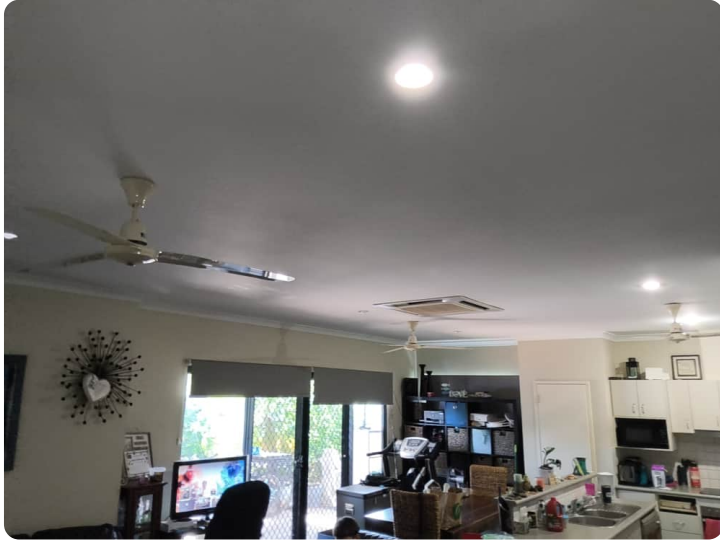
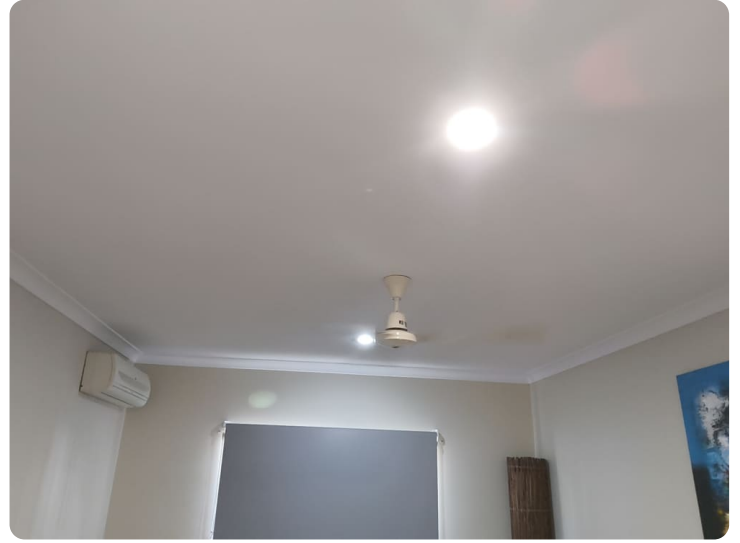
38. Lights and power points

Several lights were turned on during the inspection and the lights appeared not to be fully operational. Further investigation is required. The Building Inspector is not an Electrical Contractor and is not permitted to test Electrical items under WA Law. Where appropriate an Electrical Contractor should be engaged to test the electrical items in the property.
