# **Houspect**

### **Pre purchase inspection**

**Job ID:** 93039

**Address:** 44 Hunt Way, Bulgarra WA 6714

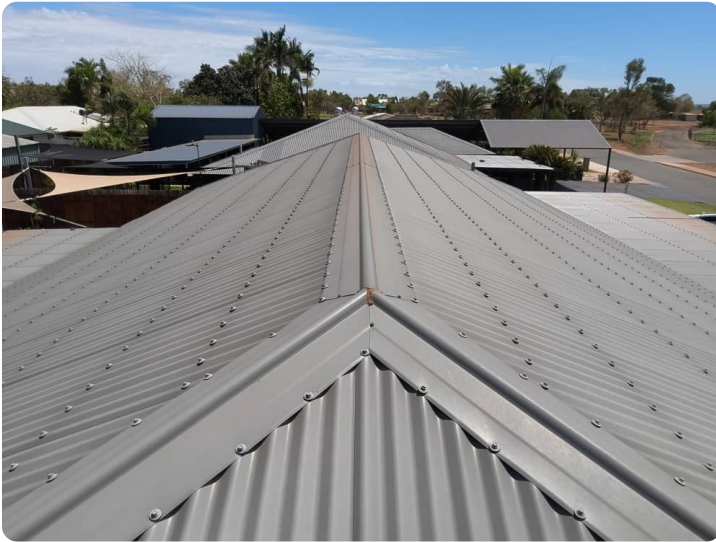
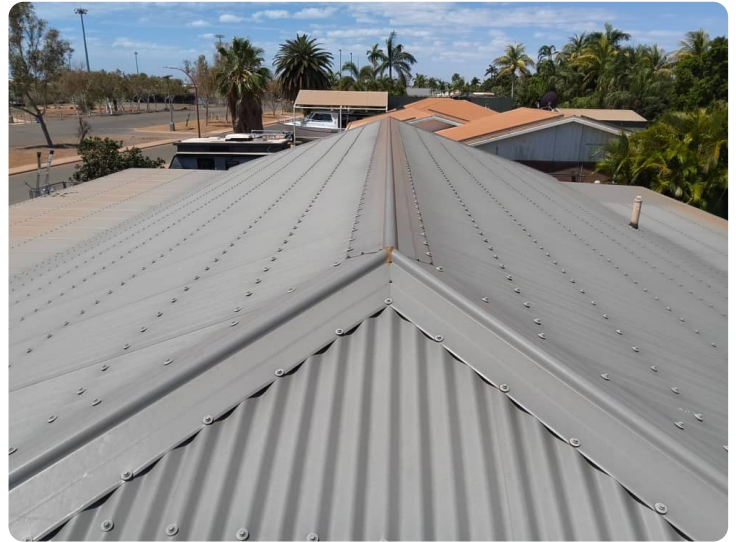
## 2. Ridges

The ridges and capping are satisfactory in relation to its age and will require normal ongoing maintenance.

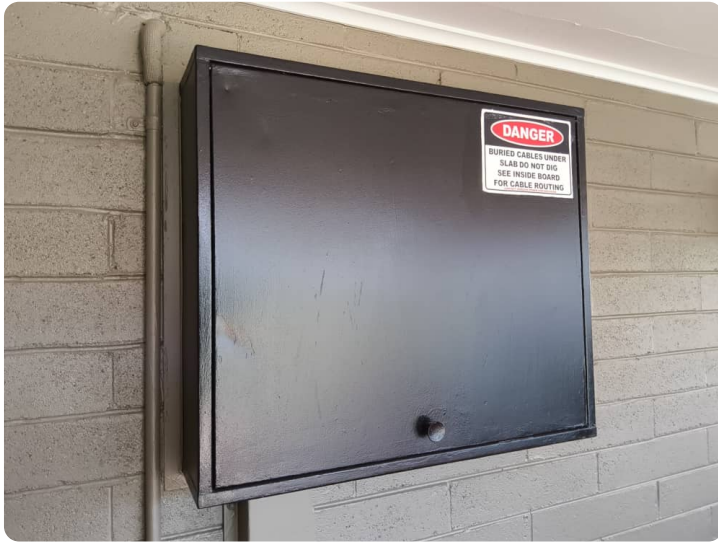
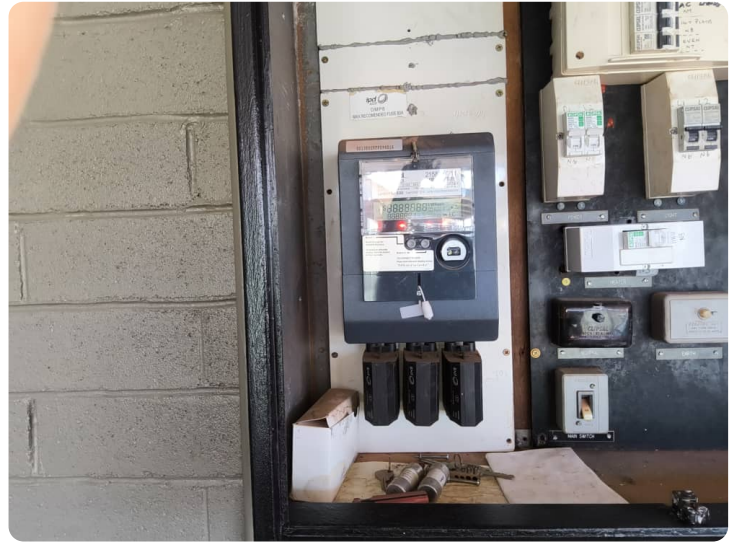
#### 14. Meter box and power

Access to the meter box or sub board was available. The meter box or sub board is not lockable. Power phase type to the site is three phase.

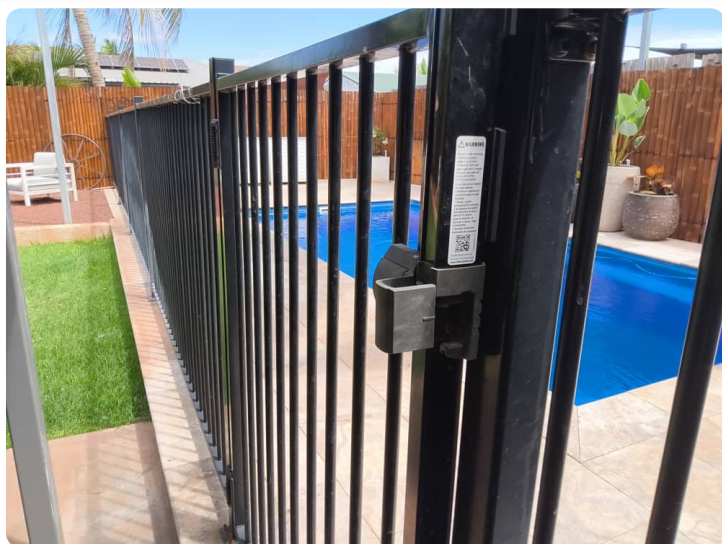
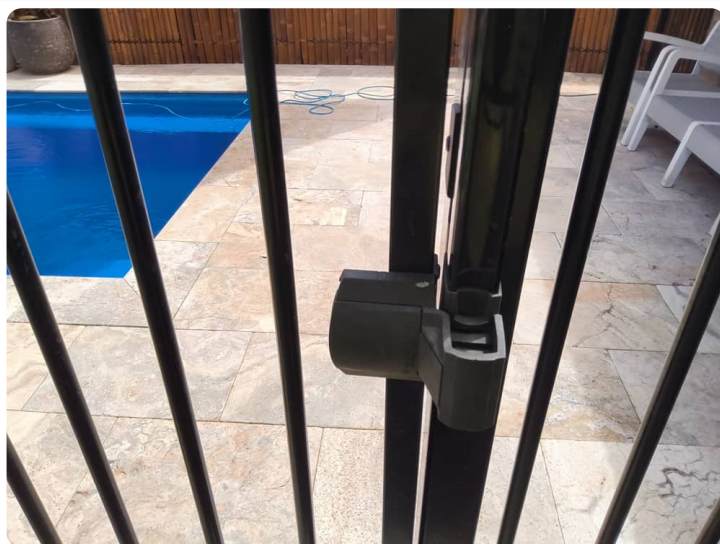
##### **Issue flag:** Safety Item

The pool fence gate does not appear to meet WA requirements as it is not self closing and locking. A pool compliance certificate should be obtained. Remediation work should be undertaken as required.

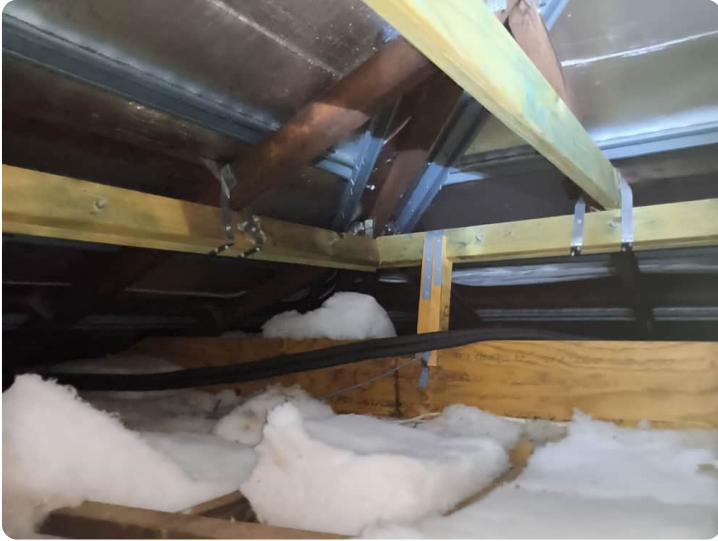
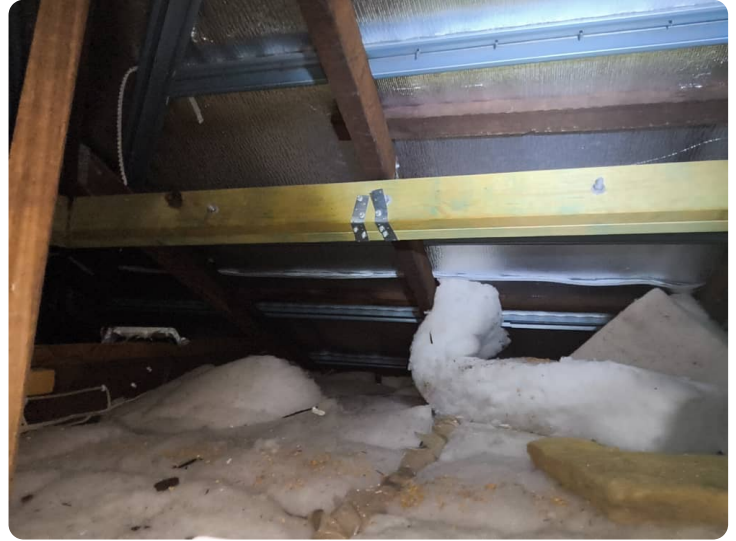
## 25. Sarking

Sarking to the underside of the roof was installed and was considered effective.

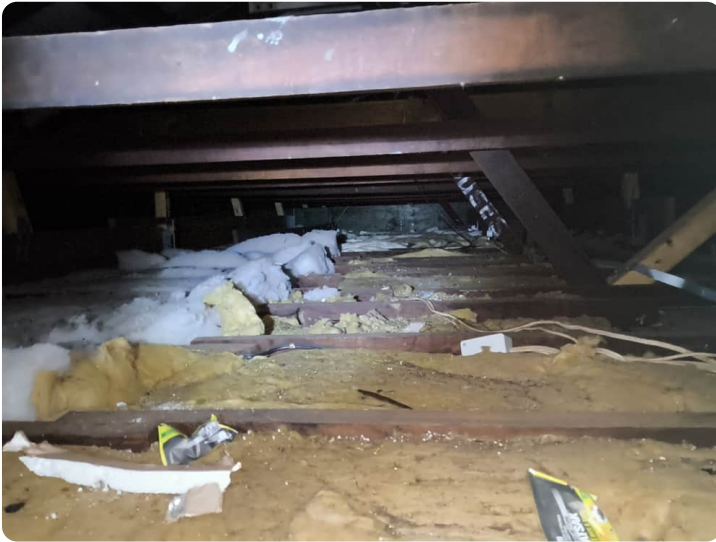
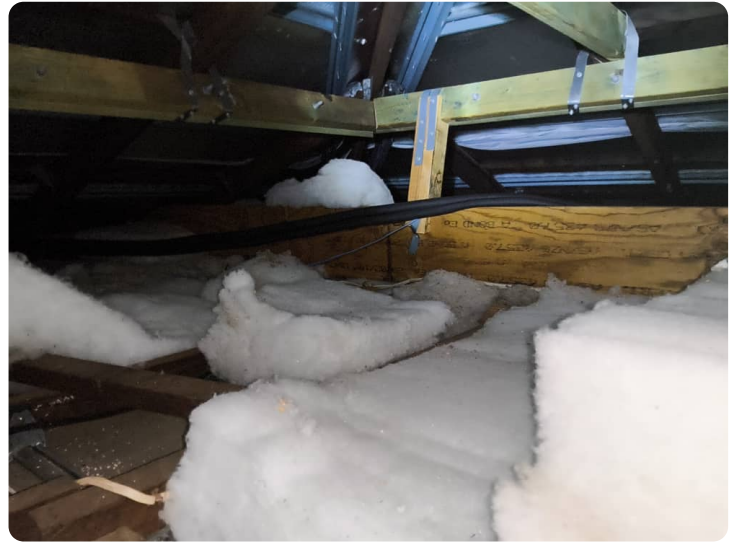
## 27. Insulation

Insulation was installed. Where insulation was installed it was considered effective. The insulation type was predominately batt or rolled type insulation.

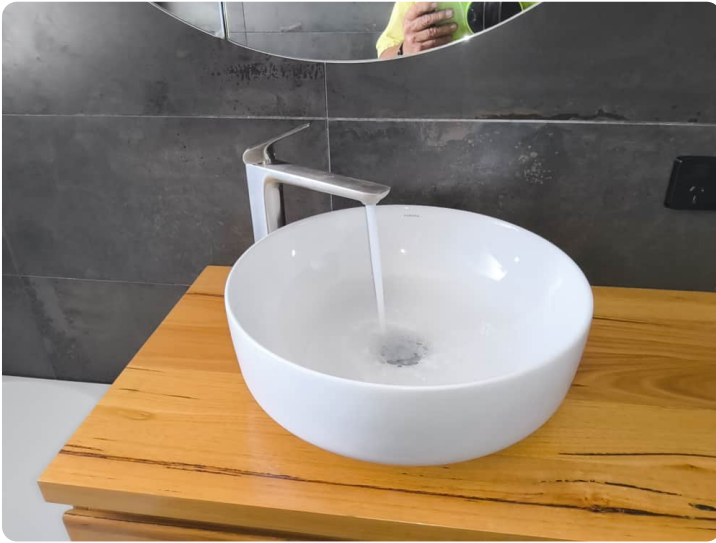
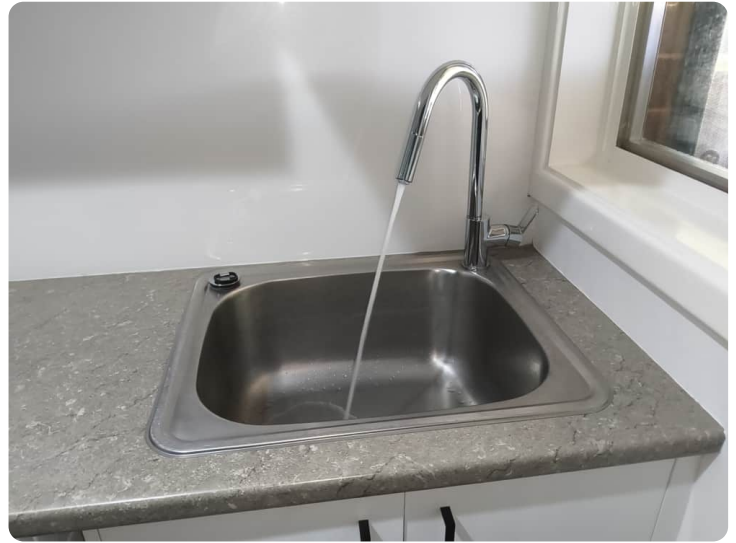
### 38. Plumbing

The taps to multiple areas were turned on and the water flow appeared to be reasonable. Water draining to several sinks and toilets appeared to be reasonable. The Building Inspector is not a Plumbing Contractor and is not permitted to test Plumbing items under WA Law. Where appropriate a Plumbing Contractor should be engaged to test the plumbing in the property.

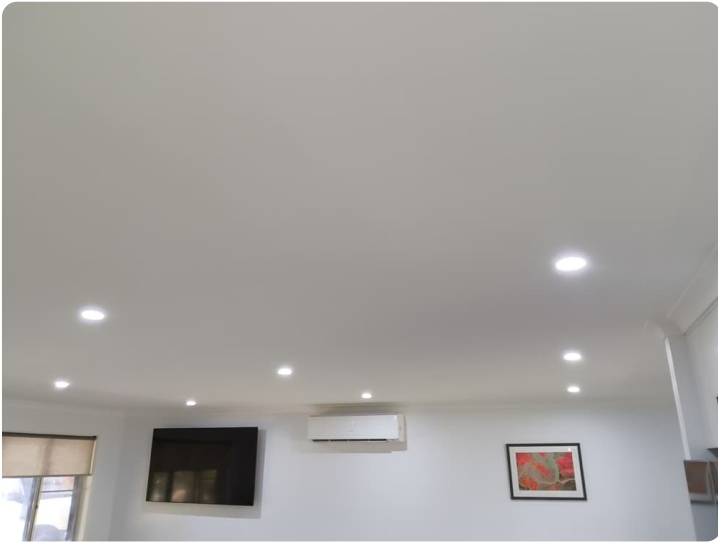
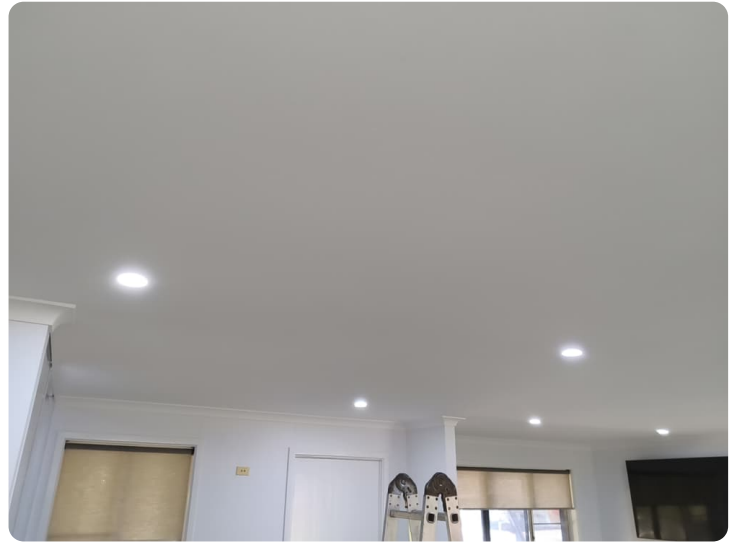
### 39. Lights and power points

Several lights were turned on during the inspection and the lights appeared to be operational. The Building Inspector is not an Electrical Contractor and is not permitted to test Electrical items under WA Law. Where appropriate an Electrical Contractor should be engaged to test the electrical items in the property.

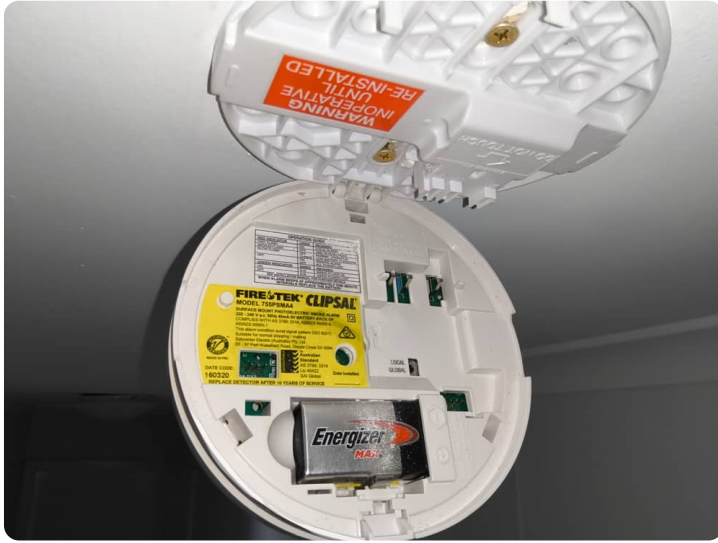
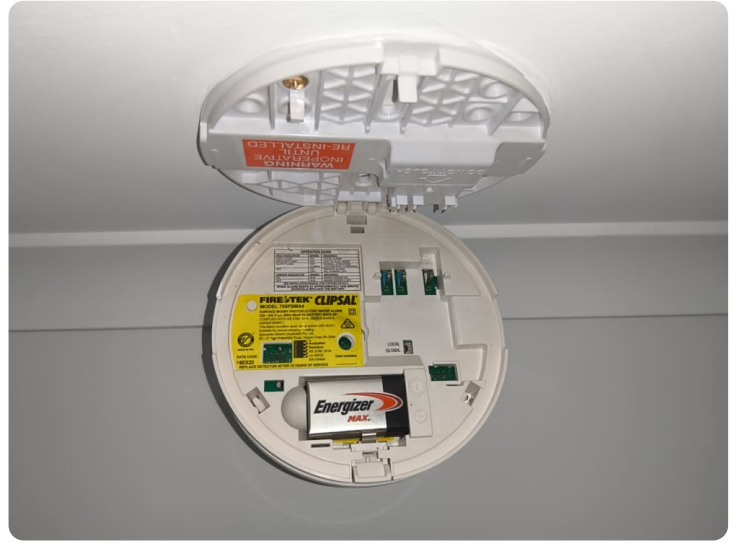
#### 40. Smoke Alarms

There were two hardwired smoke alarms on site. There were no battery smoke alarms on site. The location, number and type of smoke alarms appeared to be consistent with Legislative requirements. It is suggested that an Electrical Compliance Certificate be obtained in relation to the smoke alarms.
