Building inspection

Job ID: 91579

Address: 68 Hunt Way, Bulgarra WA

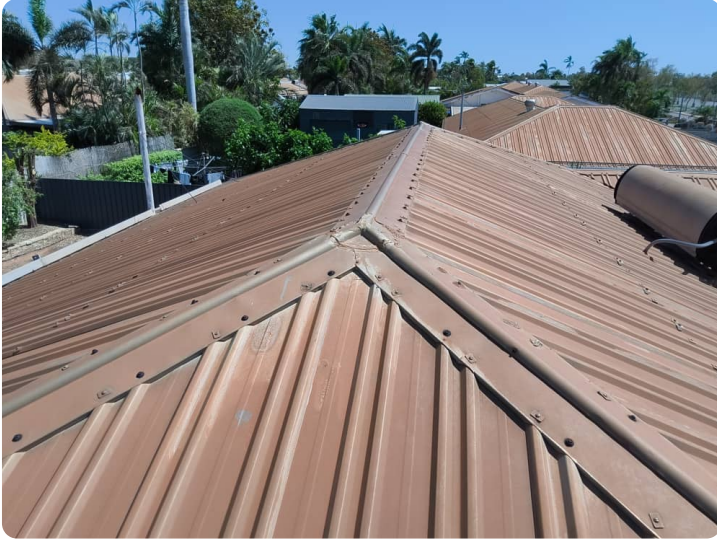
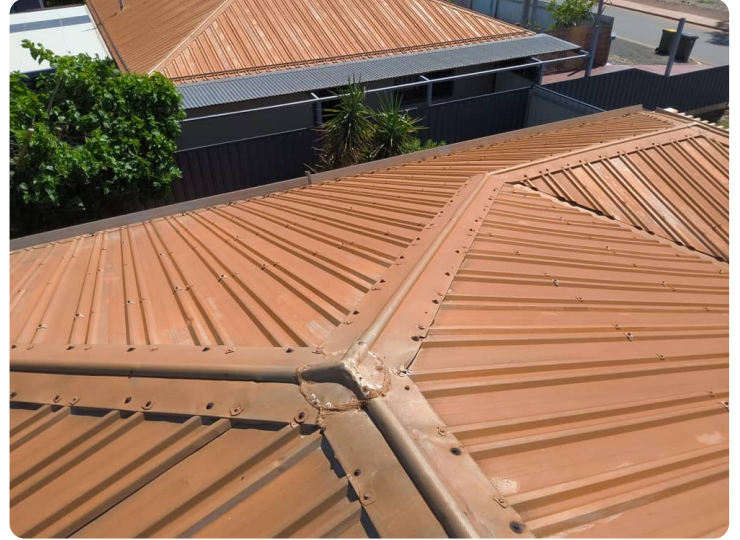
2. Ridges

The ridges and capping are fair in relation to its age and will require ongoing maintenance.

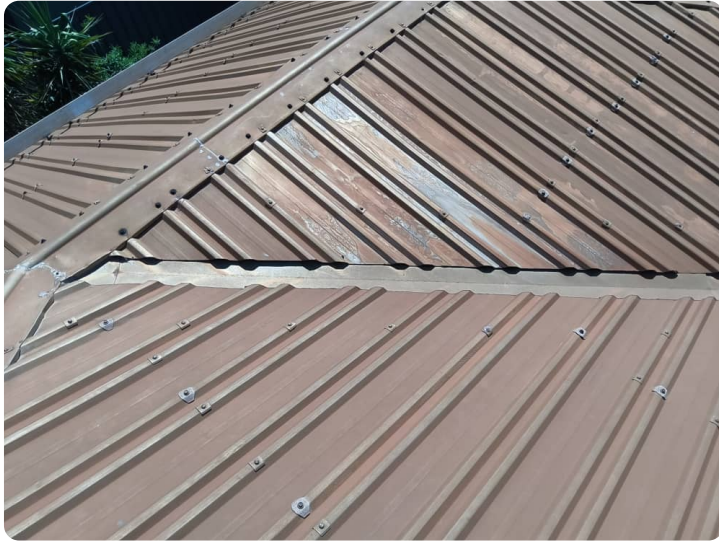
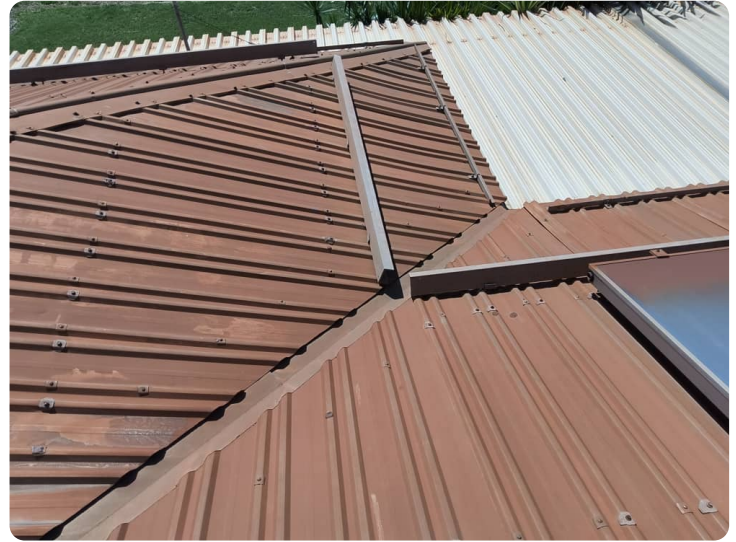
4. Valleys

The valleys are constructed of metal and are unpainted. The condition of the valleys is fair in relation to its age and will require ongoing maintenance. The valleys appear to be relatively free of debris.

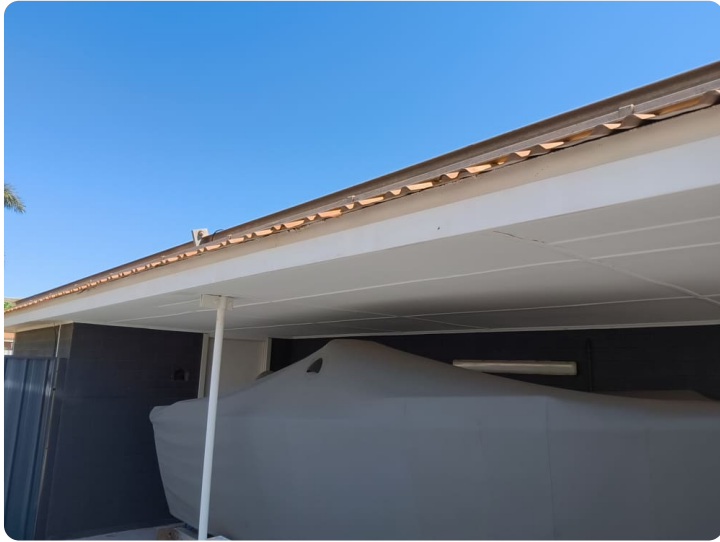
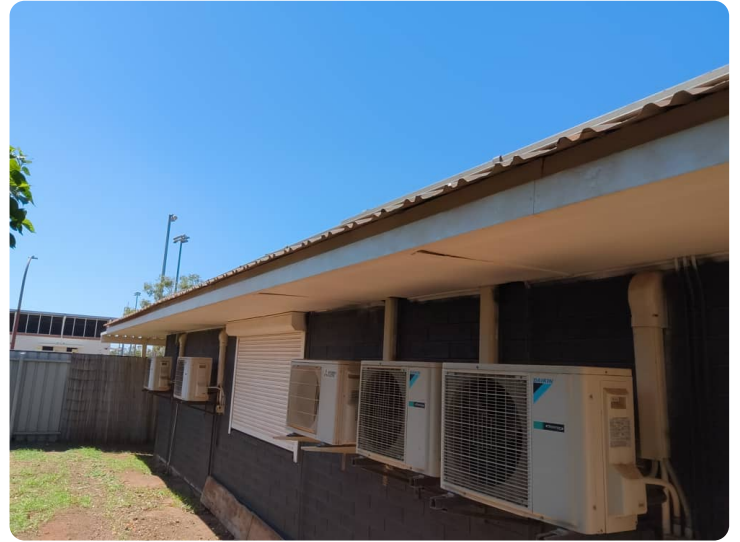
5. Fascia

The fascia are constructed of metal and they are painted. The condition of the fascia is satisfactory in relation to their age and will require normal ongoing maintenance.

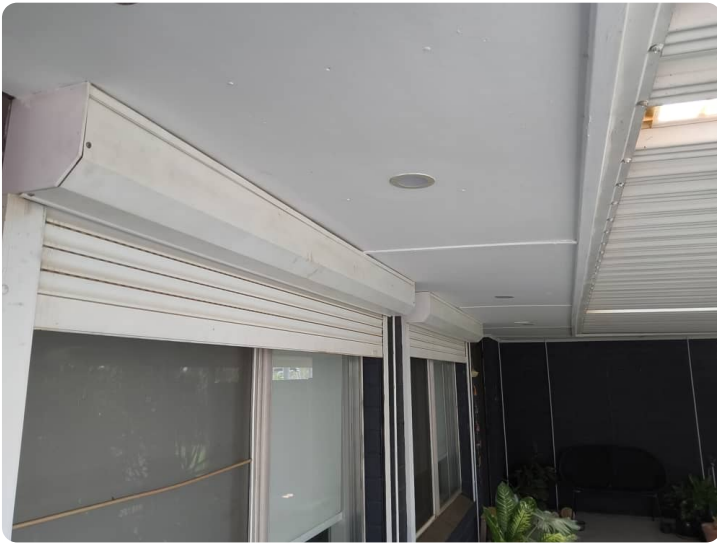
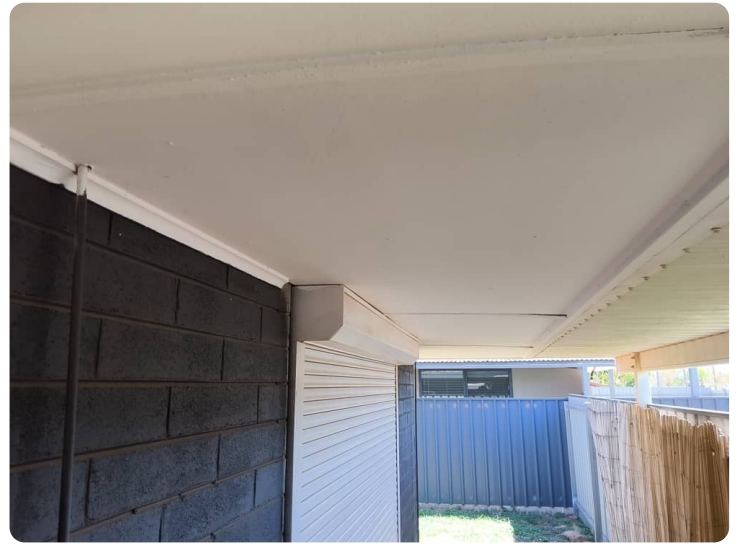
6. Eaves

The eaves are boxed and constructed of painted fibre cement. The condition of the eaves is satisfactory in relation to their age and will require normal ongoing maintenance. Please note that some of the building material utilised on or within the building may or may not contain asbestos. The Australian Government has indicated that asbestos can only be correctly identified through laboratory testing. The material on this building site may not pose a concern in the current static state if maintained but for any future works the material should be tested and appropriate measures used for asbestos handling if the material is subsequently found to contain asbestos.

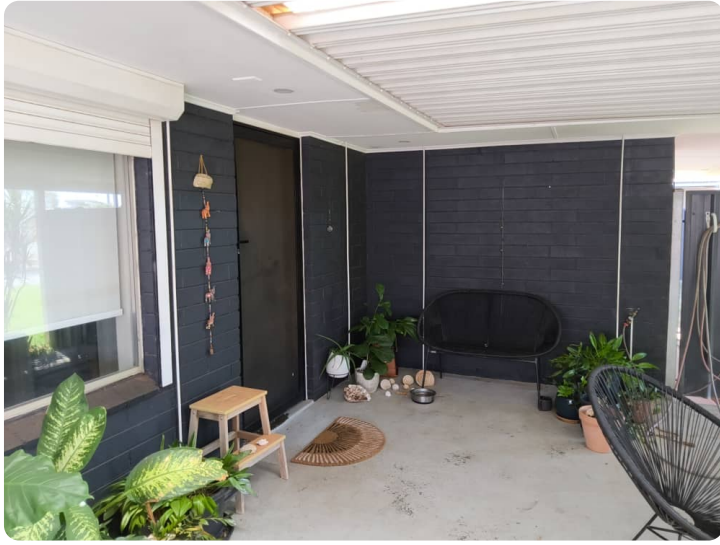
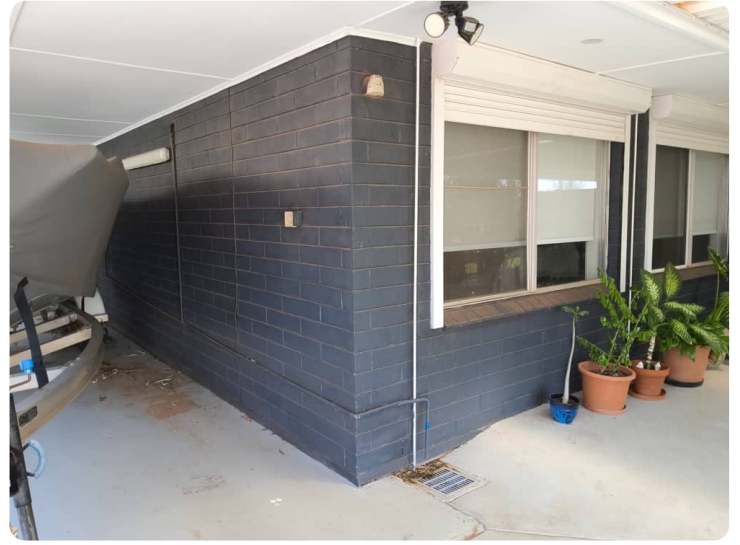
7. External walls

The external walls are constructed of painted brick. The condition of the walls generally is satisfactory in relation to their age and will require normal ongoing maintenance.

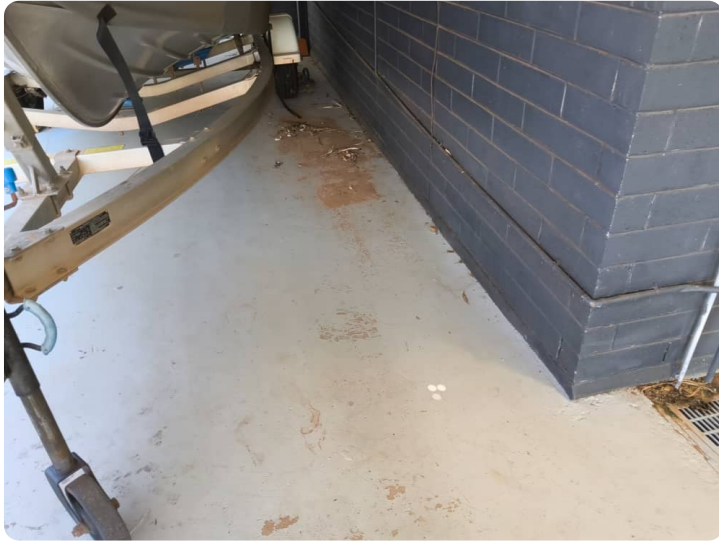
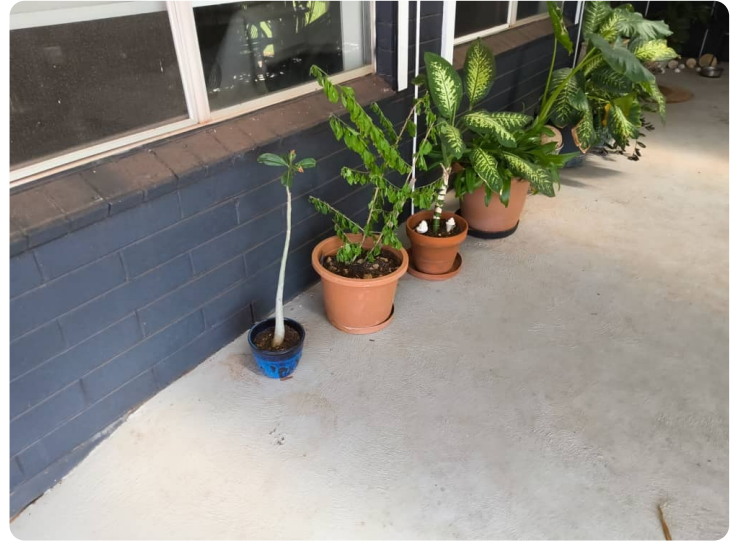
8. Footings

The footings are below ground and cannot be seen. The condition of the footings cannot be determined.

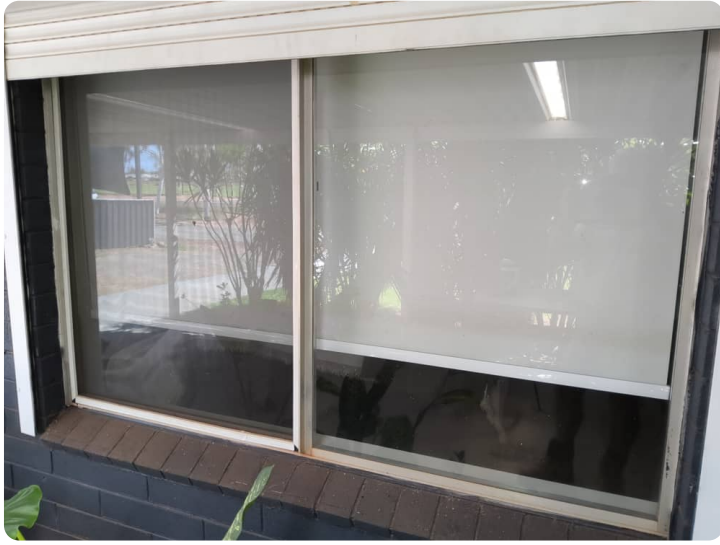
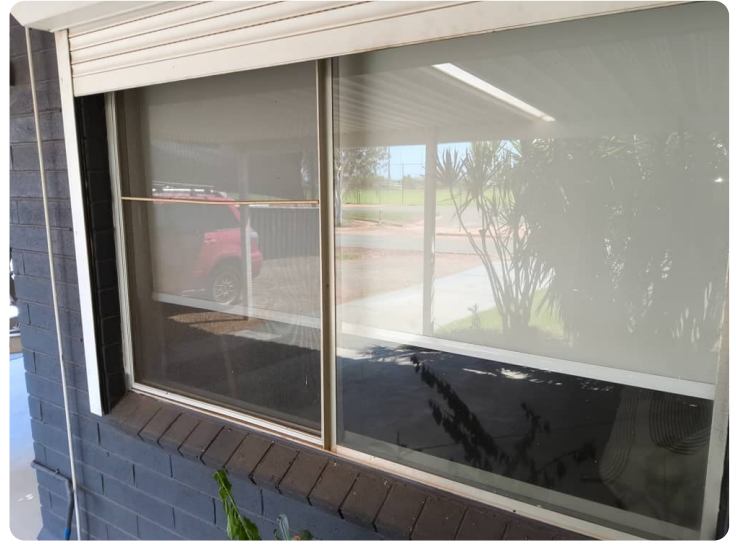
9. Windows and window frames

The window and window frames are primarily constructed of aluminium. The condition of the window and window frames is generally fair in relation to its age and will require ongoing maintenance.

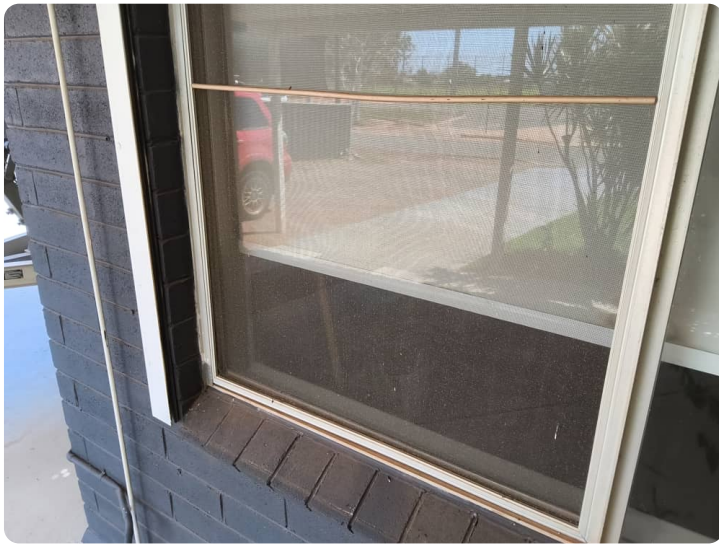
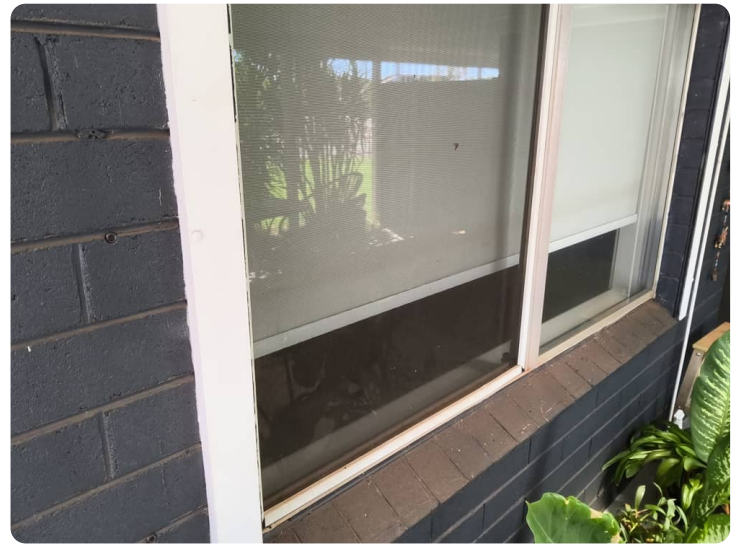
10. Window fly screens

Fly screens have been installed to all of the windows. The condition of the window fly screens is generally satisfactory in relation to its age and will require normal ongoing maintenance. Current Building Codes require that glass in windows and doors in close proximity to the floor must be safety glass to minimise personal injury in the case of breakage. Houses built prior to the 1980(s) did not have this requirement. There is no current requirement to retrospectively remediate however it is suggested that consideration be given to upgrading where applicable.

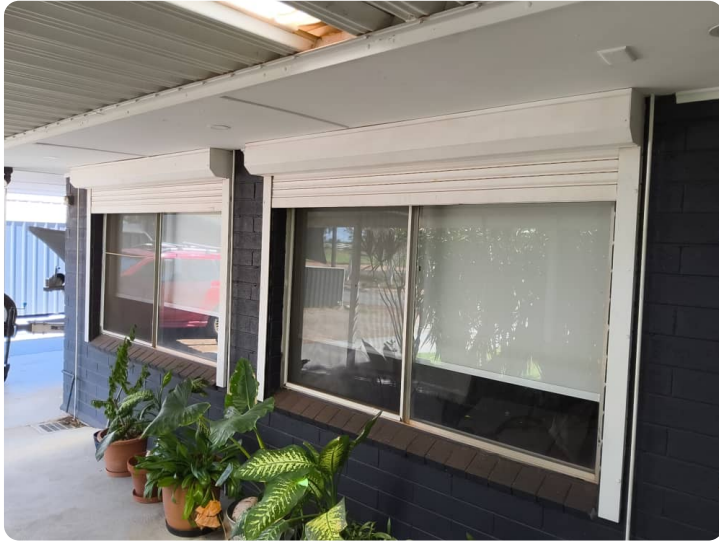
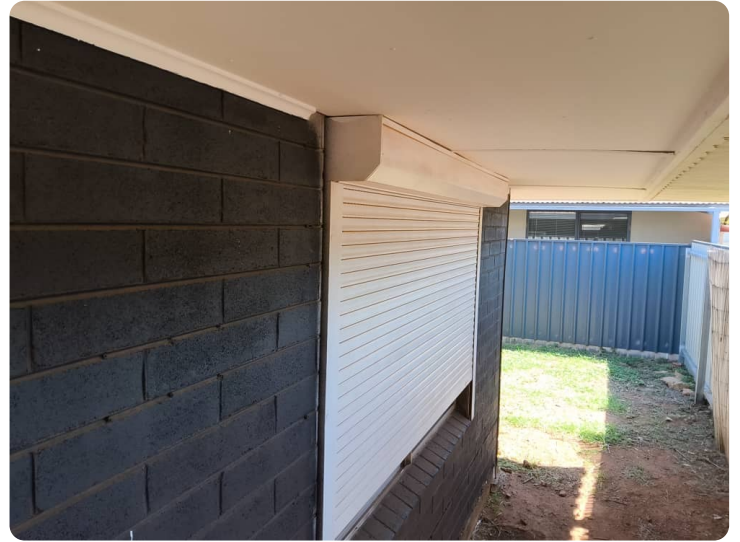
11. Roller shutters

Roller shutters have been installed to most of the windows. The condition of the roller shutters is satisfactory in relation to its age and will require normal ongoing maintenance.

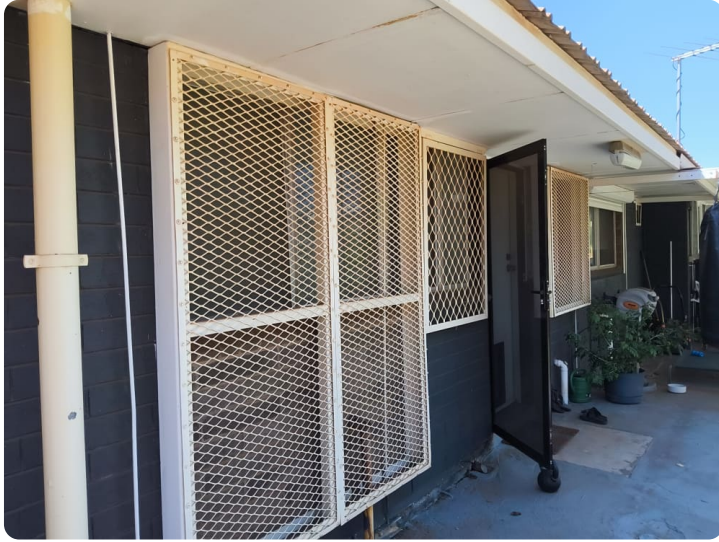
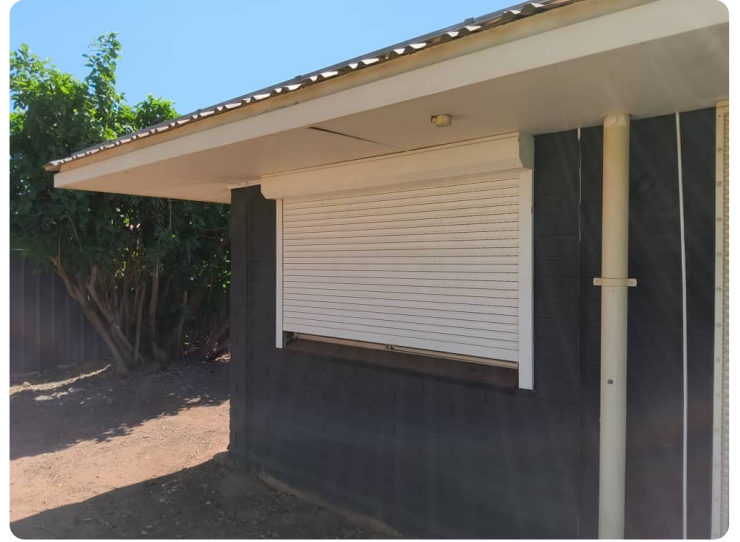
12. Cyclone screens

Cyclone screens have been installed to all of the windows. The condition of the cyclone screens is satisfactory in relation to its age and will require normal ongoing maintenance. The cyclone screens appear to be compliant with local requirements.

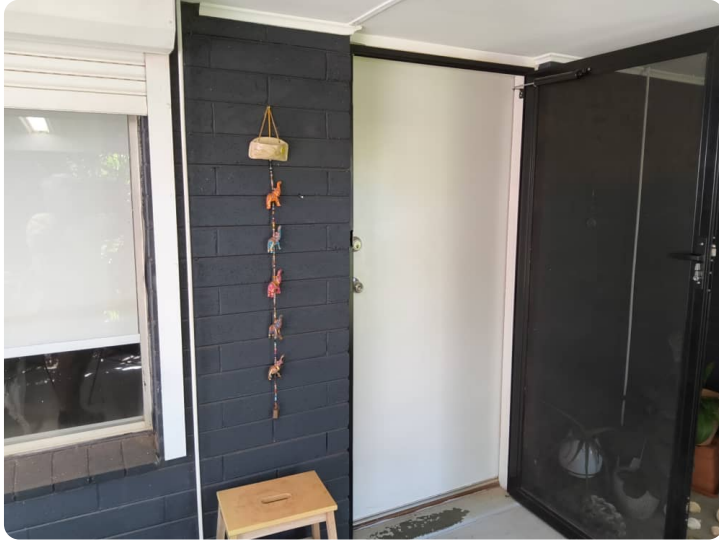
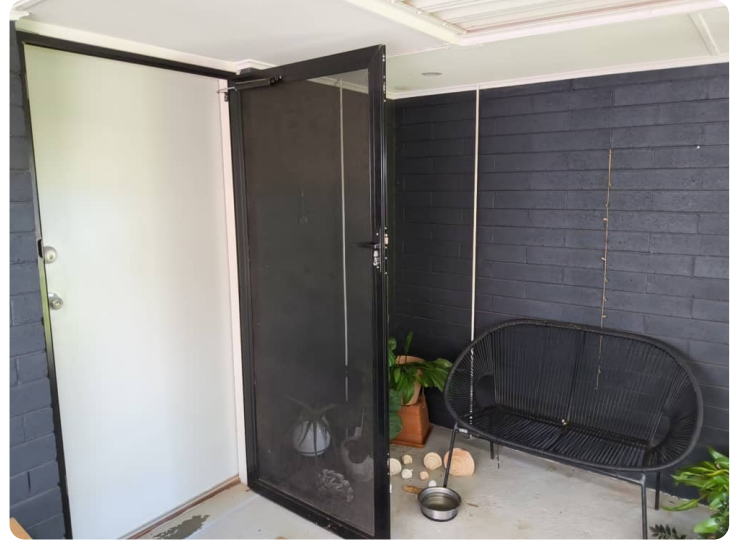
13. Front door

The front door is constructed of solid timber. The condition of the front door is satisfactory in relation to its age and will require normal ongoing maintenance. Deadlocks have been installed. A security screen door has been fitted.

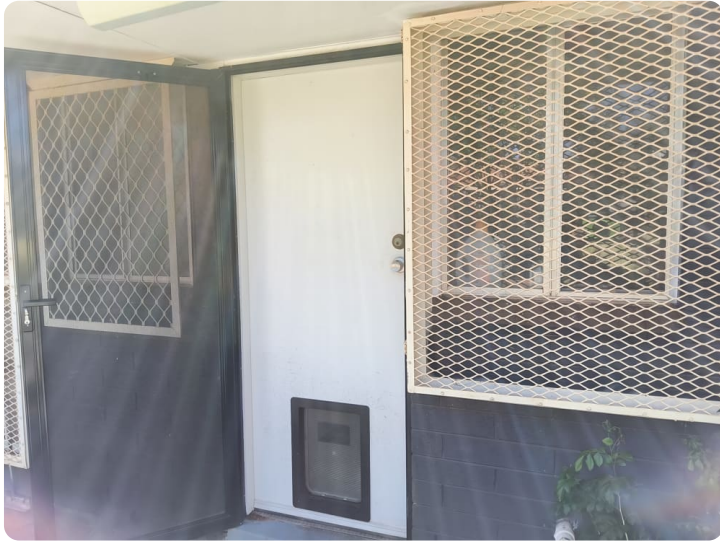
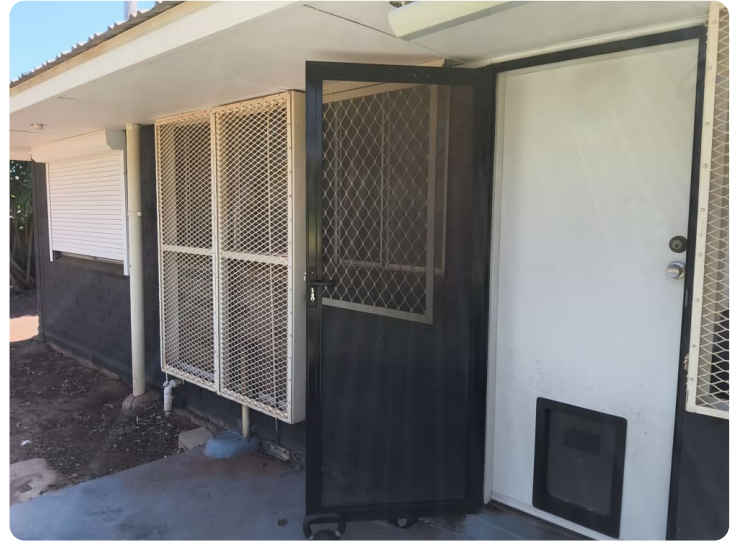
14. Other external doors

Other external doors are constructed of solid timber. The condition of the other external doors is satisfactory in relation to its age and will require normal ongoing maintenance.

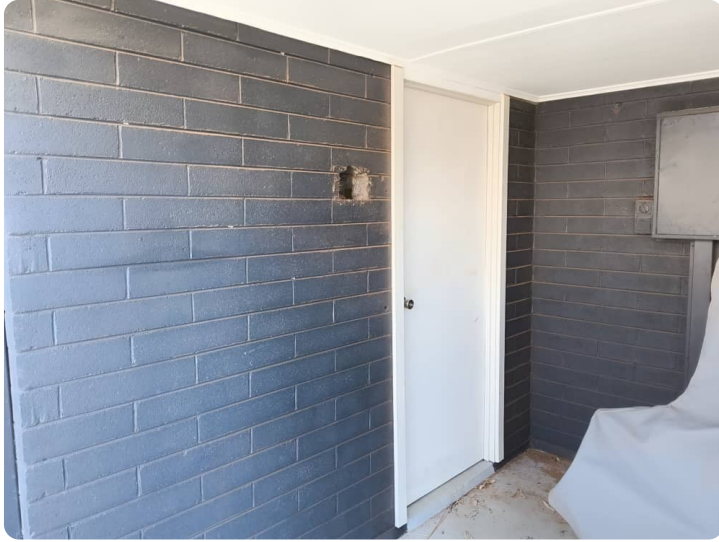
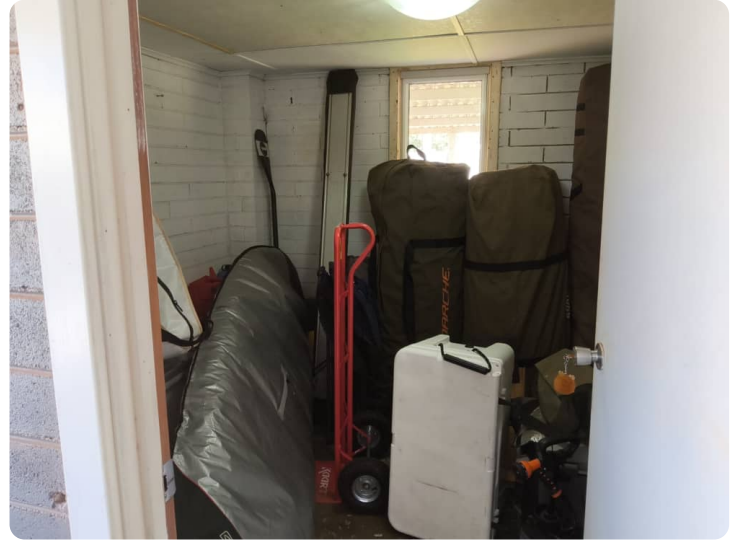
15. Storeroom 1

An external storeroom for the property is located adjacent and under the main roof of the building. The condition of the storeroom is satisfactory in relation to its age and will require normal ongoing maintenance. Access and visibility of the area was restricted by stored items.

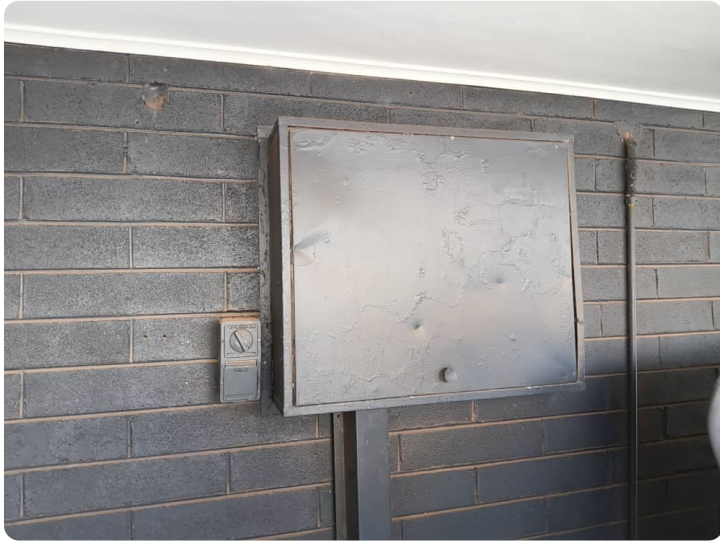
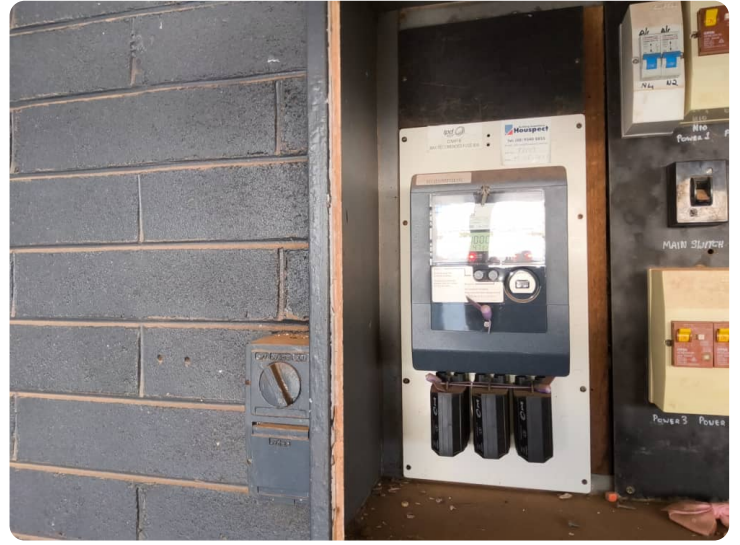
16. Meter box and power

Access to the meter box or sub board was available. The meter box or sub board is not lockable. Power phase type to the site is three phase.

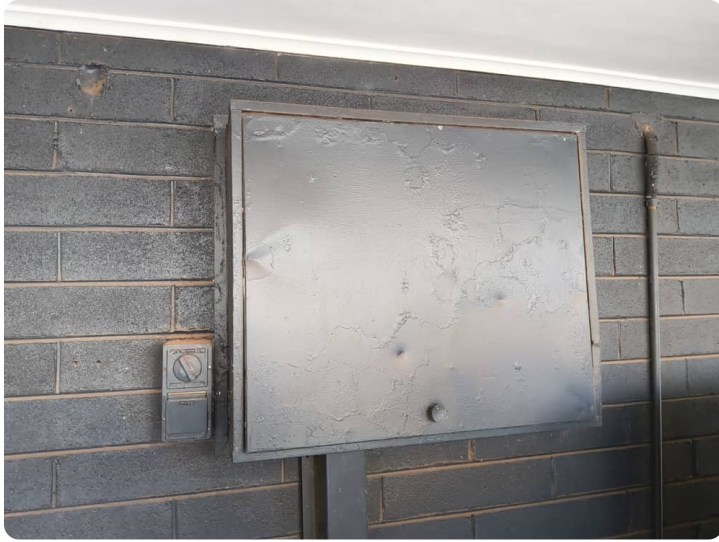
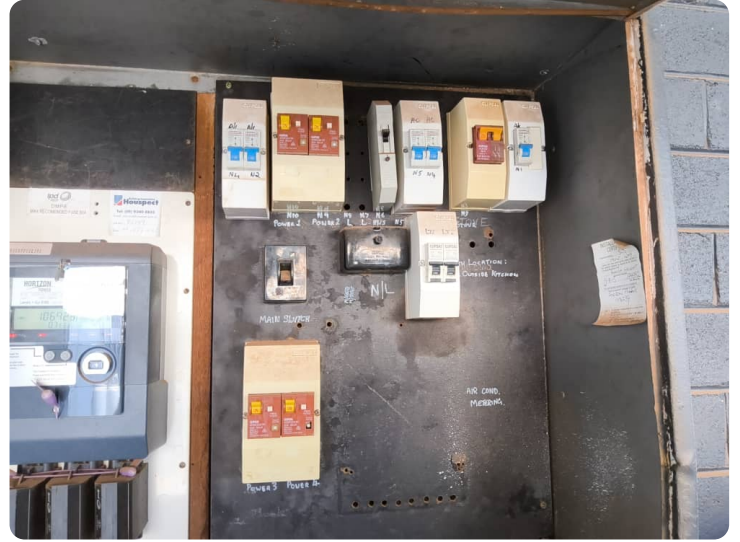
17. Residual Current Devices

There were multiple Residual Current Devices (RCD)(s) noted in the meter box or sub meter box. The RCD(s) were not tested. It is suggested that an Electrical Compliance Certificate be obtained in relation to the RCD(s).

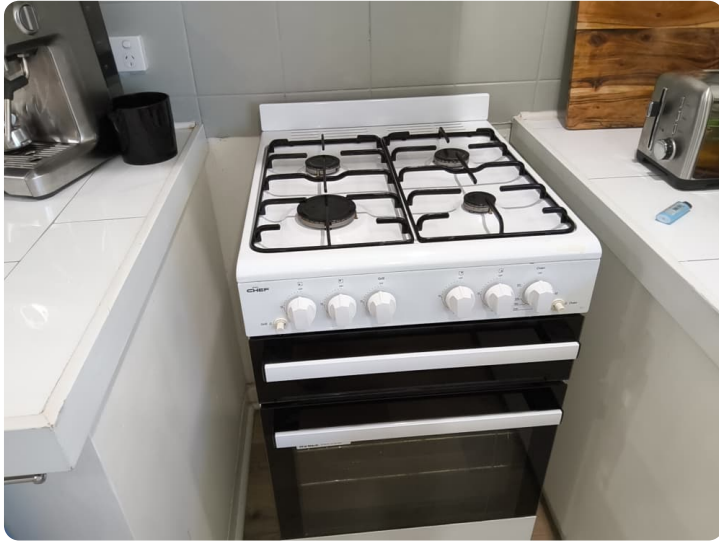
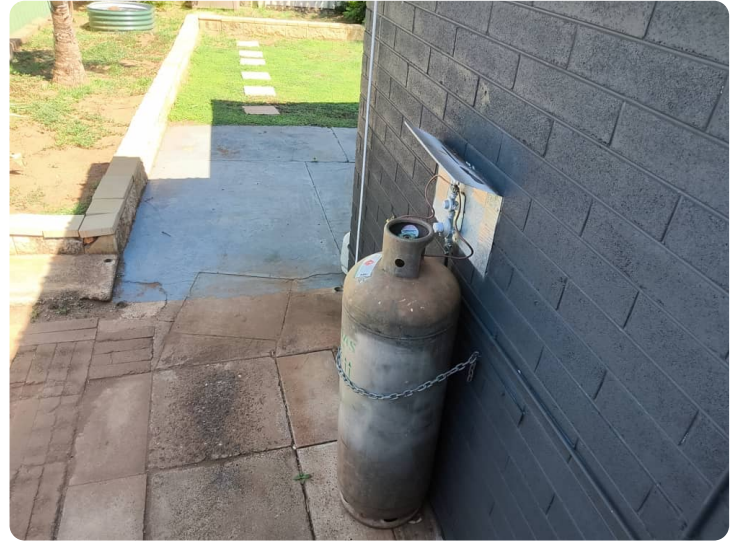
18. Gas Supply

Gas supply to the property is via LPG bottles. While on site the inspector could not smell detectable gas leaks.

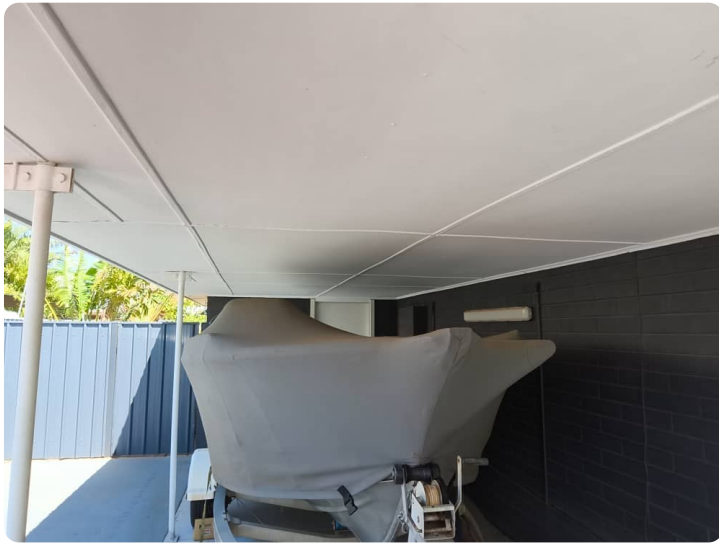
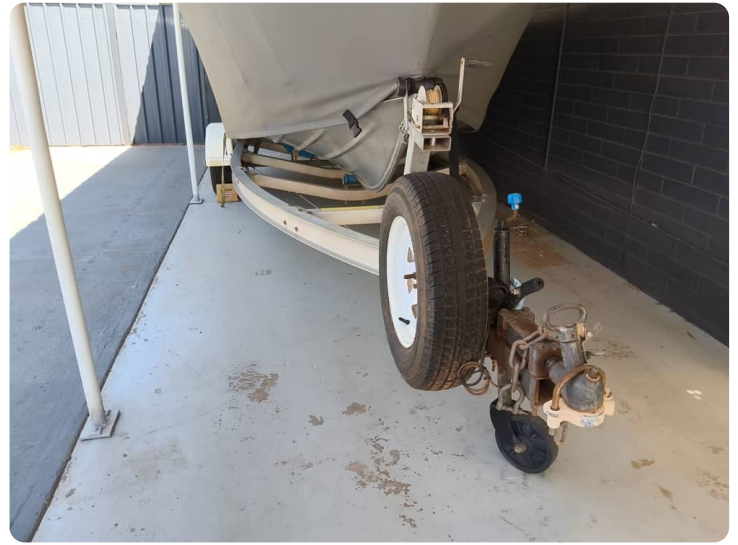
19. Carport or Garage (Primary)

There is a primary carport on the property constructed of same materials as the primary structure. The condition of the carport or garage is satisfactory in relation to its age and will require normal ongoing maintenance. Please note that some of the building material utilised on or within the building may or may not contain asbestos. The Australian Government has indicated that asbestos can only be correctly identified through laboratory testing. The material on this building site may not pose a concern in the current static state if maintained but for any future works the material should be tested and appropriate measures used for asbestos handling if the material is subsequently found to contain asbestos.

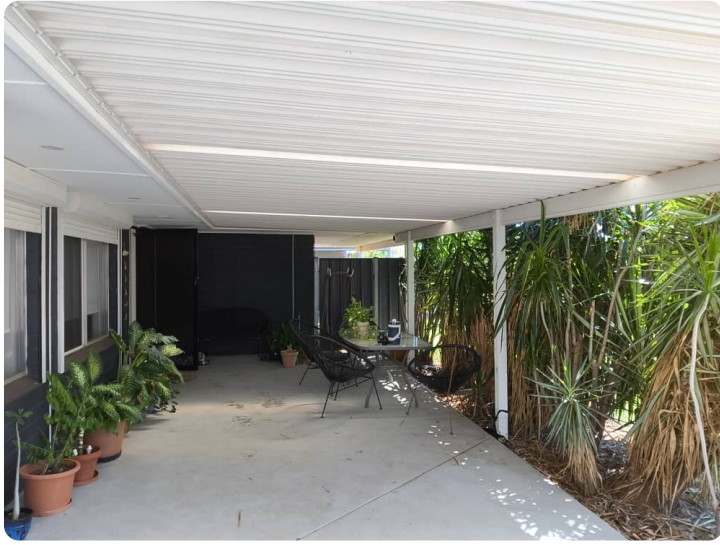
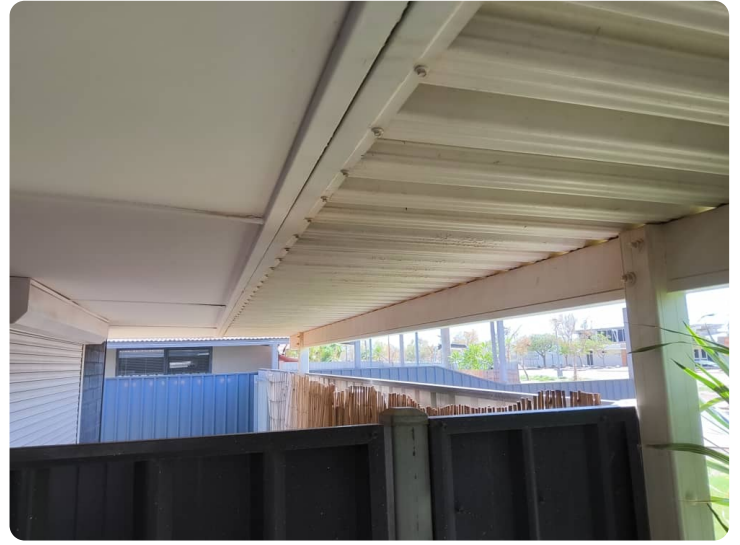
20. Veranda (Primary)

The primary veranda is constructed of metal. The condition of the veranda is satisfactory in relation to its age and will require normal ongoing maintenance.

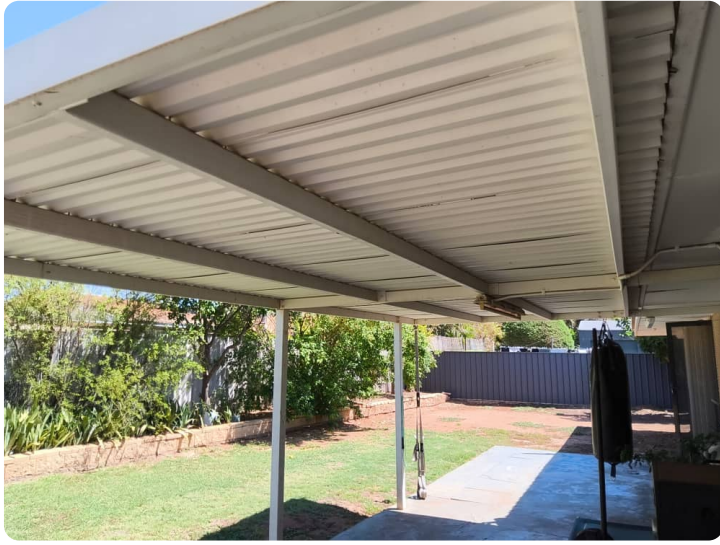
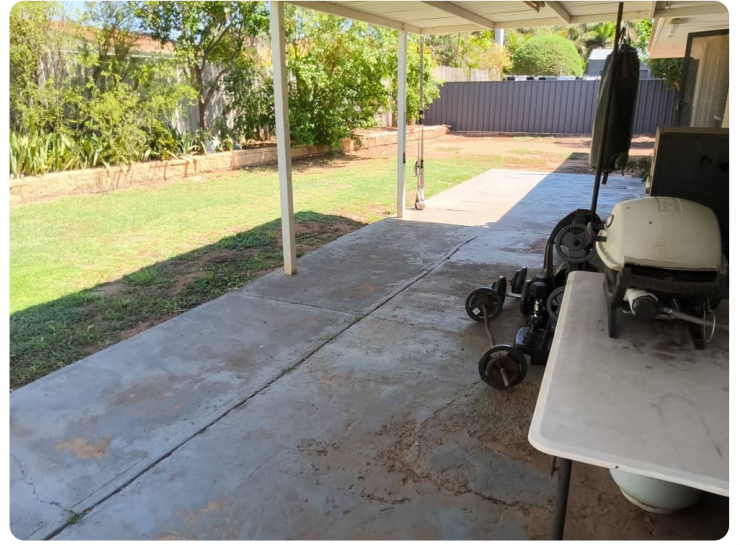
21. Patio

The primary patio is constructed of metal. The condition of the patio is satisfactory in relation to its age and will require normal ongoing maintenance.

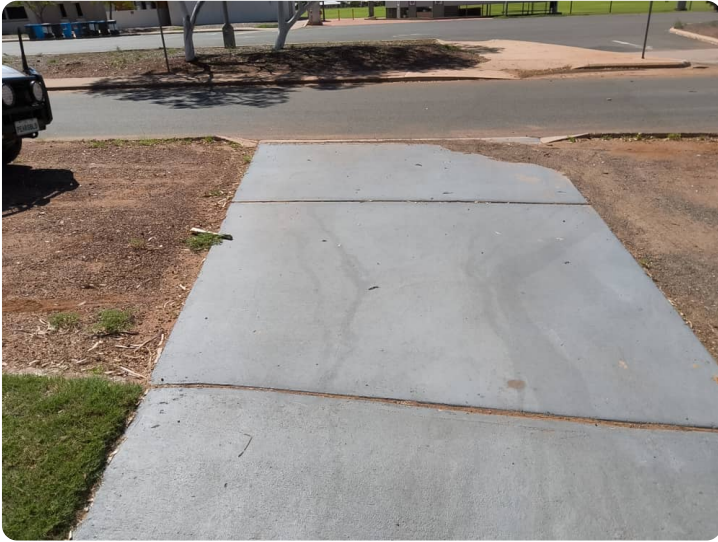
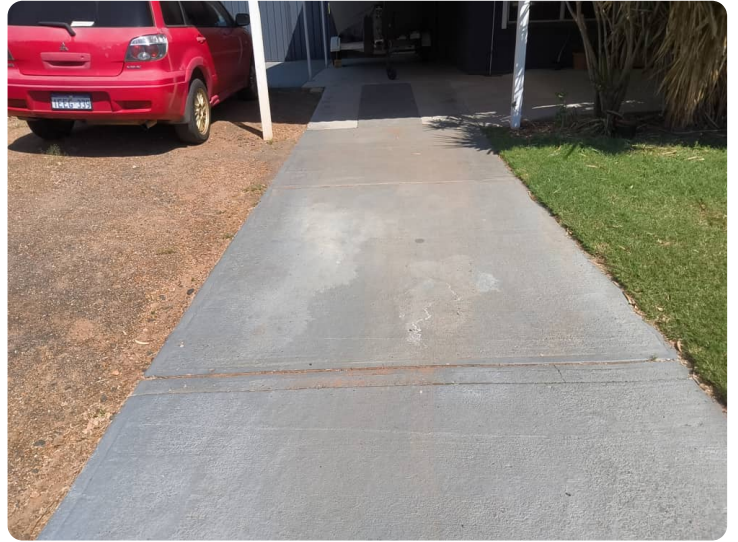
22. Driveway

The driveway and cross over is constructed of concrete. The condition of the driveway is satisfactory in relation to its age and will require normal ongoing maintenance.

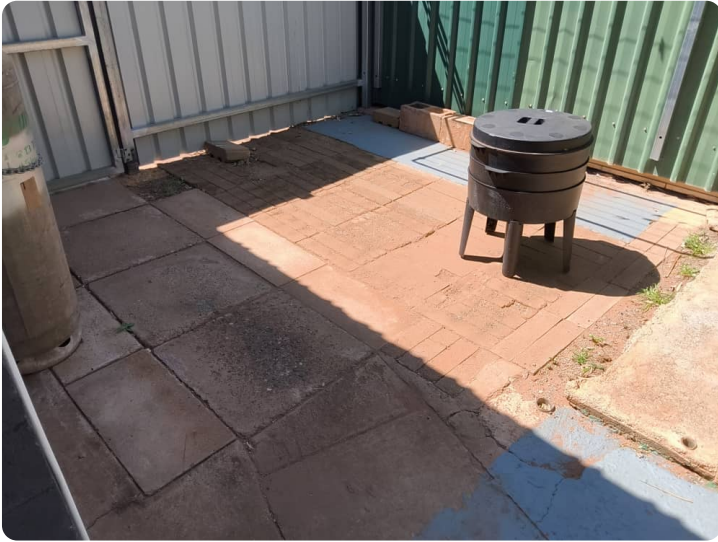
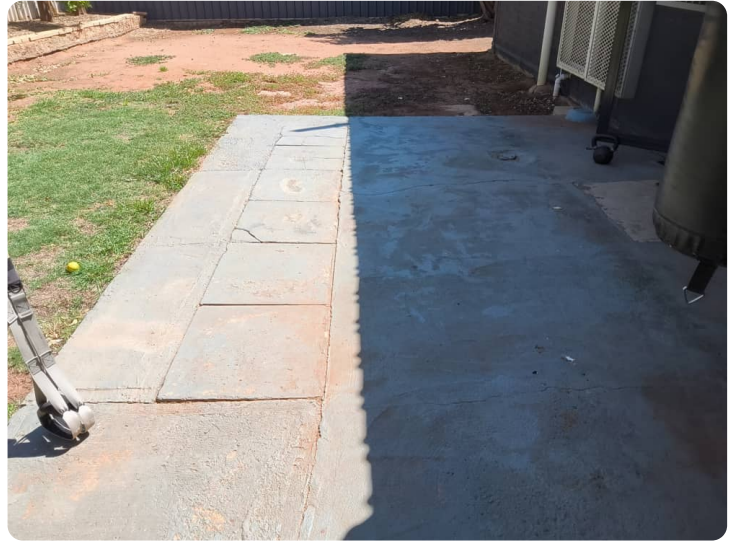
23. External walkways and paved areas

The external walkways and paved areas are constructed of a variety of materials. The condition of the external walkways and paved areas is fair in relation to its age and will require ongoing maintenance.

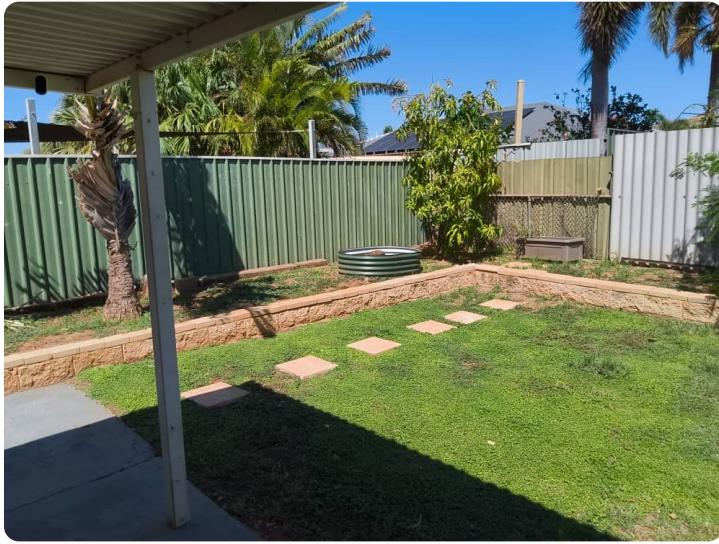
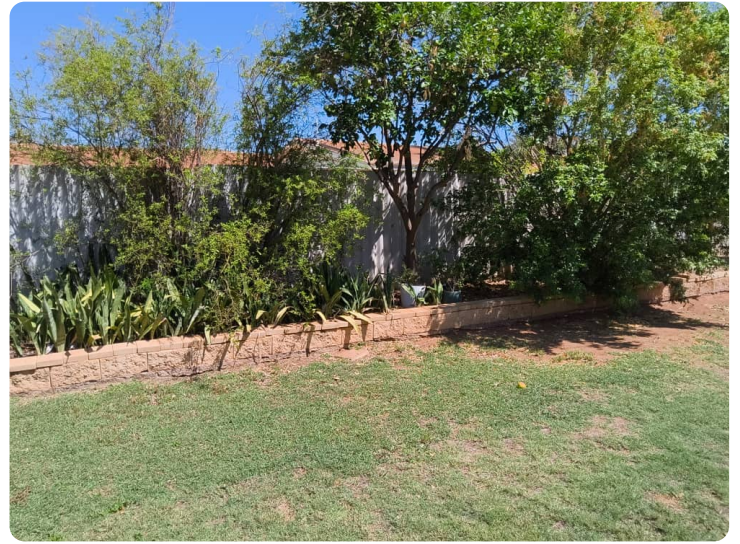
24. Fences - boundary

The boundary fences are constructed of variety of materials. The condition of the boundary fence is satisfactory in relation to its age and will require normal ongoing maintenance. Some of the fences could not be viewed due to vegetation, stored items or secondary structures. Please note that some of the building material utilised on or within the building may or may not contain asbestos. The Australian Government has indicated that asbestos can only be correctly identified through laboratory testing. The material on this building site may not pose a concern in the current static state if maintained but for any future works the material should be tested and appropriate measures used for asbestos handling if the material is subsequently found to contain asbestos.

24.1 Fibre cement damage

There was loose, missing or damaged fibre cement fence components that requires remediation. The material should be tested, where required, and then a remediation plan established.

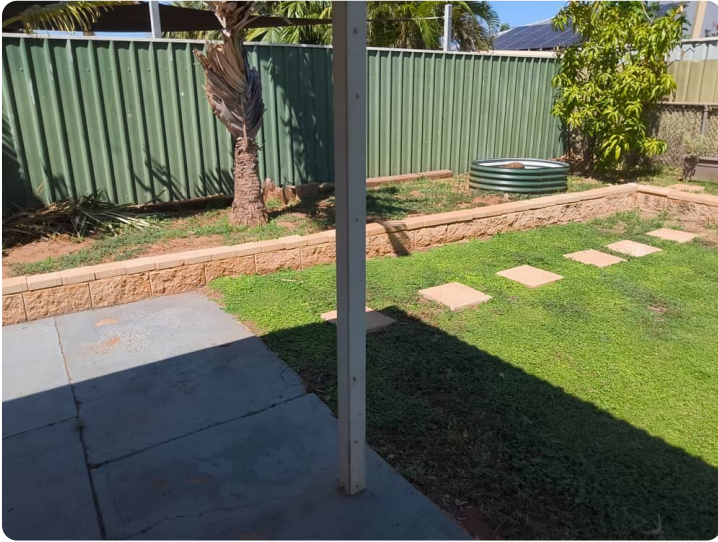
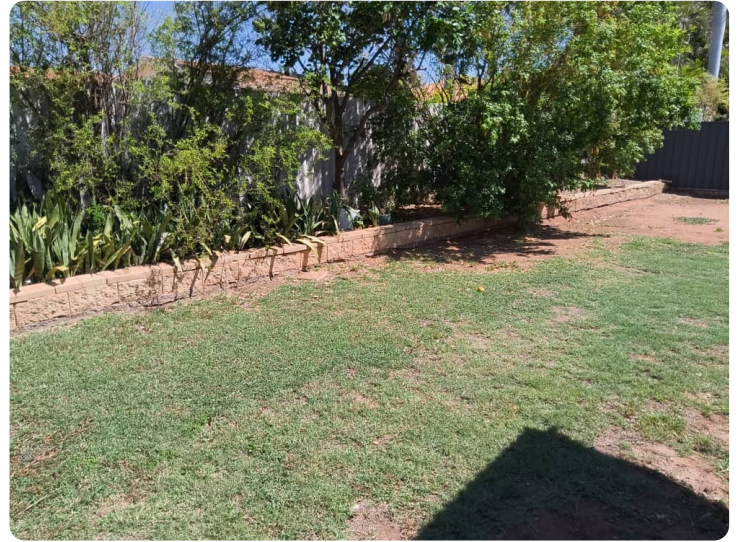
25. Retaining walls

The retaining walls are constructed of limestone or concrete blocks. The condition of the retaining wall is satisfactory in relation to its age and will require normal ongoing maintenance.

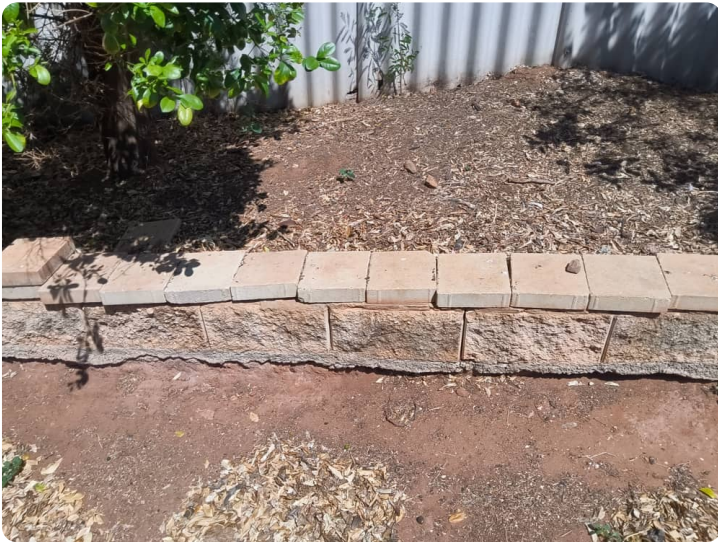
25.1 Header bricks loose

The header bricks are loose and require re-fixing.

Issue: Header bricks loose

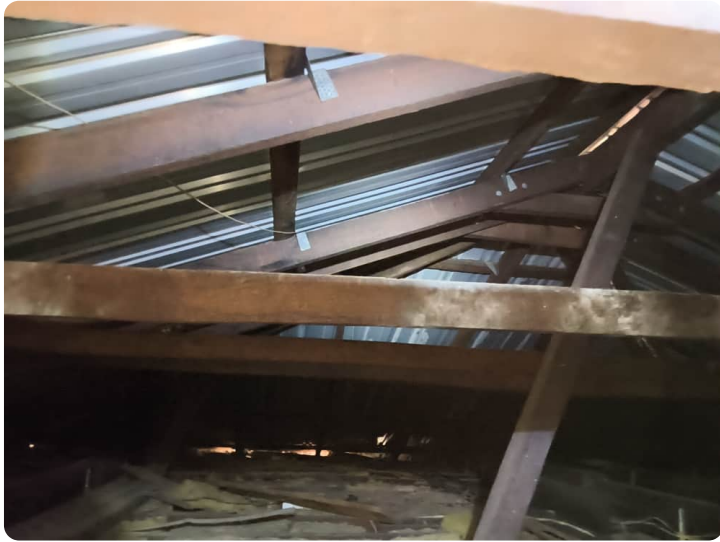
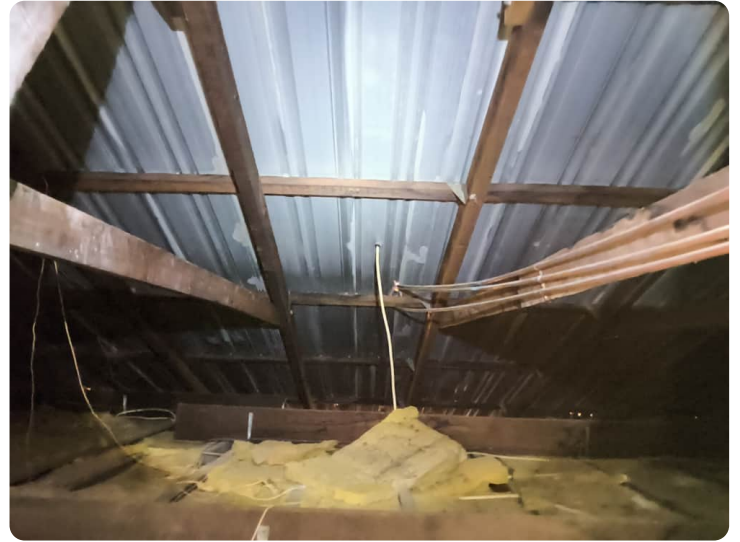
26. Under side of roof cover

The condition of the underside of the roof cover is satisfactory in relation to its age and will require normal ongoing maintenance.

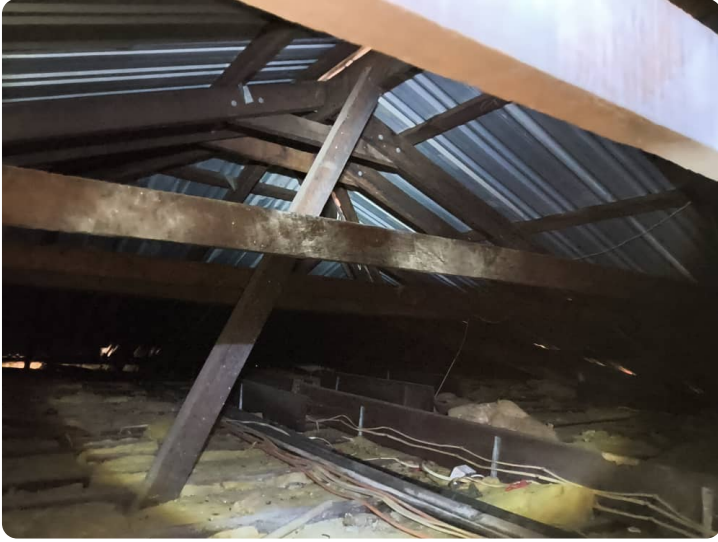
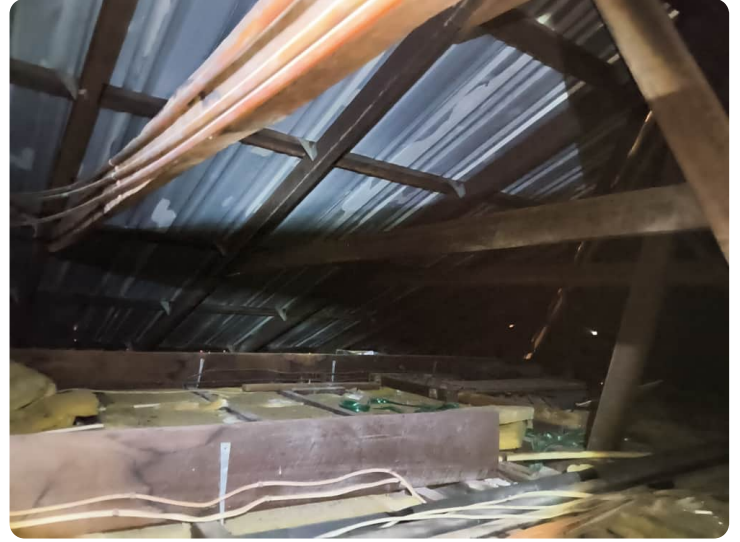
27. Sarking

Sarking to the underside of the roof was not installed and was not considered effective.

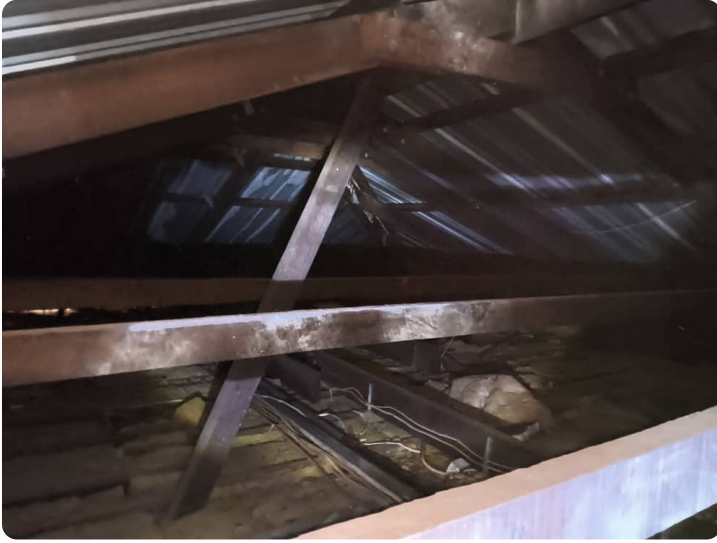
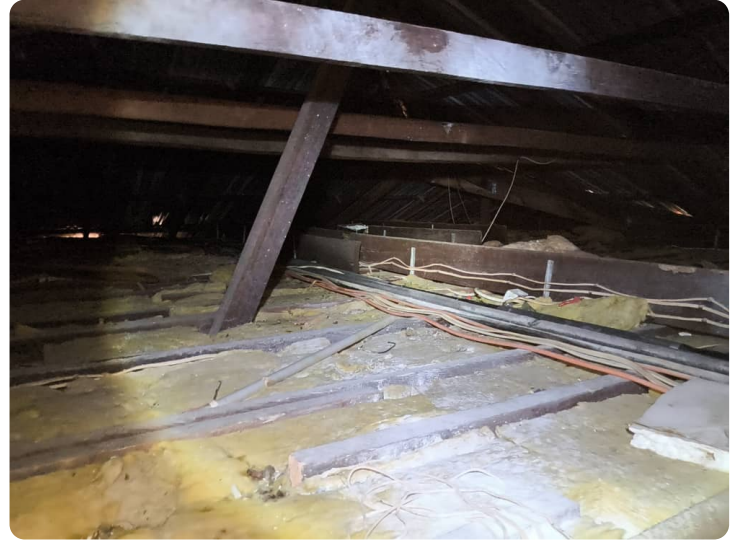
28. Roof frame

The roof frame type is a traditional timber stick frame. The condition of the roof frame is satisfactory in relation to its age and will require normal ongoing maintenance. Access to the roof space was restricted by the pitch of the roof, insulation, ducting or other items. The inspector estimates that visibility was available to more than 75% of the area.
