Building inspection

Job ID: 91579

Address: 68 Hunt Way, Bulgarra WA

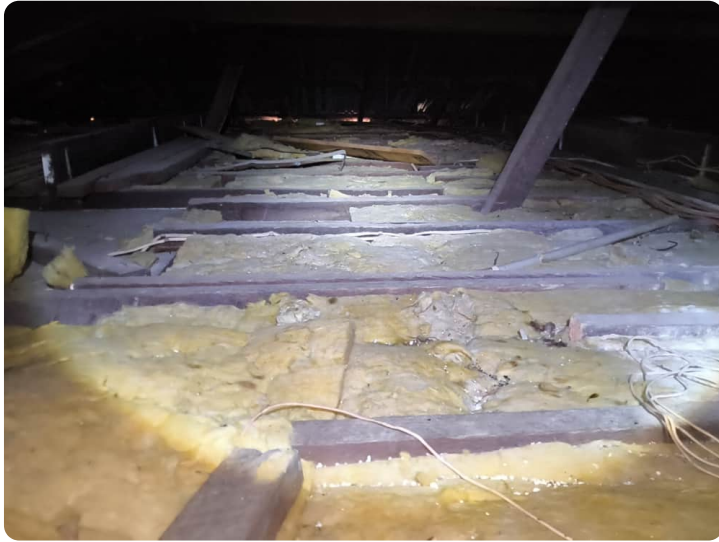
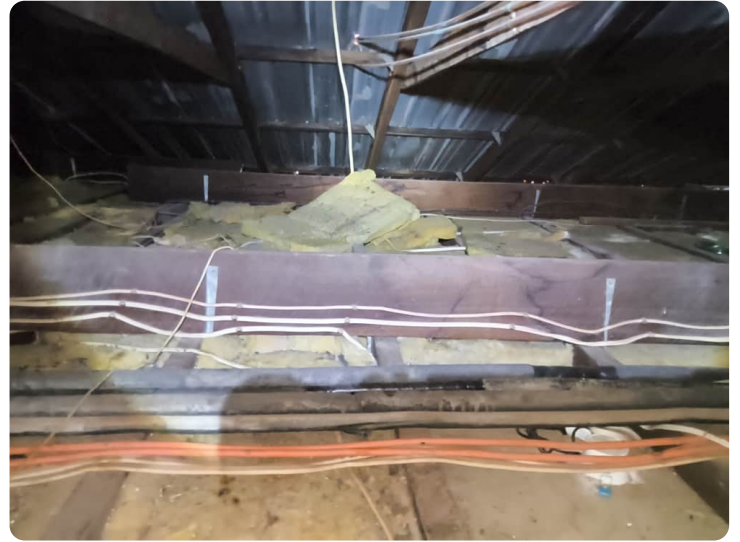
29. Insulation

Insulation was installed. Where insulation was installed it was considered effective. The insulation type was predominately batt or rolled type insulation.

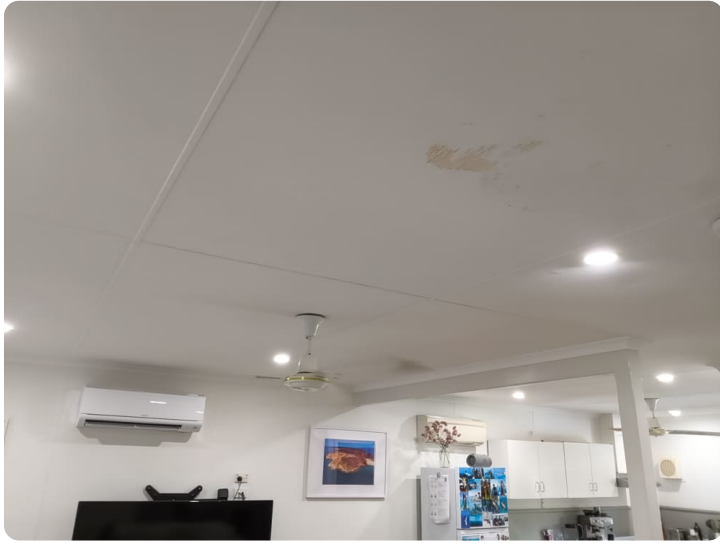
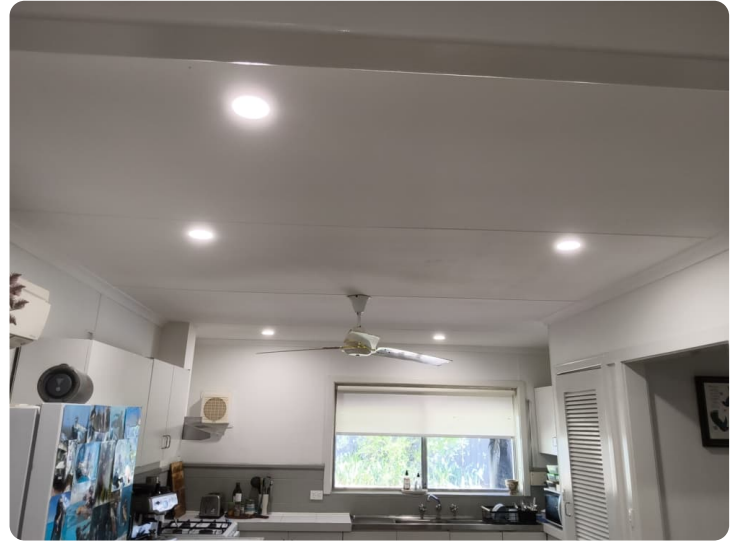
30. Ceilings

The ceilings are constructed of plasterboard with cornices constructed of plasterboard. The condition of the ceilings is satisfactory in relation to its age and will require normal ongoing maintenance.

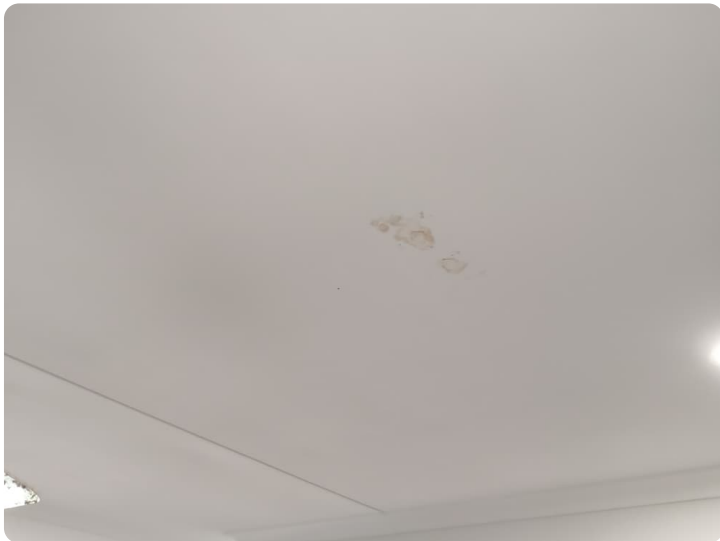
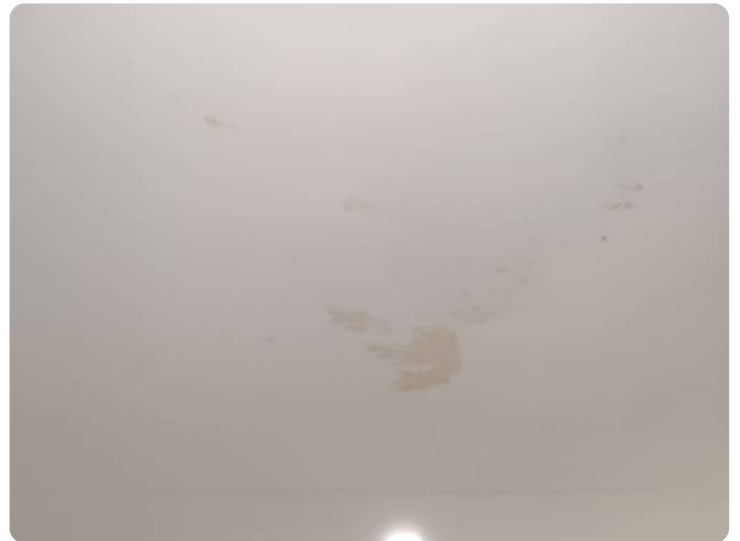
30.1 Water ingress - ceilings

The ceilings in the images indicate water ingress. The source of the water ingress needs to be located and resolved prior to preparing and painting the ceiling.

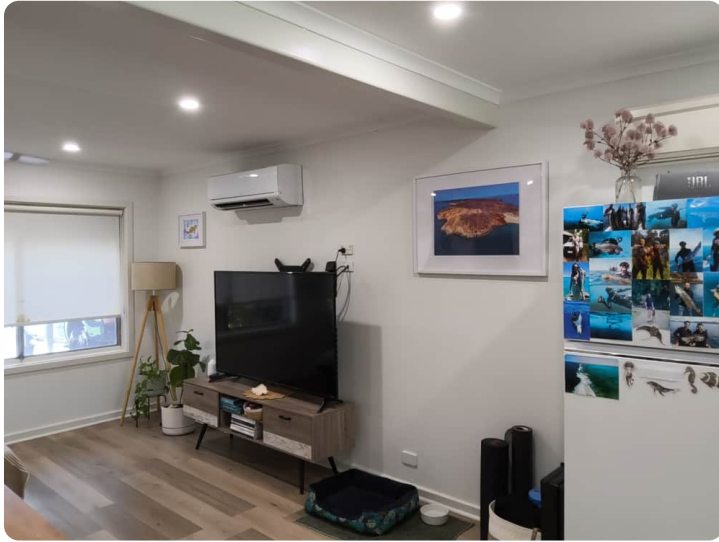
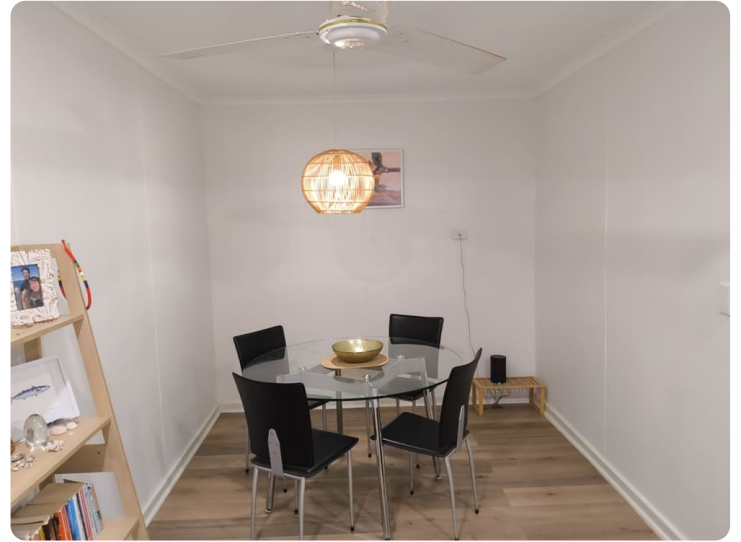
31. Internal walls

The internal walls are constructed of a frame with plaster board cladding. The condition of the internal walls is satisfactory in relation to its age and will require normal ongoing maintenance.

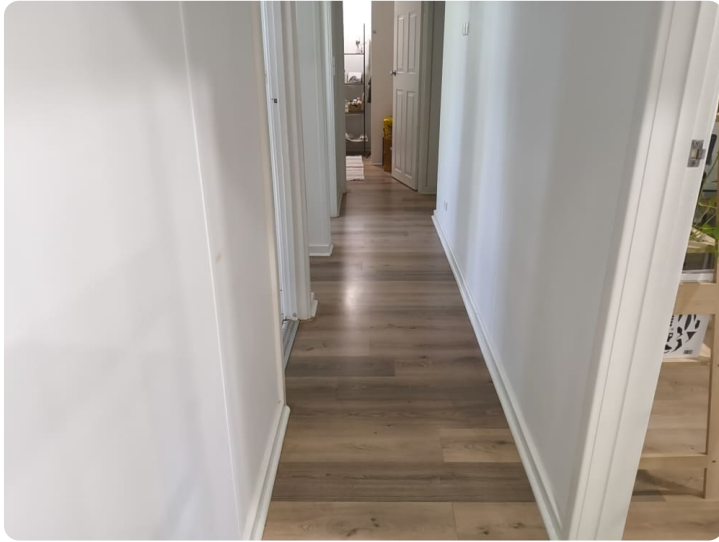
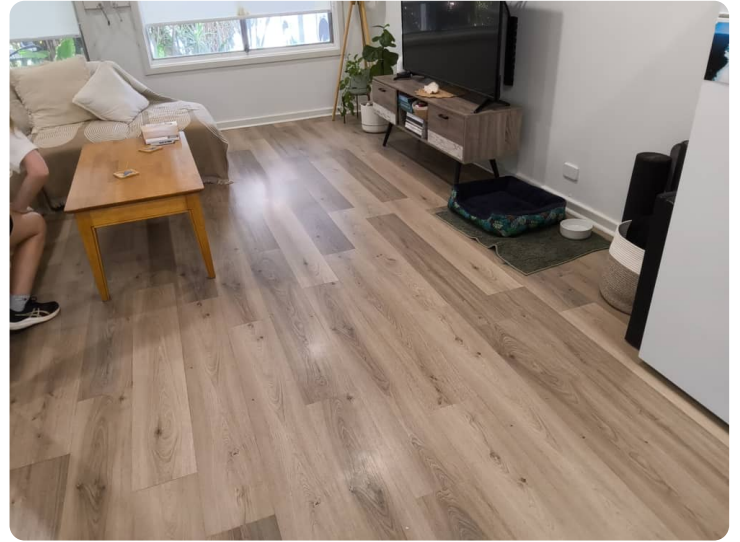
32. Internal floors

The internal floors are constructed of concrete and are covered in vinyl planks. The condition of the internal floors is unable to be determined as they could not be seen due to coverings.

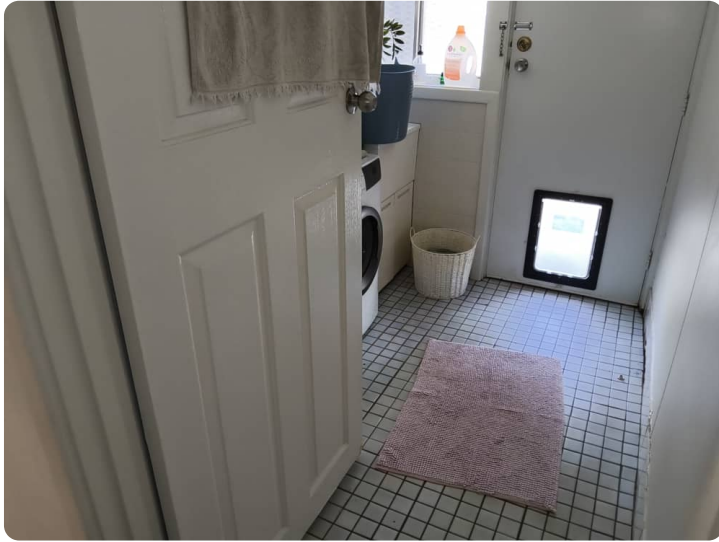
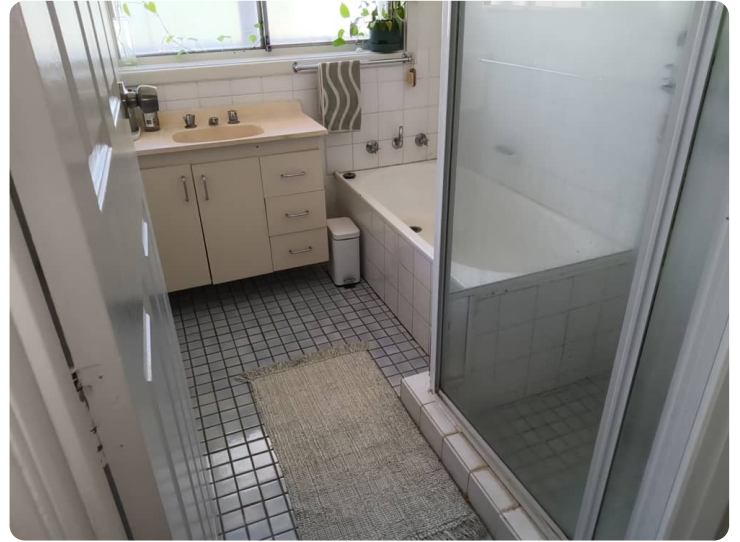
33. Tiled floors and walls

There are areas of internal floors and walls which are covered with a tile covering. The condition of the tiles is satisfactory in relation to its age and will require normal ongoing maintenance.

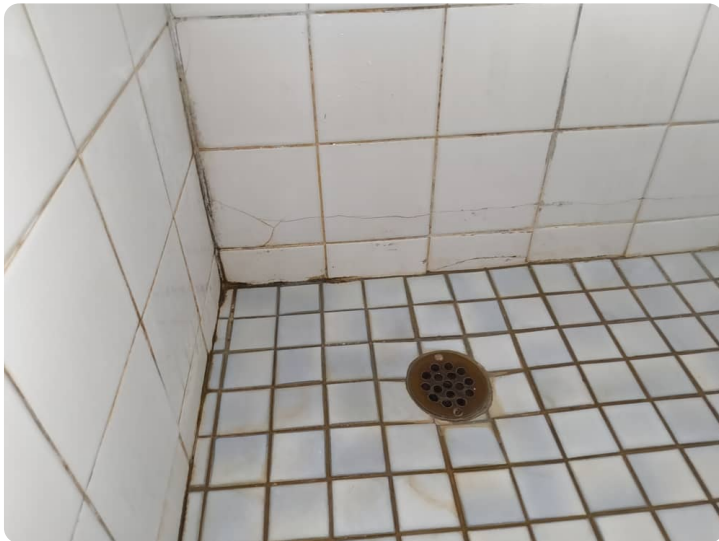
33.1 Tile damage - major

Based on the images provided, there is significant damage to the wall and/or floor tiles, requiring repair or replacement. This damage may have compromised the waterproofing.

Issue: Tile damage - major

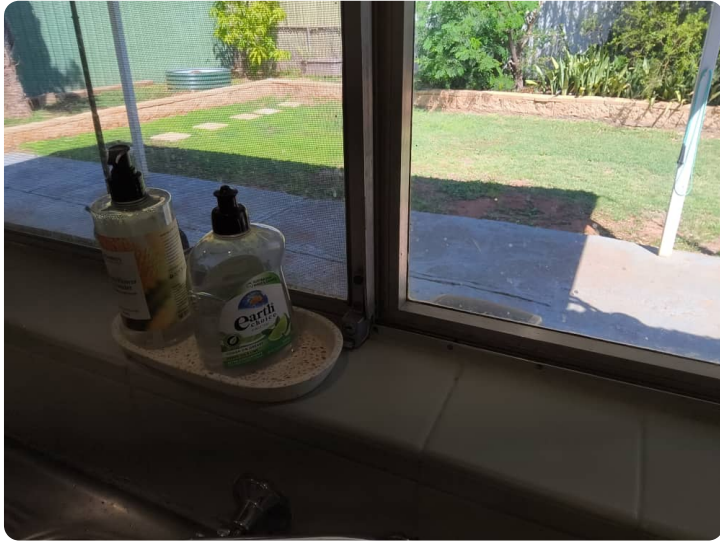
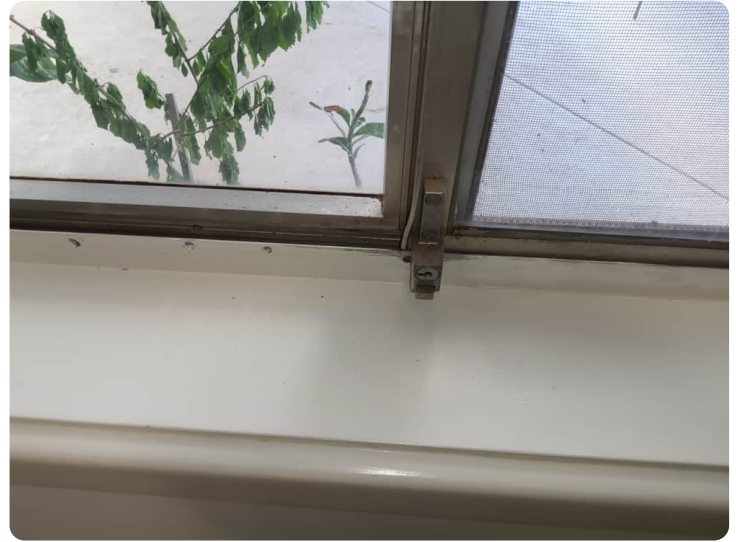
34. Windows (internal)

The condition of the windows, as viewed from within the property, is fair in relation to its age and will require ongoing maintenance. Window locks have been installed to all of the windows.

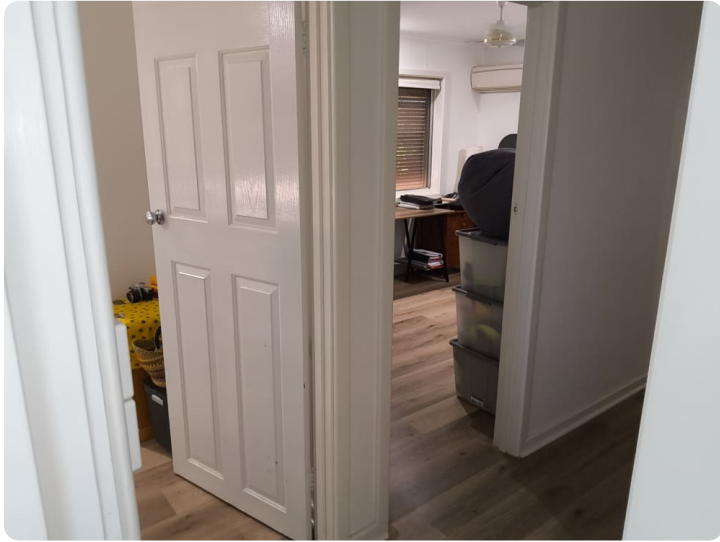
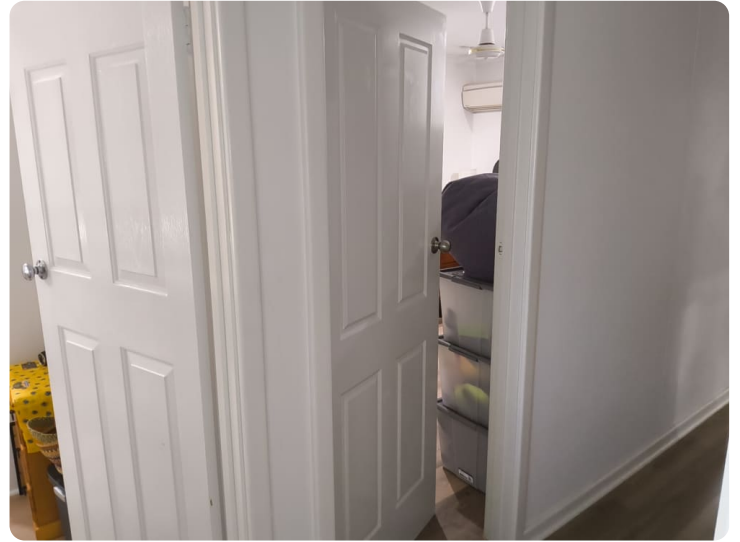
35. Internal doors

The internal doors were mainly constructed of timber hollow core. The condition of the internal doors is satisfactory in relation to its age and will require normal ongoing maintenance.

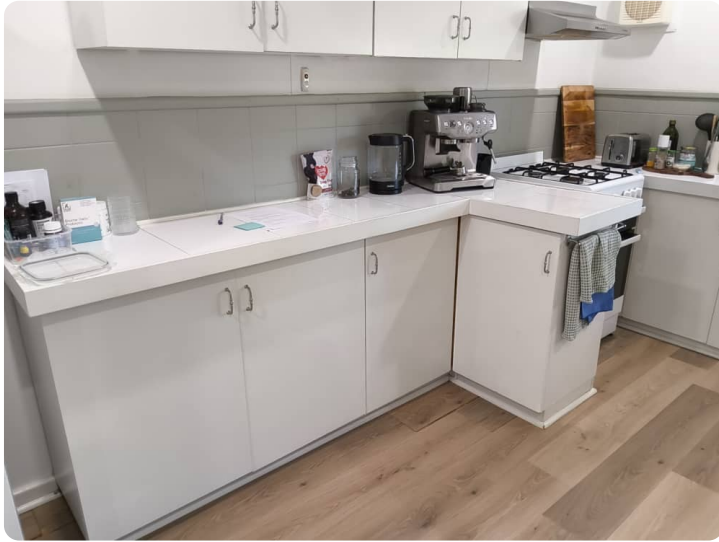
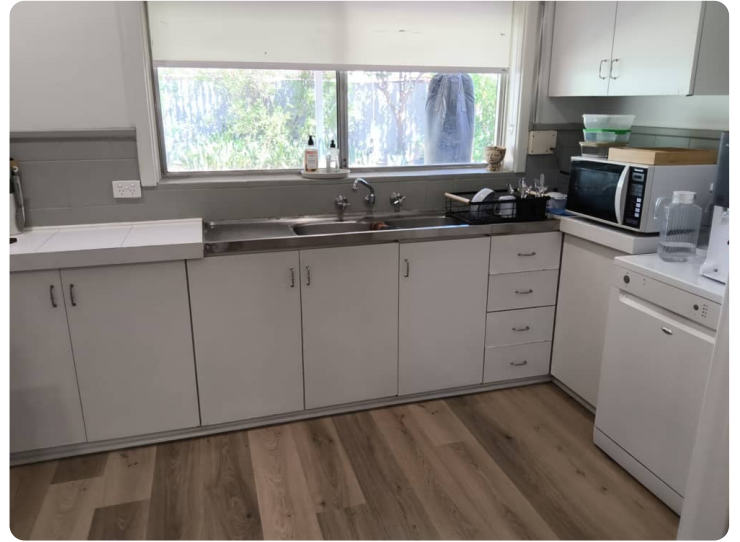
36. Kitchen cabinets

The condition of the kitchen cabinets in general is fair in relation to its age and will require ongoing maintenance.

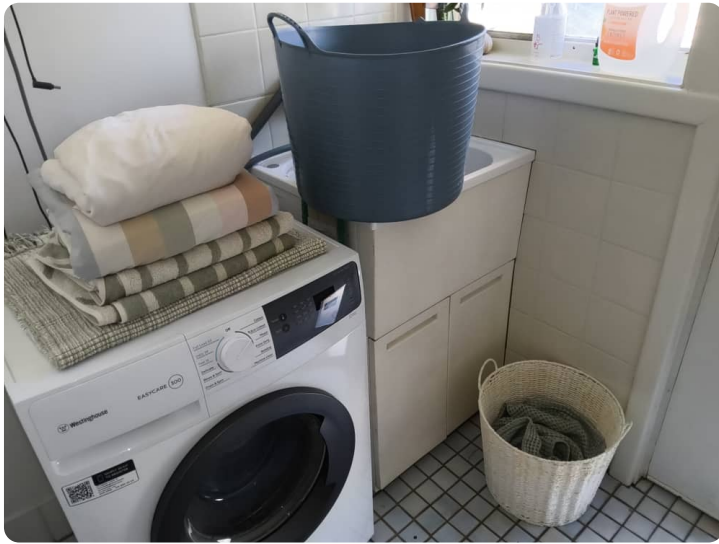
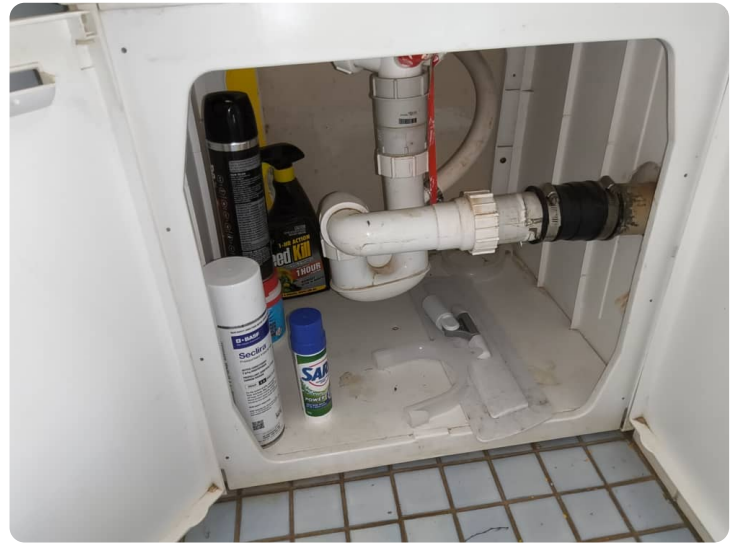
37. Laundry cabinets

The condition of the laundry cabinets is satisfactory in relation to their age and require normal maintenance.

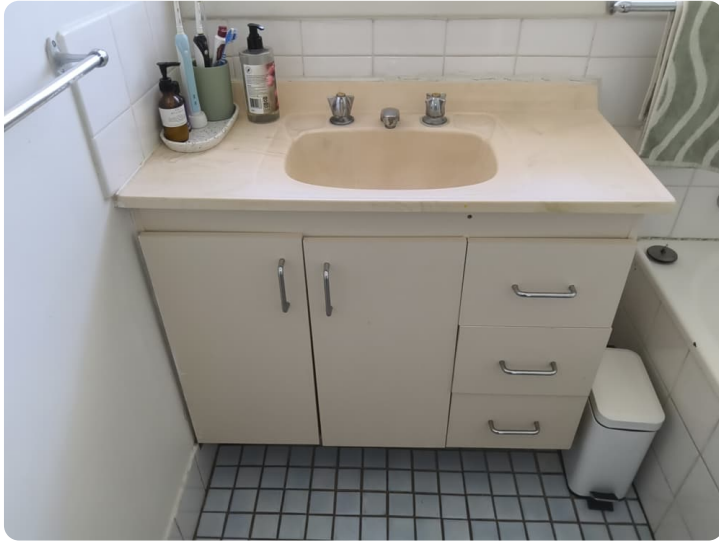
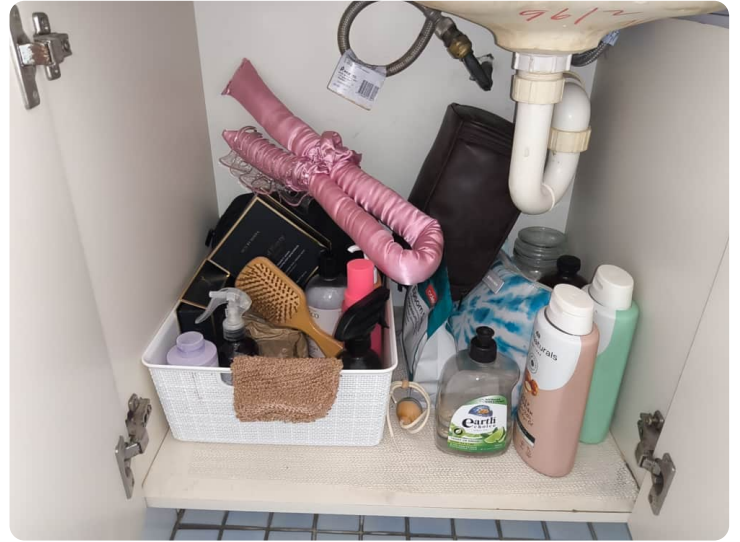
38. Bathroom cabinets

The condition of the bathroom cabinets is fair in relation to its age and will require ongoing maintenance.

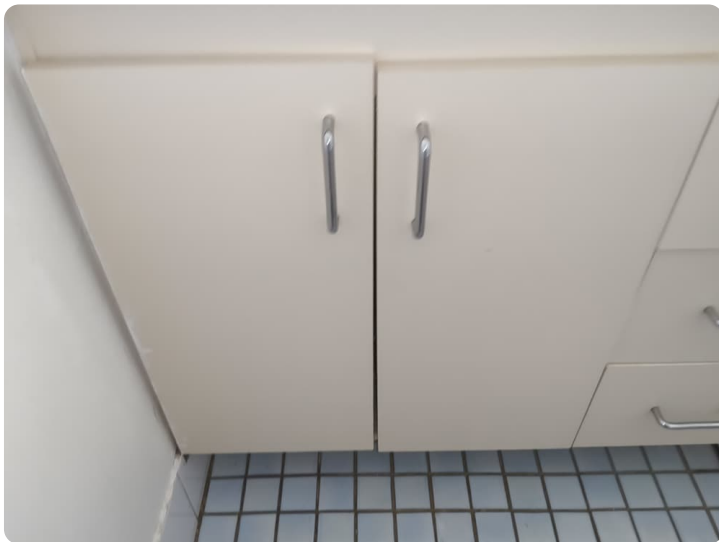
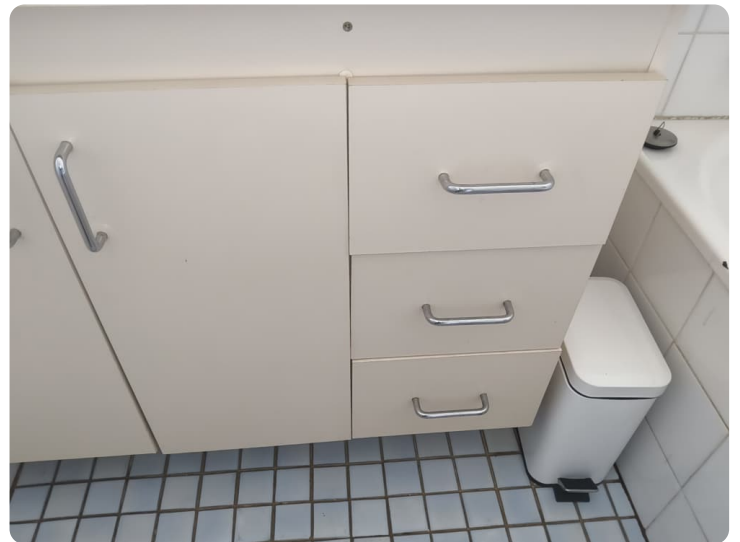
38.1 Cabinet door drawer adjustment

As per the images some cupboard doors or drawers require adjustment to close correctly.

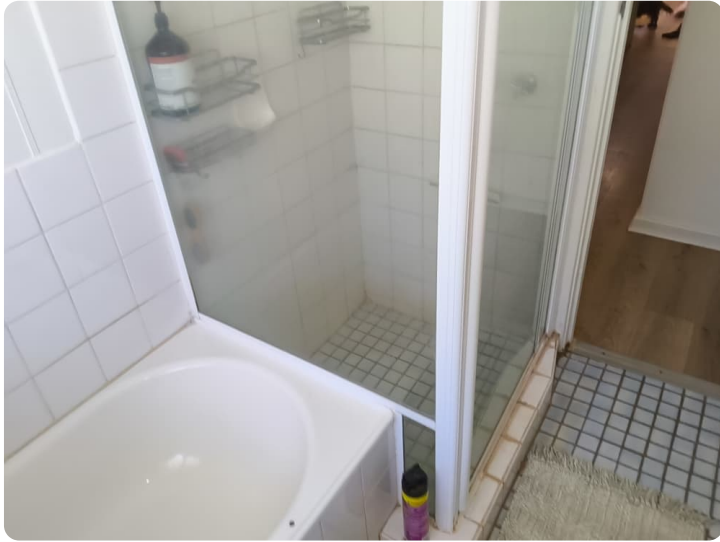
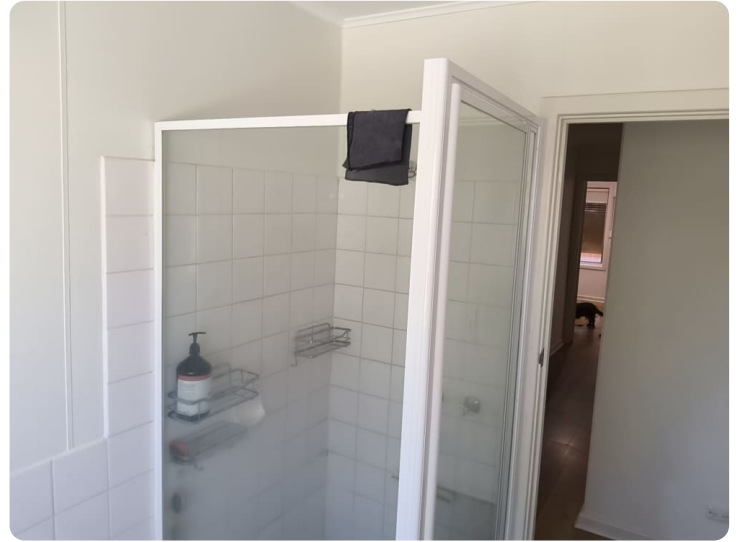
39. Shower screens

The condition of the shower screens is satisfactory in relation to their age and require normal maintenance.

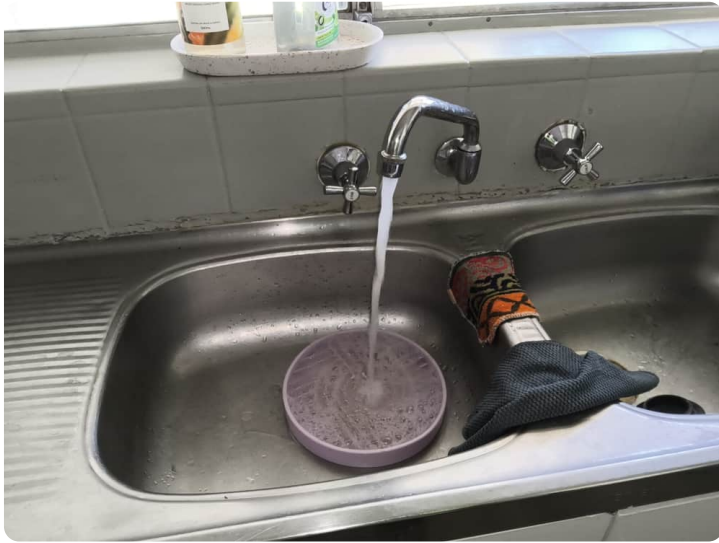
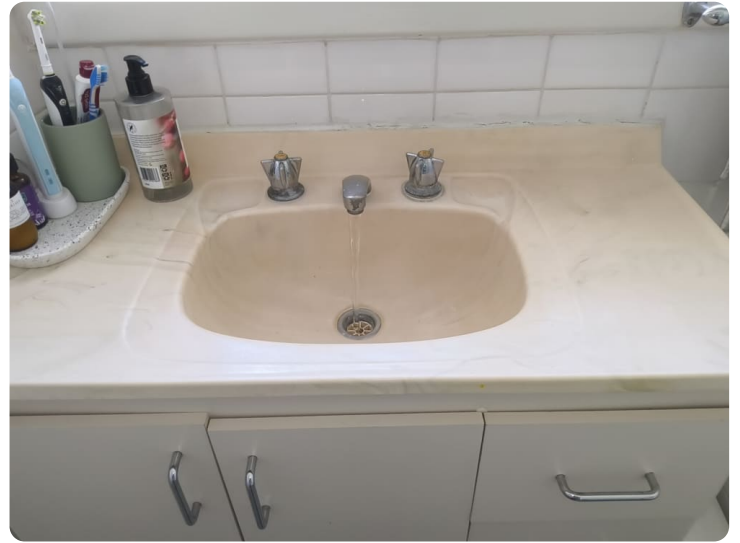
40. Plumbing

The taps to multiple areas were turned on and the water flow appeared to be reasonable. Water draining to several sinks and toilets appeared to be reasonable. The Building Inspector is not a Plumbing Contractor and is not permitted to test Plumbing items under WA Law. Where appropriate a Plumbing Contractor should be engaged to test the plumbing in the property.

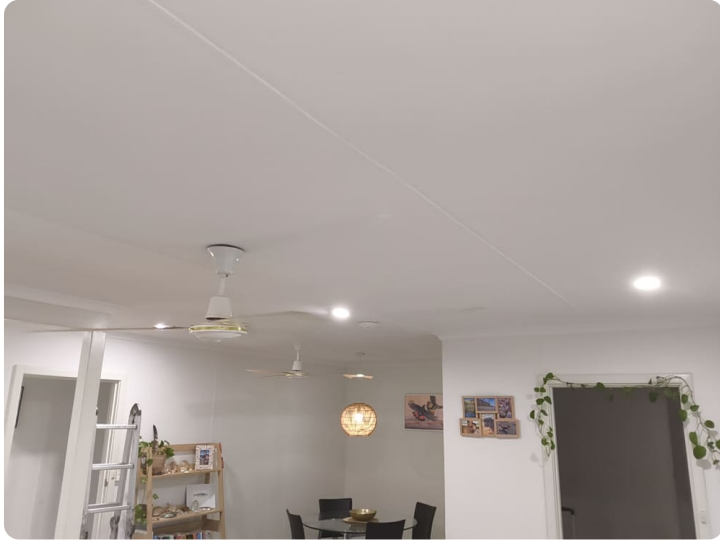
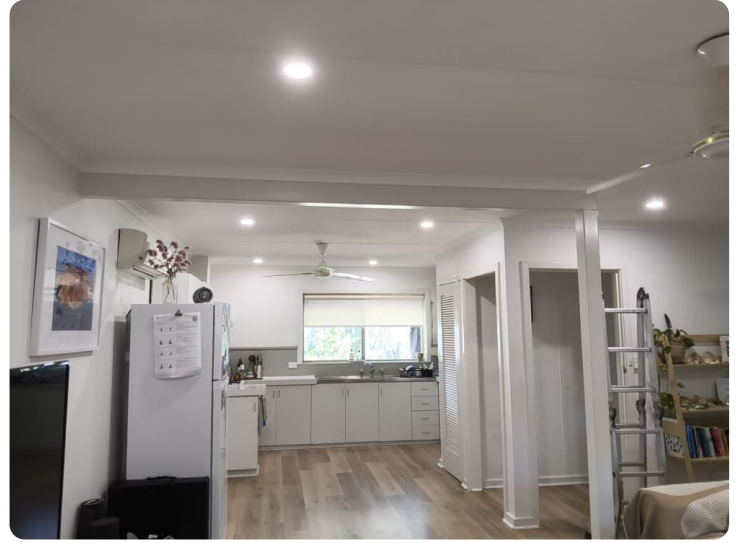
41. Lights and power points

Several lights were turned on during the inspection and the lights appeared to be operational. The Building Inspector is not an Electrical Contractor and is not permitted to test Electrical items under WA Law. Where appropriate an Electrical Contractor should be engaged to test the electrical items in the property.
