# **Houspect**

### **Pre purchase inspection**

**Job ID:** 93044

**Address:** 17 Lady Douglas Way, Pegs Creek WA 6714

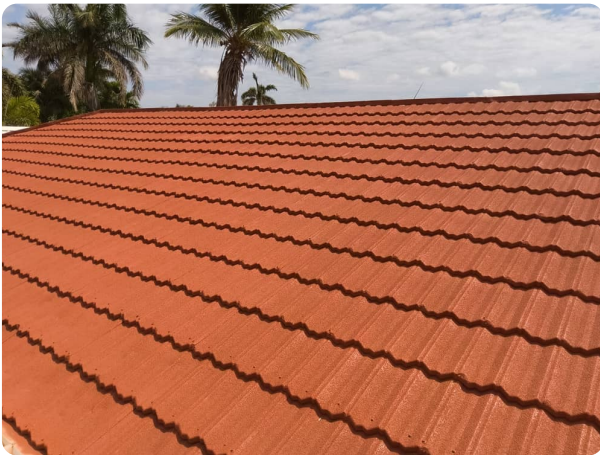
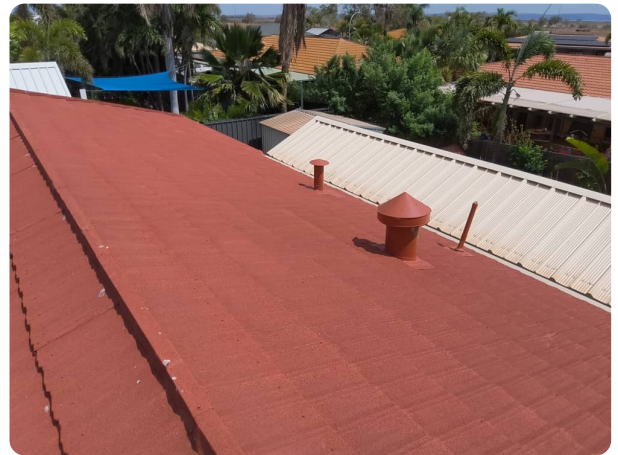
## 1. Roof covering

The roof covering is constructed of Decramastic roof tiles. The condition of the roof covering is fair in relation to its age and will require ongoing maintenance. It appears as if the roof cover has been painted or sealed (i.e. restored) at some stage post installation. Please note that some of the building material utilised on or within the building may or may not contain asbestos. The Australian Government has indicated that asbestos can only be correctly identified through laboratory testing. The material on this building site may not pose a concern in the current static state if maintained but for any future works the material should be tested and appropriate measures used for asbestos handling if the material is subsequently found to contain asbestos.

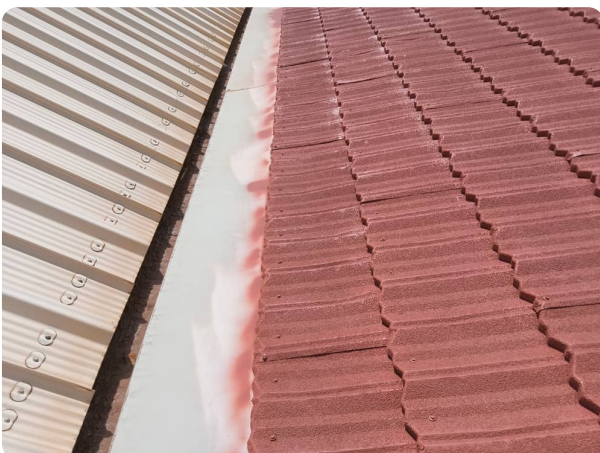
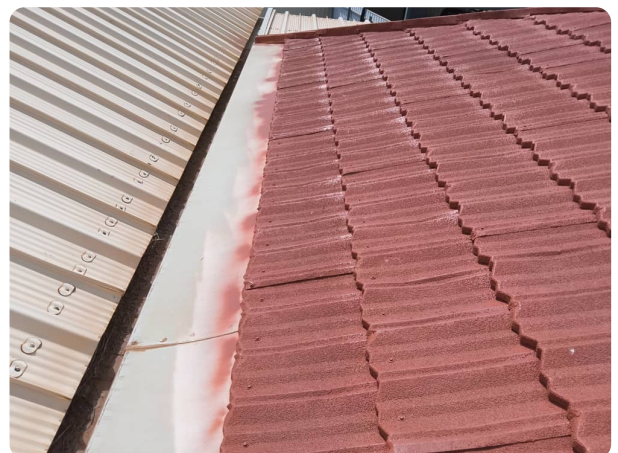
### 1.1 Decramastic roof tile damage - minor

The stone coating has come off most of the decramastic tiles leaving the galvanized metal sheeting exposed. While this is just cosmetic and does not diminish the tiles primary performance, the roof space can heat up quicker in summer and transfer this heat into the roof space and the building. Remediation or replacement is recommended. The material should be tested, where required, and then a remediation plan established.

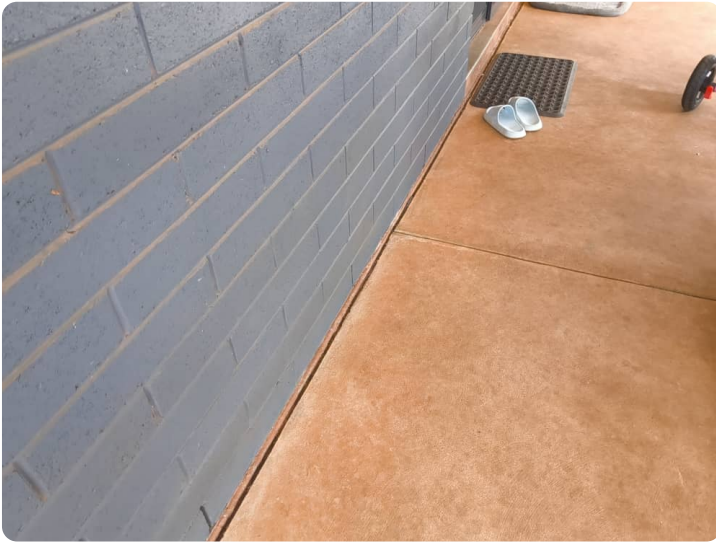
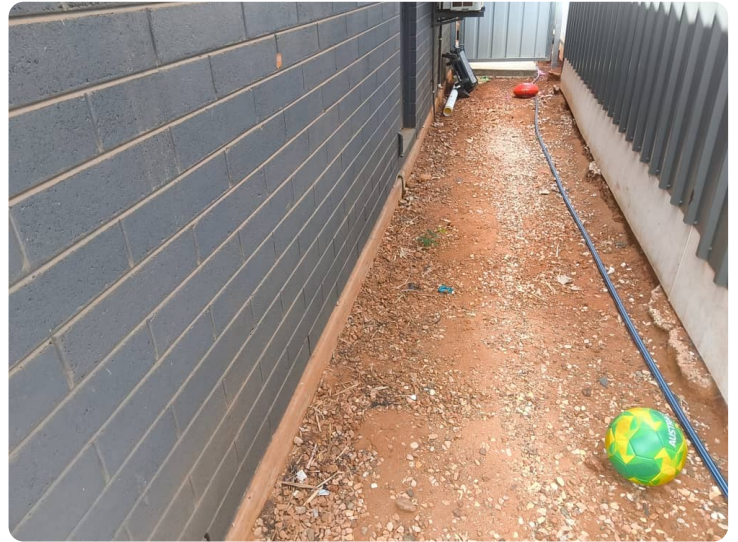
## 8. Footings

The footings are below ground and cannot be seen. The condition of the footings cannot be determined.

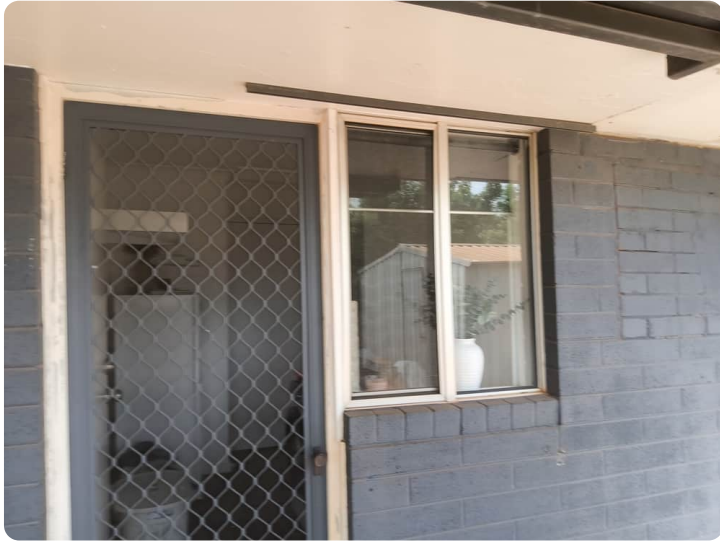
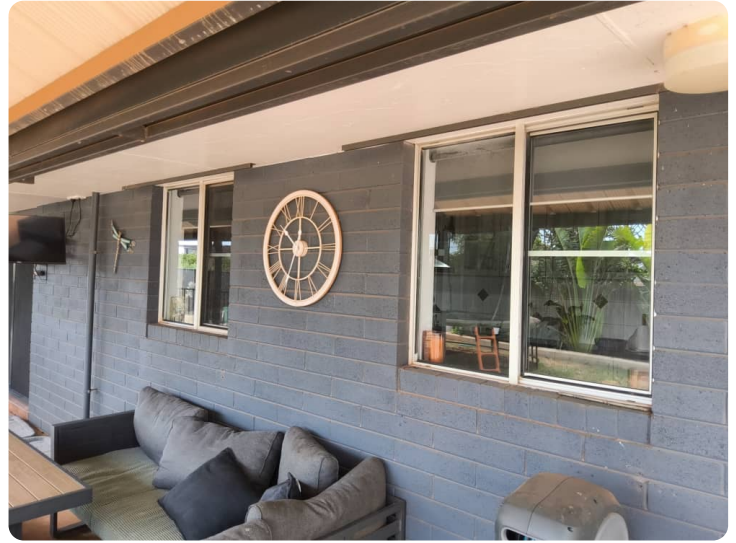
## 9. Windows and window frames

The window and window frames are primarily constructed of aluminium. The condition of the window and window frames is generally satisfactory in relation to its age and will require normal ongoing maintenance.

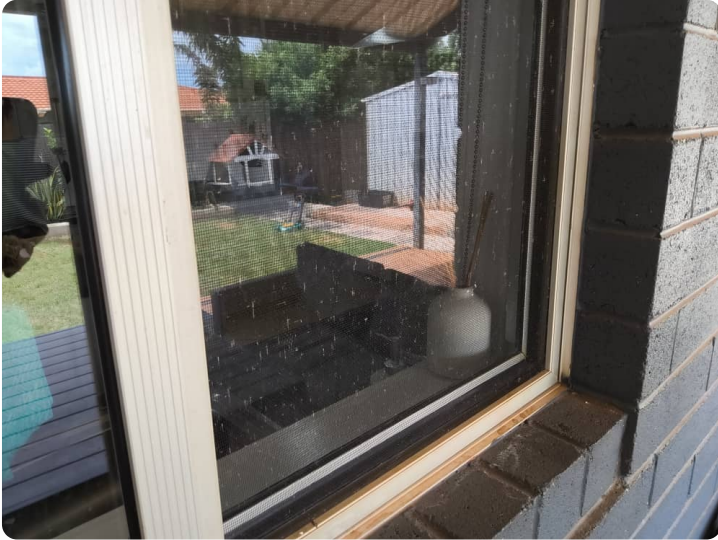
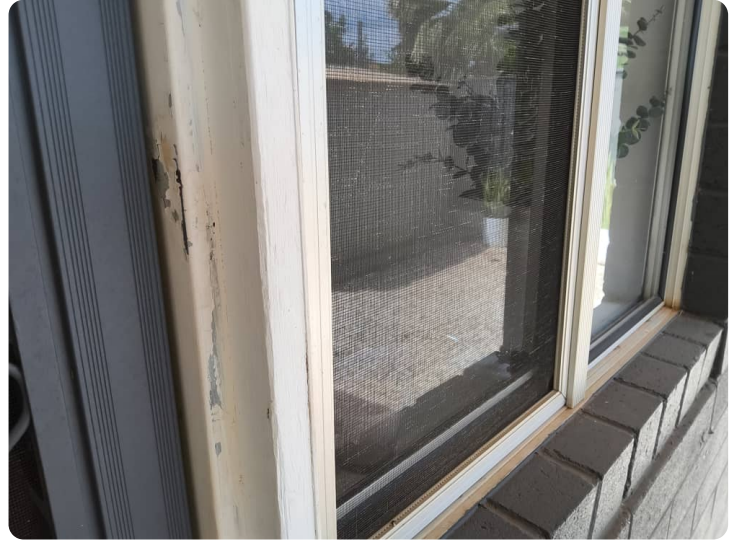
## 10. Window fly screens

Fly screens have been installed to most of the windows. The condition of the window fly screens is generally satisfactory in relation to its age and will require normal ongoing maintenance.

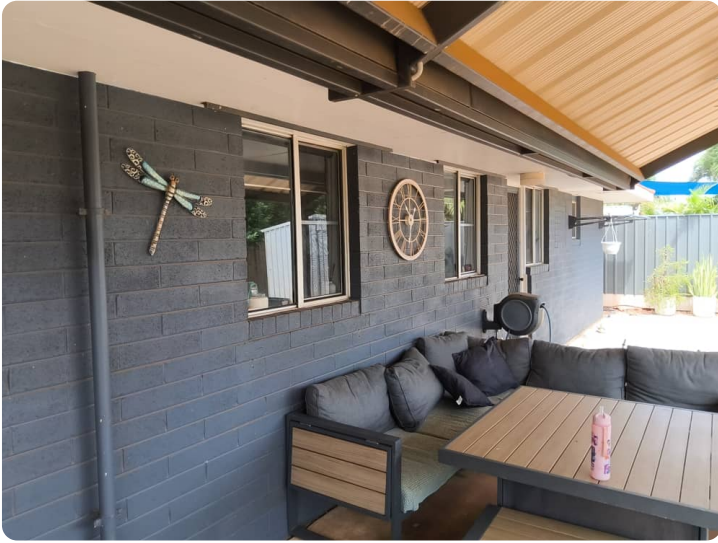
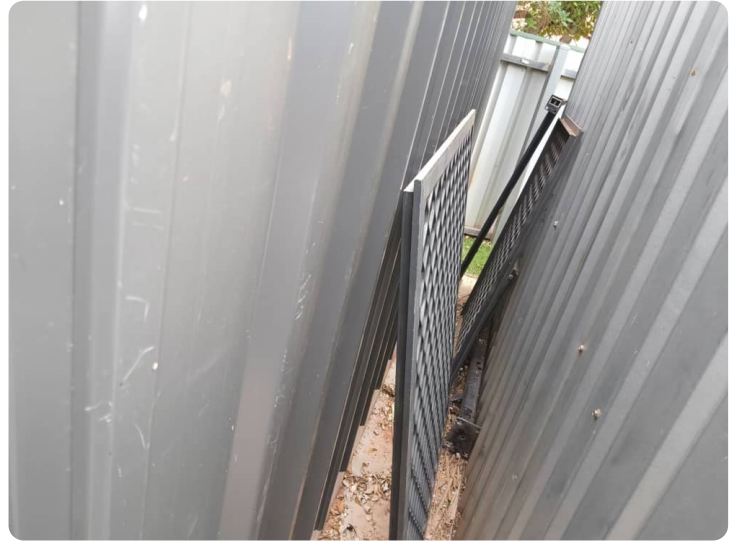
## 11. Cyclone screens

Cyclone screens have been installed to all of the windows. The condition of the cyclone screens is satisfactory in relation to its age and will require normal ongoing maintenance. The cyclone screens appear to be compliant with local requirements.

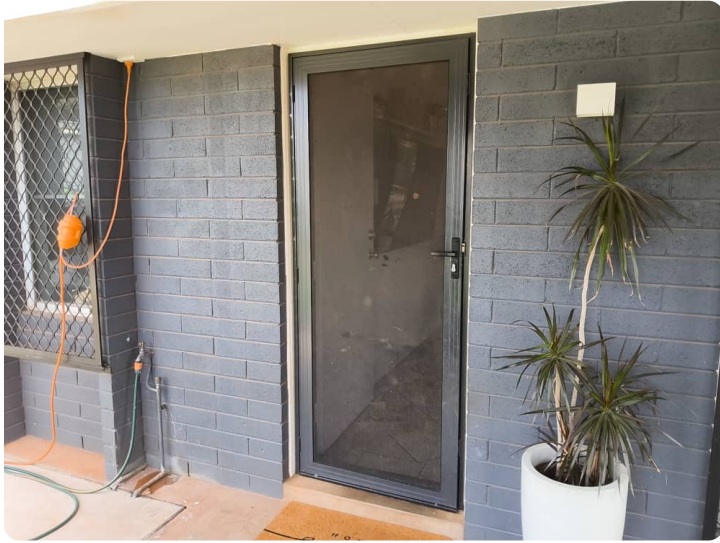
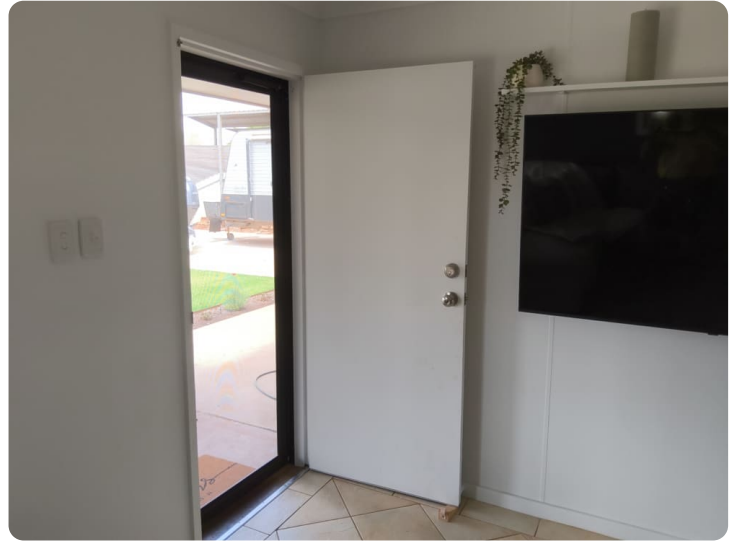
## 12. Front door

The front door is constructed of solid timber. The condition of the front door is satisfactory in relation to its age and will require normal ongoing maintenance. Deadlocks have been installed. A security screen door has been fitted.

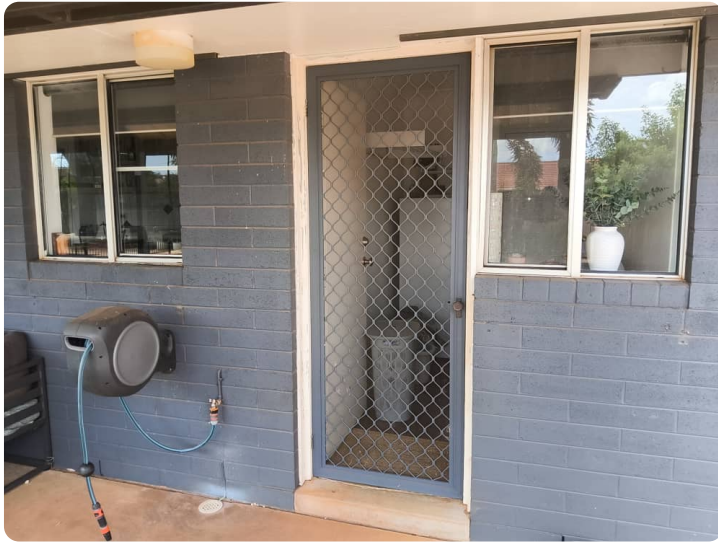
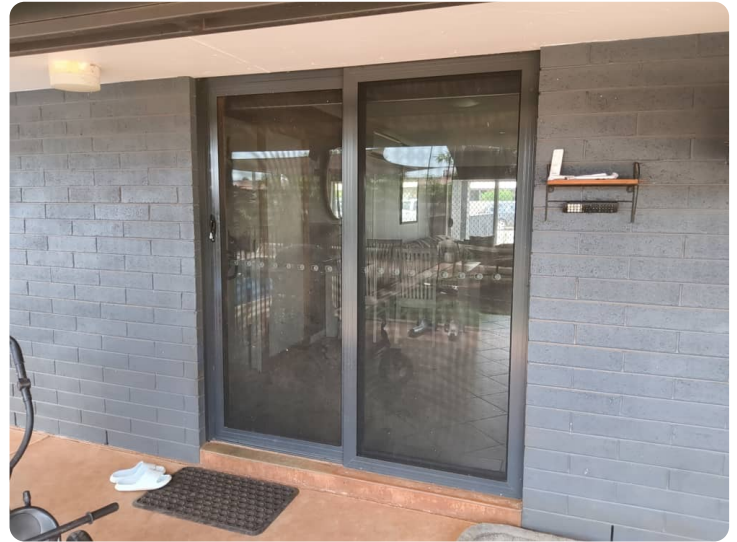
### 13. Other external doors

Other external doors are constructed of a variety of materials. The condition of the other external doors is satisfactory in relation to its age and will require normal ongoing maintenance.

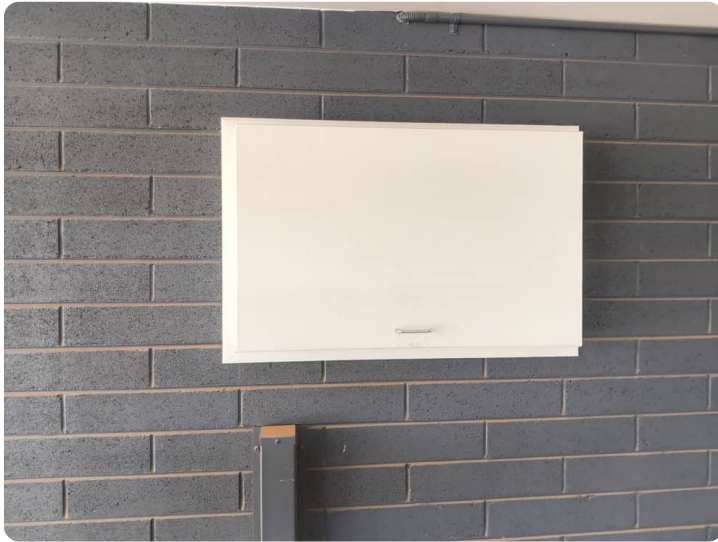
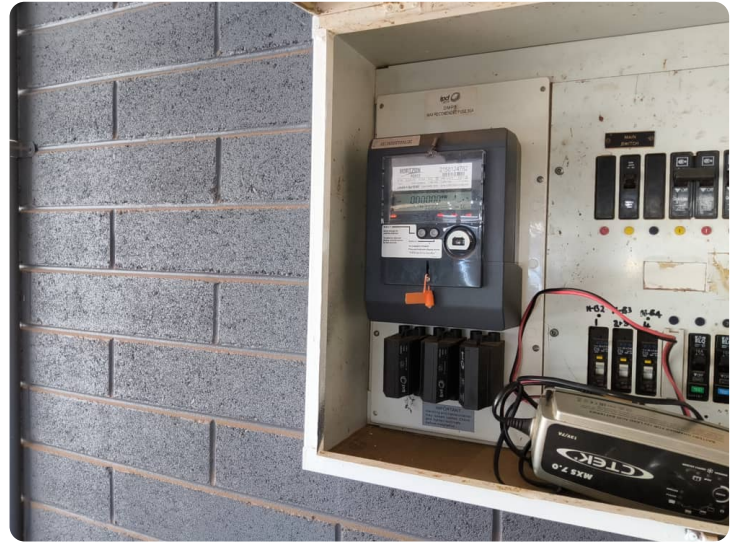
#### 14. Meter box and power

Access to the meter box or sub board was available. The meter box or sub board is not lockable. Power phase type to the site is three phase.

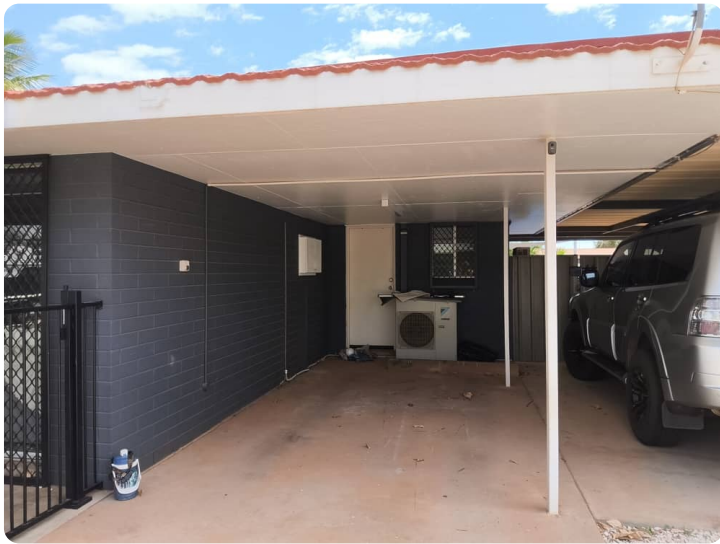
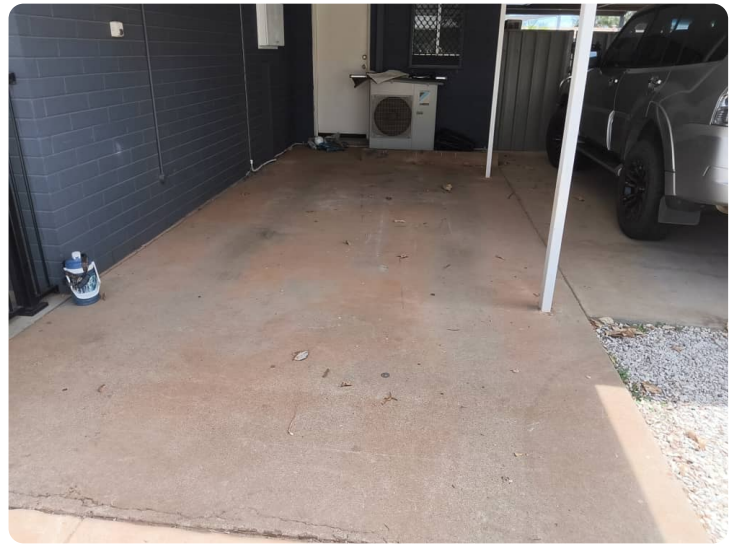
## 16. Carport or Garage (Primary)

There is a primary carport on the property constructed of same materials as the primary structure. The condition of the carport or garage is satisfactory in relation to its age and will require normal ongoing maintenance. Please note that some of the building material utilised on or within the building may or may not contain asbestos. The Australian Government has indicated that asbestos can only be correctly identified through laboratory testing. The material on this building site may not pose a concern in the current static state if maintained but for any future works the material should be tested and appropriate measures used for asbestos handling if the material is subsequently found to contain asbestos.

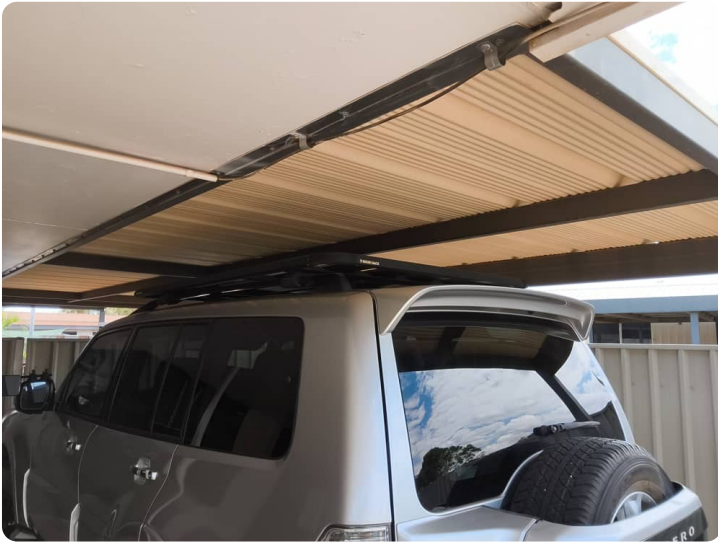
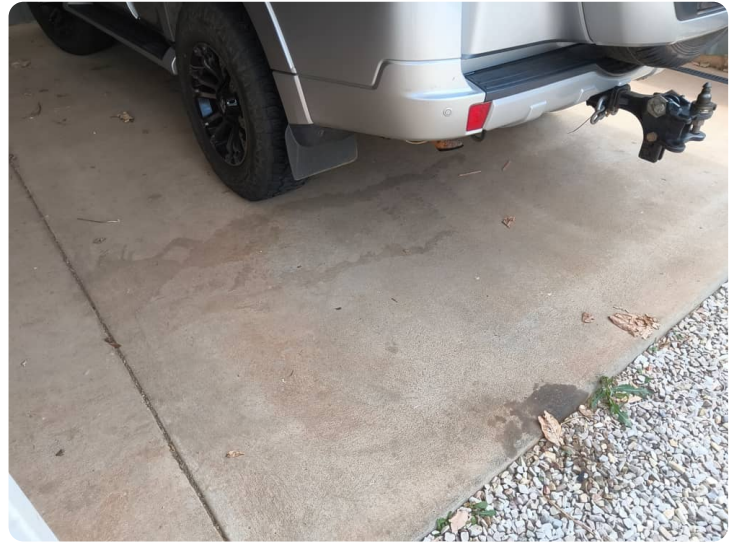
### 17. Carport or Garage (Secondary)

There is a secondary carport on the property constructed of metal. The condition of the detached carport or garage is satisfactory in relation to its age and will require normal ongoing maintenance.

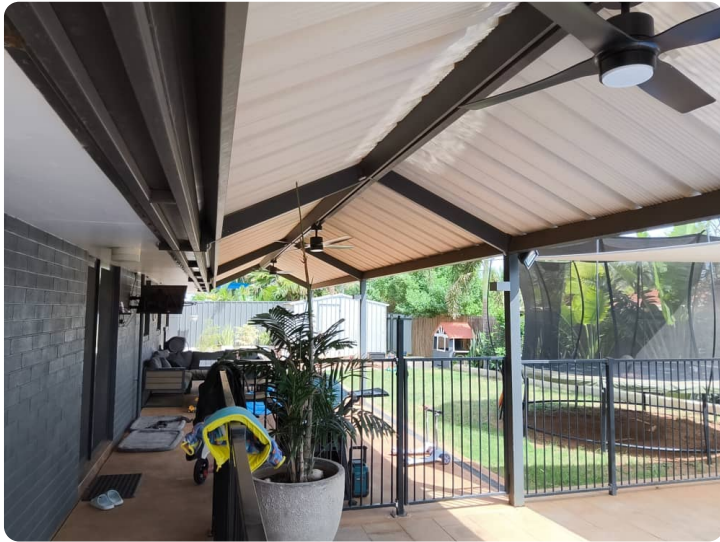
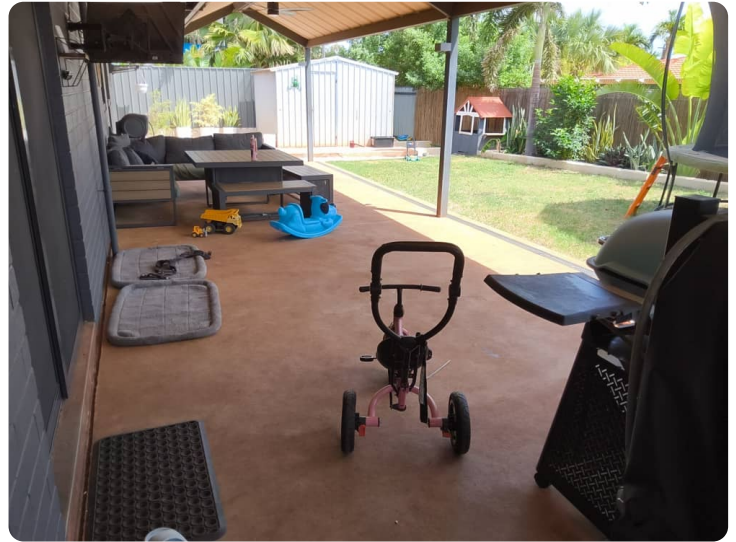
## 19. Patio

The primary patio is constructed of metal. The condition of the patio is satisfactory in relation to its age and will require normal ongoing maintenance.

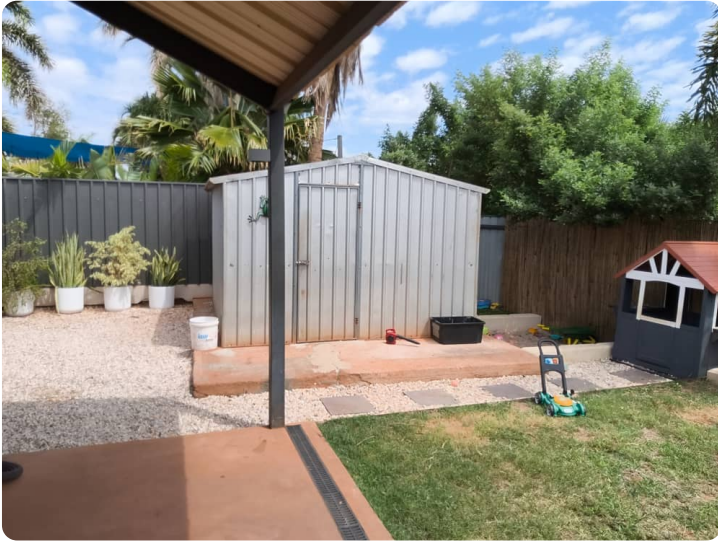
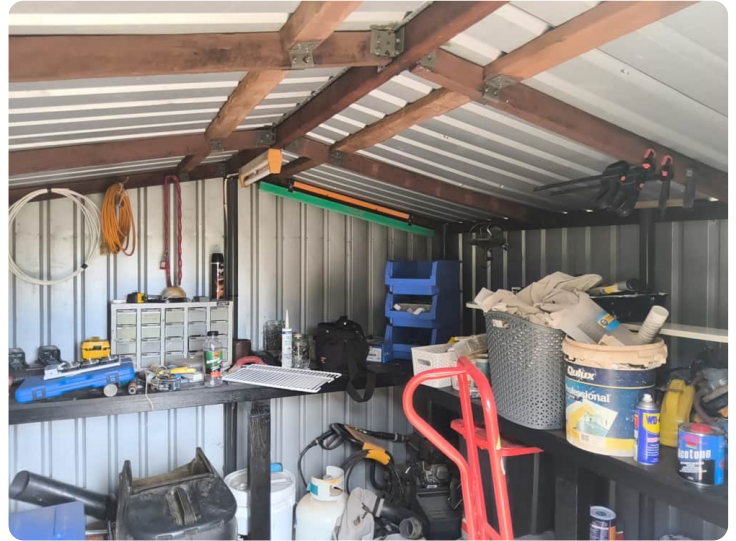
## 20. Garden shed primary

The primary garden shed is constructed of metal. The condition of the garden shed is satisfactory in relation to its age and will require normal ongoing maintenance. Access and visibility of the area was restricted by stored items.

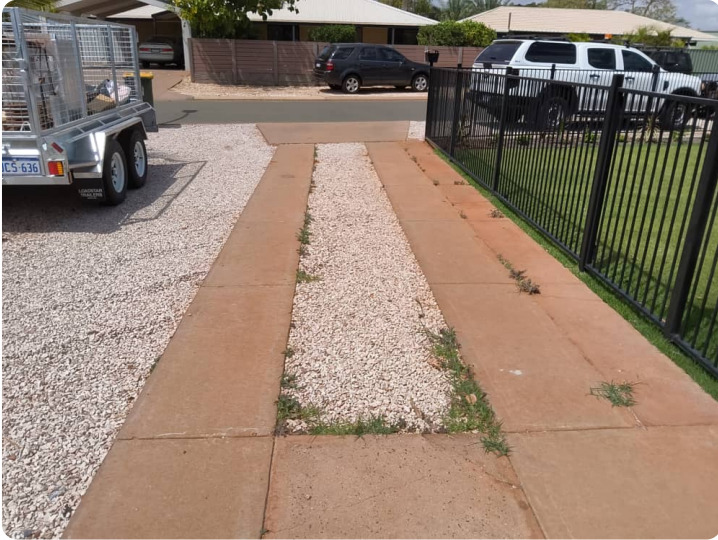
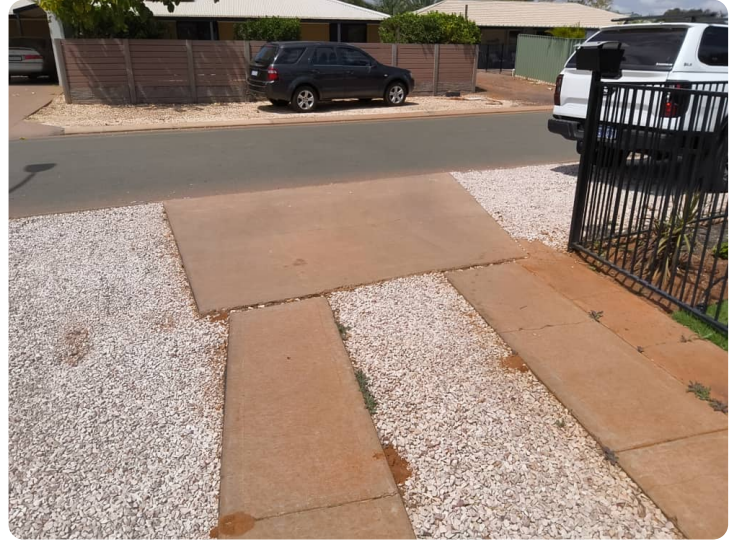
## 21. Driveway

The driveway and cross over is constructed of concrete. The condition of the driveway is satisfactory in relation to its age and will require normal ongoing maintenance.

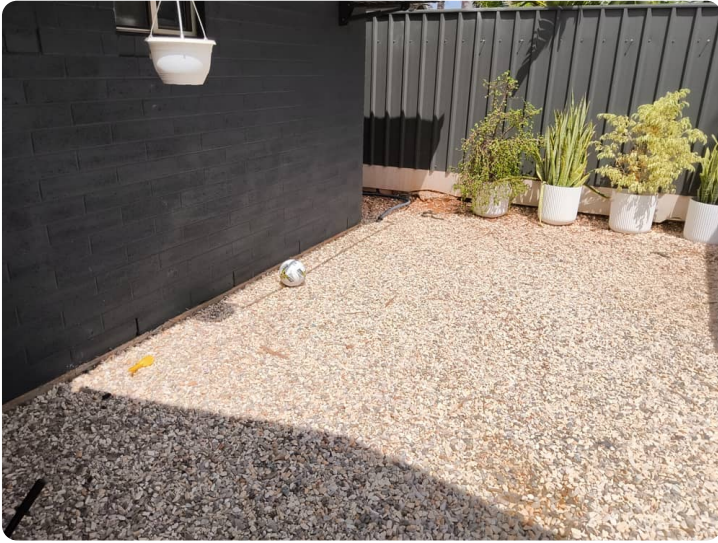
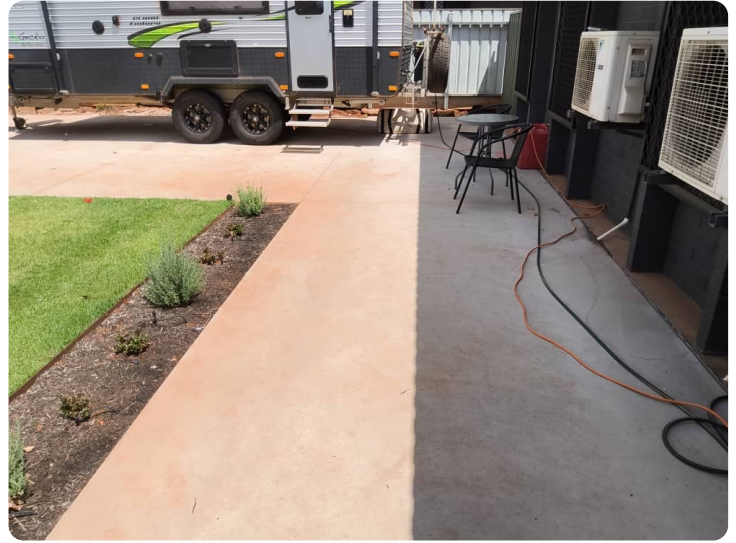
## 22. External walkways and paved areas

The external walkways and paved areas are constructed of a variety of materials. The condition of the external walkways and paved areas is satisfactory in relation to its age and will require normal ongoing maintenance.

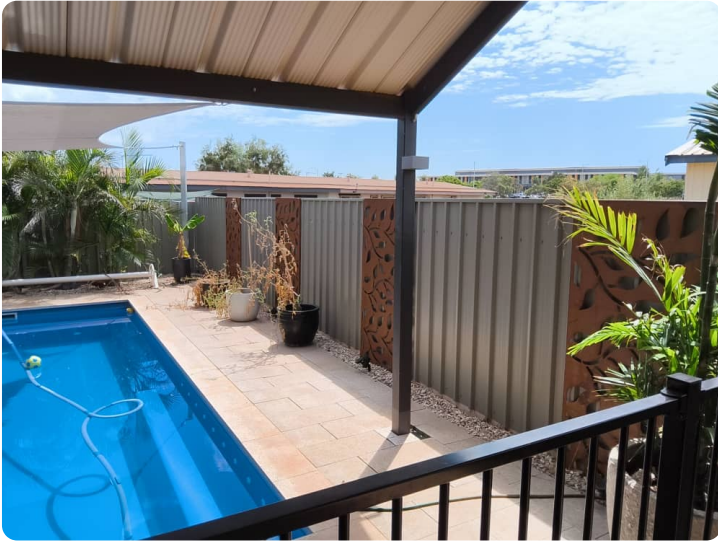
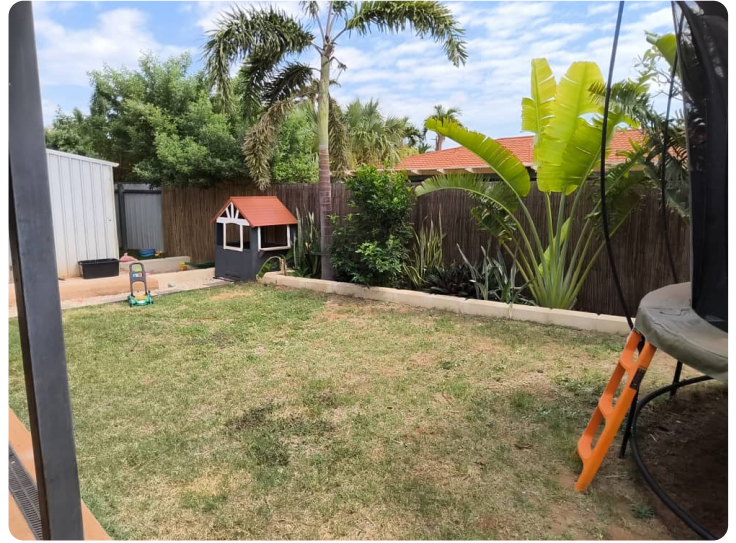
### 23. Fences - boundary

The boundary fences are constructed of metal. The condition of the boundary fence is satisfactory in relation to its age and will require normal ongoing maintenance. Some of the fences could not be viewed due to vegetation, stored items or secondary structures.

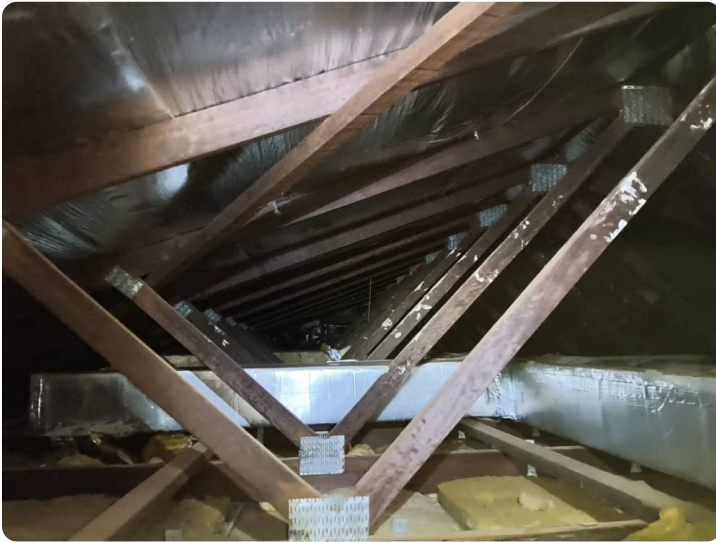
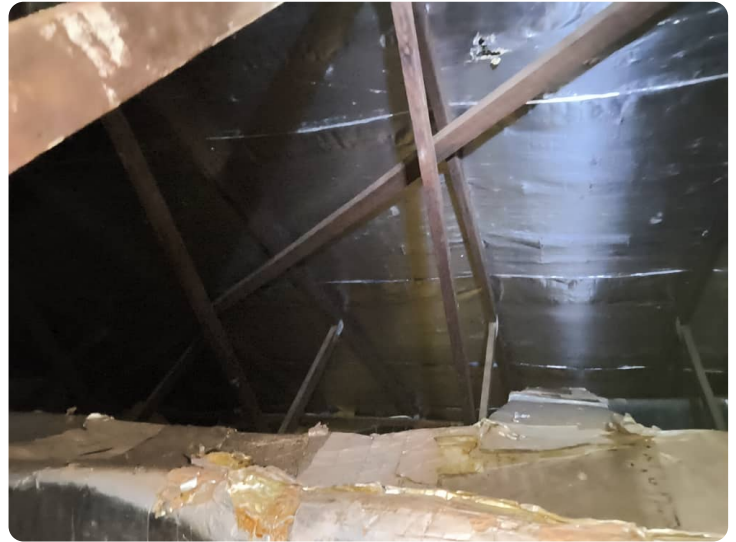
## 25. Under side of roof cover

The condition of the underside of the roof cover could not be determined as sarking had been installed.

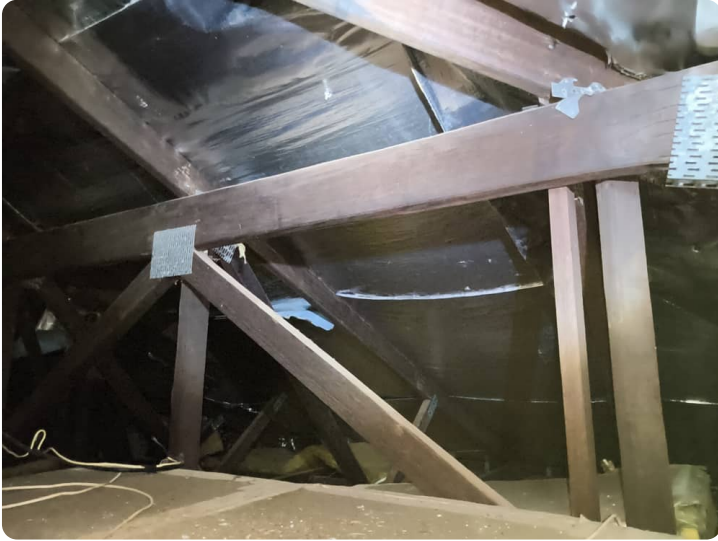
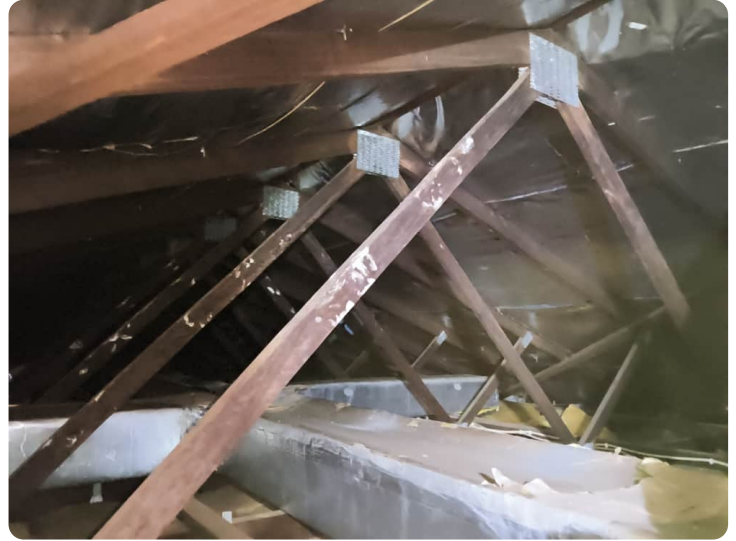
## 26. Sarking

Sarking to the underside of the roof was installed and was considered effective.

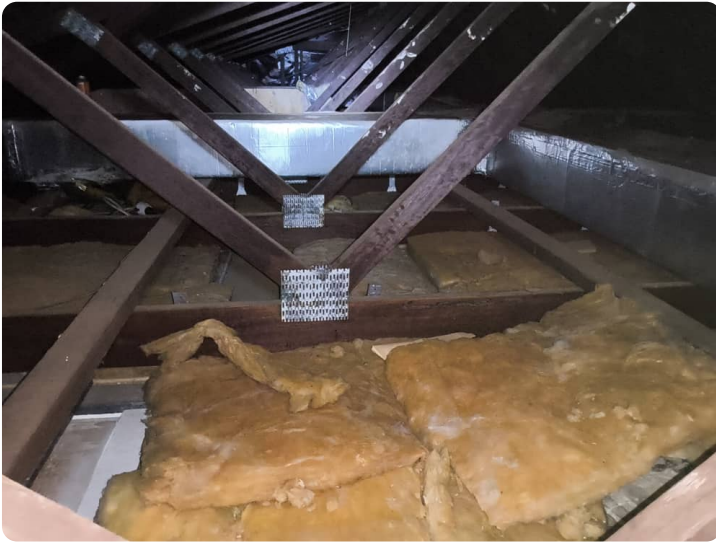
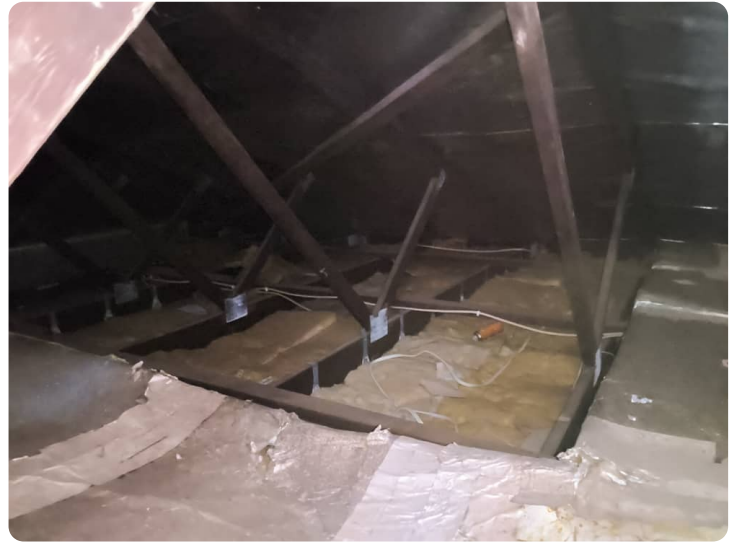
## 28. Insulation

Insulation was installed. Where insulation was installed it was considered effective. The insulation type was predominately batt or rolled type insulation.

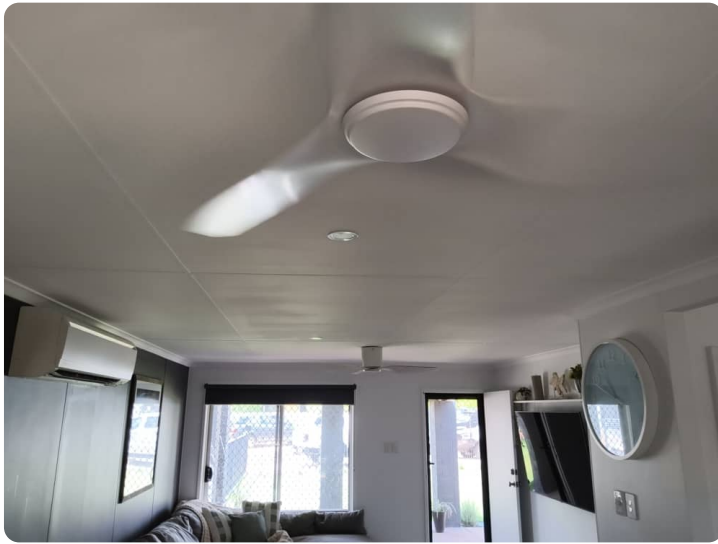
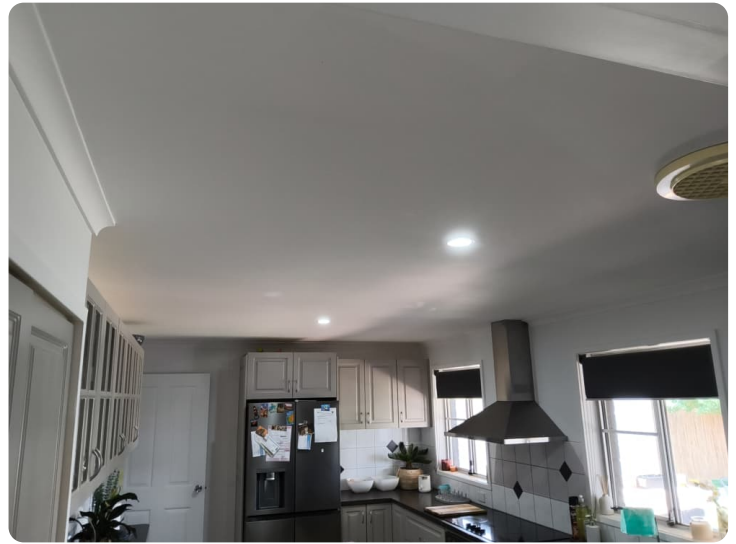
## 29. Ceilings

The ceilings are constructed of plasterboard with cornices constructed of plasterboard. The condition of the ceilings is satisfactory in relation to its age and will require normal ongoing maintenance. Please note that some of the building material utilised on or within the building may or may not contain asbestos. The Australian Government has indicated that asbestos can only be correctly identified through laboratory testing. The material on this building site may not pose a concern in the current static state if maintained but for any future works the material should be tested and appropriate measures used for asbestos handling if the material is subsequently found to contain asbestos.

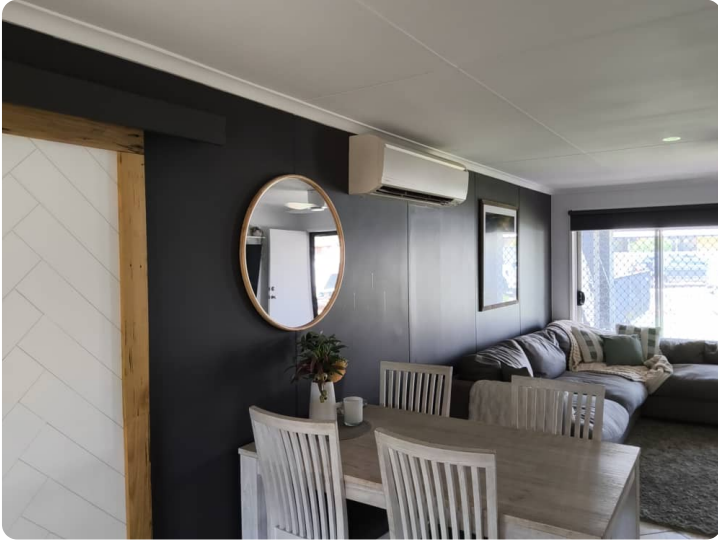
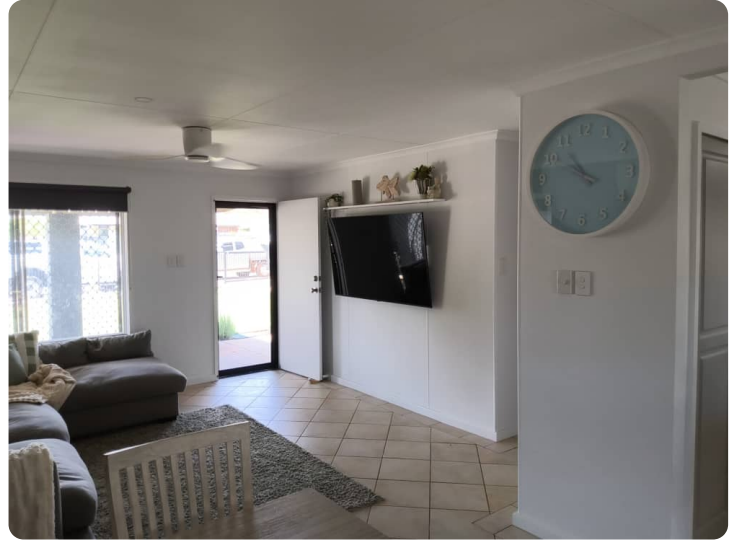
### 30. Internal walls

The internal walls are constructed of a frame with plaster board cladding. The condition of the internal walls is satisfactory in relation to its age and will require normal ongoing maintenance.

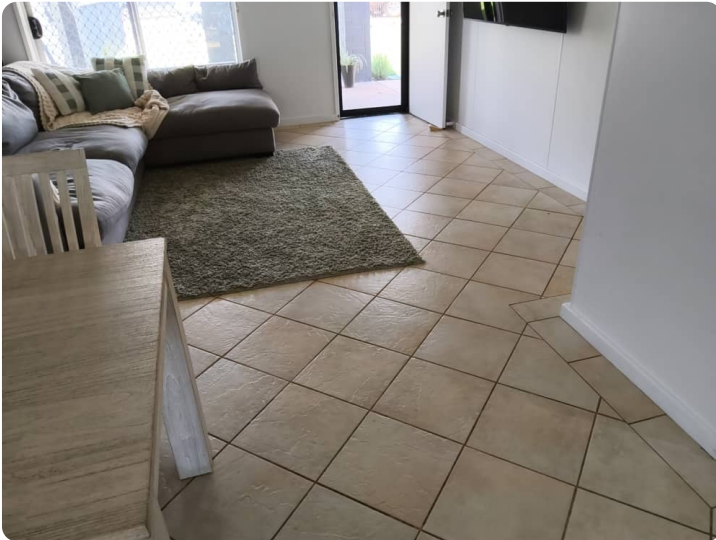
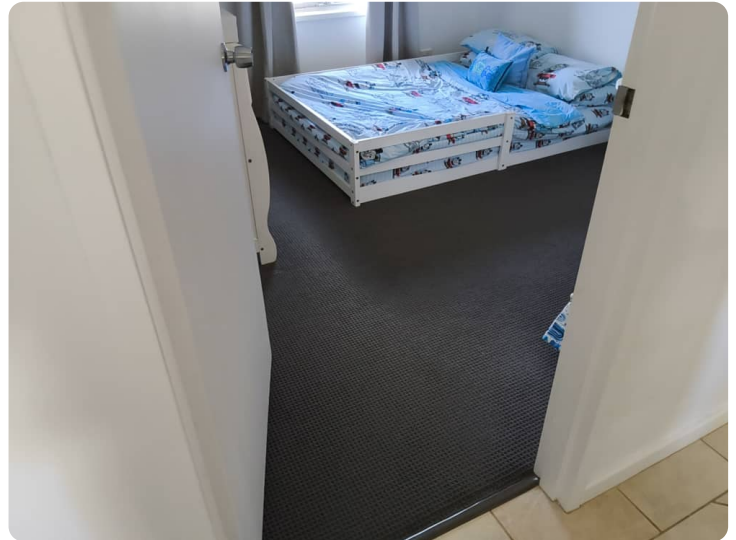
### 31. Internal floors

The internal floors are constructed of concrete and are covered in a variety of coverings. The condition of the internal floors is unable to be determined as they could not be seen due to coverings.

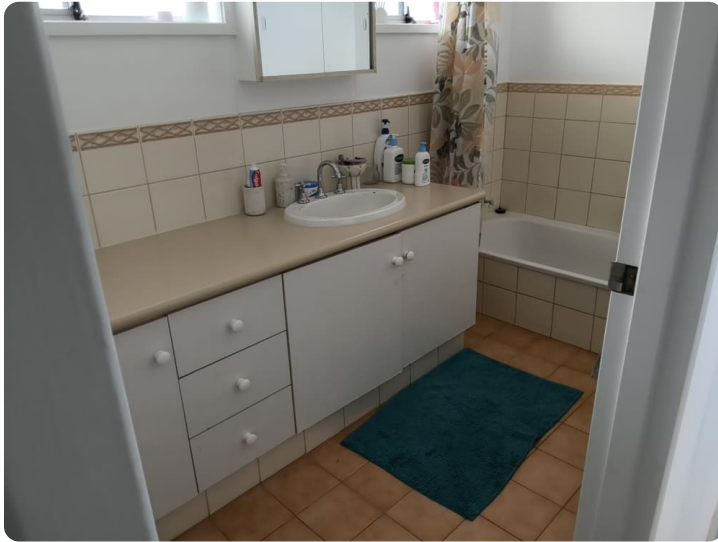
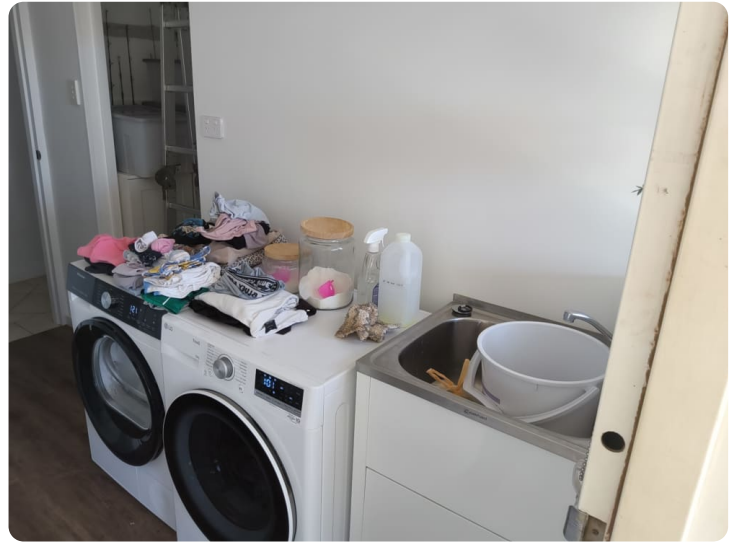
### 32. Tiled floors and walls

There are areas of internal floors and walls which are covered with a tile covering. The condition of the tiles is satisfactory in relation to its age and will require normal ongoing maintenance.

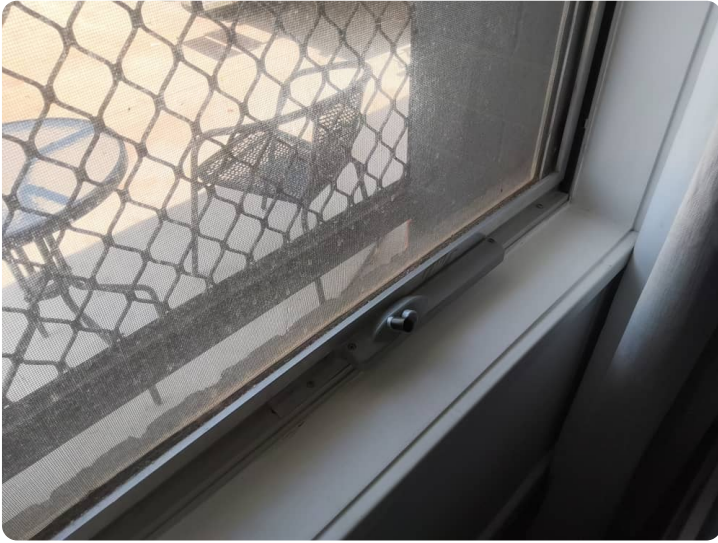
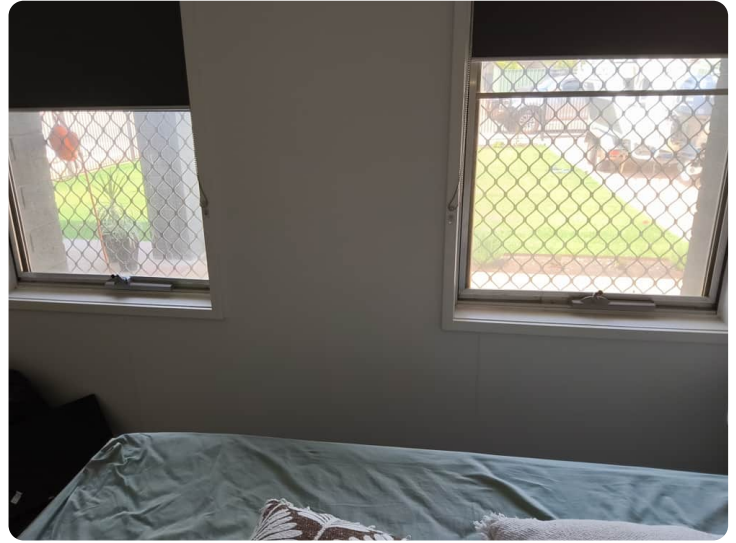
### 33. Windows (internal)

The condition of the windows, as viewed from within the property, is satisfactory in relation to its age and will require normal ongoing maintenance. Window locks have been installed to none of the windows.

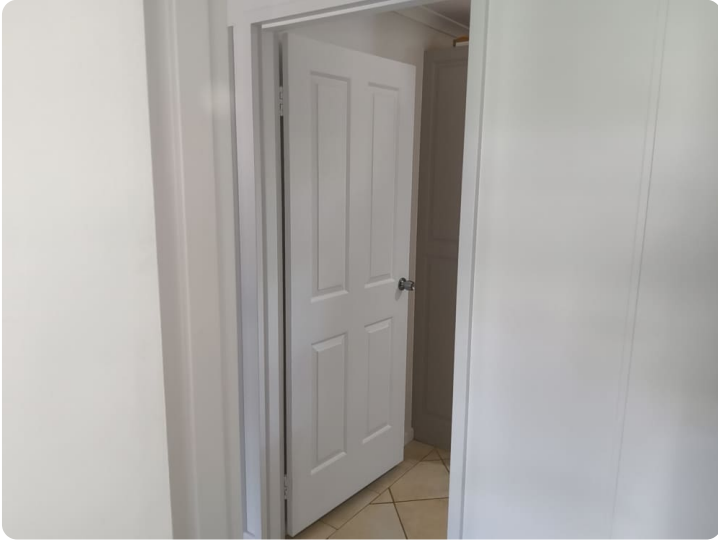
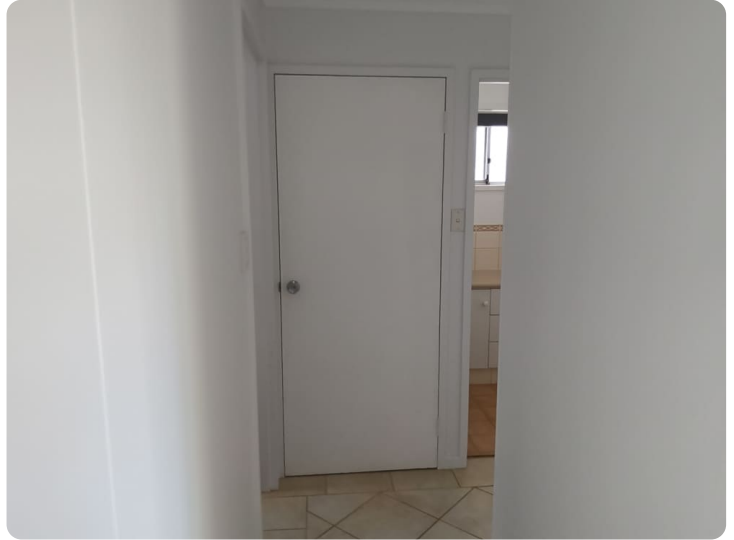
### 34. Internal doors

The internal doors were mainly constructed of timber hollow core. The condition of the internal doors is satisfactory in relation to its age and will require normal ongoing maintenance.

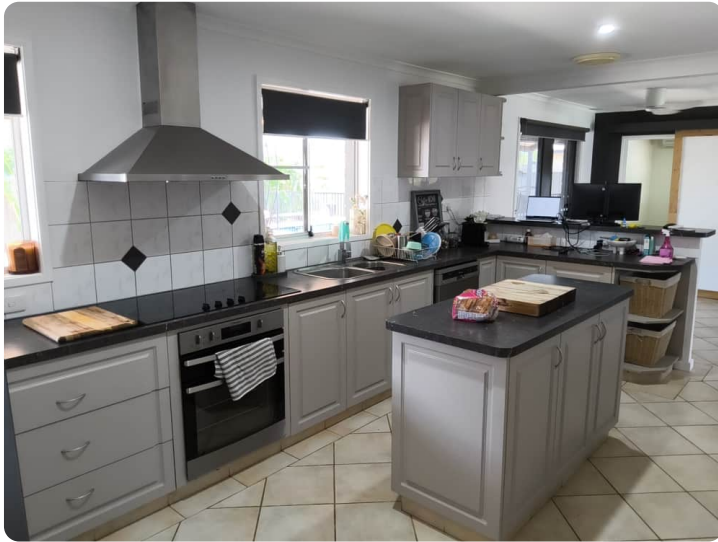
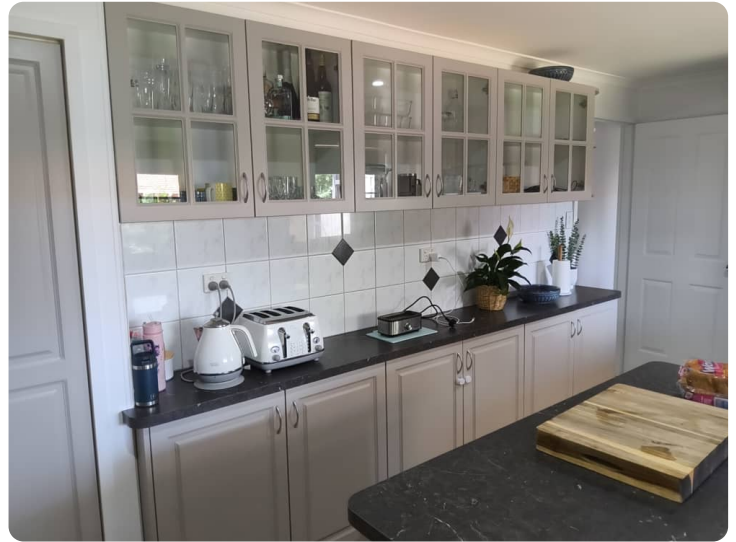
### 35. Kitchen cabinets

The condition of the kitchen cabinets in general is satisfactory in relation to their age and require normal maintenance.

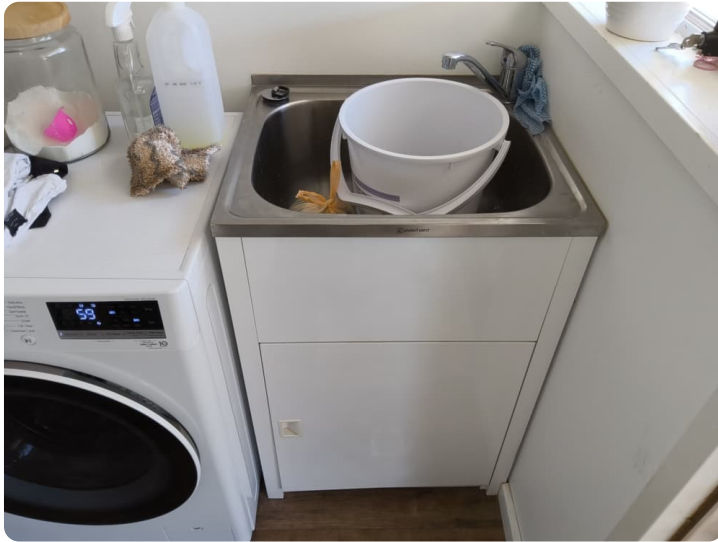
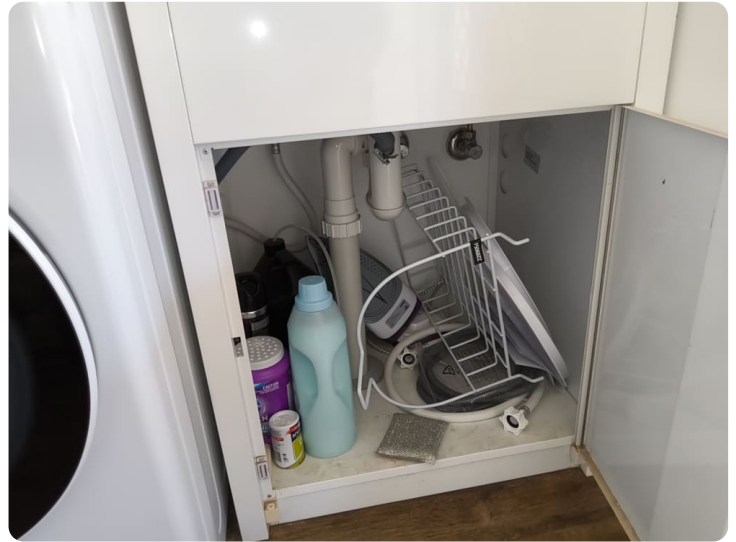
### 36. Laundry cabinets

The condition of the laundry cabinets is satisfactory in relation to their age and require normal maintenance.
