# **Houspect**

### **Pre purchase inspection**

**Job ID:** 93044

**Address:** 17 Lady Douglas Way, Pegs Creek WA 6714

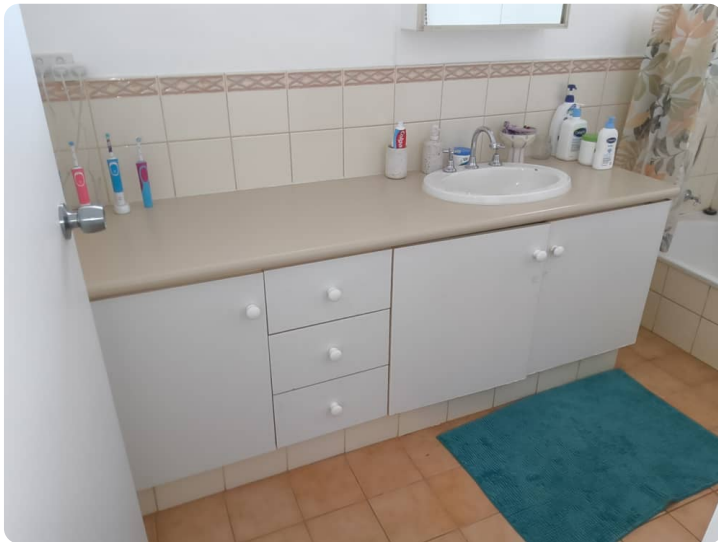
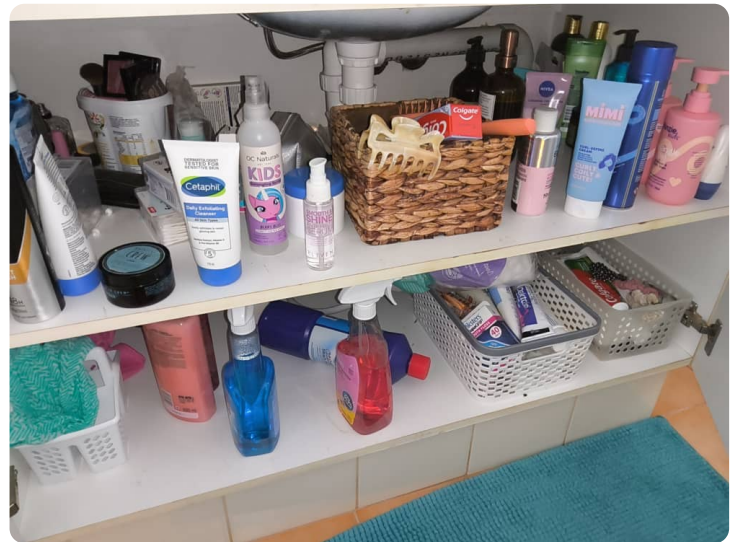
### 37. Bathroom cabinets

The condition of the bathroom cabinets is satisfactory in relation to their age and require normal maintenance.

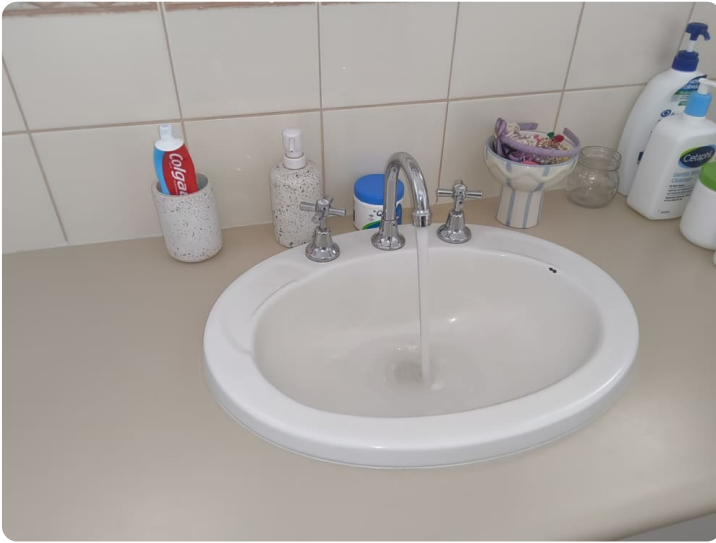
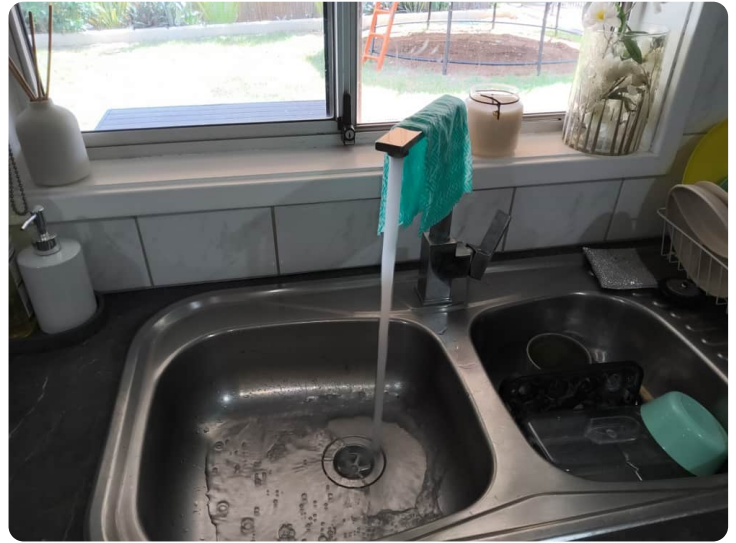
### 38. Plumbing

The taps to multiple areas were turned on and the water flow appeared to be reasonable. Water draining to several sinks and toilets appeared to be reasonable. The Building Inspector is not a Plumbing Contractor and is not permitted to test Plumbing items under WA Law. Where appropriate a Plumbing Contractor should be engaged to test the plumbing in the property.

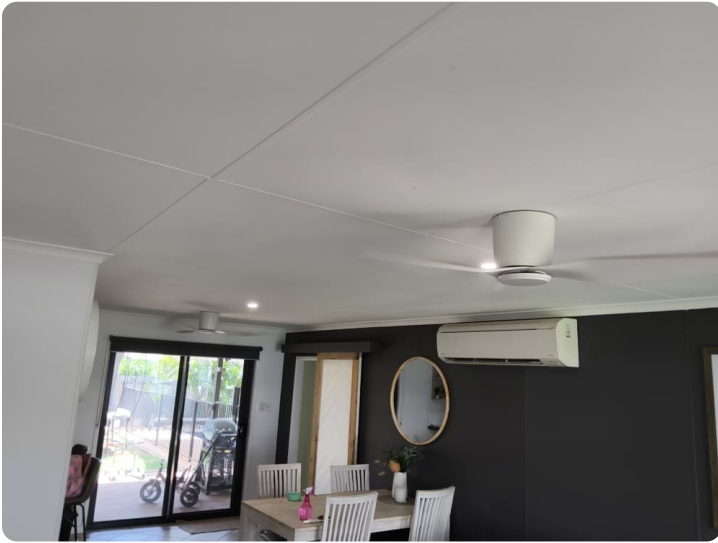
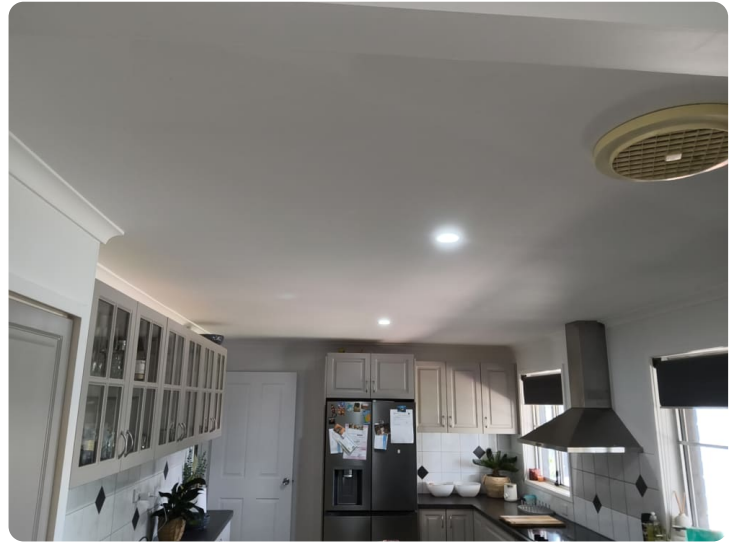
### 39. Lights and power points

Several lights were turned on during the inspection and the lights appeared to be operational. The Building Inspector is not an Electrical Contractor and is not permitted to test Electrical items under WA Law. Where appropriate an Electrical Contractor should be engaged to test the electrical items in the property.

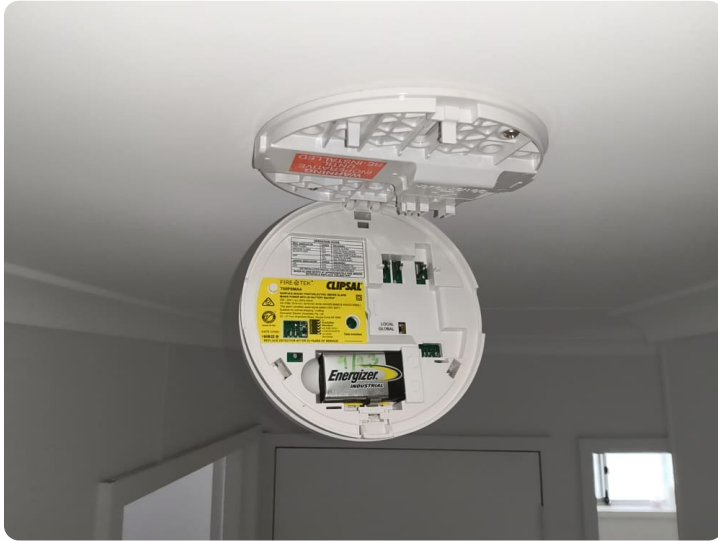
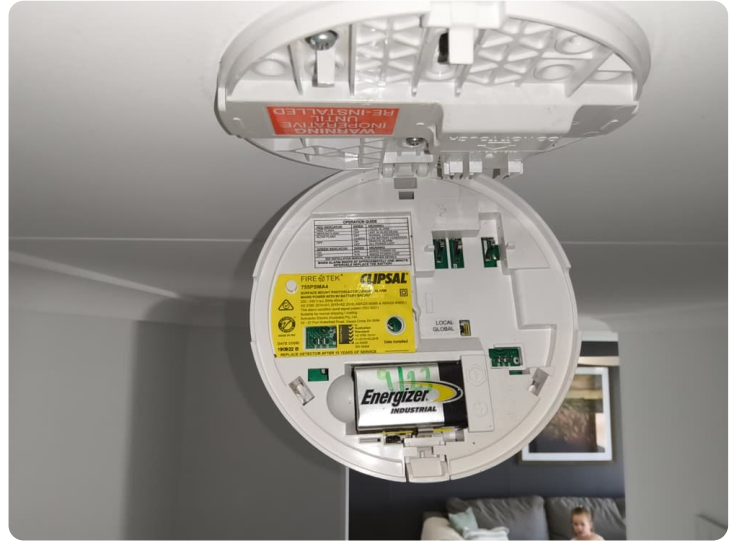
#### 40. Smoke Alarms

There were two hardwired smoke alarms on site. There were no battery smoke alarms on site. The location, number and type of smoke alarms appeared to be consistent with Legislative requirements. It is suggested that an Electrical Compliance Certificate be obtained in relation to the smoke alarms.
