Building inspection

Job ID: 91855

Address: 35 Hunt Way, Bulgarra WA

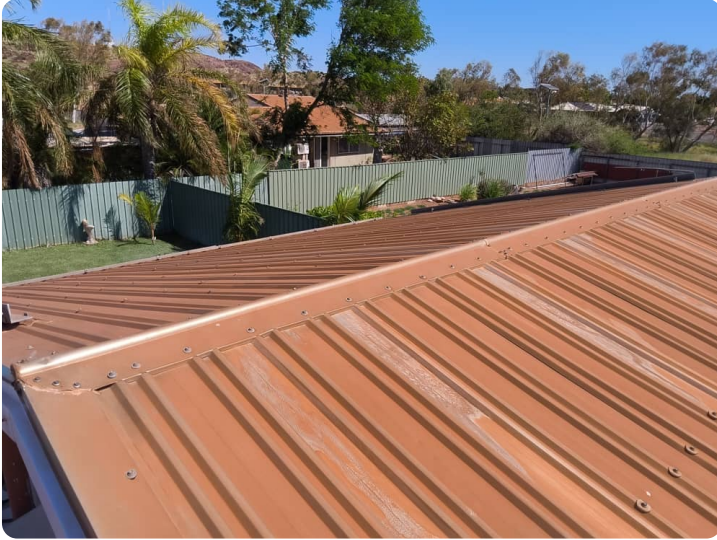
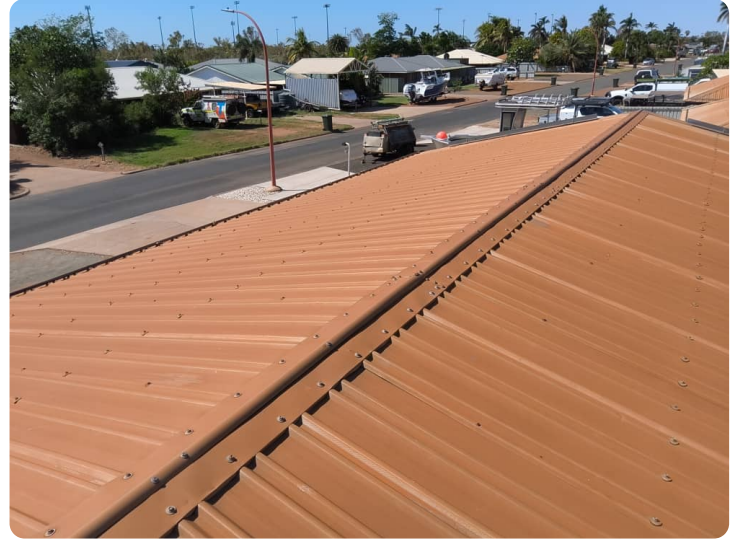
2. Ridges

The ridges and capping are fair in relation to its age and will require ongoing maintenance.

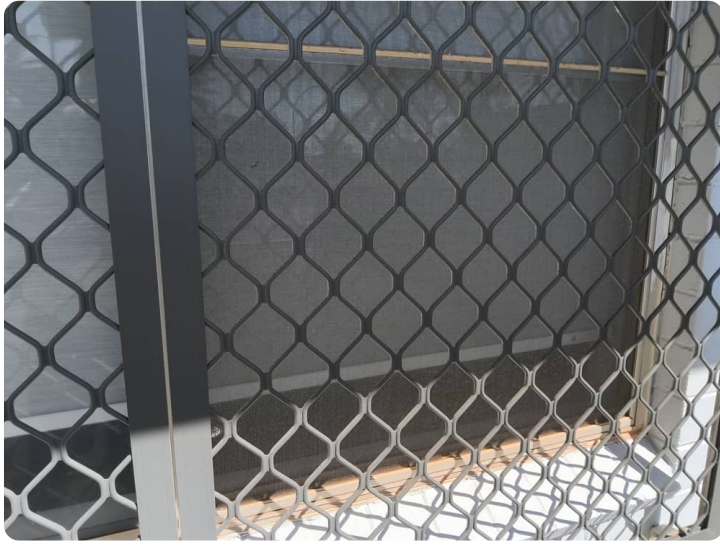
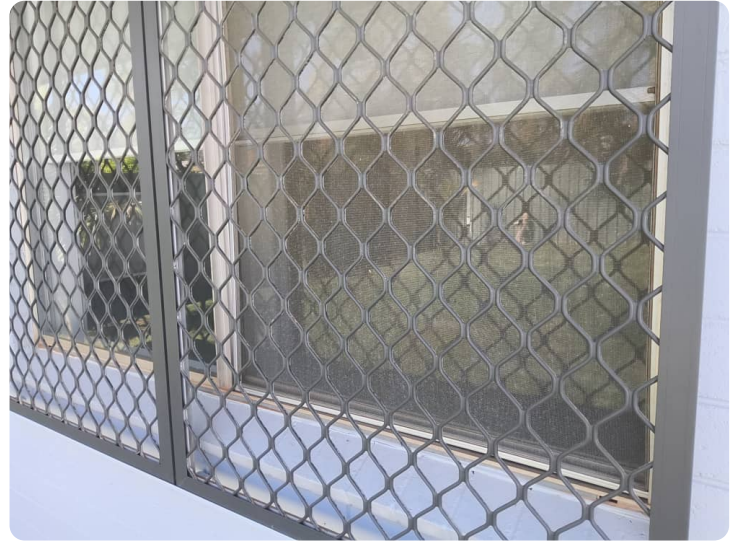
10. Window fly screens

Fly screens have been installed to all of the windows. The condition of the window fly screens is generally satisfactory in relation to its age and will require normal ongoing maintenance.

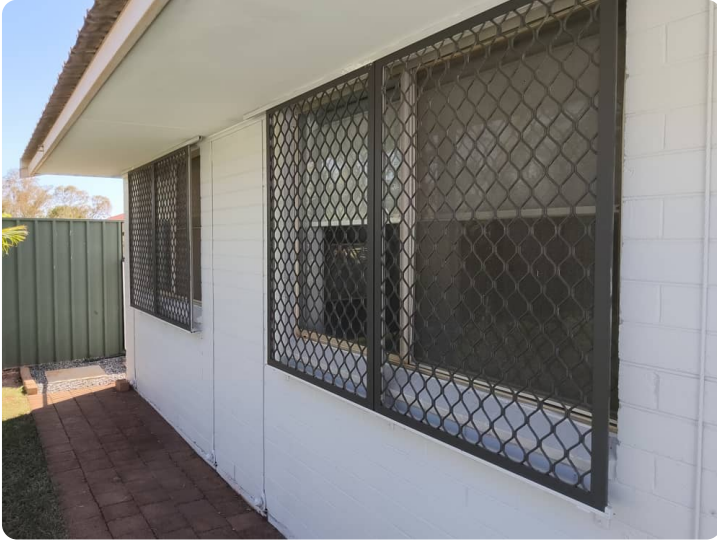
11.1 Cyclone screen missing

The cyclone screen is missing and requires replacement to meet local requirements.

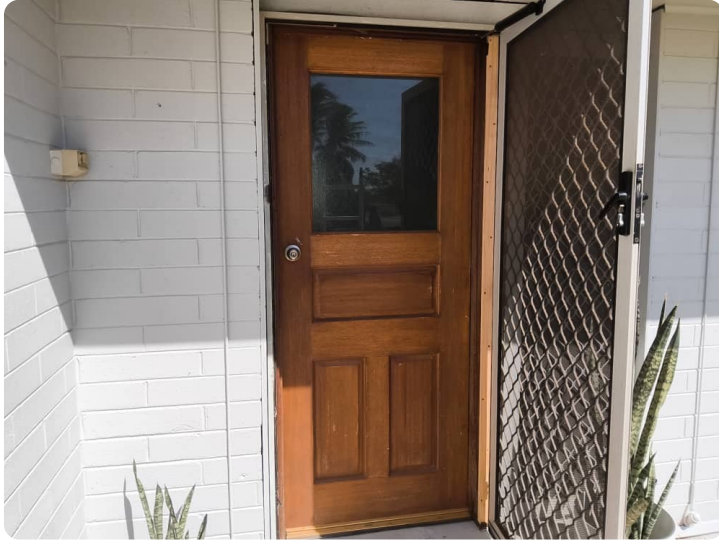
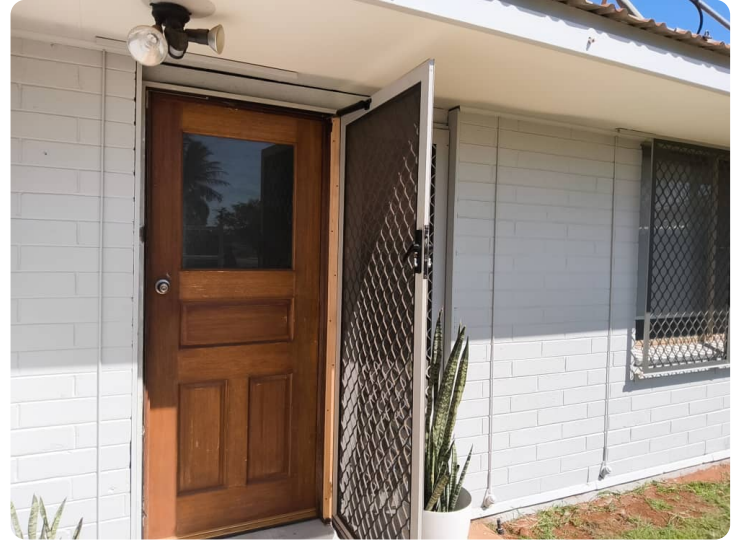
12. Front door

The front door is constructed of timber and glass. The condition of the front door is satisfactory in relation to its age and will require normal ongoing maintenance. Deadlocks have been installed. A security screen door has not been fitted.

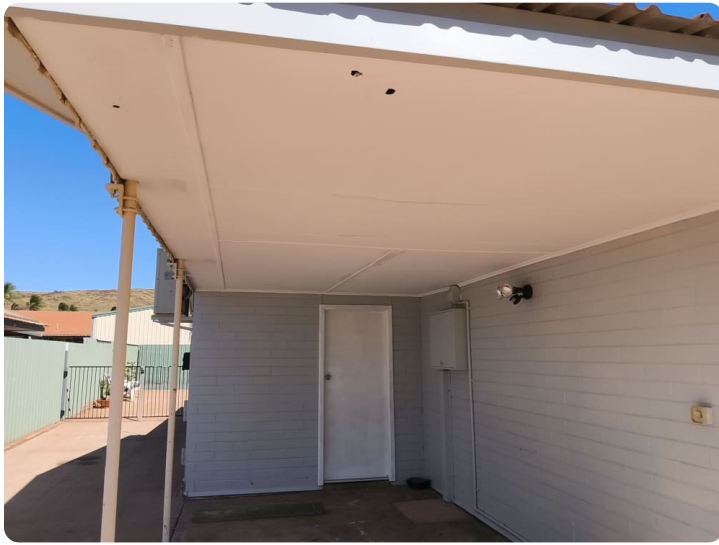
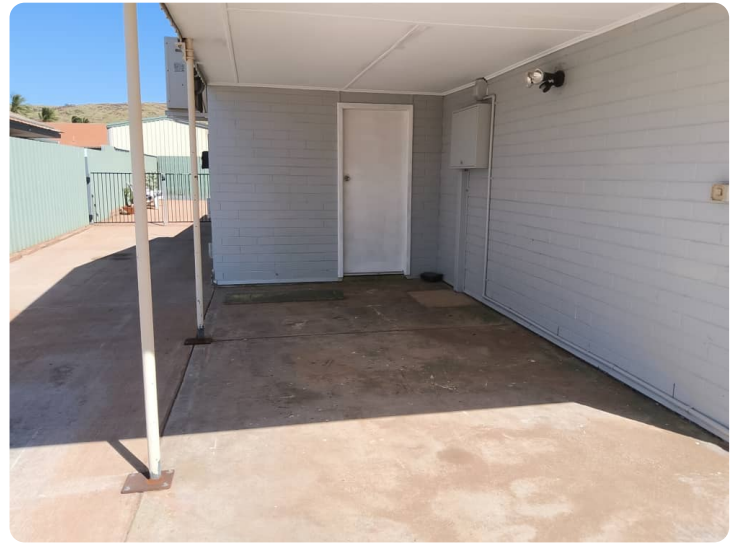
17. Carport or Garage (Primary)

There is a primary carport on the property constructed of same materials as the primary structure. The condition of the carport or garage is satisfactory in relation to its age and will require normal ongoing maintenance. Please note that some of the building material utilised on or within the building may or may not contain asbestos. The Australian Government has indicated that asbestos can only be correctly identified through laboratory testing. The material on this building site may not pose a concern in the current static state if maintained but for any future works the material should be tested and appropriate measures used for asbestos handling if the material is subsequently found to contain asbestos.

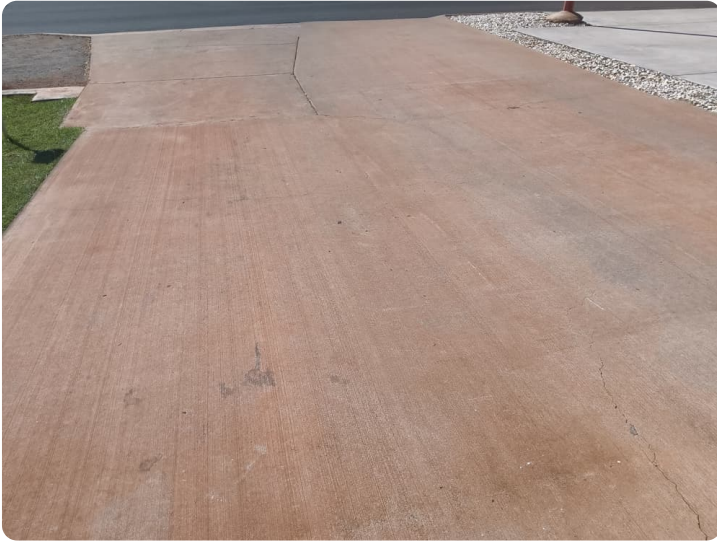
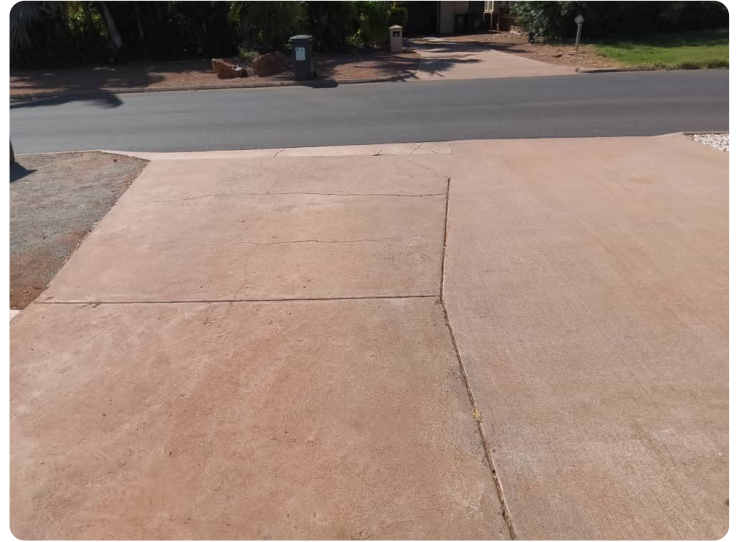
20. Driveway

The driveway and crossover is constructed of concrete. The condition of the driveway is satisfactory in relation to its age and will require normal ongoing maintenance.

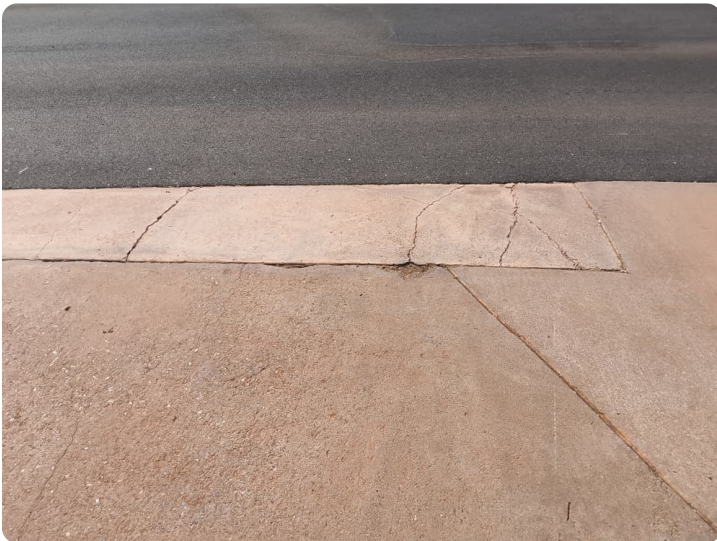
20.1 Concrete cracking - minor

Cracking was noted to the concrete driveway. This is not of a structural concern. Cracks should be filled to avoid further deterioration.

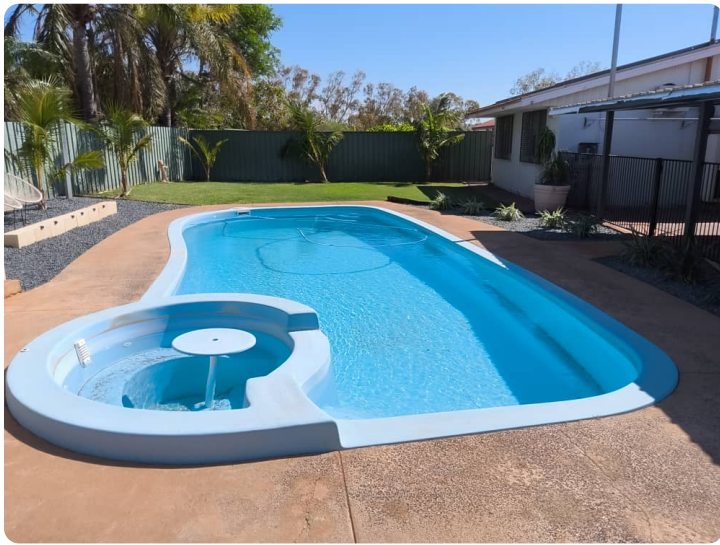
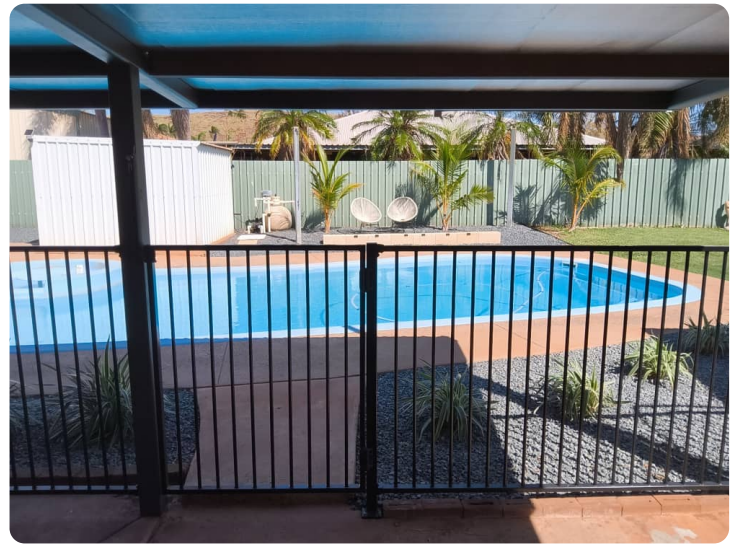
The pool is situated below ground. The external pool on the property is constructed of fibreglass. In relation to subsidence to the ground immediately adjacent to the pool, no significant subsidence was noted. The building and or boundary fences form part of barrier fencing for the pool and appear to be consistent with current pool fencing requirements. It is recommended that a copy of the previous Council Pool Safety Compliance Certificate is obtained. It is recommended that a pool maintenance contractor review and confirm the operation of all pool equipment.

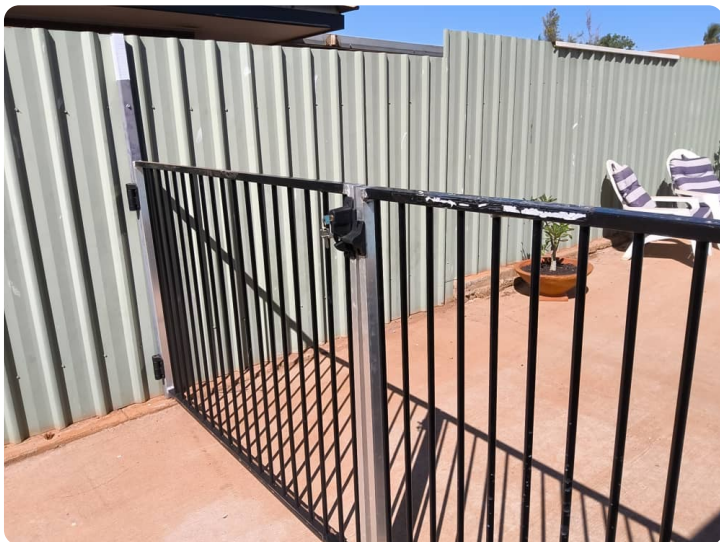
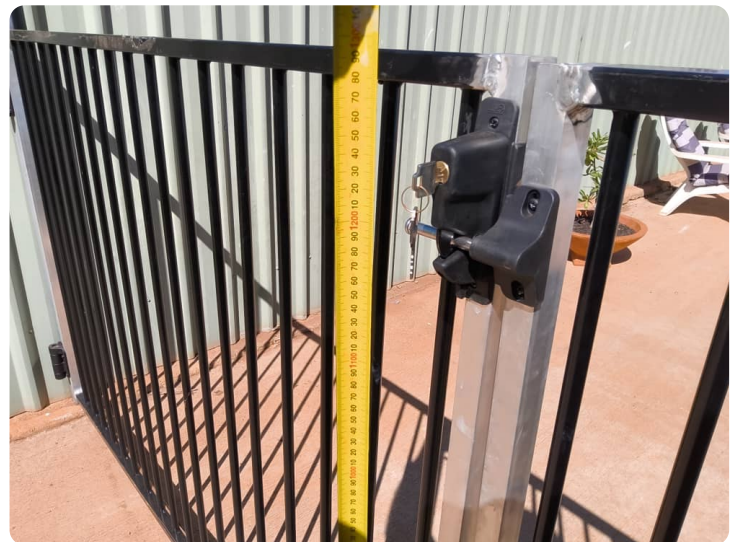
24.1 Gate latch to low

Issue flag: Safety Item

The boundary fence gate latch does not appear to meet WA requirements as located below 1.5 m above the ground. A pool compliance certificate should be obtained. Remediation work should be undertaken as required.

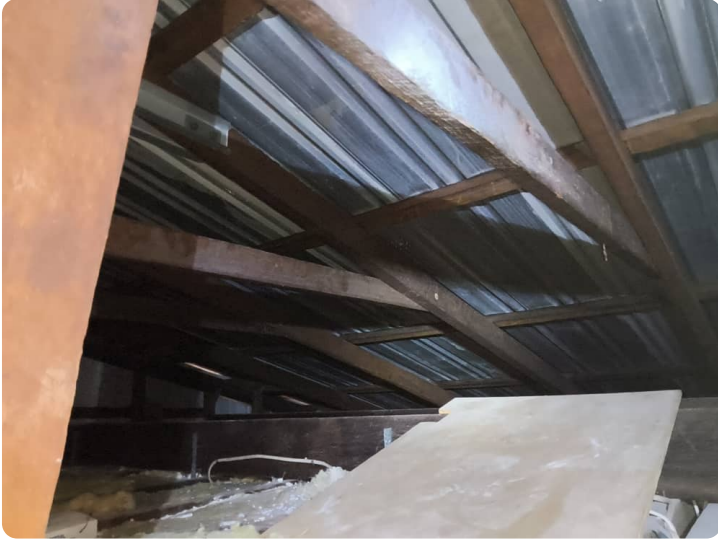
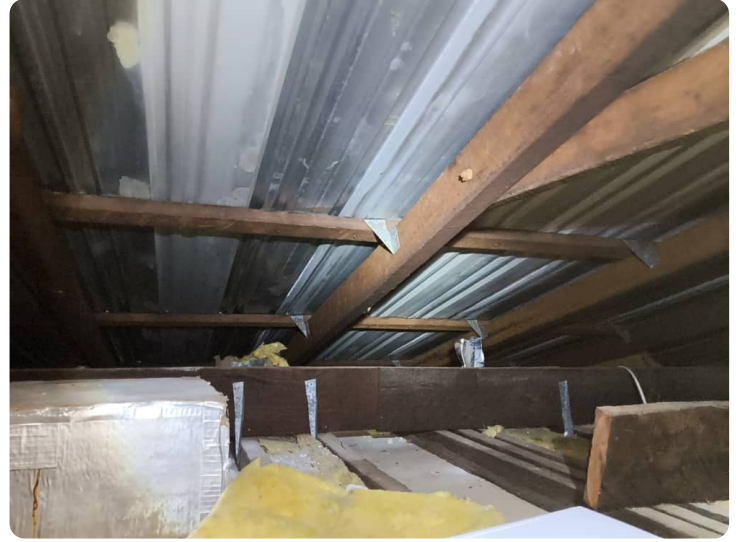
Sarking to the underside of the roof was not installed and was not considered effective.

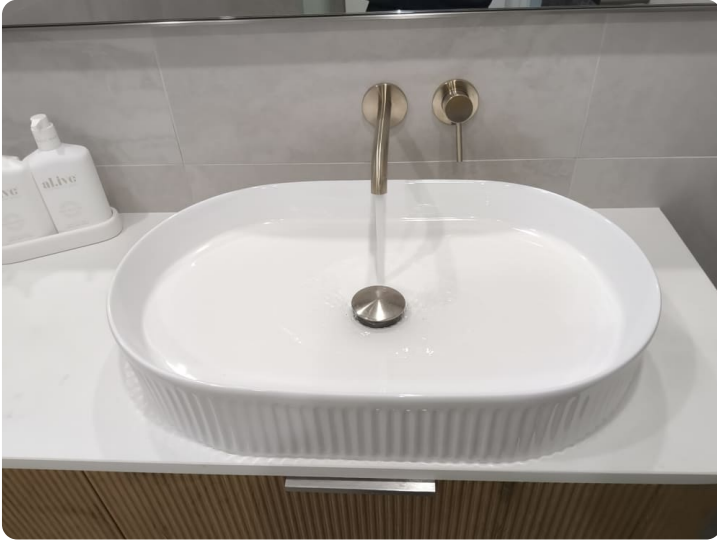
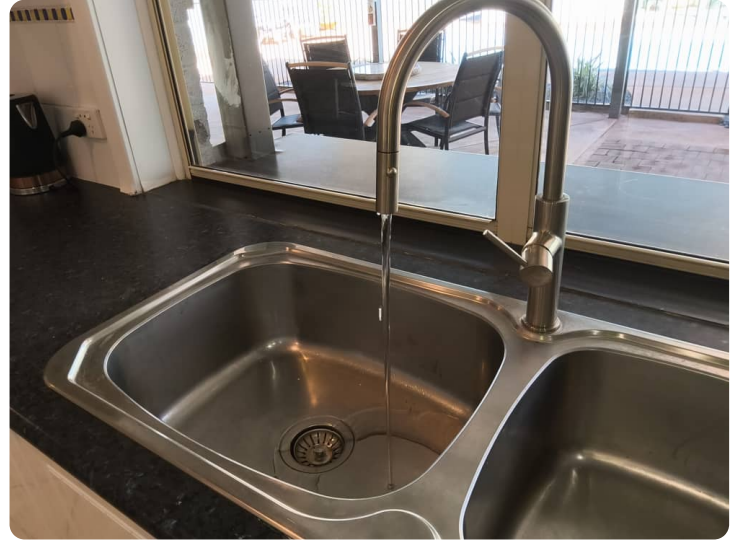
The taps to multiple areas were turned on and the water flow appeared to be reasonable. Water draining to several sinks and toilets appeared to be reasonable. The Building Inspector is not a Plumbing Contractor and is not permitted to test Plumbing items under WA Law. Where appropriate a Plumbing Contractor should be engaged to test the plumbing in the property.

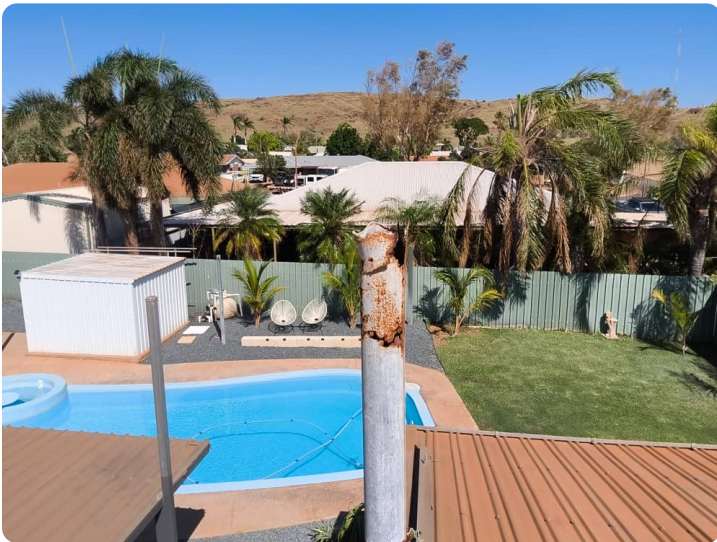
40.1 Sewer vent pipe damage

As per the images the sewer vent pipe is damaged and requires repairs or replacement by a plumber.

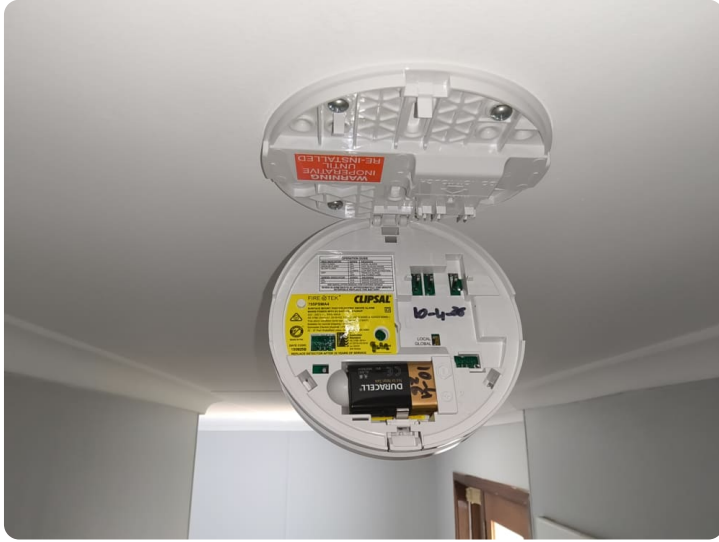
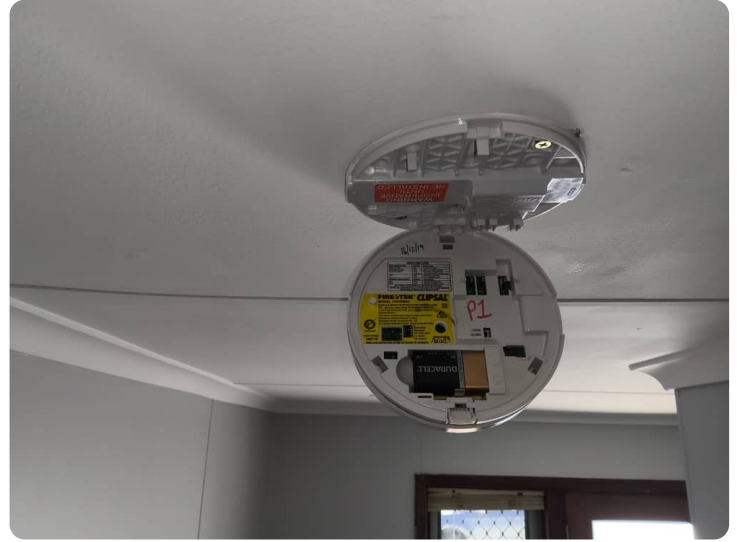
42. Smoke Alarms

There were two hardwired smoke alarms on site. There were no battery smoke alarms on site. The location, number and type of smoke alarms appeared to be consistent with Legislative requirements. It is suggested that an Electrical Compliance Certificate be obtained in relation to the smoke alarms.
