# **Houspect**

**Building inspection**

**Job ID:** 92397

**Address:** 5 Edney Way, Pegs Creek WA

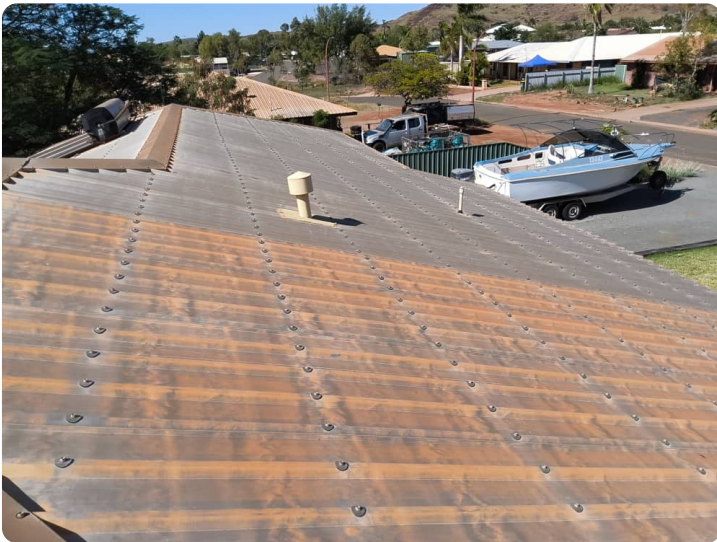
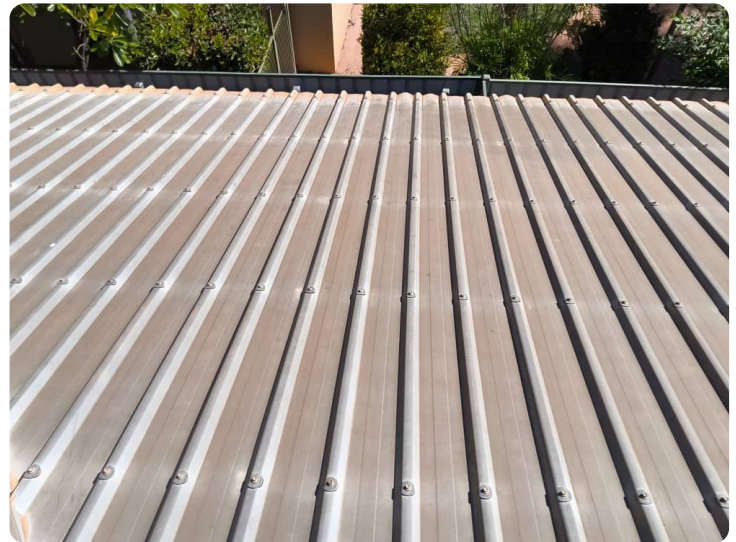
### 1.1 Metal (colorbond) roof colour faded

As per the images the colorbond roof sheeting has or is losing its colour on most of the roof, leaving the zincalume finish. This is a cosmetic issue and does not diminish the sheets performance broader performance.

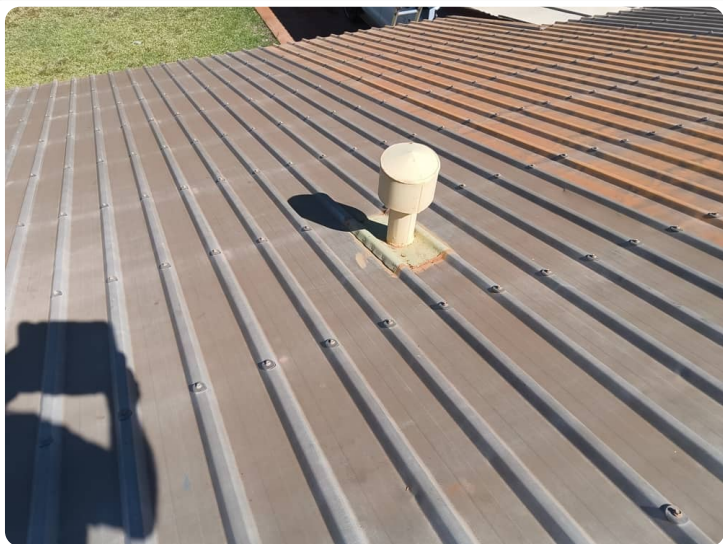
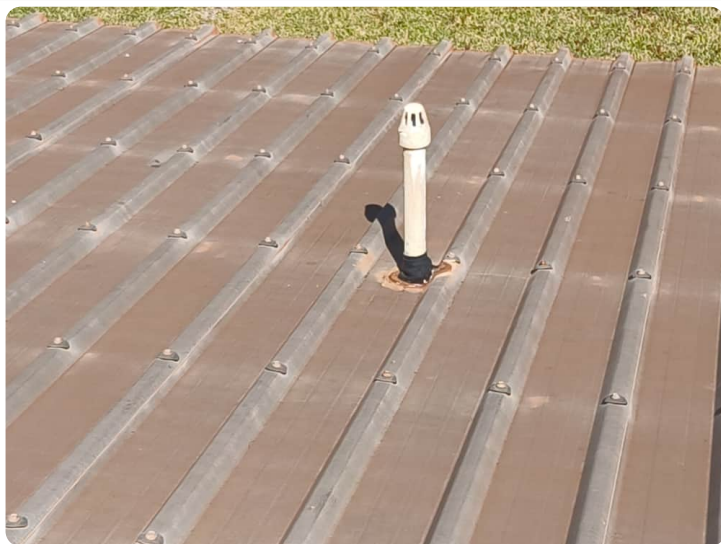
#### 3.1 Flashings general - only silicone

The flashings are covered with a variety of finishes and are constructed of a mixture of materials. The condition of the flashings is satisfactory in relation to their age and will require normal ongoing maintenance.

There is insufficient or no flashing installed around the roof penetrations which have only been silicone sealed. Installing flashing around these penetrations is recommended to prevent water ingress into the roof space.

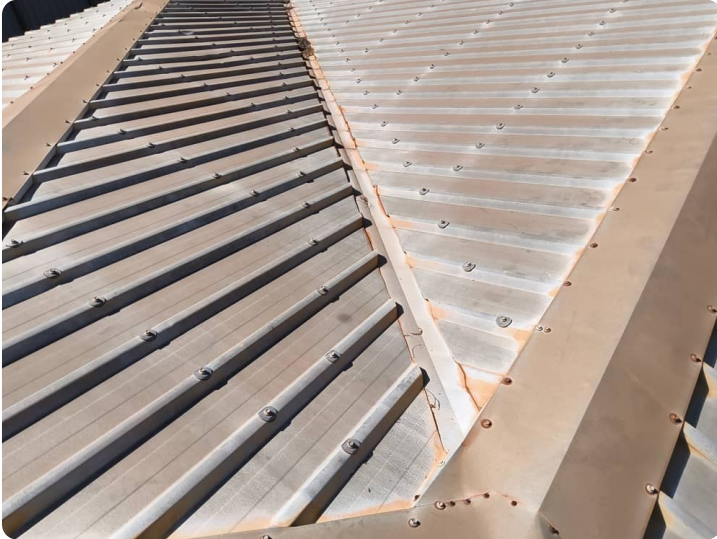
The valleys are constructed of metal and have a colorbond covering. The condition of the valleys is satisfactory in relation to their age and will require normal ongoing maintenance. The valleys need to be cleared of debris.

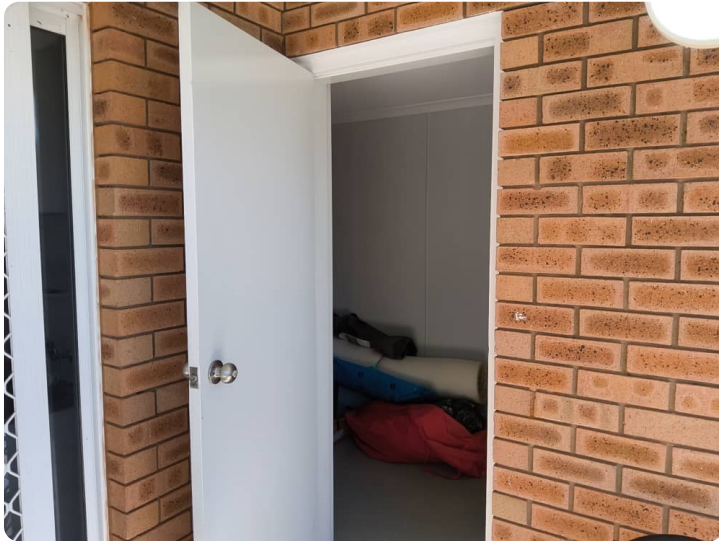
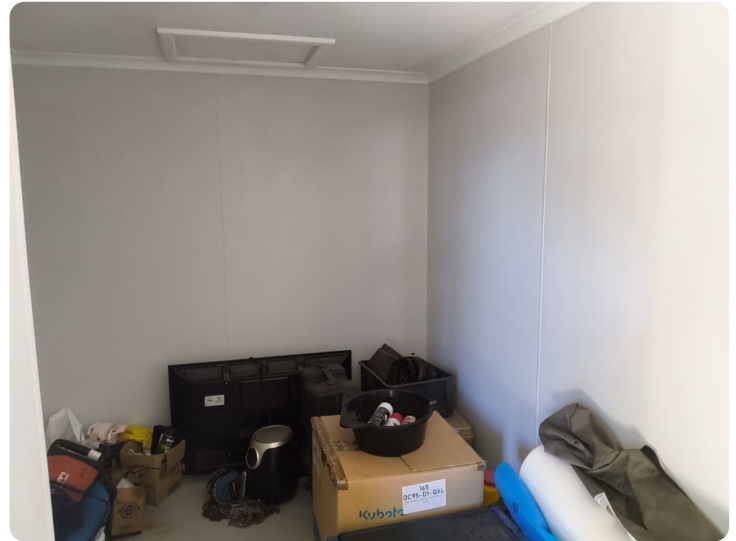
An external storeroom for the property is located adjacent and under the main roof of the building. The condition of the storeroom is satisfactory in relation to its age and will require normal ongoing maintenance. Access and visibility of the area was restricted by stored items.

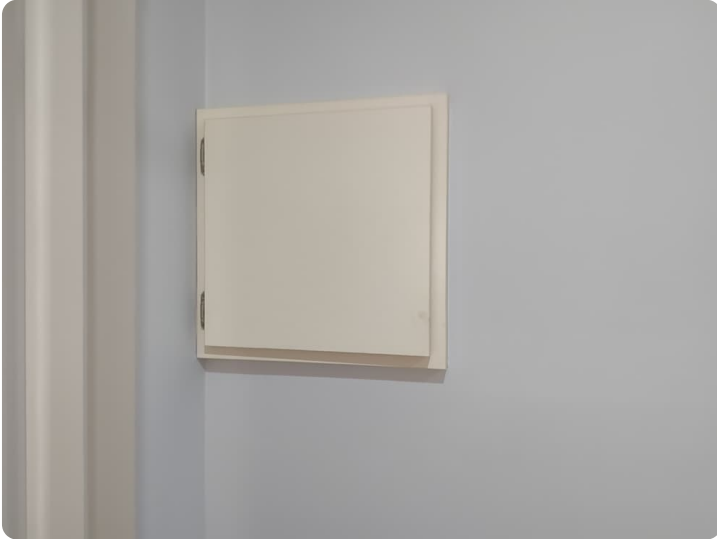
There were two Residual Current Devices (RCD)(s) noted in the meter box or sub meter box. The RCD(s) were not tested. It is suggested that an Electrical Compliance Certificate be obtained in relation to the RCD(s).

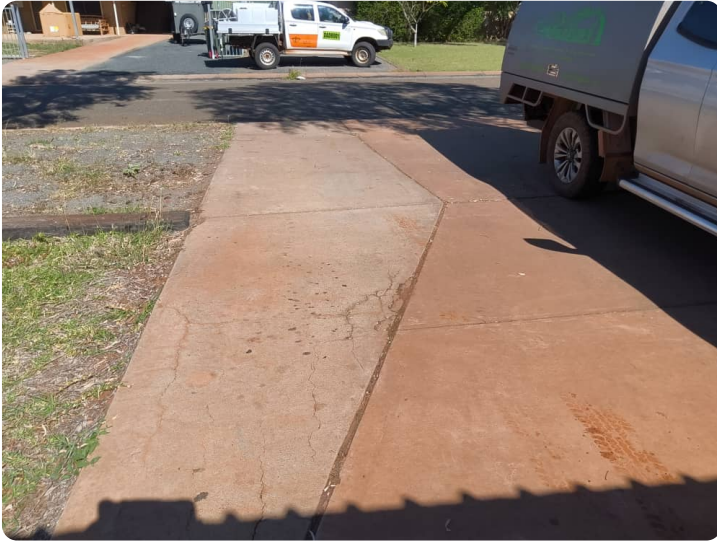
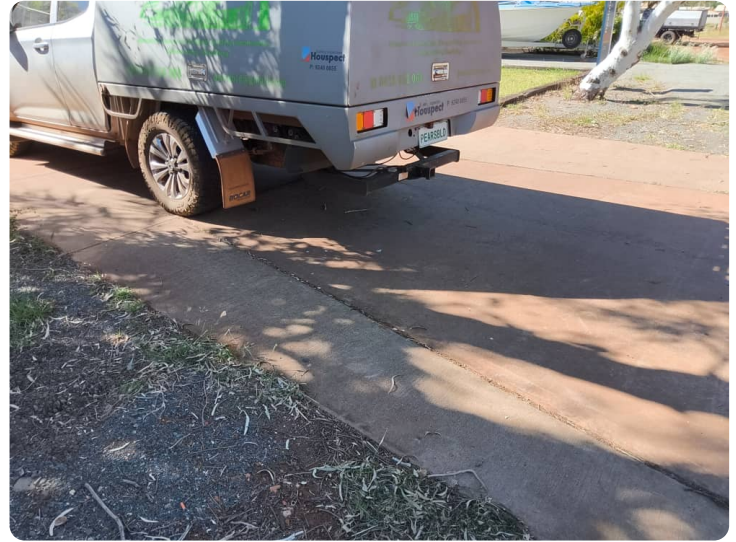
### 23. Driveway

The driveway and cross over is constructed of concrete. The condition of the driveway is satisfactory in relation to its age and will require normal ongoing maintenance.

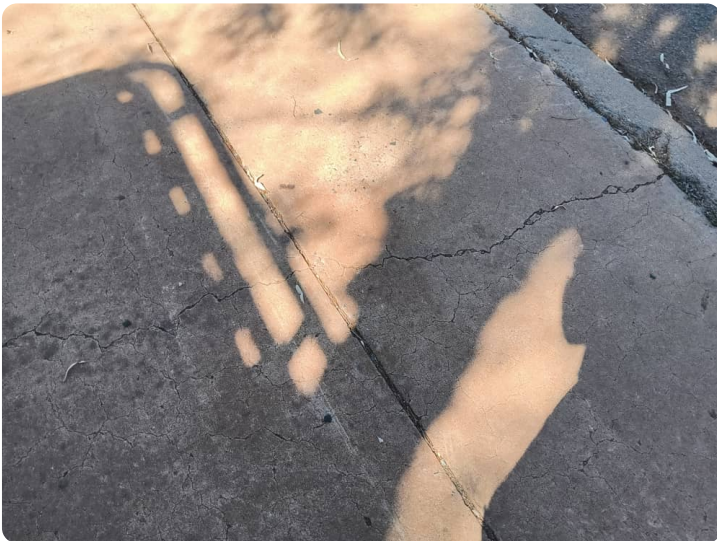
#### 23.1 Concrete cracking - minor

Cracking was noted to the concrete driveway. This is not of a structural concern. Cracks should be filled to avoid further deterioration.

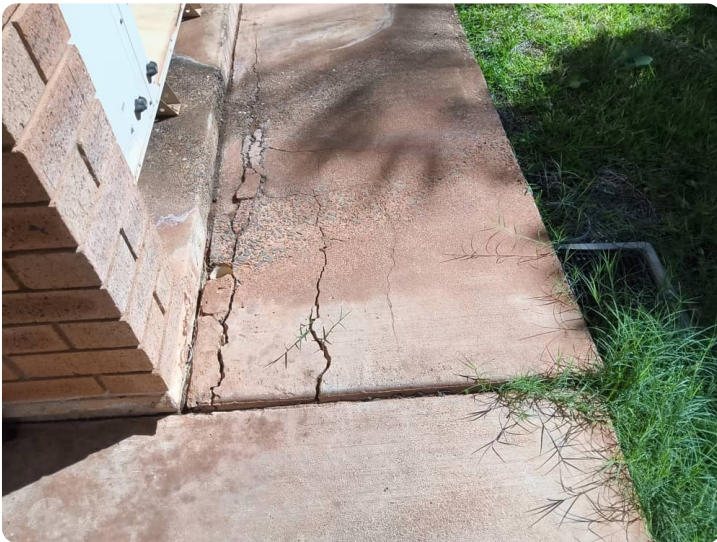
### 24.1 Cracking - major

Cracking was noted to the walkways. Repairs should be carried out to ensure the cracks do not become a trip hazard or cause further damage.

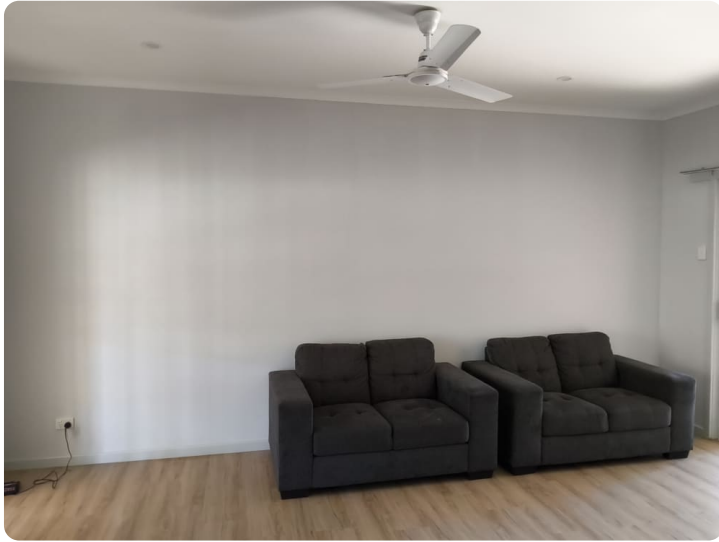
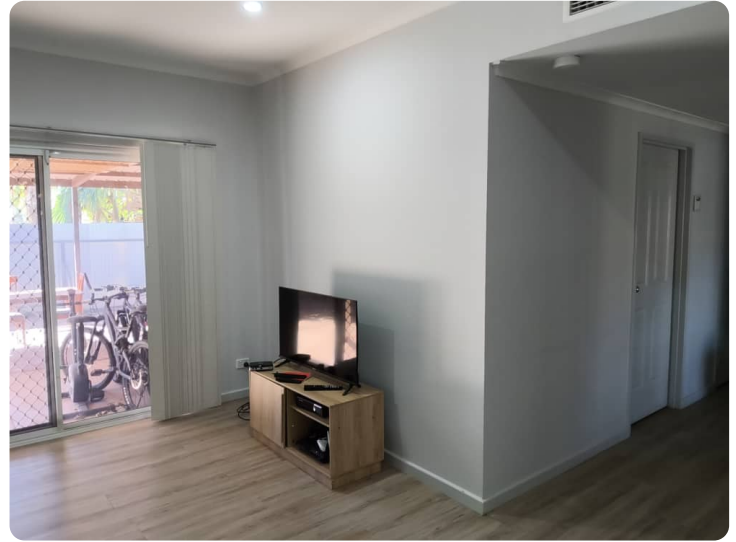
### 31. Internal walls

The internal walls are constructed of a frame with plaster board cladding. The condition of the internal walls is satisfactory in relation to its age and will require normal ongoing maintenance.

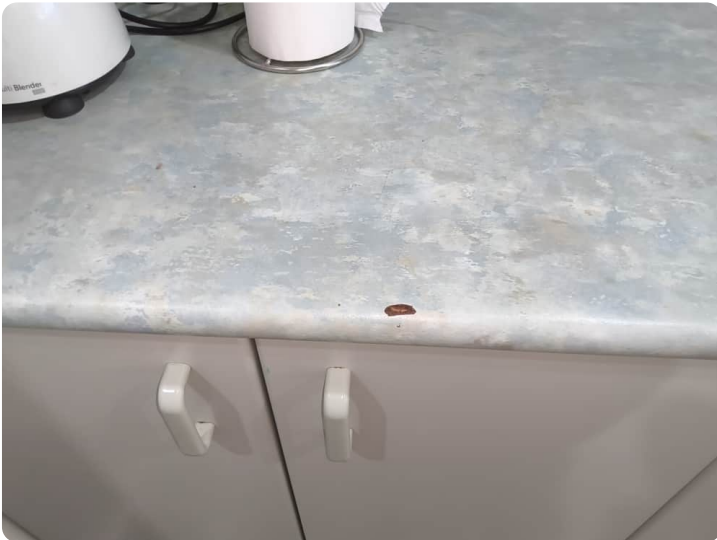
#### 36.1 Bench top damage

As per the images the kitchen benchtop is damage requiring repairs or replacement.

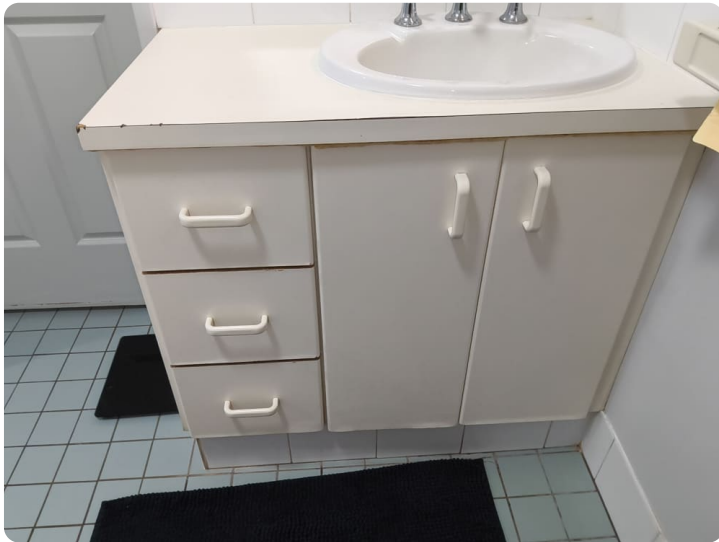
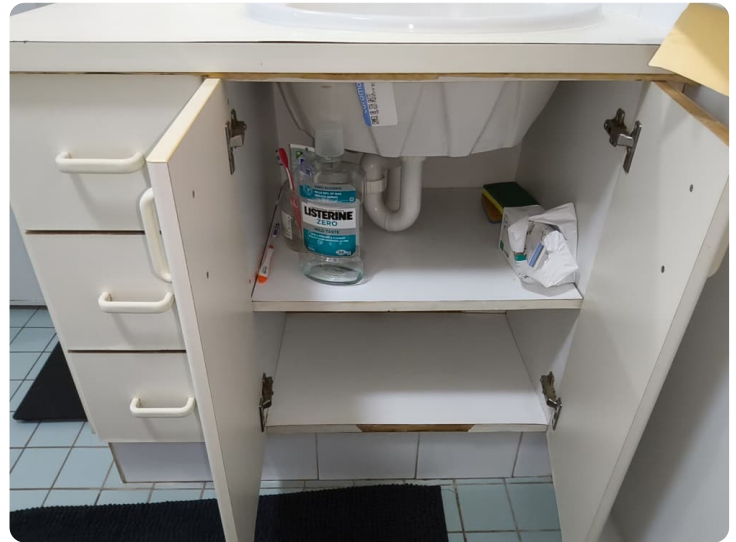
### 38. Bathroom cabinets

The condition of the bathroom cabinets is satisfactory in relation to their age and require normal maintenance.

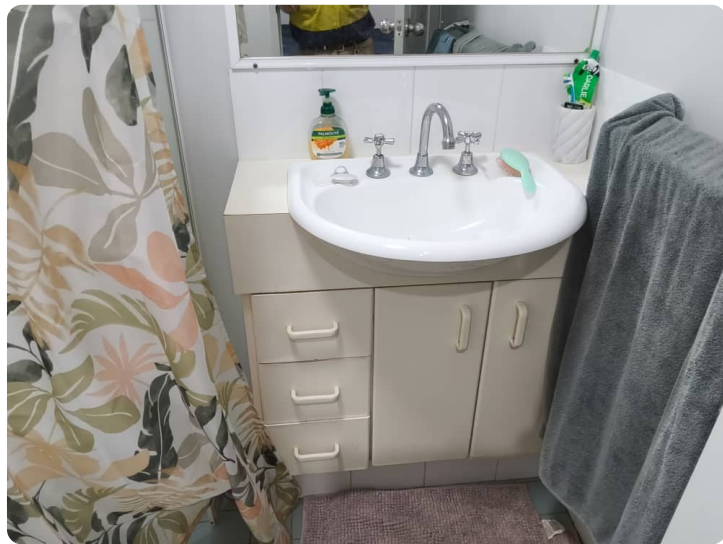
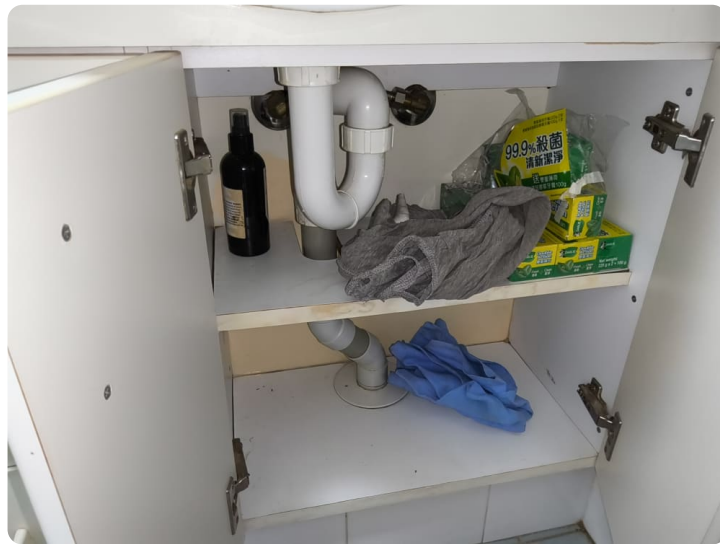
### 39. Ensuite cabinets

The condition of the ensuite cabinets is satisfactory in relation to their age and require normal maintenance.

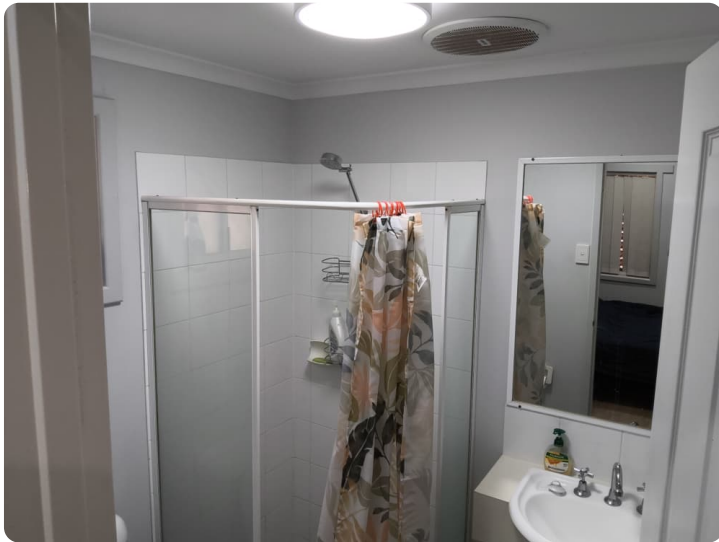
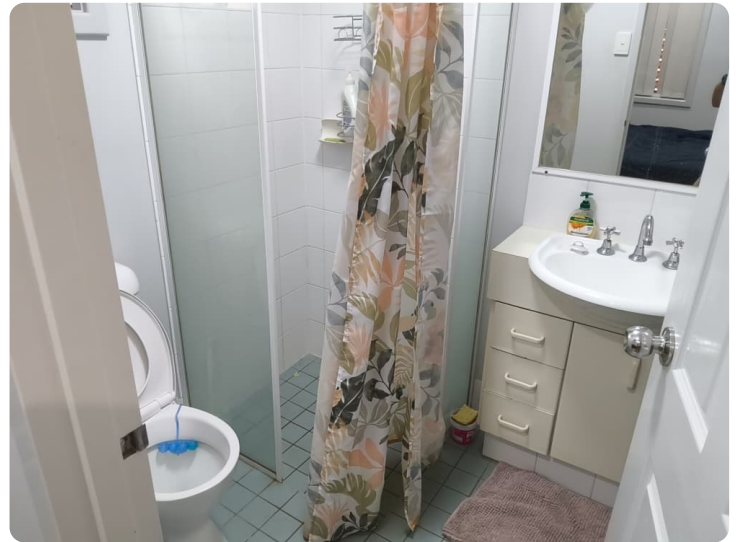
#### 40. Shower screens

The condition of the shower screens is satisfactory in relation to their age and require normal maintenance.

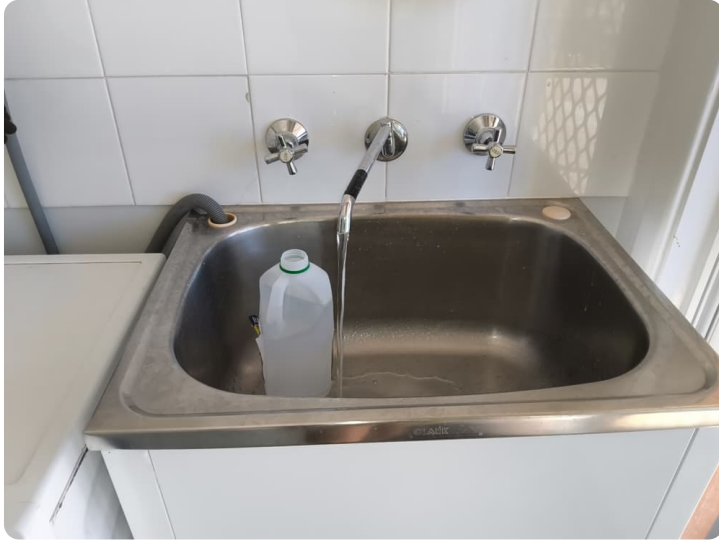
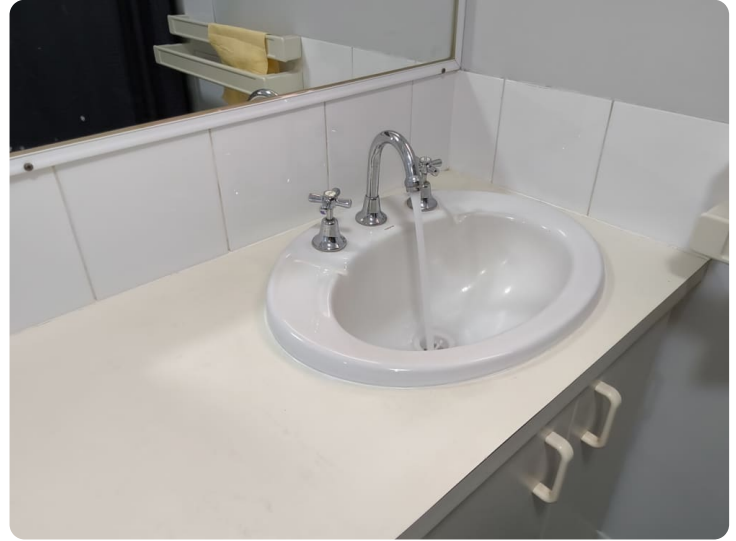
#### 41. Plumbing

The taps to multiple areas were turned on and the water flow appeared to be reasonable. Water draining to several sinks and toilets appeared to be reasonable. The Building Inspector is not a Plumbing Contractor and is not permitted to test Plumbing items under WA Law. Where appropriate a Plumbing Contractor should be engaged to test the plumbing in the property.

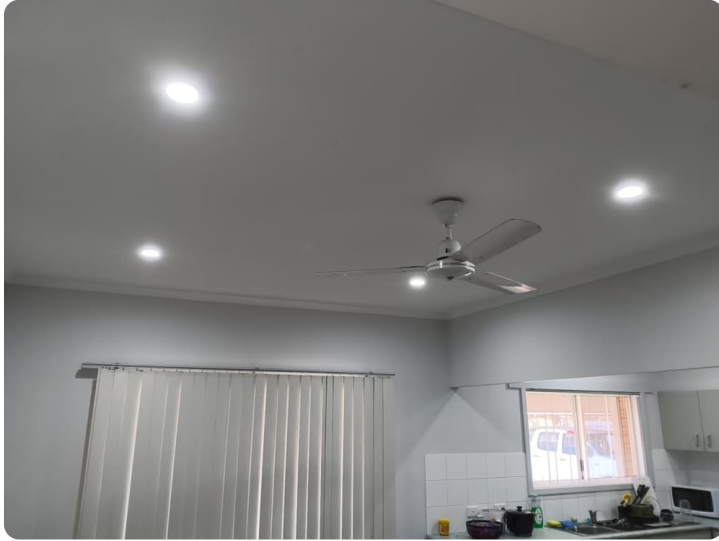
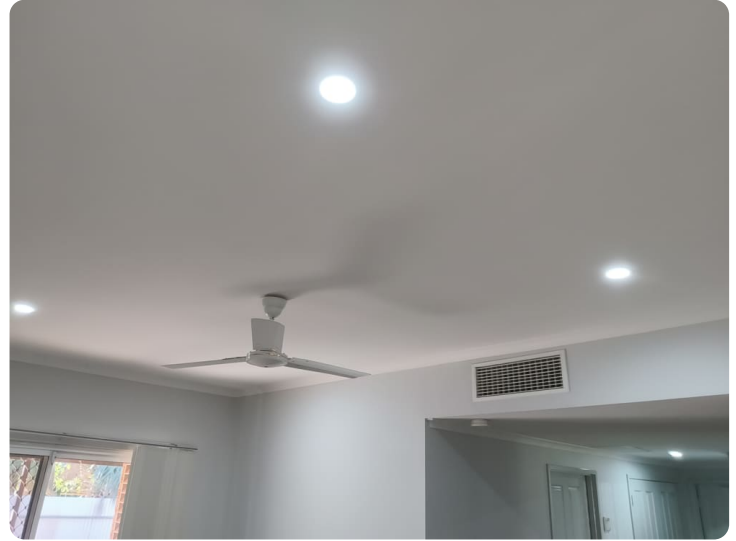
#### 42. Lights and power points

Several lights were turned on during the inspection and the lights appeared to be operational. The Building Inspector is not an Electrical Contractor and is not permitted to test Electrical items under WA Law. Where appropriate an Electrical Contractor should be engaged to test the electrical items in the property.

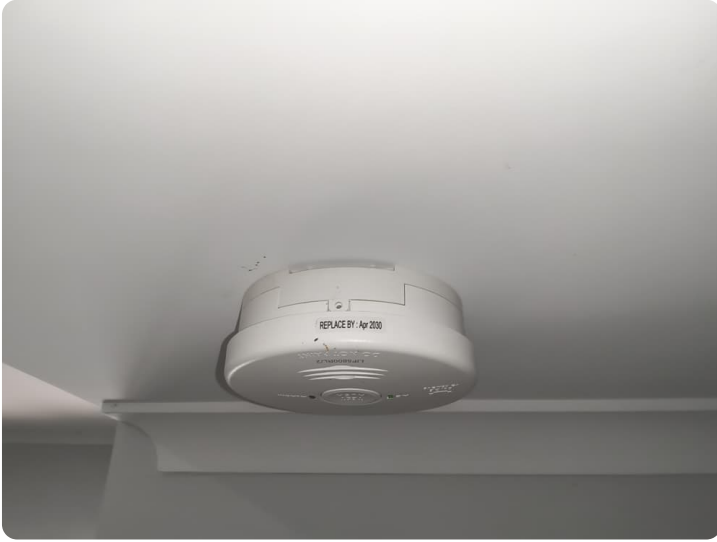
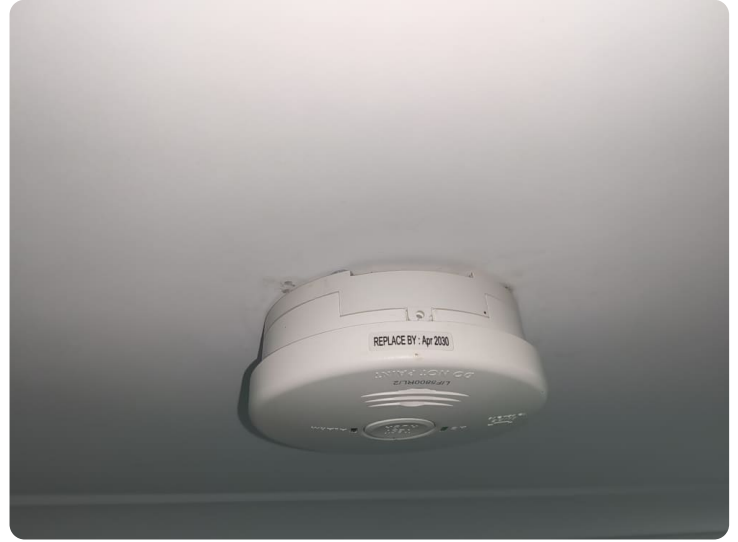
### 43. Smoke Alarms

There were two hardwired smoke alarms on site. There were no battery smoke alarms on site. The location, number and type of smoke alarms appeared to be consistent with Legislative requirements. It is suggested that an Electrical Compliance Certificate be obtained in relation to the smoke alarms.
