# **Houspect**

### **Pre purchase inspection**

**Job ID:** 92886

**Address:** 3/31 Withnell Way, Bulgarra WA 6714

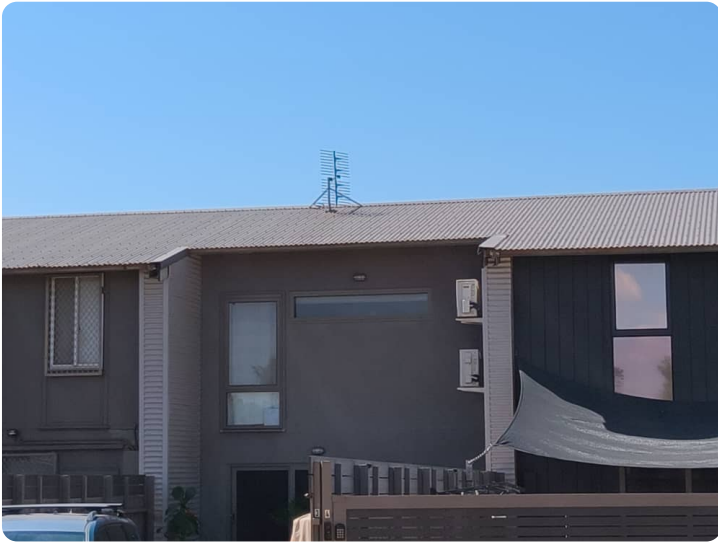
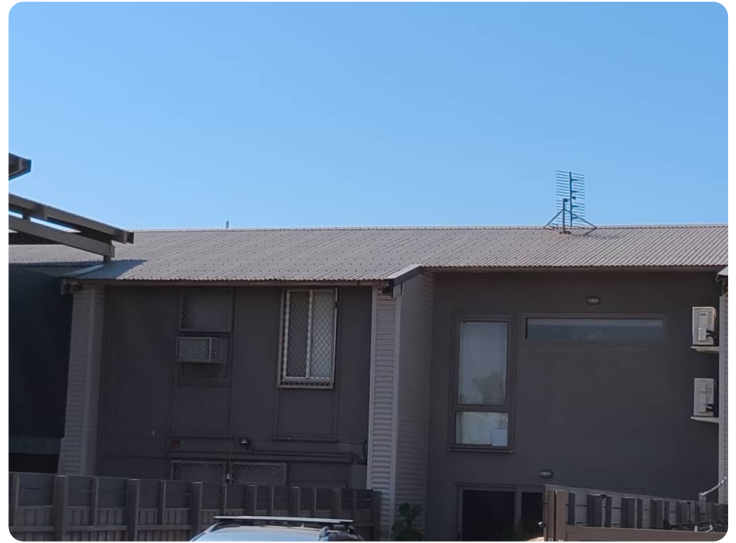
## 1. Roof covering

The roof covering is constructed of colorbond. The condition of the roof covering is satisfactory in relation to its age and will require normal ongoing maintenance. Please note that on the day of the inspection the Inspector considered it unsafe under WA WH&S requirements to get onto the roof cover. All observations of the roof cover were made from the ground

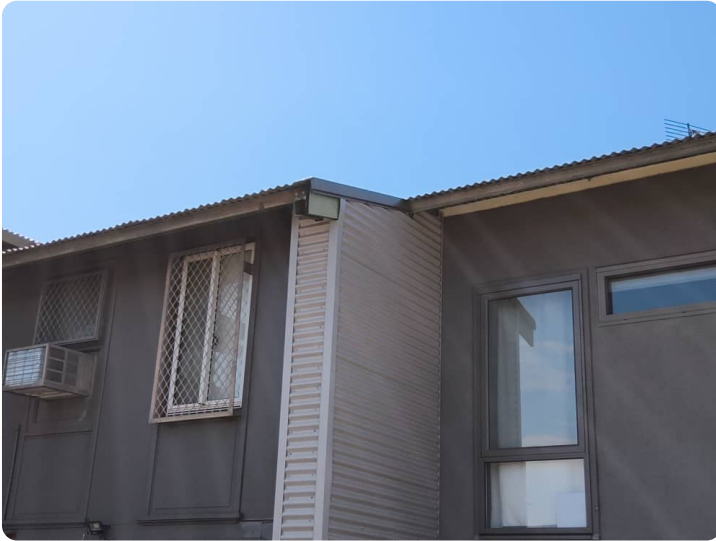
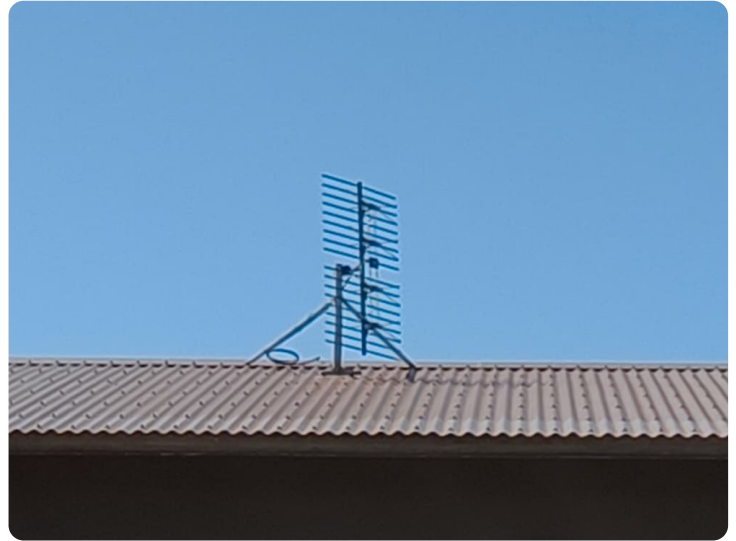
## 2. Flashings

The flashings are covered with a variety of finishes and are constructed of a mixture of materials. The condition of the flashings is satisfactory in relation to their age and will require normal ongoing maintenance.

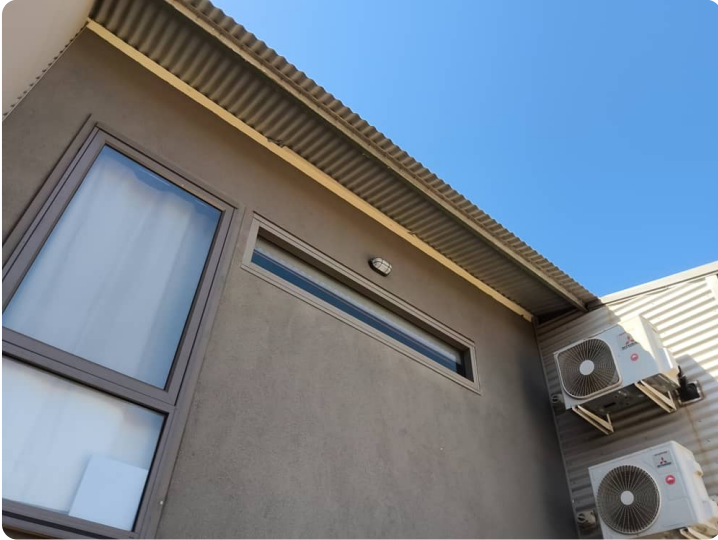
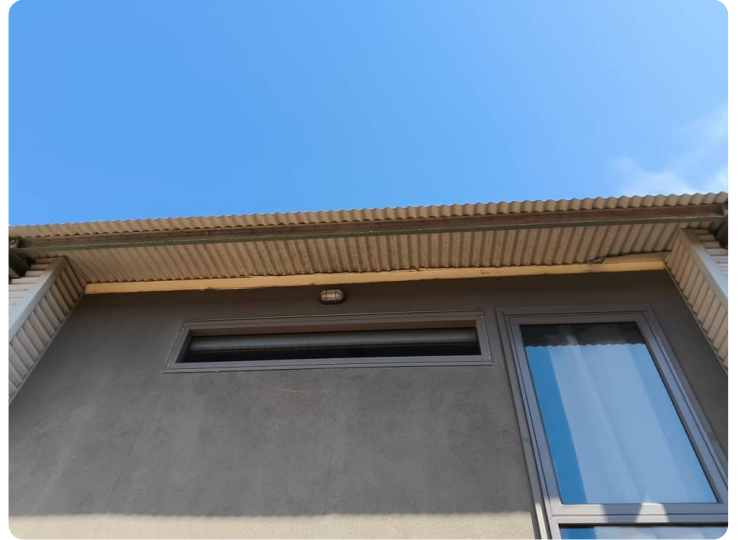
### 3. Eaves

The eaves are exposed and constructed of exposed rafters. The condition of the eaves is satisfactory in relation to their age and will require normal ongoing maintenance.

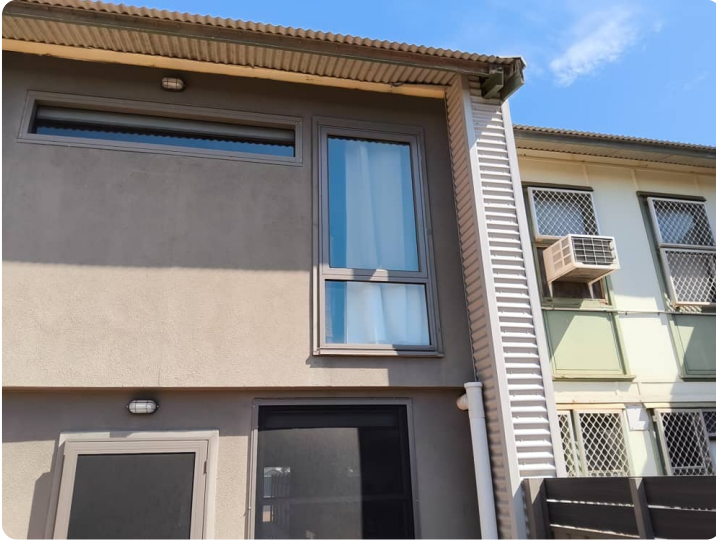
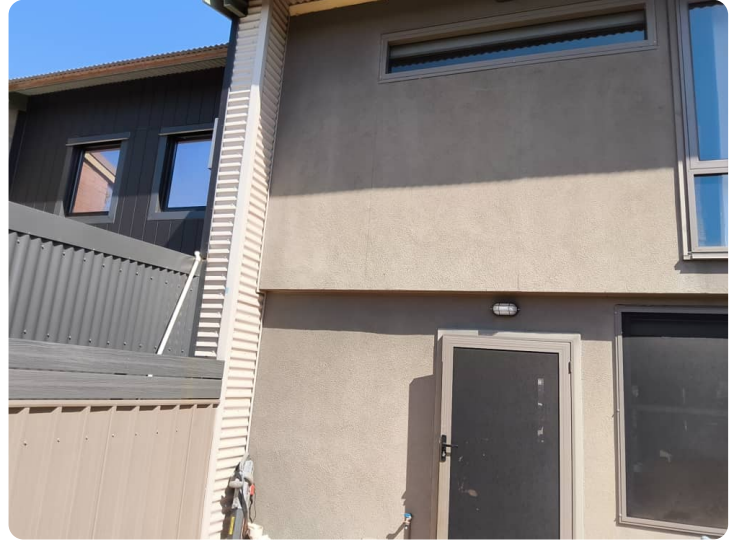
#### 4. External walls

The external walls are constructed of a mixture of materials. The condition of the walls generally is satisfactory in relation to their age and will require normal ongoing maintenance.

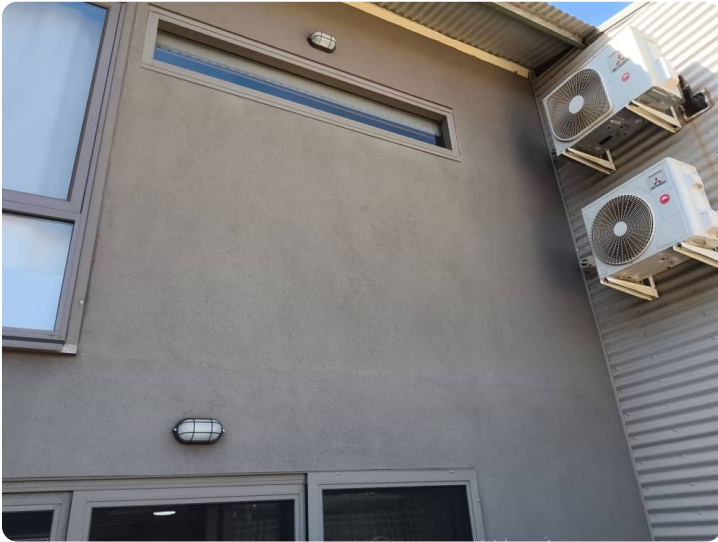
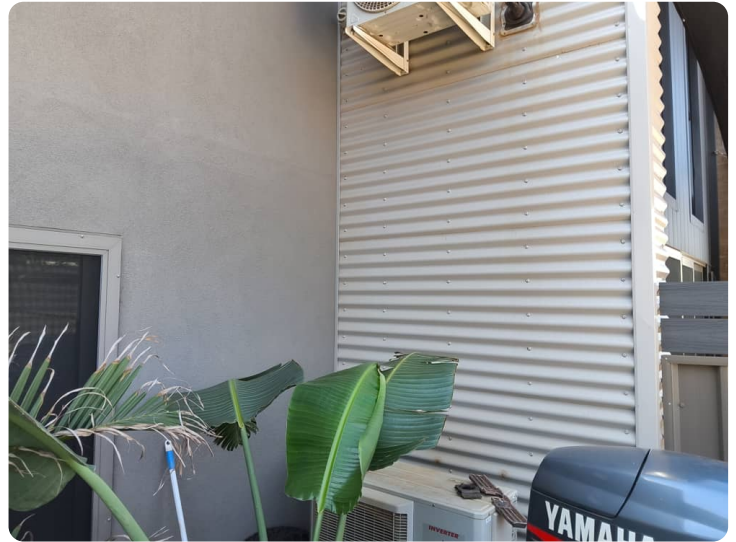
## 5. Wall cladding

The external walls are (or partially are) clad with fibre cement and colorbond. The condition of the cladding is generally satisfactory in relation to its age and will require normal ongoing maintenance.

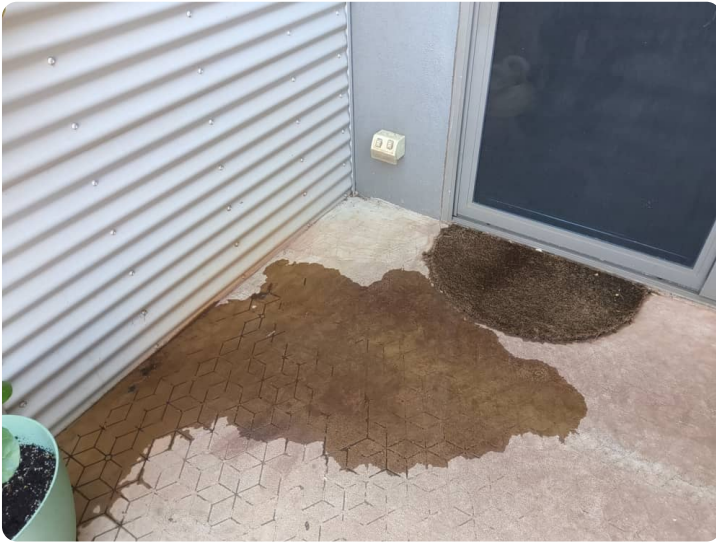
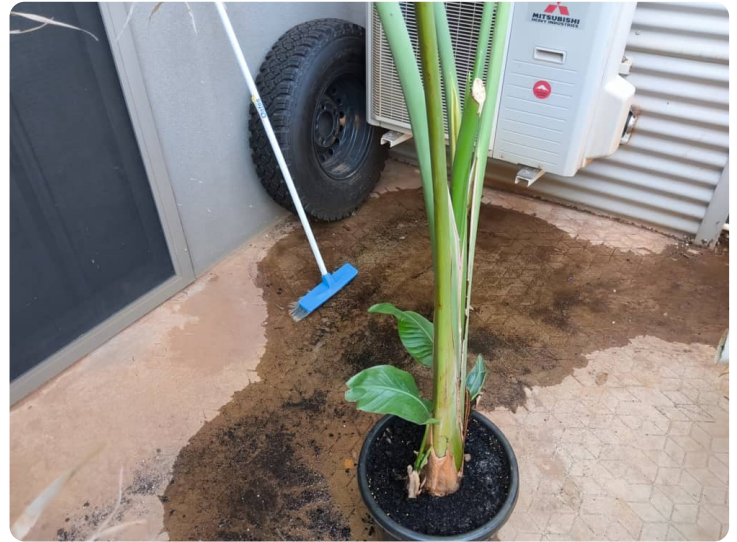
## 6. Footings

The footings are below ground and cannot be seen. The condition of the footings cannot be determined.

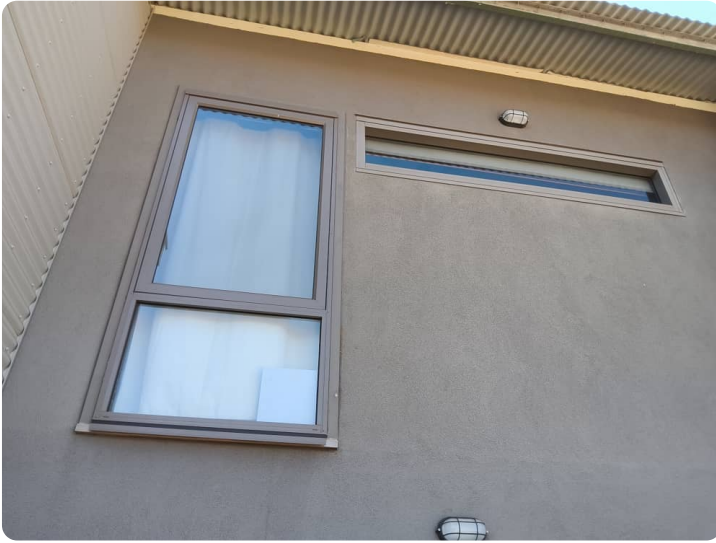
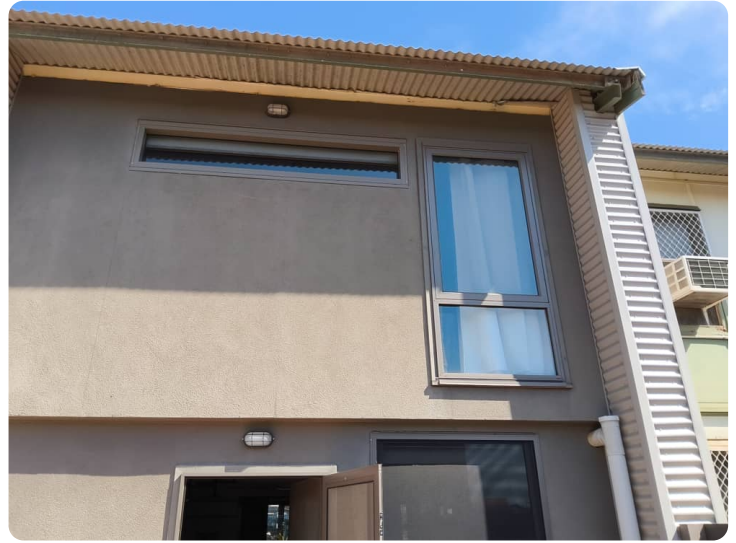
## 7. Windows and window frames

The window and window frames are primarily constructed of aluminium. The condition of the window and window frames is generally satisfactory in relation to its age and will require normal ongoing maintenance.

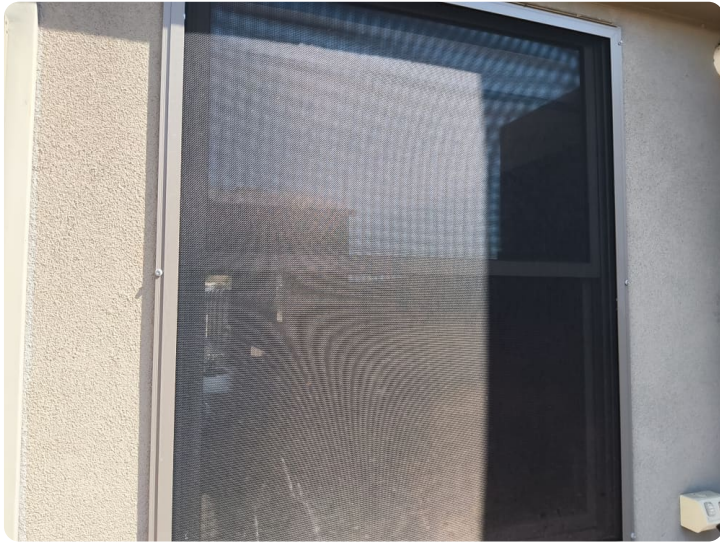
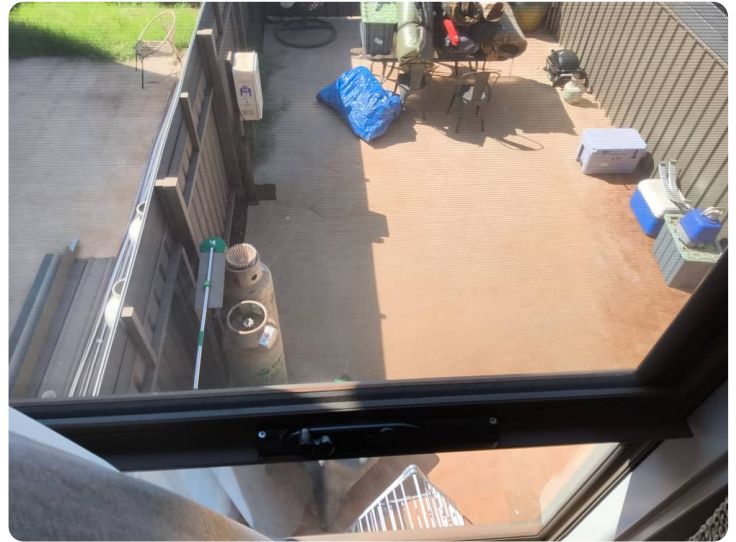
## 8. Window fly screens

Fly screens have been installed to all of the windows. The condition of the window fly screens is generally satisfactory in relation to its age and will require normal ongoing maintenance.

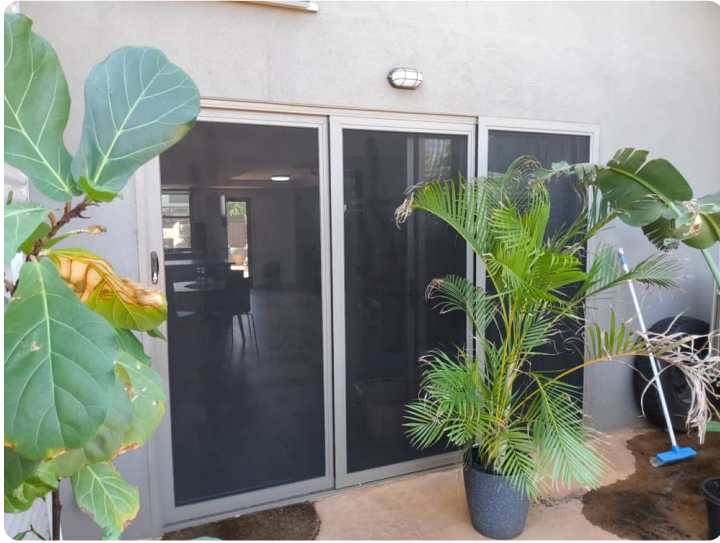
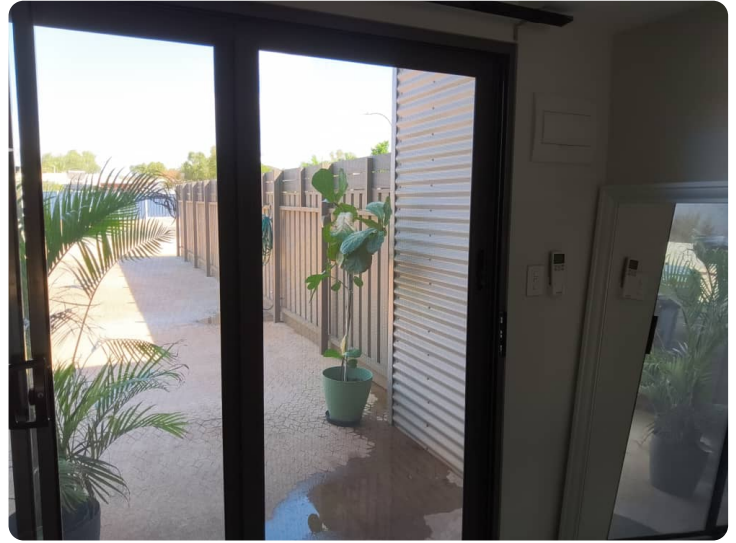
## 10. Front door

The front door is constructed of aluminium and glass . The condition of the front door is satisfactory in relation to its age and will require normal ongoing maintenance. Deadlocks have been installed. A security screen door has been fitted.

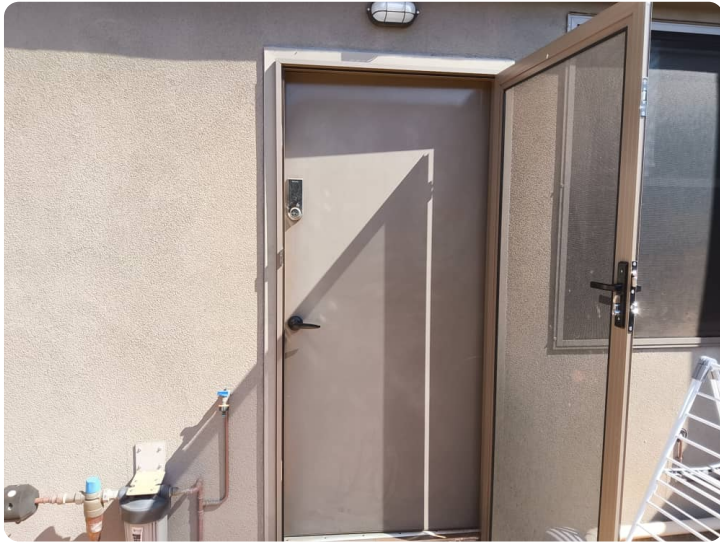
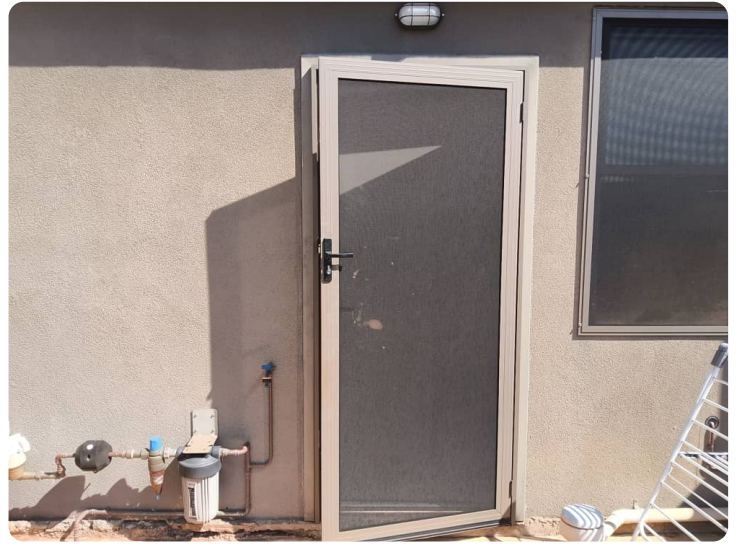
## 11. Other external doors

Other external doors are constructed of solid timber. The condition of the other external doors is satisfactory in relation to its age and will require normal ongoing maintenance.

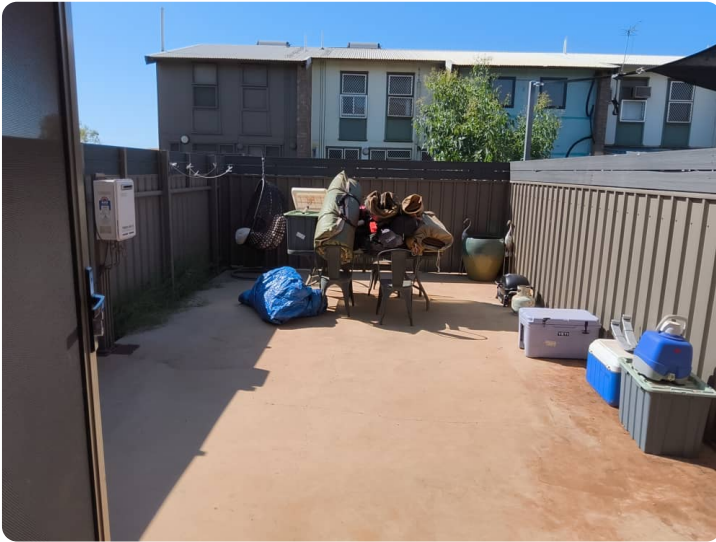
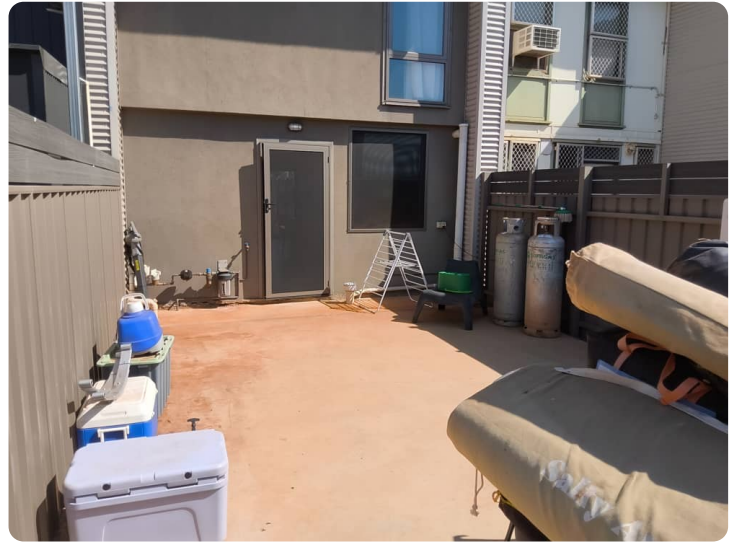
## 12. Storeroom 1

An external storeroom has not been built or installed on the property. The condition of the storeroom is not applicable as it has not been built or installed.

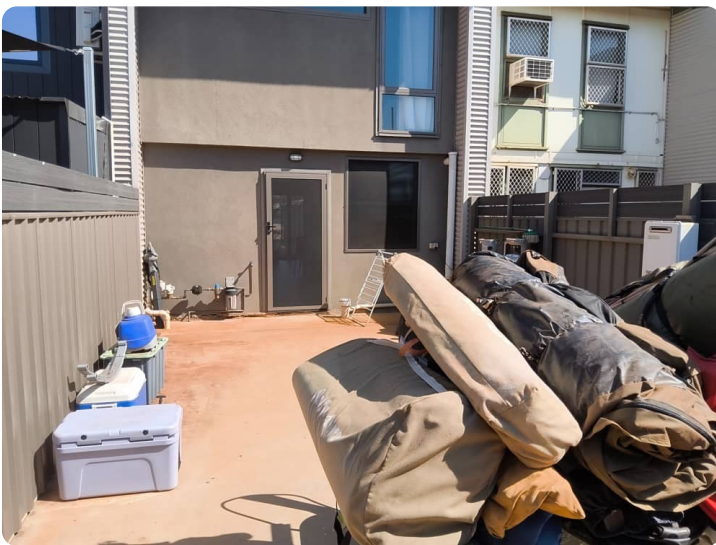
### 12.1 Store room not available

There is no external storeroom on site. Under local building requirements a storeroom is required for all properties.

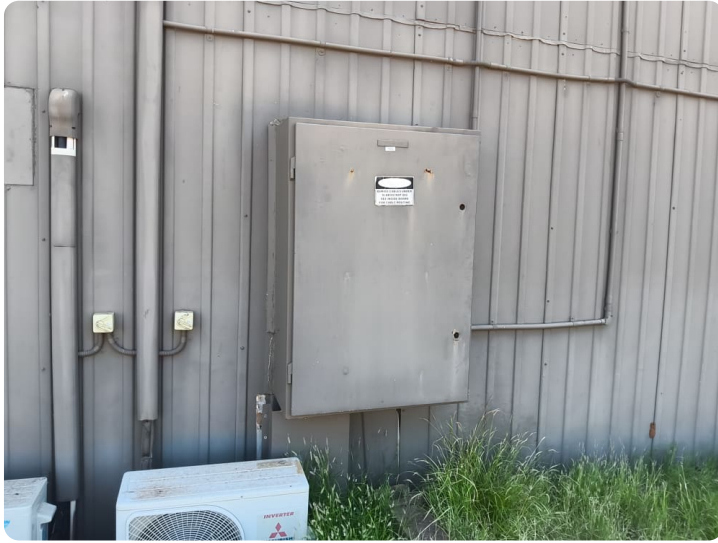
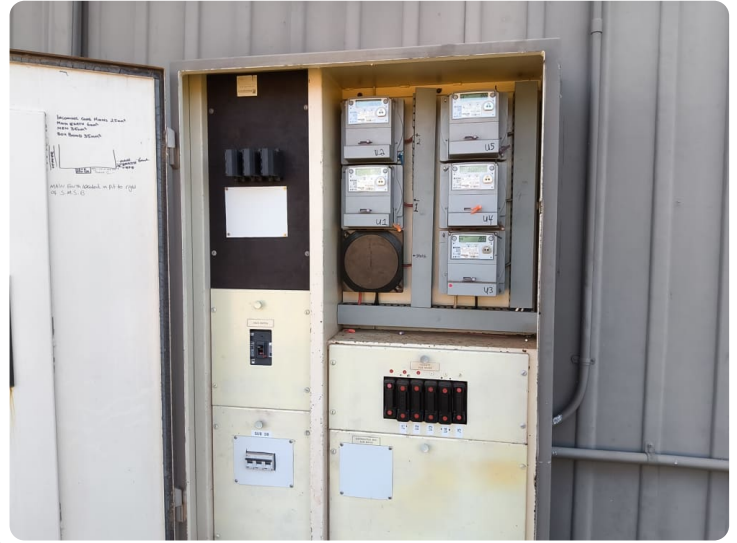
### 13. Meter box and power

Access to the meter box or sub board was available. The meter box or sub board is not lockable. Power phase type to the site is three phase. The primary power board is located at the street entrance to the property.

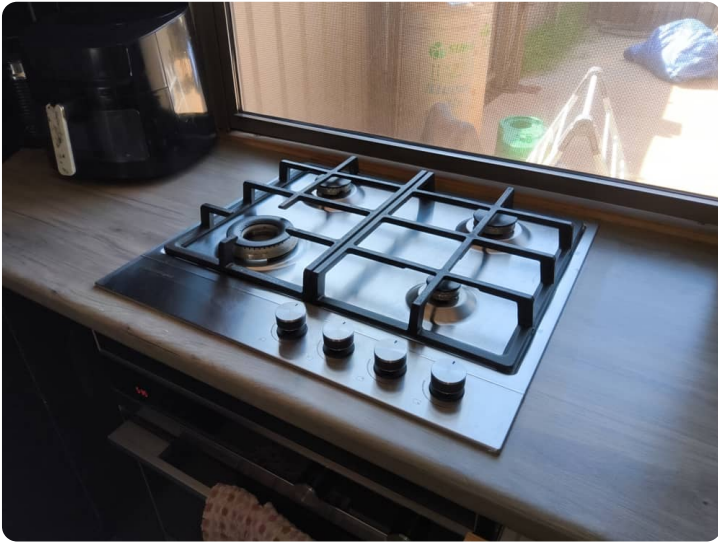
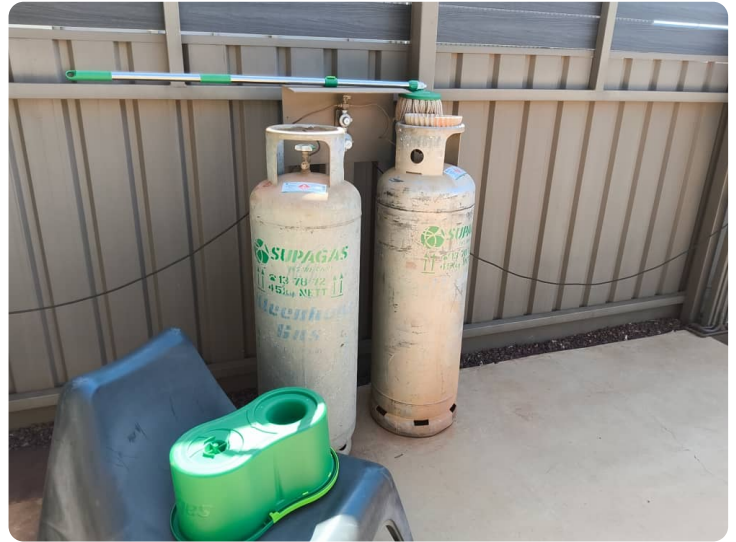
## 15. Gas Supply

Gas supply to the property is via LPG bottles. While on site the inspector could not smell detectable gas leaks.

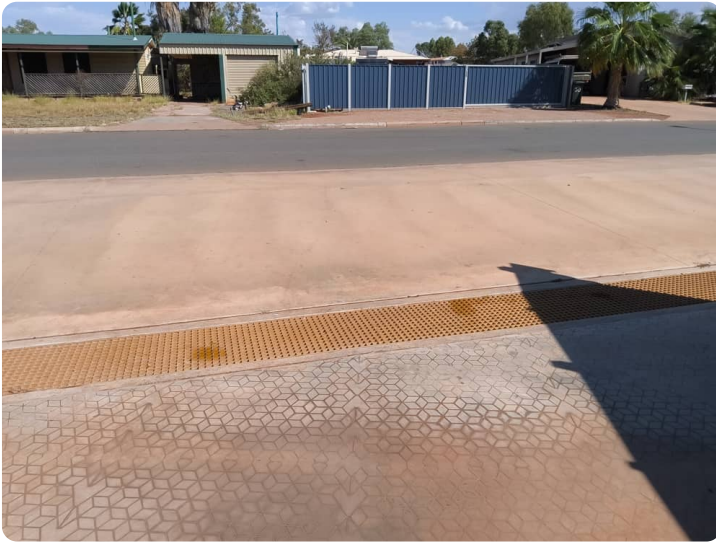
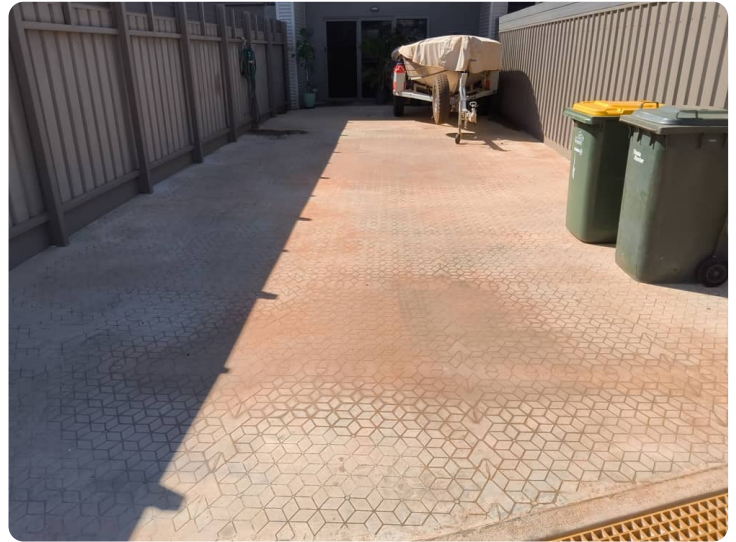
## 16. Driveway

The driveway and cross over is constructed of concrete. The condition of the driveway is satisfactory in relation to its age and will require normal ongoing maintenance.

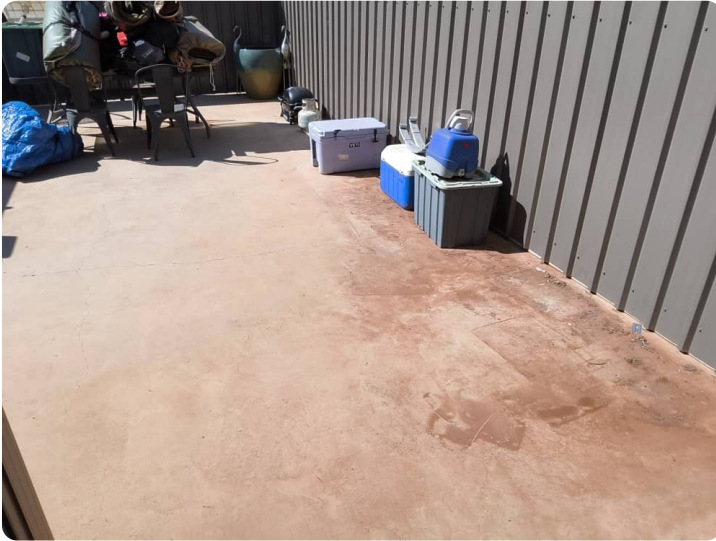
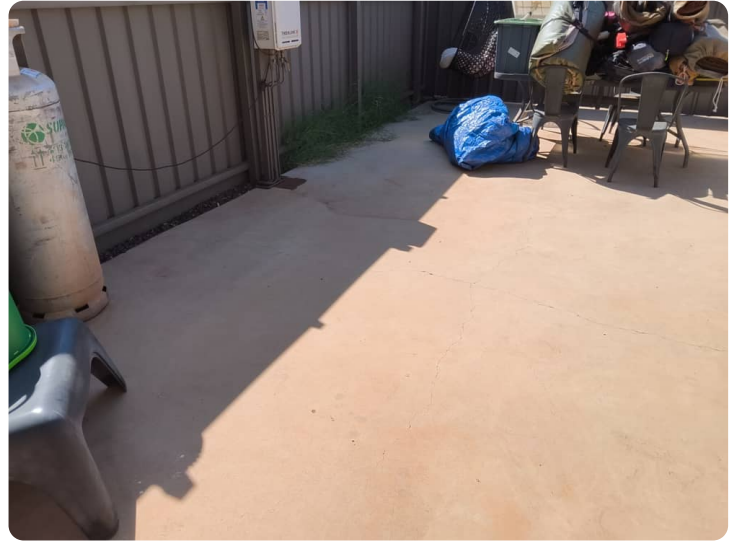
## 17. External walkways and paved areas

The external walkways and paved areas are constructed of concrete. The condition of the external walkways and paved areas is satisfactory in relation to its age and will require normal ongoing maintenance.

There was some cracking visible that is consistent with the age and type of construction. The cracking is not of a structural nature but the cracks should be sealed to stop water from entering the structure and causing further damage. Cracks should be monitored to ensure that they do not deteriorate. If deterioration occurs professional advice should be sought.

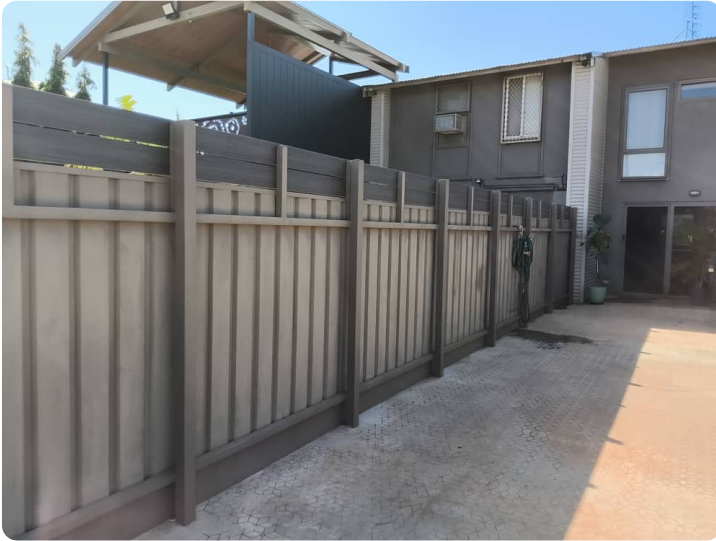
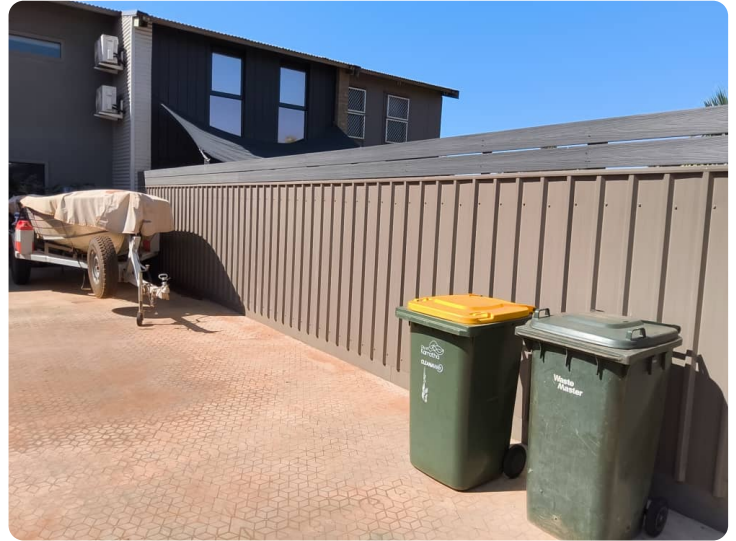
## 18. Fences - boundary

The boundary fences are constructed of metal. The condition of the boundary fence is satisfactory in relation to its age and will require normal ongoing maintenance. Some of the fences could not be viewed due to vegetation, stored items or secondary structures.

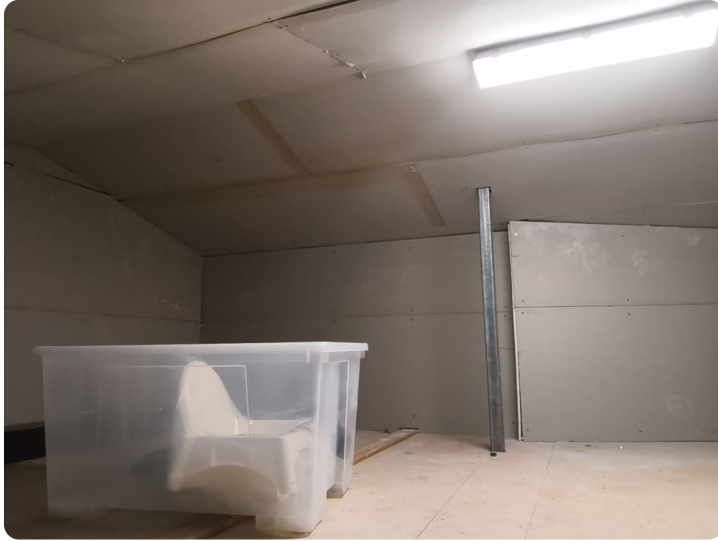
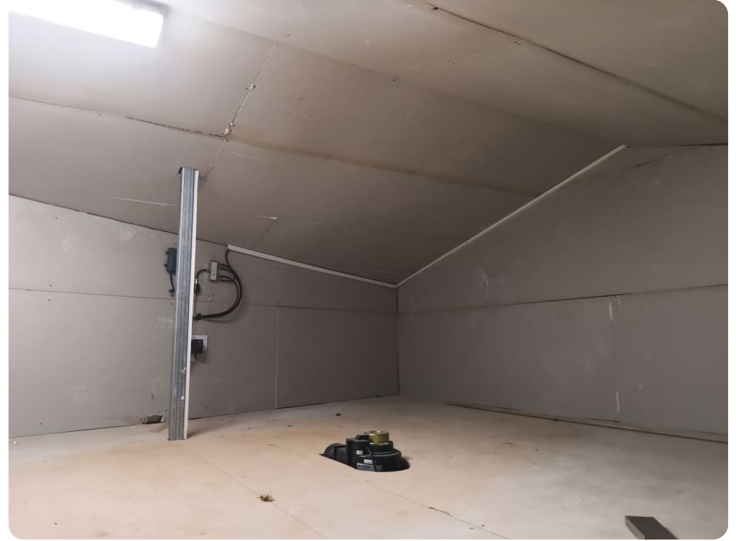
#### 19. Under side of roof cover

The condition of the underside of the roof cover could not be determined as access was not available.

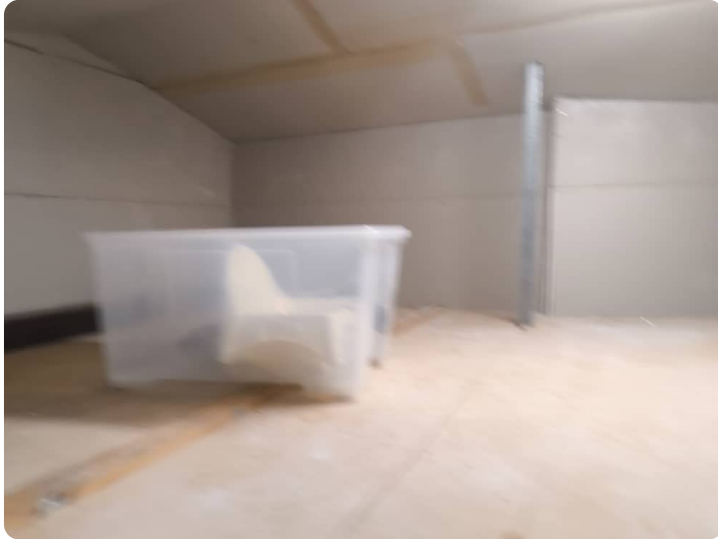
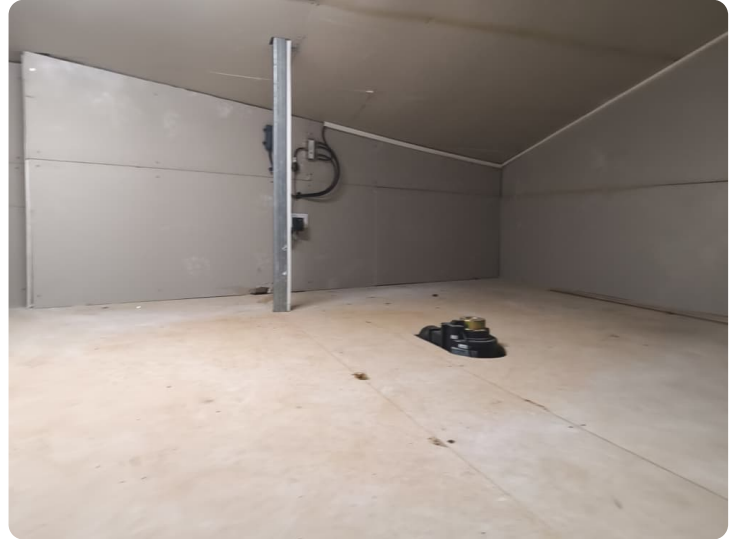
## 20. Roof frame

The roof frame type and condition is unable to be determined as access was not available.

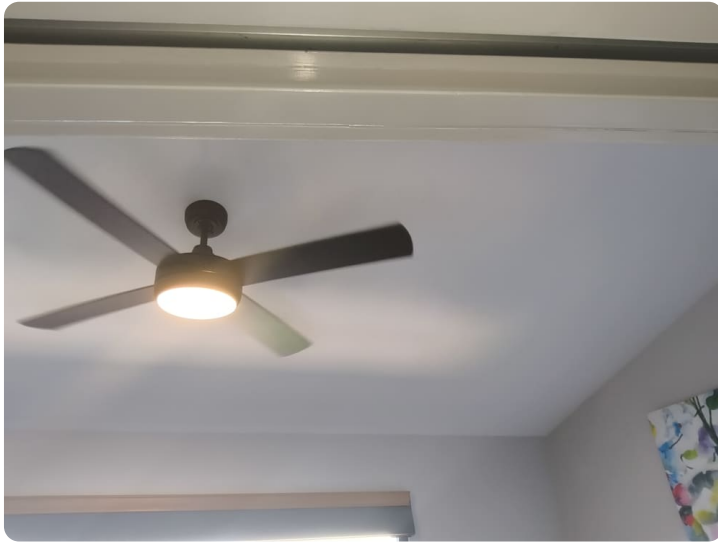
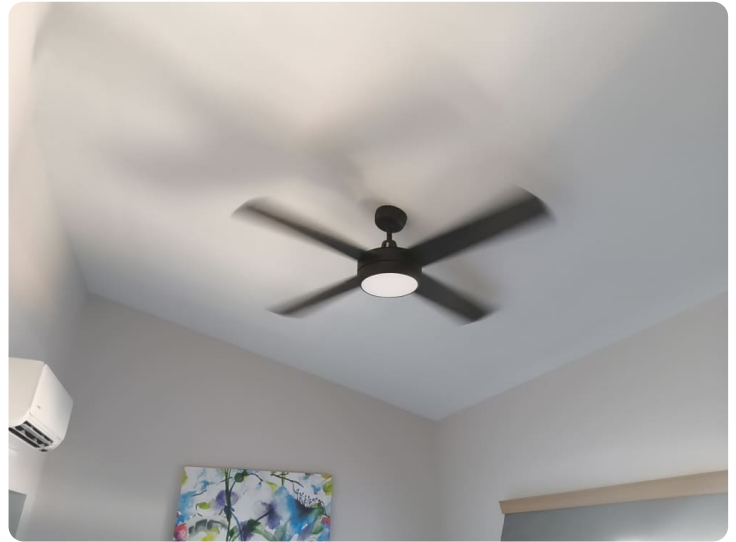
## 21. Ceilings

The ceilings are constructed of plasterboard with cornices constructed of plasterboard. The condition of the ceilings is satisfactory in relation to its age and will require normal ongoing maintenance.

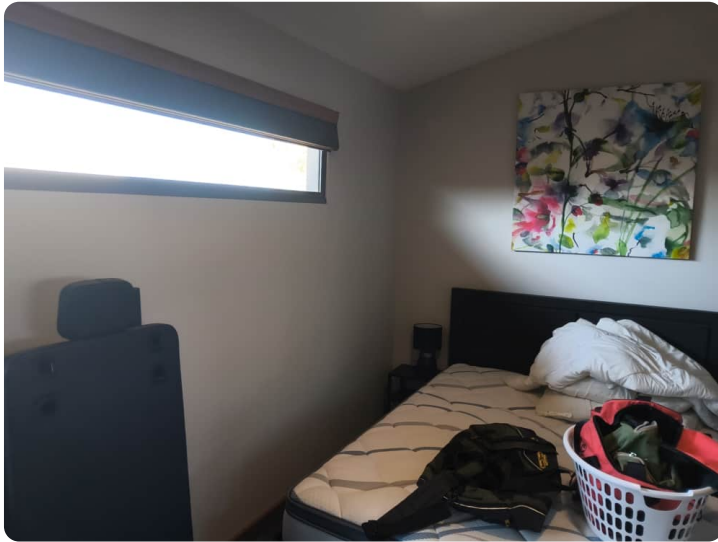
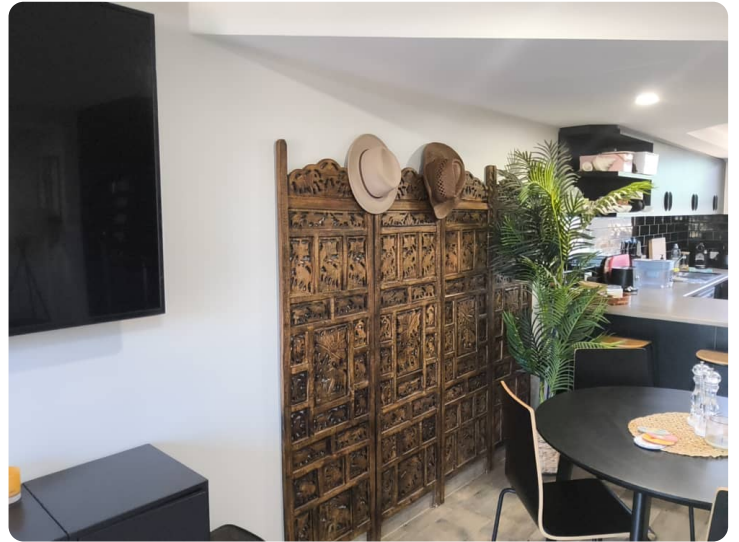
## 22. Internal walls

The internal walls are constructed of a frame with plaster board cladding. The condition of the internal walls is satisfactory in relation to its age and will require normal ongoing maintenance.

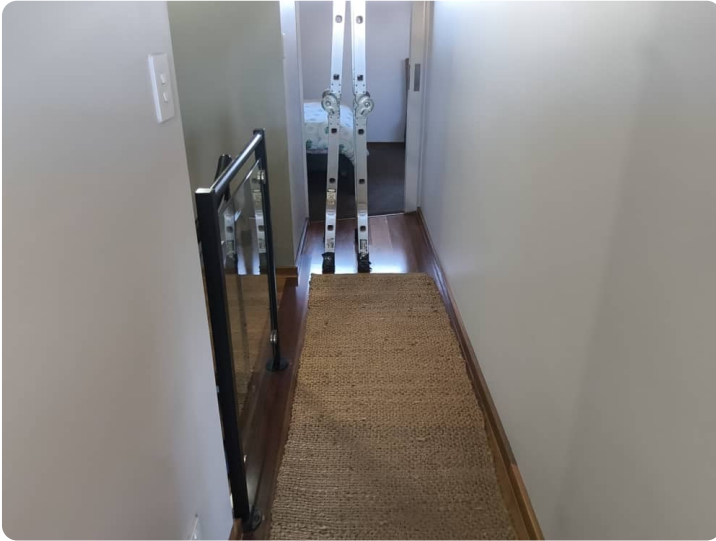
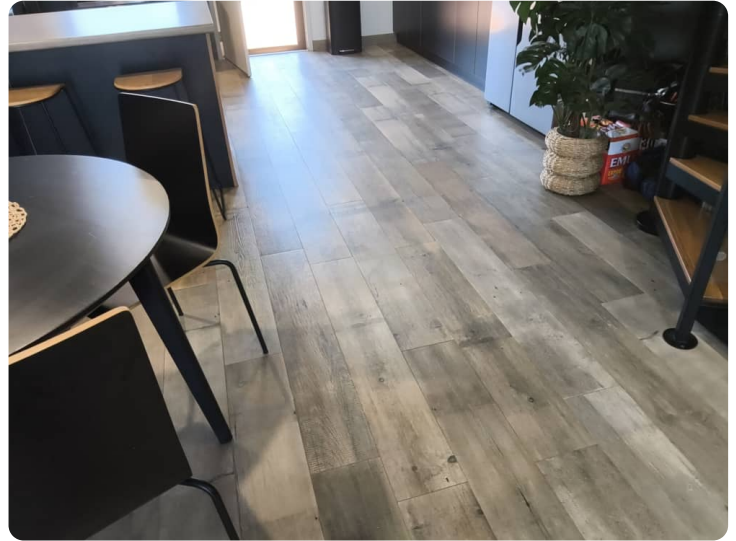
### 23. Internal floors

The internal floors are constructed of a mixture of materials and are covered in a variety of coverings. The condition of the internal floors is unable to be determined as they could not be seen due to coverings.

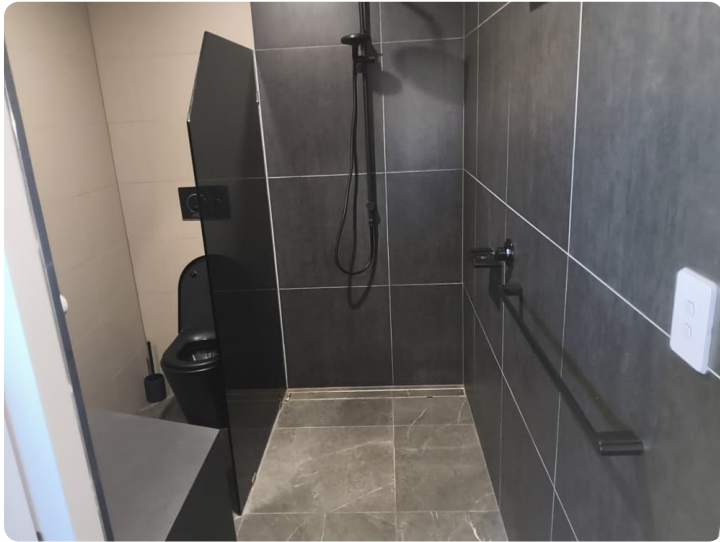
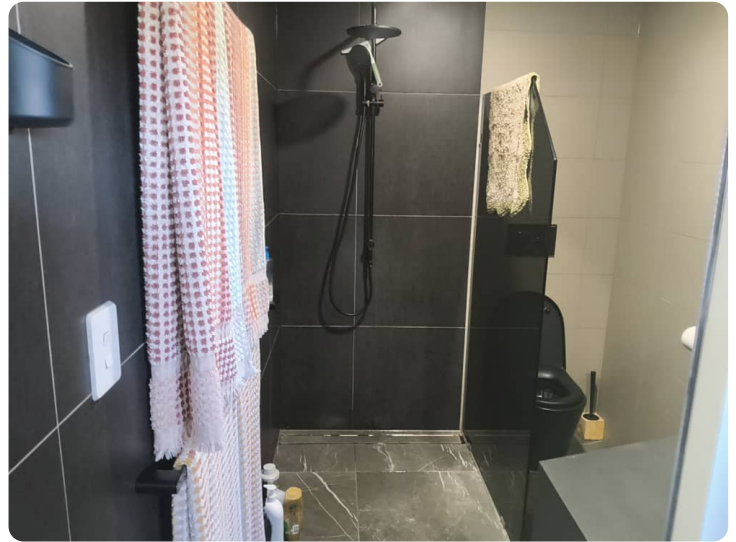
#### 24. Tiled floors and walls

There are areas of internal floors and walls which are covered with a tile covering. The condition of the tiles is satisfactory in relation to its age and will require normal ongoing maintenance.

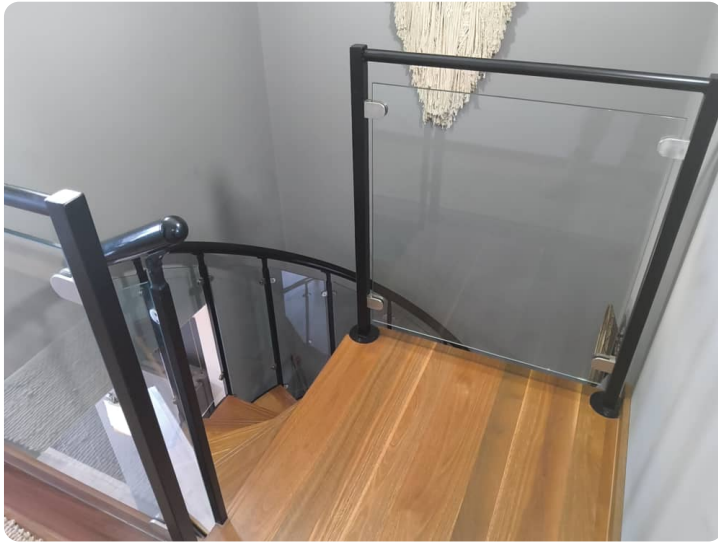
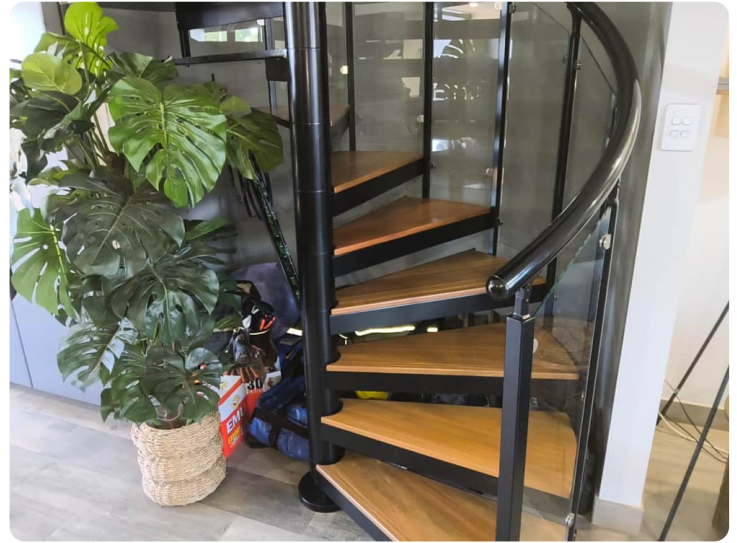
## 25. Primary internal stairs

The internal stairs were constructed of timber. The condition of the internal stairs is satisfactory in relation to its age and will require normal ongoing maintenance. The handrail appeared to be consistent with current requirements. The balustrade appeared to be consistent with current requirements. The stair tread, goings and risers appeared to be consistent with current requirements.

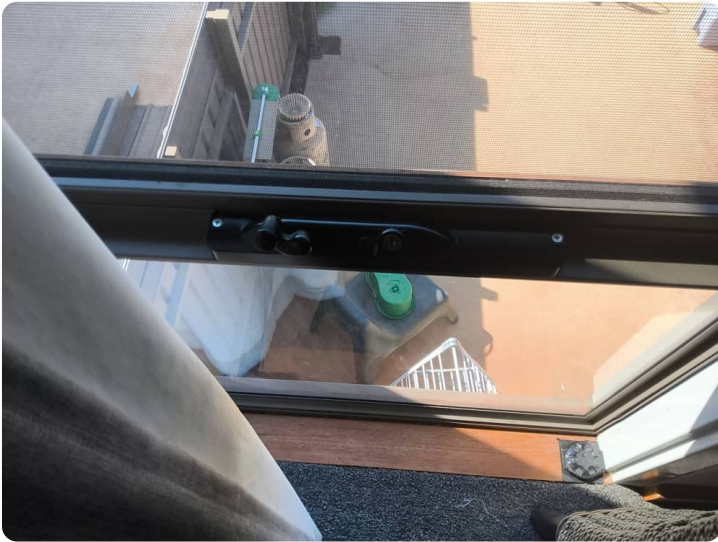
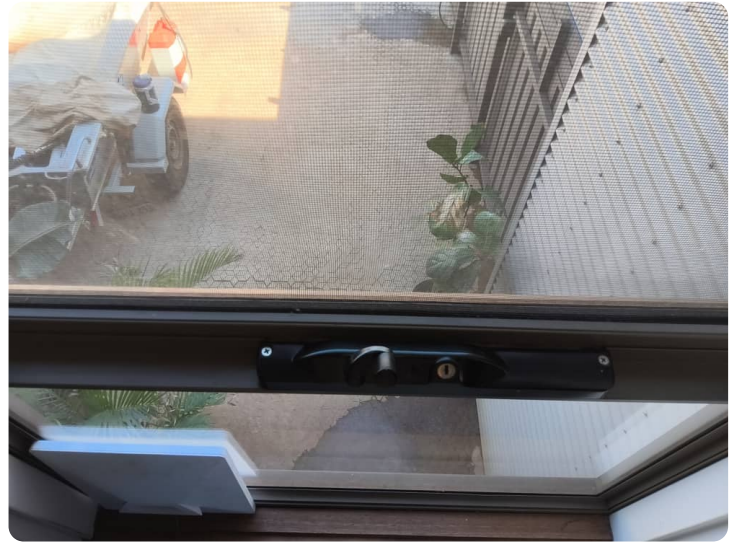
## 26. Windows (internal)

The condition of the windows, as viewed from within the property, is satisfactory in relation to its age and will require normal ongoing maintenance. Window locks have been installed to all of the windows.

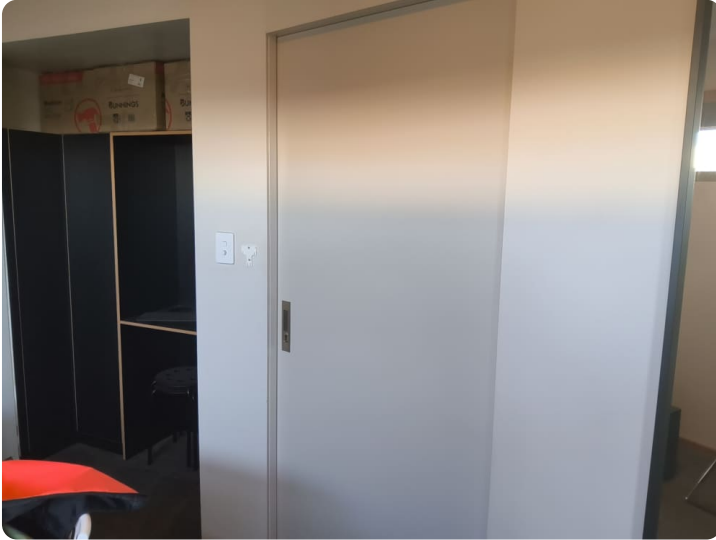
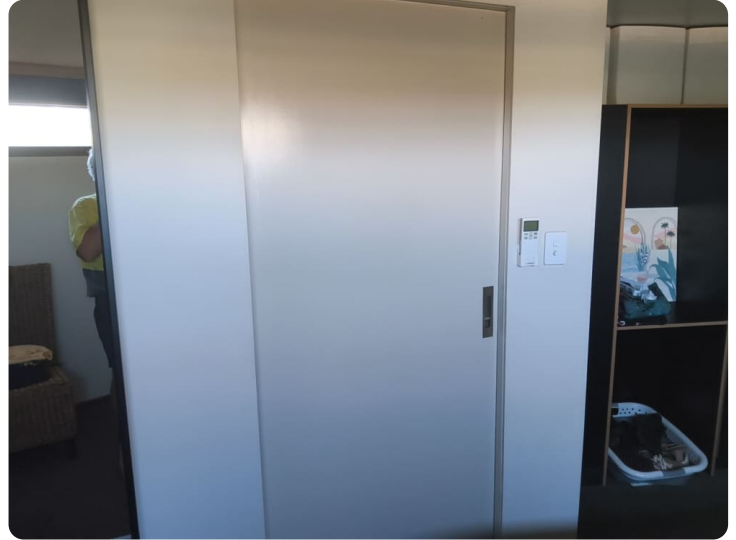
## 27. Internal doors

The internal doors were mainly constructed of timber hollow core. The condition of the internal doors is satisfactory in relation to its age and will require normal ongoing maintenance.

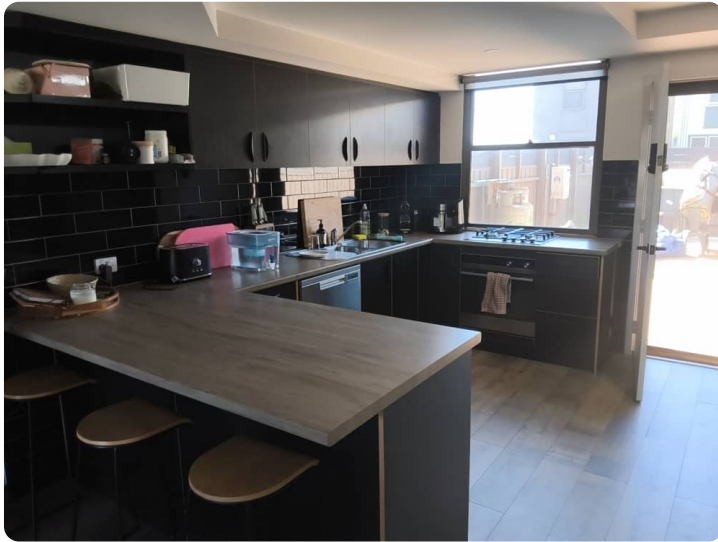
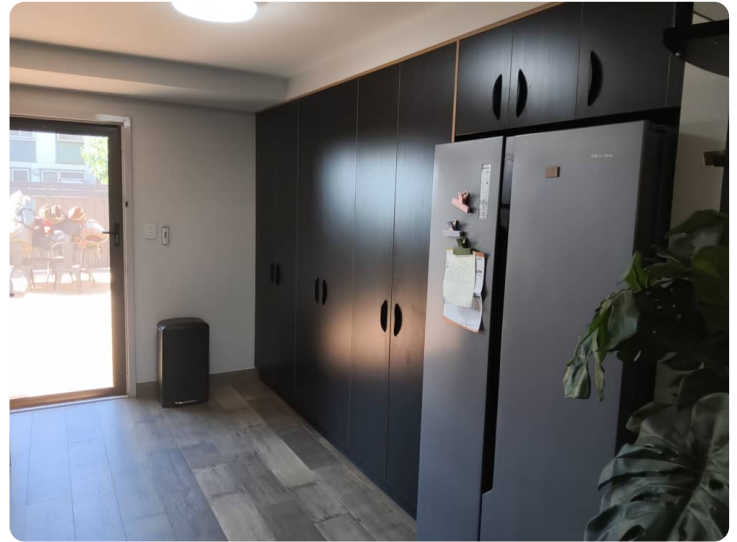
## 28. Kitchen cabinets

The condition of the kitchen cabinets in general is satisfactory in relation to their age and require normal maintenance.
