# **Houspect**

### **Pre purchase inspection**

**Job ID:** 92886

**Address:** 3/31 Withnell Way, Bulgarra WA 6714

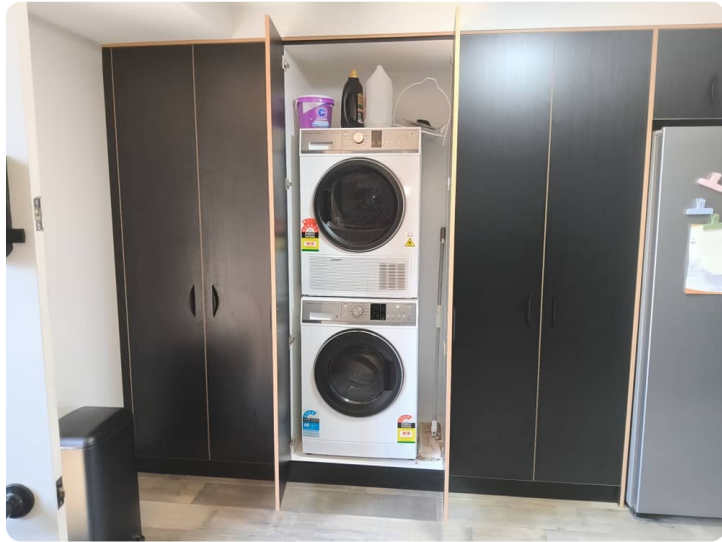
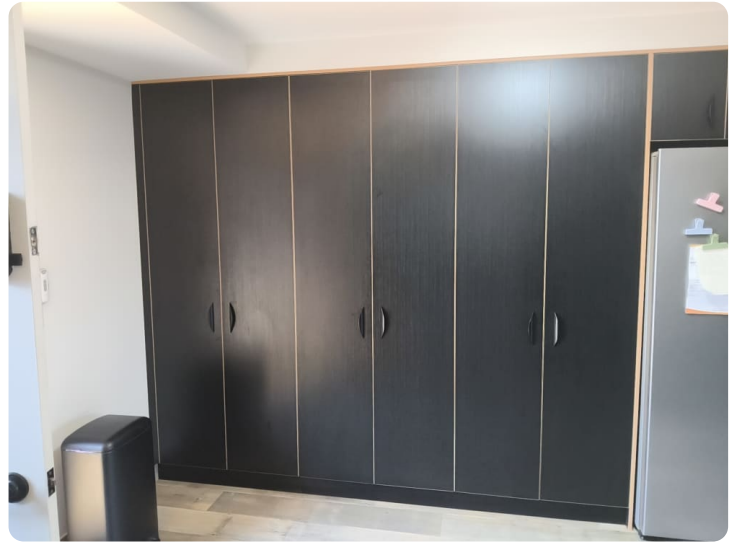
## 29. Laundry cabinets

The condition of the laundry cabinets is satisfactory in relation to their age and require normal maintenance.

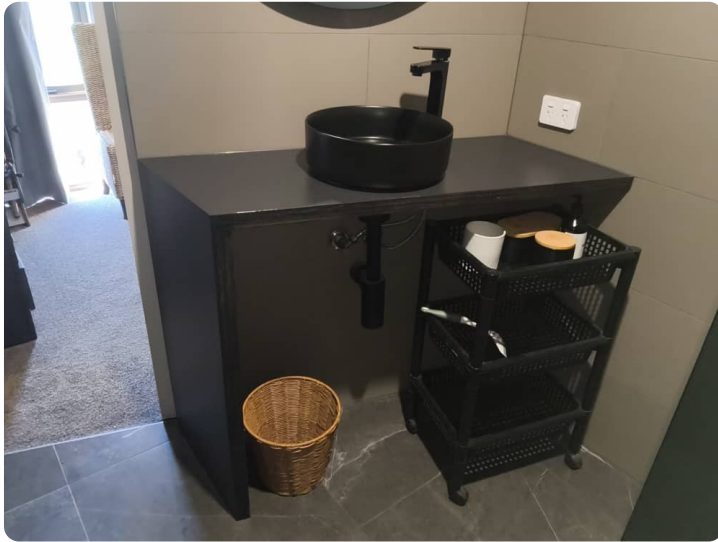
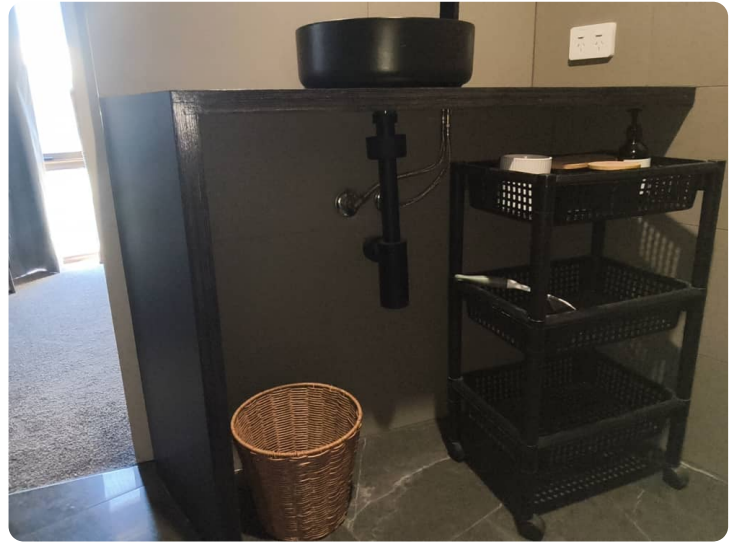
### 30. Bathroom cabinets

The condition of the bathroom cabinets is satisfactory in relation to their age and require normal maintenance.

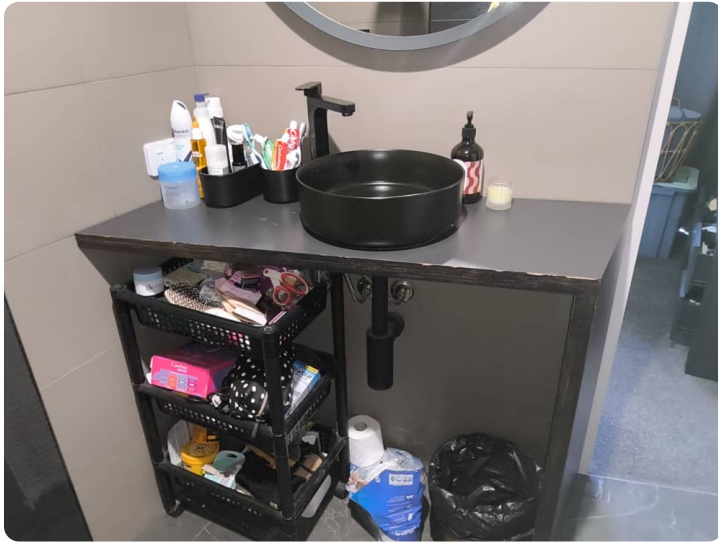
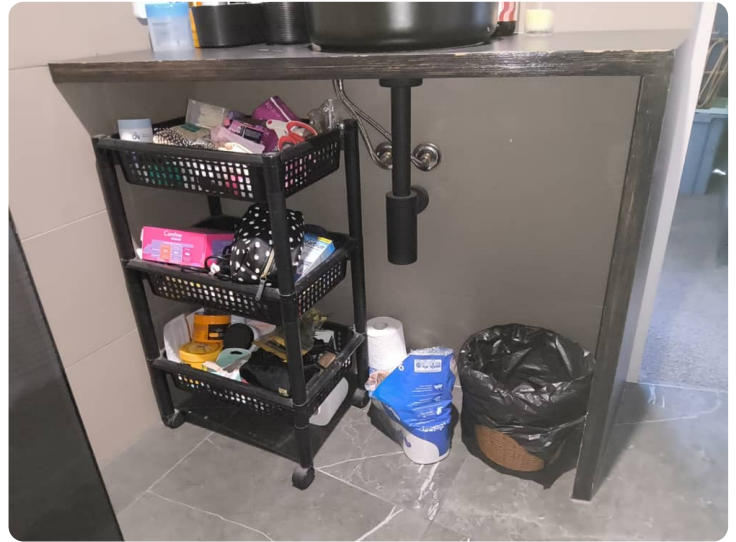
### 31. Ensuite cabinets

The condition of the ensuite cabinets is satisfactory in relation to their age and require normal maintenance.

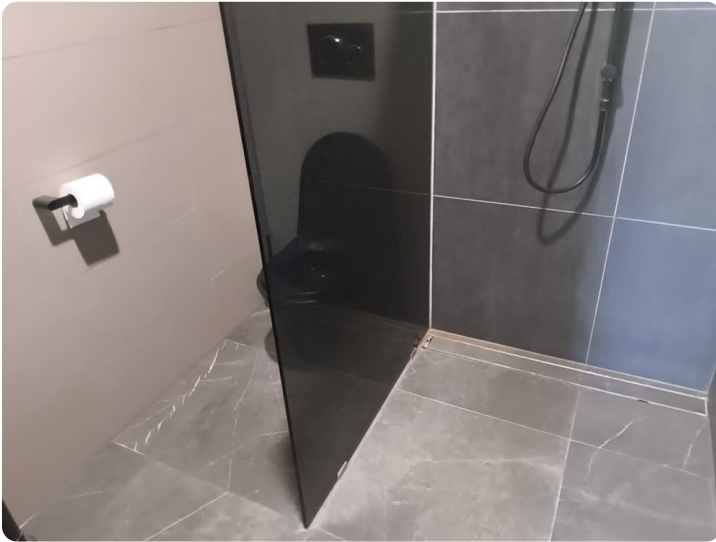
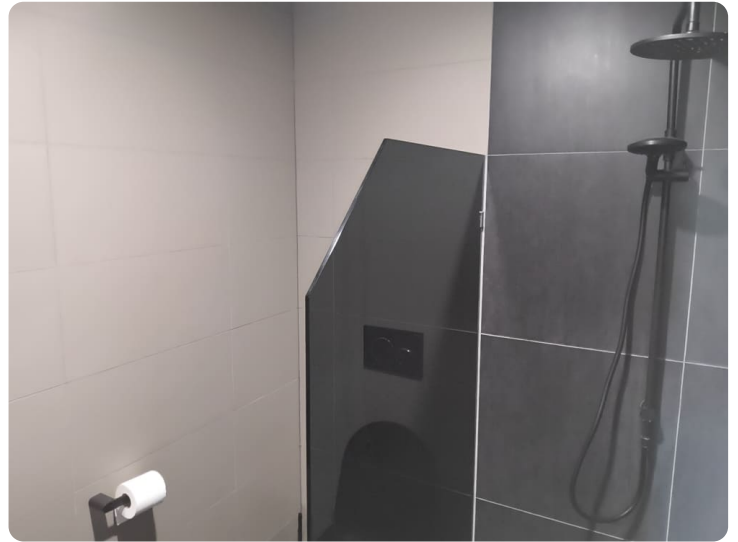
### 32. Shower screens

The condition of the shower screens is satisfactory in relation to their age and require normal maintenance.

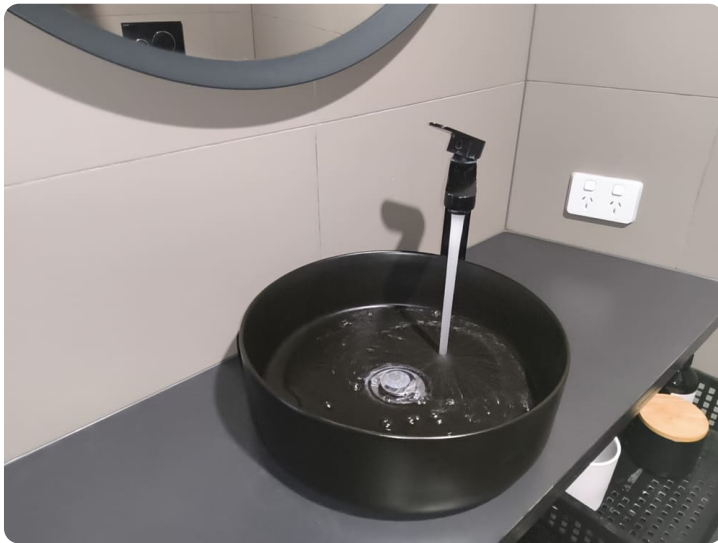
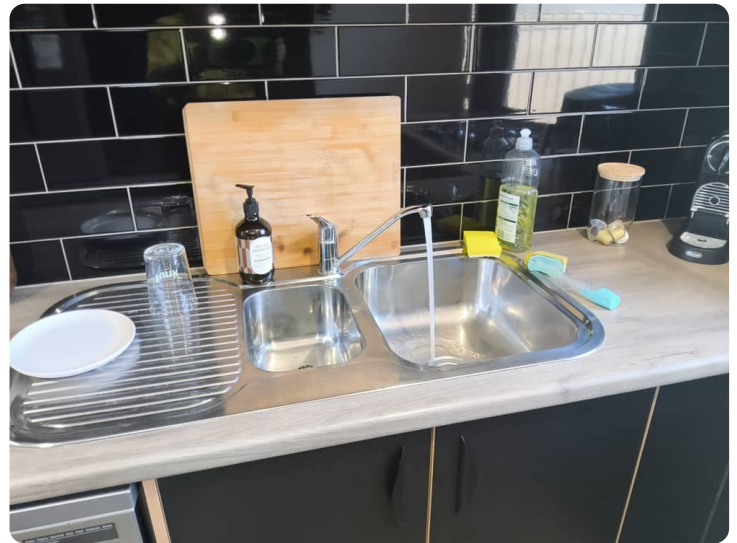
### 33. Plumbing

The taps to multiple areas were turned on and the water flow appeared to be reasonable. Water draining to several sinks and toilets appeared to be reasonable. The Building Inspector is not a Plumbing Contractor and is not permitted to test Plumbing items under WA Law. Where appropriate a Plumbing Contractor should be engaged to test the plumbing in the property.

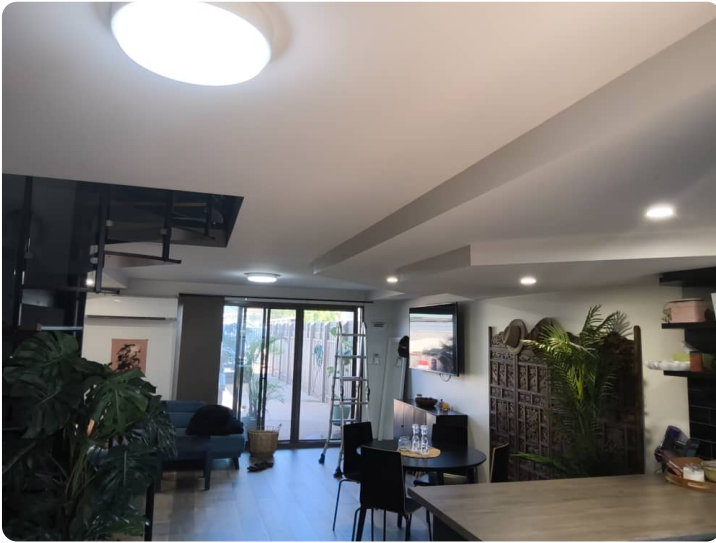
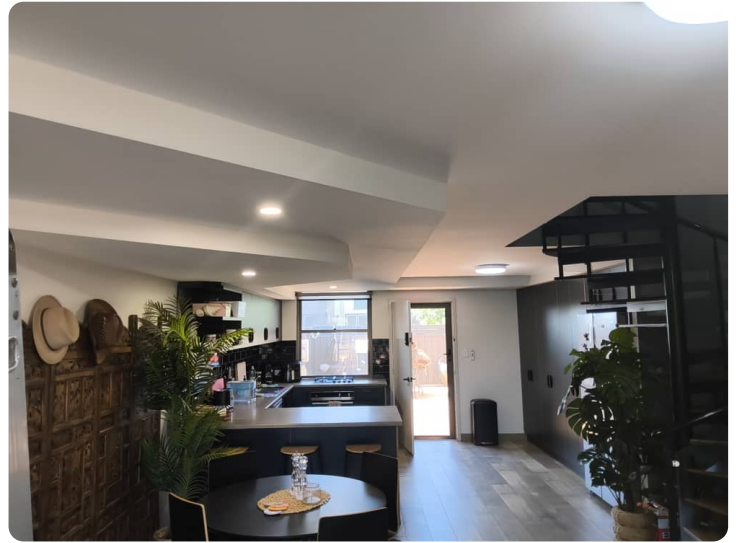
### 34. Lights and power points

Several lights were turned on during the inspection and the lights appeared to be operational. The Building Inspector is not an Electrical Contractor and is not permitted to test Electrical items under WA Law. Where appropriate an Electrical Contractor should be engaged to test the electrical items in the property.

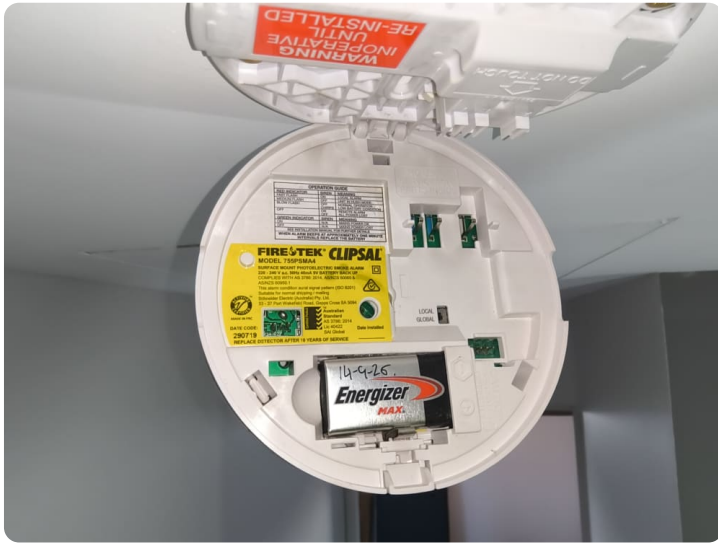
### 35. Smoke Alarms

There was one hardwired smoke alarms on site. There were no battery smoke alarms on site. The location, number and type of smoke alarms appeared to be consistent with Legislative requirements. It is suggested that an Electrical Compliance Certificate be obtained in relation to the smoke alarms.
