# **Houspect**

**Building inspection**

**Job ID:** 92365

**Address:** 2 Cowan Way, Pegs Creek WA

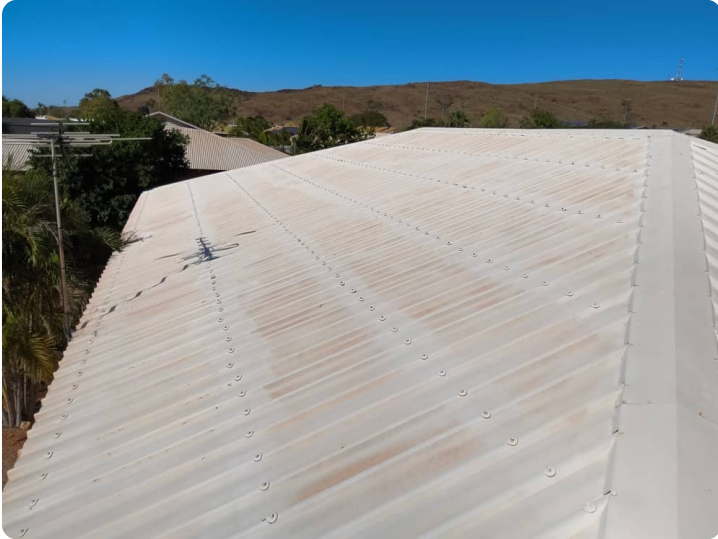
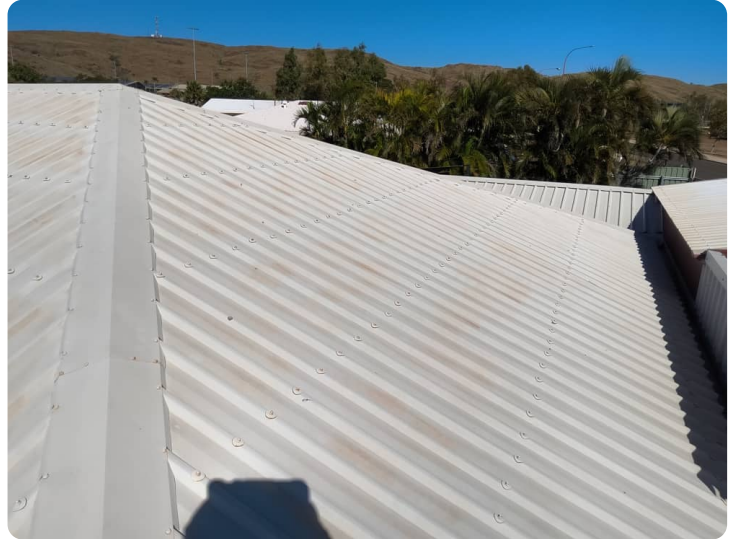
## 1. Roof covering

The roof covering is constructed of colorbond. The condition of the roof covering is satisfactory in relation to its age and will require normal ongoing maintenance. It appears as if the roof cover has been painted or sealed (i.e. restored) at some stage post installation.

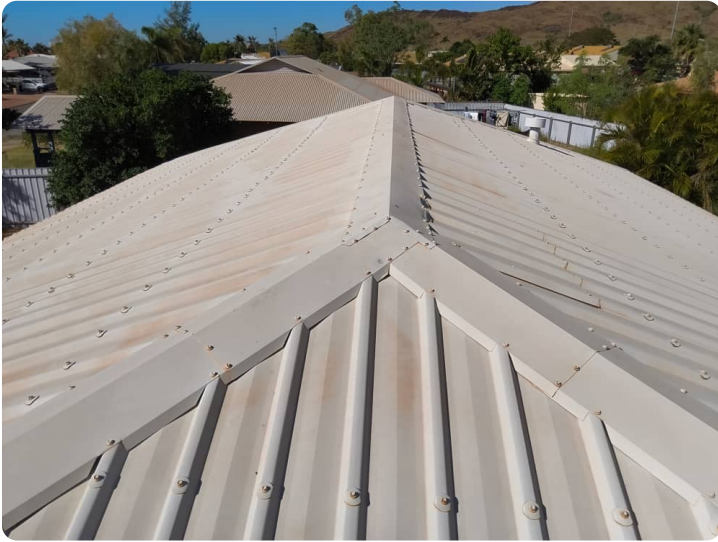
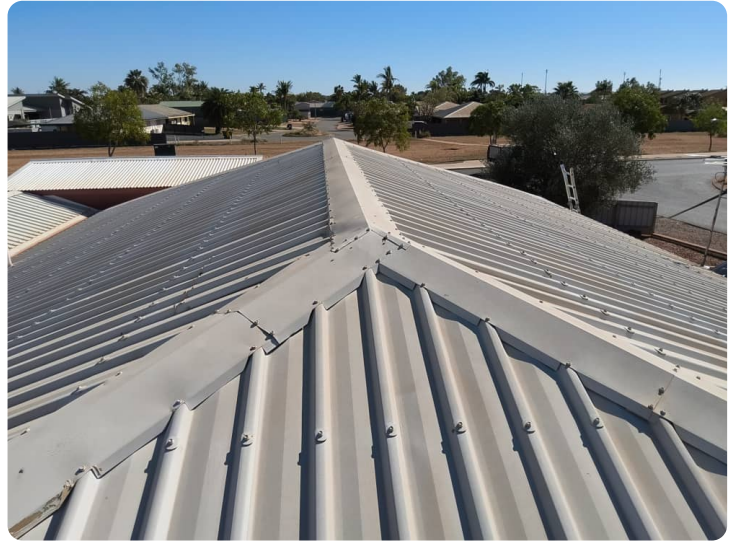
## 2. Ridges

The ridges and capping are satisfactory in relation to its age and will require normal ongoing maintenance.

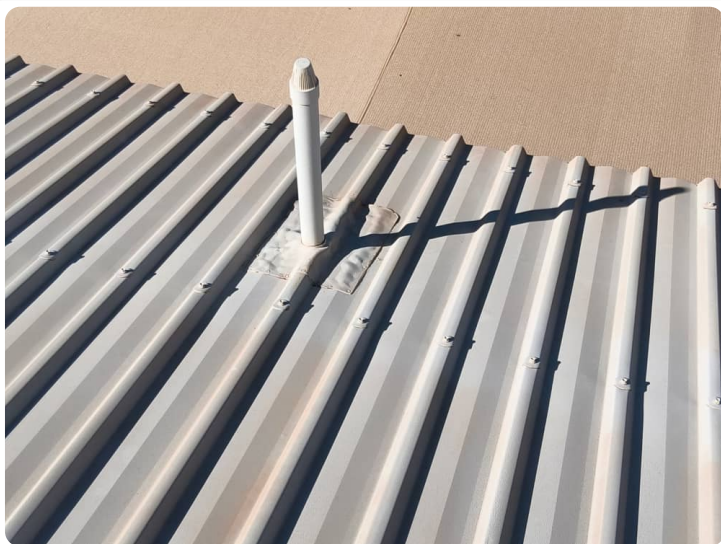
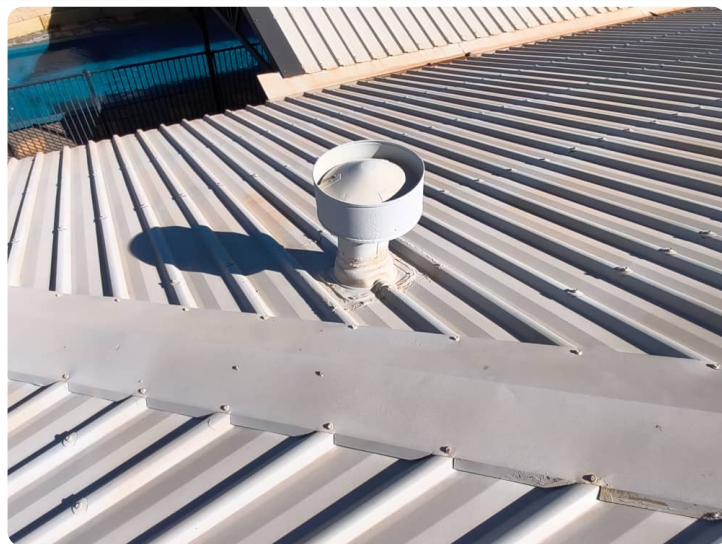
### 3. Flashings

The flashings are covered with a variety of finishes and are constructed of a mixture of materials. The condition of the flashings is satisfactory in relation to their age and will require normal ongoing maintenance.

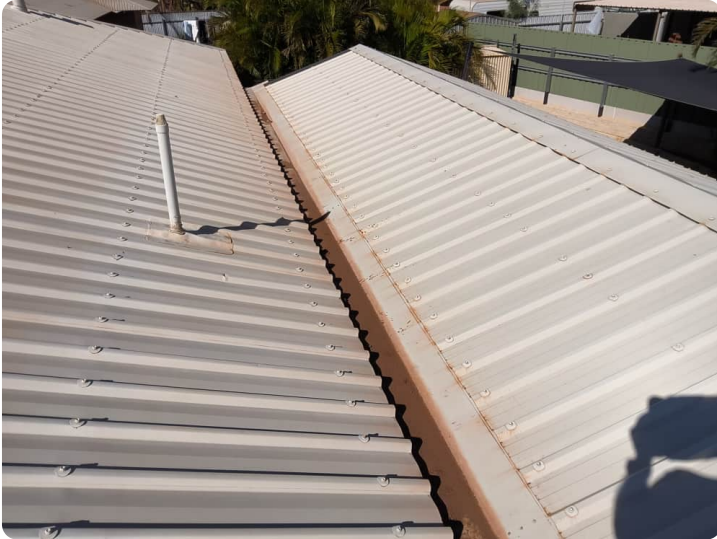
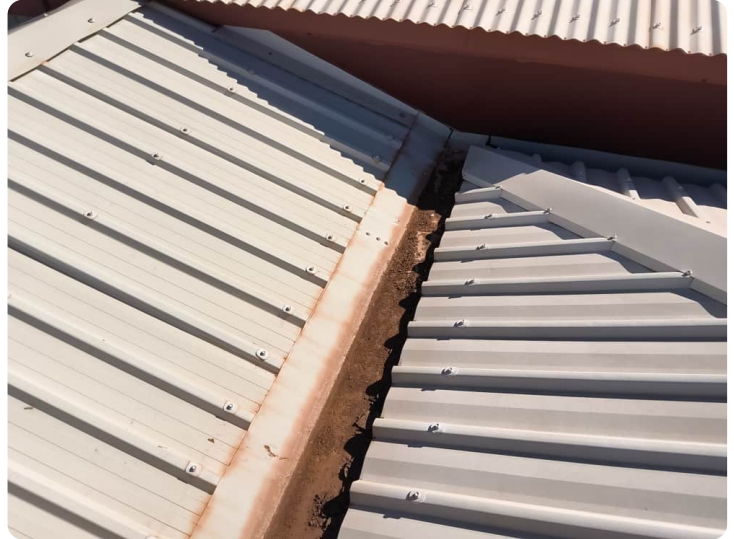
#### 4. Box gutters

The box gutters are constructed of metal and they have a colorbond covering. The condition of the box gutters is satisfactory in relation to their age and will require normal ongoing maintenance. The box gutters appear to be relatively free of debris.

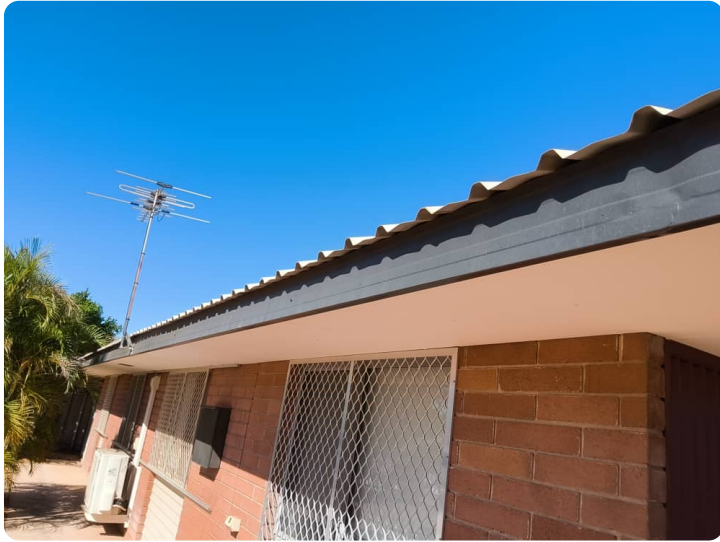
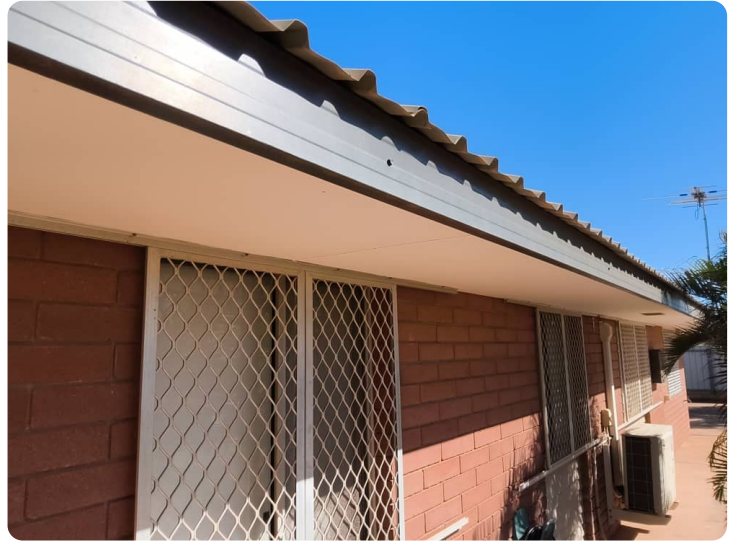
## 5. Fascia

The fascia are constructed of metal and they are painted. The condition of the fascia is satisfactory in relation to their age and will require normal ongoing maintenance.

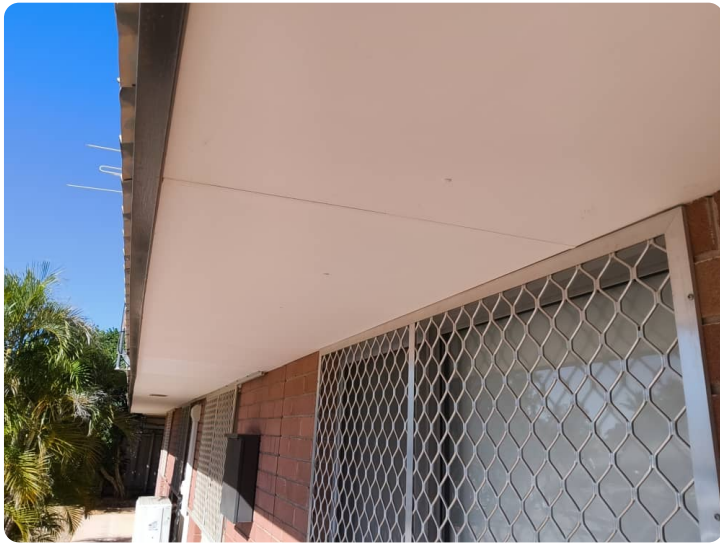
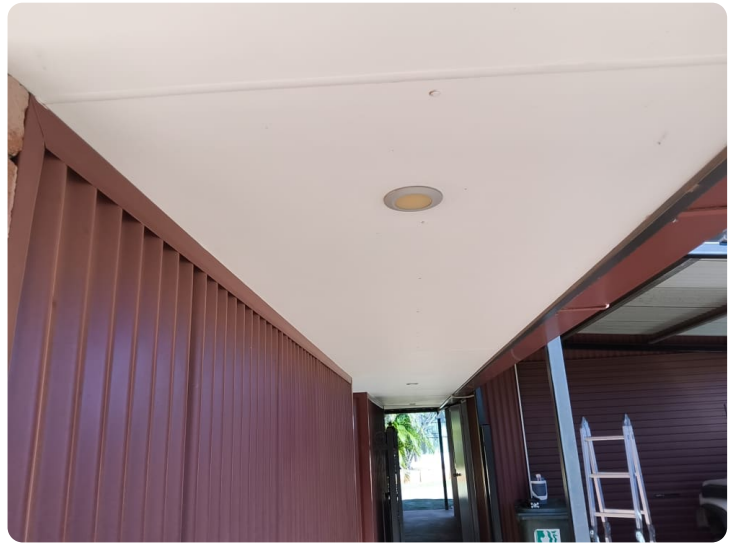
## 6. Eaves

The eaves are boxed and constructed of painted fibre cement. The condition of the eaves is satisfactory in relation to their age and will require normal ongoing maintenance. Please note that some of the building material utilised on or within the building may or may not contain asbestos. The Australian Government has indicated that asbestos can only be correctly identified through laboratory testing. The material on this building site may not pose a concern in the current static state if maintained but for any future works the material should be tested and appropriate measures used for asbestos handling if the material is subsequently found to contain asbestos.

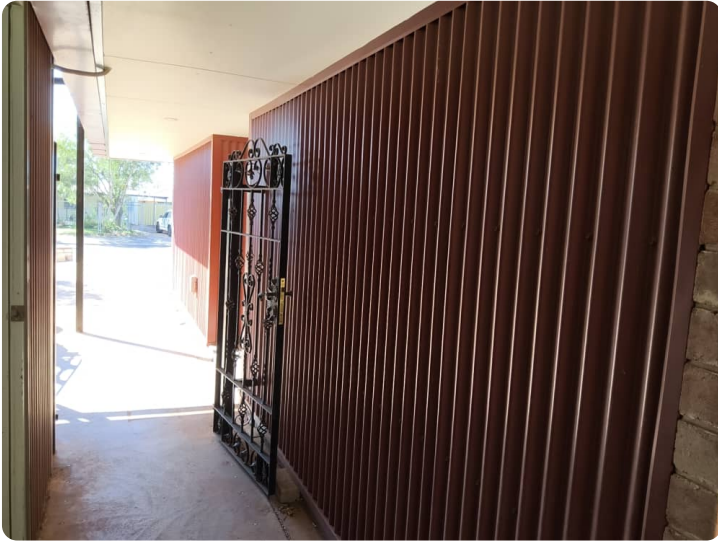
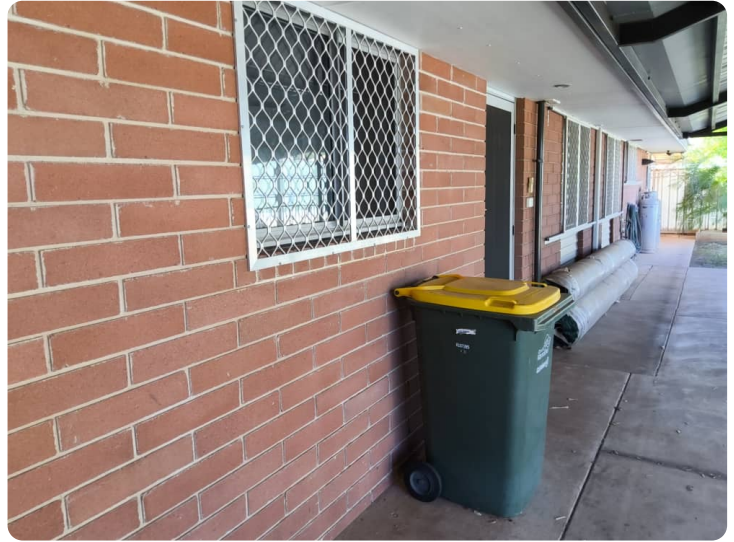
## 7. External walls

The external walls are constructed of a mixture of materials. The condition of the walls generally is satisfactory in relation to their age and will require normal ongoing maintenance.

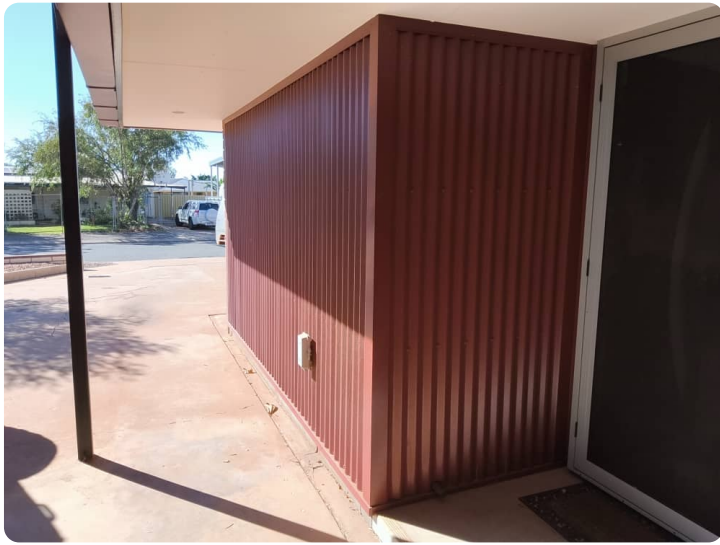
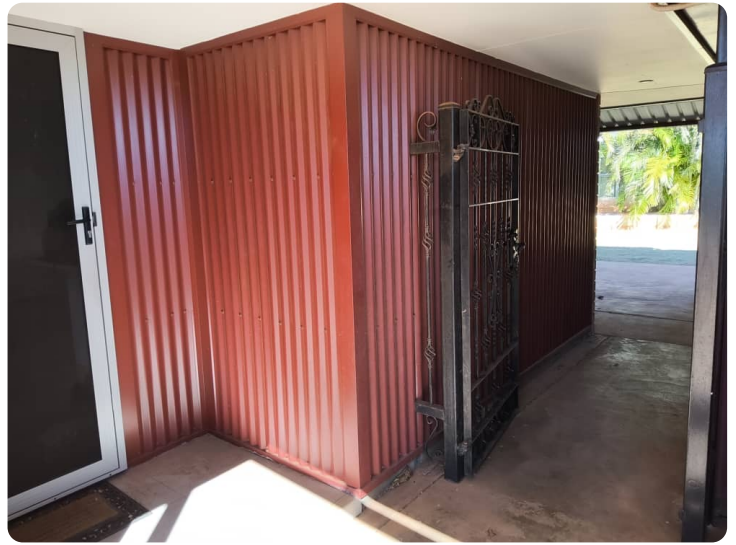
## 8. Wall cladding

The external walls are (or partially are) clad with colorbond and fibre cement. The condition of the cladding is generally satisfactory in relation to its age and will require normal ongoing maintenance. Please note that some of the building material utilised on or within the building may or may not contain asbestos. The Australian Government has indicated that asbestos can only be correctly identified through laboratory testing. The material on this building site may not pose a concern in the current static state if maintained but for any future works the material should be tested and appropriate measures used for asbestos handling if the material is subsequently found to contain asbestos.

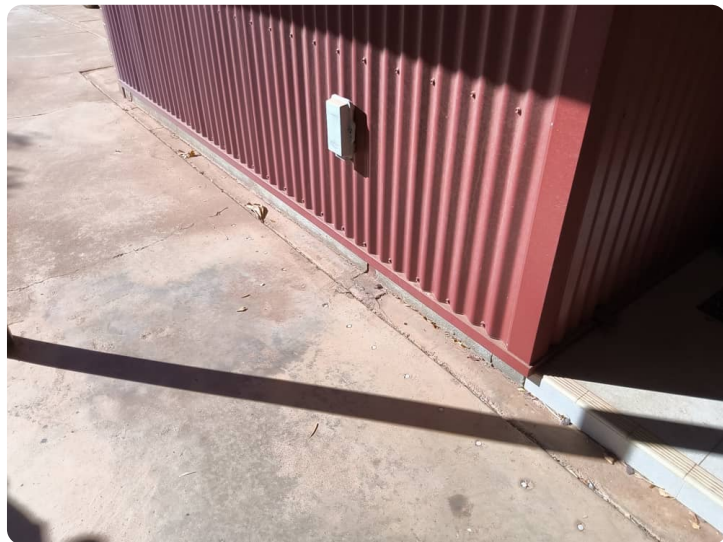
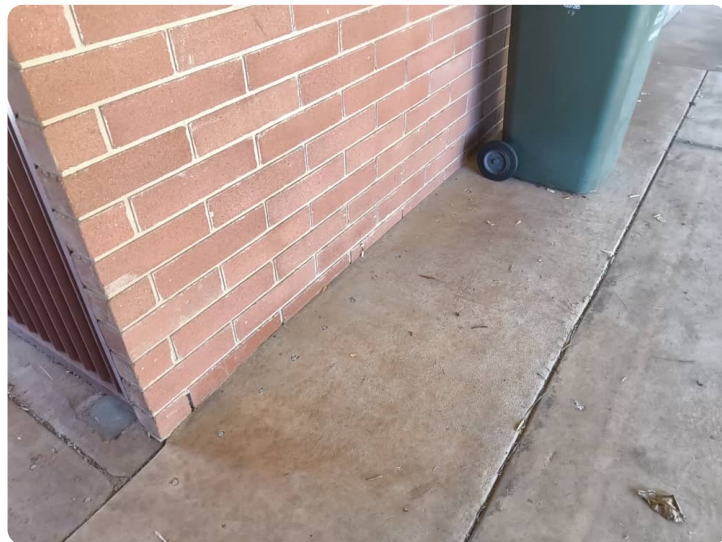
## 9. Footings

The footings are below ground and cannot be seen. The condition of the footings cannot be determined.

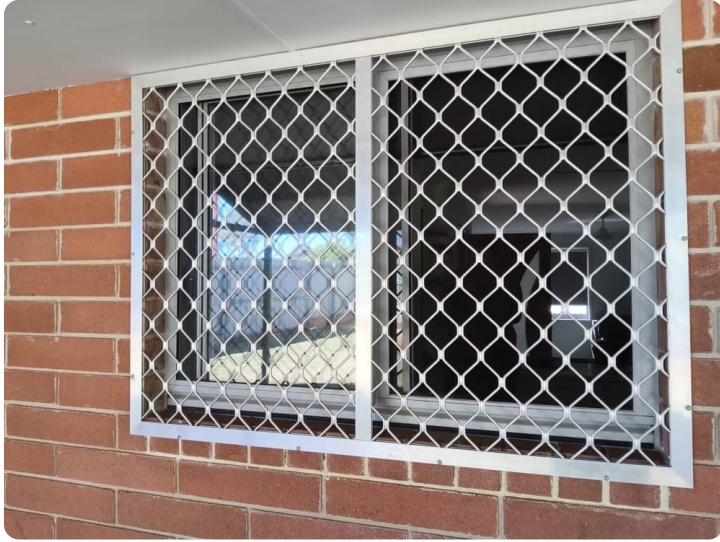
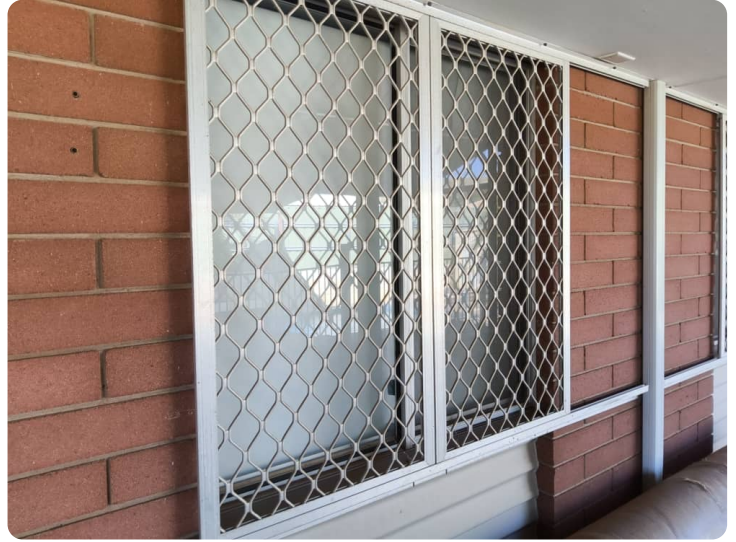
## 10. Windows and window frames

The window and window frames are primarily constructed of aluminium. The condition of the window and window frames is generally satisfactory in relation to its age and will require normal ongoing maintenance.

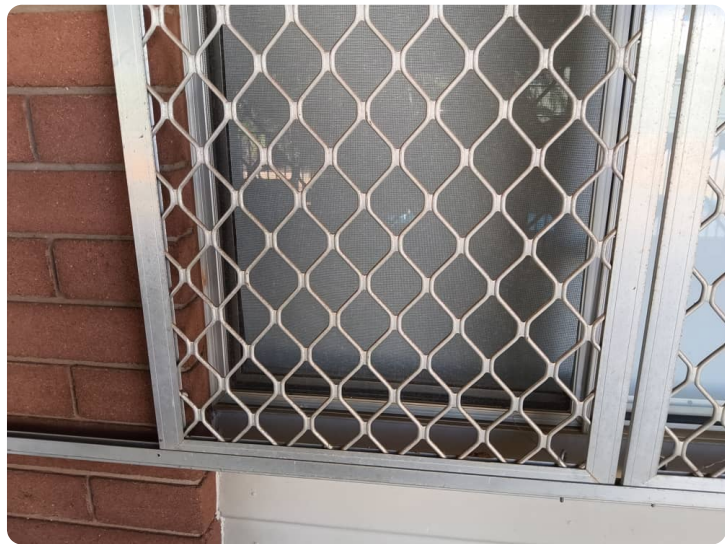
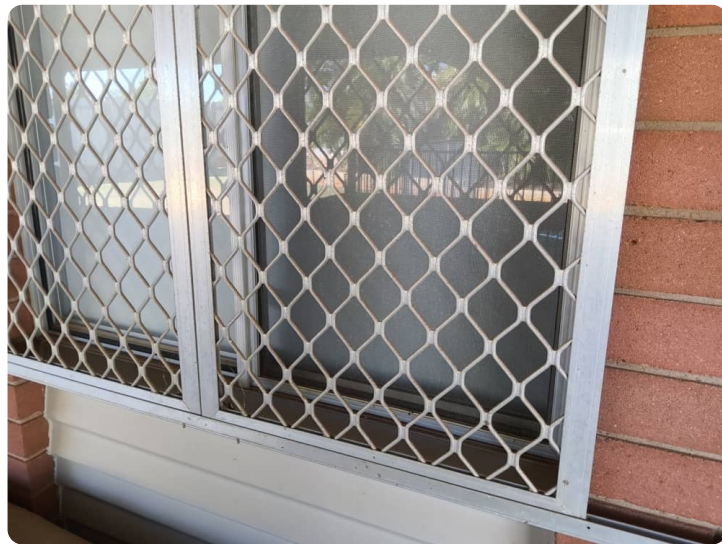
### 11. Window fly screens

Fly screens have been installed to all of the windows. The condition of the window fly screens is generally satisfactory in relation to its age and will require normal ongoing maintenance.

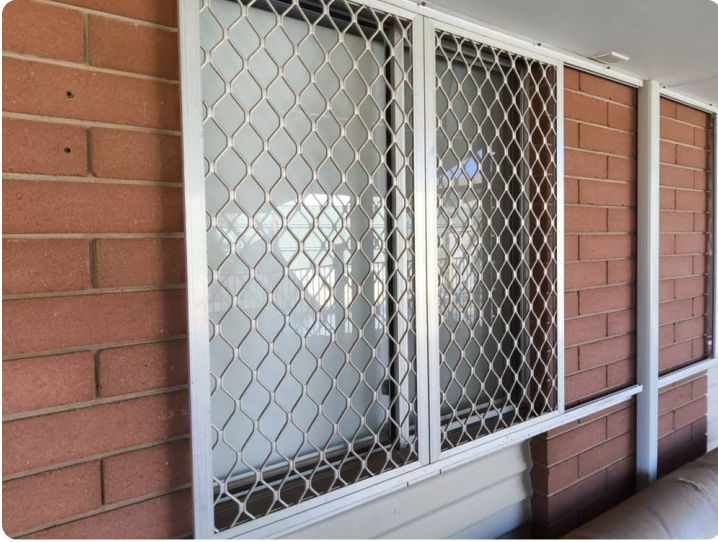
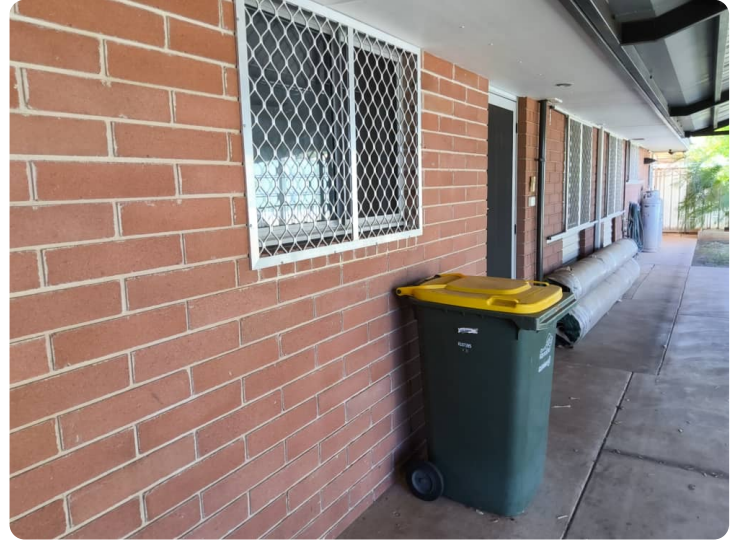
## 12. Cyclone screens

Cyclone screens have been installed to all of the windows. The condition of the cyclone screens is satisfactory in relation to its age and will require normal ongoing maintenance. The cyclone screens appear to be compliant with local requirements.

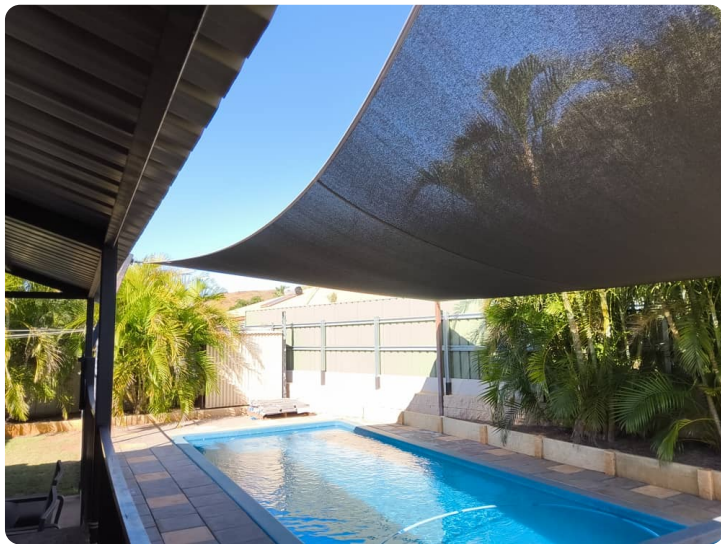
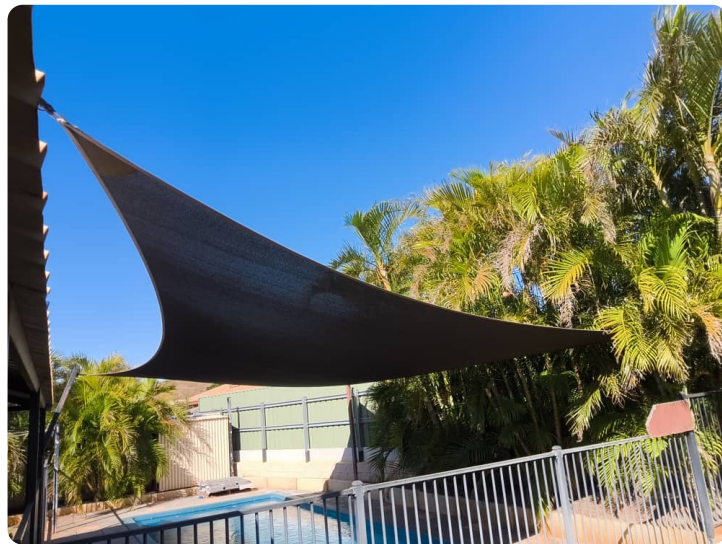
### 13. Shade sails

Shade sails have been installed at the property. The condition of the shade sails is satisfactory in relation to its age and will require normal ongoing maintenance.

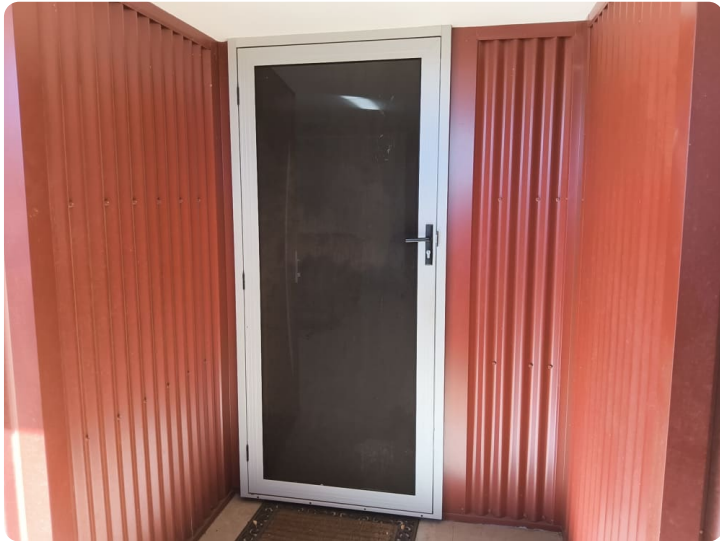
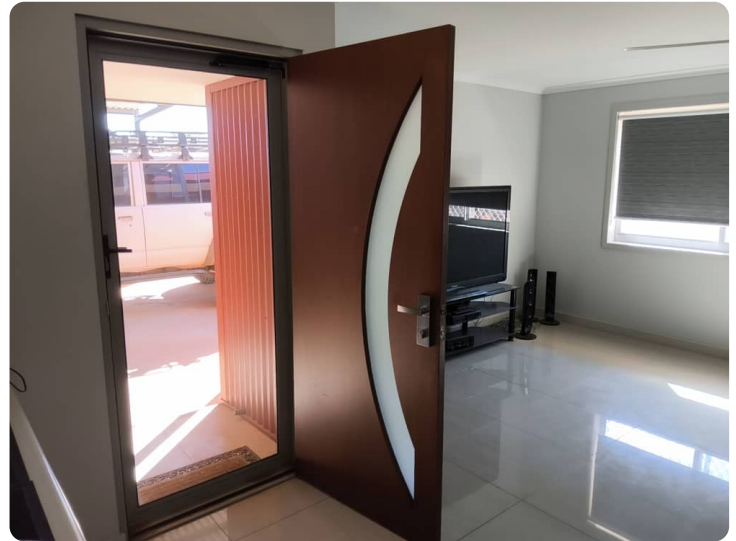
#### 14. Front door

The front door is constructed of timber and glass. The condition of the front door is satisfactory in relation to its age and will require normal ongoing maintenance. Deadlocks have been installed. A security screen door has been fitted.

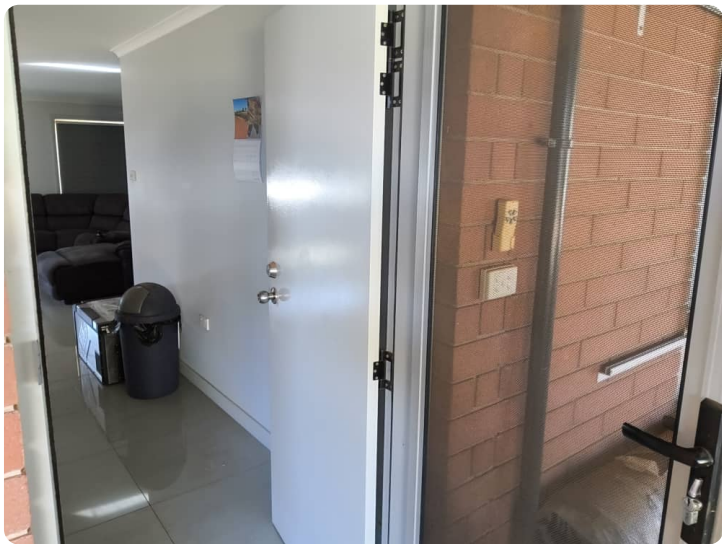
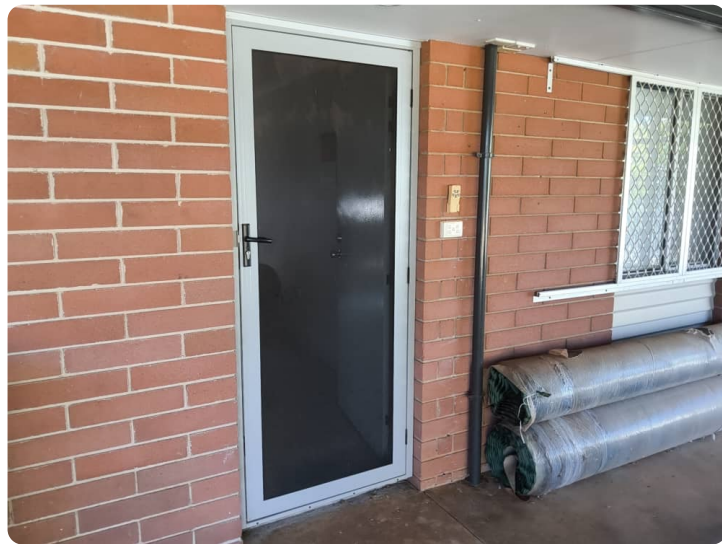
### 15. Other external doors

Other external doors are constructed of solid timber. The condition of the other external doors is satisfactory in relation to its age and will require normal ongoing maintenance.

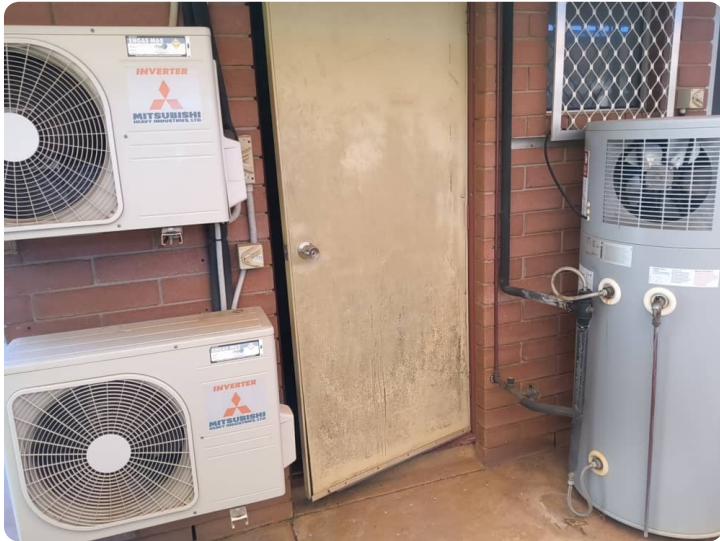
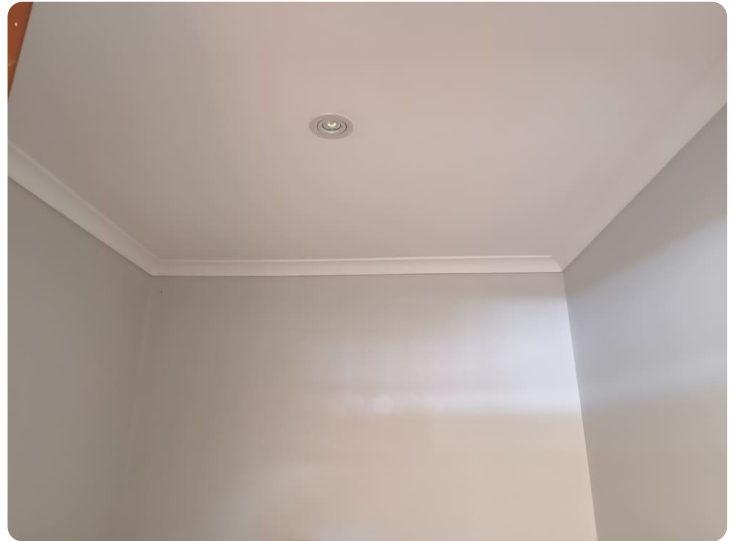
## 16. Storeroom 1

An external storeroom for the property is located adjacent and under the main roof of the building. The condition of the storeroom is satisfactory in relation to its age and will require normal ongoing maintenance.

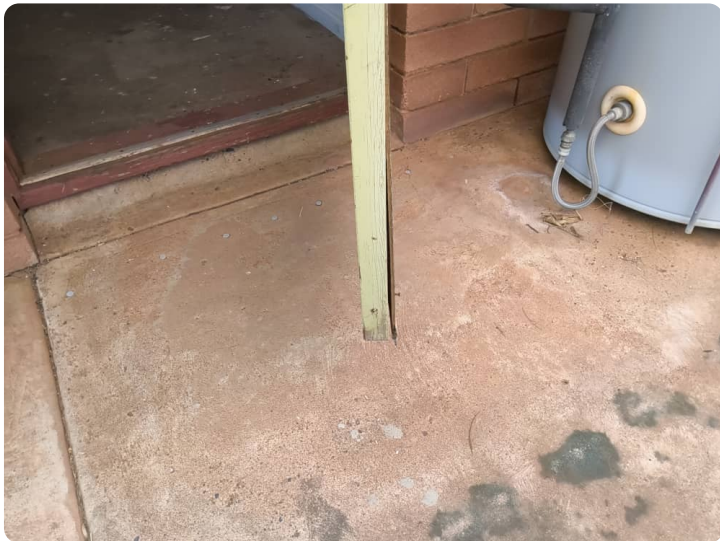
### 16.1 Door weathered

The door in the images is weathered and needs repairs or replacing.

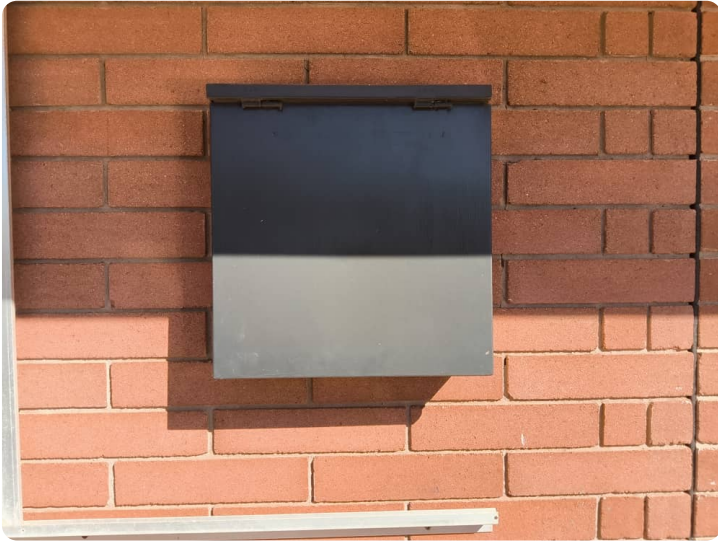
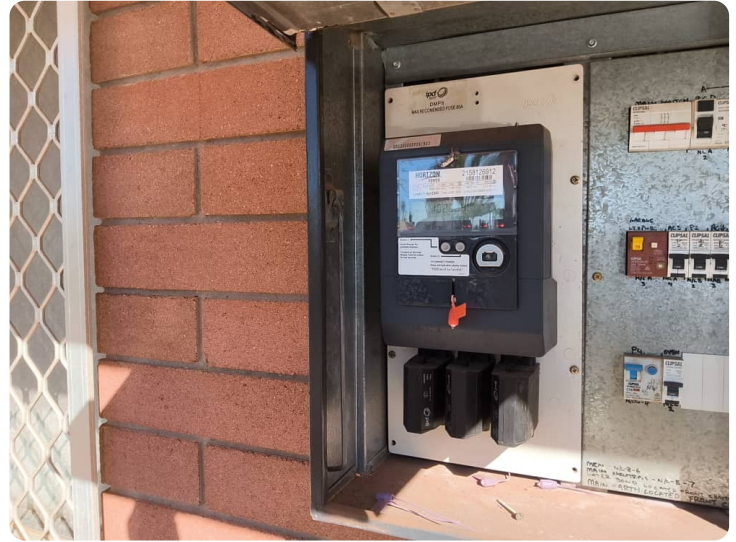
### 17. Meter box and power

Access to the meter box or sub board was available. The meter box or sub board is not lockable. Power phase type to the site is three phase.

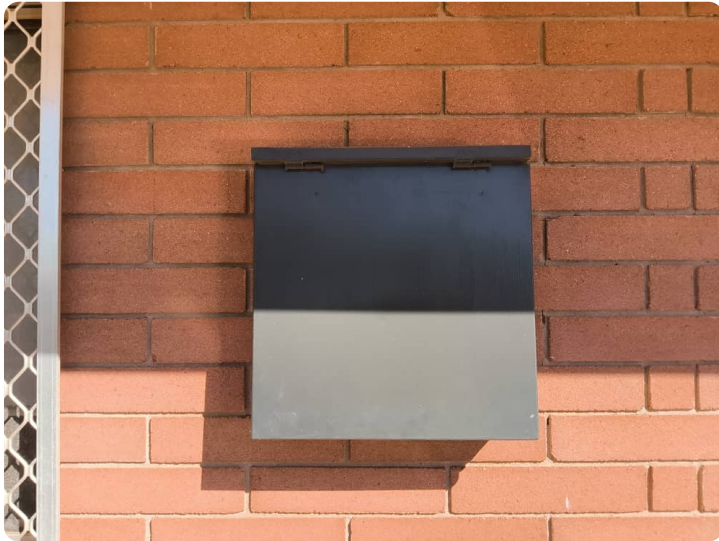
## 18. Residual Current Devices

There were multiple Residual Current Devices (RCD)(s) noted in the meter box or sub meter box. The RCD(s) were not tested. It is suggested that an Electrical Compliance Certificate be obtained in relation to the RCD(s).

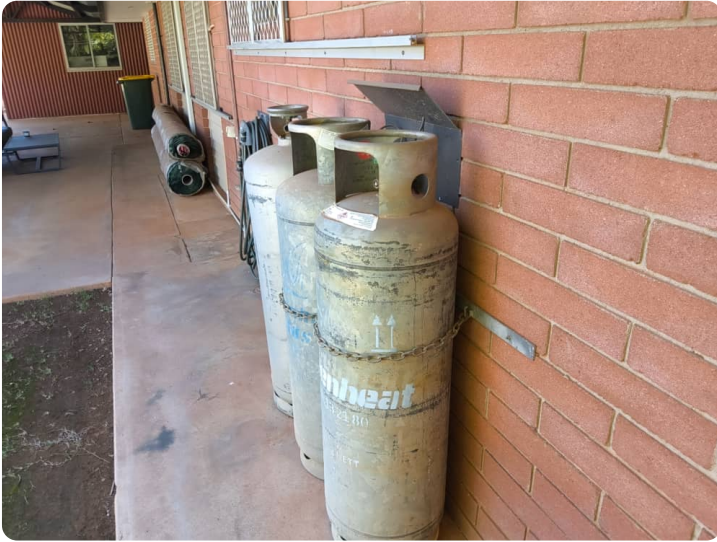
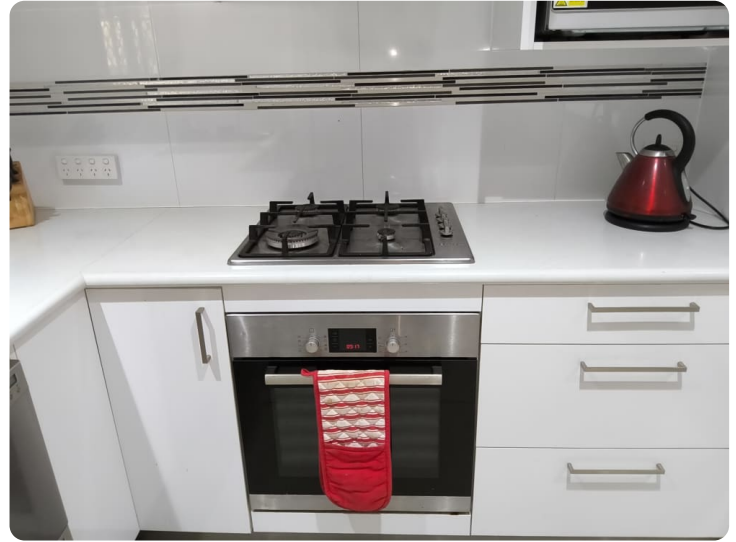
## 19. Gas Supply

Gas supply to the property is via LPG bottles. While on site the inspector could not smell detectable gas leaks.

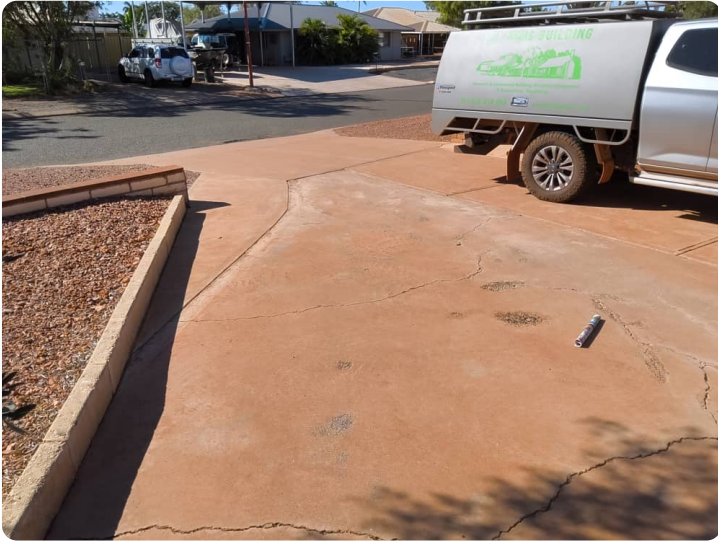
The driveway and cross over is constructed of concrete. The condition of the driveway is fair in relation to its age and will require ongoing maintenance.

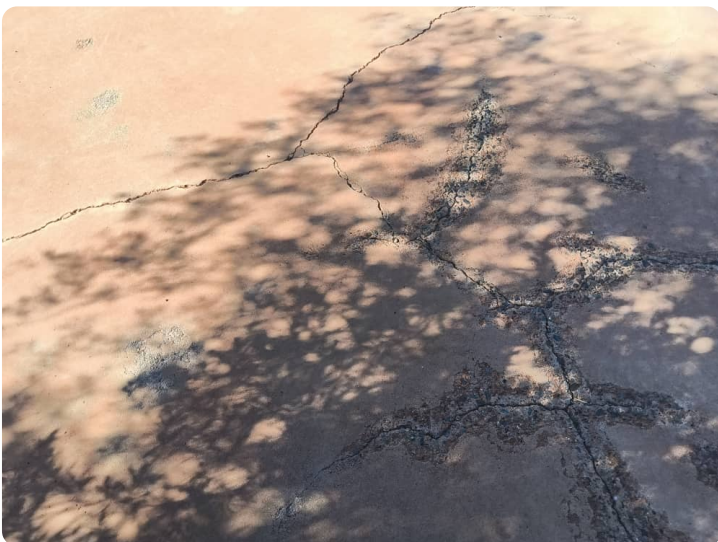
### 24.1 Concrete cracking - major

Significant cracking was noted to the concrete paving. This is not of a structural concern however repairs are required.

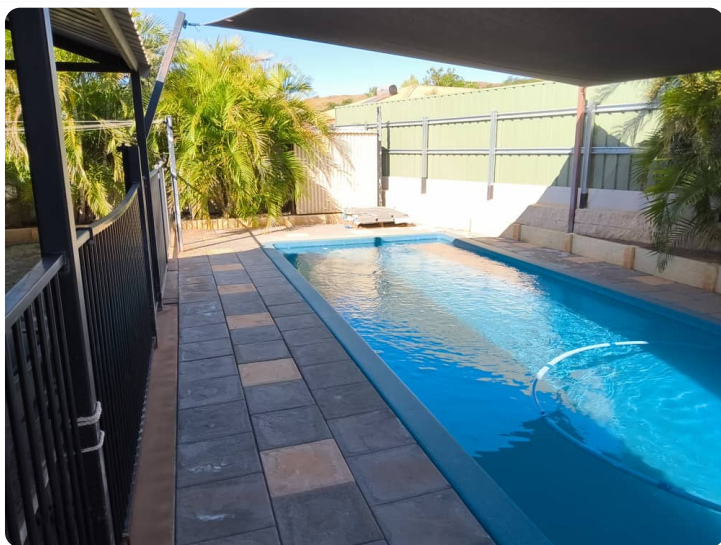
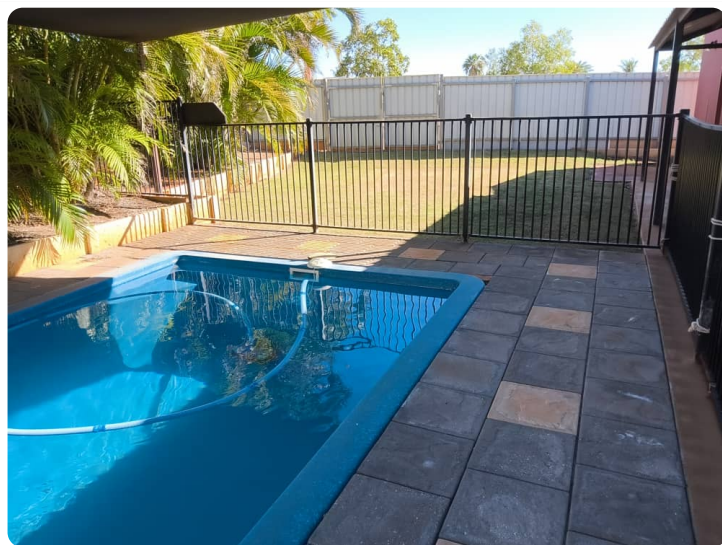
The pool is situated below ground. The external pool on the property is constructed of fibreglass. In relation to subsidence to the ground immediately adjacent to the pool, no significant subsidence was noted. There is isolation fencing installed around the pool. The isolation fencing and gates appear to be consistent with current pool fencing requirements. It is recommended that a copy of the previous Council Pool Safety Compliance Certificate is obtained. It is recommended that a pool maintenance contractor review and confirm the operation of all pool equipment.

### 28.1 Pool fence rusting minor

The pool fence is rusting action should be taken to prolong it life. Remediation work should be undertaken as required.

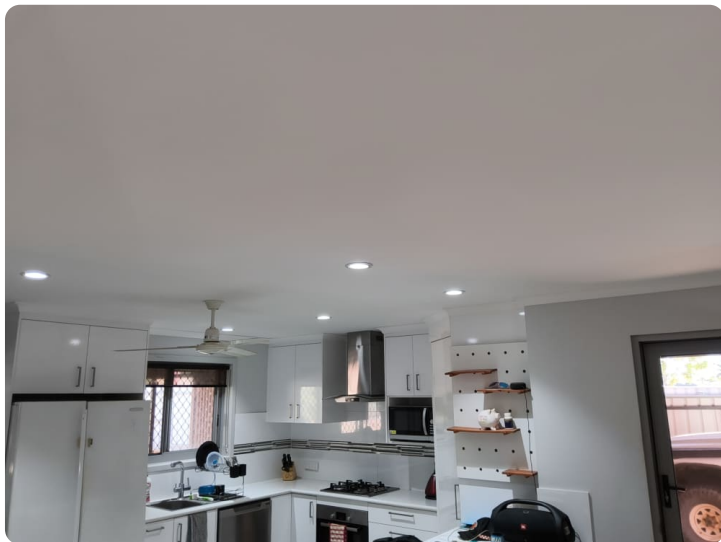
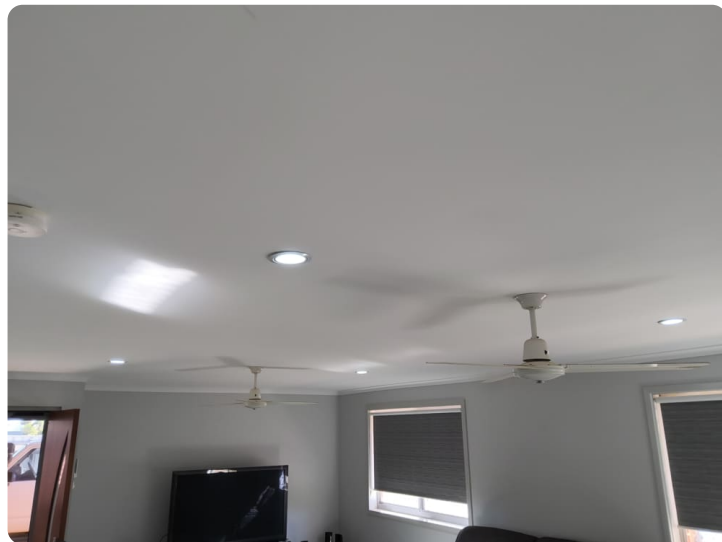
The ceilings are constructed of plasterboard with cornices constructed of plasterboard. The condition of the ceilings is satisfactory in relation to its age and will require normal ongoing maintenance.

#### 33.1 Cornice cracking - minor

Cornice cracking noted likely due to thermal contraction and expansion and or settlement and is not a structural issue. Patch and paint as required.

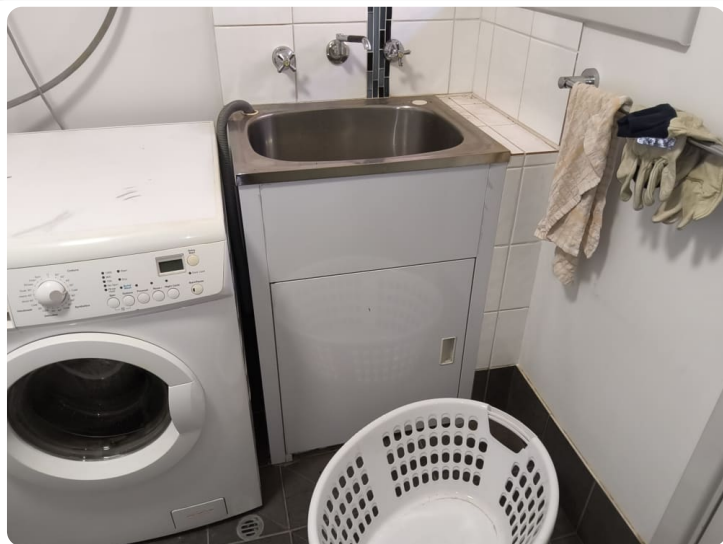
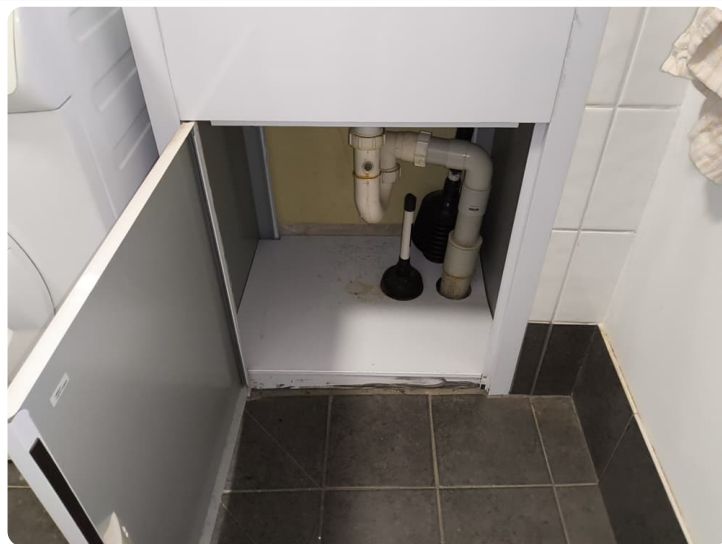
#### 40. Laundry cabinets

The condition of the laundry cabinets is satisfactory in relation to their age and require normal maintenance.

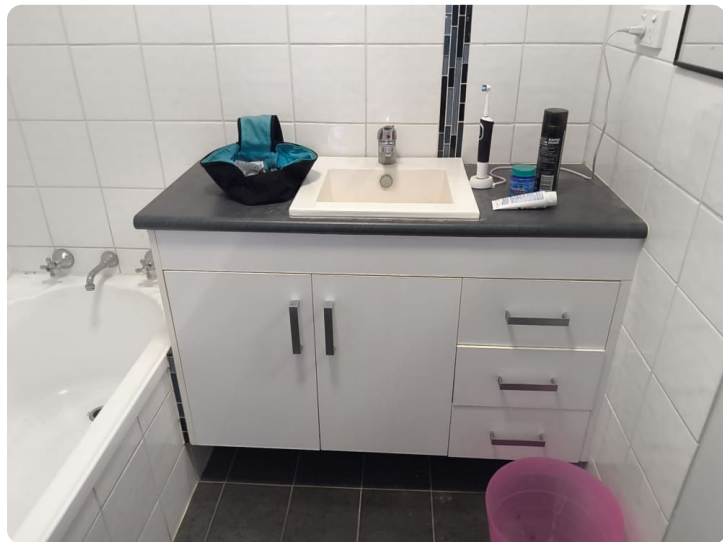
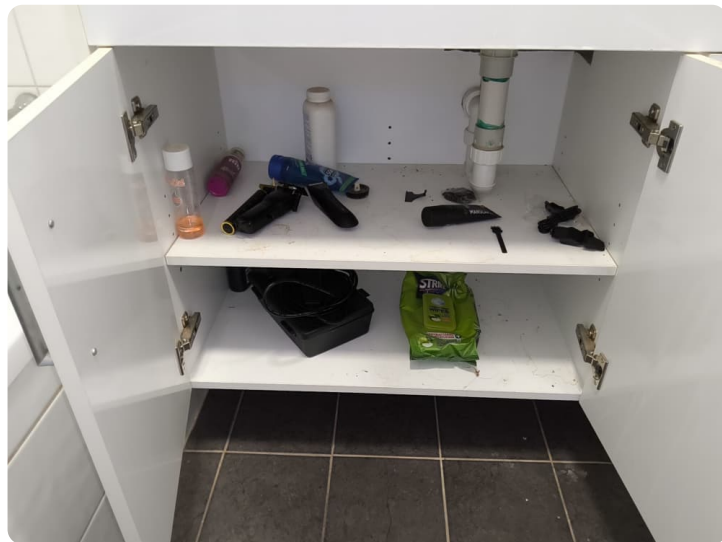
#### 41. Bathroom cabinets

The condition of the bathroom cabinets is satisfactory in relation to their age and require normal maintenance.

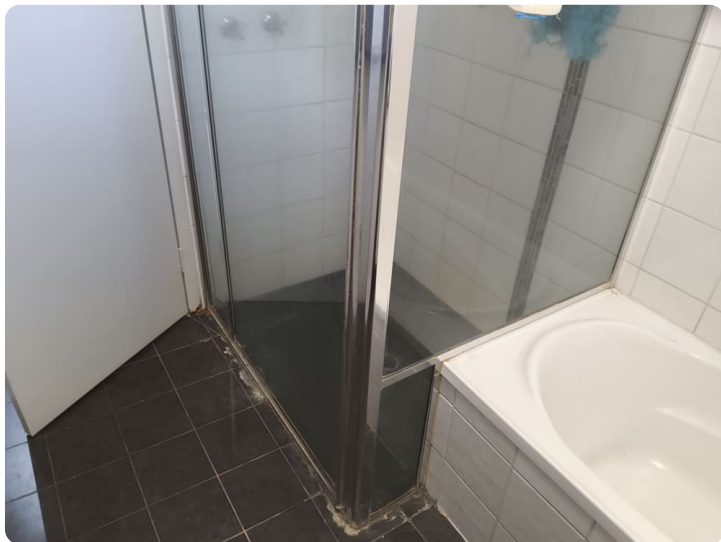
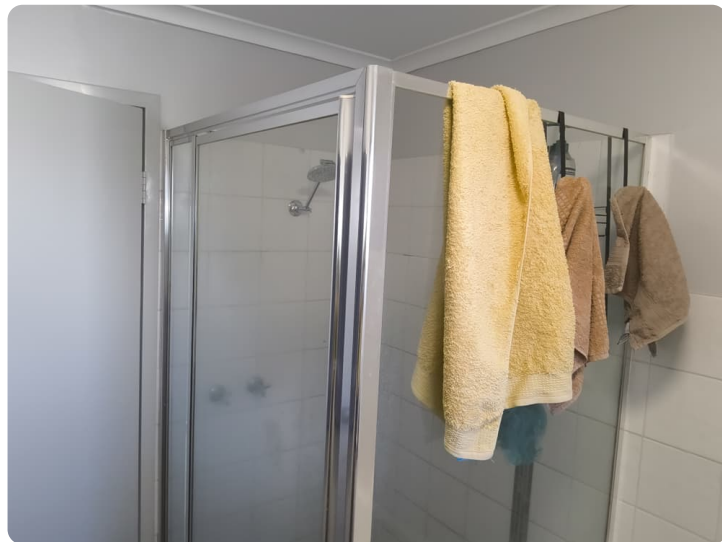
#### 42. Shower screens

The condition of the shower screens is satisfactory in relation to their age and require normal maintenance.

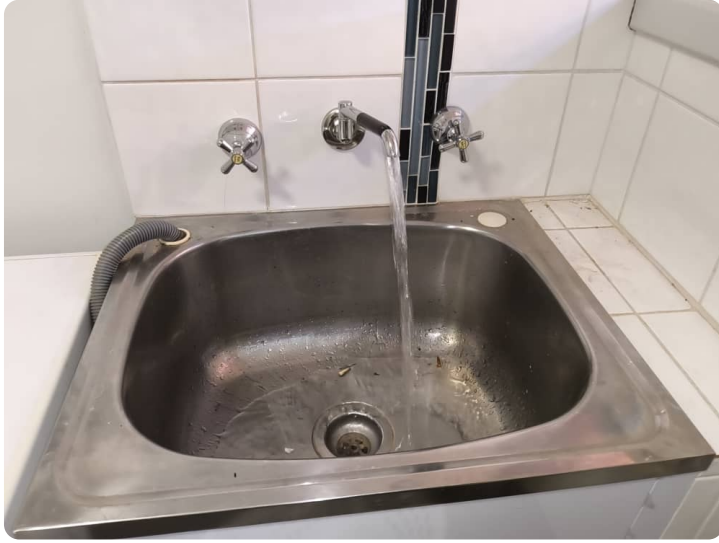
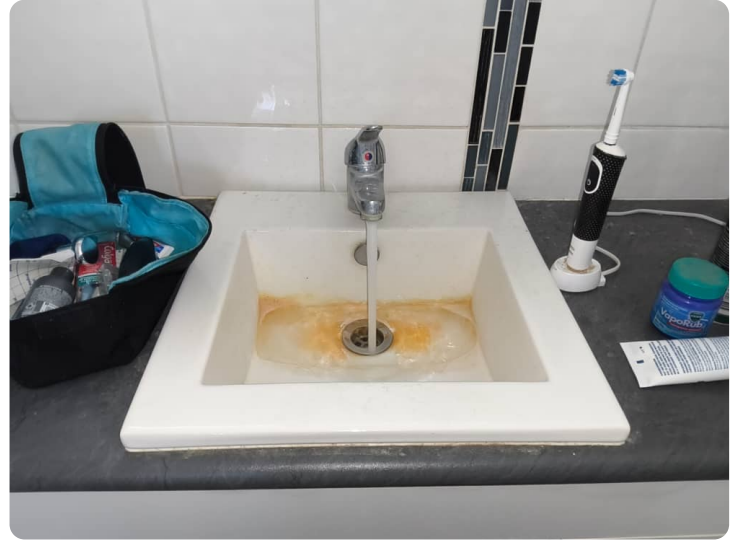
### 43. Plumbing

The taps to multiple areas were turned on and the water flow appeared to be reasonable. Water draining to several sinks and toilets appeared to be reasonable. The Building Inspector is not a Plumbing Contractor and is not permitted to test Plumbing items under WA Law. Where appropriate a Plumbing Contractor should be engaged to test the plumbing in the property.
