# **Houspect**

**Building inspection**

**Job ID:** 92365

**Address:** 2 Cowan Way, Pegs Creek WA

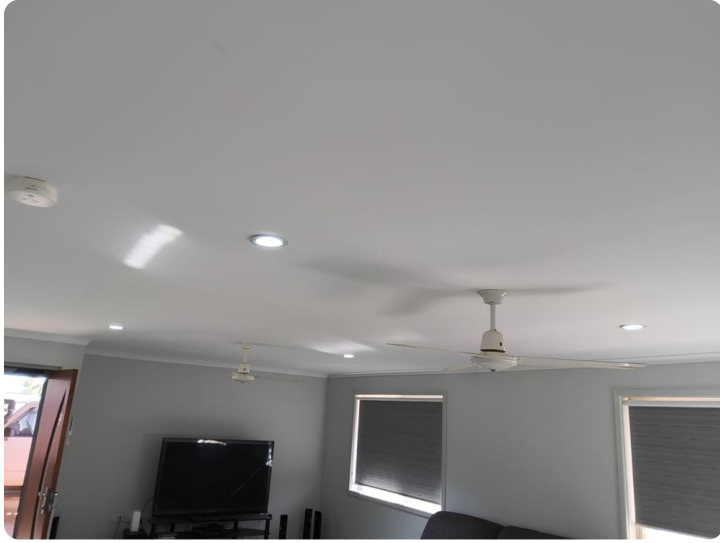
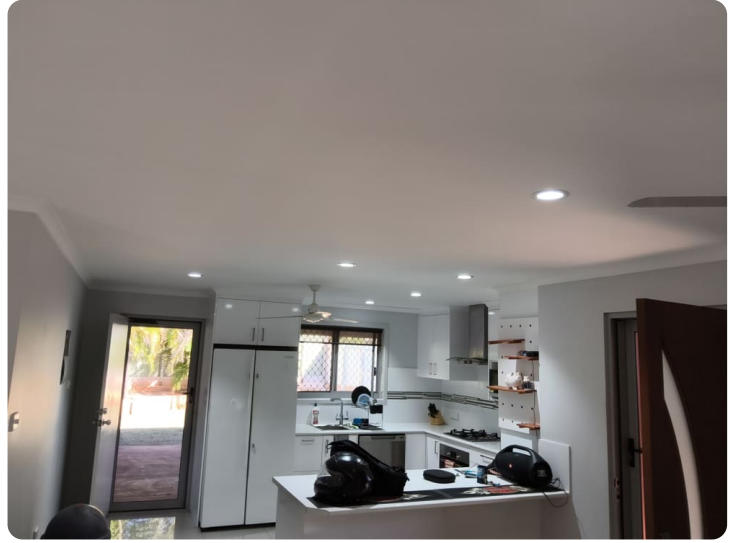
#### 44. Lights and power points

Several lights were turned on during the inspection and the lights appeared to be operational. The Building Inspector is not an Electrical Contractor and is not permitted to test Electrical items under WA Law. Where appropriate an Electrical Contractor should be engaged to test the electrical items in the property.

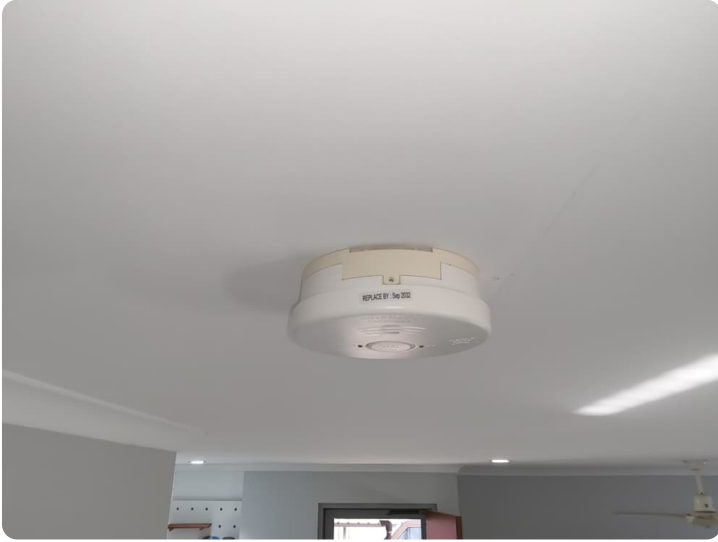
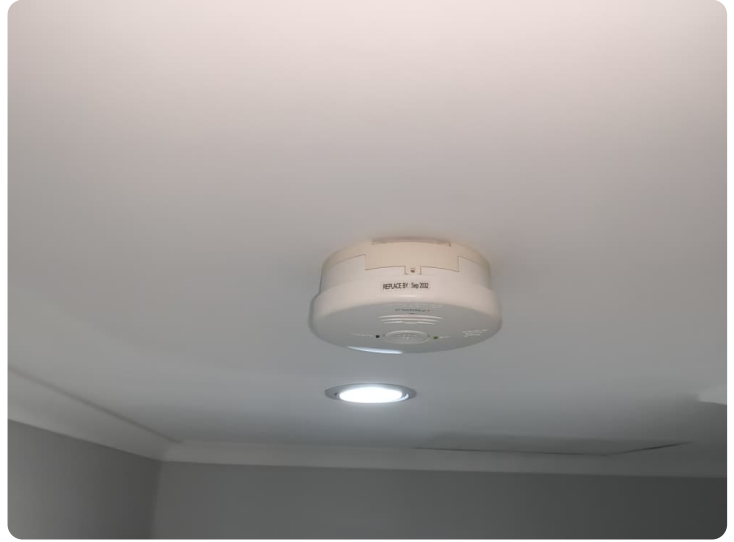
#### 45. Smoke Alarms

There were two hardwired smoke alarms on site. There were no battery smoke alarms on site. The location, number and type of smoke alarms appeared to be consistent with Legislative requirements. It is suggested that an Electrical Compliance Certificate be obtained in relation to the smoke alarms.
