Building inspection

Job ID: 90916

Address: 13 Pymn Court, Pegs Creek WA

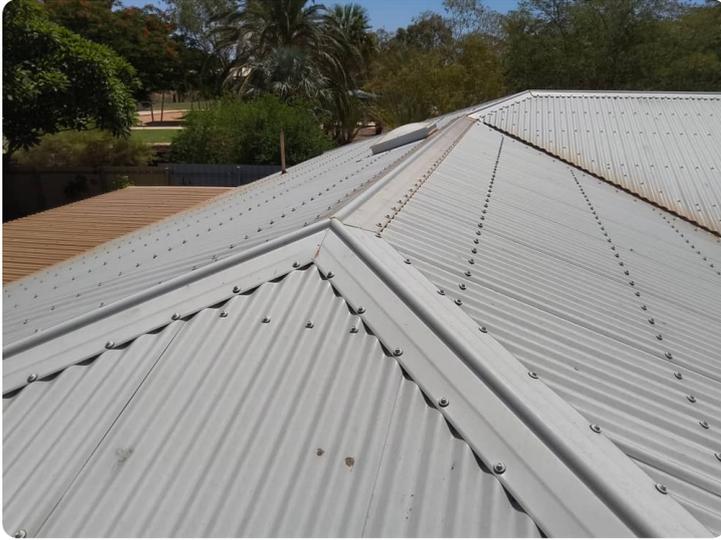
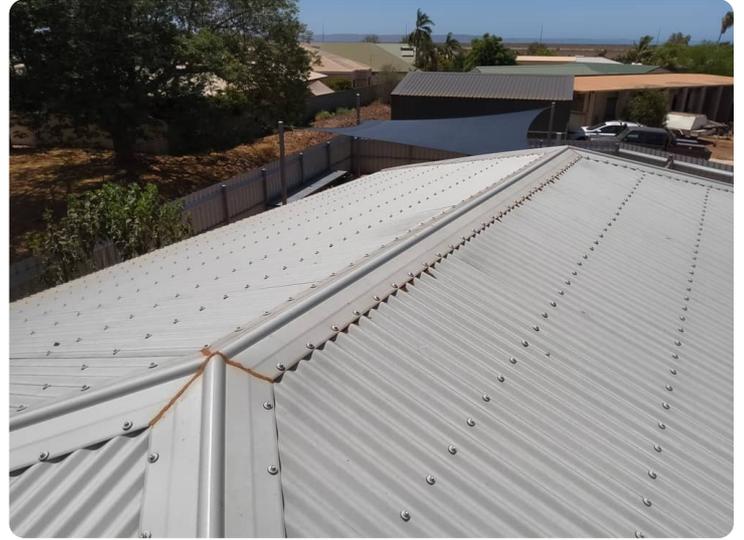
2. Ridges

The ridges and capping are satisfactory in relation to its age and will require normal ongoing maintenance.

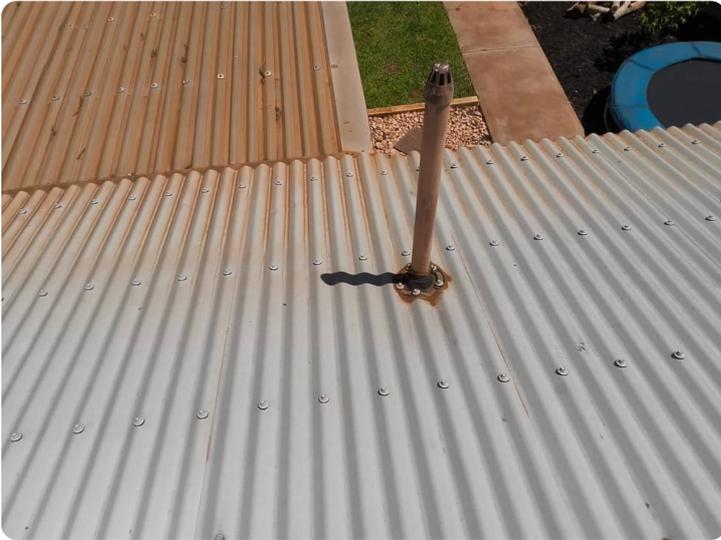
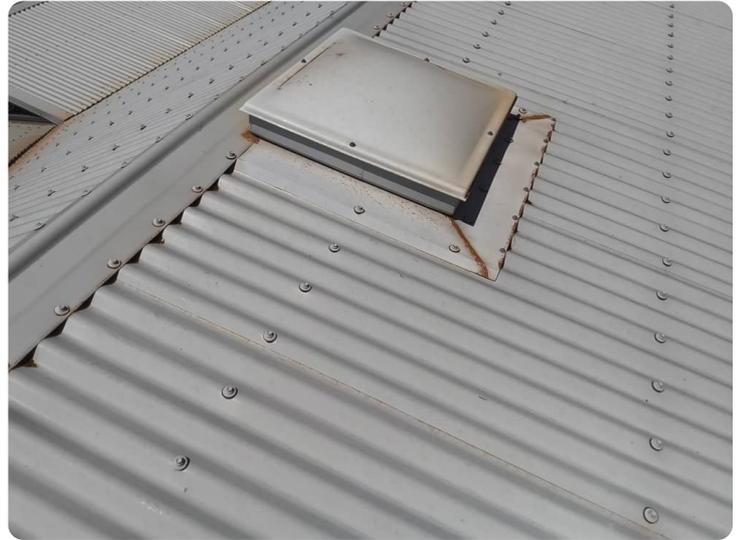
3. Flashings

The flashings are covered with a variety of finishes and are constructed of a mixture of materials. The condition of the flashings is satisfactory in relation to their age and will require normal ongoing maintenance.

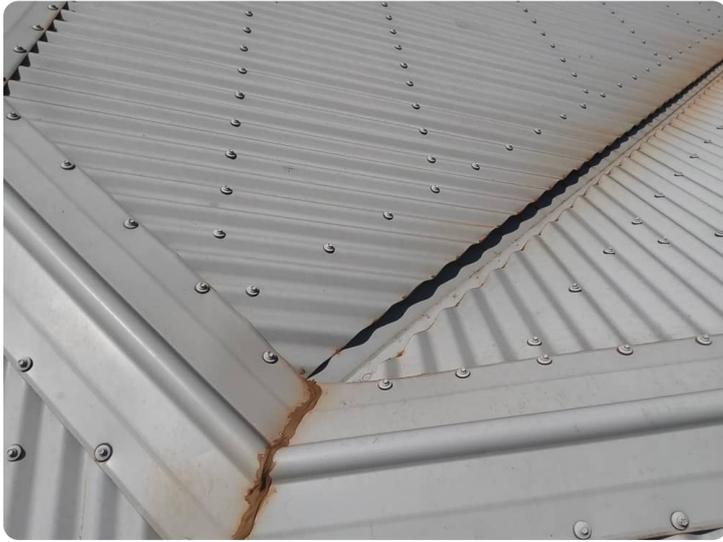
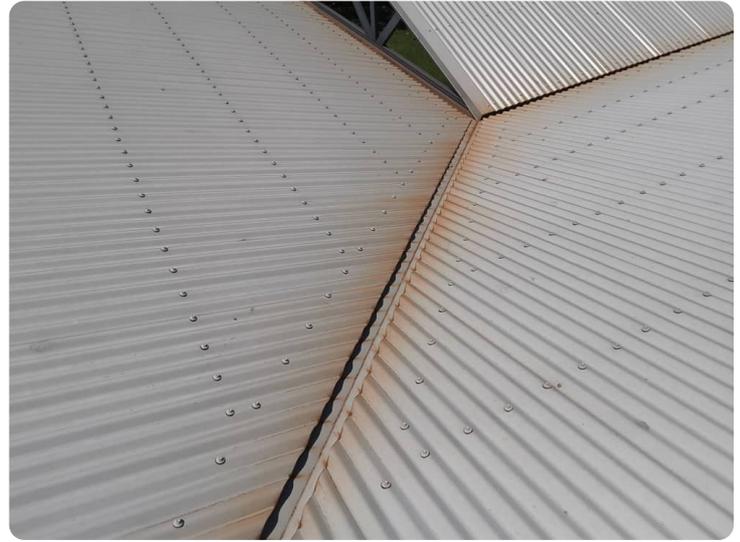
4. Valleys

The valleys are constructed of metal and have a Colorbond covering. The condition of the valleys is satisfactory in relation to their age and will require normal ongoing maintenance. The valleys appear to be relatively free of debris.

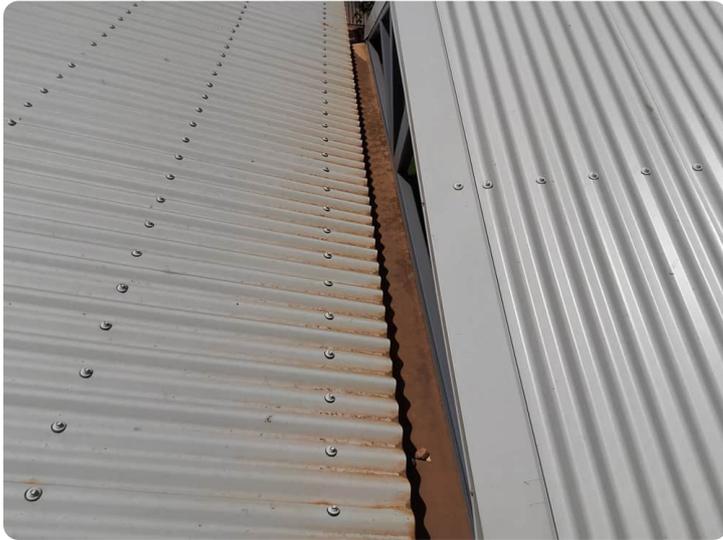
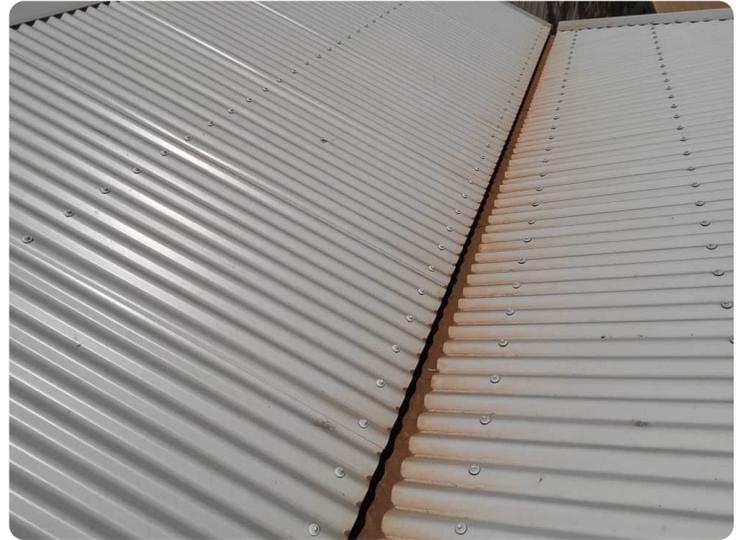
5. Box gutters

The box gutters are constructed of metal and they have a colorbond covering. The condition of the box gutters is satisfactory in relation to their age and will require normal ongoing maintenance. The box gutters appear to be relatively free of debris.

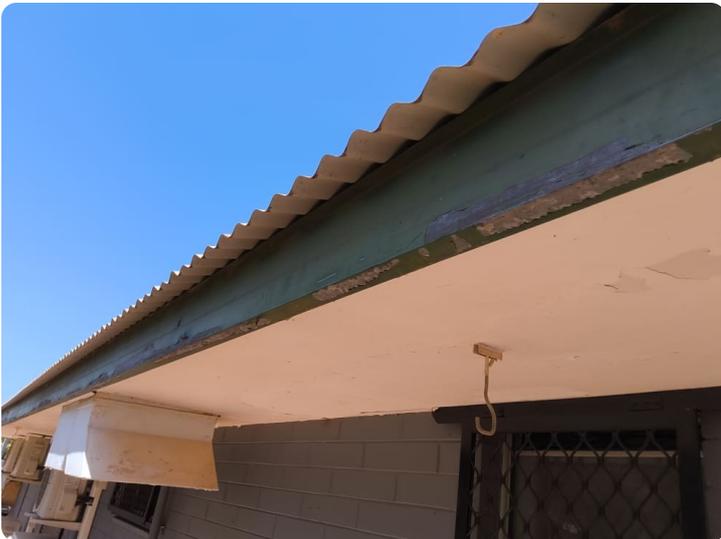
6.1 Fascia general peeling paint

There was peeling paint noted to the fascia. Recommended fascia is repainted.

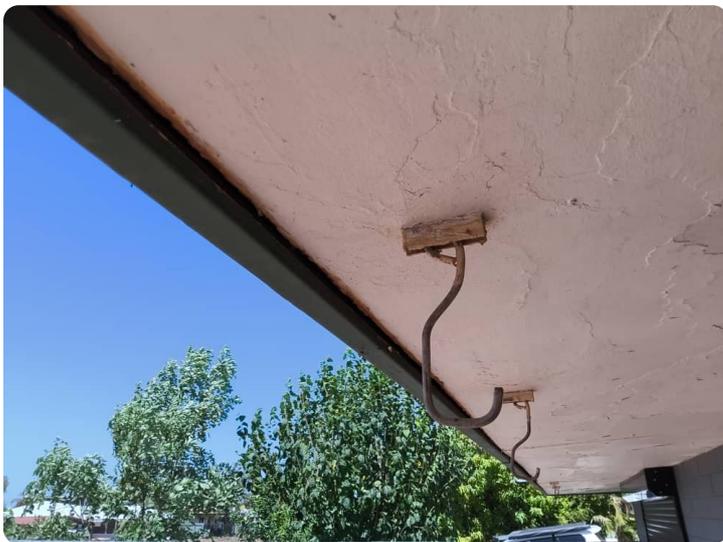
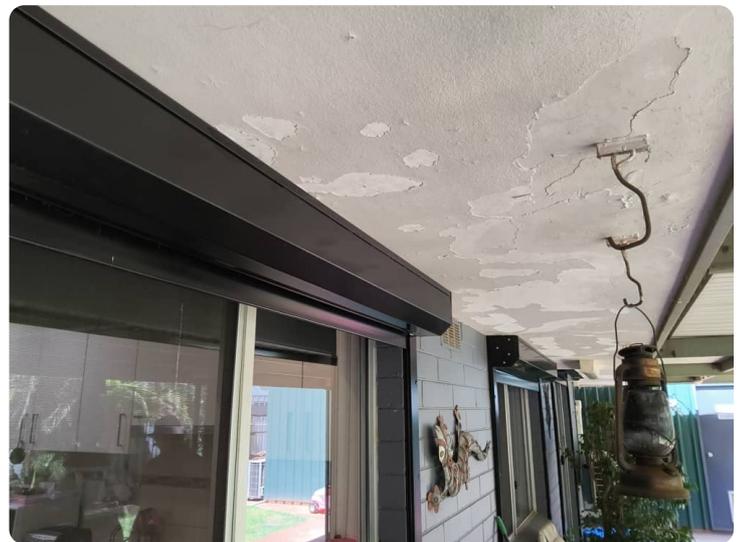
7.1 Eaves sheet weathered

The eaves are weathered and need to be repainted. The material should be tested where required and then a remediation plan established.

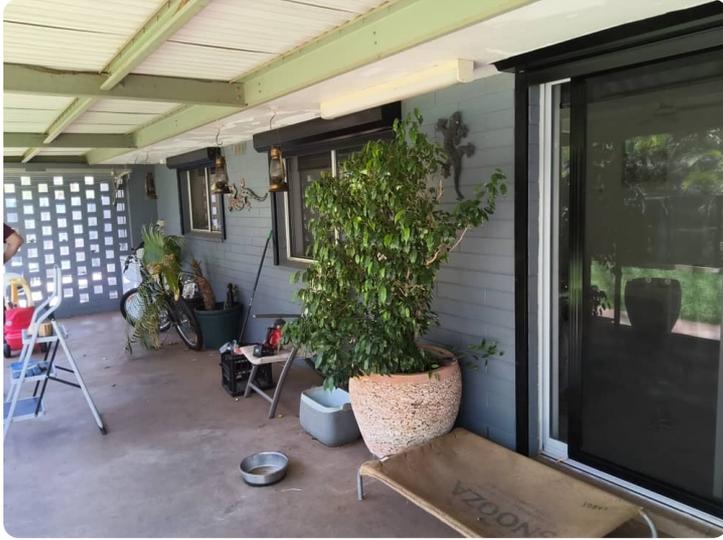
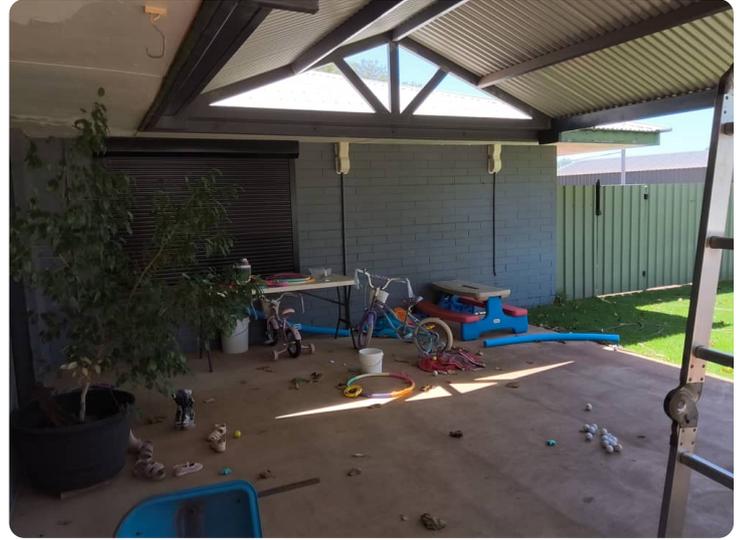
8. External walls

The external walls are constructed of painted brick. The condition of the walls generally is satisfactory in relation to their age and will require normal ongoing maintenance.

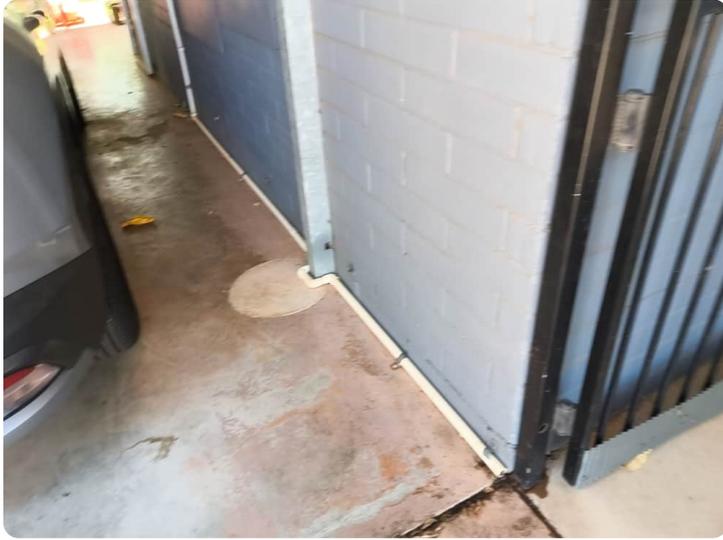
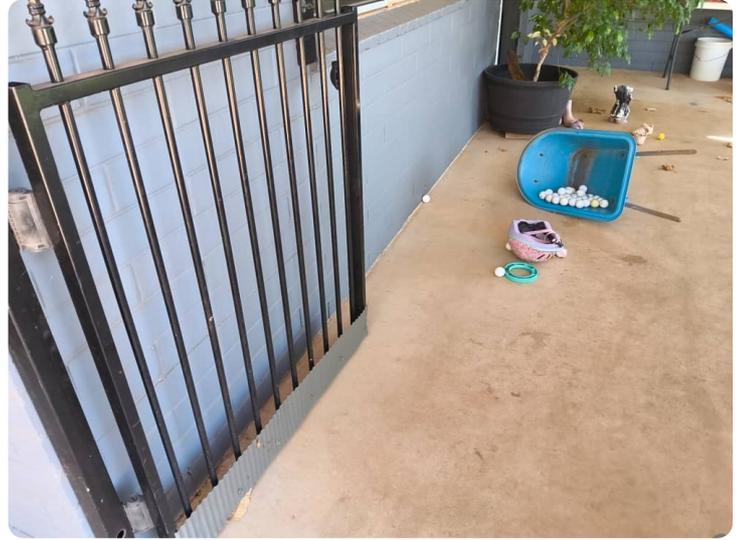
9. Footings

The footings are below ground and cannot be seen. The condition of the footings cannot be determined.

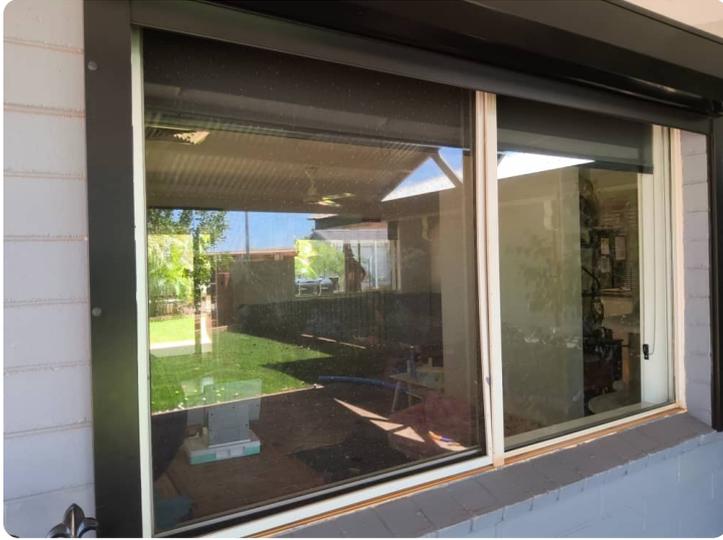
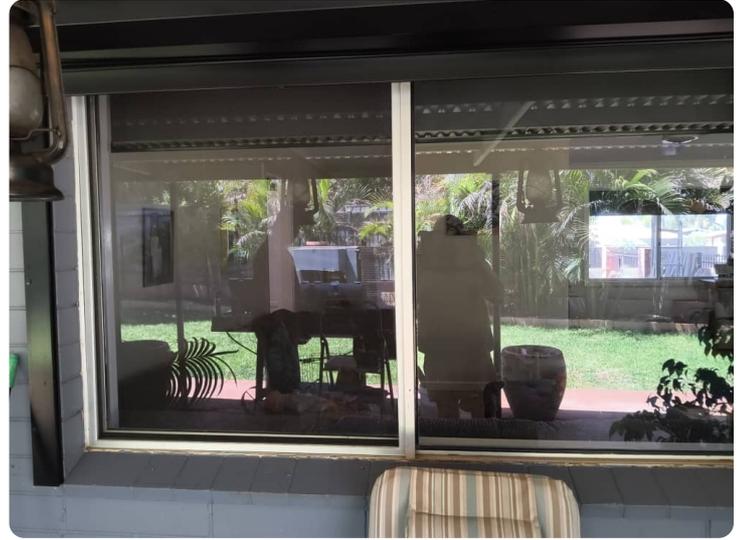
10. Windows and window frames

The window and window frames are primarily constructed of aluminium. The condition of the window and window frames is generally satisfactory in relation to its age and will require normal ongoing maintenance.

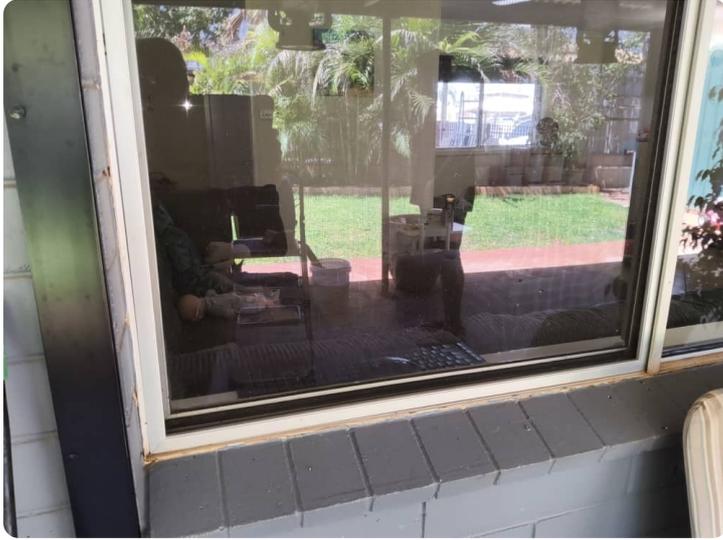
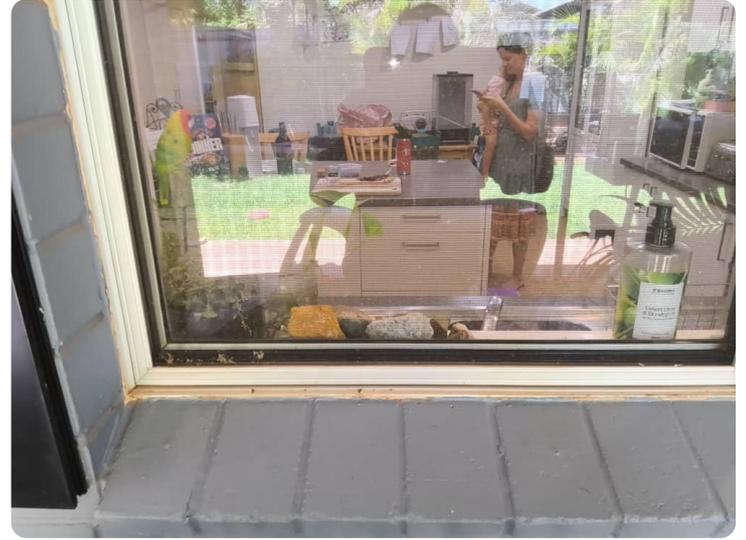
11. Window fly screens

Fly screens have been installed to all of the windows. The condition of the window fly screens is generally satisfactory in relation to its age and will require normal ongoing maintenance.

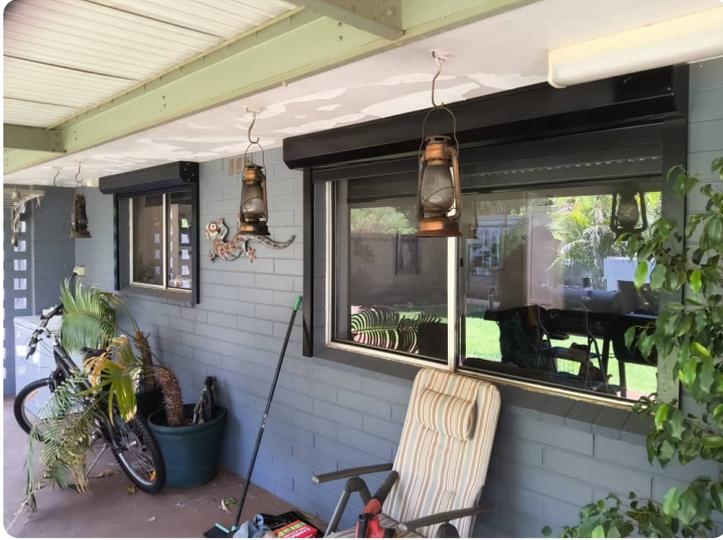
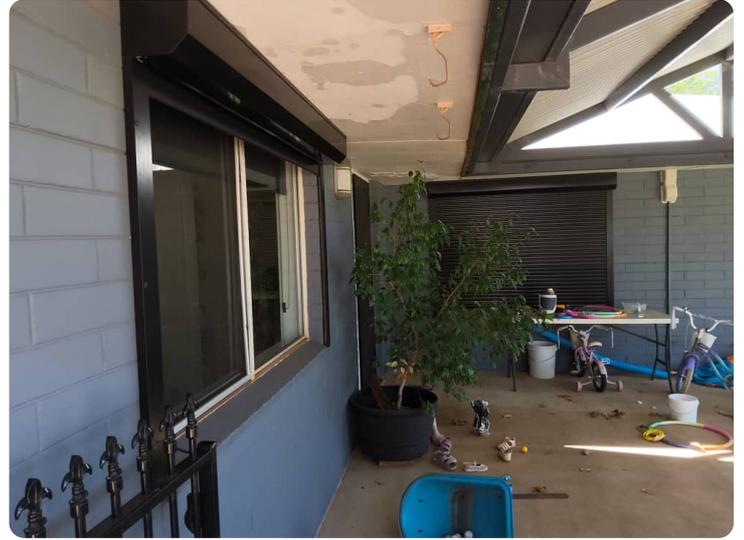
12. Roller shutters

Roller shutters have been installed to all of the windows. The condition of the roller shutters is satisfactory in relation to its age and will require normal ongoing maintenance.

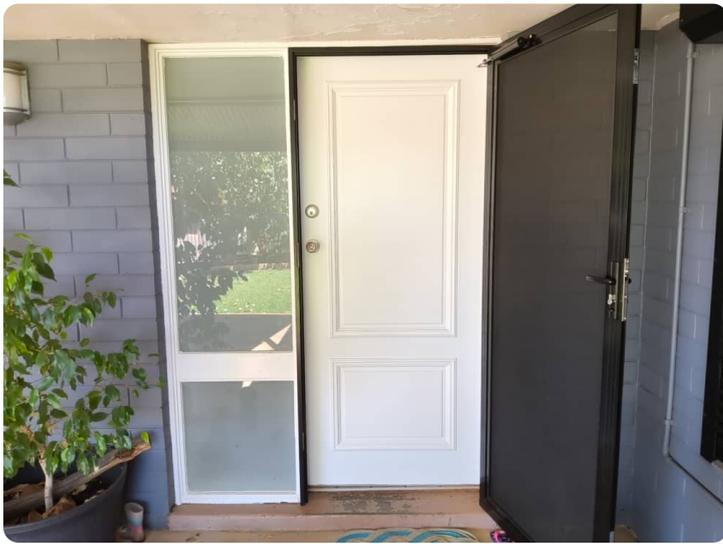
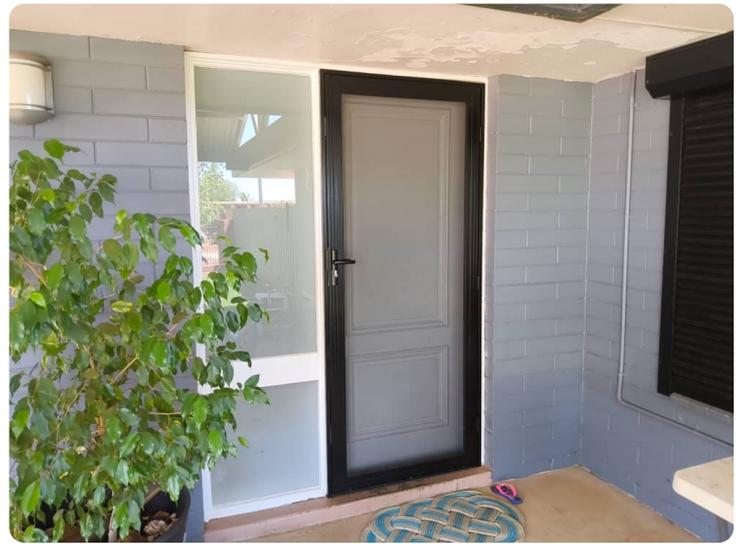
13. Front door

The front door is constructed of solid timber with glazed sidelight panels. The condition of the front door is satisfactory in relation to its age and will require normal ongoing maintenance. Deadlocks have been installed. A security screen door has been fitted. Current Building Codes require that glass in windows and doors in close proximity to the floor must be safety glass to minimise personal injury in the case of breakage. Houses built prior to the 1980(s) did not have this requirement. There is no current requirement to retrospectively remediate however it is suggested that consideration be given to upgrading where applicable.

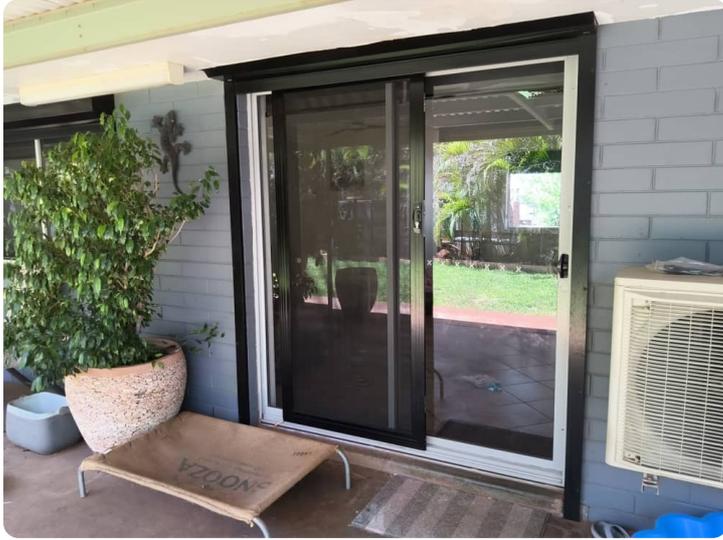
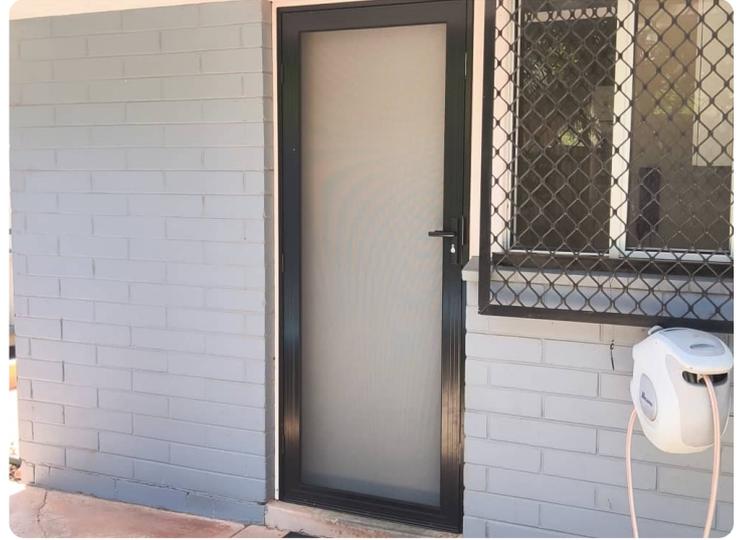
14. Other external doors

Other external doors are constructed of a variety of materials. The condition of the other external doors is satisfactory in relation to its age and will require normal ongoing maintenance.

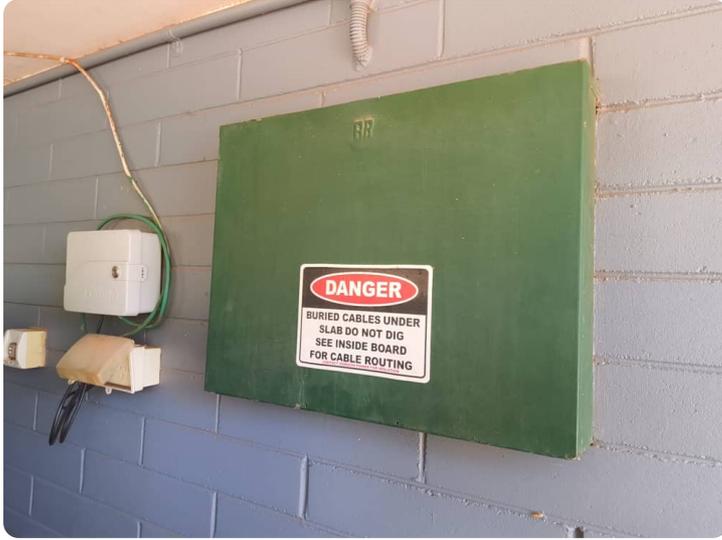
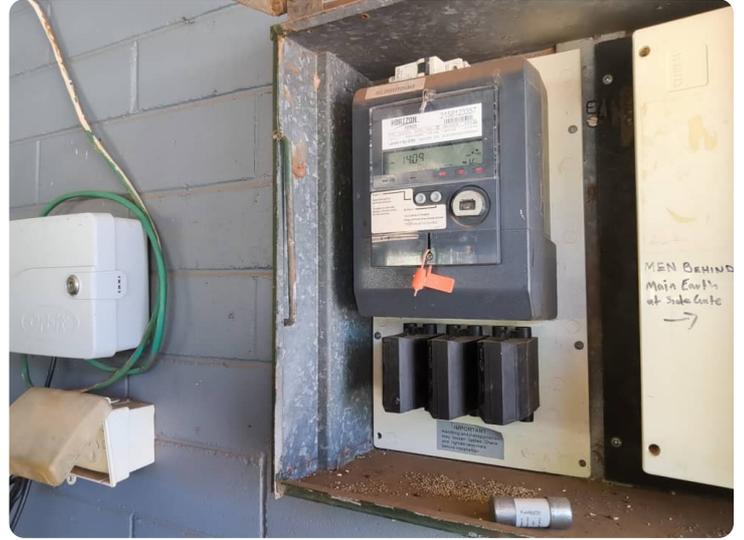
15. Meter box and power

Access to the meter box or sub board was available. The meter box or sub board is not lockable. Power phase type to the site is three phase.

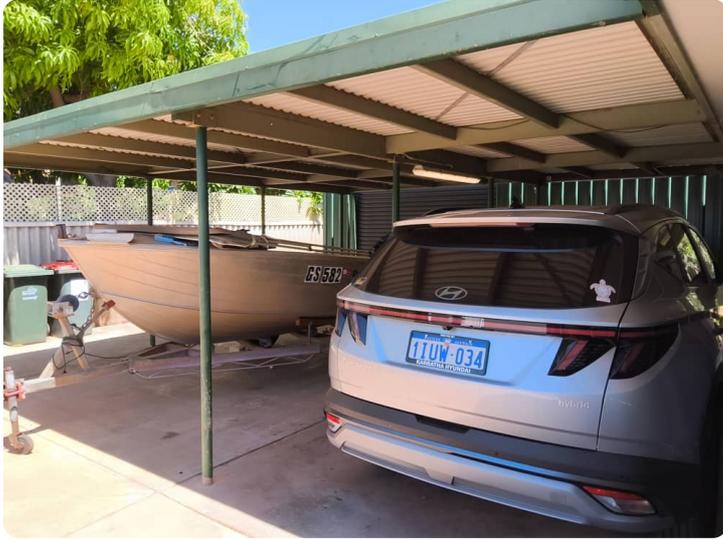
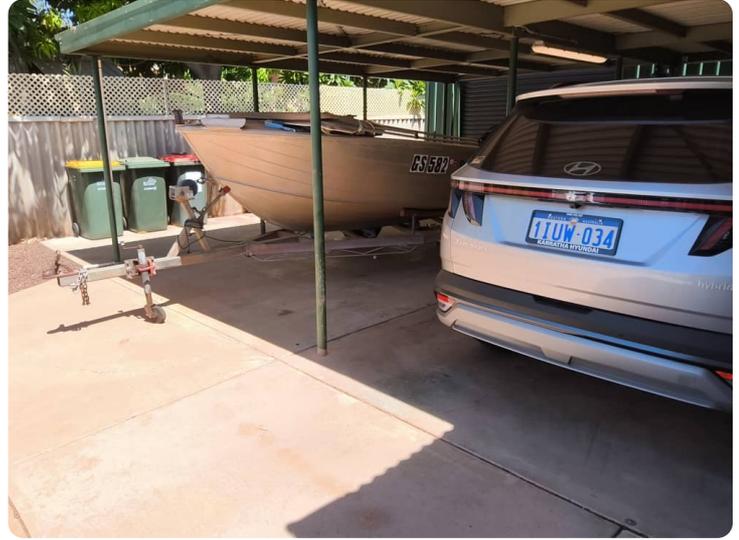
17. Carport or Garage (Primary)

There is a primary carport on the property constructed of metal. The condition of the carport or garage is satisfactory in relation to its age and will require normal ongoing maintenance.

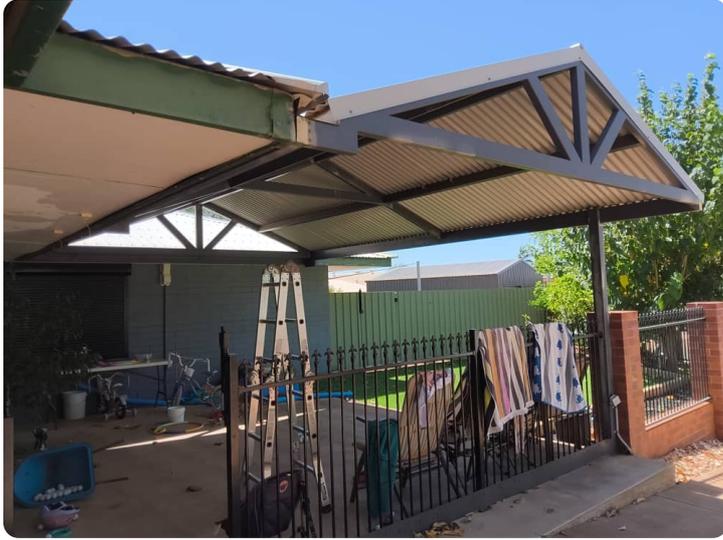
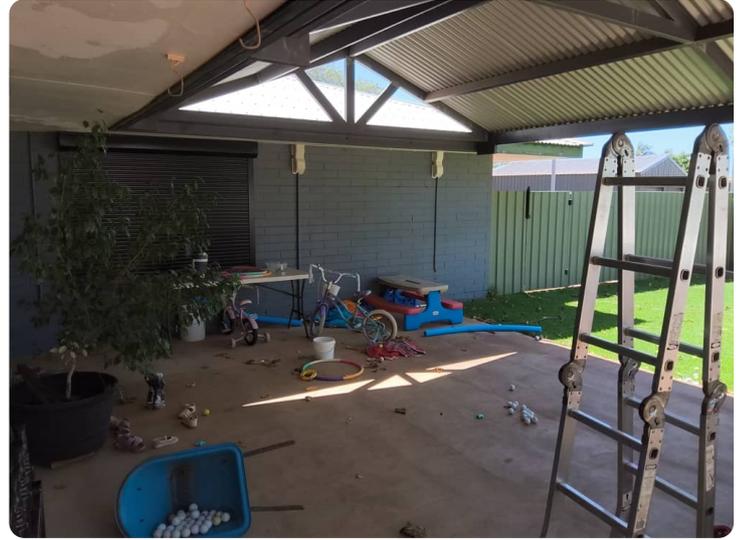
18. Veranda (Primary)

The primary veranda is constructed of metal. The condition of the veranda is satisfactory in relation to its age and will require normal ongoing maintenance.

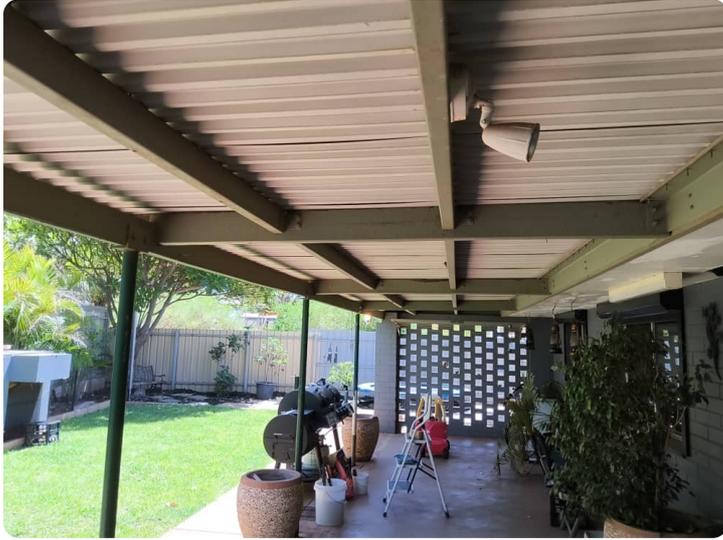
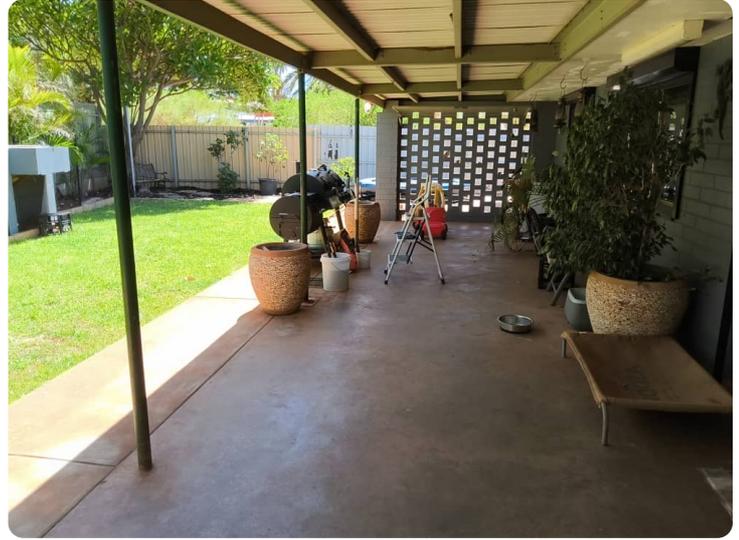
19. Patio

The primary patio is constructed of timber and metal. The condition of the patio is satisfactory in relation to its age and will require normal ongoing maintenance.

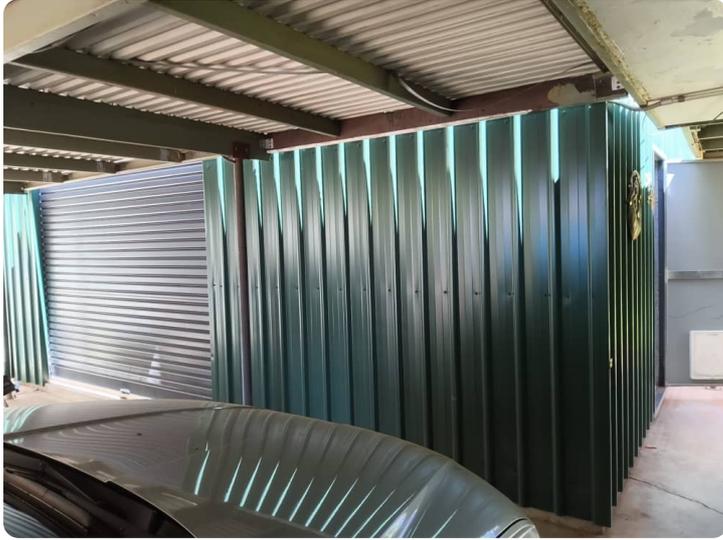
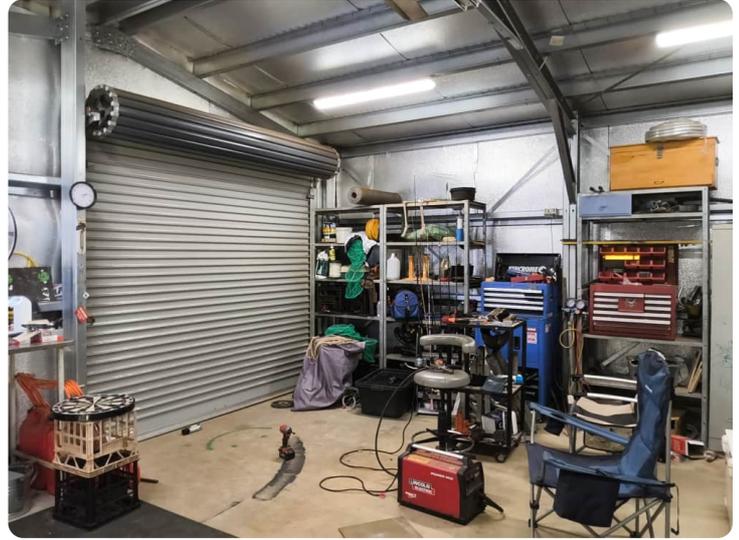
20. Large shed

The large shed is constructed of metal. The condition of the large shed is satisfactory in relation to its age and will require normal ongoing maintenance.

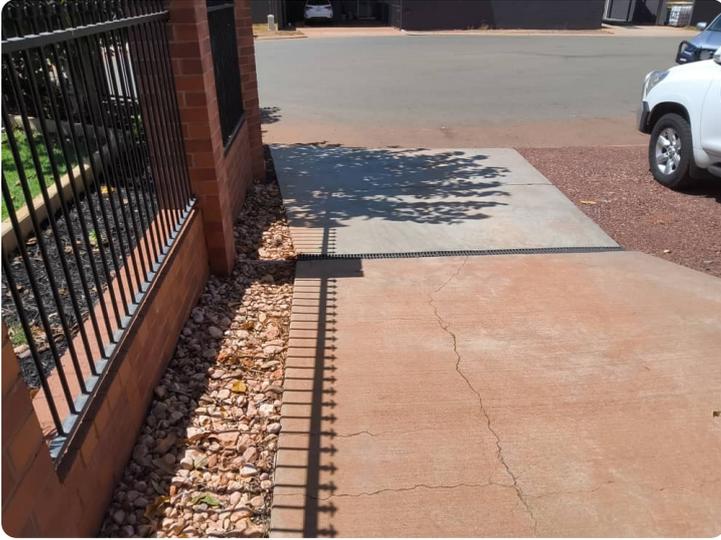
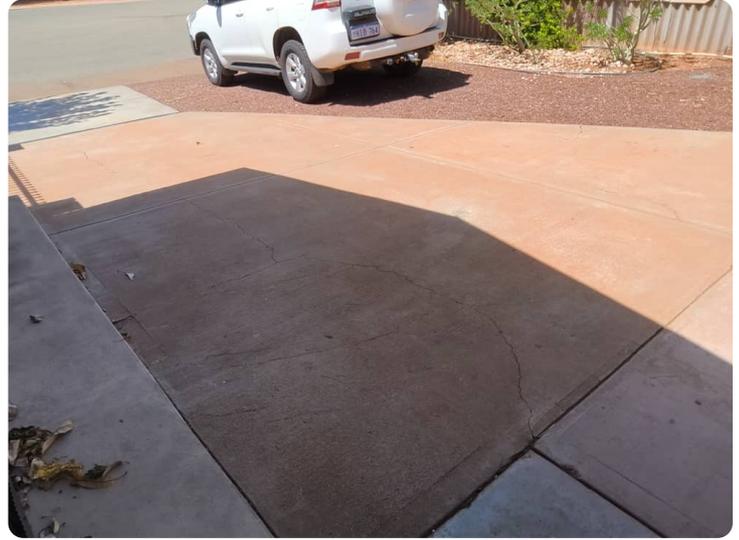
21. Driveway

The driveway and cross over is constructed of concrete. The condition of the driveway is satisfactory in relation to its age and will require normal ongoing maintenance.

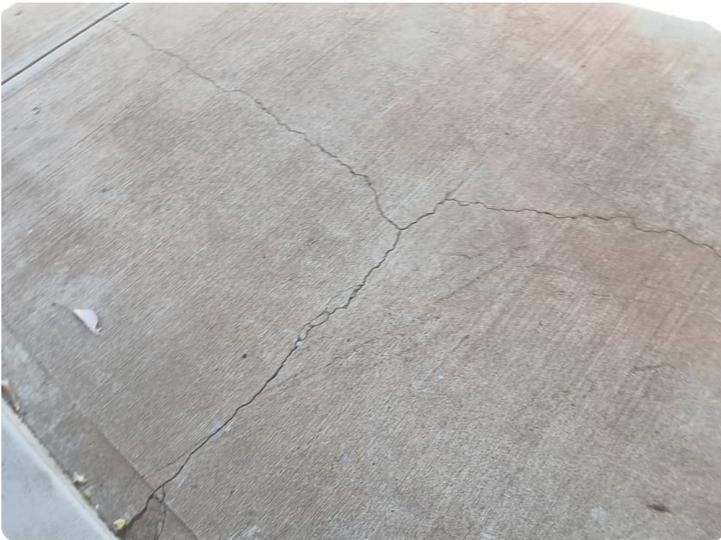
21.1 Concrete cracking - minor

Cracking was noted to the concrete driveway. This is not of a structural concern. Cracks should be filled to avoid further deterioration.

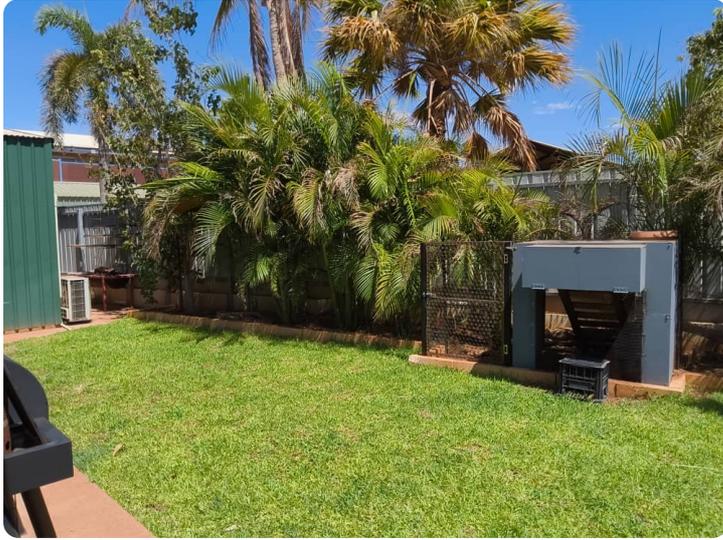
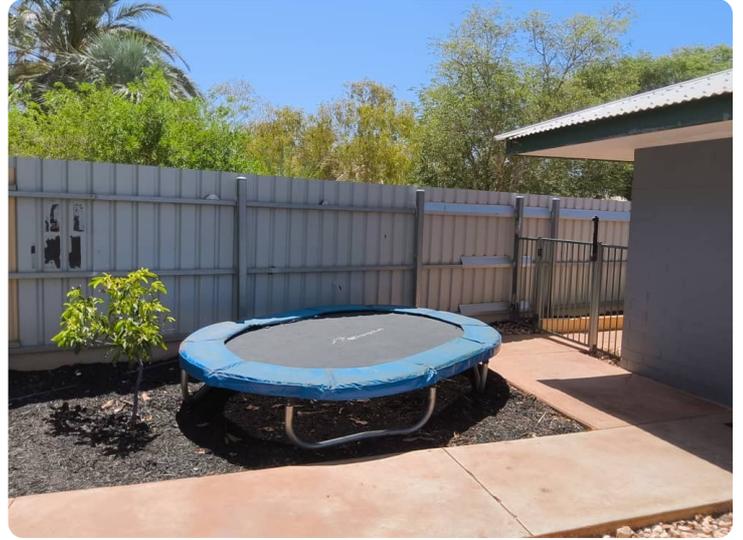
23. Fences - boundary

The boundary fences are constructed of metal. The condition of the boundary fence is satisfactory in relation to its age and will require normal ongoing maintenance. Some of the fences could not be viewed due to vegetation, stored items or secondary structures.

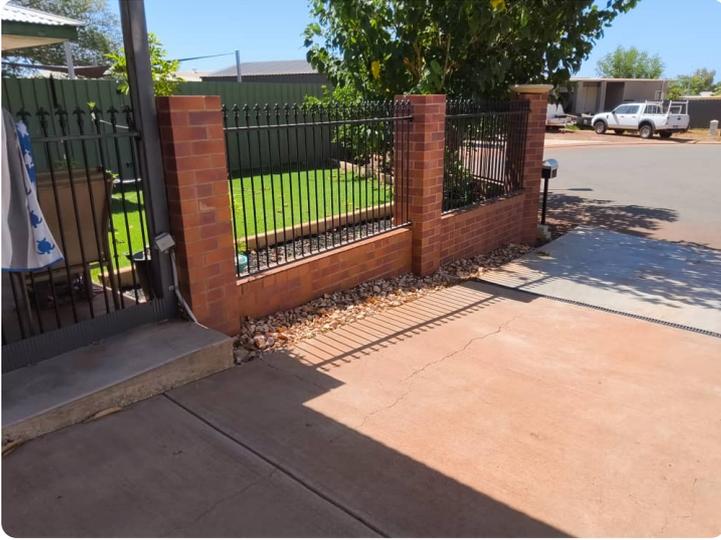
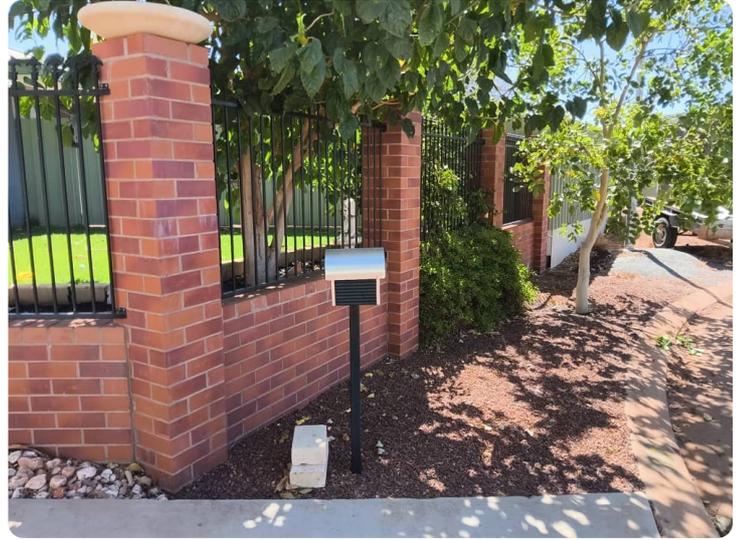
24. Retaining walls

The retaining walls are constructed of brick. The condition of the retaining wall is satisfactory in relation to its age and will require normal ongoing maintenance.

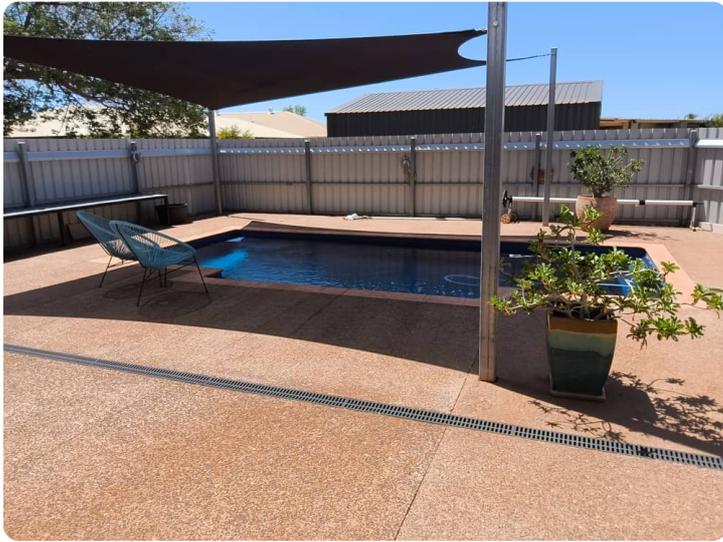
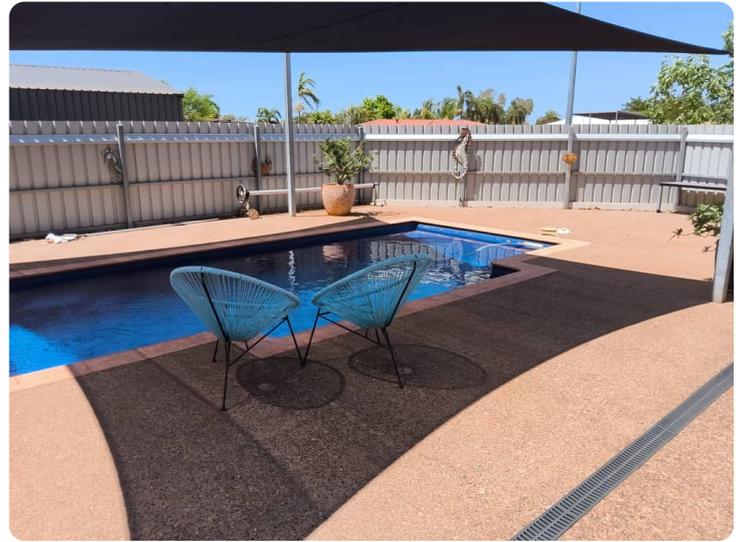
25. Pool (Building forms a portion of the pool fence barrier)

The pool is situated below ground. The external pool on the property is constructed of fibreglass. In relation to subsidence to the ground immediately adjacent to the pool, no significant subsidence was noted. The building and or boundary fences form part of barrier fencing for the pool and appear to be consistent with current pool fencing requirements. It is recommended that a copy of the previous Council Pool Safety Compliance Certificate is obtained. It is recommended that a pool maintenance contractor review and confirm the operation of all pool equipment.

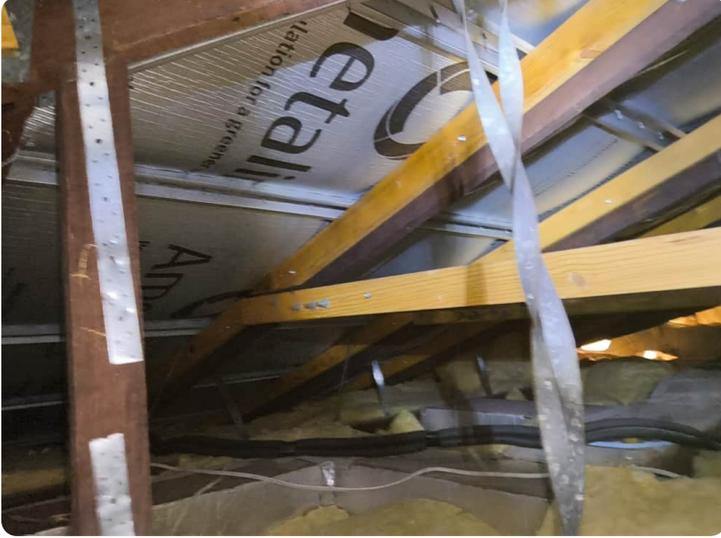
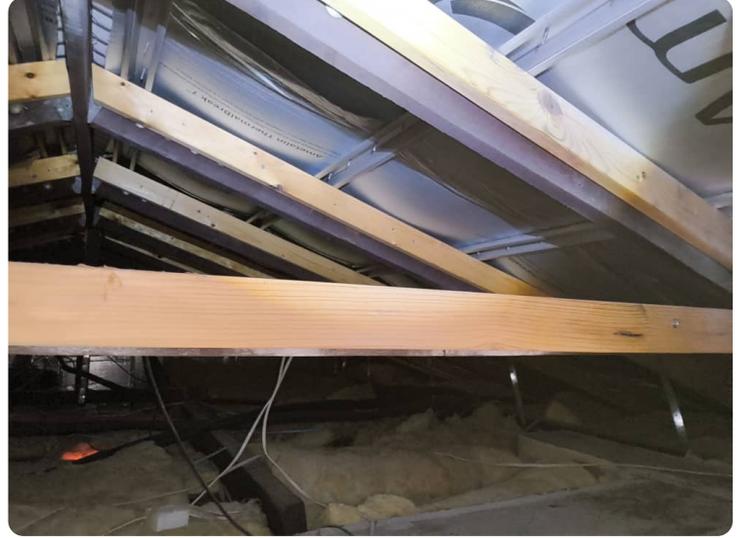
26. Under side of roof cover

The condition of the underside of the roof cover could not be determined as sarking had been installed. It appears as if the roof cover has been replaced or converted to a metal roof at some stage.

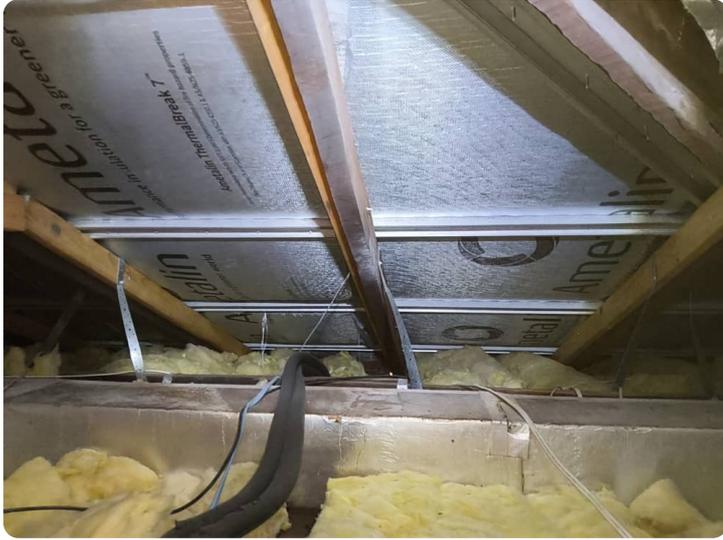
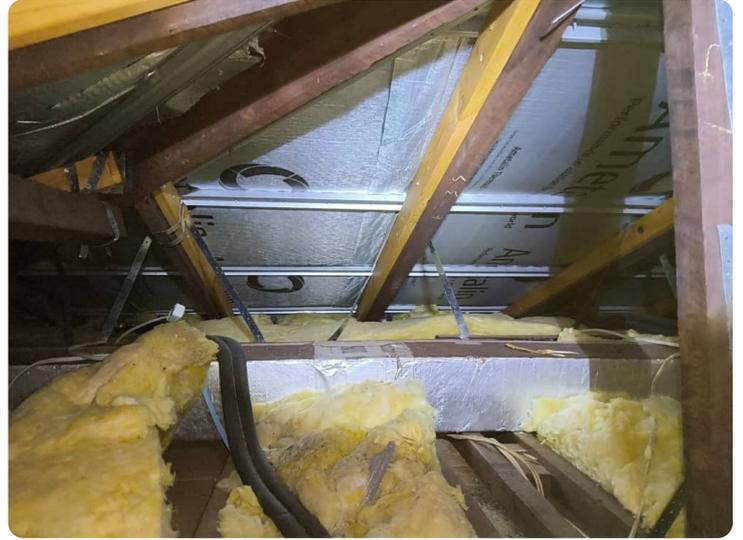
27. Sarking

Sarking to the underside of the roof was installed and was considered effective.

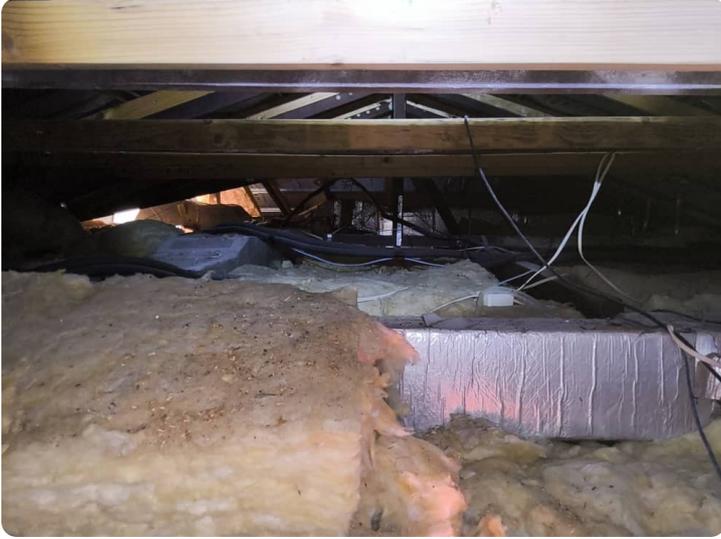
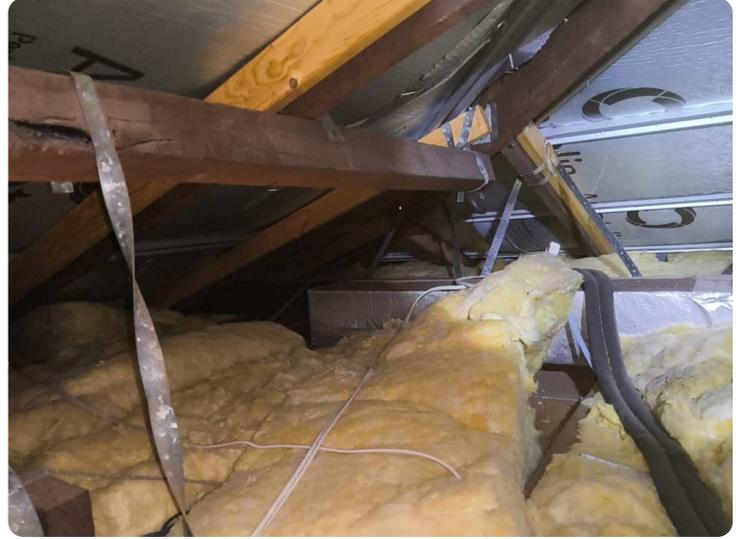
28. Roof frame

The roof frame type is a traditional timber stick frame. The condition of the roof frame is satisfactory in relation to its age and will require normal ongoing maintenance. Access to the roof space was restricted by the pitch of the roof, insulation, ducting or other items. The inspector estimates that visibility was available to more than 50% of the area.

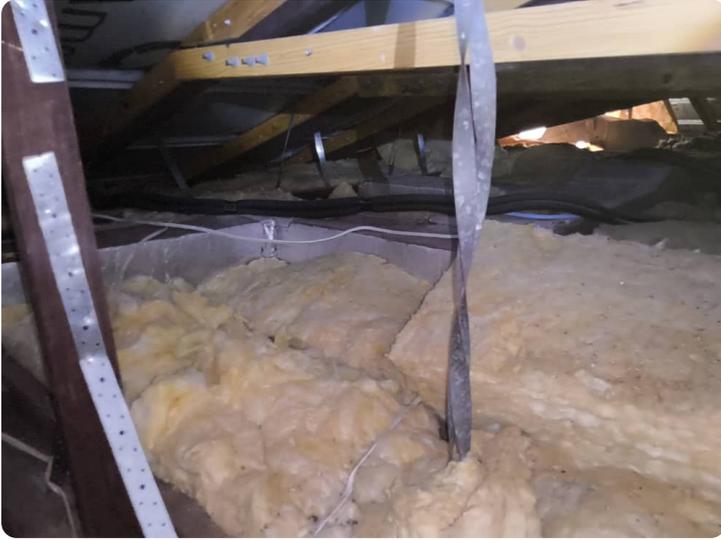
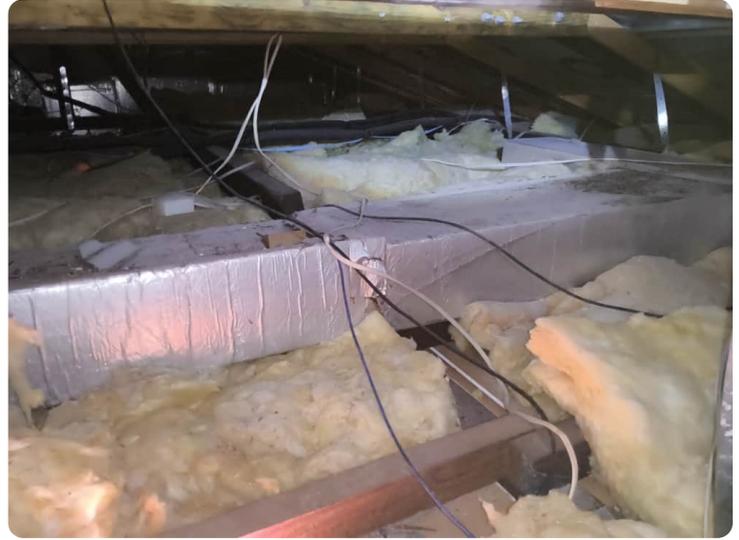
29. Insulation

Insulation was installed. Where insulation was installed it was considered effective. The insulation type was predominately batt or rolled type insulation.

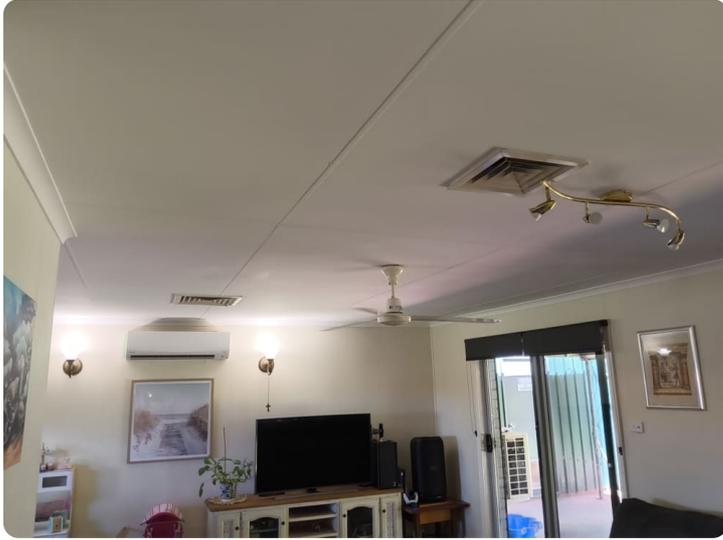
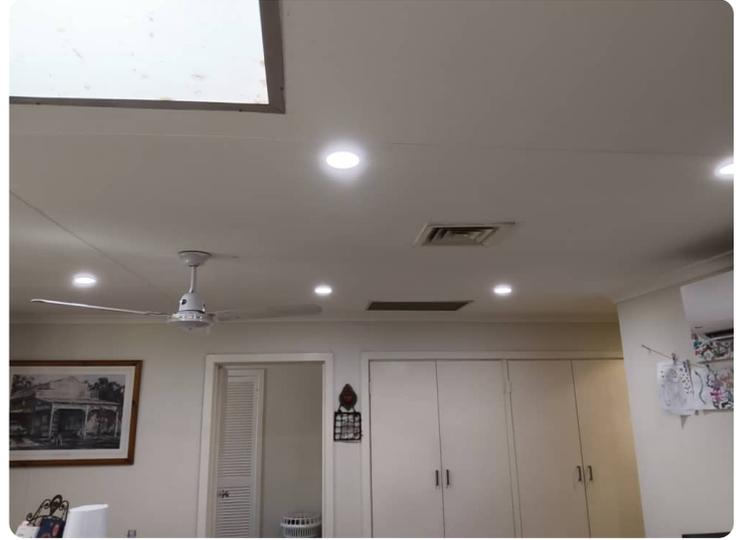
30. Ceilings

The ceilings are constructed of plasterboard with cornices constructed of plasterboard. The condition of the ceilings is satisfactory in relation to its age and will require normal ongoing maintenance.
