Building inspection

Job ID: 90916

Address: 13 Pymn Court, Pegs Creek WA

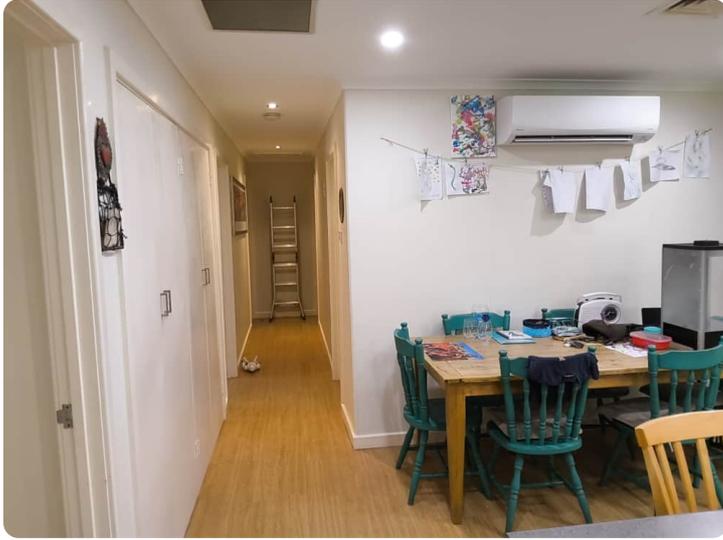
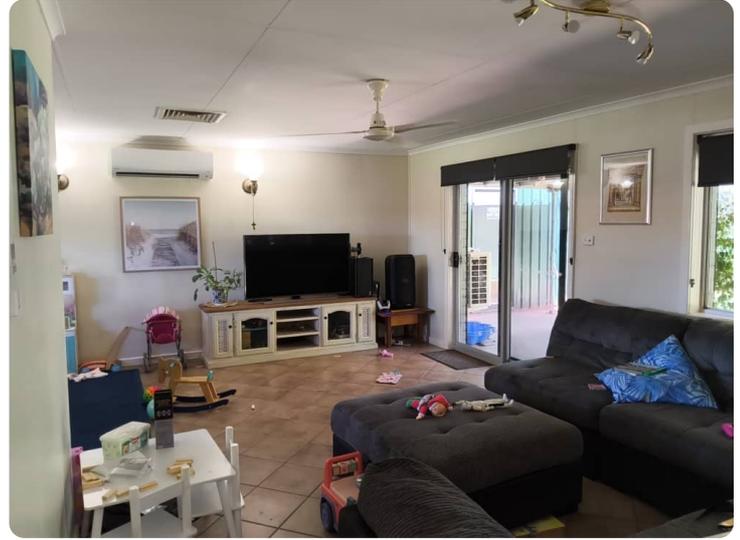
31. Internal walls

The internal walls are constructed of a frame with plaster board cladding. The condition of the internal walls is satisfactory in relation to its age and will require normal ongoing maintenance.

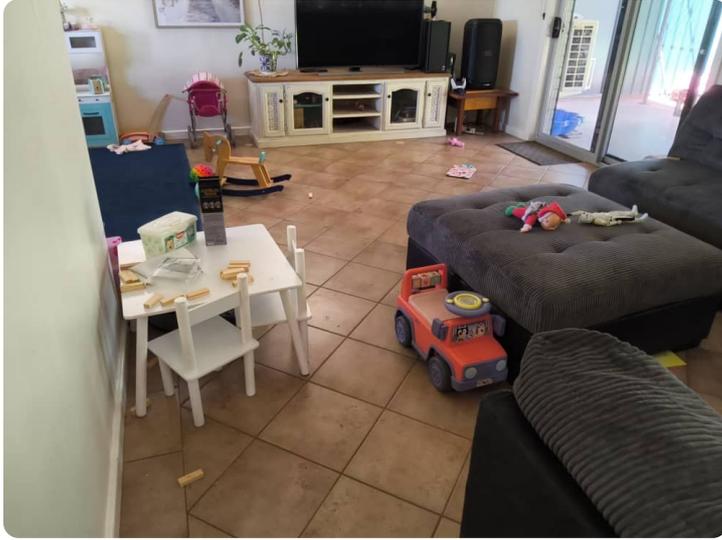
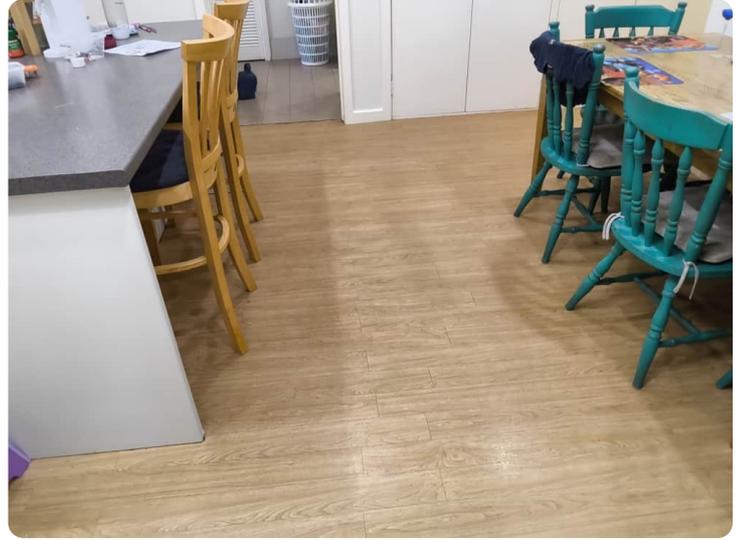
32. Internal floors

The internal floors are constructed of concrete and are covered in a variety of coverings. The condition of the internal floors is unable to be determined as they could not be seen due to coverings.

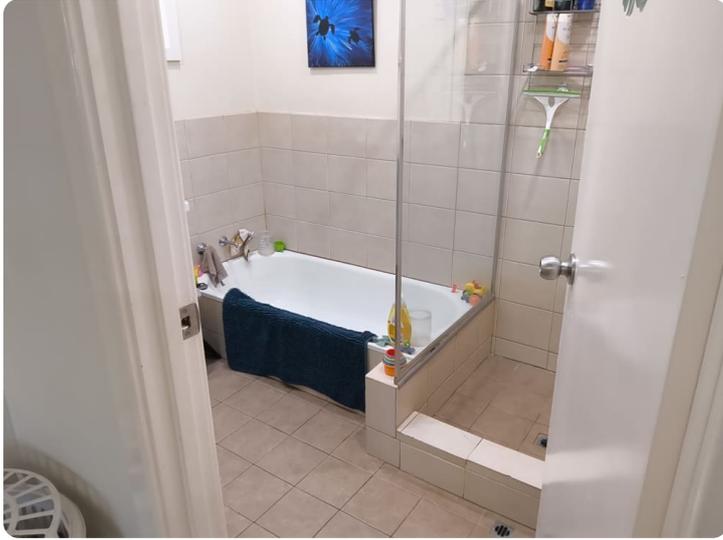
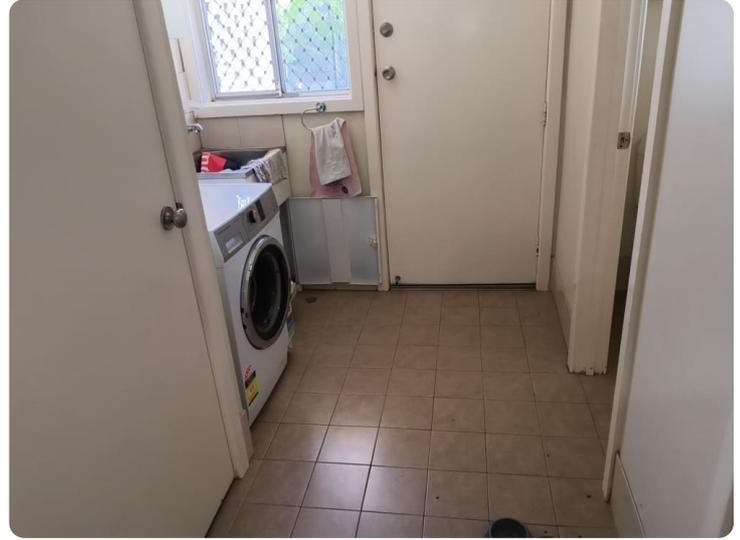
33. Tiled floors and walls

There are areas of internal floors and walls which are covered with a tile covering. The condition of the tiles is satisfactory in relation to its age and will require normal ongoing maintenance.

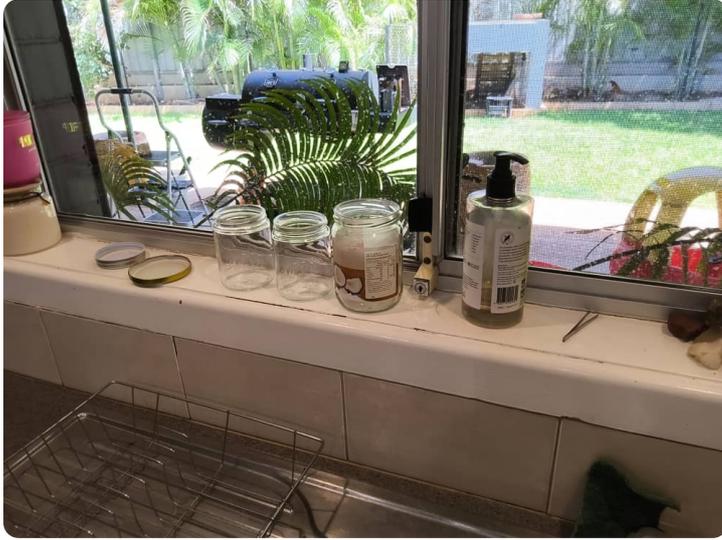
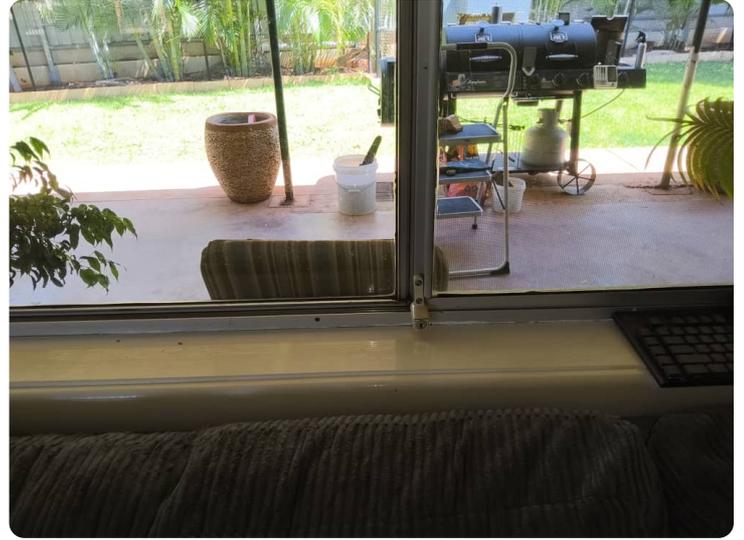
34. Windows (internal)

The condition of the windows, as viewed from within the property, is satisfactory in relation to its age and will require normal ongoing maintenance. Window locks have been installed to all of the windows.

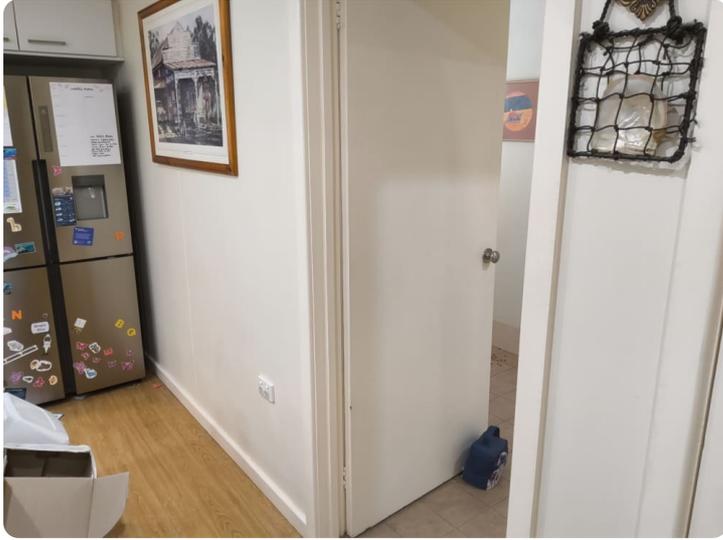
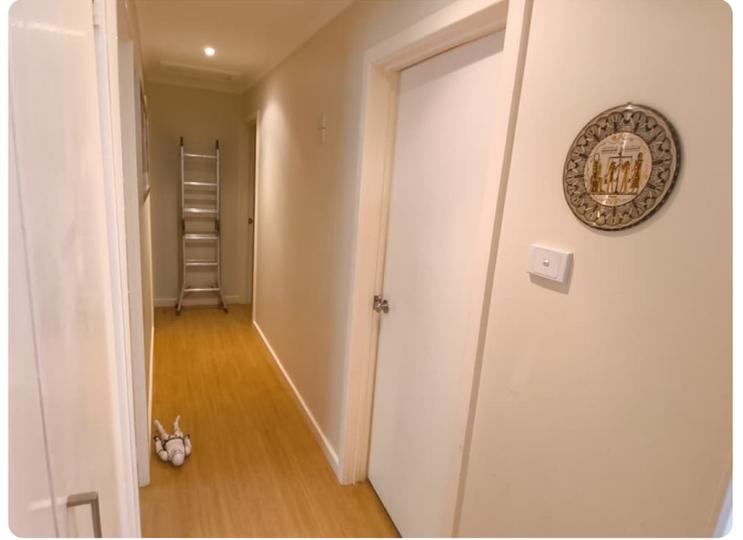
35. Internal doors

The internal doors were mainly constructed of timber hollow core. The condition of the internal doors is satisfactory in relation to its age and will require normal ongoing maintenance.

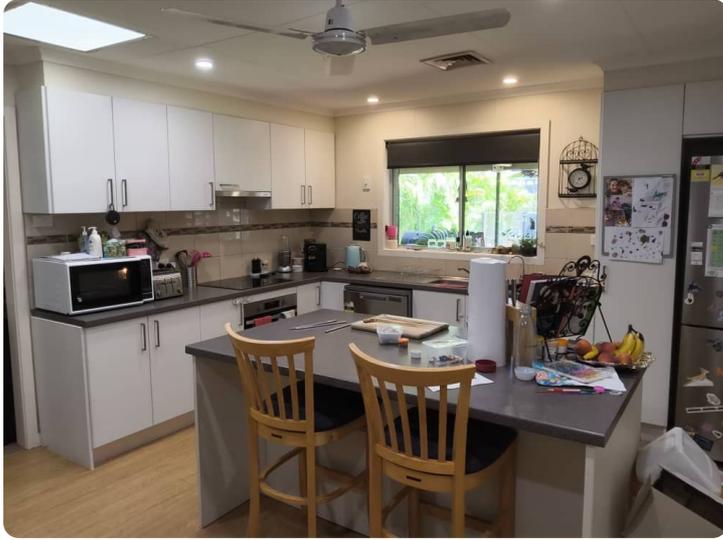
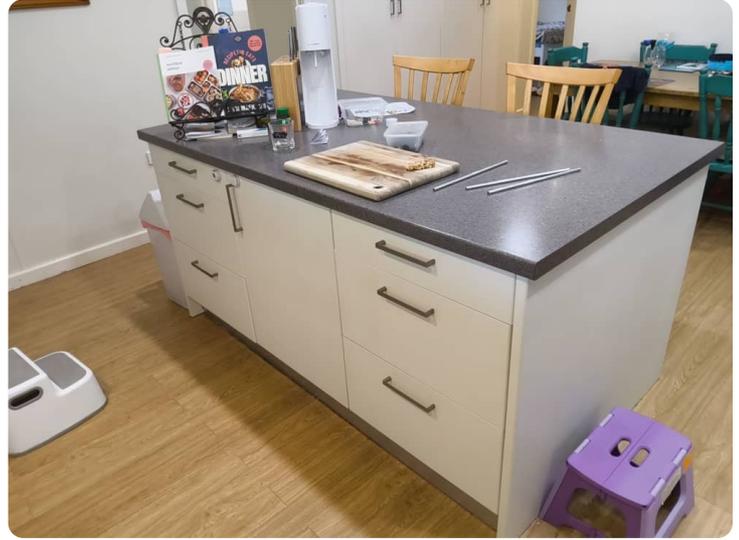
36. Kitchen cabinets

The condition of the kitchen cabinets in general is satisfactory in relation to their age and require normal maintenance.

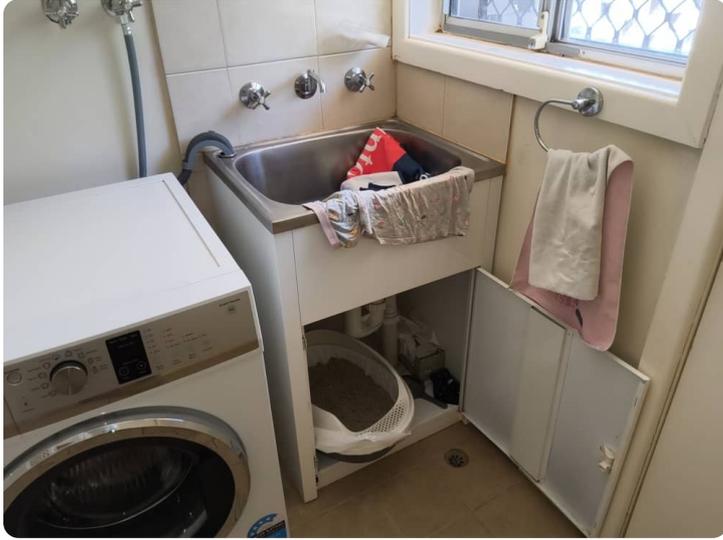
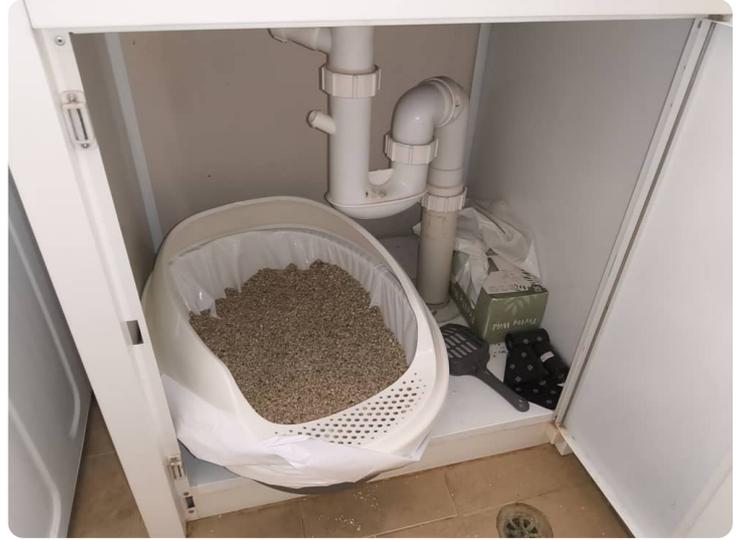
37. Laundry cabinets

The condition of the laundry cabinets is satisfactory in relation to their age and require normal maintenance.

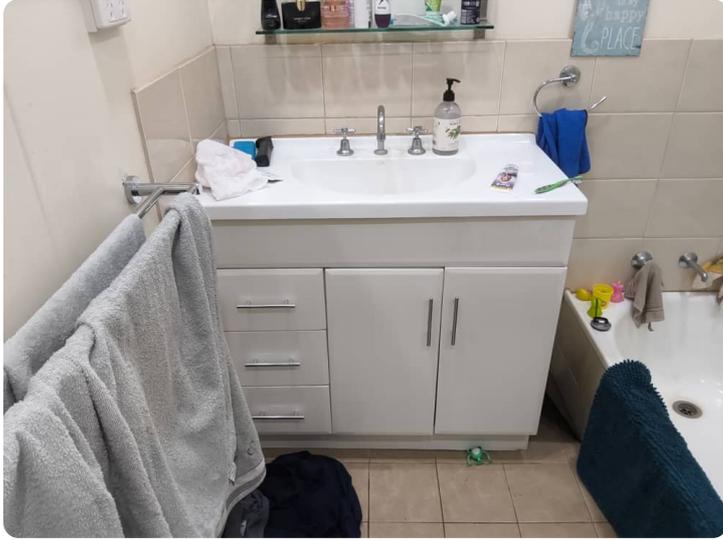
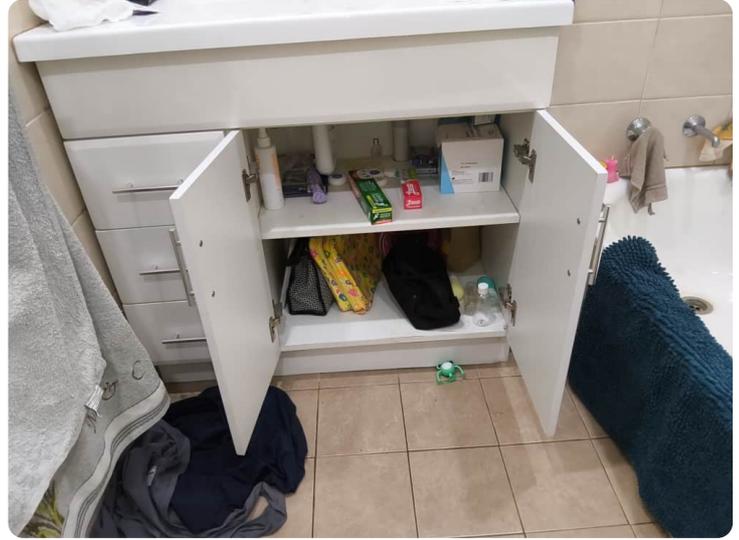
38. Bathroom cabinets

The condition of the bathroom cabinets is satisfactory in relation to their age and require normal maintenance.

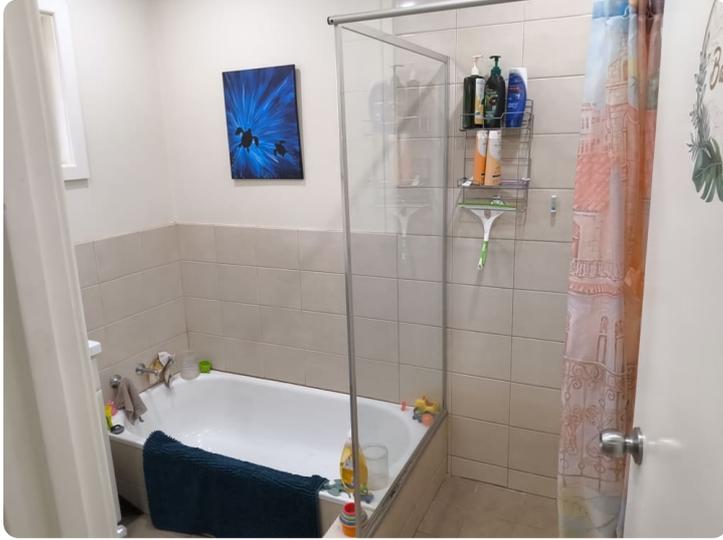
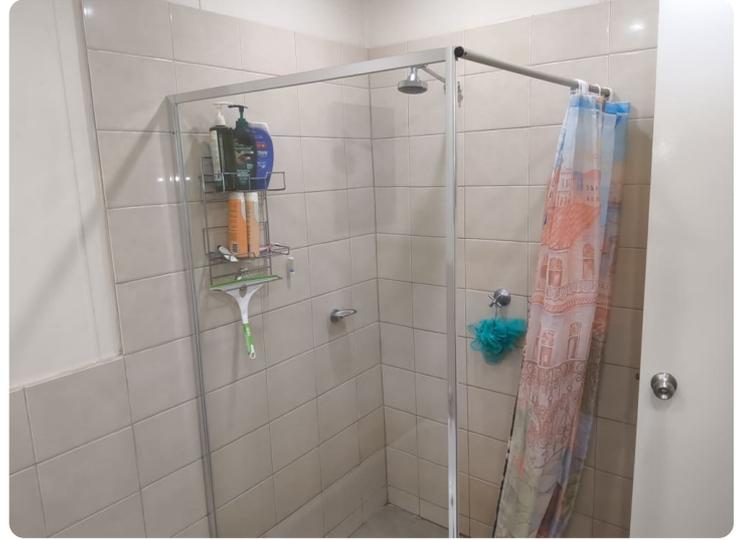
39. Shower screens

The condition of the shower screens is satisfactory in relation to their age and require normal maintenance.

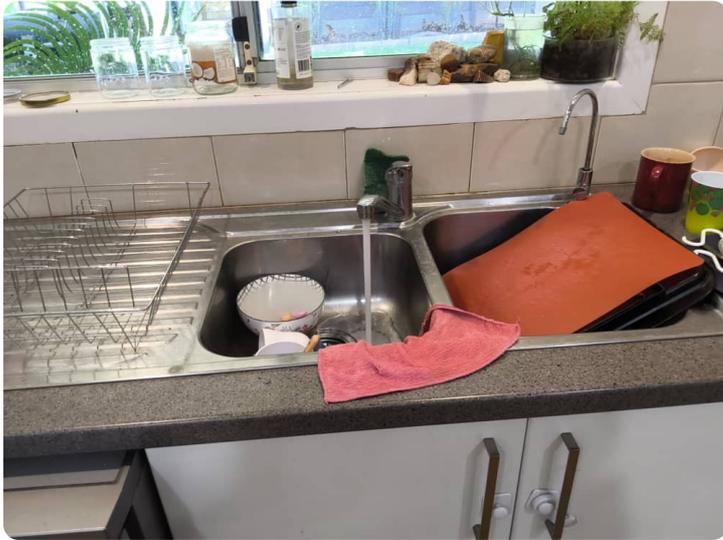
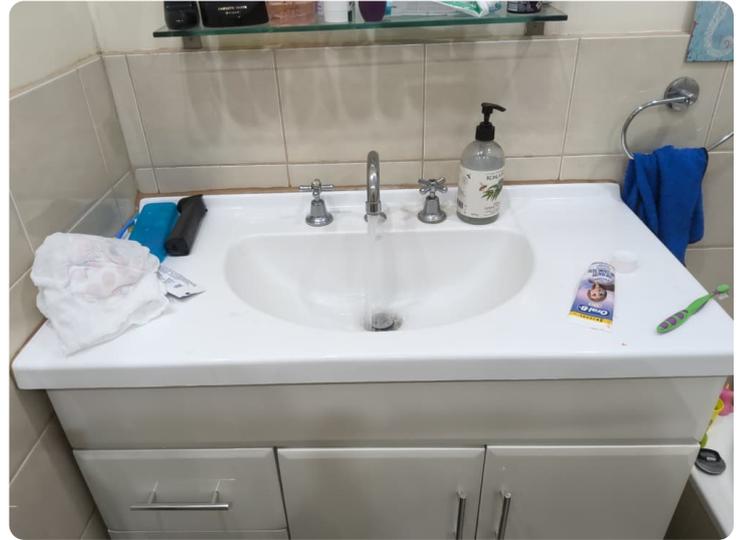
40. Plumbing

The taps to multiple areas were turned on and the water flow appeared to be reasonable. Water draining to several sinks and toilets appeared to be reasonable. The Building Inspector is not a Plumbing Contractor and is not permitted to test Plumbing items under WA Law. Where appropriate a Plumbing Contractor should be engaged to test the plumbing in the property.

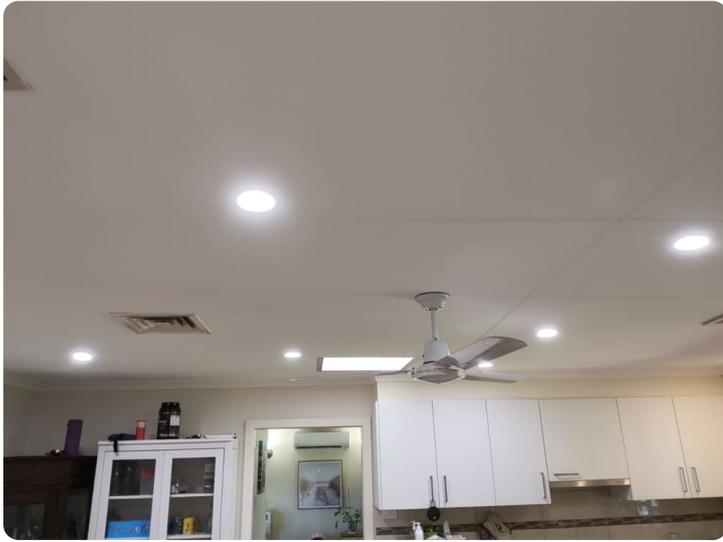
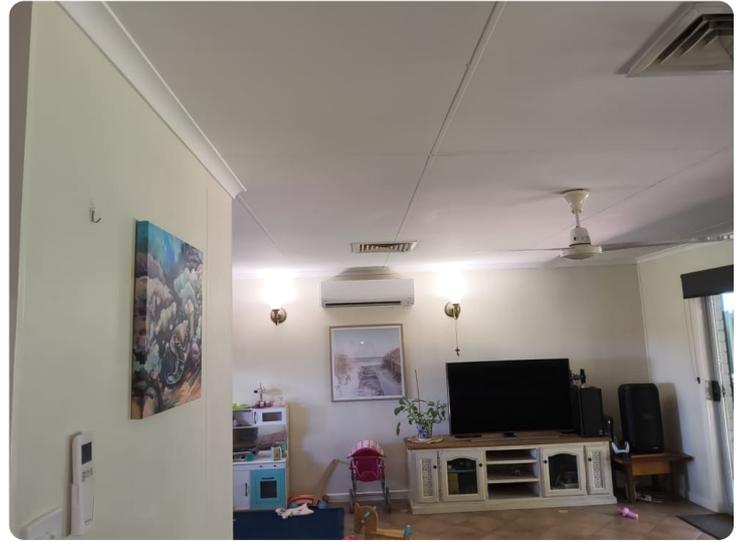
41. Lights and power points

Several lights were turned on during the inspection and the lights appeared to be operational. The Building Inspector is not an Electrical Contractor and is not permitted to test Electrical items under WA Law. Where appropriate an Electrical Contractor should be engaged to test the electrical items in the property.

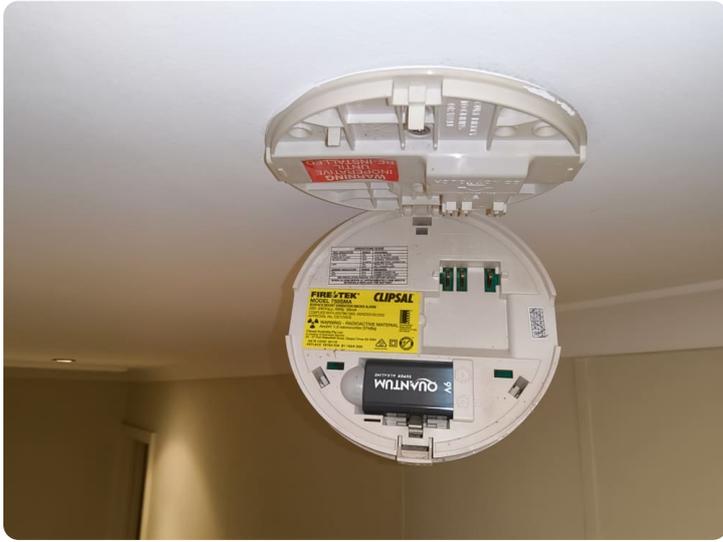
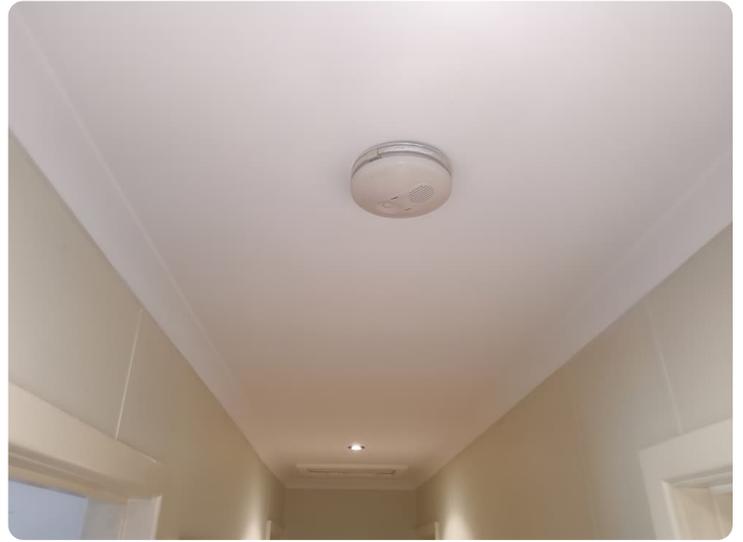
42. Smoke Alarms

There was one hardwired smoke alarms on site. There were no battery smoke alarms on site. The location, number and type of smoke alarms appeared to be inconsistent with Legislative requirements. It is suggested that an Electrical Compliance Certificate be obtained in relation to the smoke alarms.
