# **Houspect**

### **Pre purchase inspection**

**Job ID:** 92957

**Address:** 44 Campbell Cres, Baynton WA 6714

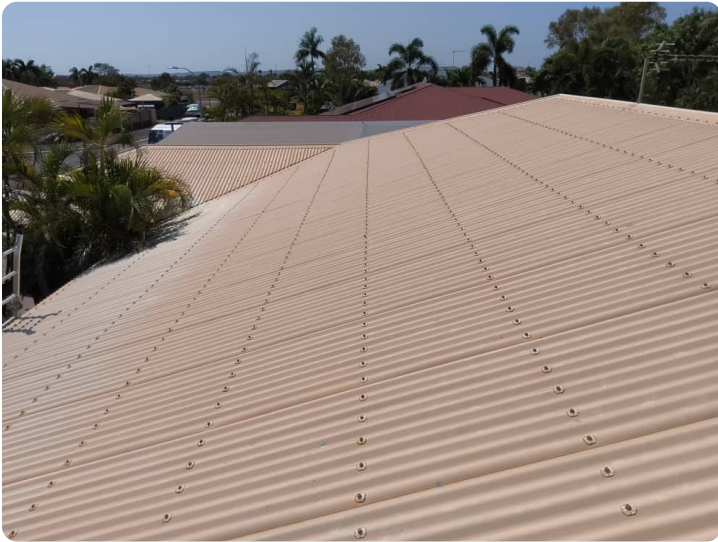
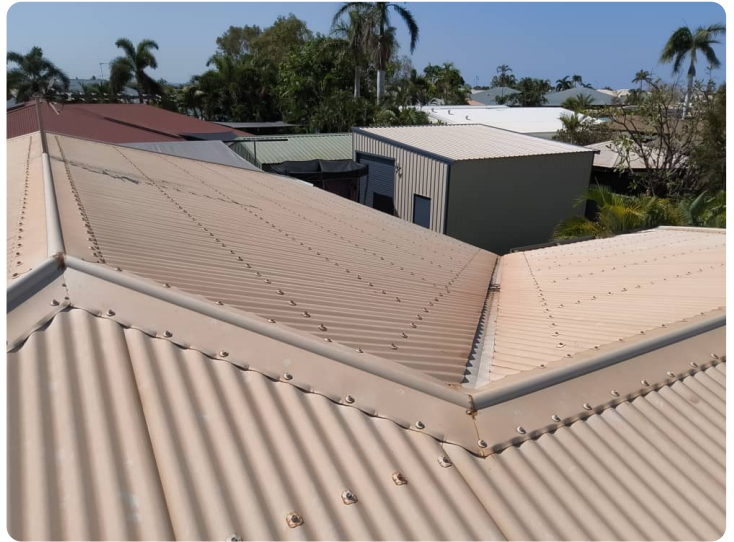
## 1. Roof covering

The roof covering is constructed of colorbond. The condition of the roof covering is satisfactory in relation to its age and will require normal ongoing maintenance.

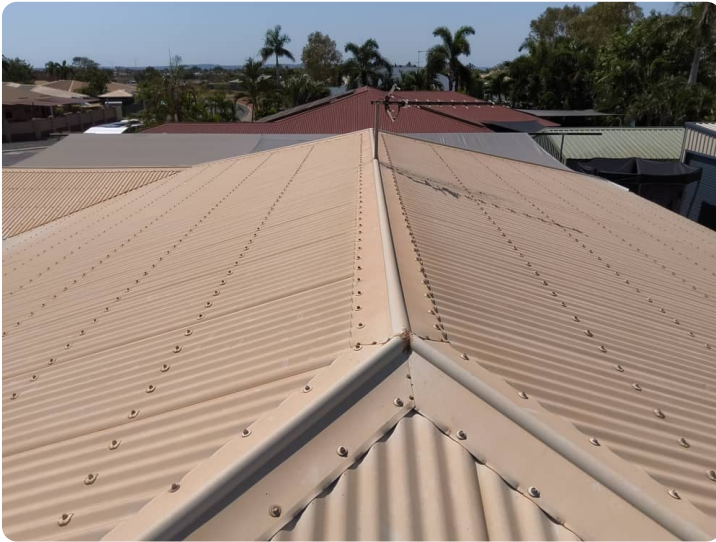
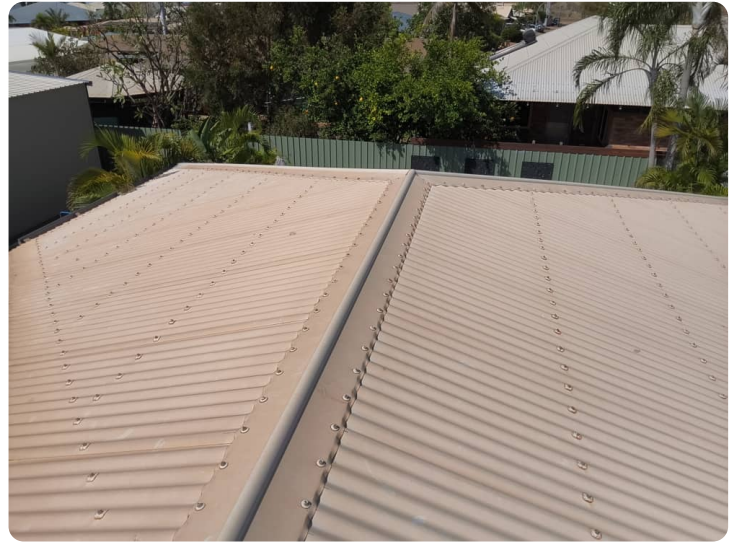
## 2. Ridges

The ridges and capping are satisfactory in relation to its age and will require normal ongoing maintenance.

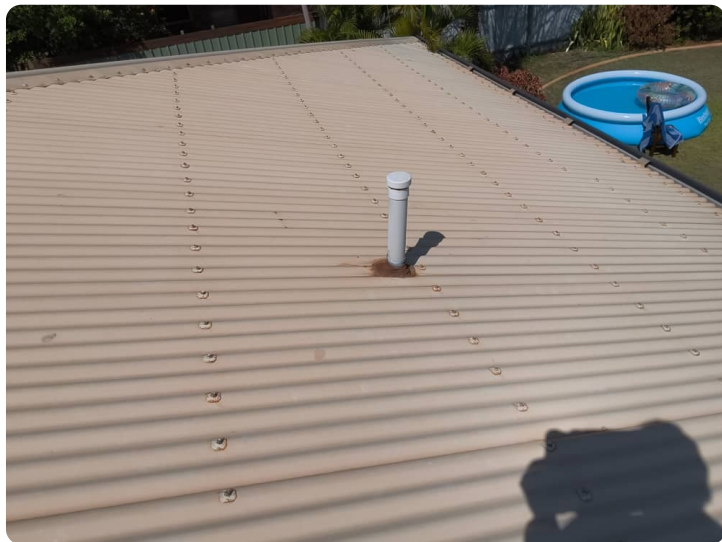
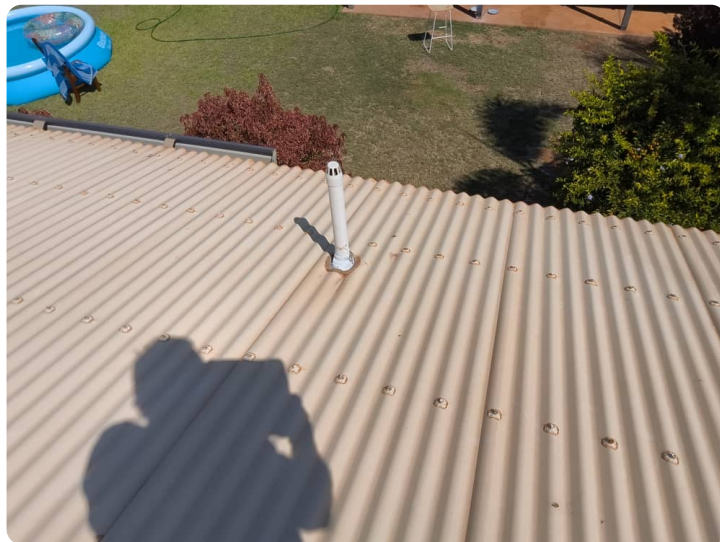
### 3. Flashings

The flashings are covered with a variety of finishes and are constructed of a mixture of materials. The condition of the flashings is satisfactory in relation to their age and will require normal ongoing maintenance.

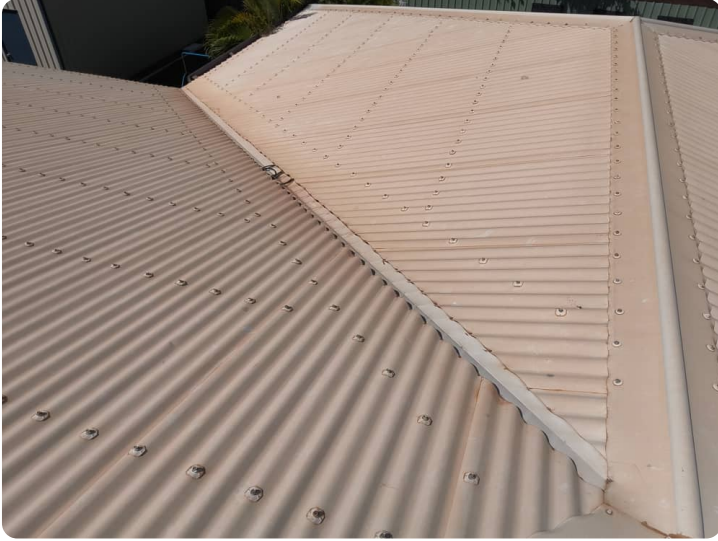
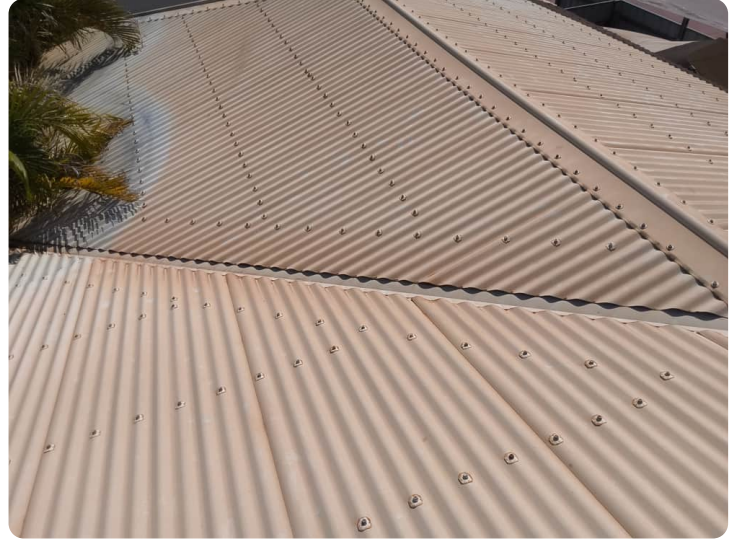
#### 4. Valleys

The valleys are constructed of metal and have a colorbond covering. The condition of the valleys is satisfactory in relation to their age and will require normal ongoing maintenance. The valleys appear to be relatively free of debris.

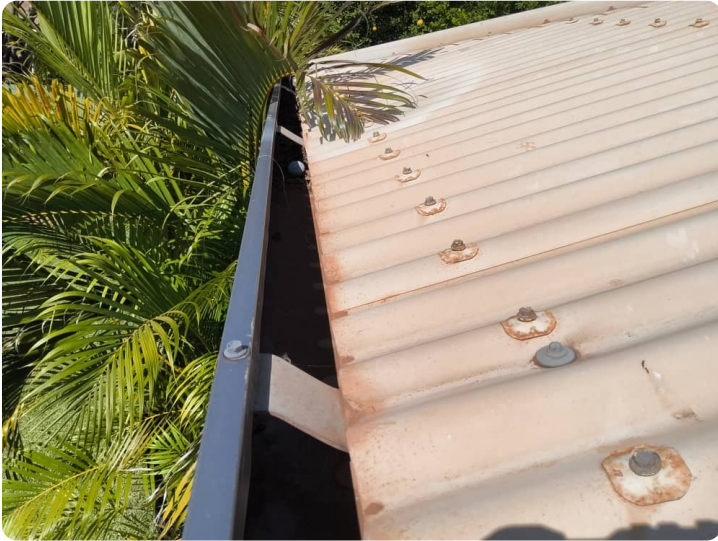
## 5. Gutters

The gutters are constructed of metal and they have a colorbond covering. The condition of the gutters is satisfactory in relation to their age and will require normal ongoing maintenance. The gutters need to be cleared of debris.

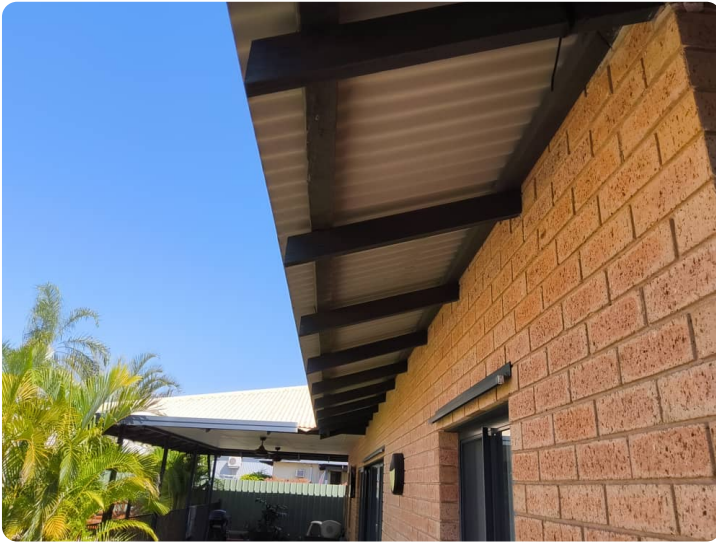
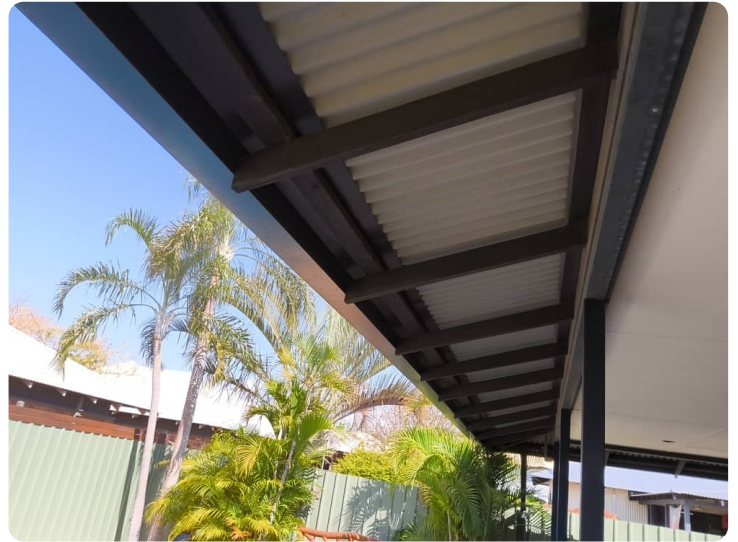
## 6. Eaves

The eaves are exposed and constructed of exposed rafters. The condition of the eaves is satisfactory in relation to their age and will require normal ongoing maintenance.

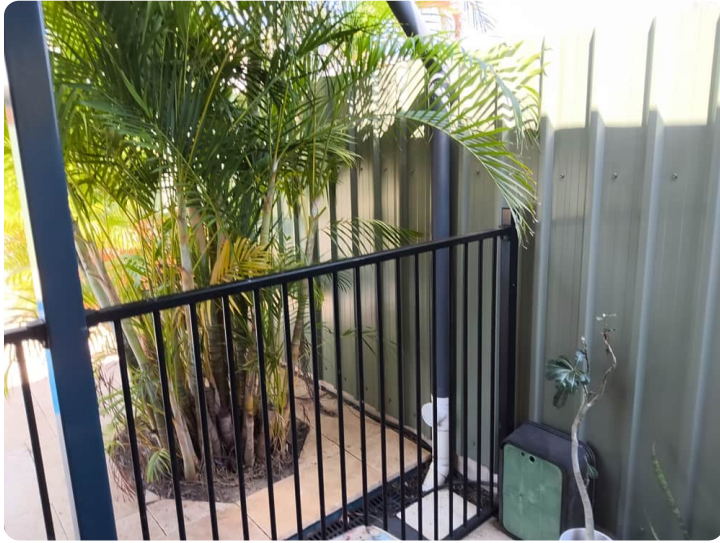
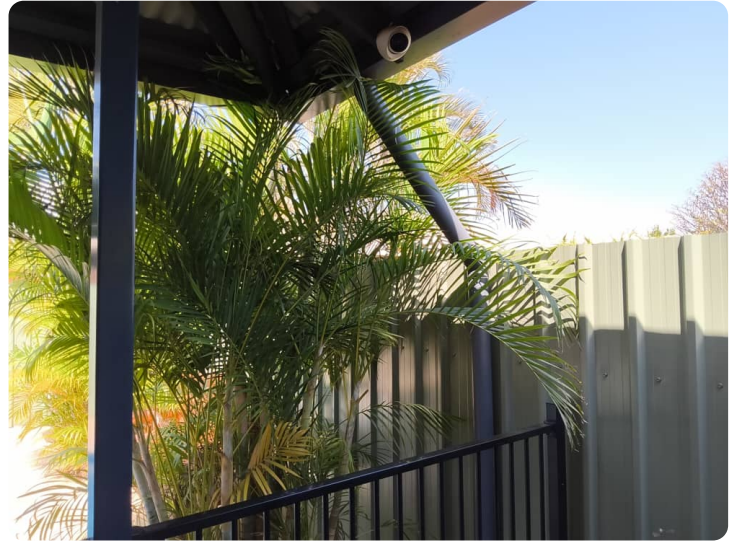
## 7. Downpipes

The downpipes are constructed of pvc or similar and they are painted. The condition of the downpipes is satisfactory in relation to their age and will require normal ongoing maintenance. The downpipes are all connected to soakwells or divert storm water well away from the building.

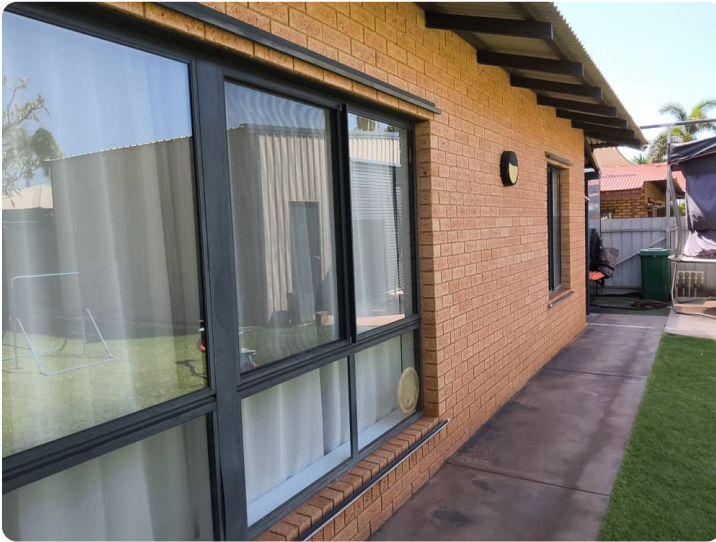
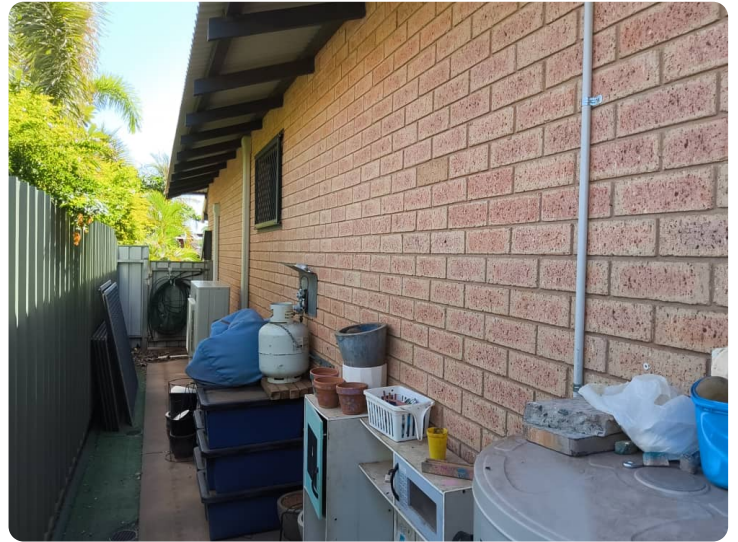
## 8. External walls

The external walls are constructed of brick. The condition of the walls generally is satisfactory in relation to their age and will require normal ongoing maintenance.

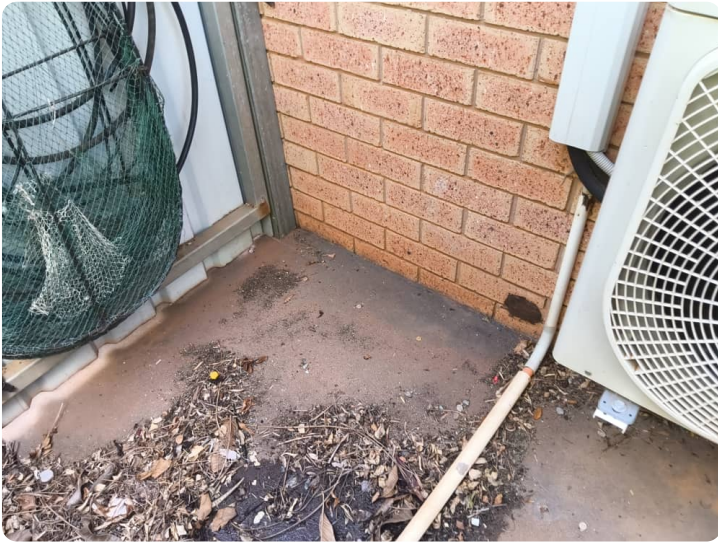
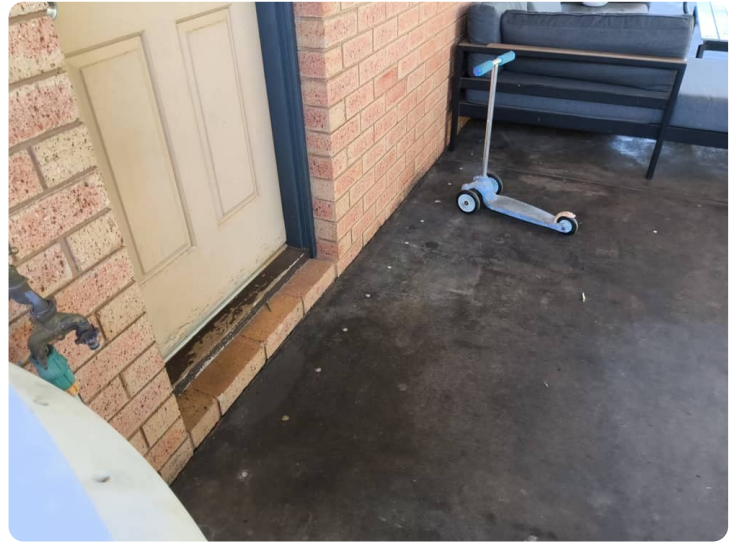
## 9. Footings

The footings are below ground and cannot be seen. The condition of the footings cannot be determined.

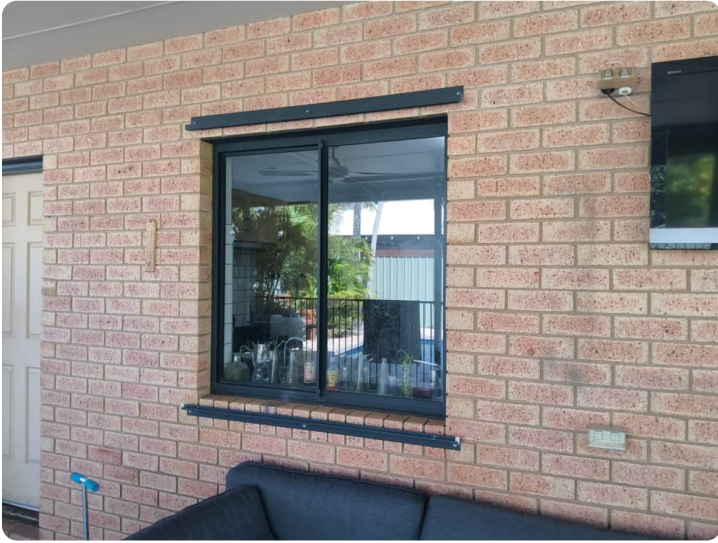
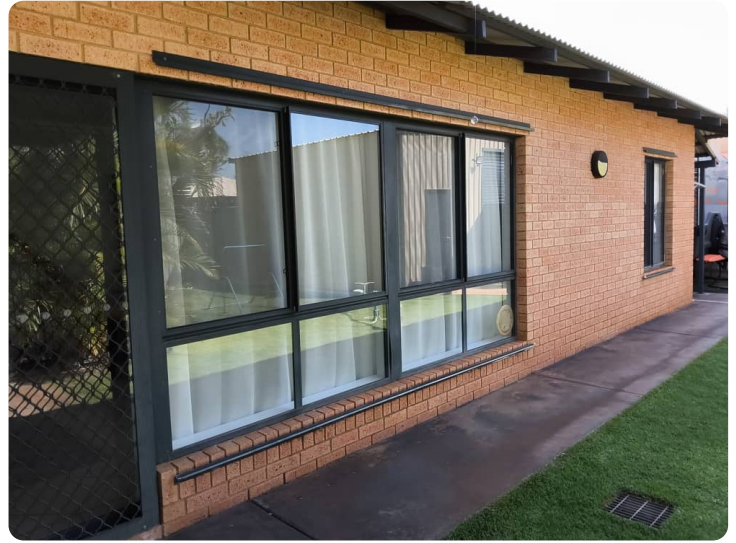
## 10. Windows and window frames

The window and window frames are primarily constructed of aluminium. The condition of the window and window frames is generally satisfactory in relation to its age and will require normal ongoing maintenance.

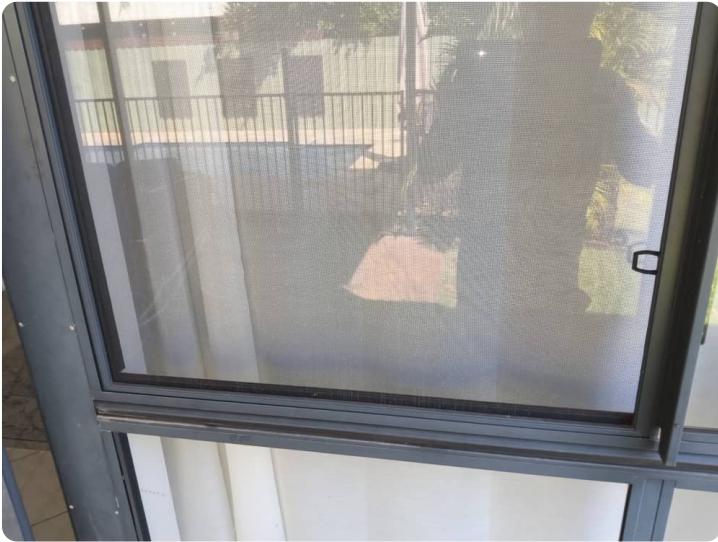
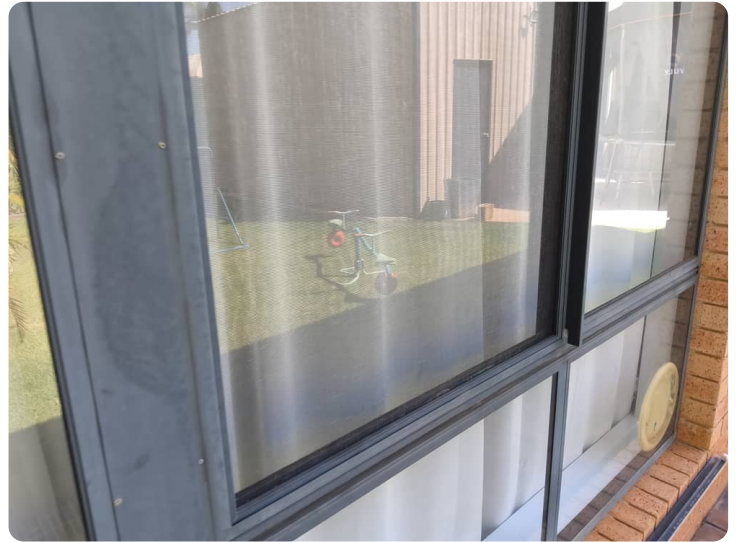
## 11. Window fly screens

Fly screens have been installed to all of the windows. The condition of the window fly screens is generally satisfactory in relation to its age and will require normal ongoing maintenance.

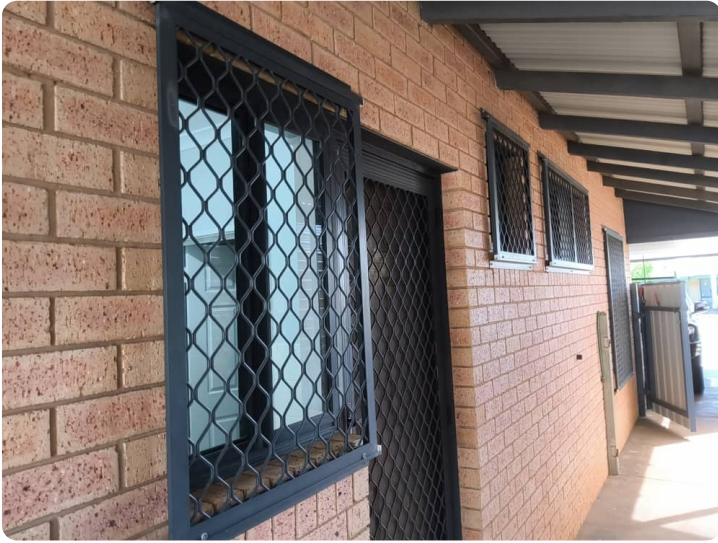
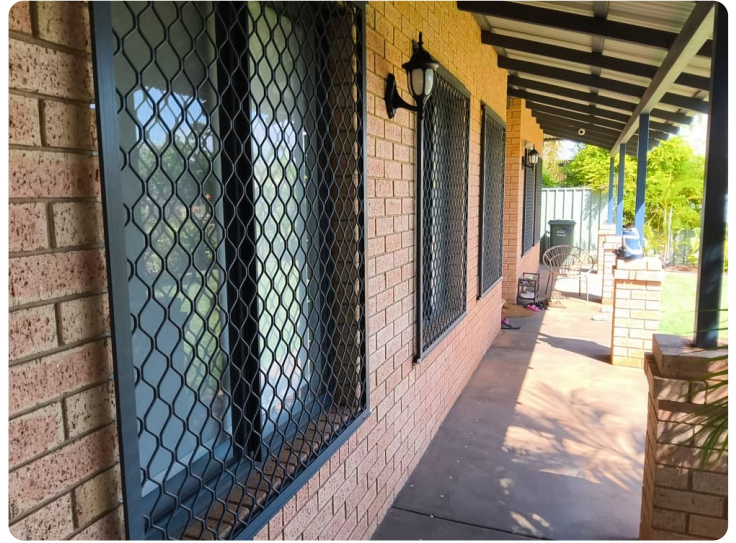
## 12. Cyclone screens

Cyclone screens have been installed to all of the windows. The condition of the cyclone screens is satisfactory in relation to its age and will require normal ongoing maintenance. The cyclone screens appear to be compliant with local requirements.

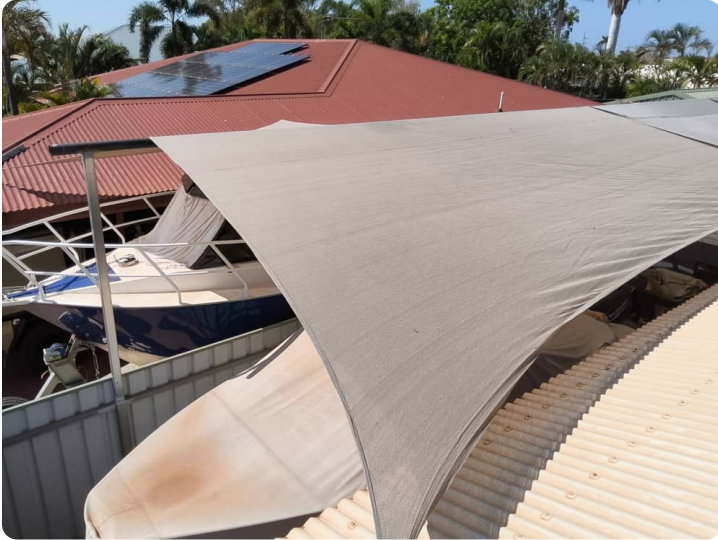
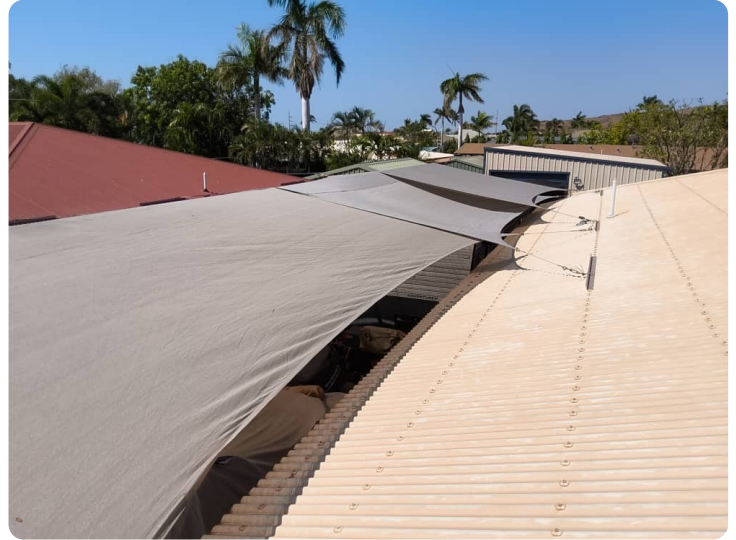
### 13. Shade sails

Shade sails have been installed at the property. The condition of the shade sails is satisfactory in relation to its age and will require normal ongoing maintenance.

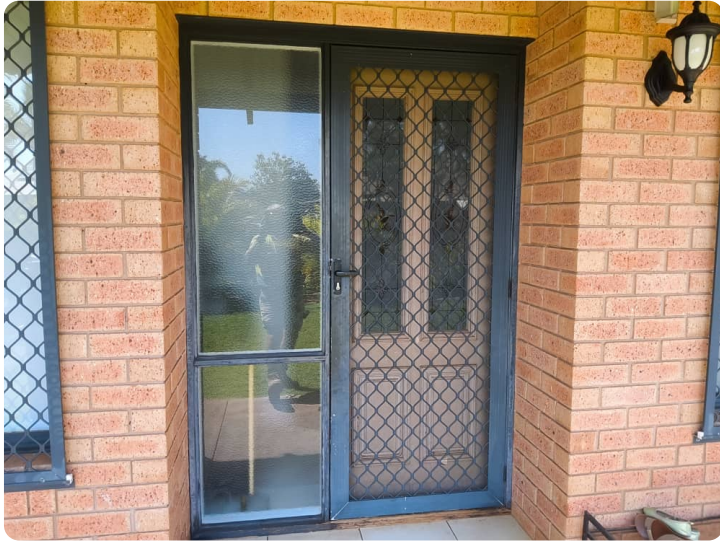
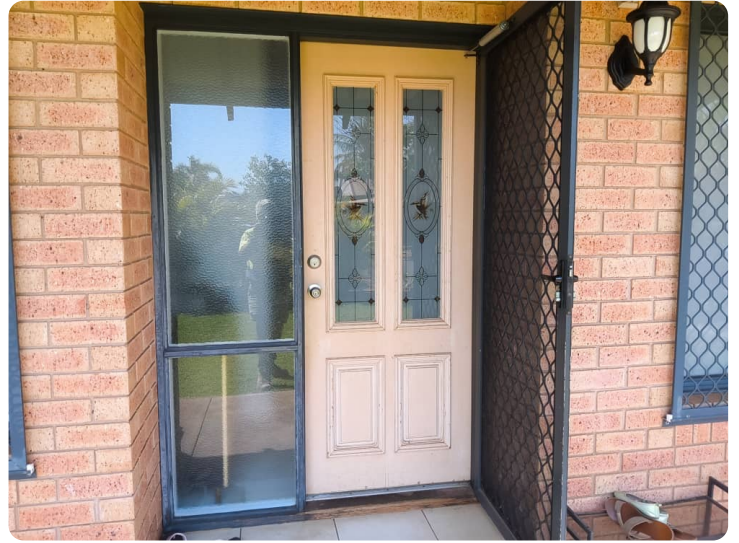
#### 14. Front door

The front door is constructed of timber and glass. The condition of the front door is satisfactory in relation to its age and will require normal ongoing maintenance. Deadlocks have been installed. A security screen door has not been fitted.

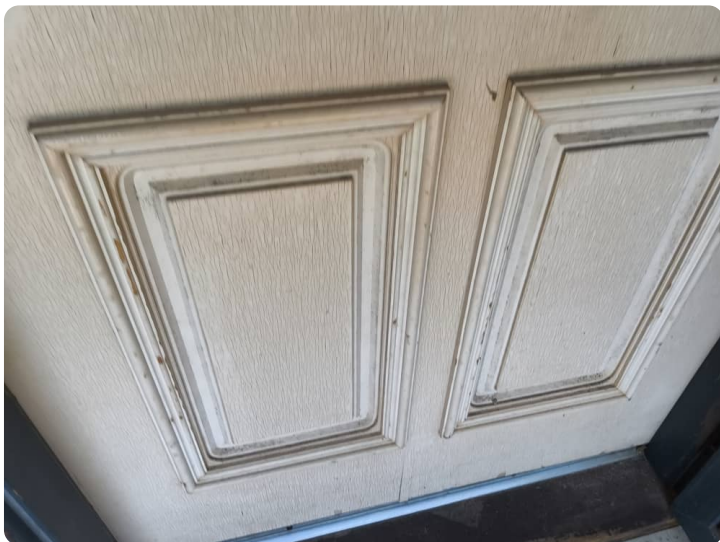
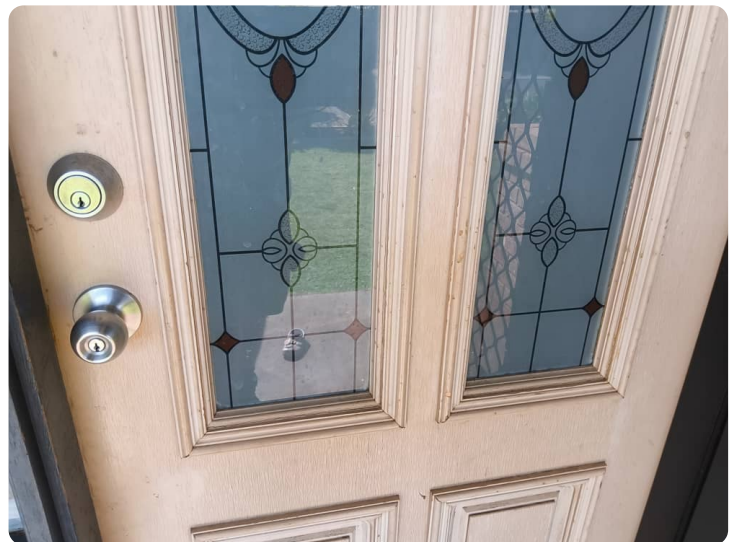
##### 14.1 Door painting required

As per the images the door requires painting to prolong its life.

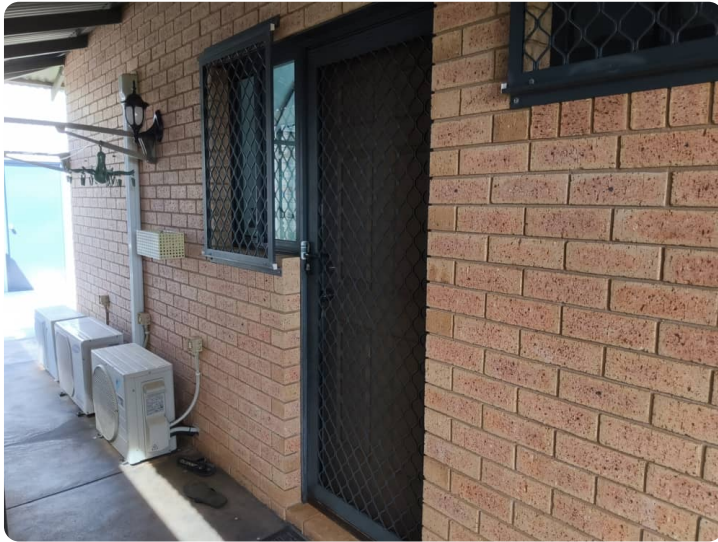
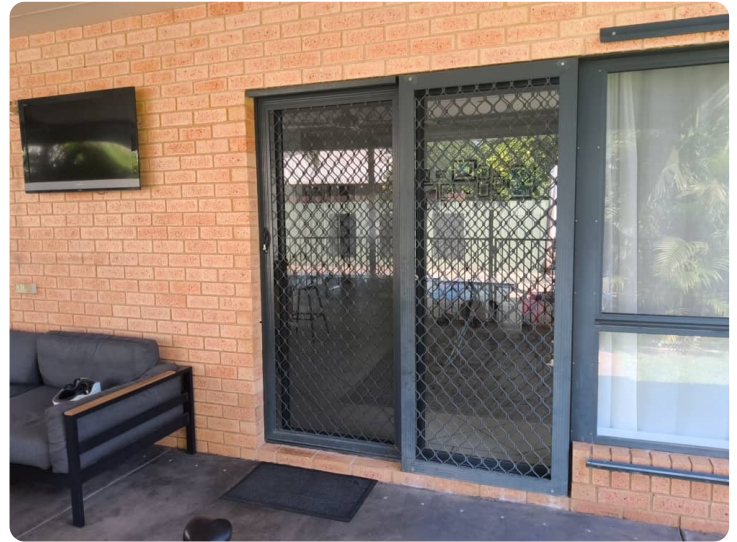
### 15. Other external doors

Other external doors are constructed of a variety of materials. The condition of the other external doors is satisfactory in relation to its age and will require normal ongoing maintenance.

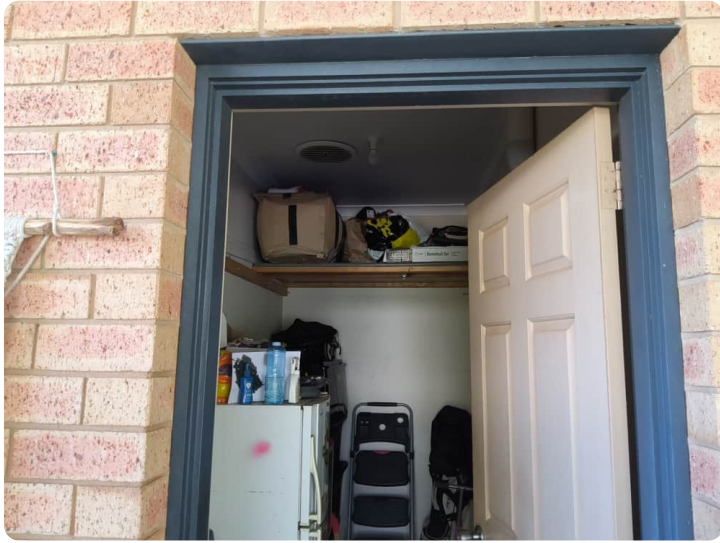
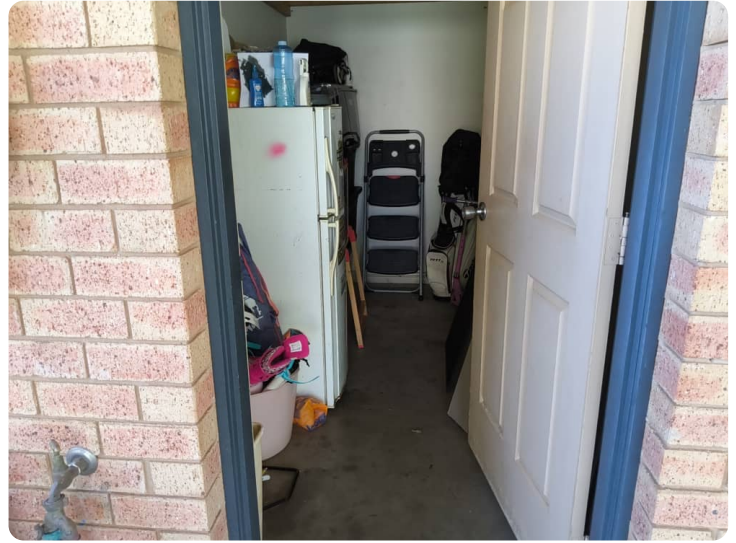
## 16. Storeroom 1

An external storeroom for the property is located adjacent and under the main roof of the building. The condition of the storeroom is satisfactory in relation to its age and will require normal ongoing maintenance. Access and visibility of the area was restricted by stored items.

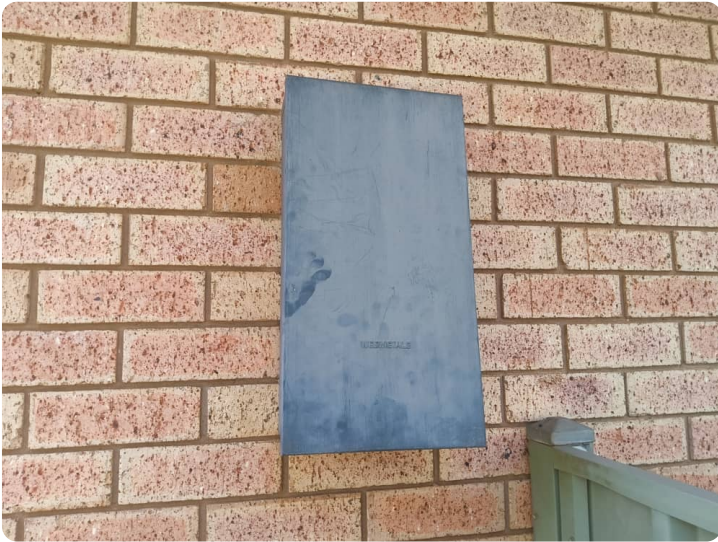
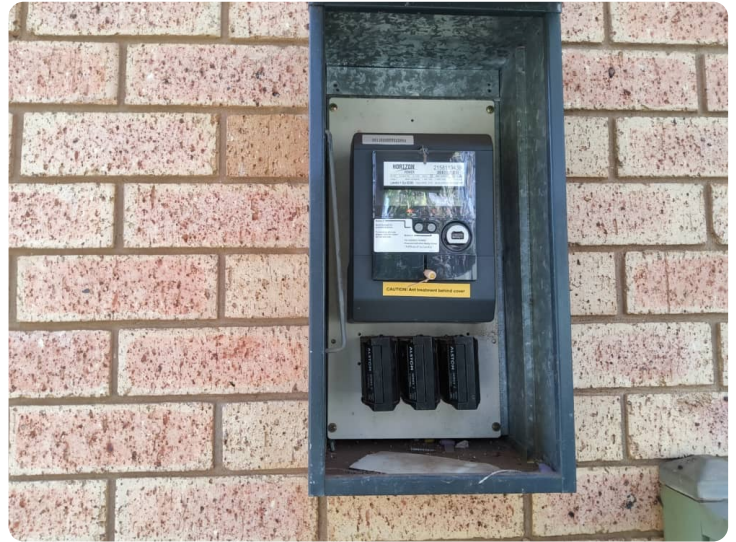
## 17. Meter box and power

Access to the meter box or sub board was available. The meter box or sub board is not lockable. Power phase type to the site is three phase.

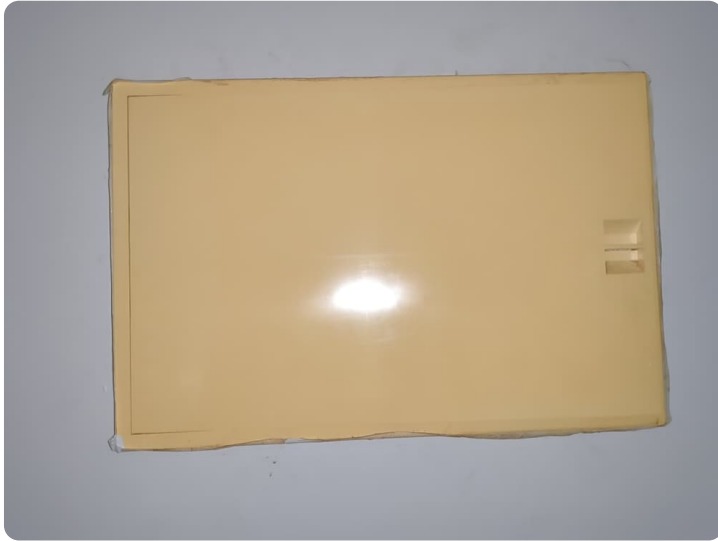
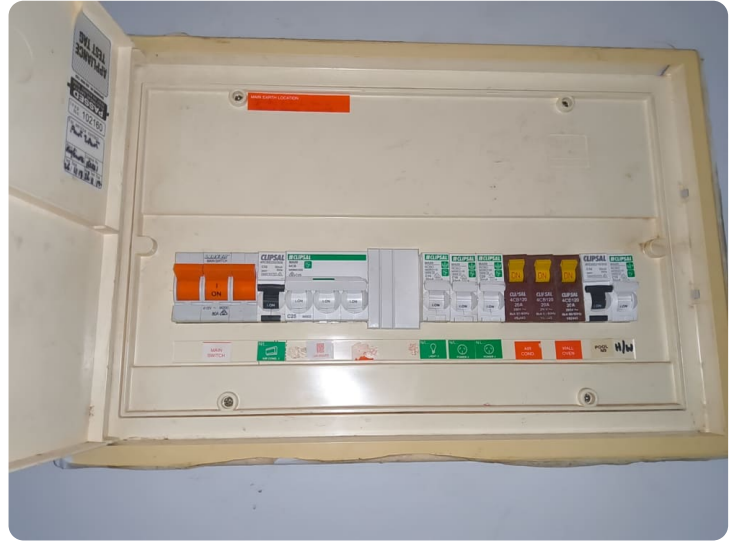
## 18. Residual Current Devices

There were multiple Residual Current Devices (RCD)(s) noted in the meter box or sub meter box. The RCD(s) were not tested. It is suggested that an Electrical Compliance Certificate be obtained in relation to the RCD(s).

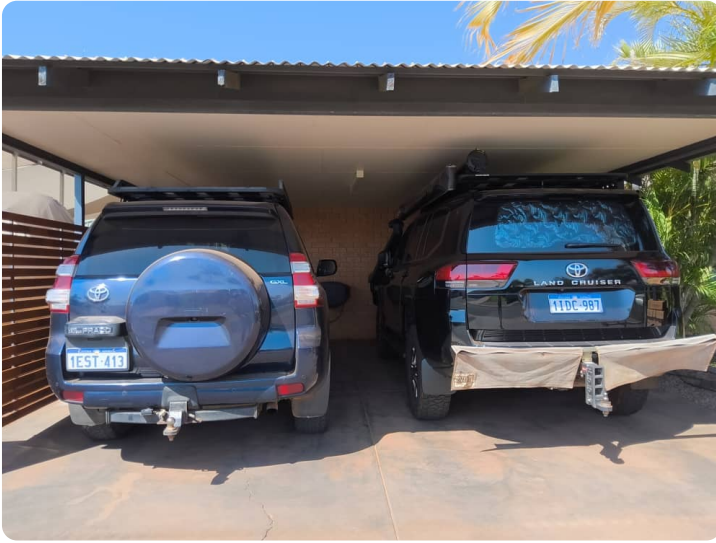
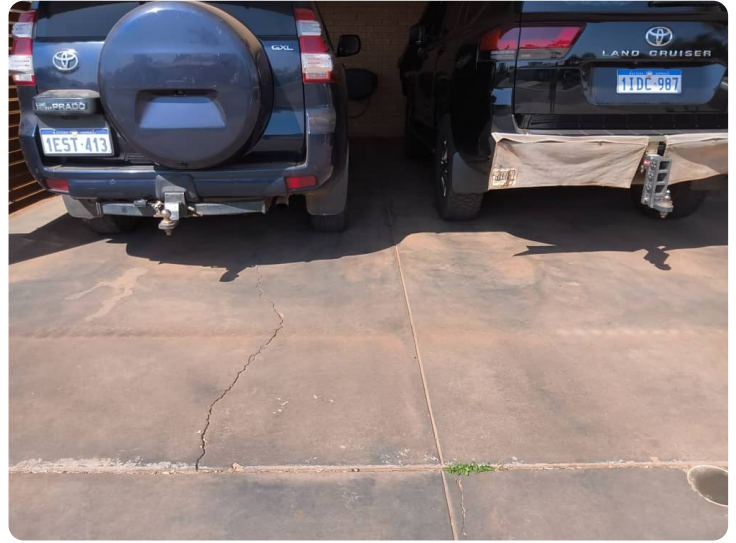
There is a primary carport on the property constructed of same materials as the primary structure. The condition of the carport or garage is satisfactory in relation to its age and will require normal ongoing maintenance.

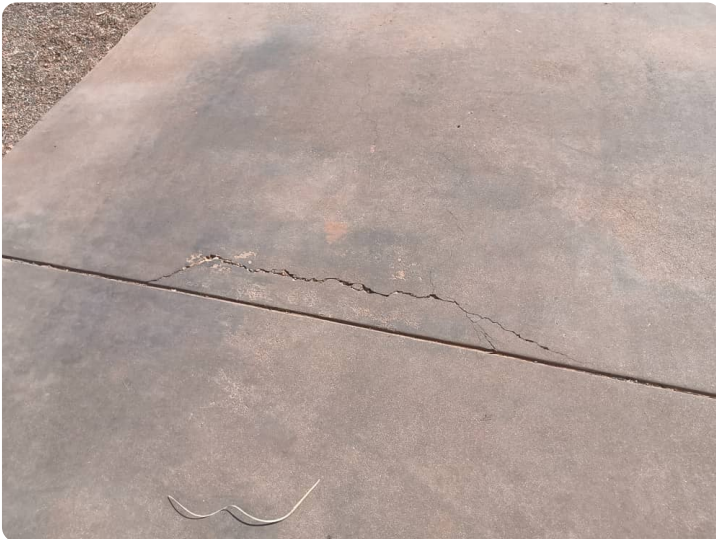
### 25.1 Concrete cracking - major

Significant cracking was noted to the concrete paving. This is not of a structural concern however repairs are required.

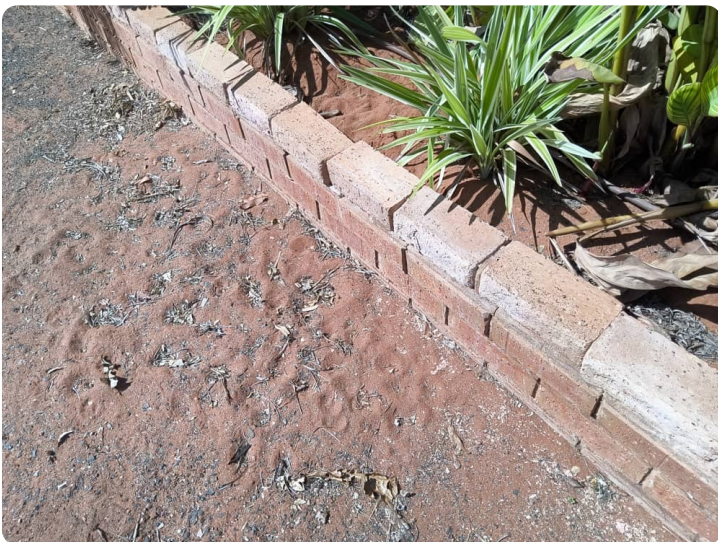
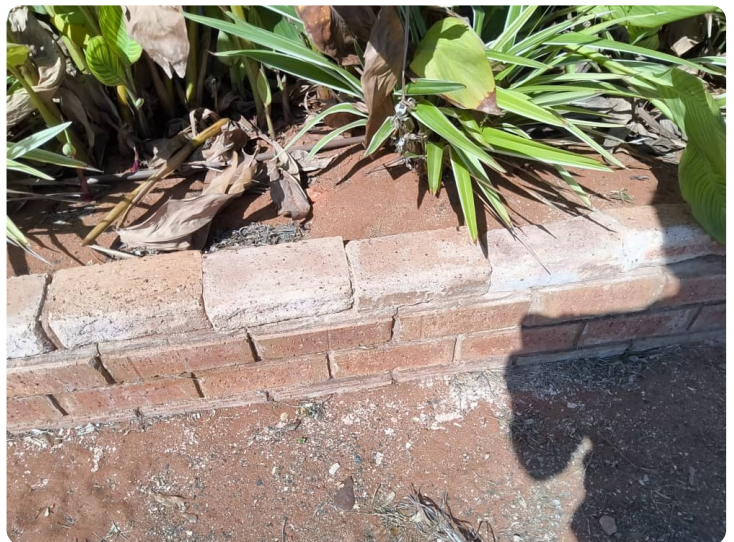
### 28.1 Movement and or deflection - minor

There was some movement and deflection visible that is consistent with the age and type of construction. The movement and deflection is not of a structural nature at this stage.

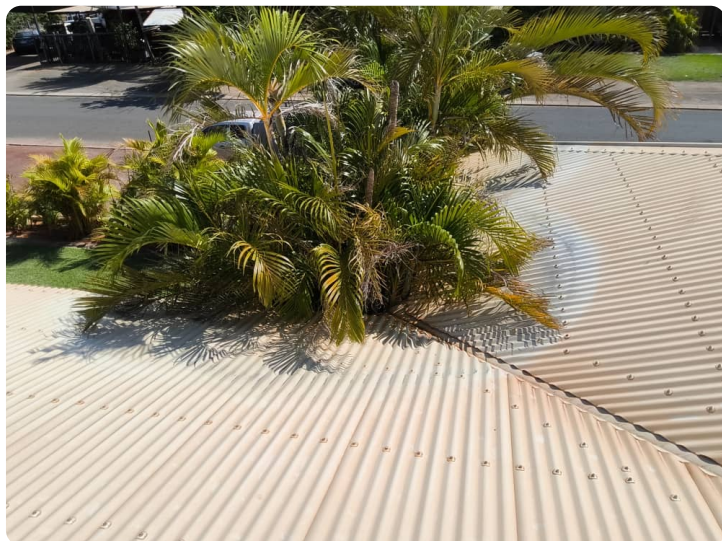
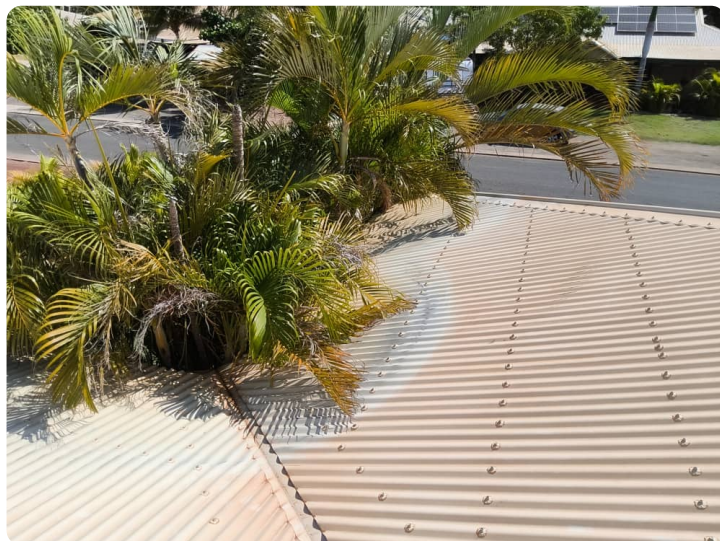
There are trees and or vegetation which are or may be adversely impacting the building or other structures on the property.

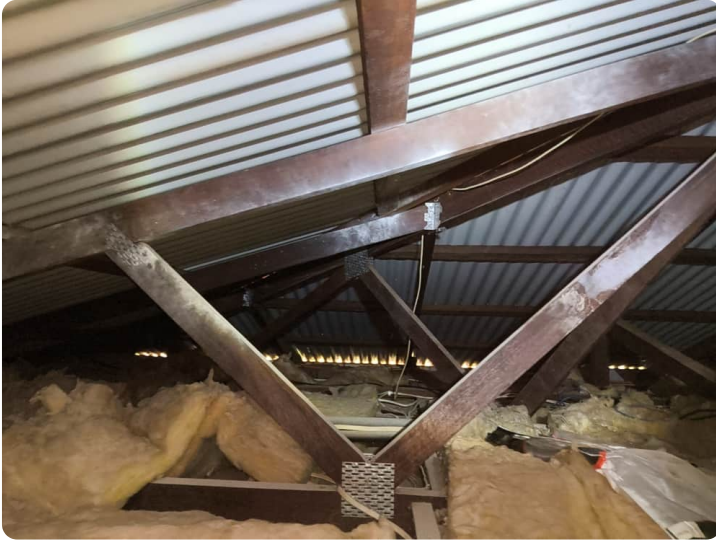
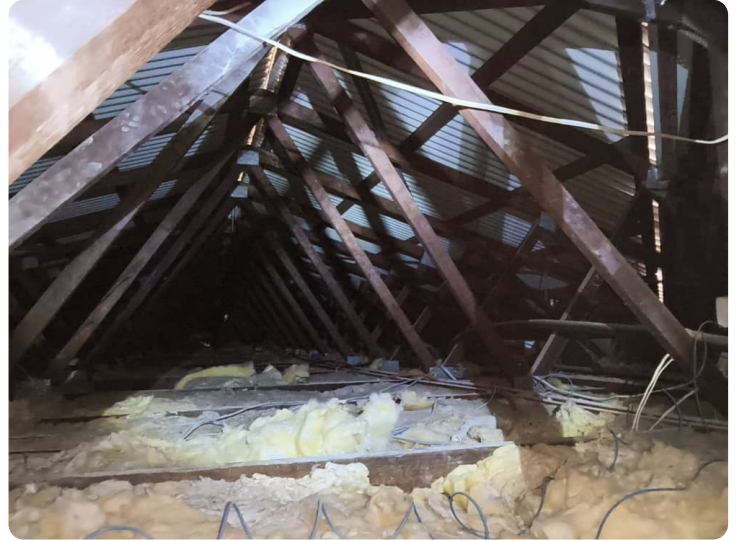
Sarking to the underside of the roof was not installed and was not considered effective.

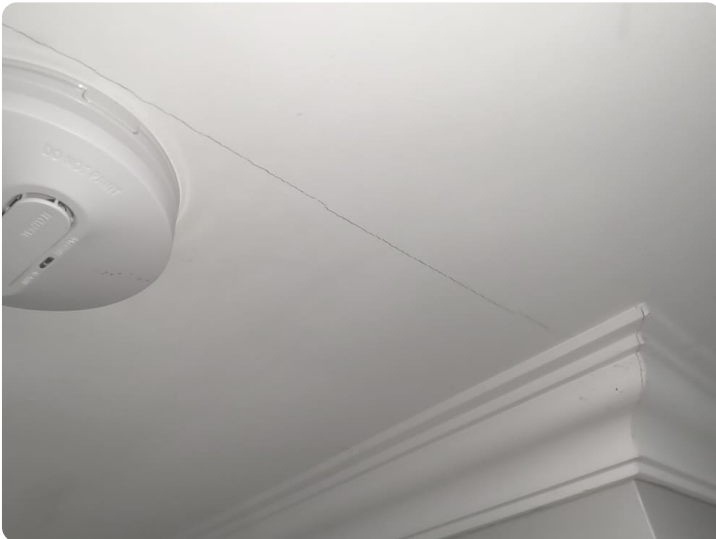
#### 35.1 Cracking - minor

The ceilings in the images contain multiple cracks, likely caused by thermal expansion and contraction. This is not a structural issue but repairs are required.

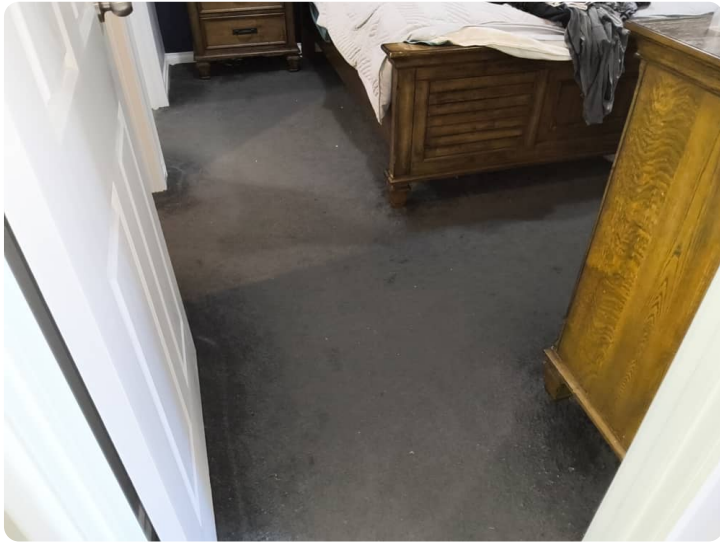
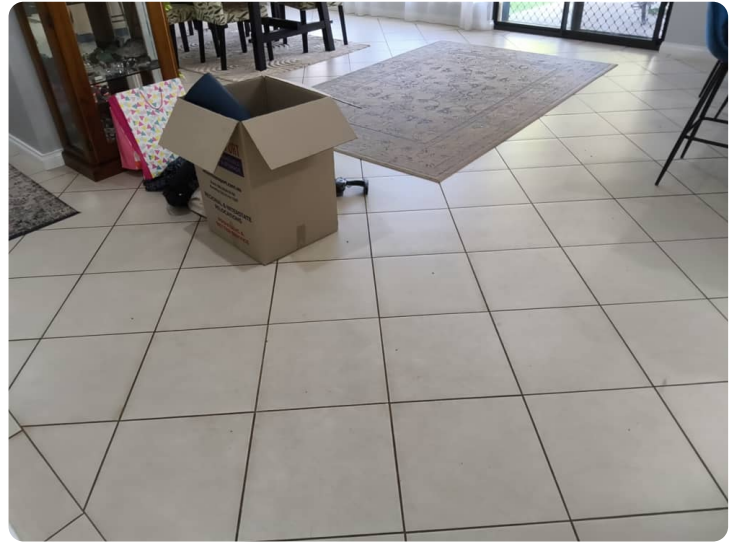
The internal floors are constructed of concrete and are covered in a variety of coverings. The condition of the internal floors is unable to be determined as they could not be seen due to coverings.

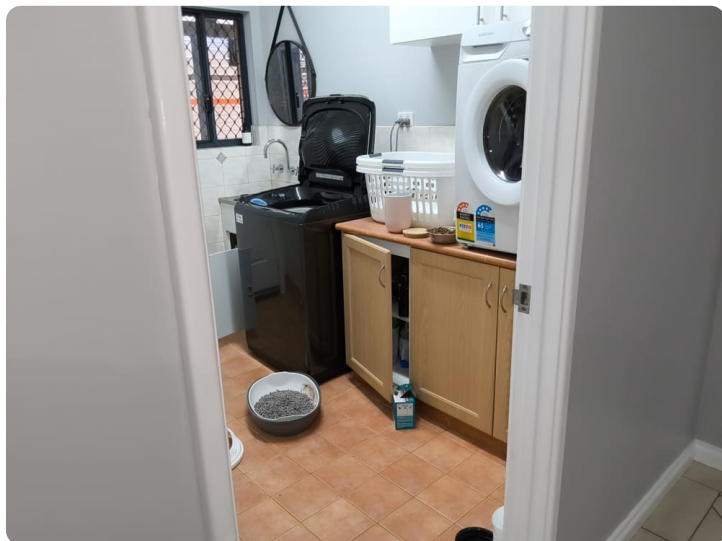
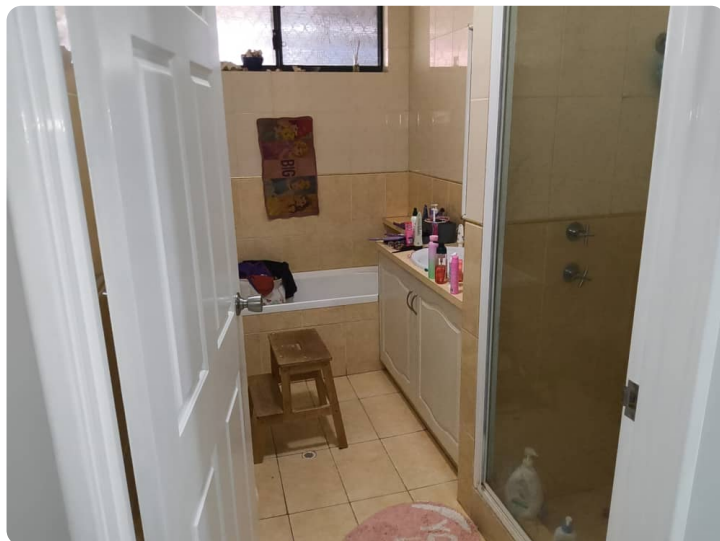
There are areas of internal floors and walls which are covered with a tile covering. The condition of the tiles is satisfactory in relation to its age and will require normal ongoing maintenance.

#### 38.1 Silicon seal damaged and mouldy

As per the images provided the silicone seal is damaged and mouldy. Recommend the silicon seal is replaced.

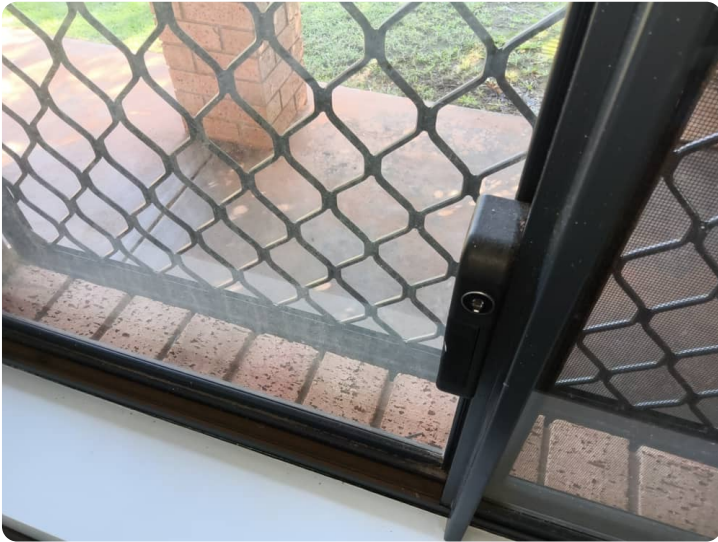
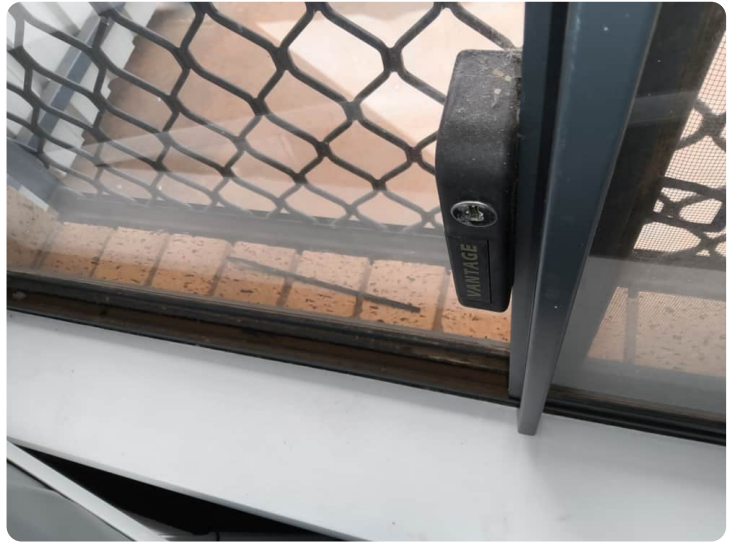
The condition of the windows, as viewed from within the property, is satisfactory in relation to its age and will require normal ongoing maintenance. Window locks have been installed to all of the windows.
