# **Houspect**

### **Pre purchase inspection**

**Job ID:** 92957

**Address:** 44 Campbell Cres, Baynton WA 6714

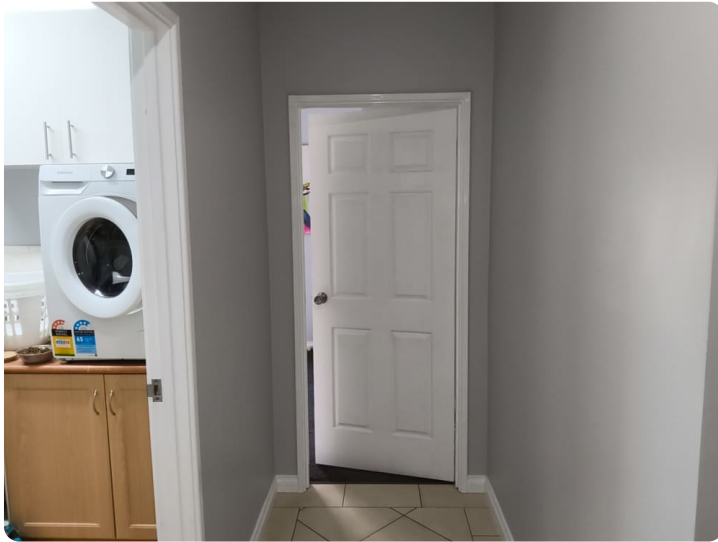
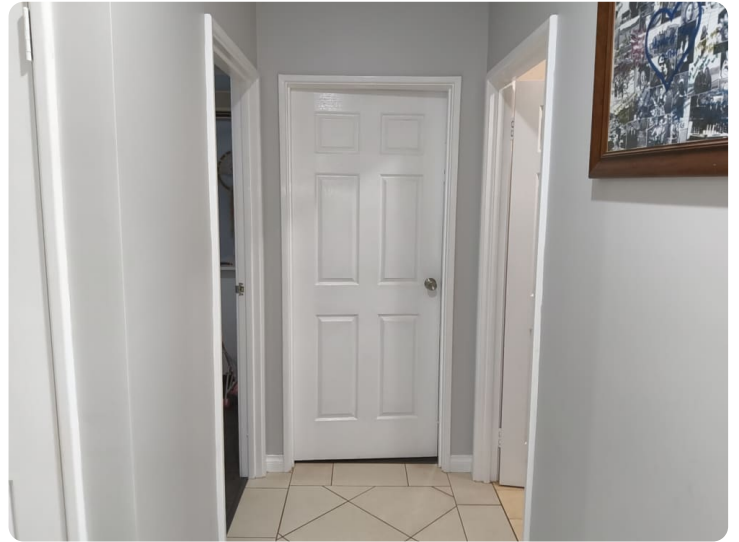
The internal doors were mainly constructed of timber hollow core. The condition of the internal doors is satisfactory in relation to its age and will require normal ongoing maintenance.

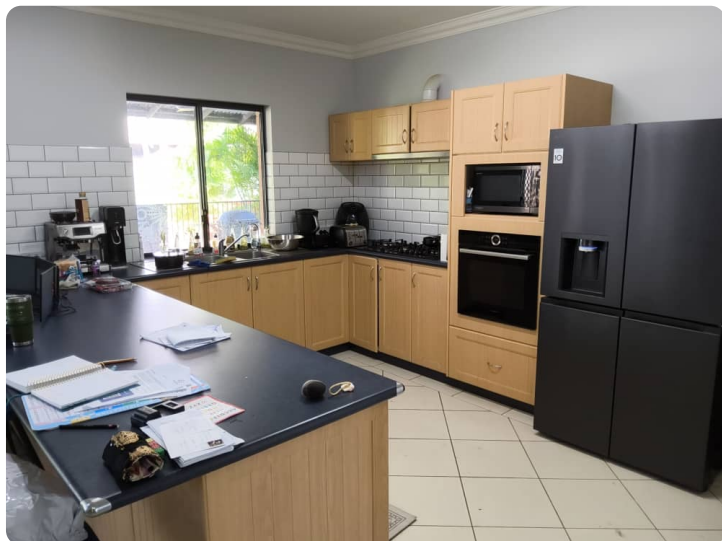
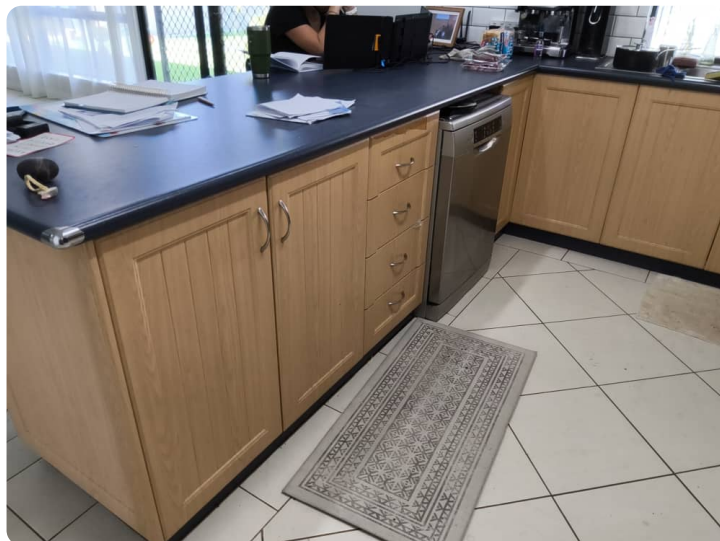
The condition of the kitchen cabinets in general is satisfactory in relation to their age and require normal maintenance.

##### 41.1 Cabinet door damage

As per the images some cabinet doors drawers damaged requiring repairs or replacement.

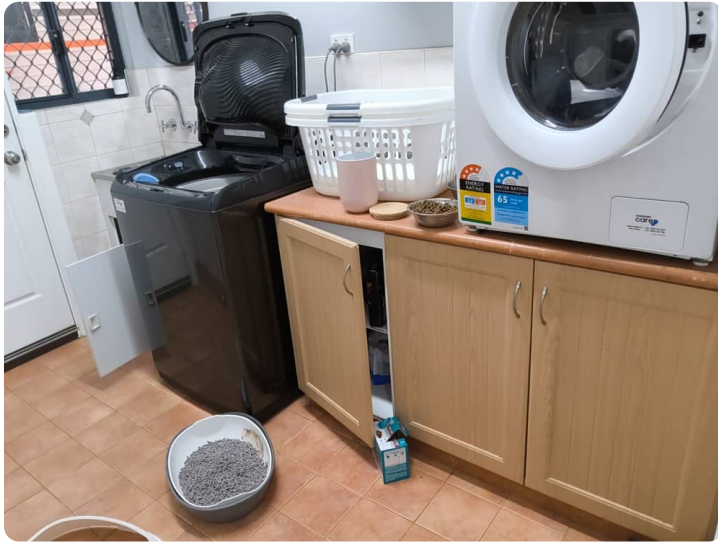
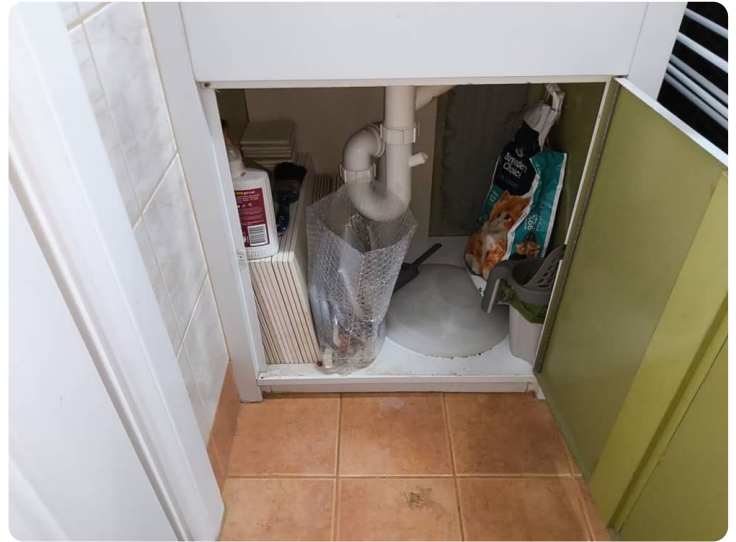
The condition of the laundry cabinets is satisfactory in relation to their age and require normal maintenance.

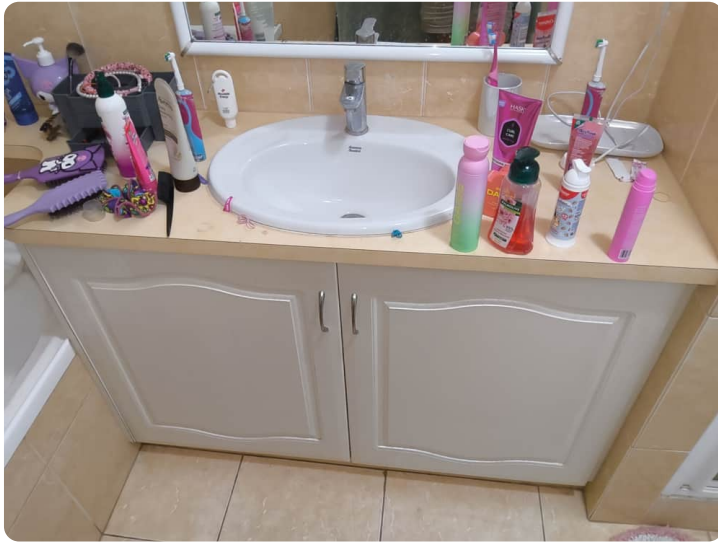
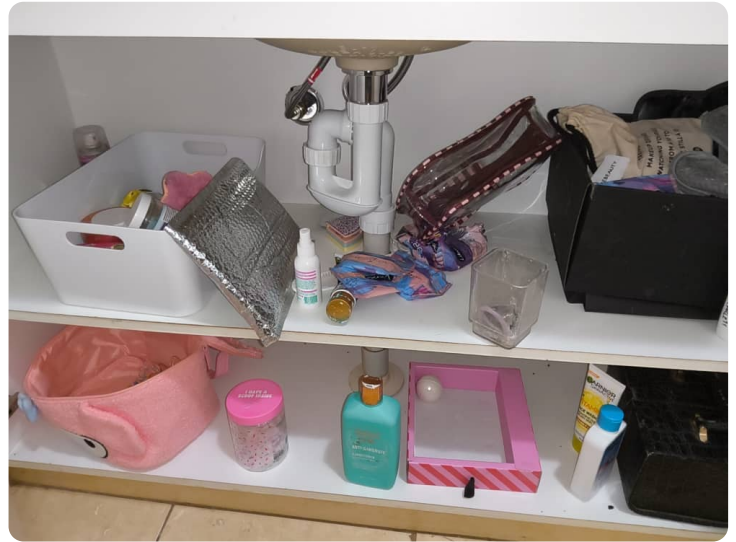
The condition of the bathroom cabinets is satisfactory in relation to their age and require normal maintenance.

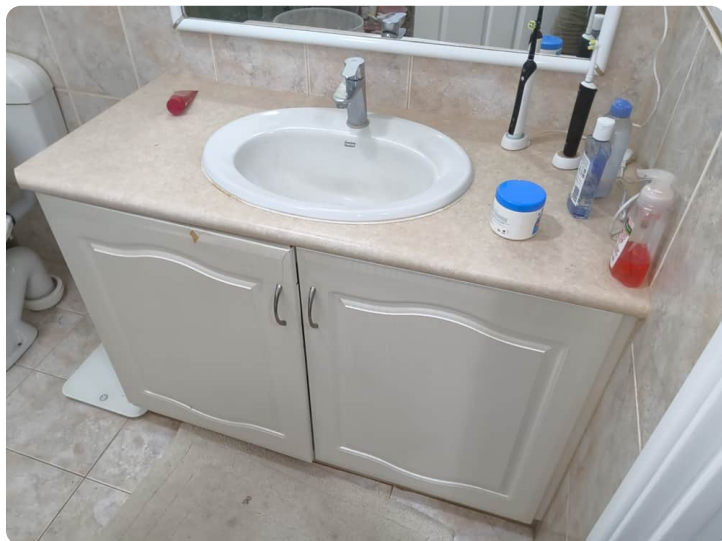
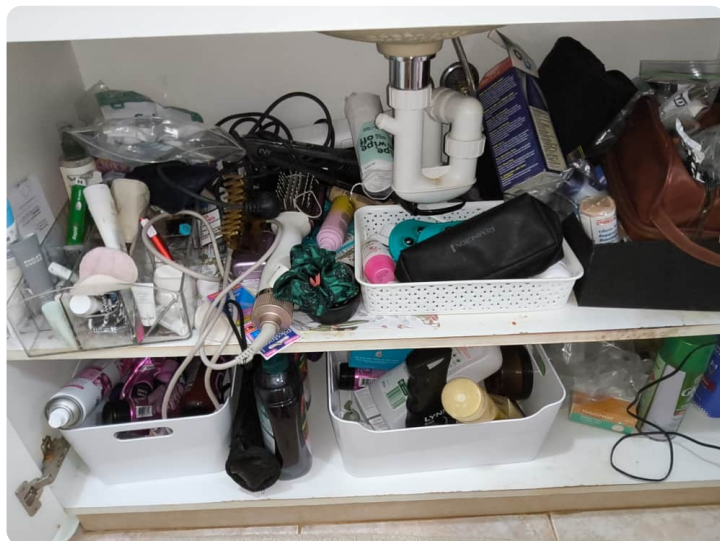
The condition of the ensuite cabinets is satisfactory in relation to their age and require normal maintenance.

##### 44.1 Cabinet door damage

As per the images some cabinet doors are damaged requiring repairs or replacement.

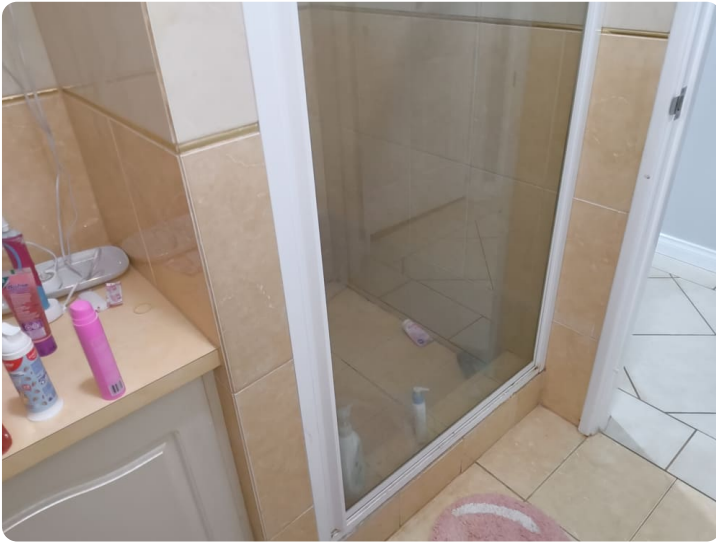
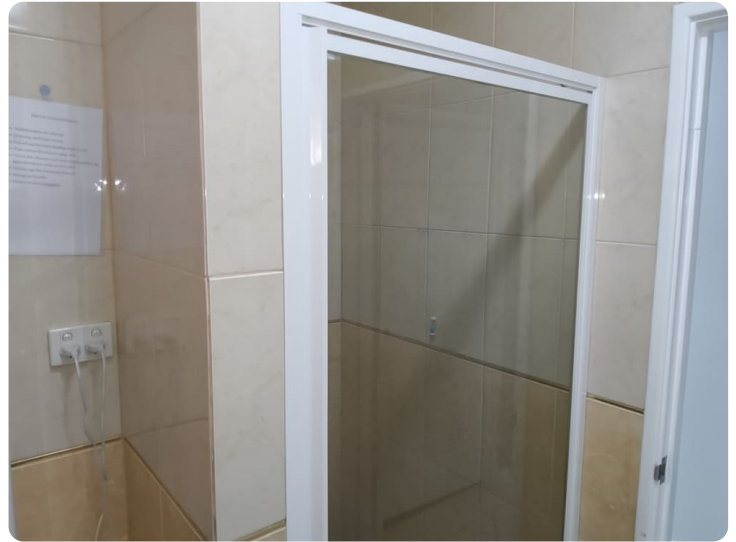
The condition of the shower screens is satisfactory in relation to their age and require normal maintenance.

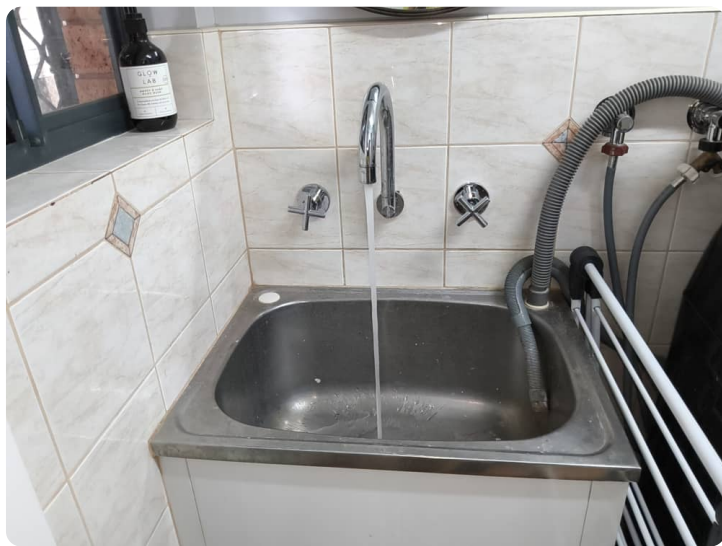
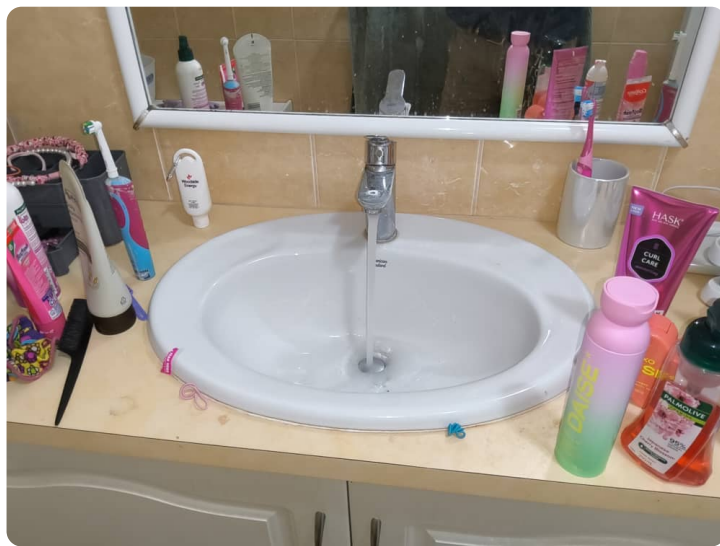
The taps to multiple areas were turned on and the water flow appeared to be reasonable. Water draining to several sinks and toilets appeared to be reasonable. The Building Inspector is not a Plumbing Contractor and is not permitted to test Plumbing items under WA Law. Where appropriate a Plumbing Contractor should be engaged to test the plumbing in the property.

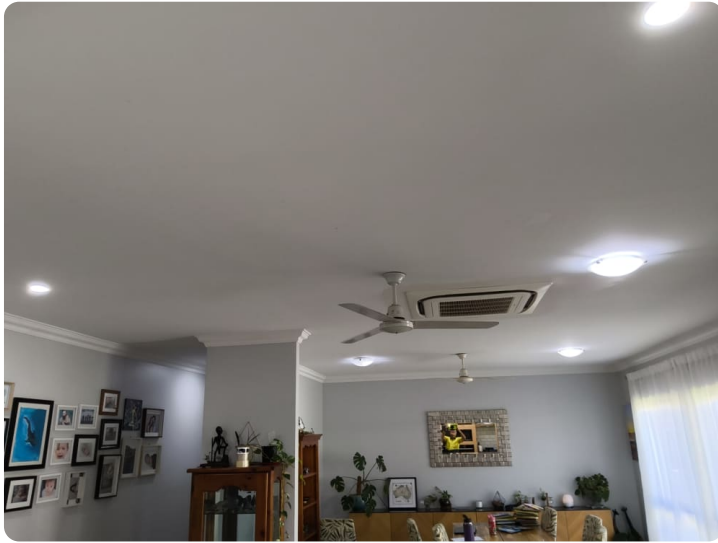
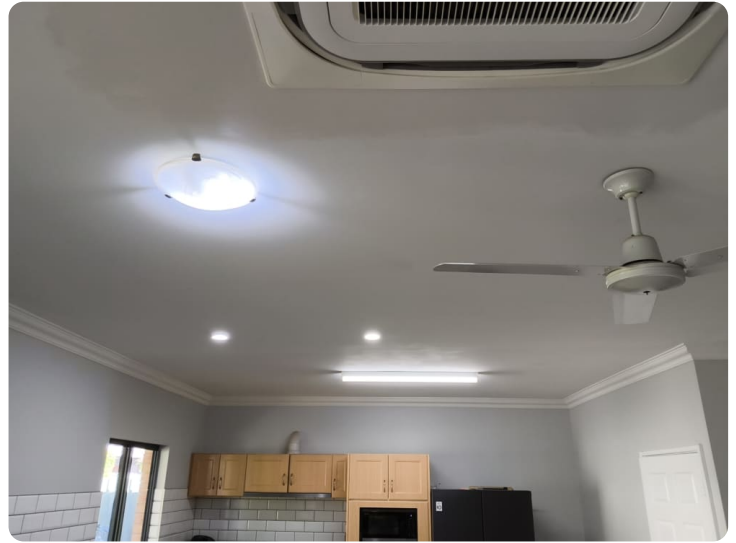
Several lights were turned on during the inspection and the lights appeared to be operational. The Building Inspector is not an Electrical Contractor and is not permitted to test Electrical items under WA Law. Where appropriate an Electrical Contractor should be engaged to test the electrical items in the property.

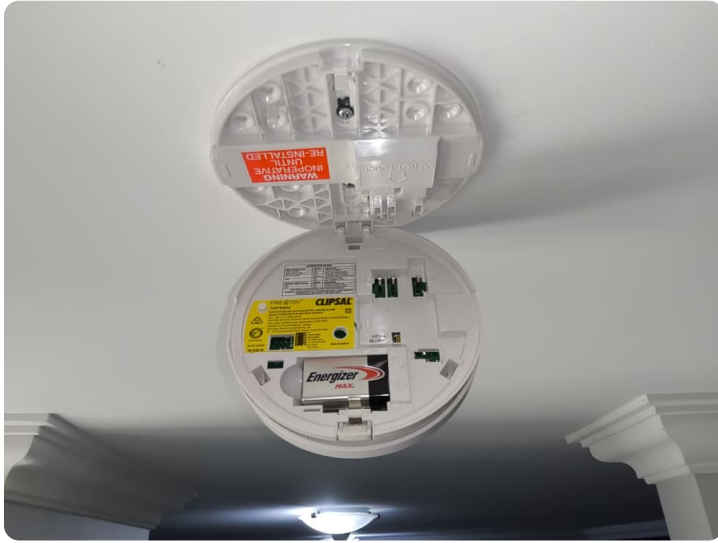
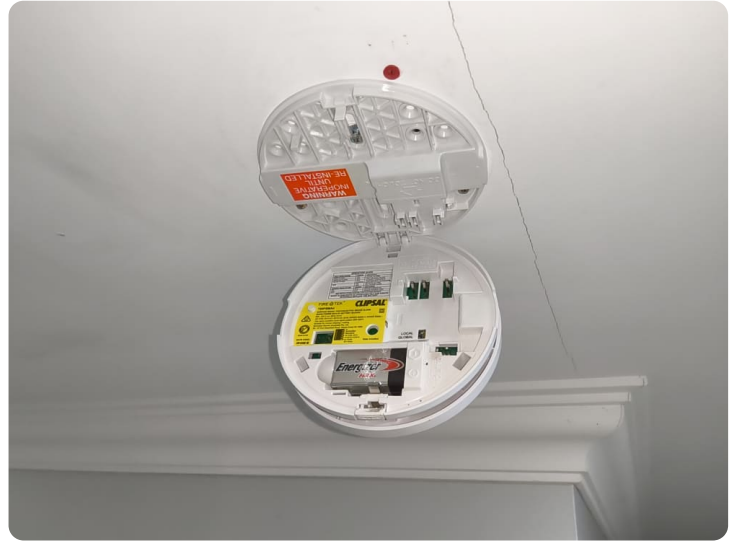
There were two hardwired smoke alarms on site. There were no battery smoke alarms on site. The location, number and type of smoke alarms appeared to be consistent with Legislative requirements. It is suggested that an Electrical Compliance Certificate be obtained in relation to the smoke alarms.
