# Pre-Purchase Inspection - Residential Building Report

Complies with Australian Standard AS 4349.1- 2007 Inspection of Buildings Part 1: Pre-Purchase inspections - Residential buildings

19 Arnisdale Road  
Duncraig WA 6023

Major Structural Defects identified to the Residential Building on day of inspection

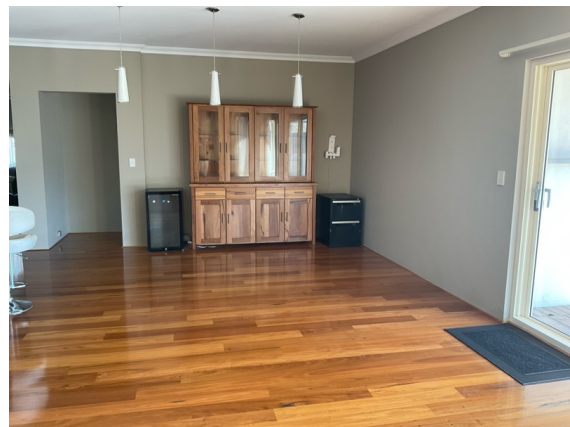
Dining room

Minor appearance cracking noted at the ceiling cornice and wall junction in the dining and in various isolated areas throughout the home. Recommend repair and paint.

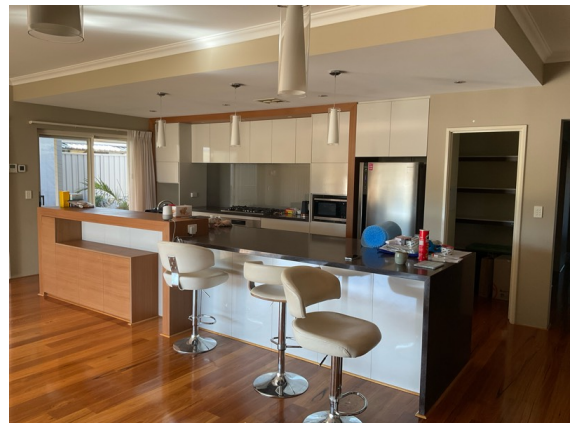
Kitchen

Minor appearance ceiling crack noted to the kitchen ceiling at the bulkhead. This is common with bulkhead ceilings at corners. Recommend repair and paint.

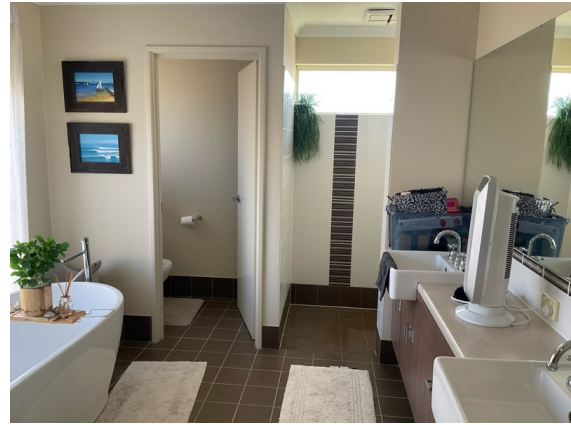
En-suite

Minor appearance cracking noted at the ceiling cornice and wall junction in the en-suite and in various isolated areas throughout the home. Recommend repair and paint.

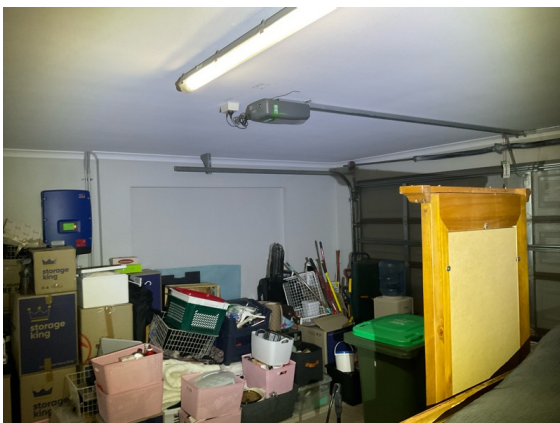
Garage

Evidence of typical moisture ingress to the lower areas of the garage walls. This is common for single skin walls and is caused by rising damp. Efflorescence is a deposit of mineral salts on surfaces of concrete and masonry walls and/or floors

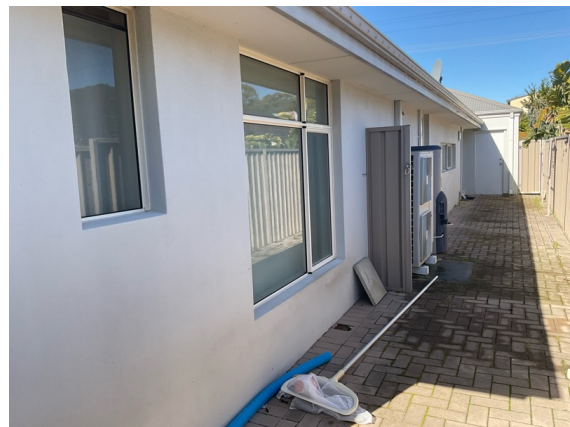
West elevation

Deterioration noted to the garage rear door. This common with external doors. Recommend repair/treat and paint
