# Pre-Purchase Inspection - Residential Building Report

Complies with Australian Standard AS 4349.1- 2007 Inspection of Buildings Part 1: Pre-Purchase inspections - Residential buildings

Property Inspected Details: 4 Mahonia Place  
Duncraig WA 6023

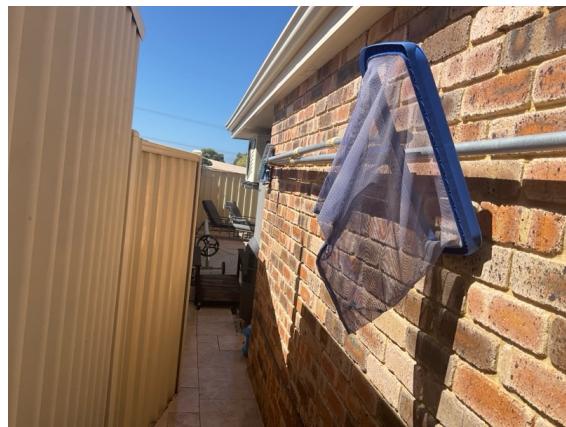
East elevation

Minor mortar deterioration noted to the lower face brickwork on the east elevation and other isolated areas. This is common for lower face brick work commonly caused by wind. Recommend repair/repoint where required.

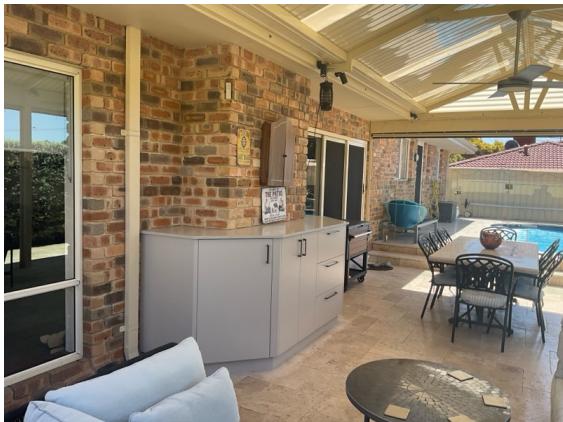
South elevation

Minor mortar deterioration noted to the lower face brickwork on the south elevation and other isolated areas. This is common for lower face brick work commonly caused by wind. Recommend repair/repoint where required.

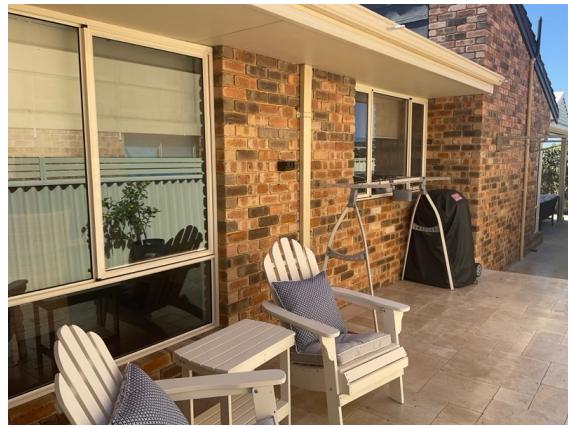
West elevation

Evidence of surface rust noted to the west elevation external brick opening lintels. This is common when maintenance painting is not carried out. Recommend treat and paint
