**PROCONSULT**  
BUILDING INSPECTIONS

# Building and Timber Pest Report

Property Address: 11/10 Clarence Street, Tuart Hill

Inspection Date: 16 Oct 2025

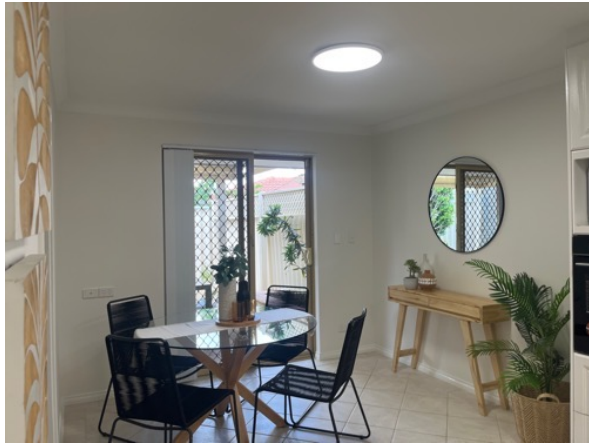
**Location:** Meals Area

**Finding:** Area ok in general and no real concerns seen

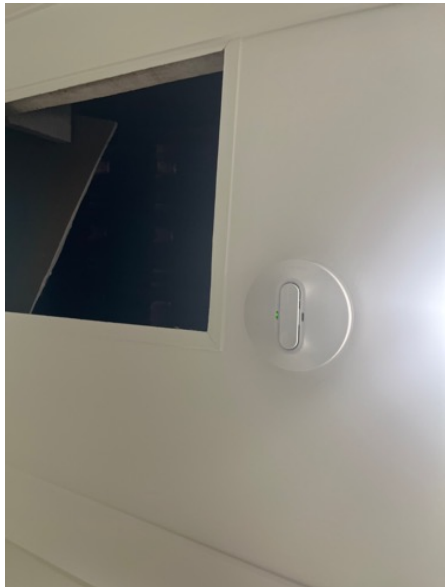
**Location:** Passageway To Bedrooms

**Finding:** Smoke alarm

Hardwired smoke alarm installed and in date.

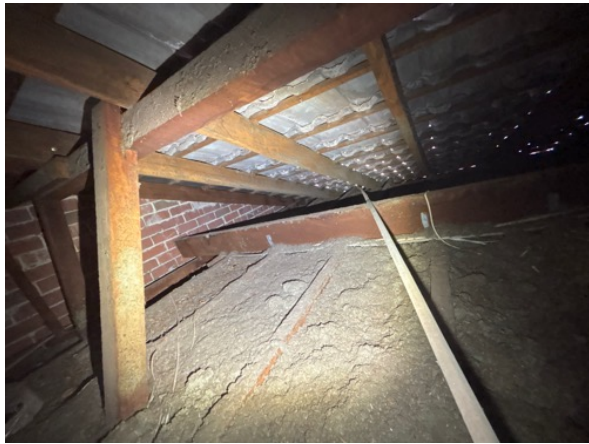
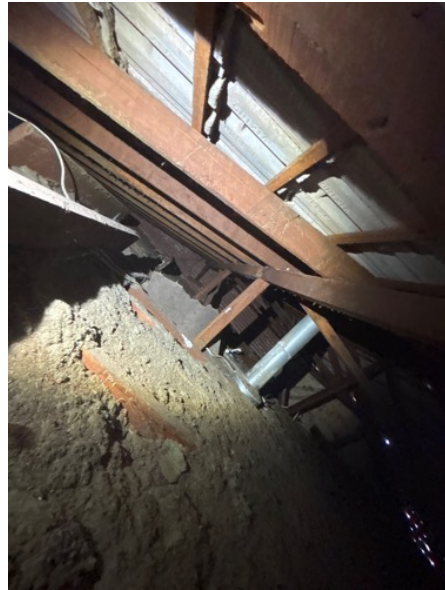
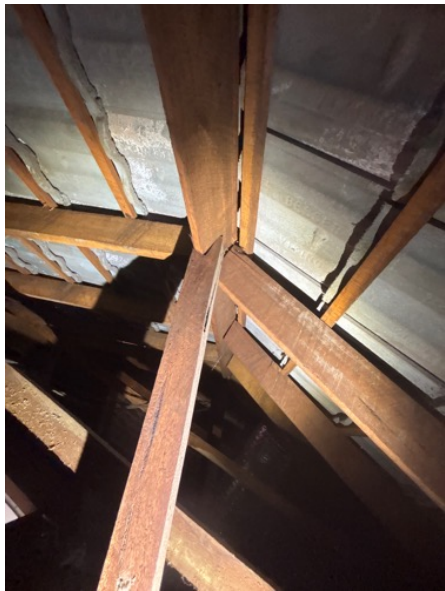
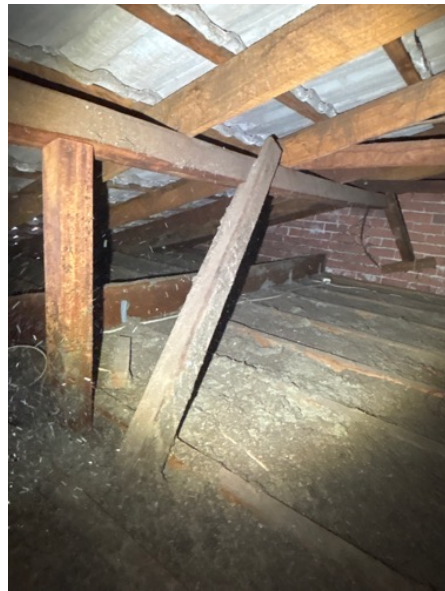
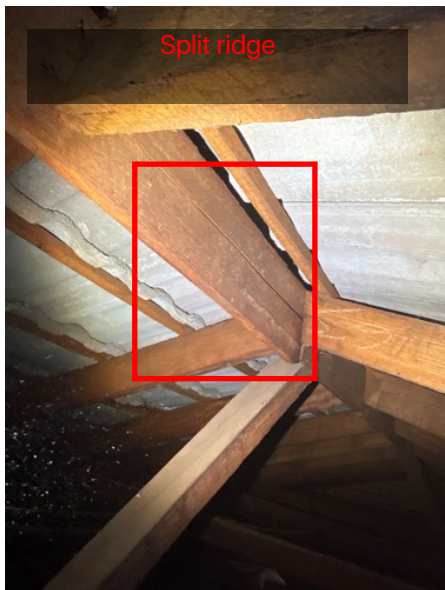
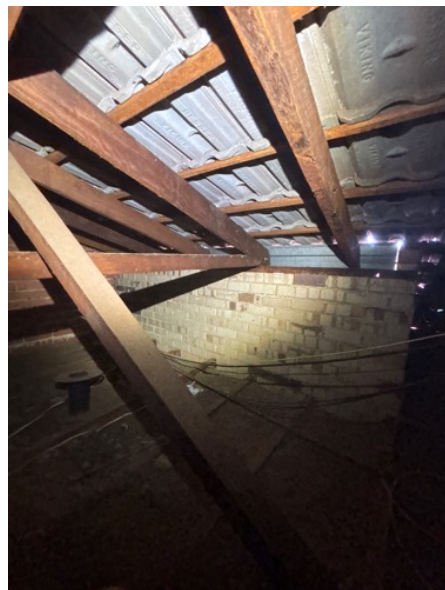
**Location:** Roof Void

The dividing party wall has not been built up completely to the under side of the roof tiles near the ridge on both ends. This is of a fire and smoke related concern and should be infilled to help prevent transfer of smoke or flames and gain the 1hr rating. Possible safety hazard and noted however a fairly standard procedure of the time when built and not of a structural issue.

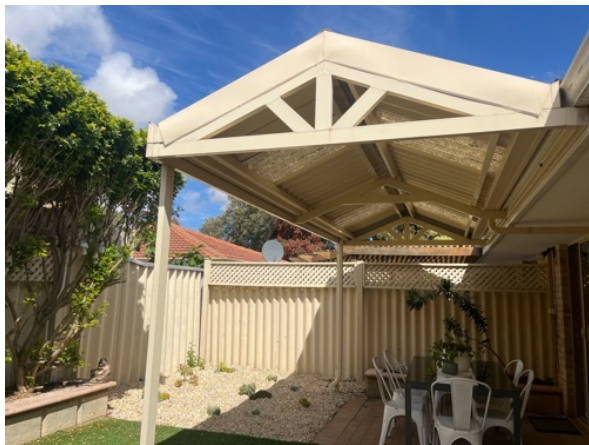
**Location:** Deck and/or Pergola

**Finding:** Alfresco Structure

The alfresco structure and area appears ok in general.  
Professionally installed

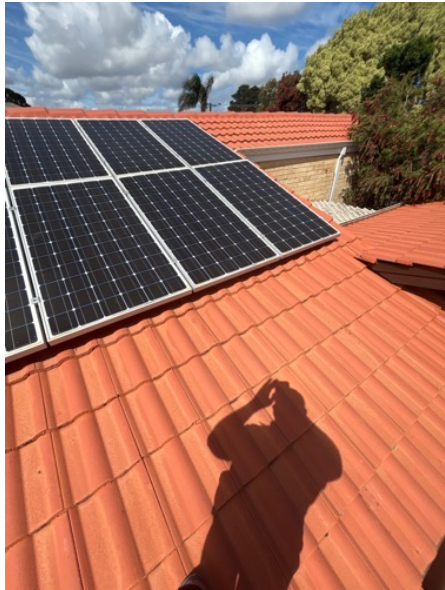
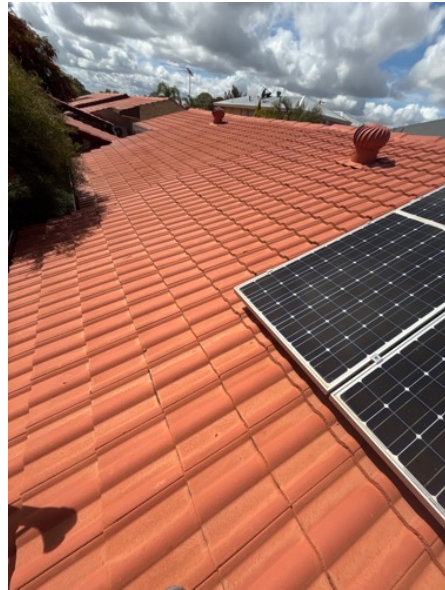
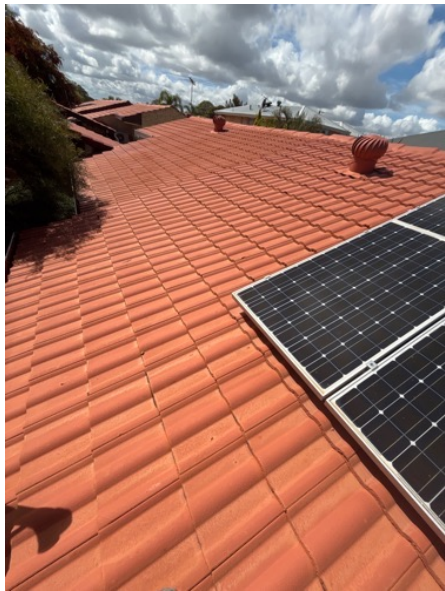
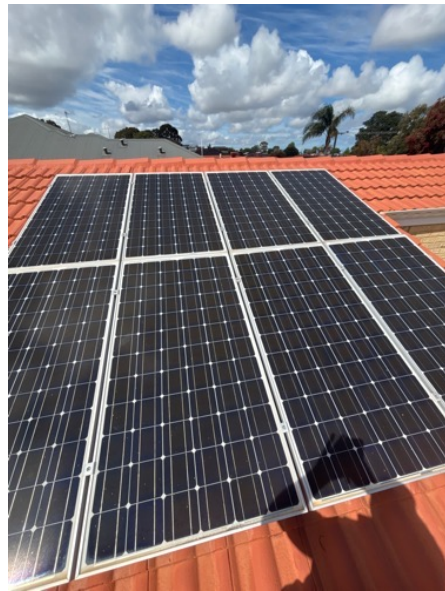
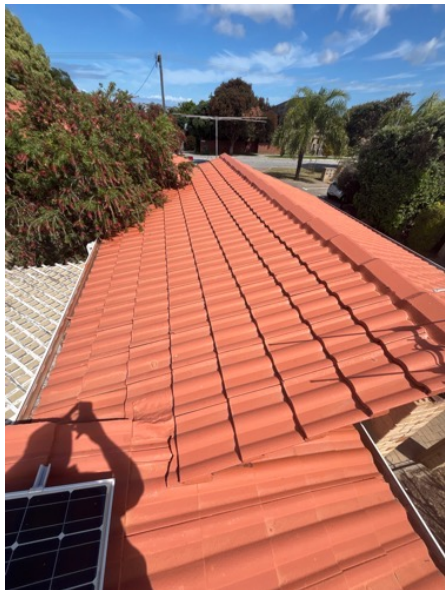
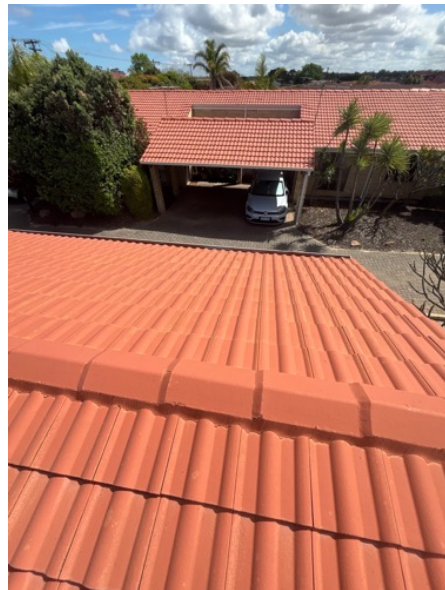
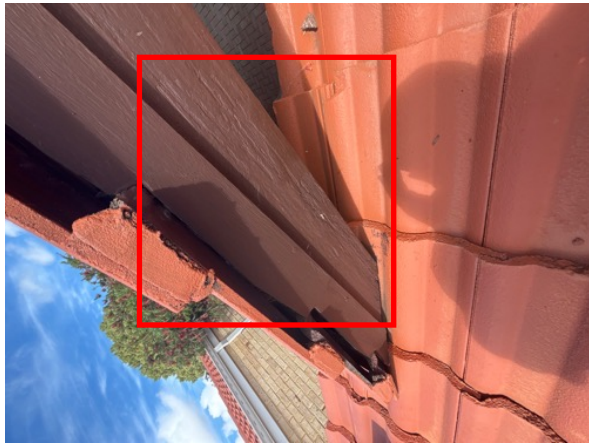
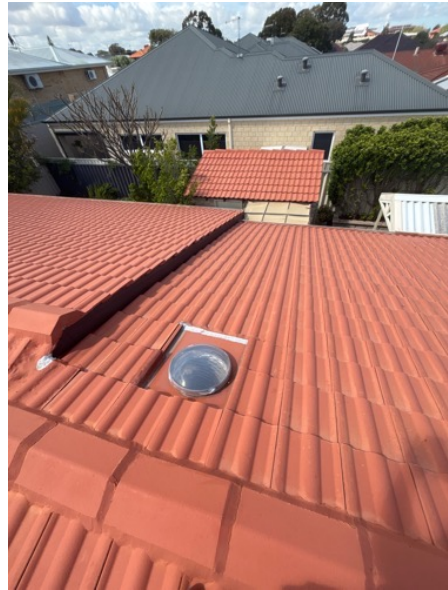
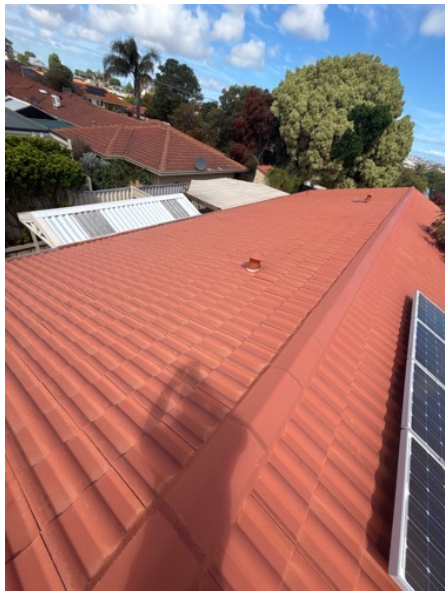
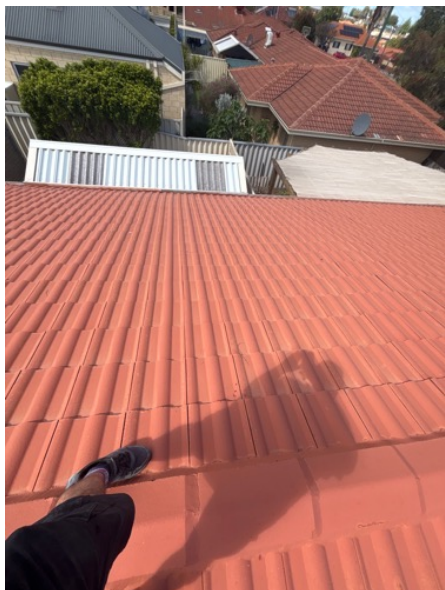
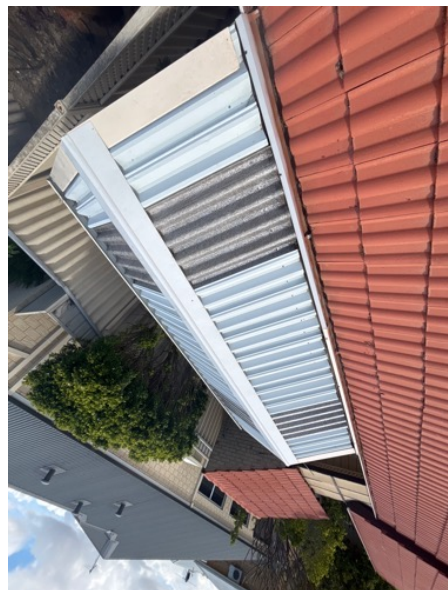
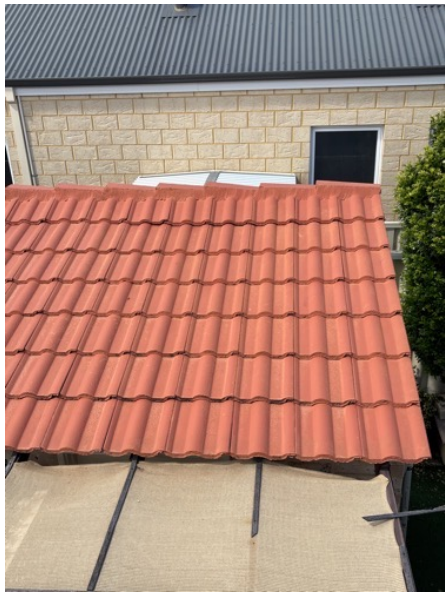
The roof covering appears okay in general and well maintained. Some general pictures were also taken here.

Some weathering to the barge board tail end as marked, this has been painted.

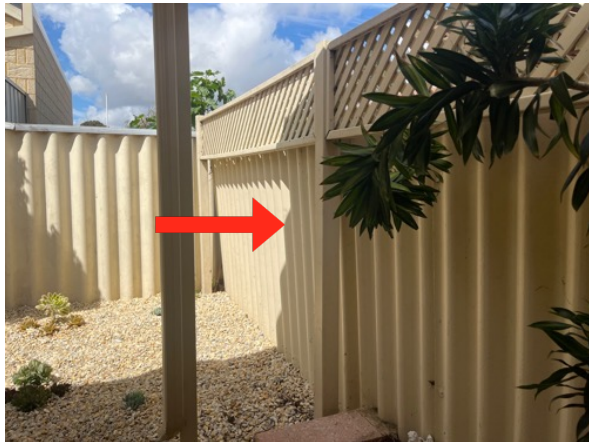
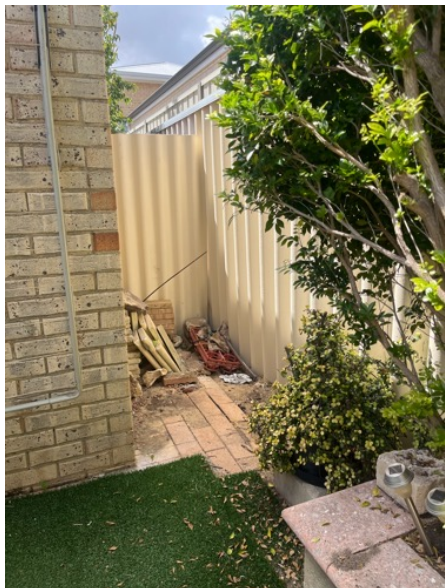
**Location:** The site

**Finding:** The side fence is asbestos based however sealed and painted and ok.  
The rear fence panels are not asbestos based.
