# **Houspect**

**Pre purchase inspection**

**Job ID:** 92652

**Address:** 10 Walker Close, Millars Well WA

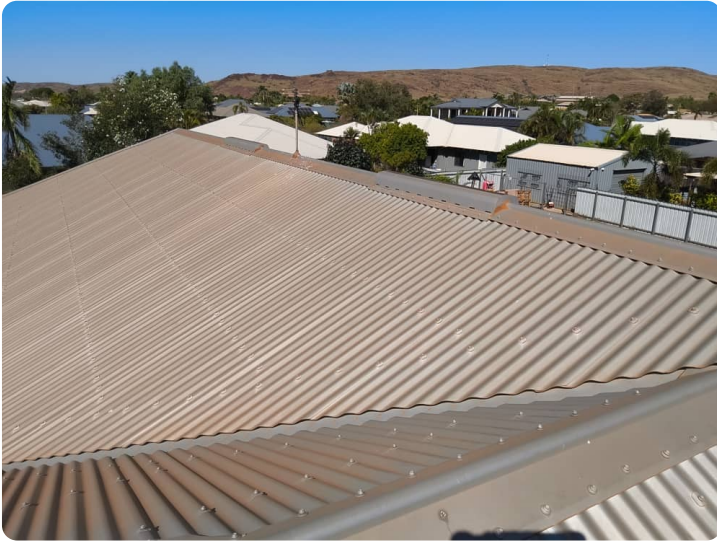
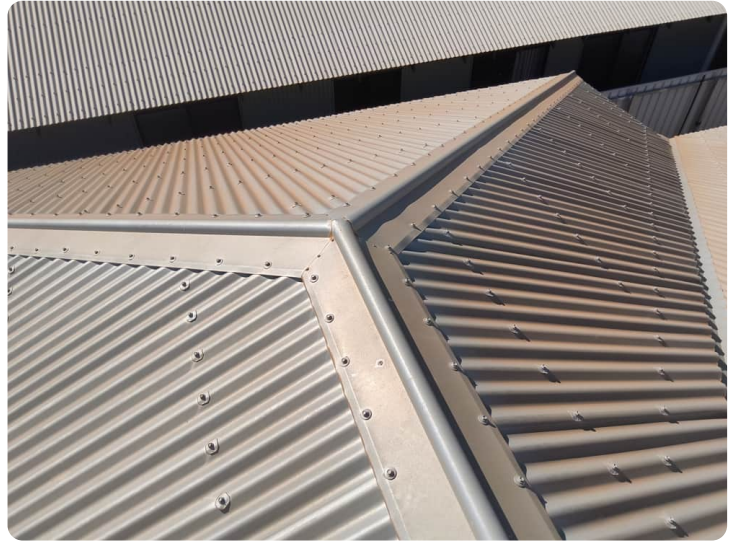
## 2. Ridges

The ridges and capping are satisfactory in relation to its age and will require normal ongoing maintenance.

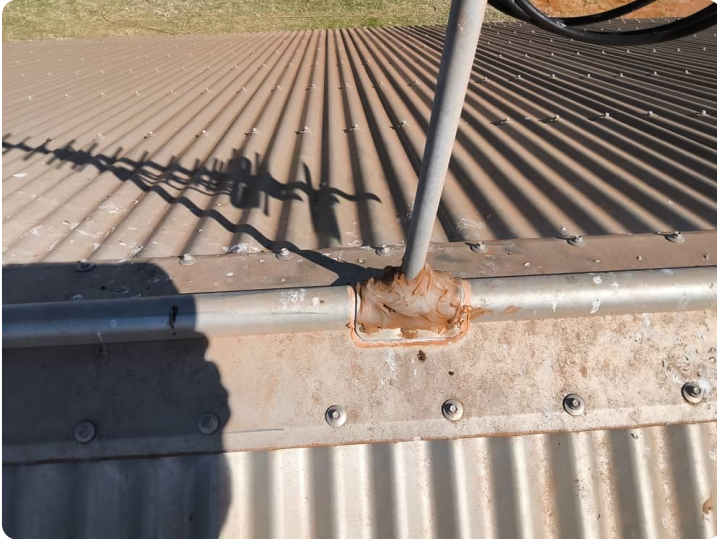
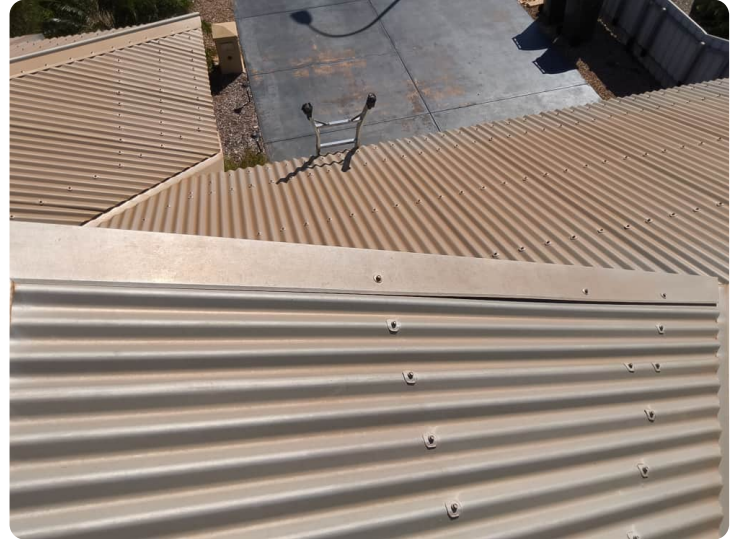
#### 4. Flashings

The flashings are covered with a variety of finishes and are constructed of a mixture of materials. The condition of the flashings is satisfactory in relation to their age and will require normal ongoing maintenance.

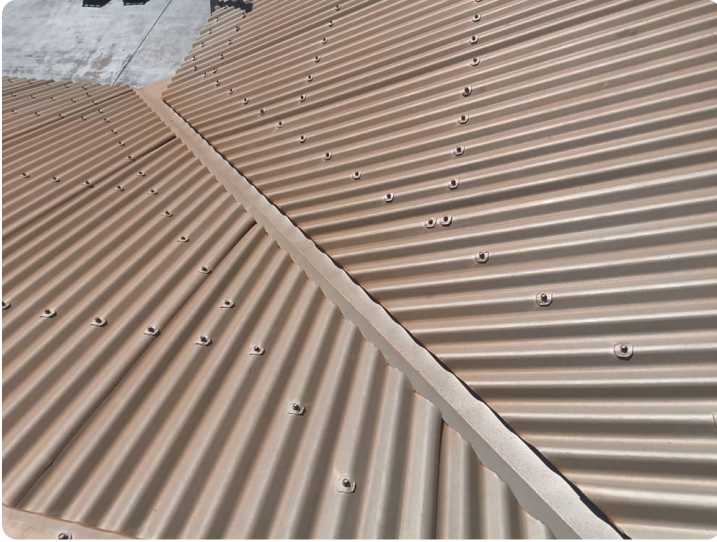
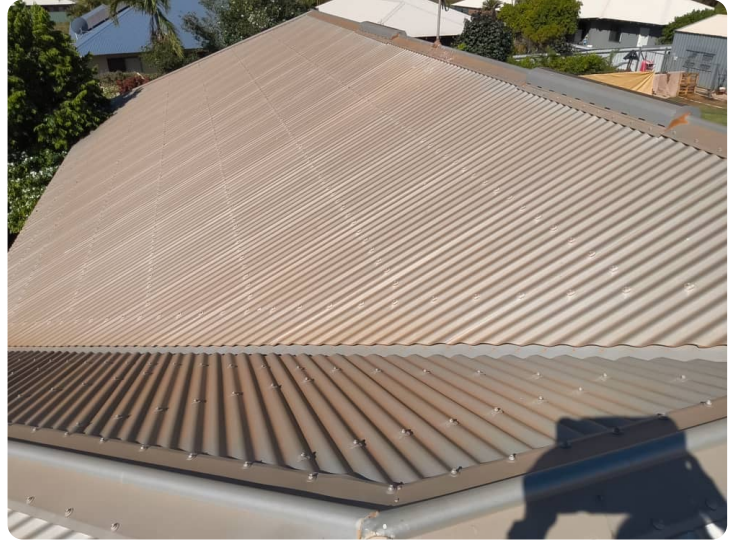
## 6. Valleys

The valleys are constructed of metal and have a colorbond covering. The condition of the valleys is satisfactory in relation to their age and will require normal ongoing maintenance. The valleys appear to be relatively free of debris.

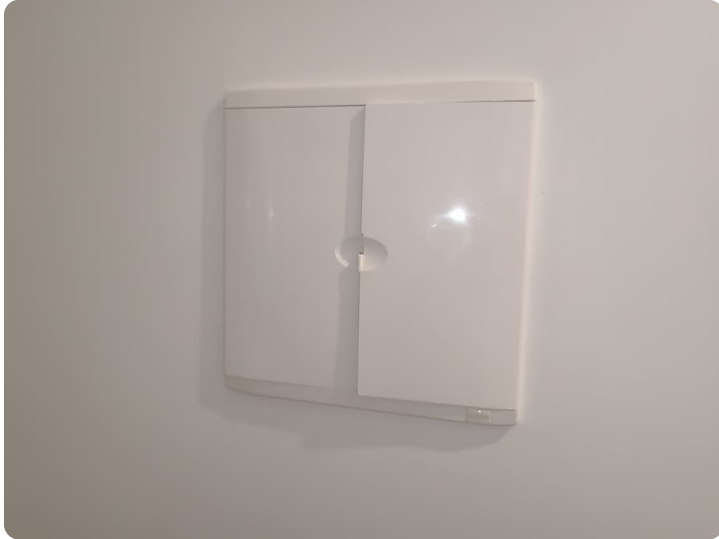
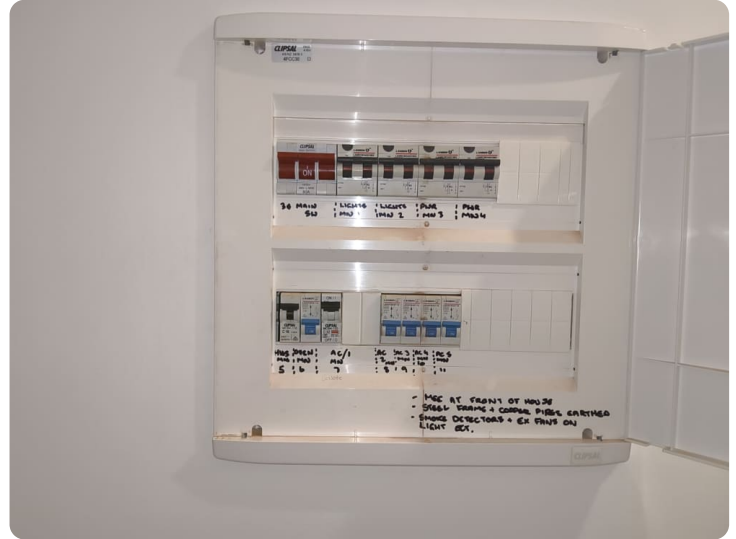
## 16. Residual Current Devices

There were four Residual Current Devices (RCD)(s) noted in the meter box or sub meter box. The RCD(s) were not tested. It is suggested that an Electrical Compliance Certificate be obtained in relation to the RCD(s).

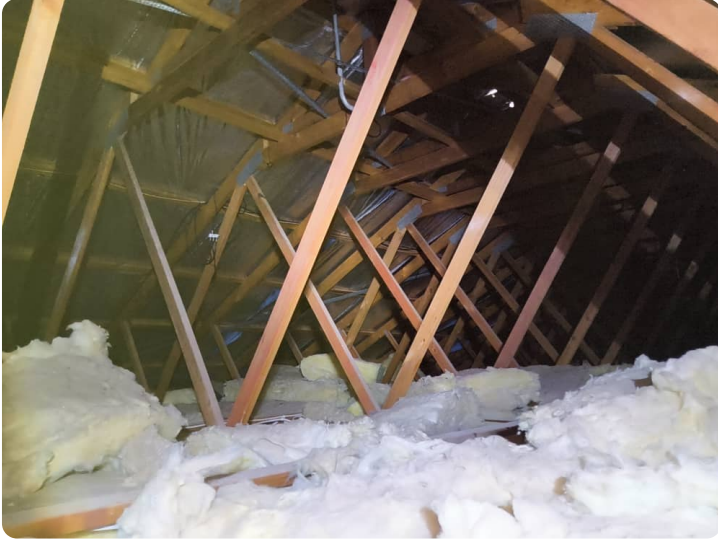
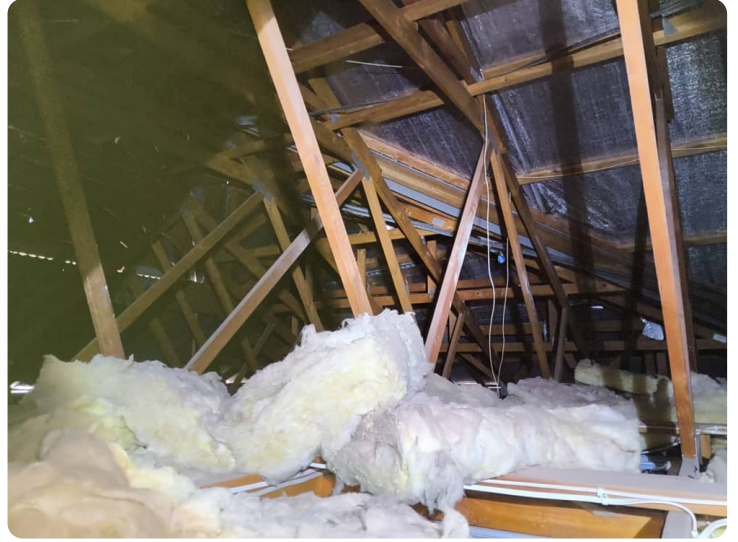
#### 24. Sarking

Sarking to the underside of the roof was installed and was considered effective.

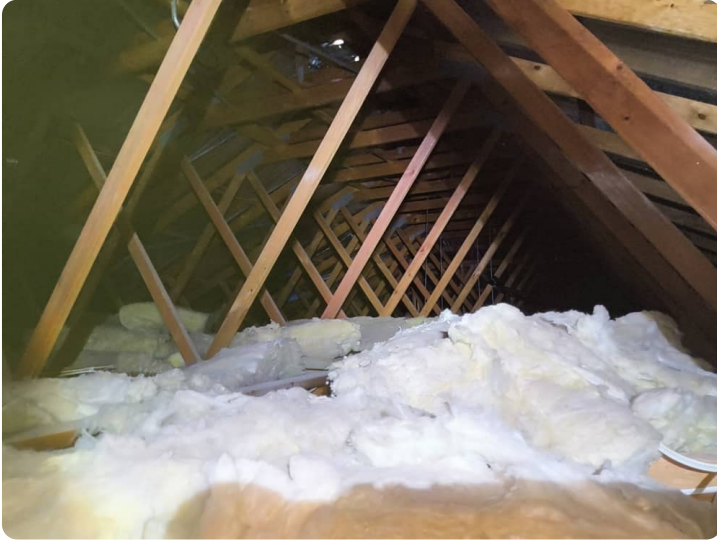
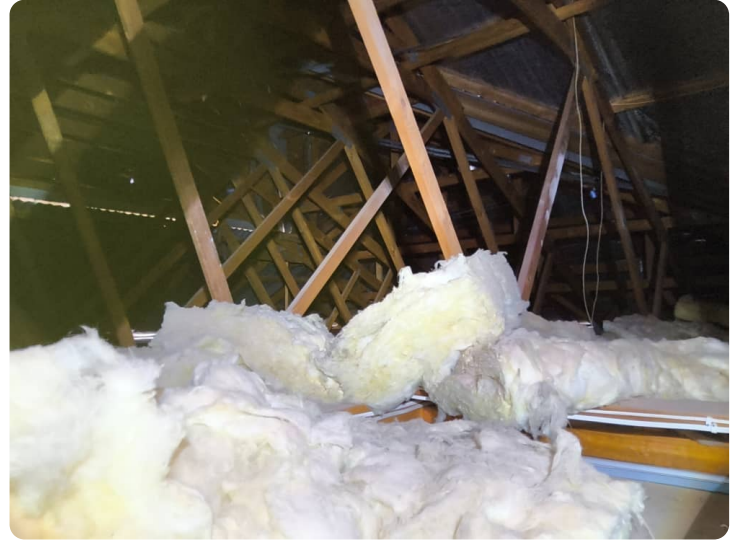
## 25. Roof frame

The roof frame type is a timber truss. The condition of the roof frame is satisfactory in relation to its age and will require normal ongoing maintenance. Access to the roof space was restricted by the pitch of the roof, insulation, ducting or other items. The inspector estimates that visibility was available to more than 75% of the area.

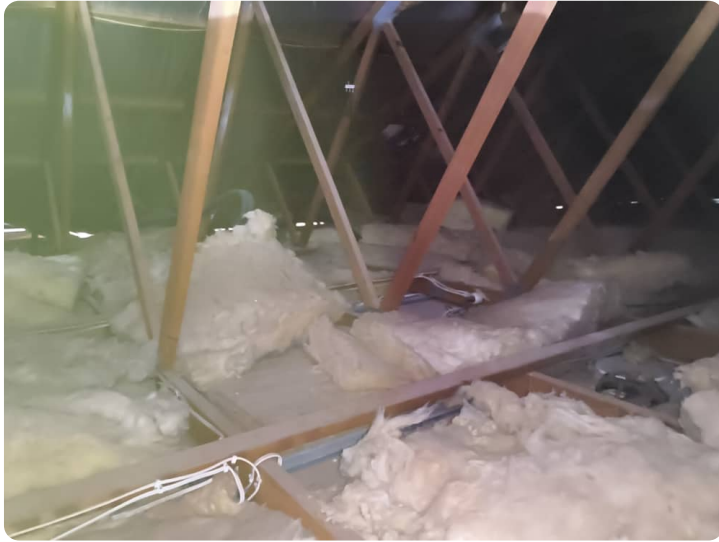
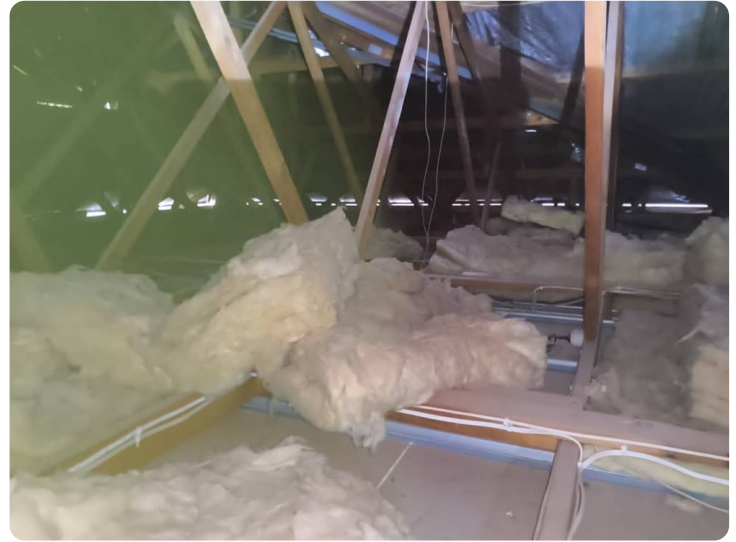
## 26. Insulation

Insulation was installed. Where insulation was installed it was considered effective. The insulation type was predominately batt or rolled type insulation.

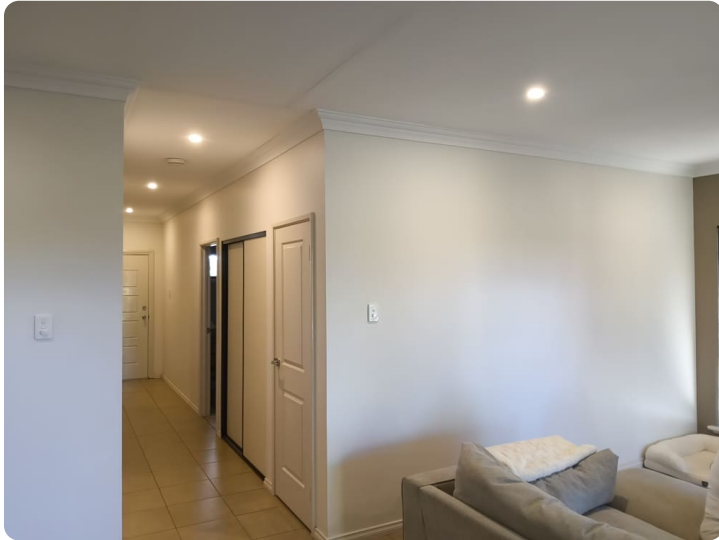
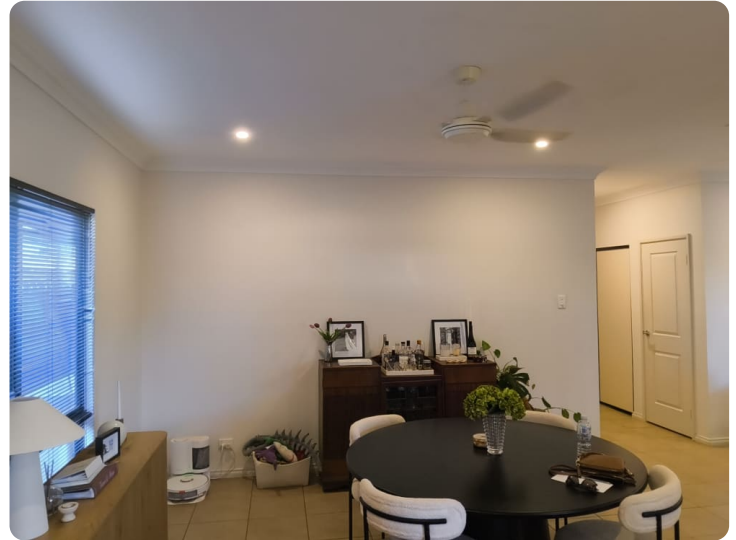
## 28. Internal walls

The internal walls are constructed of a frame with plaster board cladding. The condition of the internal walls is satisfactory in relation to its age and will require normal ongoing maintenance.

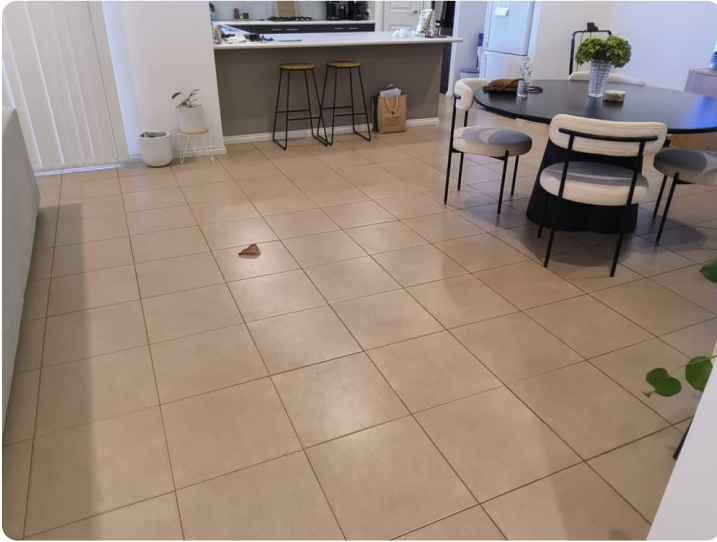
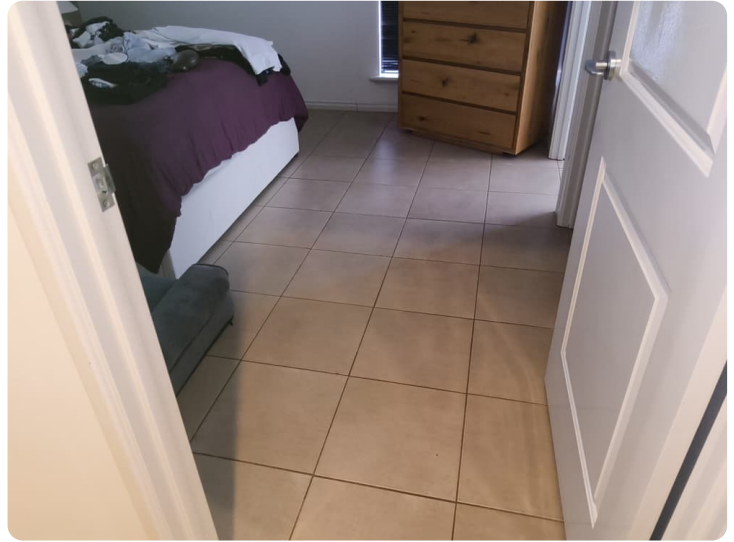
## 29. Internal floors

The internal floors are constructed of concrete and are covered in ceramic tiles. The condition of the internal floors is unable to be determined as they could not be seen due to coverings.

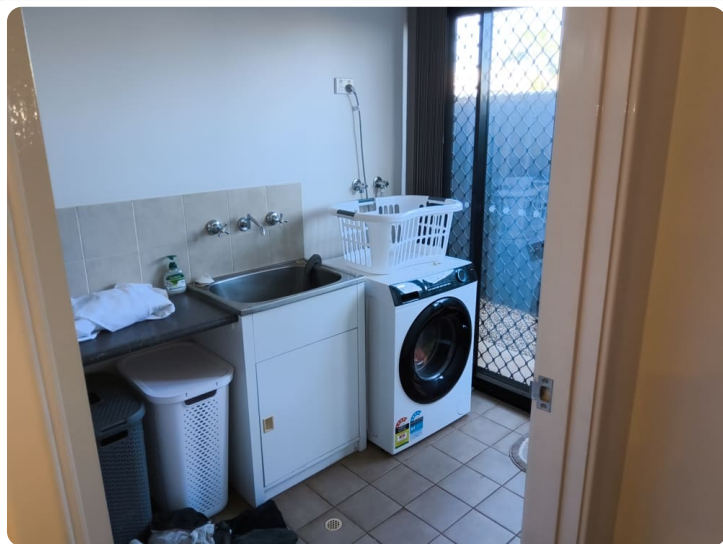
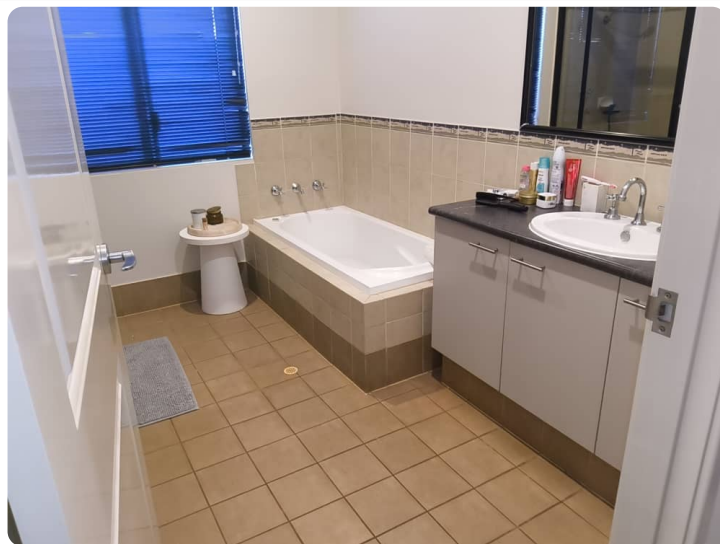
### 30. Tiled floors and walls

There are areas of internal floors and walls which are covered with a tile covering. The condition of the tiles is satisfactory in relation to its age and will require normal ongoing maintenance.

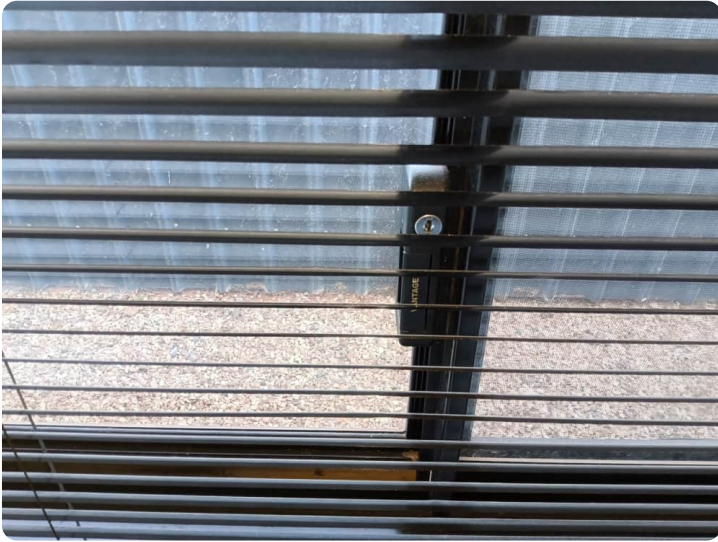
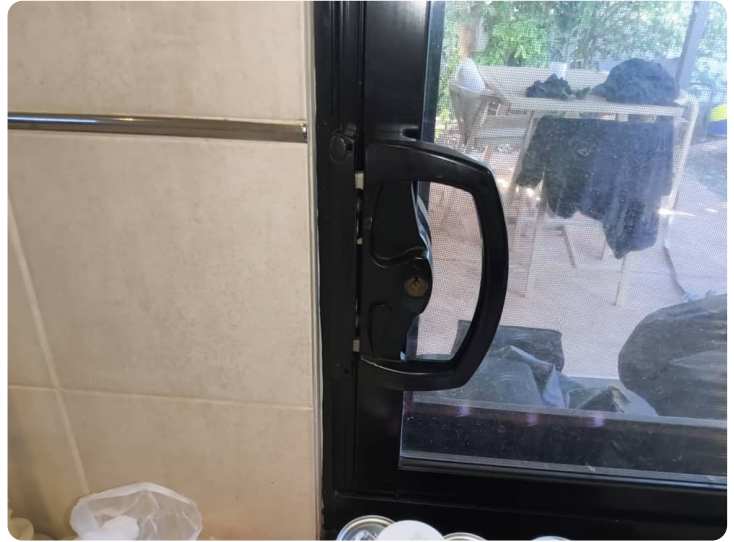
### 31. Windows (internal)

The condition of the windows, as viewed from within the property, is satisfactory in relation to its age and will require normal ongoing maintenance. Window locks have been installed to all of the windows.

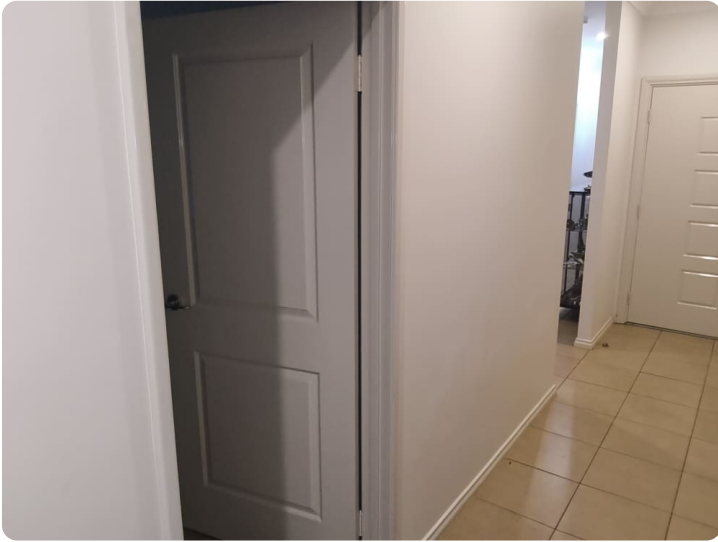
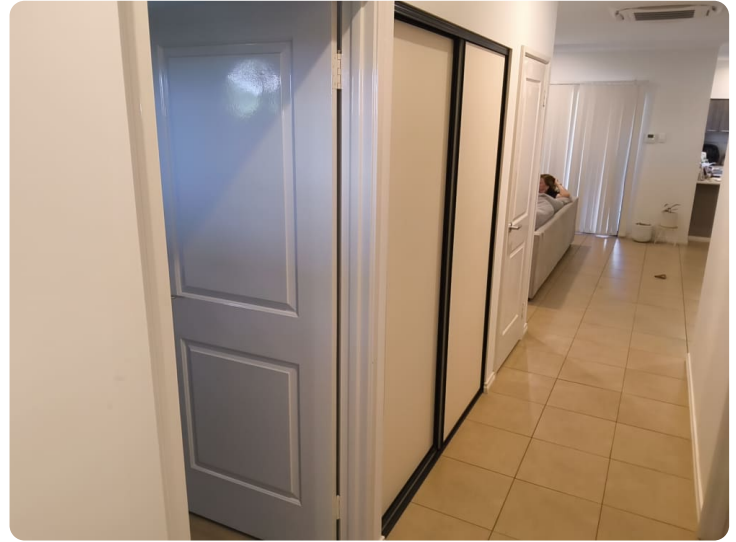
## 32. Internal doors

The internal doors were mainly constructed of timber hollow core. The condition of the internal doors is satisfactory in relation to its age and will require normal ongoing maintenance.

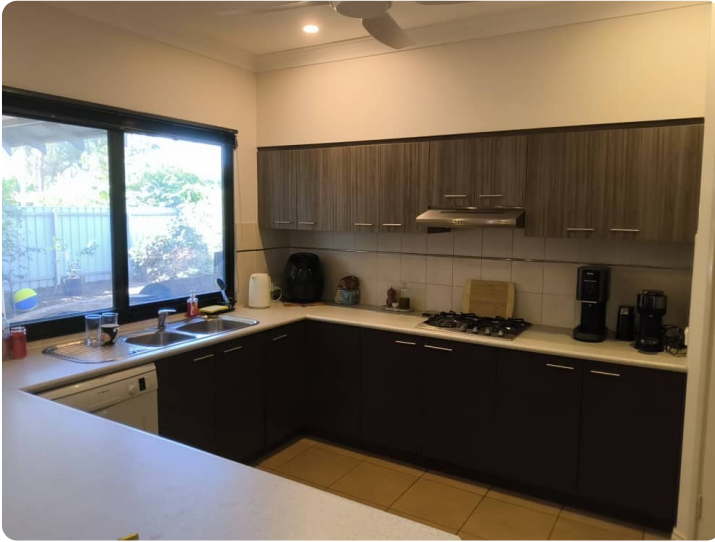
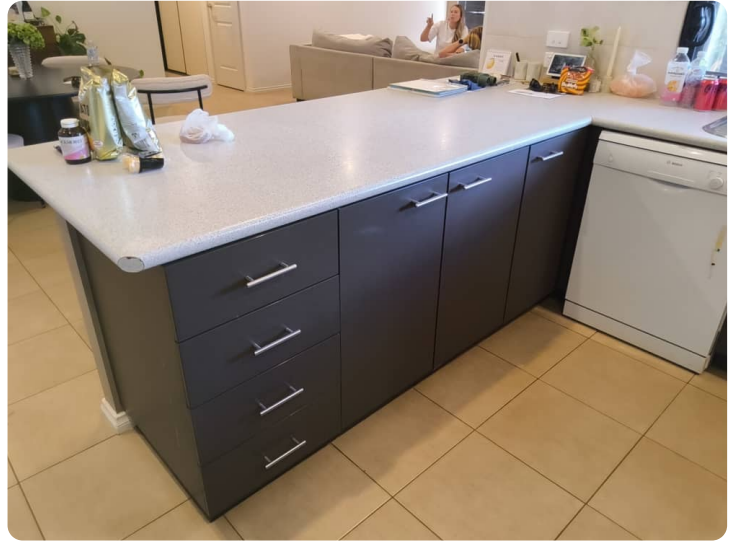
### 33. Kitchen cabinets

The condition of the kitchen cabinets in general is satisfactory in relation to their age and require normal maintenance.

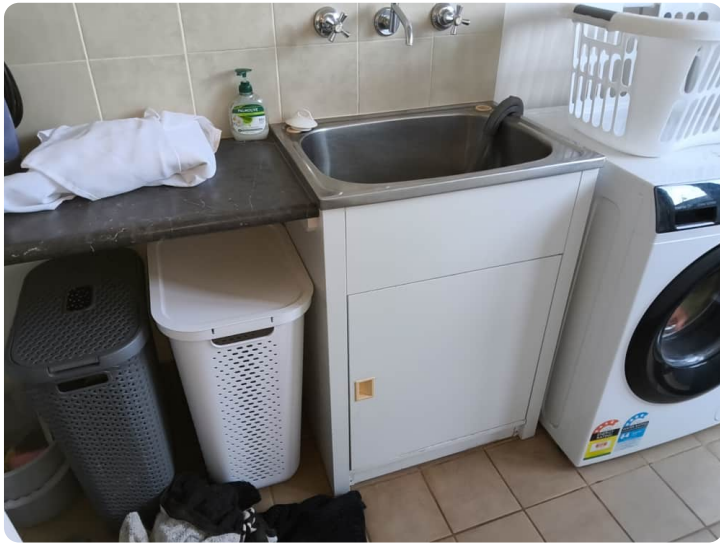
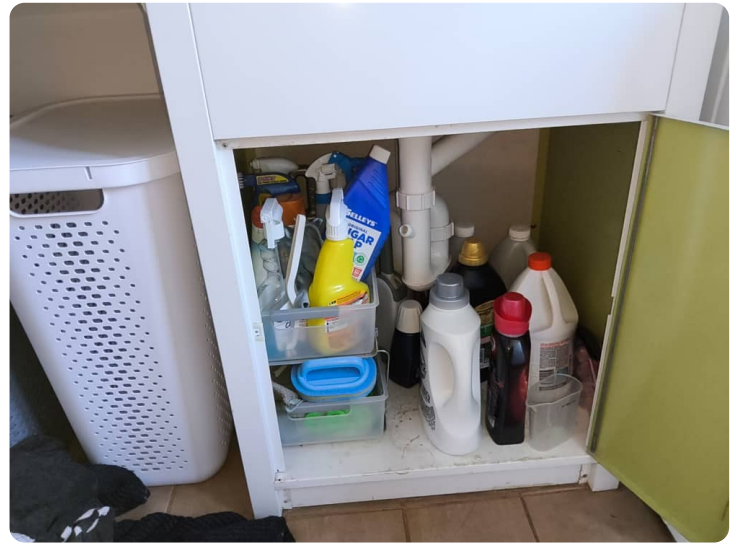
#### 34. Laundry cabinets

The condition of the laundry cabinets is satisfactory in relation to their age and require normal maintenance.

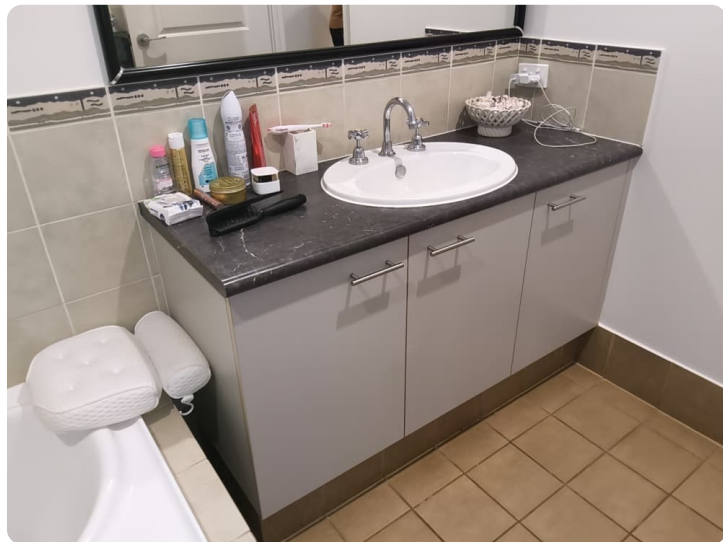
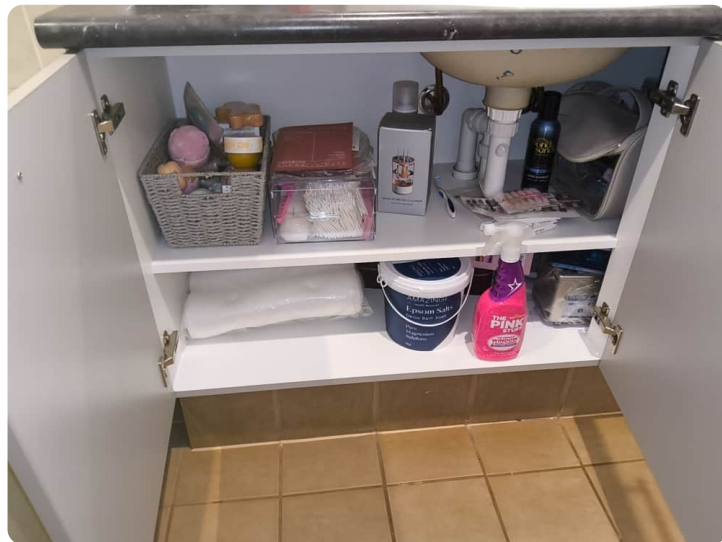
### 35. Bathroom cabinets

The condition of the bathroom cabinets is satisfactory in relation to their age and require normal maintenance.

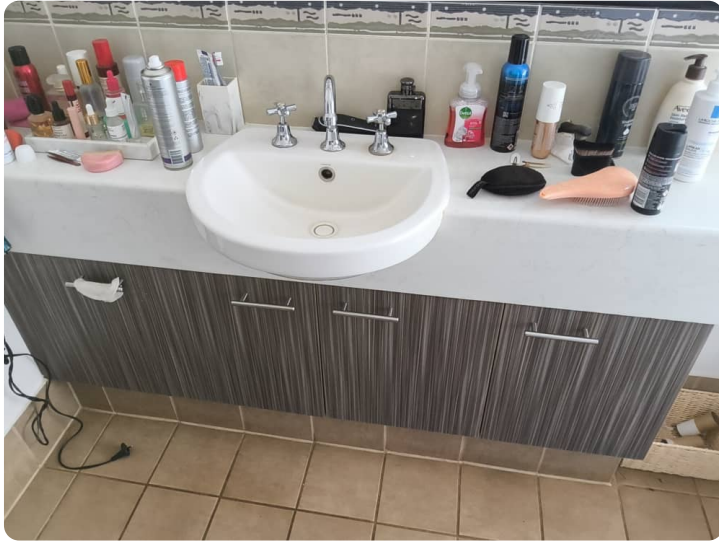
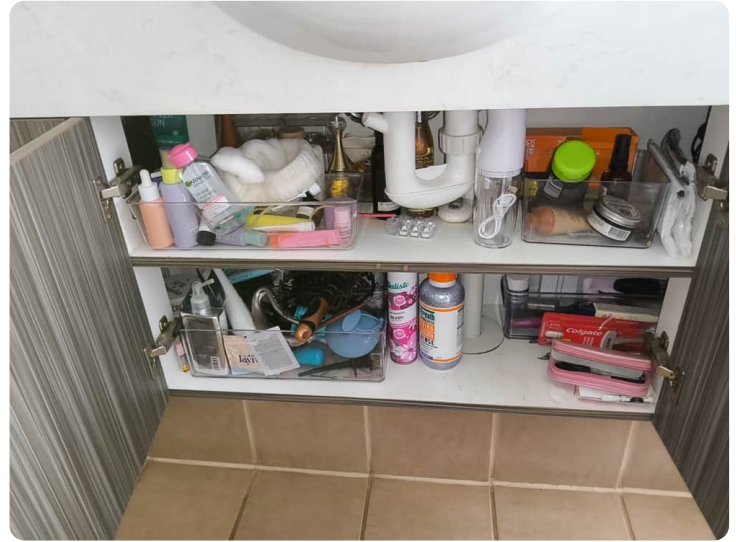
### 36. Ensuite cabinets

The condition of the ensuite cabinets is satisfactory in relation to their age and require normal maintenance.

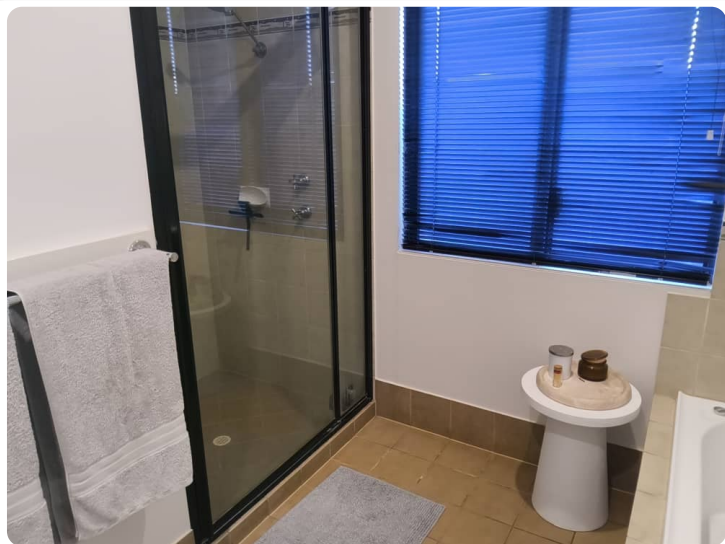
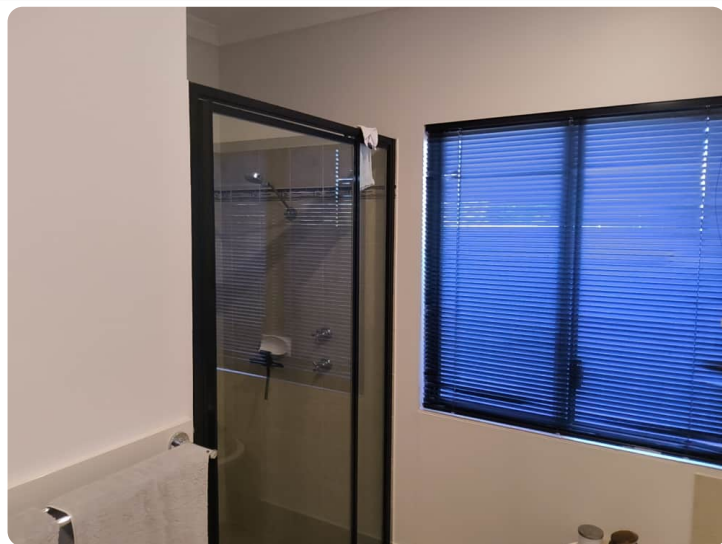
### 37. Shower screens

The condition of the shower screens is satisfactory in relation to their age and require normal maintenance.

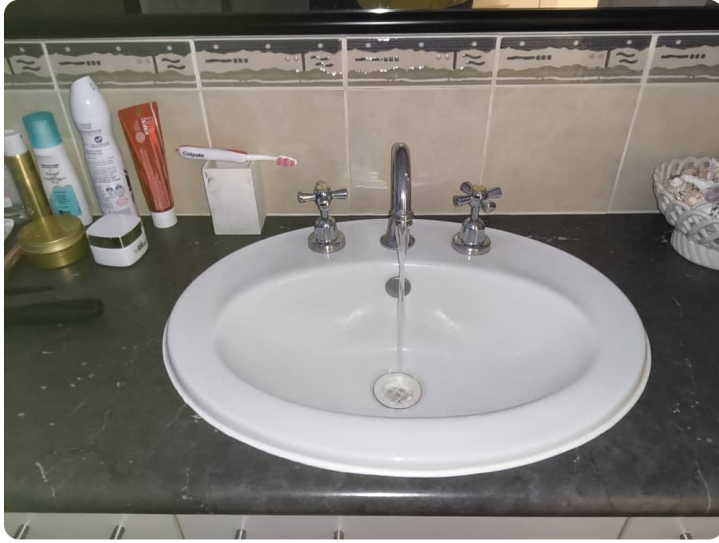
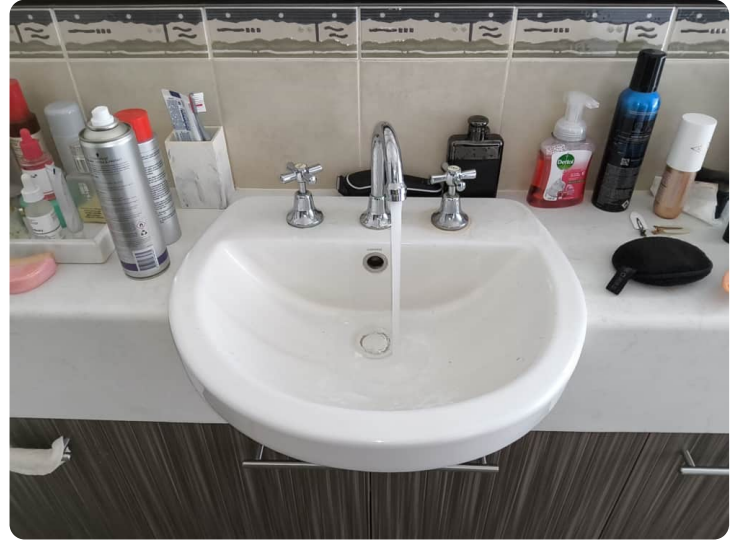
### 38. Plumbing

The taps to multiple areas were turned on and the water flow appeared to be reasonable. Water draining to several sinks and toilets appeared to be reasonable. The Building Inspector is not a Plumbing Contractor and is not permitted to test Plumbing items under WA Law. Where appropriate a Plumbing Contractor should be engaged to test the plumbing in the property.

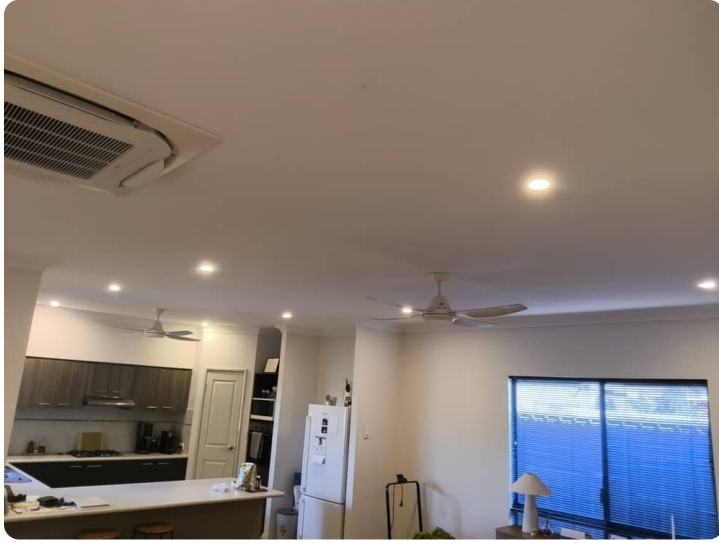
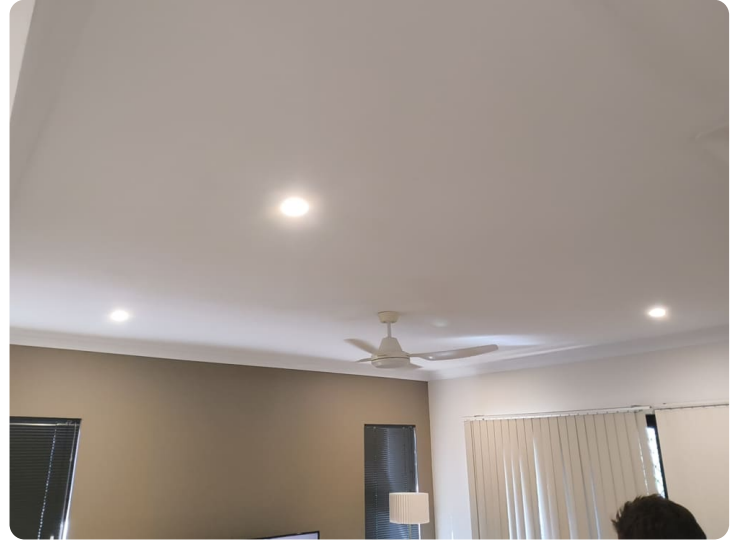
### 39. Lights and power points

Several lights were turned on during the inspection and the lights appeared to be operational. The Building Inspector is not an Electrical Contractor and is not permitted to test Electrical items under WA Law. Where appropriate an Electrical Contractor should be engaged to test the electrical items in the property.

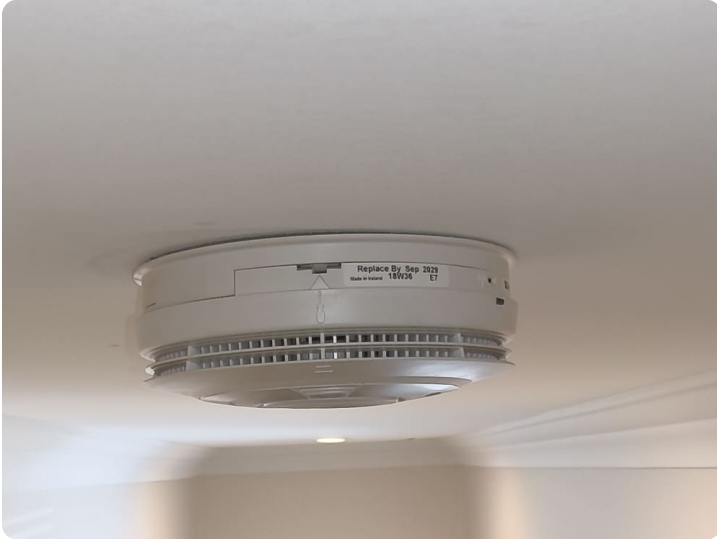
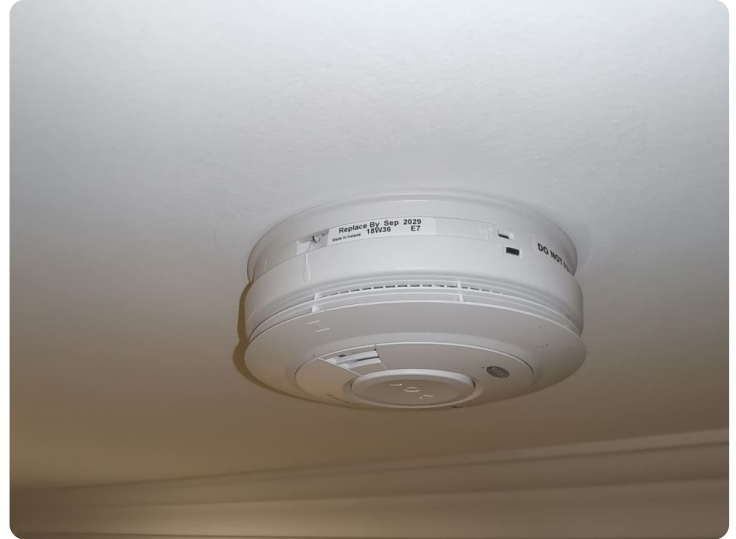
#### 40. Smoke Alarms

There were two hardwired smoke alarms on site. There were no battery smoke alarms on site. The location, number and type of smoke alarms appeared to be consistent with Legislative requirements. It is suggested that an Electrical Compliance Certificate be obtained in relation to the smoke alarms.
