Houspect

Building inspection

Job ID: 91152

Address: 20 Flinders Crescent, Dampier WA

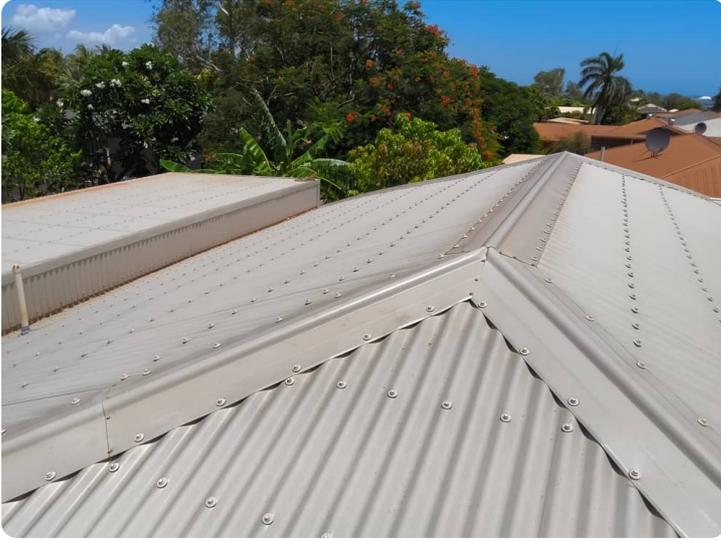
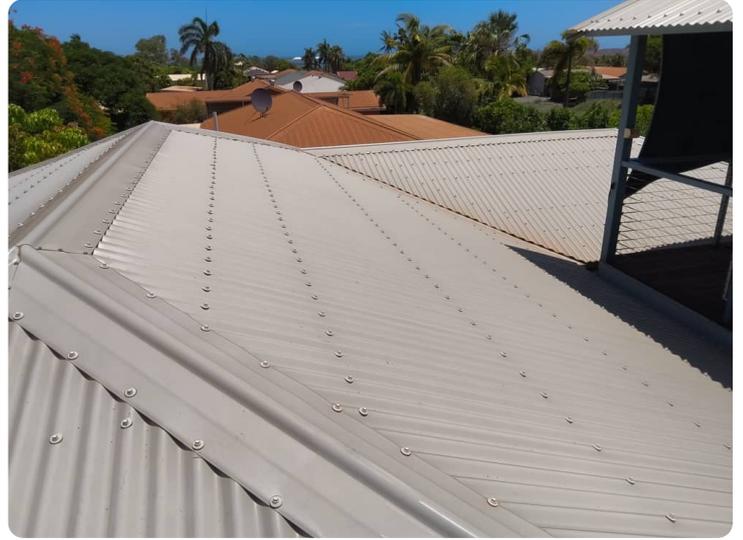
1. Roof covering

The roof covering is constructed of colorbond. The condition of the roof covering is satisfactory in relation to its age and will require normal ongoing maintenance. It appears as if the roof cover has been replaced or converted to a metal roof at some stage.

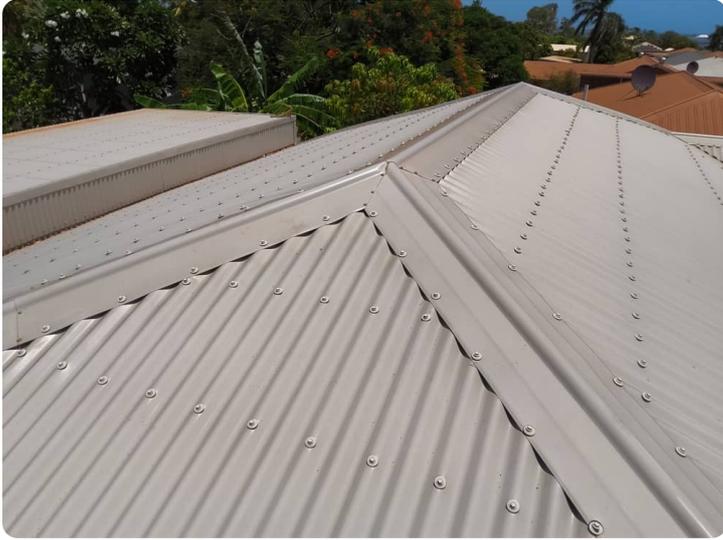
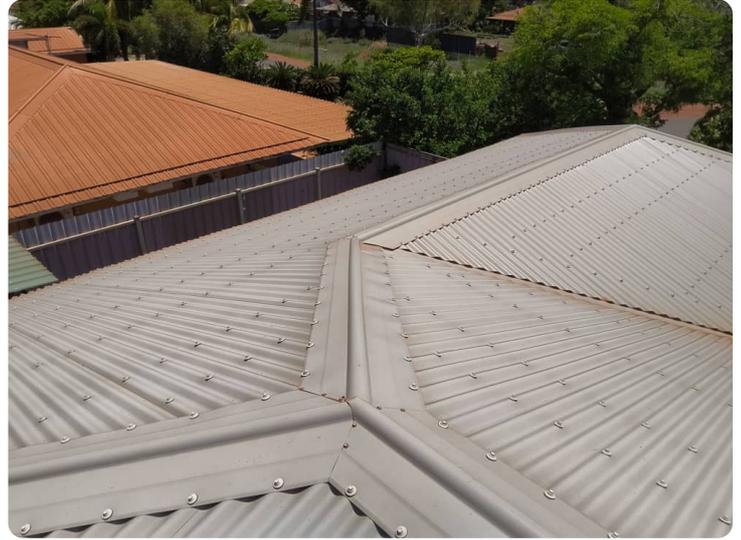
2. Ridges

The ridges and capping are satisfactory in relation to its age and will require normal ongoing maintenance.

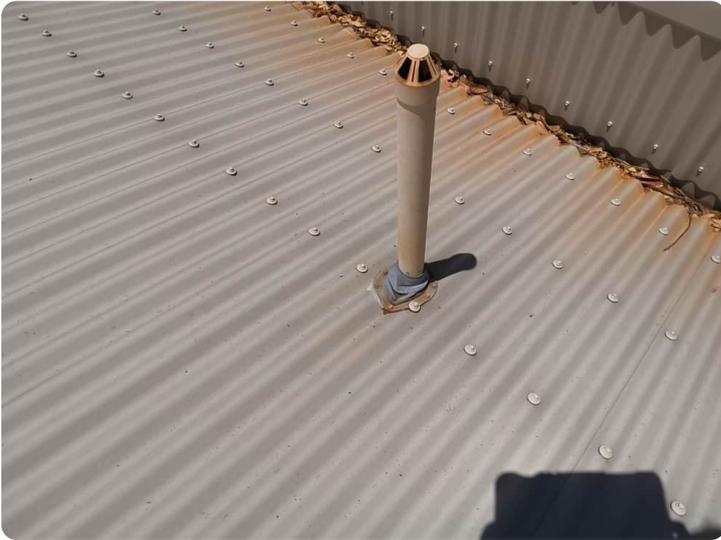
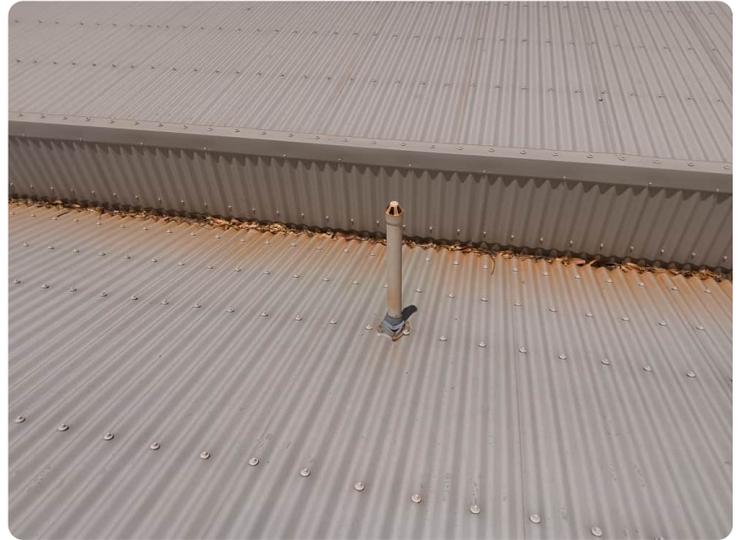
3. Flashings

The flashings are covered with a variety of finishes and are constructed of a mixture of materials. The condition of the flashings is satisfactory in relation to their age and will require normal ongoing maintenance.

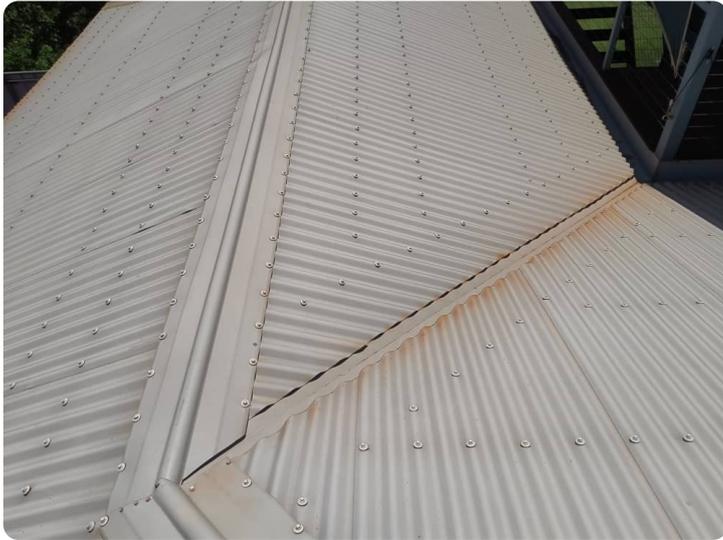
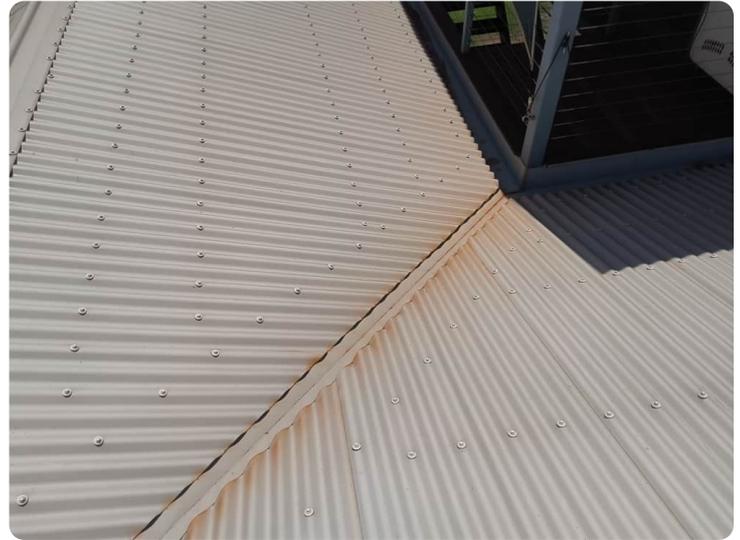
4. Valleys

The valleys are constructed of metal and have a colorbond covering. The condition of the valleys is satisfactory in relation to their age and will require normal ongoing maintenance. The valleys appear to be relatively free of debris.

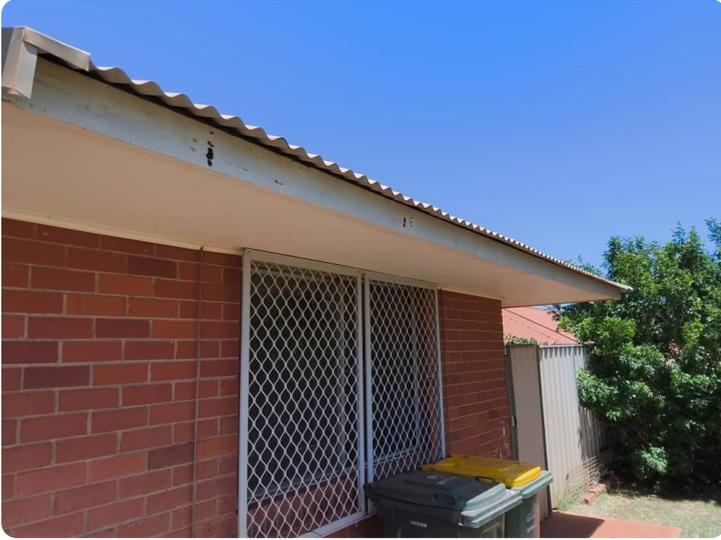
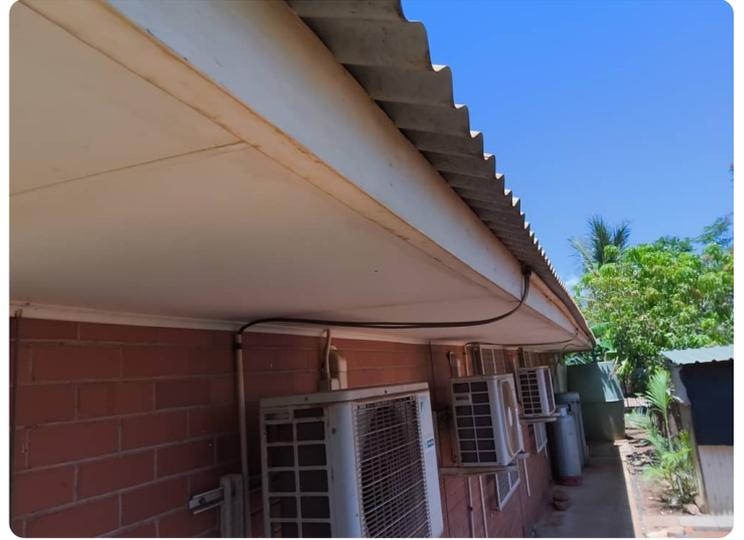
6. Fascia

The fascia are constructed of timber and they are painted. The condition of the fascia is satisfactory in relation to their age and will require normal ongoing maintenance.

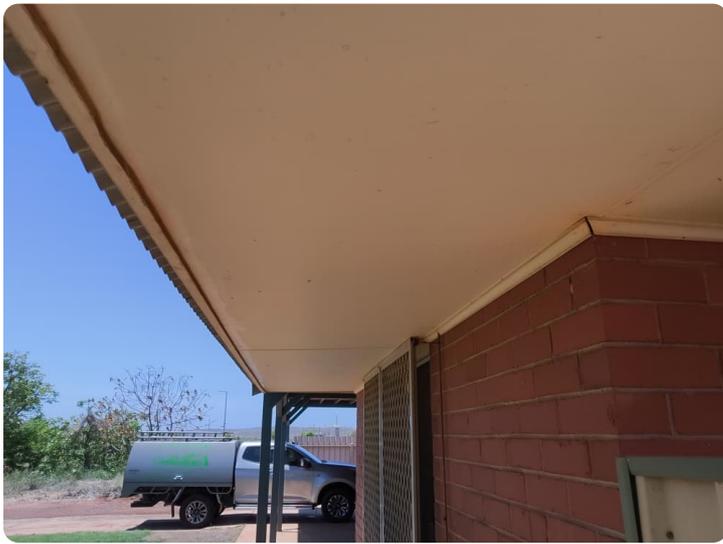
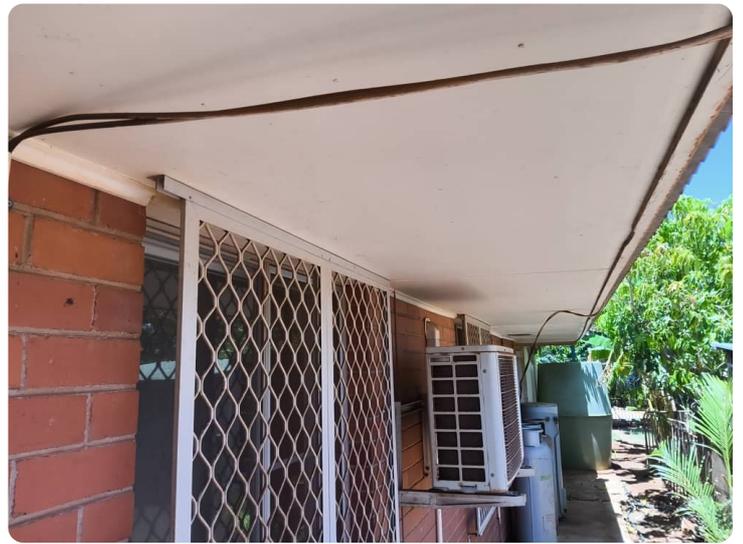
7. Eaves

The eaves are boxed and constructed of painted fibre cement. The condition of the eaves is satisfactory in relation to their age and will require normal ongoing maintenance. Please note that some of the building material utilised on or within the building may or may not contain asbestos. The Australian Government has indicated that asbestos can only be correctly identified through laboratory testing. The material on this building site may not pose a concern in the current static state if maintained but for any future works the material should be tested and appropriate measures used for asbestos handling if the material is subsequently found to contain asbestos.

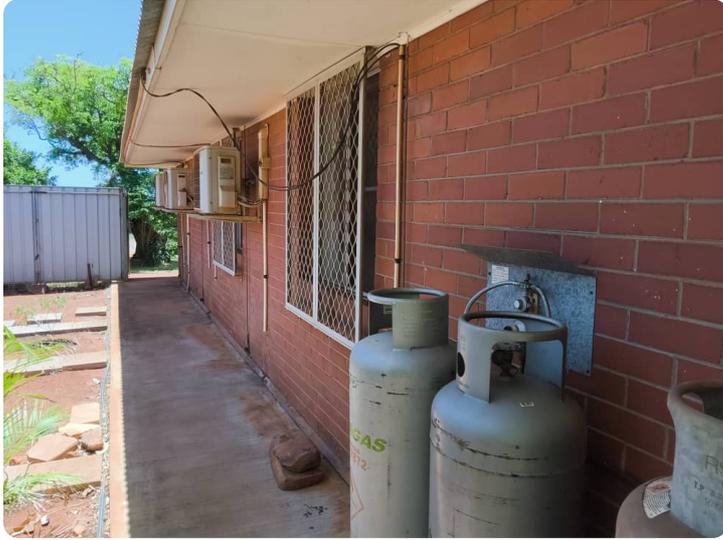
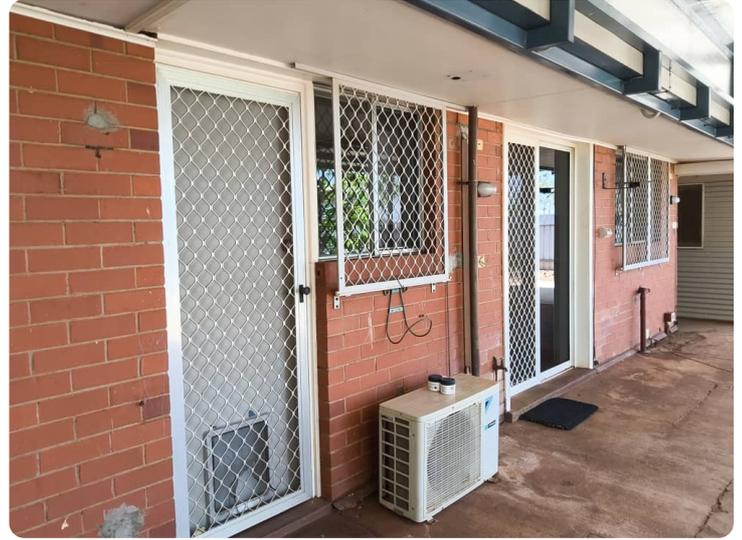
8. External walls

The external walls are constructed of brick. The condition of the walls generally is satisfactory in relation to their age and will require normal ongoing maintenance.

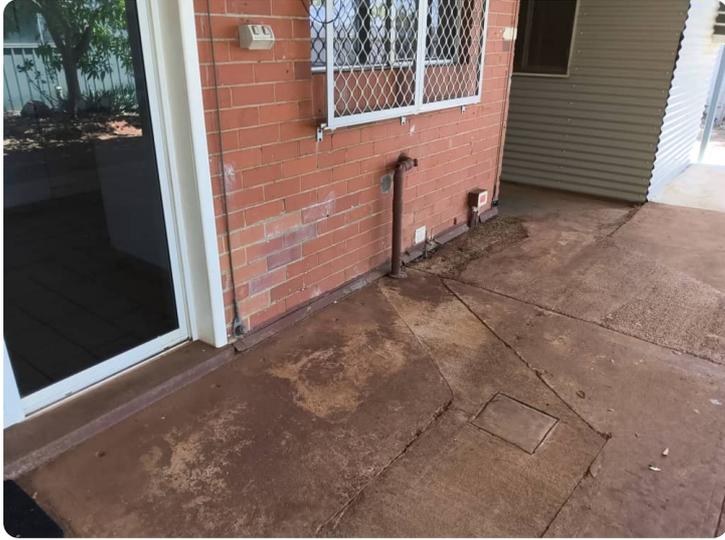
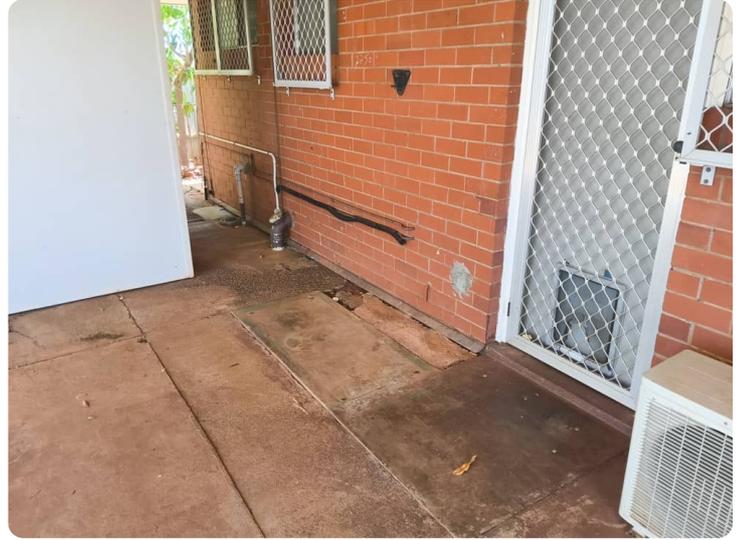
9. Footings

The footings are below ground and cannot be seen. The condition of the footings cannot be determined.

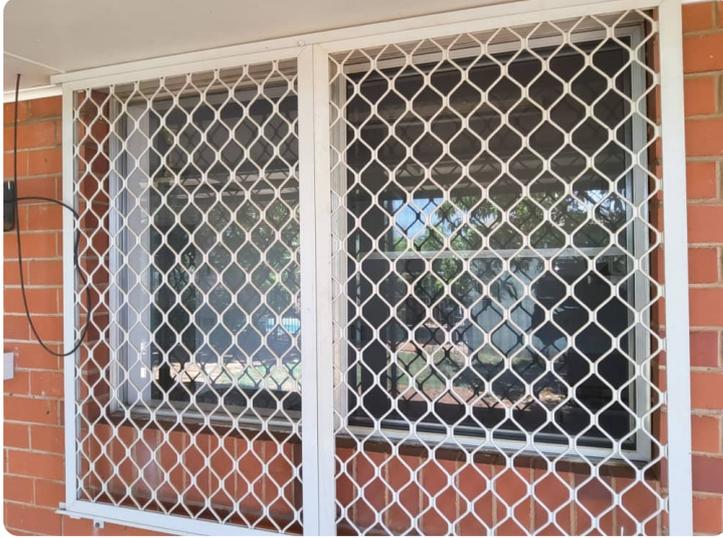
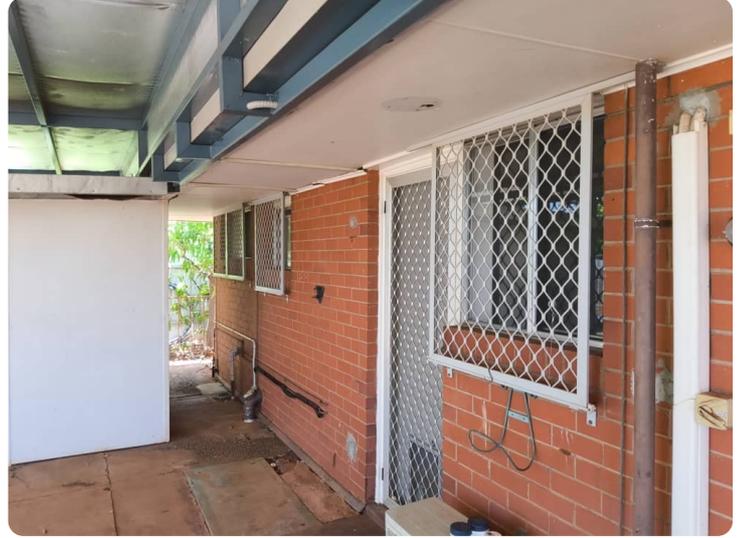
10. Windows and window frames

The window and window frames are primarily constructed of aluminium. The condition of the window and window frames is generally satisfactory in relation to its age and will require normal ongoing maintenance.

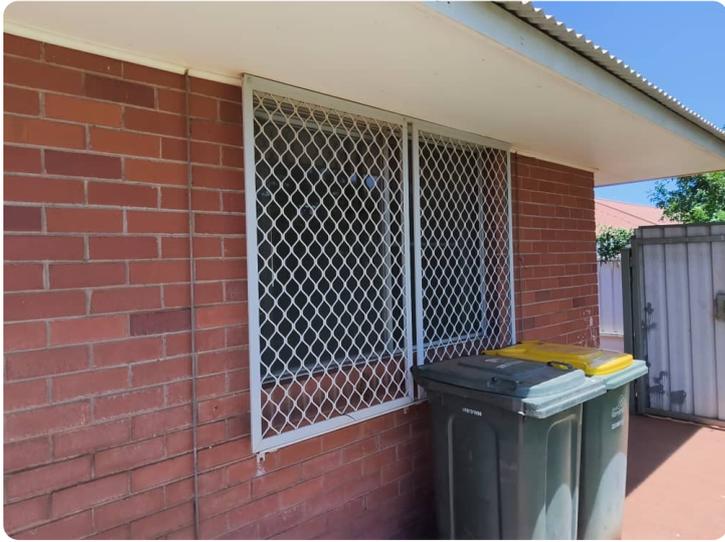
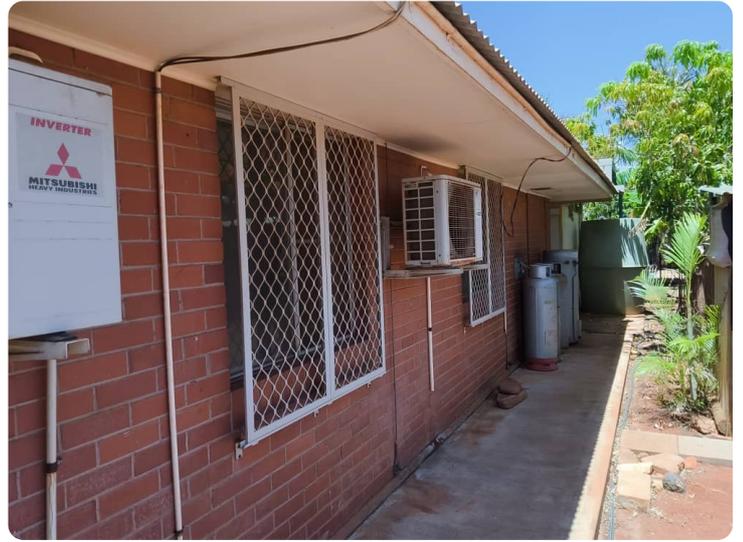
12. Cyclone screens

Cyclone screens have been installed to all of the windows. The condition of the cyclone screens is satisfactory in relation to its age and will require normal ongoing maintenance. The cyclone screens appear to be compliant with local requirements.

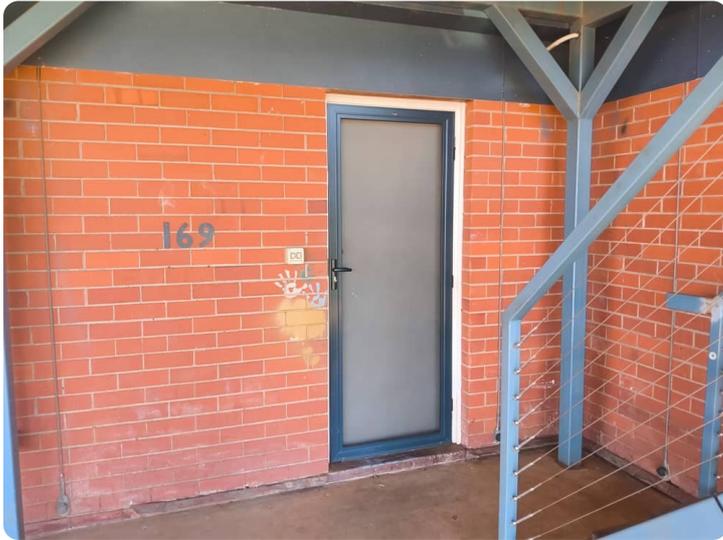
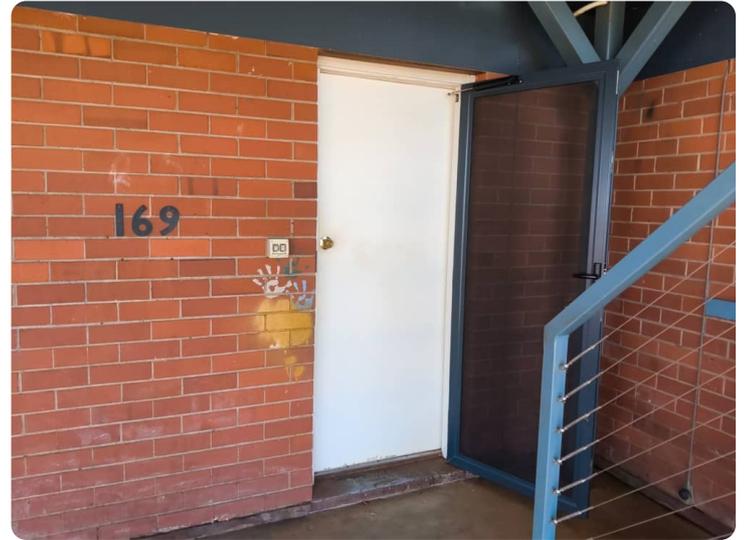
13. Front door

The front door is constructed of solid timber. The condition of the front door is satisfactory in relation to its age and will require normal ongoing maintenance. Deadlocks have not been installed. A security screen door has been fitted.

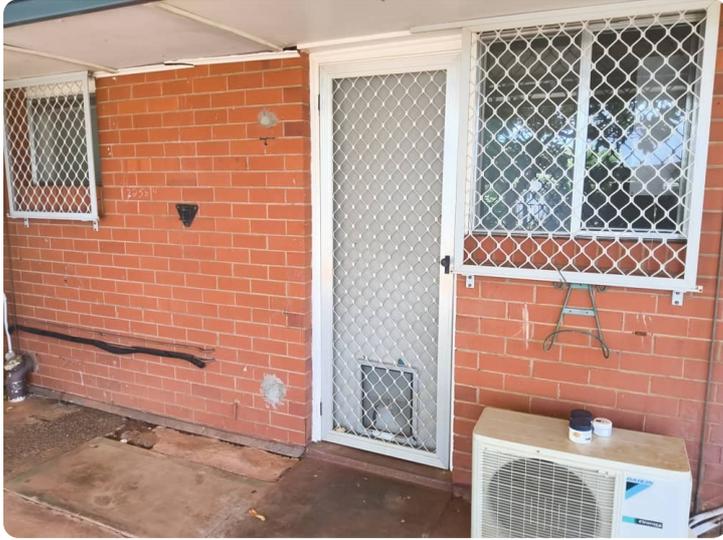
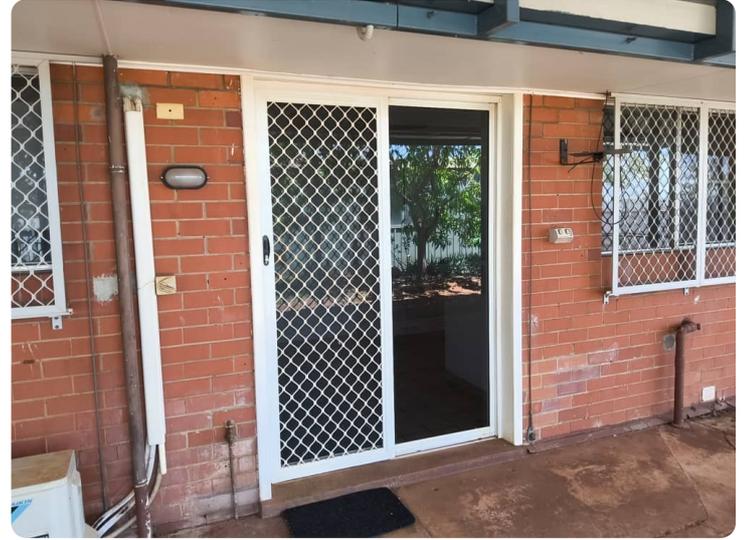
14. Other external doors

Other external doors are constructed of a variety of materials. The condition of the other external doors is satisfactory in relation to its age and will require normal ongoing maintenance.

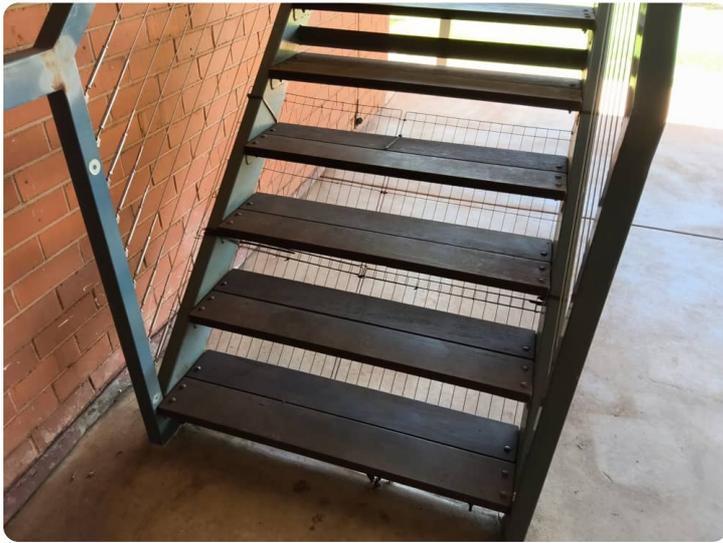
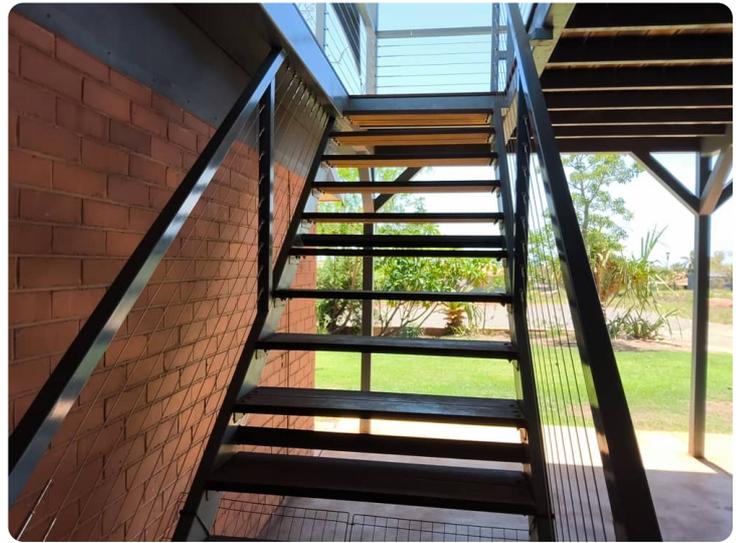
15. Primary external stairs

The external stairs are located on the west side of the property. The external stairs were constructed of timber. The condition of the external stairs is satisfactory in relation to its age and will require normal ongoing maintenance. The handrail appeared to be consistent with current requirements. The balustrade appeared to be consistent with current requirements. The stair tread, goings and risers appeared to be consistent with current requirements.

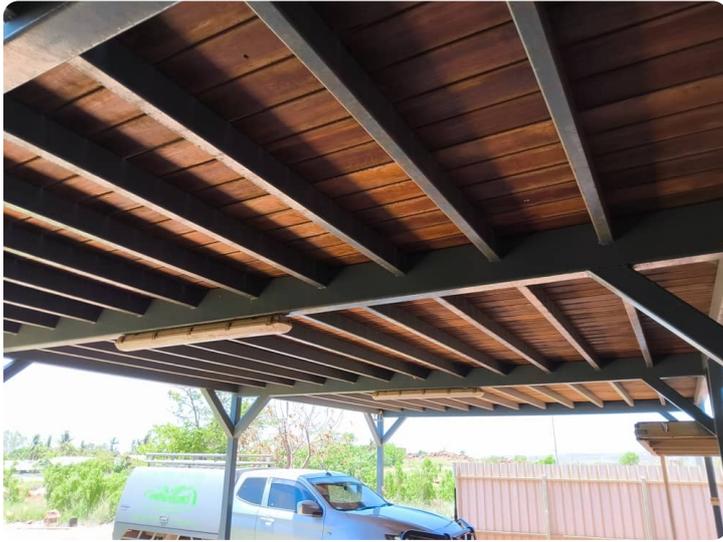
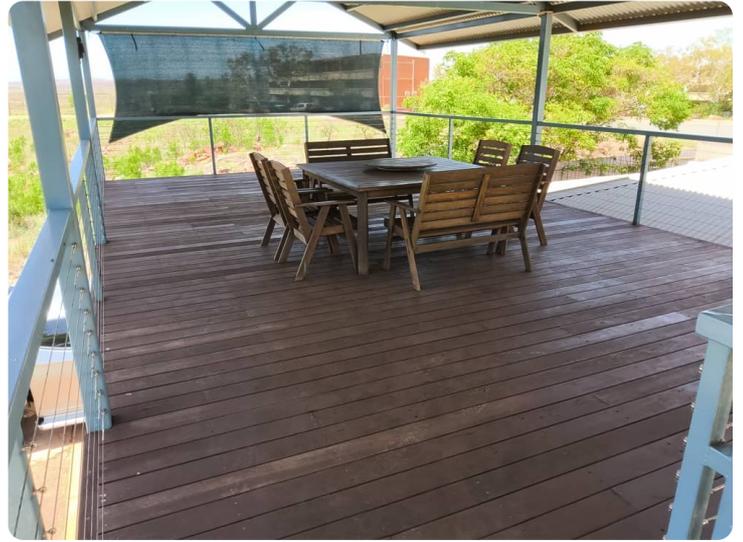
16. Primary external balcony

The primary balcony is constructed of metal. The condition of the balcony is satisfactory in relation to its age and will require normal ongoing maintenance. The balustrade appeared to be consistent with current requirements.

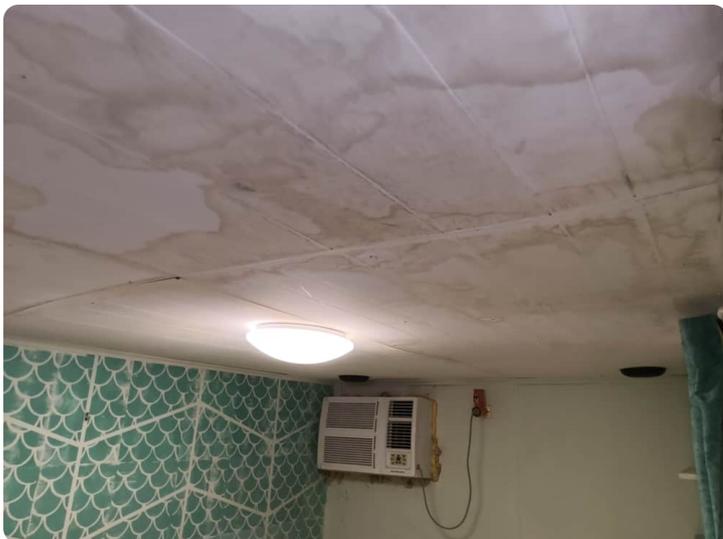
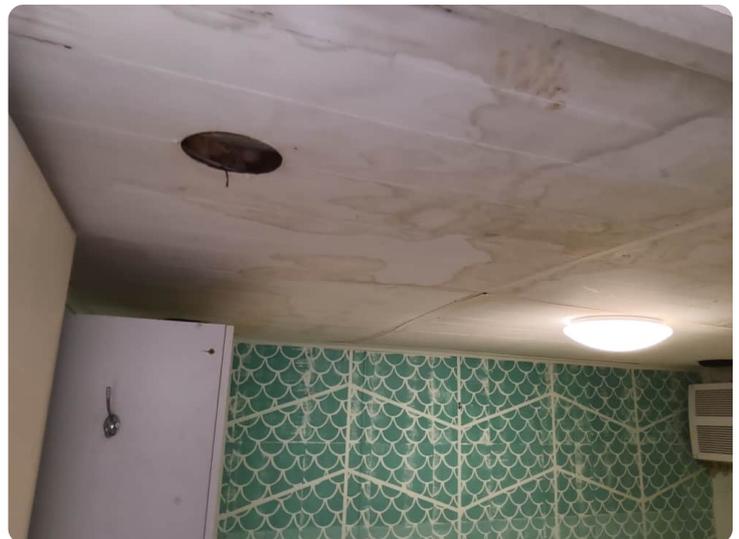
17.1 Ceiling water ingress

The ceilings in the images indicate water ingress. The source of the water ingress needs to be located and resolved prior to preparing the ceiling for painting.

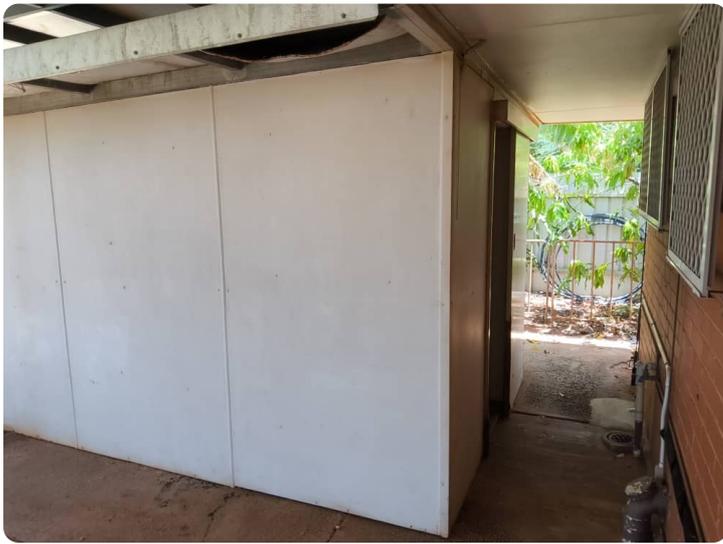
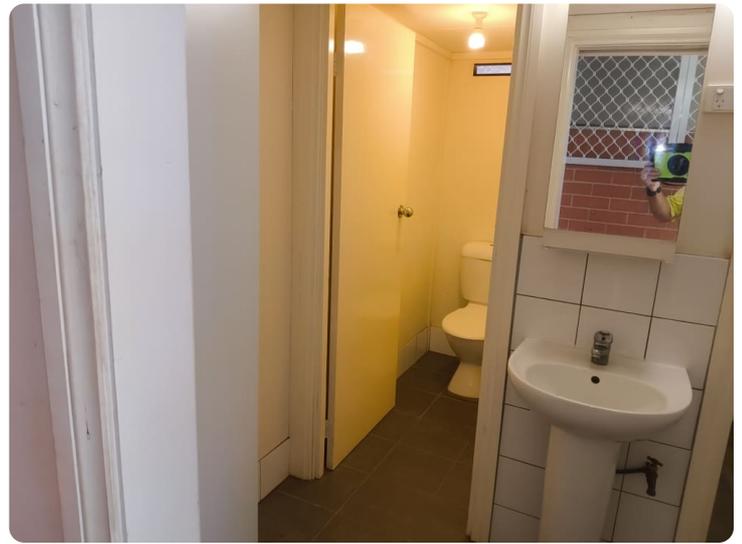
18. Out house (External Toilet)

An external out house (toilet) is located adjacent to the building. The out house is constructed of framed with fibre cement and metal. The condition of the out house is satisfactory in relation to its age and will require normal ongoing maintenance. Please note that some of the building material utilised on or within the building may or may not contain asbestos. The Australian Government has indicated that asbestos can only be correctly identified through laboratory testing. The material on this building site may not pose a concern in the current static state if maintained but for any future works the material should be tested and appropriate measures used for asbestos handling if the material is subsequently found to contain asbestos.

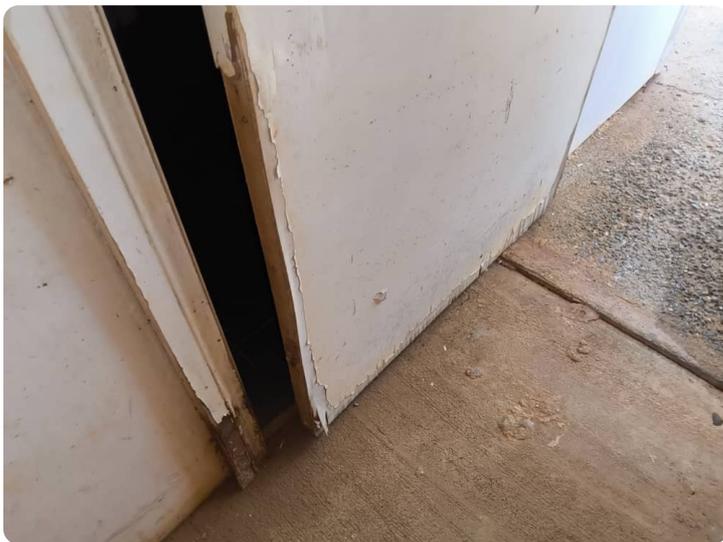
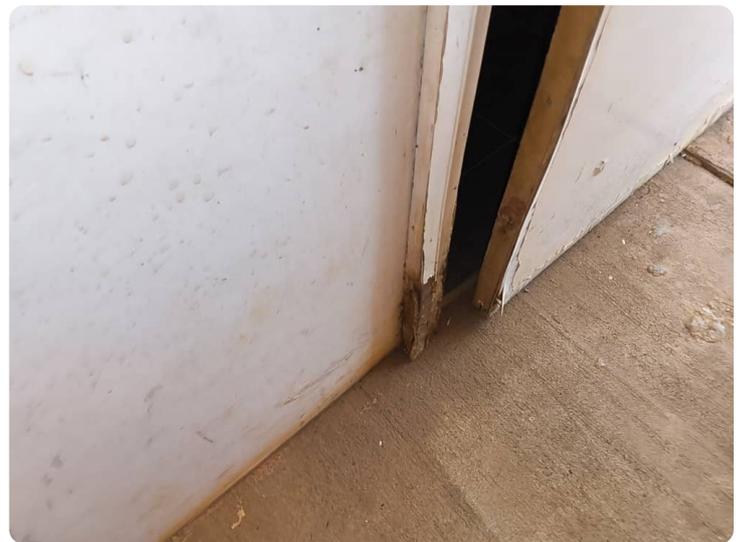
18.1 Door and or frames weathered

The door and frame in the images are weathered and needs replacing.

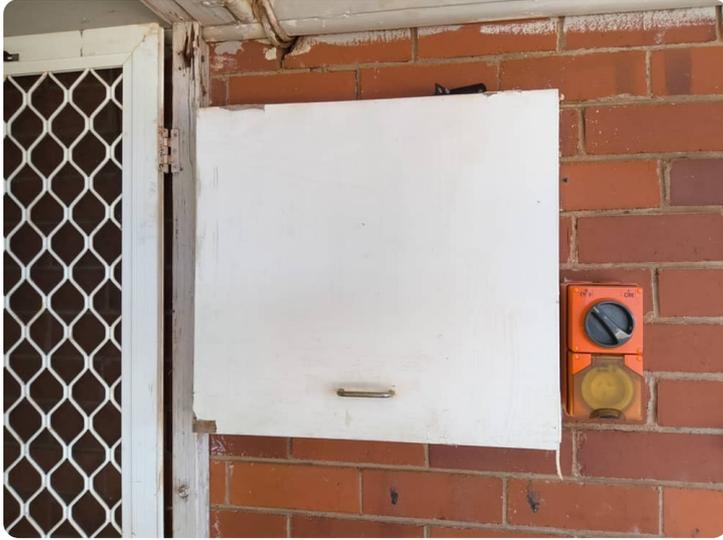
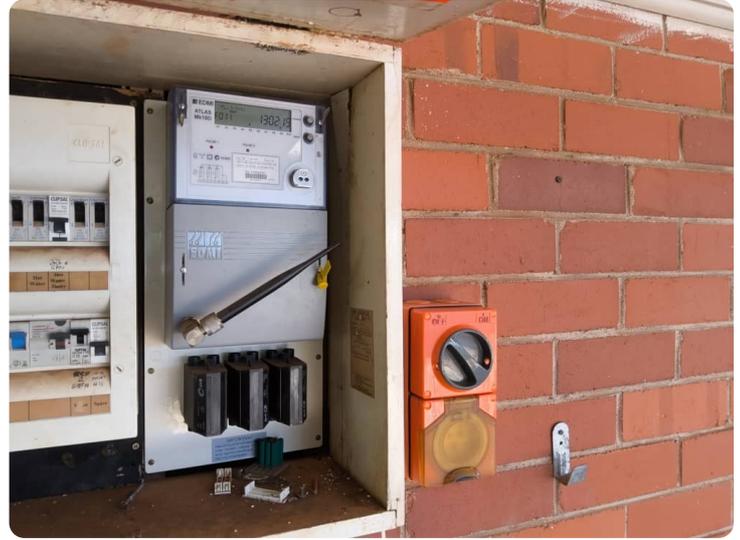
19. Meter box and power

Access to the meter box or sub board was available. The meter box or sub board is not lockable. Power phase type to the site is three phase.

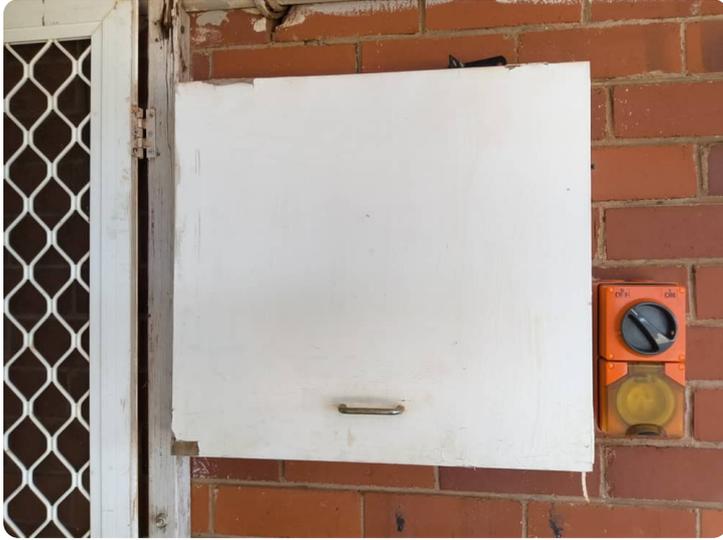
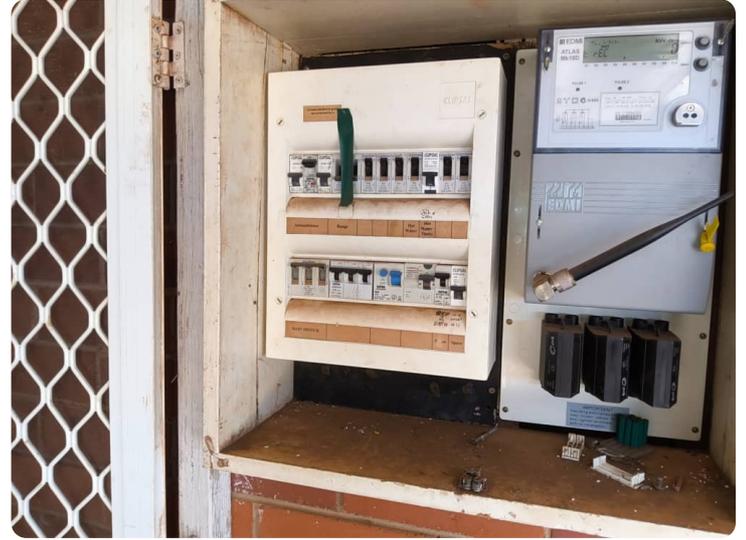
20. Residual Current Devices

There were three Residual Current Devices (RCD)(s) noted in the meter box or sub meter box. The RCD(s) were not tested. It is suggested that an Electrical Compliance Certificate be obtained in relation to the RCD(s).

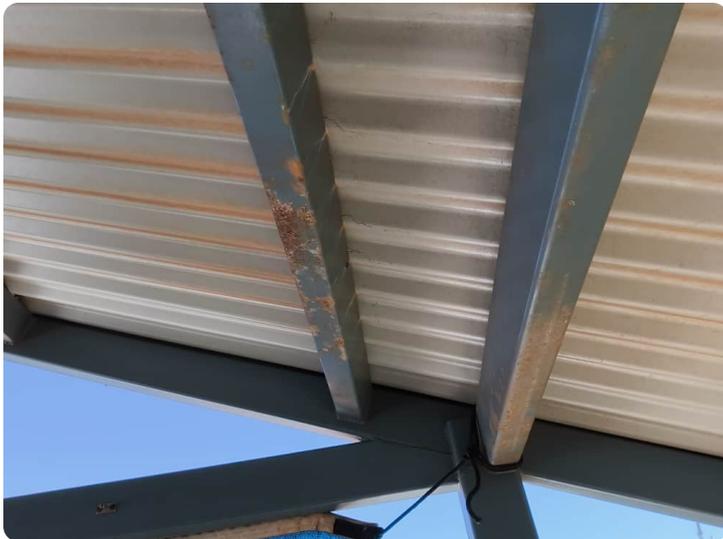
24.1 Metal frames rusted - minor

Metal frames are rusted and require maintenance to prolong their life.

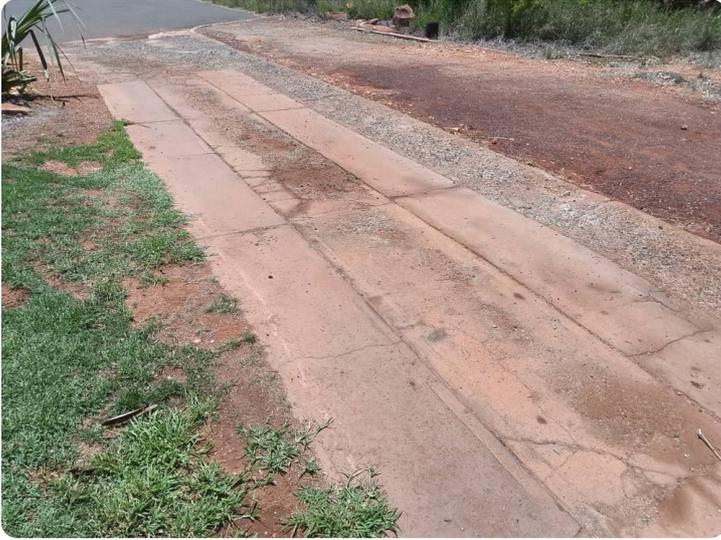
27. Driveway

The driveway and cross over is constructed of concrete. The condition of the driveway is poor in relation to its age.

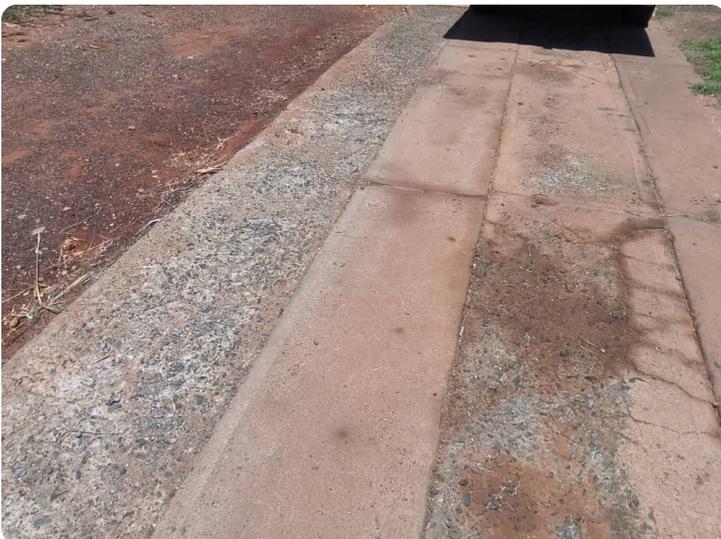
27.1 Concrete cracking - major

Significant cracking was noted to the concrete paving. This is not of a structural concern however repairs are required.

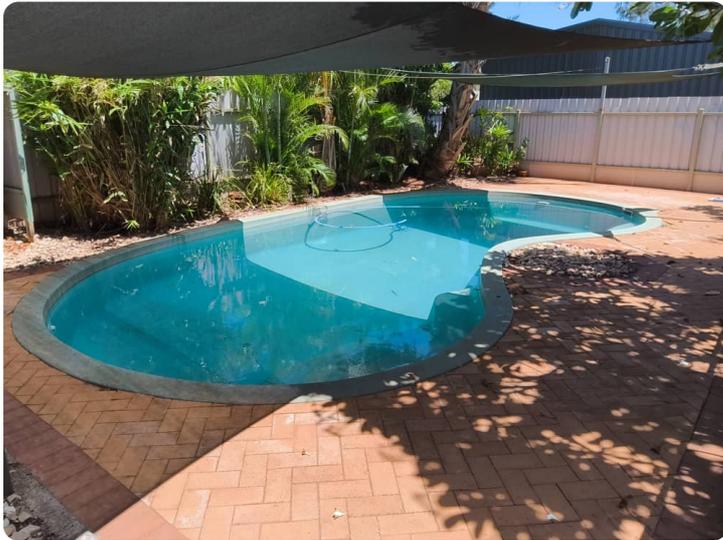
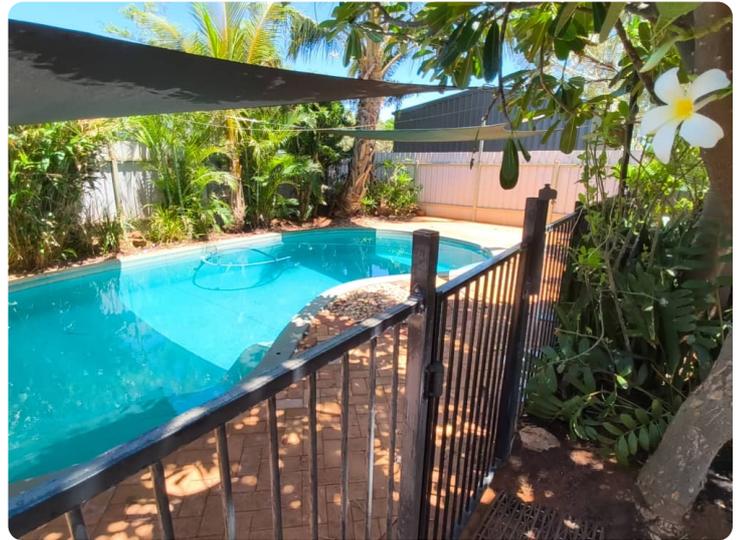
31. Pool (isolation fencing)

The pool is situated below ground. The external pool on the property is constructed of fibreglass. In relation to subsidence to the ground immediately adjacent to the pool, significant subsidence was noted requiring further inspection and or repairs. There is isolation fencing installed around the pool. The isolation fencing and gates appear to be consistent with current pool fencing requirements. It is recommended that a copy of the previous Council Pool Safety Compliance Certificate is obtained. It is recommended that a pool maintenance contractor review and confirm the operation of all pool equipment.

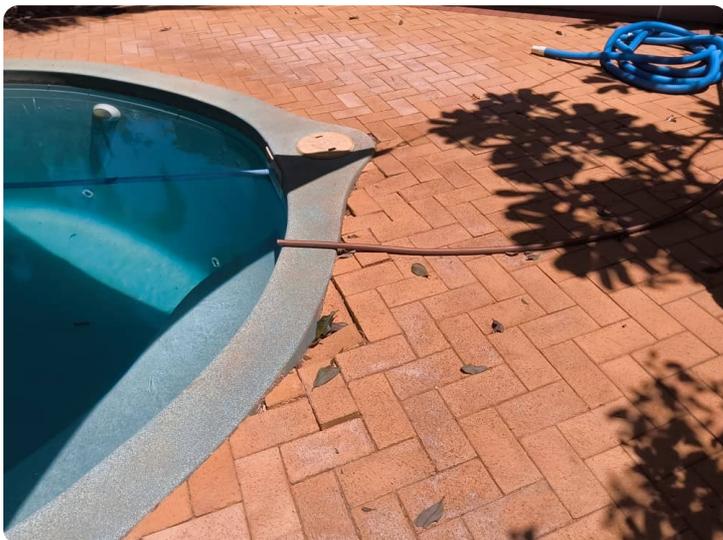
31.1 Pool surrounds subsidence

It was noted that there was minor subsidence to the ground surrounding the pool. Repairs and maintenance should be undertaken as required.

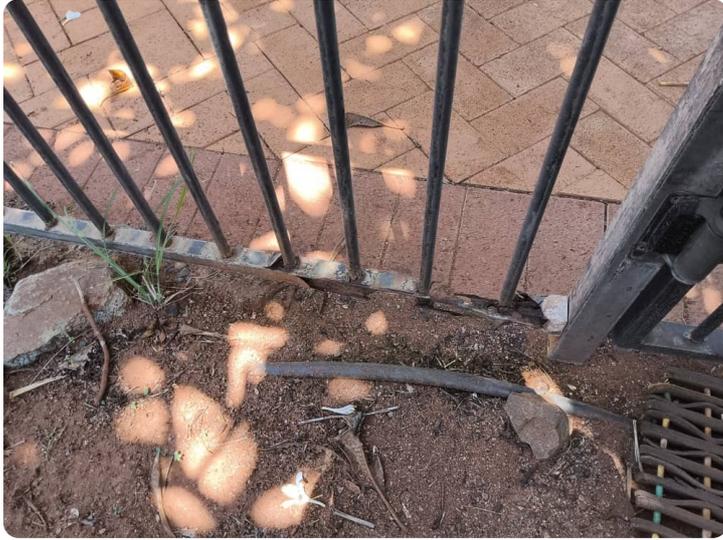
31.2 Pool fence rusting

The pool fence has rusted parts these need repairing or replacing before they become a compliance issue. A pool compliance certificate should be obtained. Remediation work should be undertaken as required.

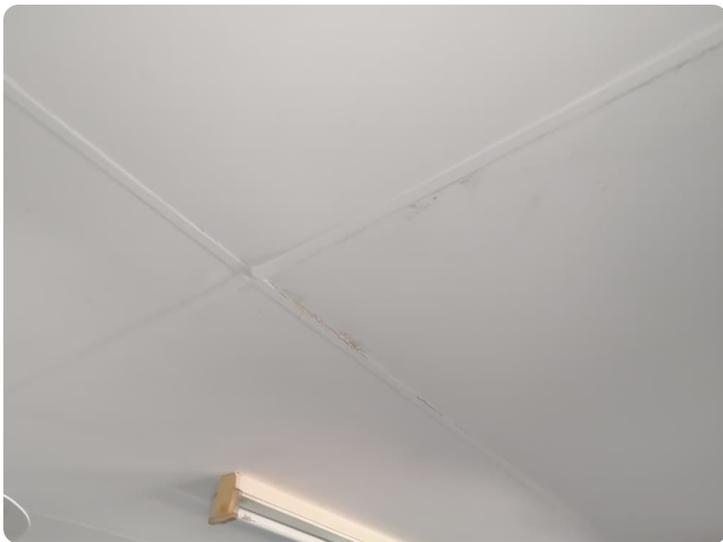
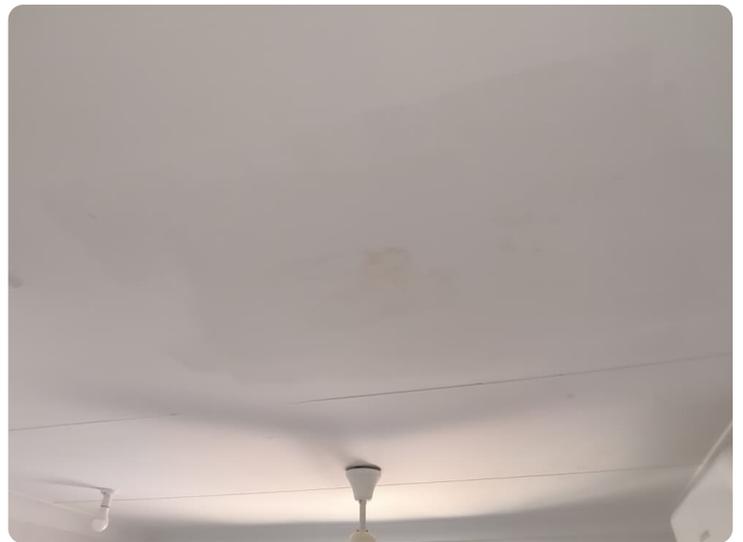
36.1 Water ingress - ceilings

The ceilings in the images indicate water ingress. The source of the water ingress needs to be located and resolved prior to preparing and painting the ceiling.

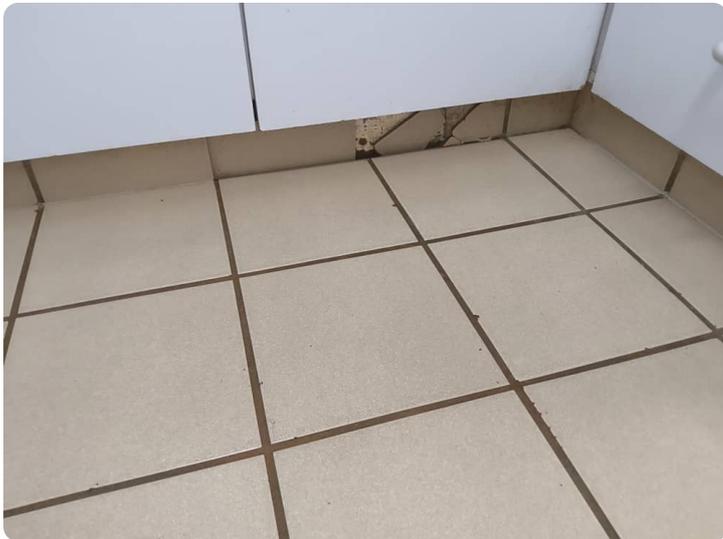
39.1 Tile damage - minor

As per the images provided there is damage to the wall or floor tiles requiring repairs or replacement.

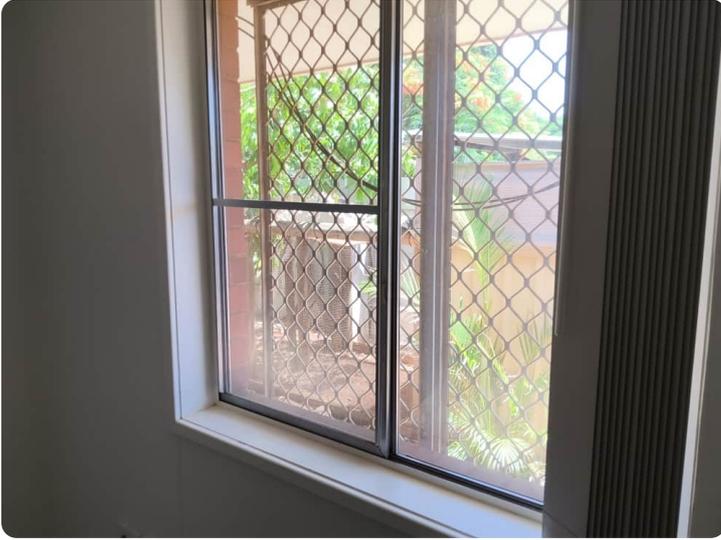
The condition of the windows, as viewed from within the property, is fair in relation to its age and will require ongoing maintenance. Window locks have been installed to none of the windows.

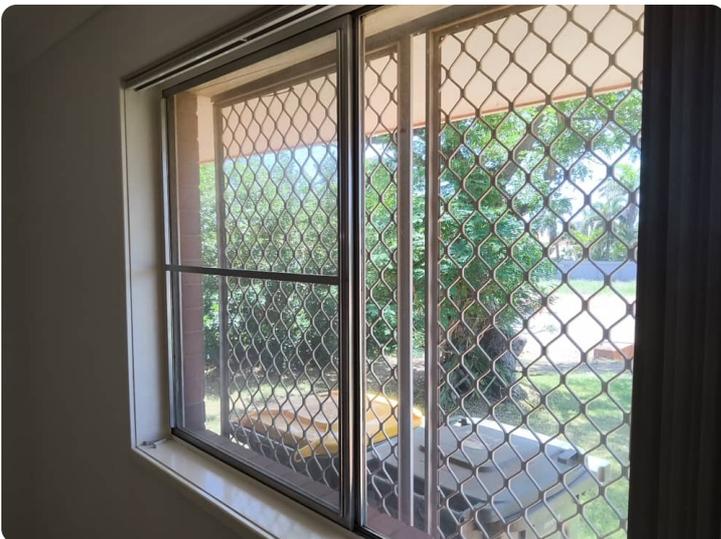
40.1 Window latches, catches or opening mechanism, damaged, broken or missing

As per the images the window latches, catches or opening mechanism is missing damaged or requires repairs or replacement.

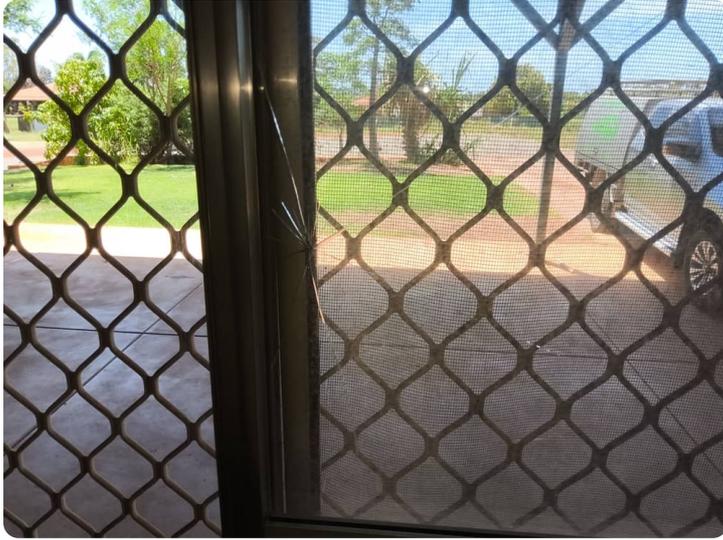
40.2 Glass pane broken

There is a broken window pane which requires replacement.

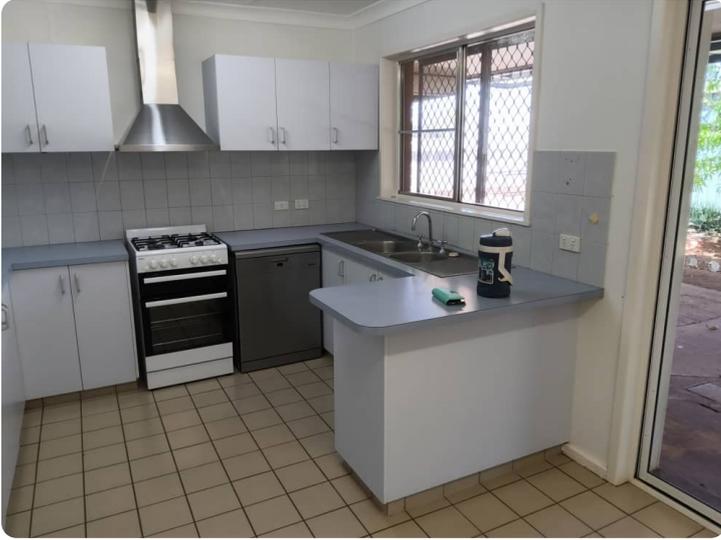
The condition of the kitchen cabinets in general is fair in relation to its age and will require ongoing maintenance.

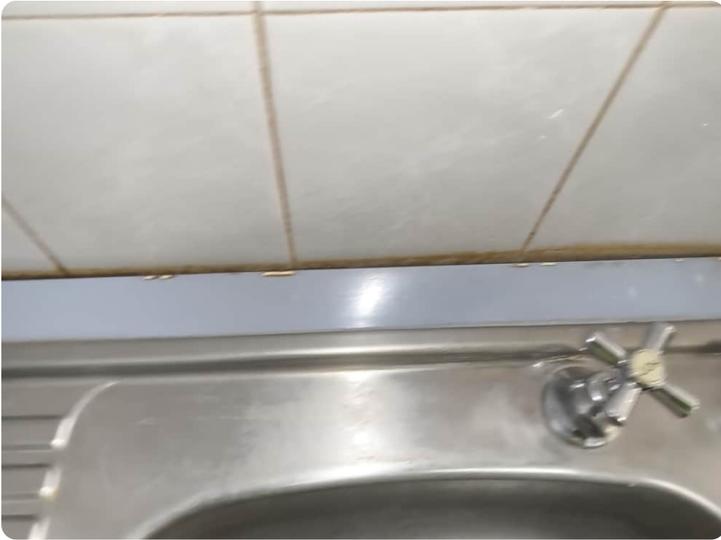
42.1 Bench top damage

As per the images the kitchen benchtop is damage requiring repairs or replacement.
