**PILBARA  
PEST CO**

# Pre-Purchase Timber Pest Inspection Report

29 Stickney Way, Baynton WA, Australia

22 Sep 2026

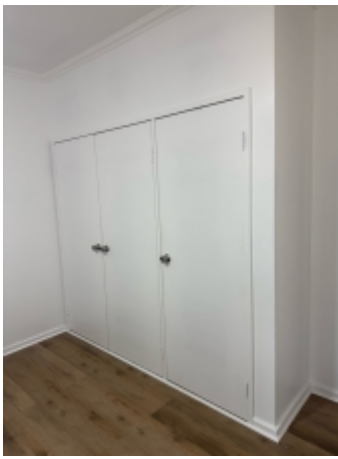
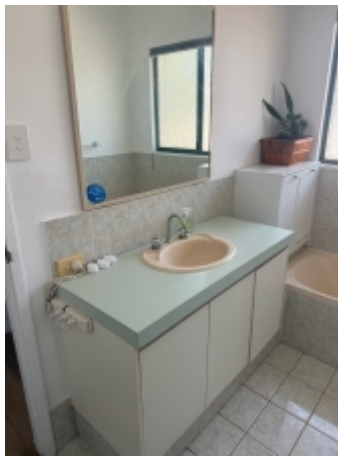
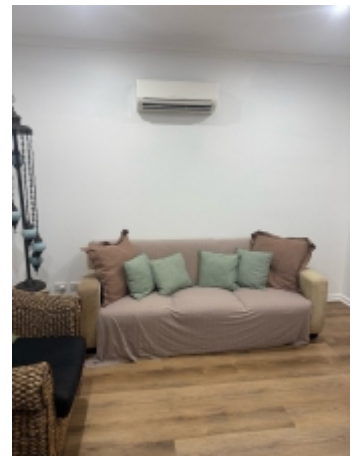
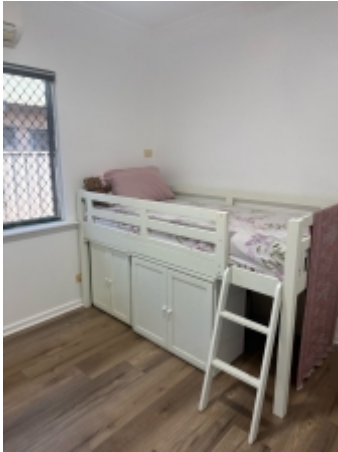
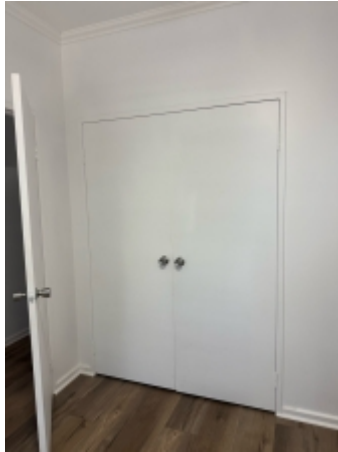
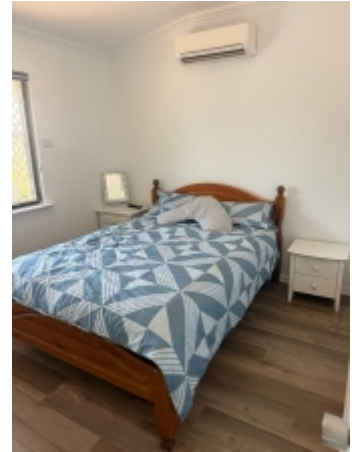
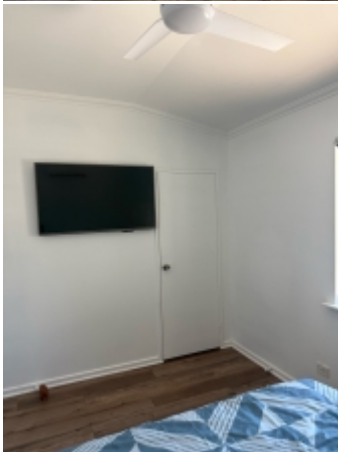
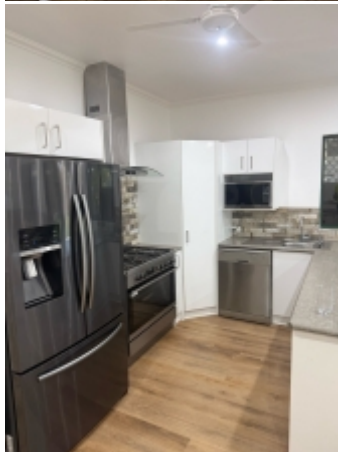
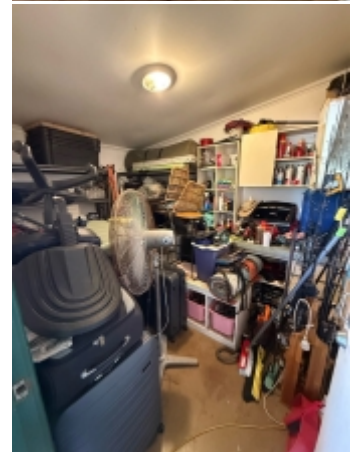
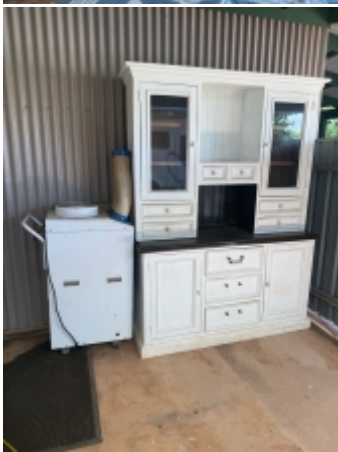
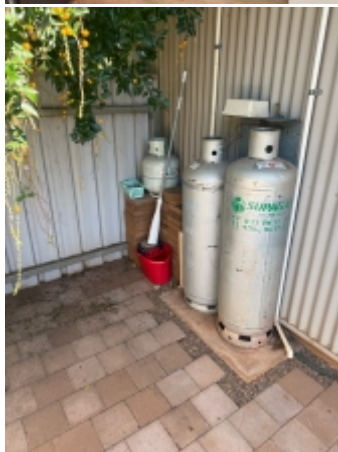
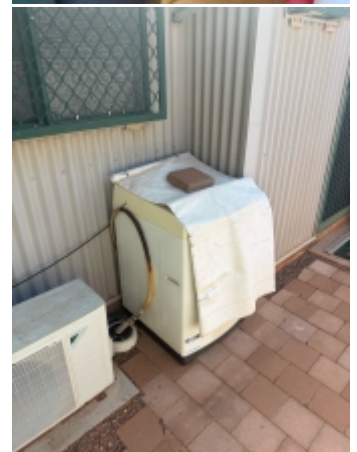
Items, fixtures and furniture etc hinder view

It is important to note that as an inspection of the above areas was not possible at the time of the inspection, timber pest activity or damage may therefore exist in these areas.
