# **Houspect**

### **Pre purchase inspection**

**Job ID:** 92961

**Address:** 29 Stickney Way, Baynton WA 6714

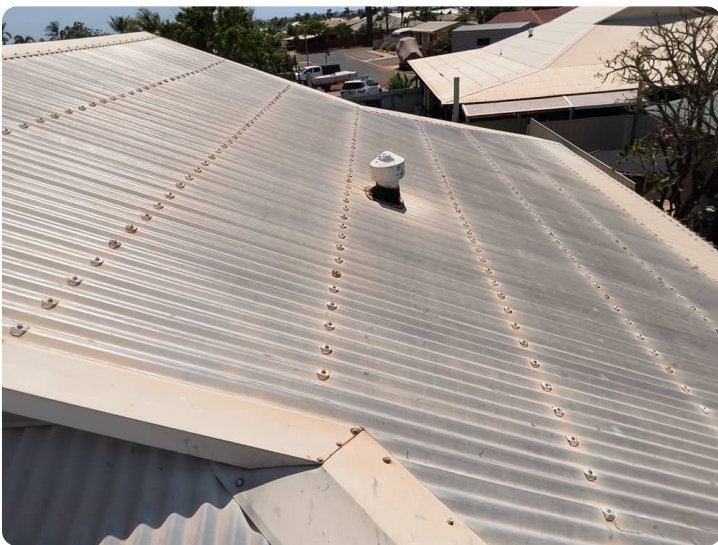
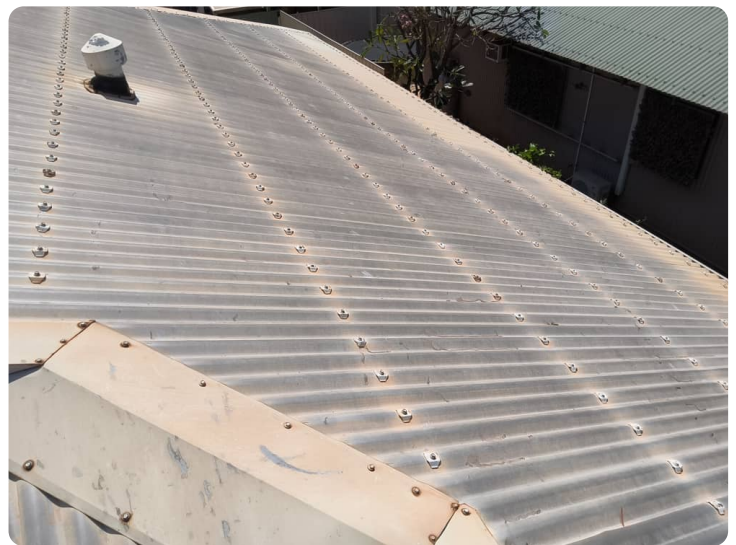
### 1.1 Metal (colorbond) roof colour faded

As per the images there the colorbond roof sheeting has or is losing its colour on most of the roof, leaving the zincalume finish. This is a cosmetic issue and does not diminish the sheets performance broader performance.

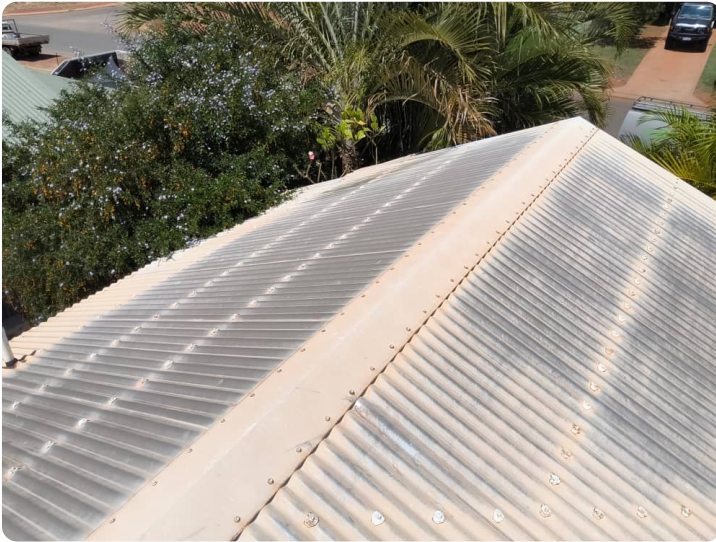
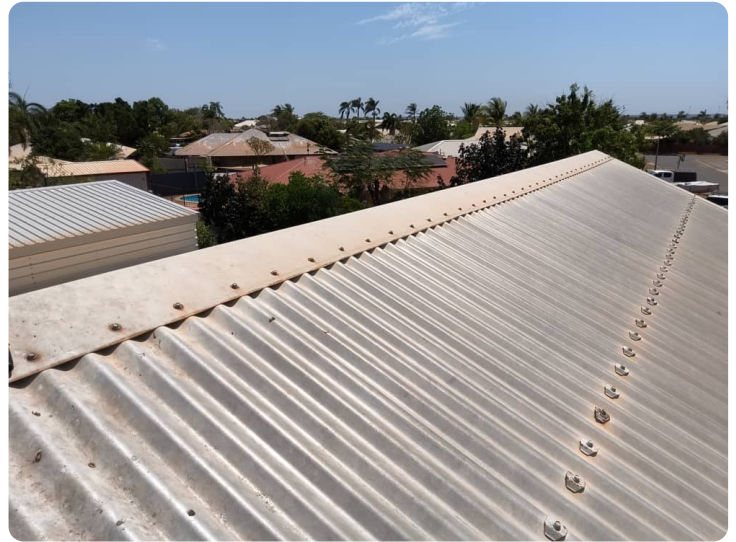
## 2. Ridges

The ridges and capping are satisfactory in relation to its age and will require normal ongoing maintenance.

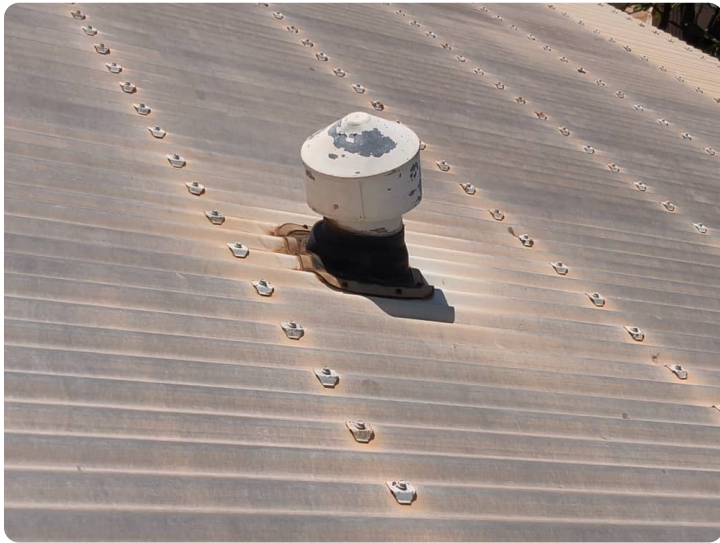
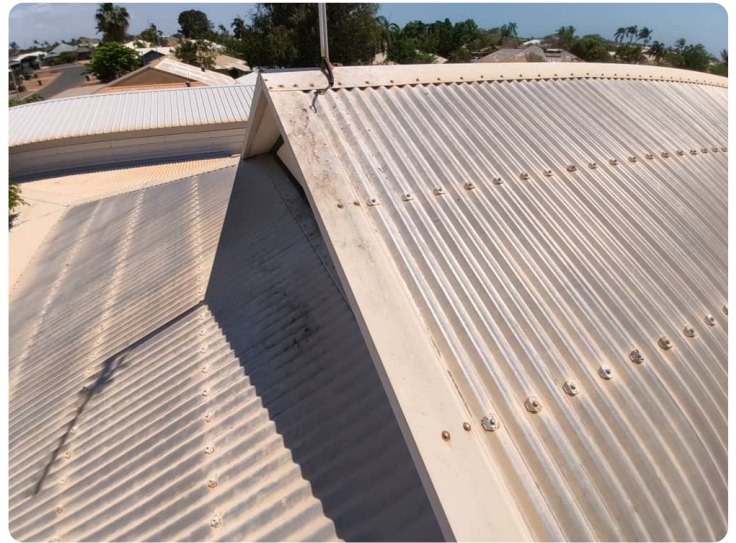
#### 3.1 Flashings general - only silicone

There is insufficient or no flashing installed around the roof penetrations which have only been silicone sealed. Installing flashing around these penetrations is recommended to prevent water ingress into the roof space.

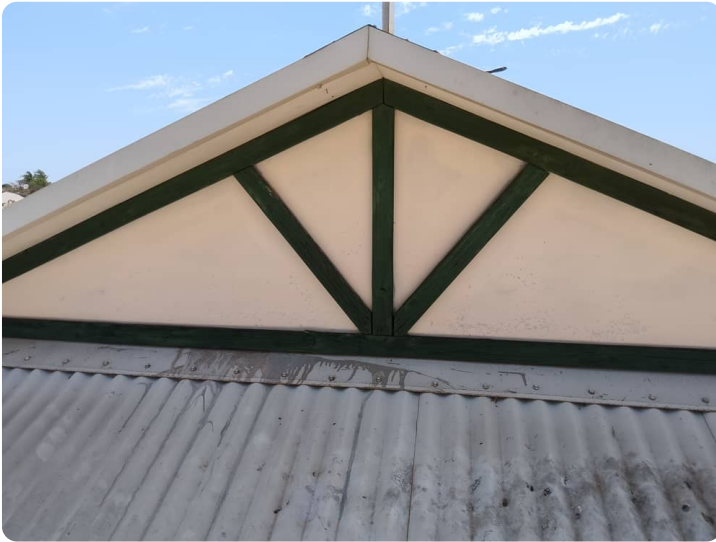
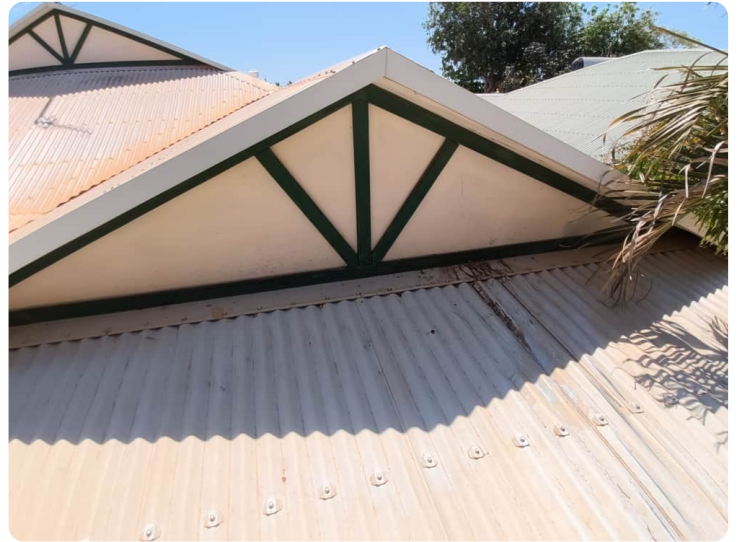
#### 4. Gables

The gables are painted and constructed of timber and fibre cement. The condition of the gables is satisfactory in relation to their age and will require normal ongoing maintenance.

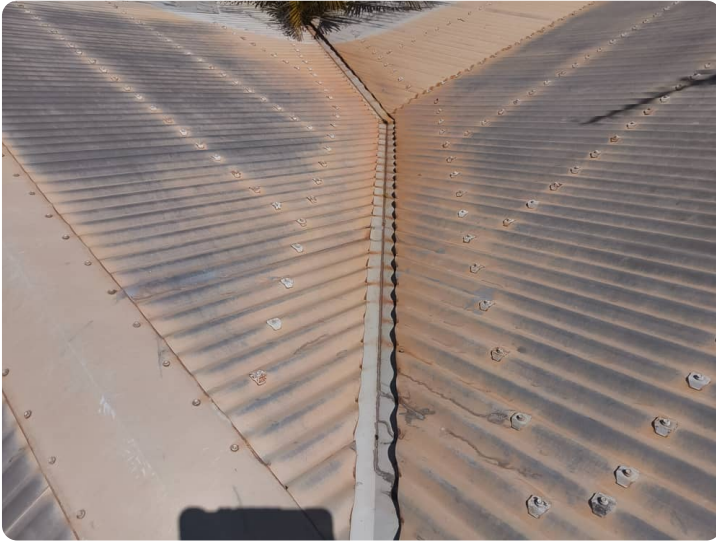
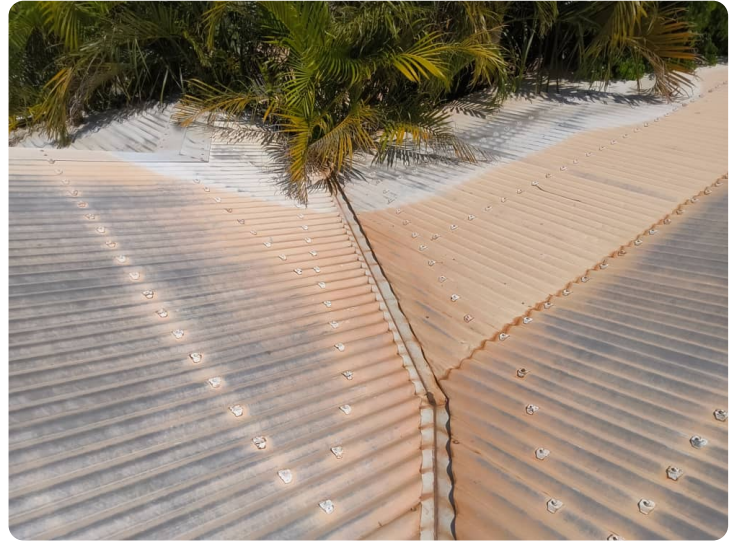
## 5. Valleys

The valleys are constructed of metal and have a colorbond covering. The condition of the valleys is satisfactory in relation to their age and will require normal ongoing maintenance. The valleys appear to be relatively free of debris.

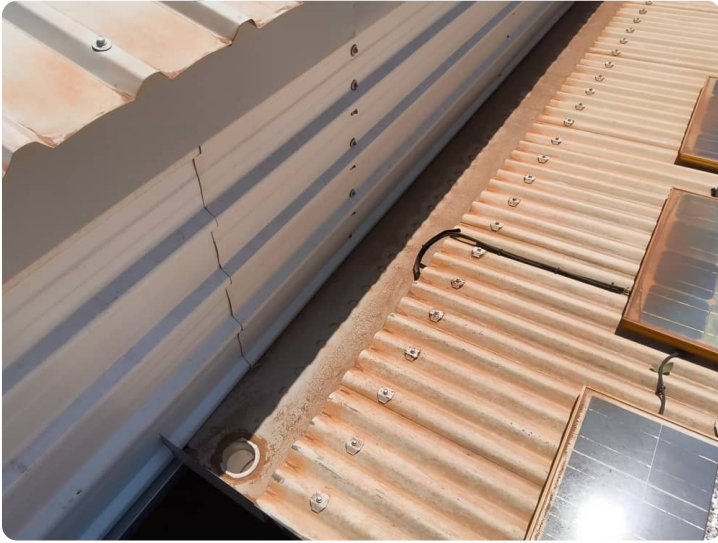
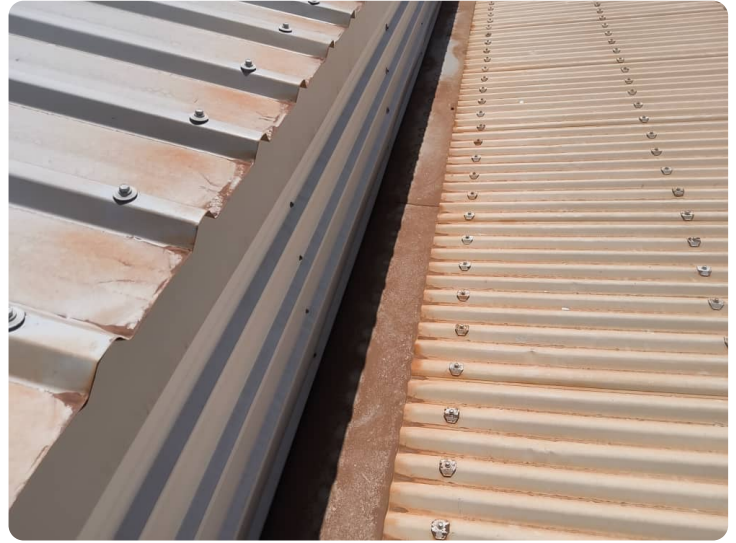
## 6. Box gutters

The box gutters are constructed of metal and they have a colorbond covering. The condition of the box gutters is satisfactory in relation to their age and will require normal ongoing maintenance. The box gutters appear to be relatively free of debris.

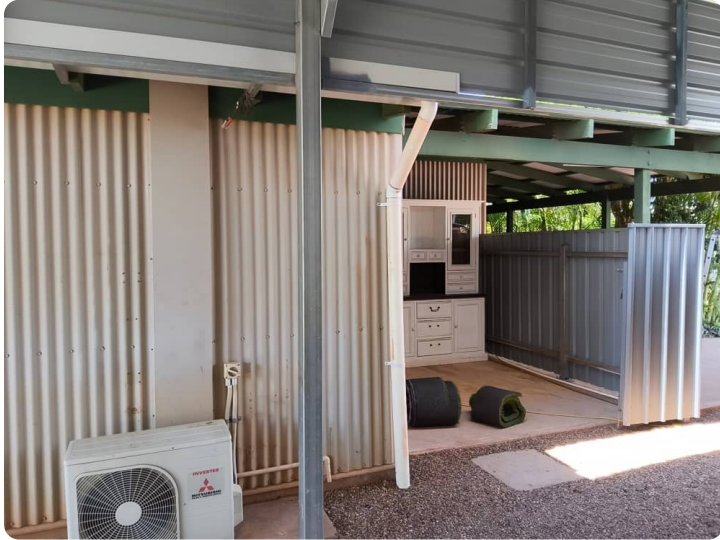
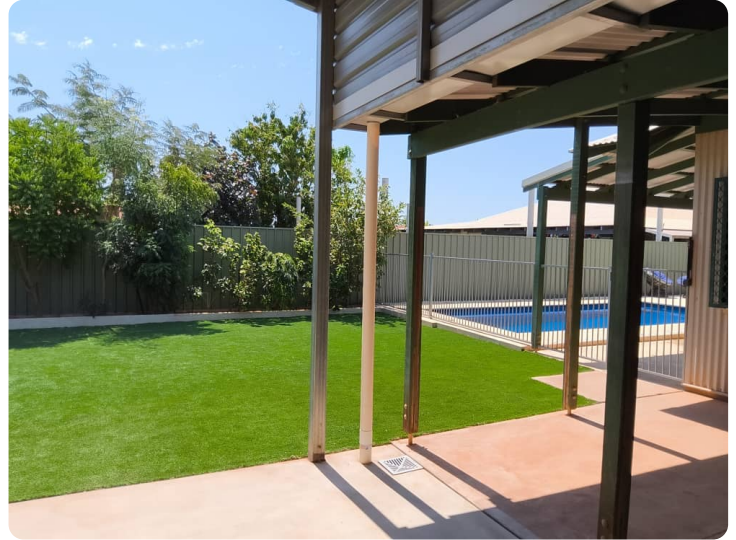
## 7. Downpipes

The downpipes are constructed of pvc or similar and they are painted. The condition of the downpipes is satisfactory in relation to their age and will require normal ongoing maintenance.

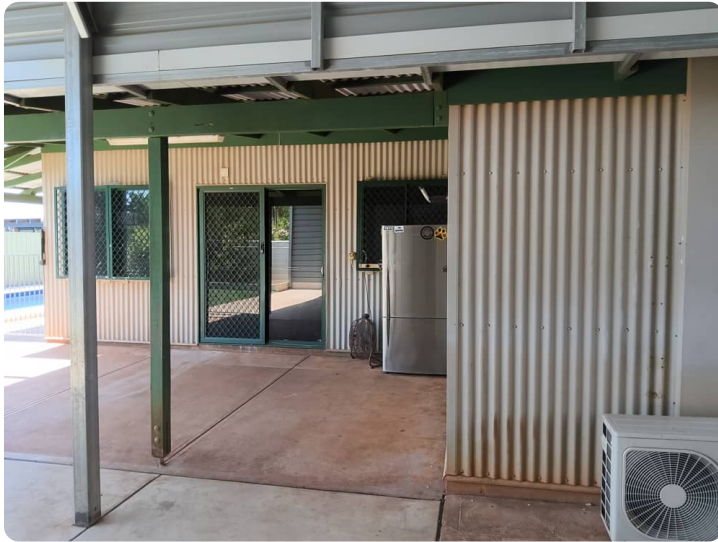
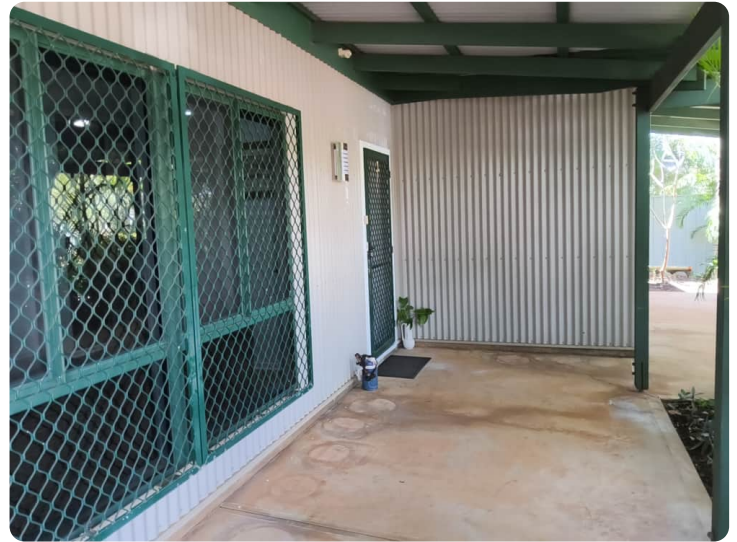
## 8. External walls

The external walls are constructed of a framed structure with cladding. The condition of the walls generally is satisfactory in relation to their age and will require normal ongoing maintenance.

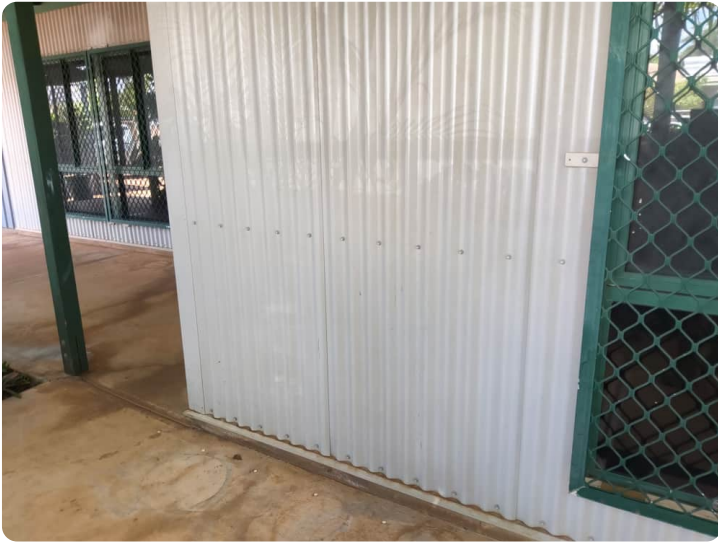
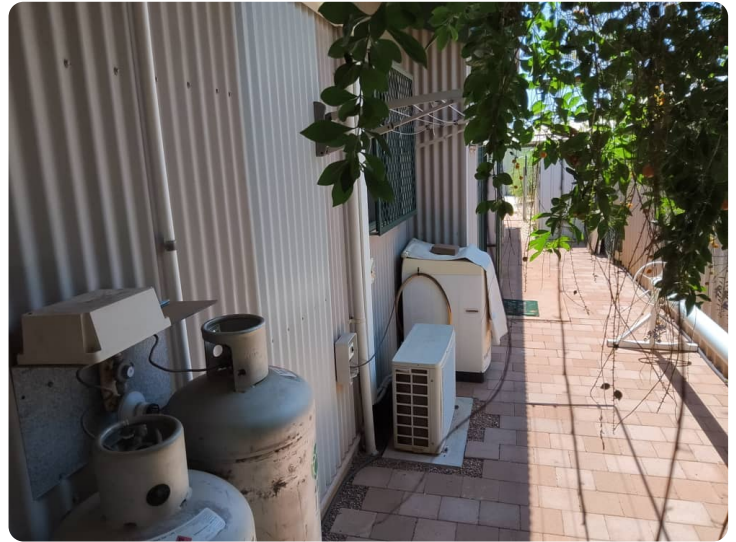
## 9. Wall cladding

The external walls are (or partially are) clad with metal. The condition of the cladding is generally satisfactory in relation to its age and will require normal ongoing maintenance.

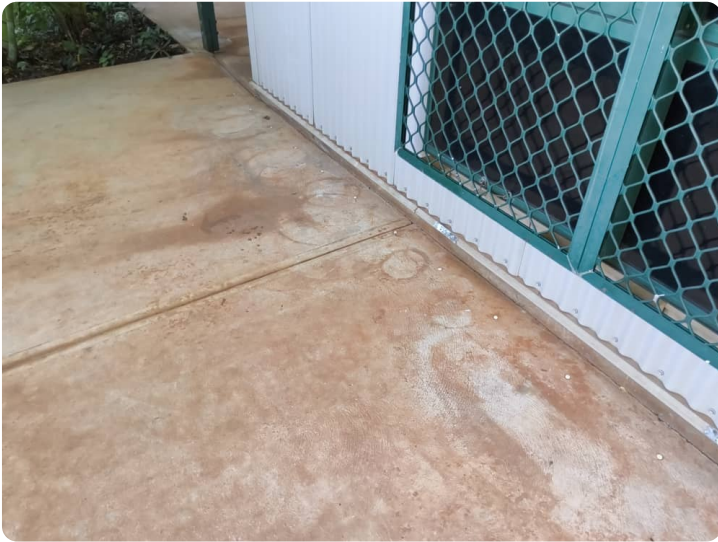
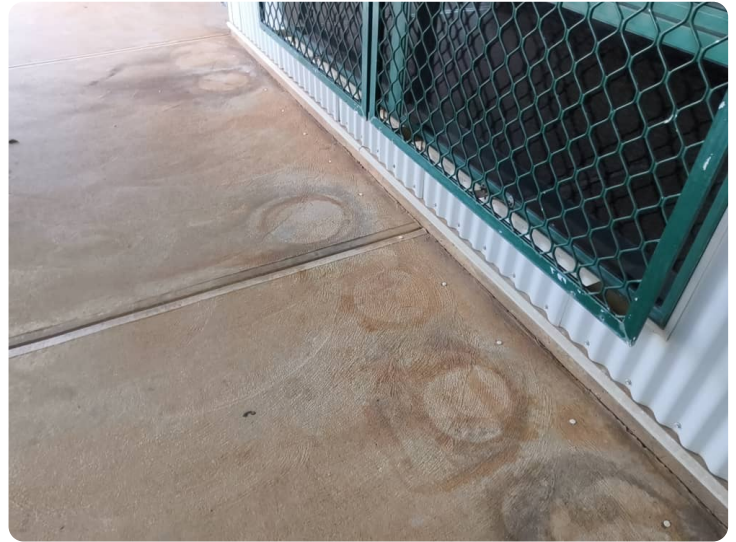
## 10. Footings

The footings are below ground and cannot be seen. The condition of the footings cannot be determined.

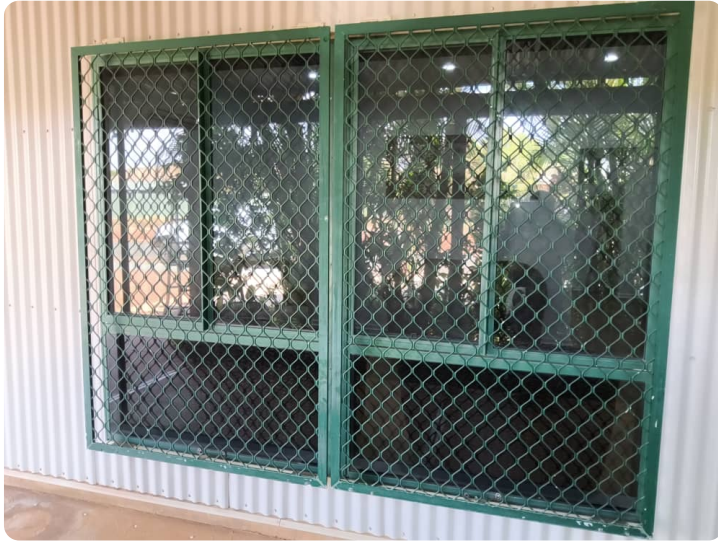
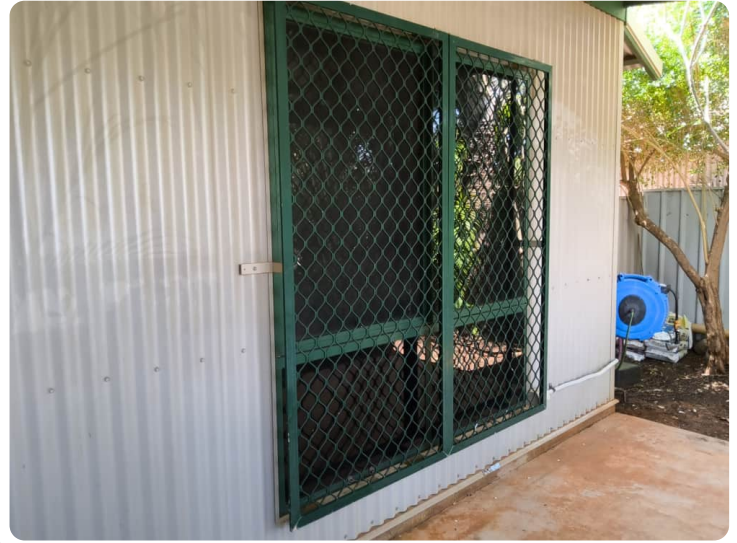
## 11. Windows and window frames

The window and window frames are primarily constructed of aluminium. The condition of the window and window frames is generally satisfactory in relation to its age and will require normal ongoing maintenance.

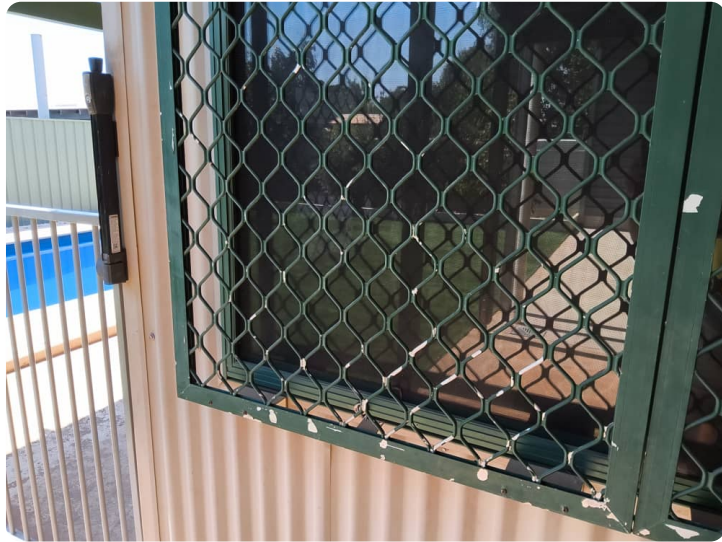
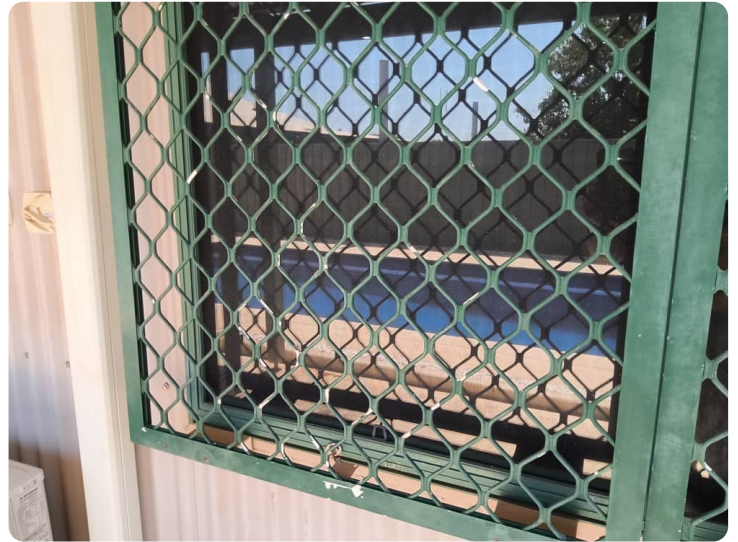
## 12. Window fly screens

Fly screens have been installed to all of the windows. The condition of the window fly screens is generally satisfactory in relation to its age and will require normal ongoing maintenance.

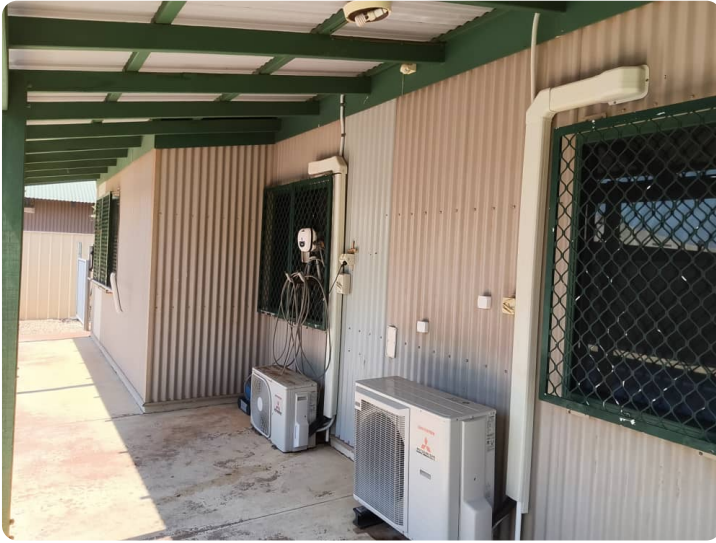
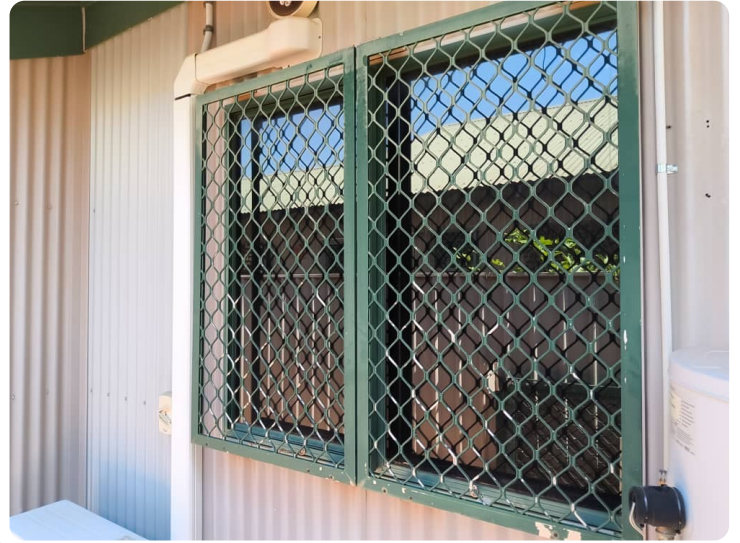
### 13. Cyclone screens

Cyclone screens have been installed to all of the windows. The condition of the cyclone screens is satisfactory in relation to its age and will require normal ongoing maintenance. The cyclone screens appear to be compliant with local requirements.

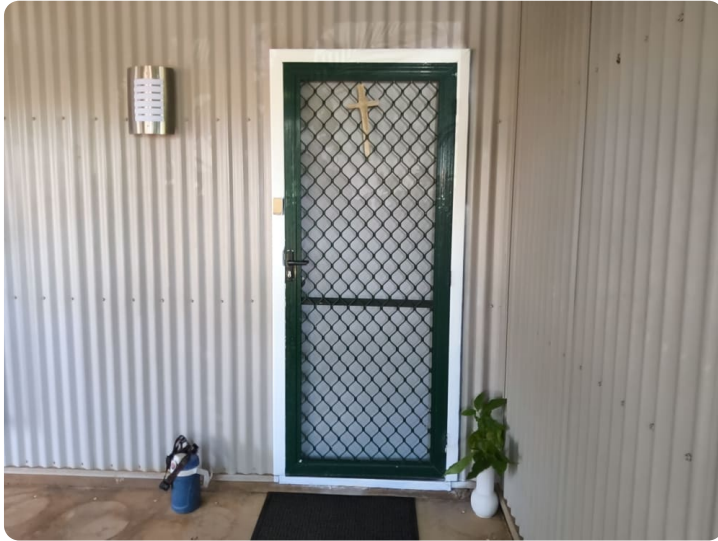
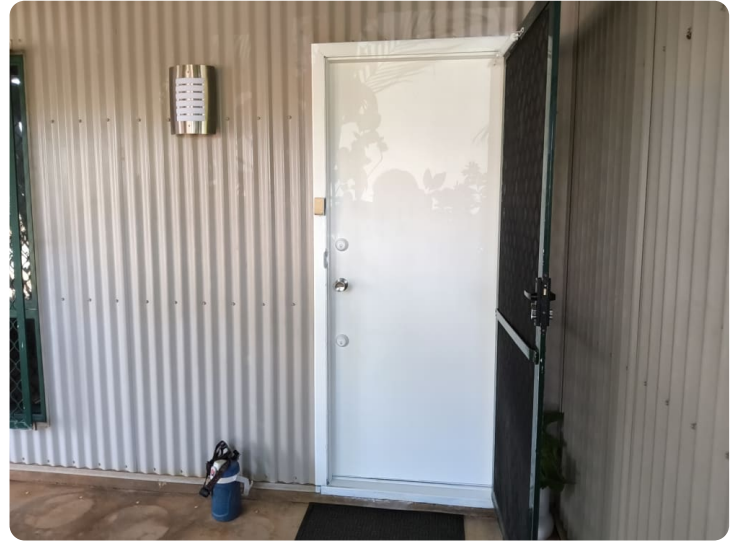
#### 14. Front door

The front door is constructed of solid timber. The condition of the front door is satisfactory in relation to its age and will require normal ongoing maintenance. Deadlocks have been installed. A security screen door has not been fitted.

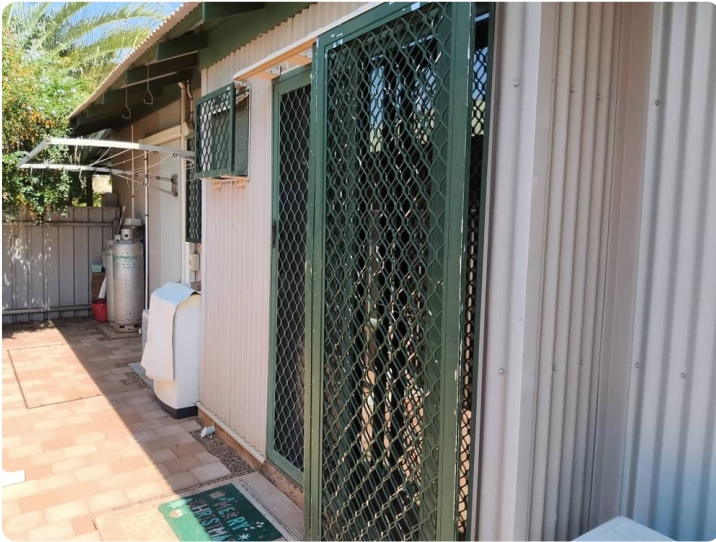
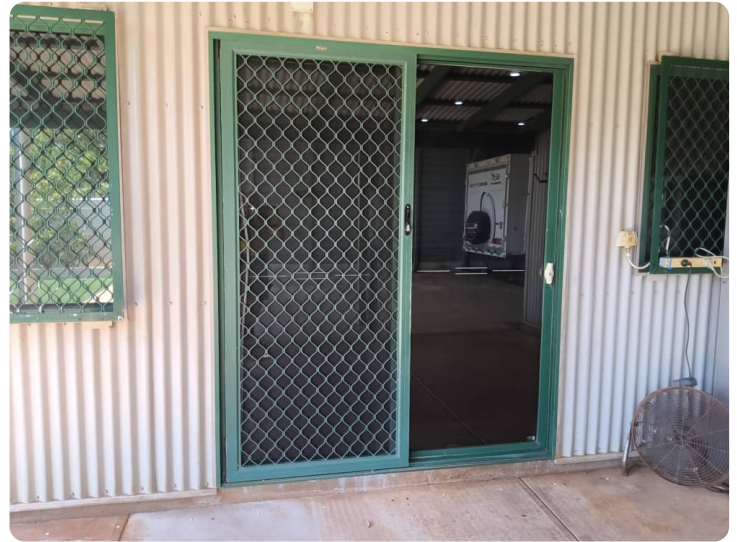
## 15. Other external doors

Other external doors are constructed of aluminium. The condition of the other external doors is satisfactory in relation to its age and will require normal ongoing maintenance.

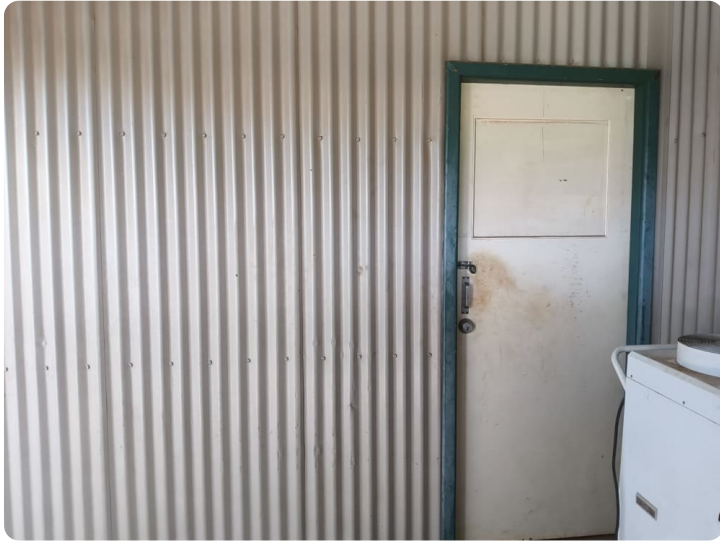
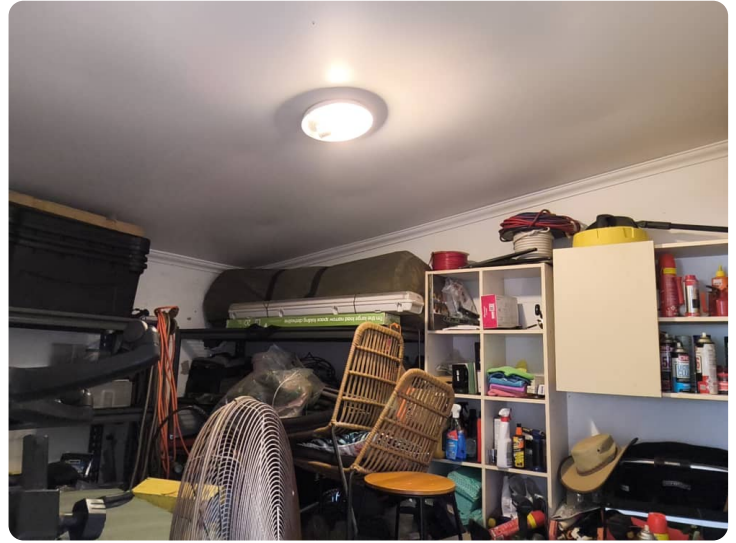
## 16. Storeroom 1

An external storeroom for the property is located adjacent and under the main roof of the building. The condition of the storeroom is satisfactory in relation to its age and will require normal ongoing maintenance. Access and visibility of the area was restricted by stored items.

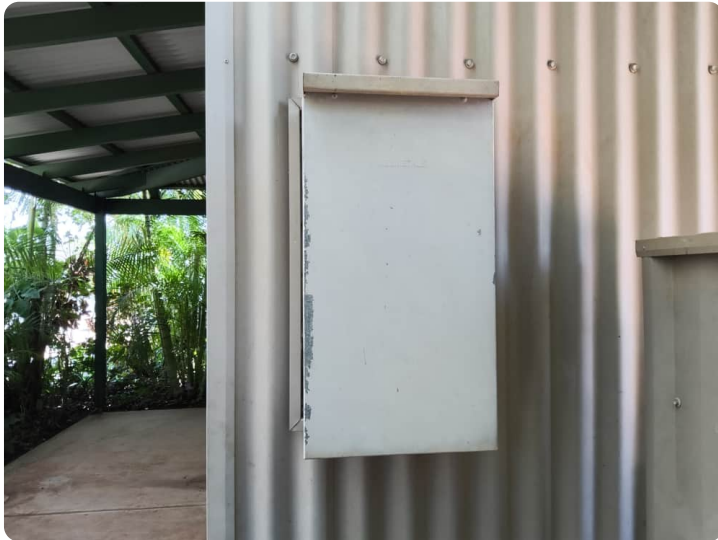
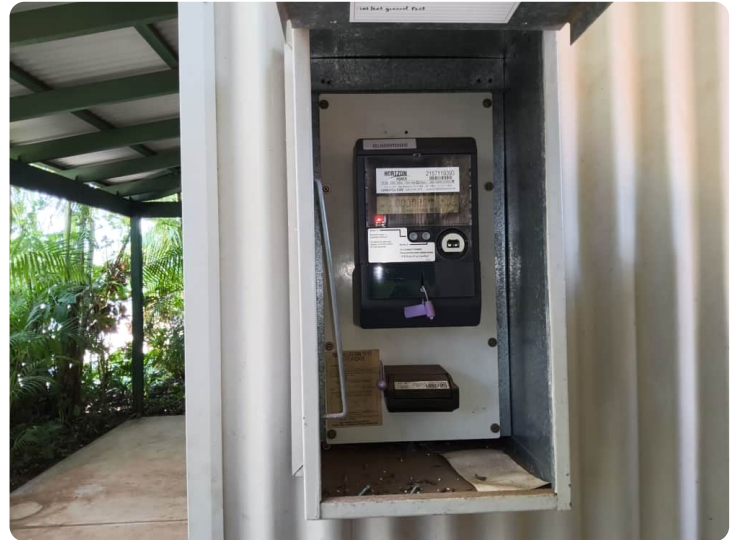
### 17. Meter box and power

Access to the meter box or sub board was available. The meter box or sub board is not lockable. Power phase type to the site is single phase.

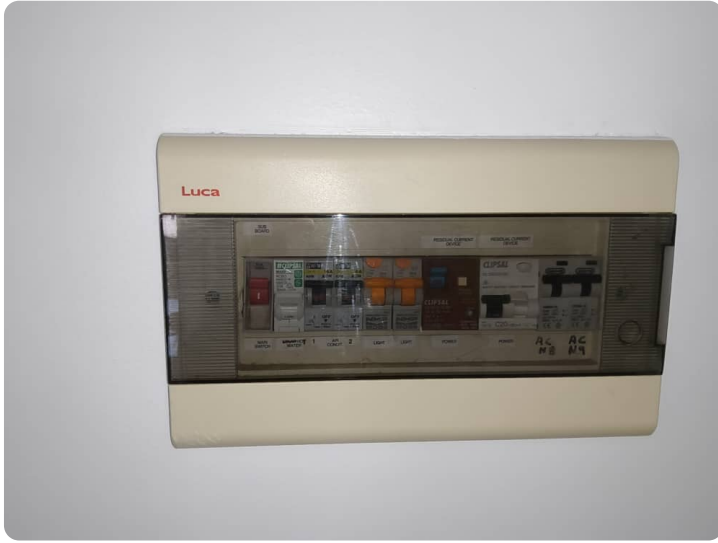
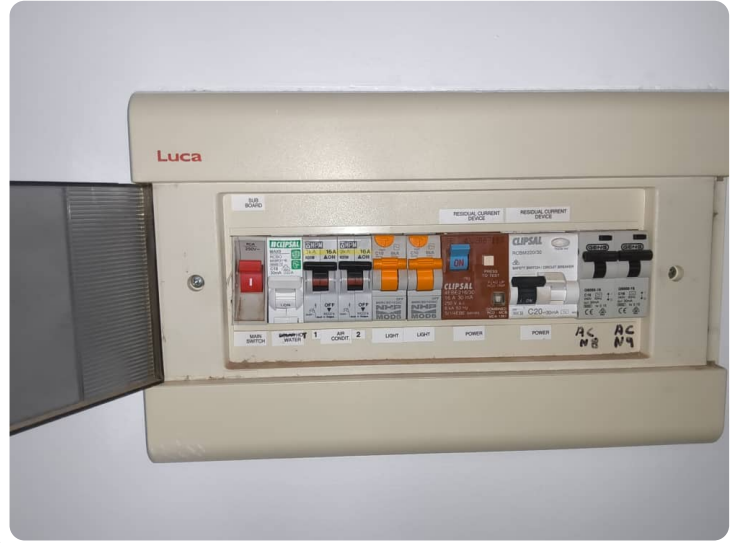
## 18. Residual Current Devices

There were multiple Residual Current Devices (RCD)(s) noted in the meter box or sub meter box. The RCD(s) were not tested. It is suggested that an Electrical Compliance Certificate be obtained in relation to the RCD(s).

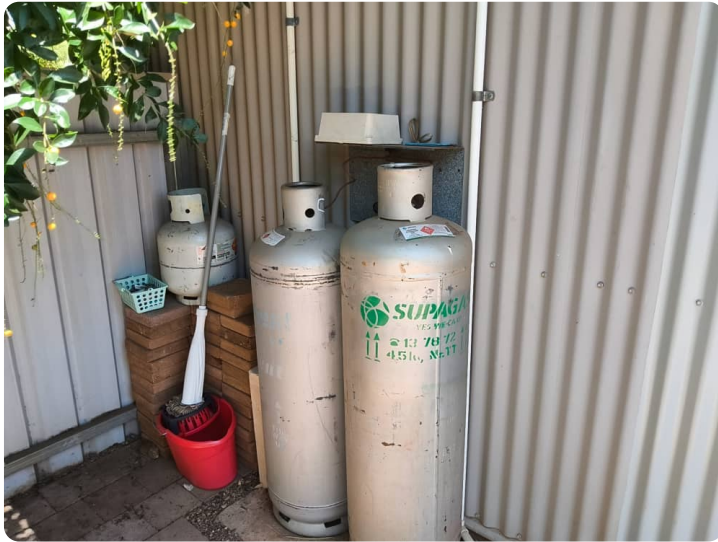
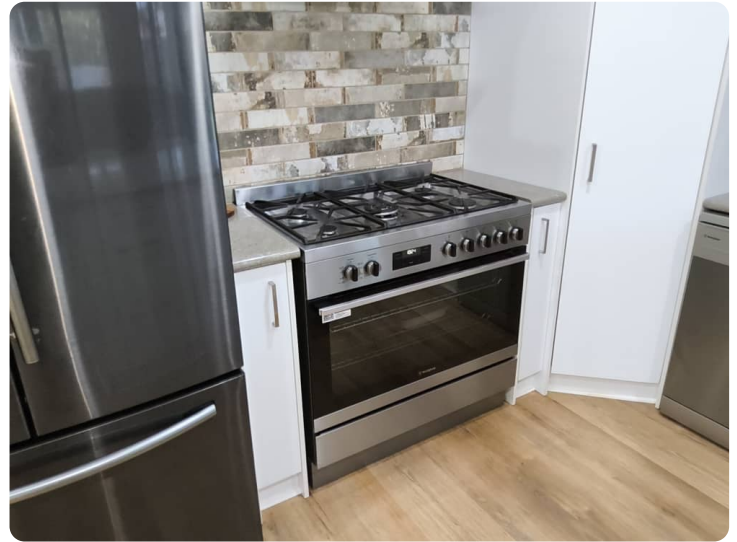
## 19. Gas Supply

Gas supply to the property is via LPG bottles. While on site the inspector could not smell detectable gas leaks.

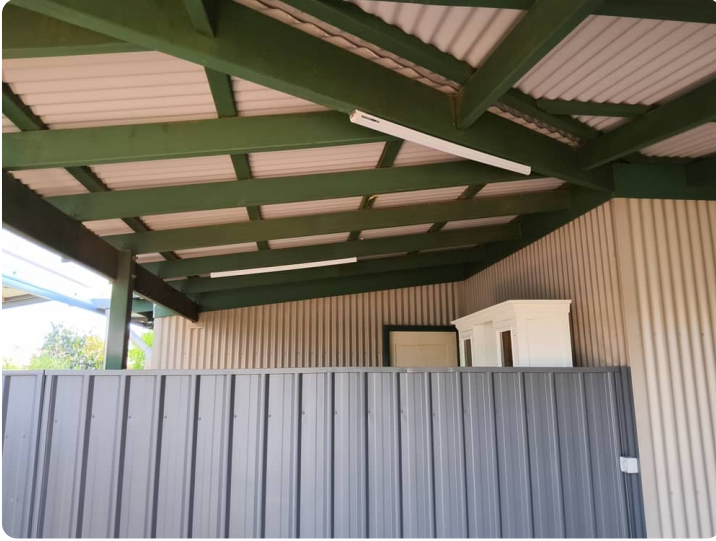
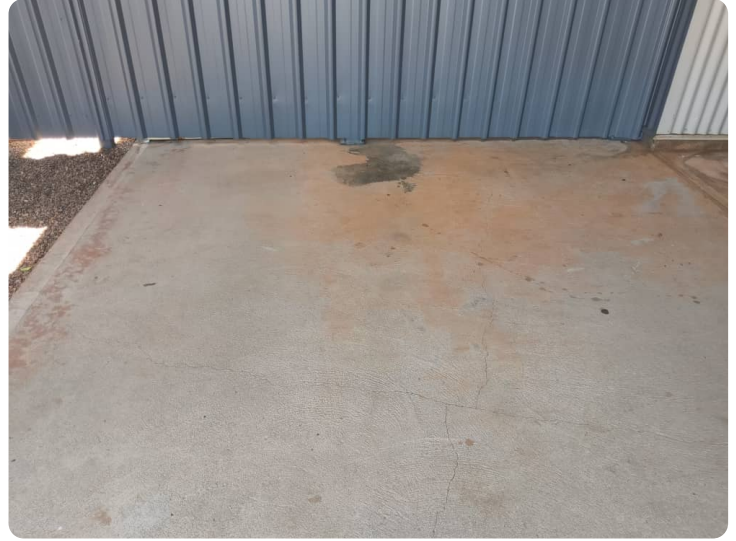
## 20. Carport or Garage (Primary)

There is a primary carport on the property constructed of same materials as the primary structure. The condition of the carport or garage is satisfactory in relation to its age and will require normal ongoing maintenance. Access and visibility of the area was restricted by stored items.

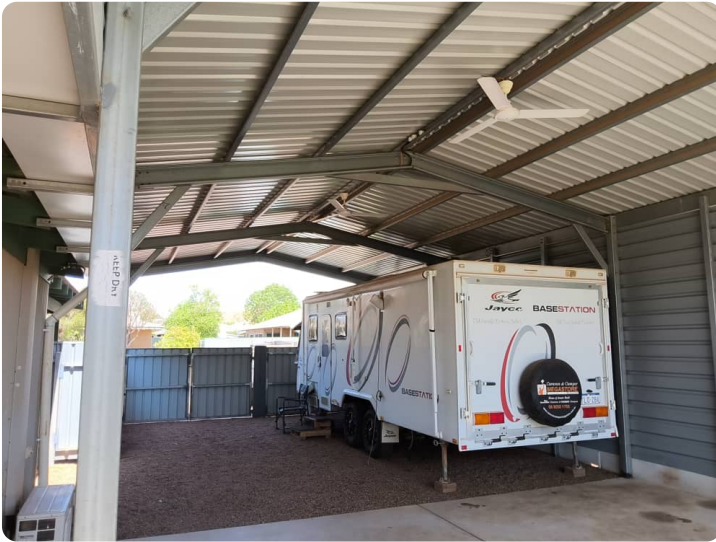
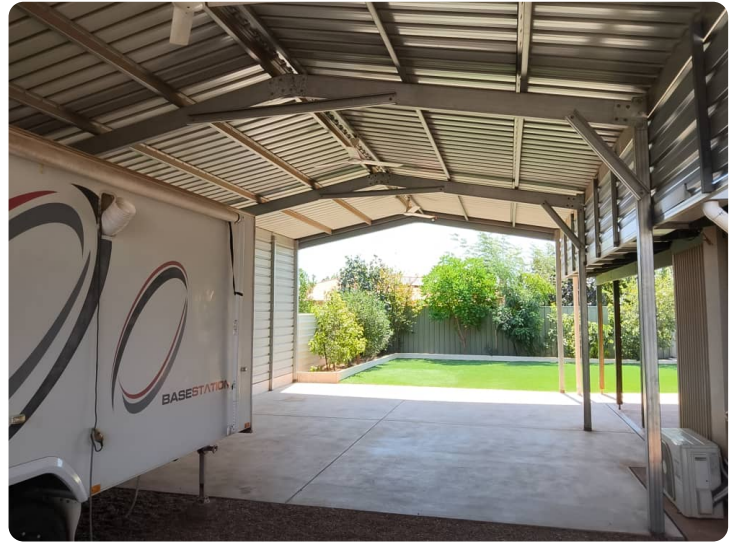
## 21. Carport or Garage (Secondary)

There is a secondary carport on the property constructed of metal. The condition of the detached carport or garage is satisfactory in relation to its age and will require normal ongoing maintenance.

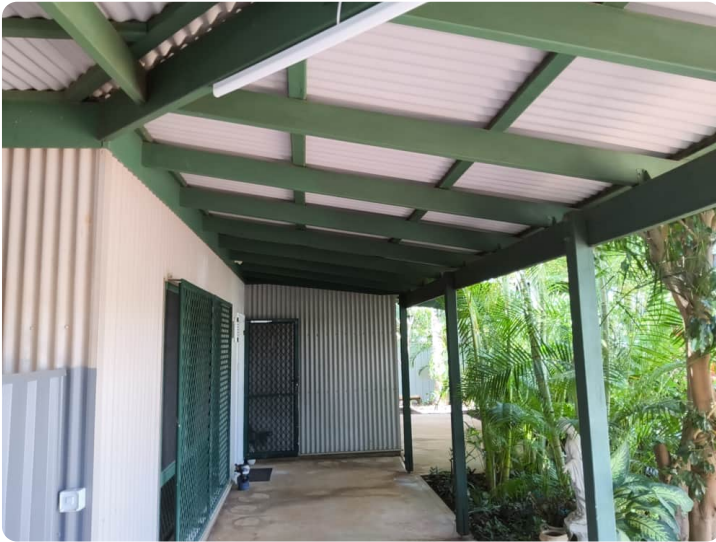
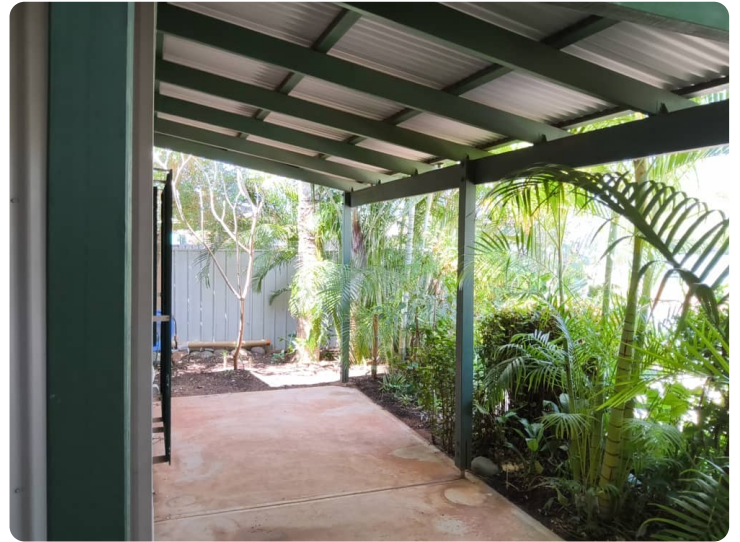
## 22. Veranda (Primary)

The primary veranda is constructed of same materials as the primary structure. The condition of the veranda is satisfactory in relation to its age and will require normal ongoing maintenance.

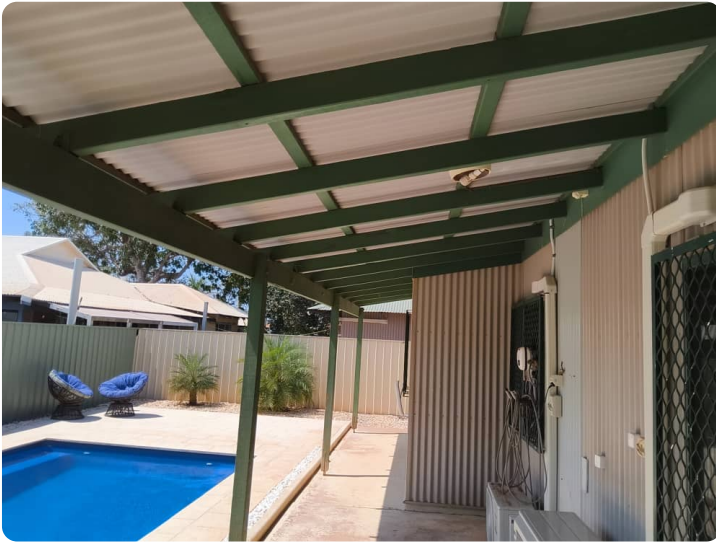
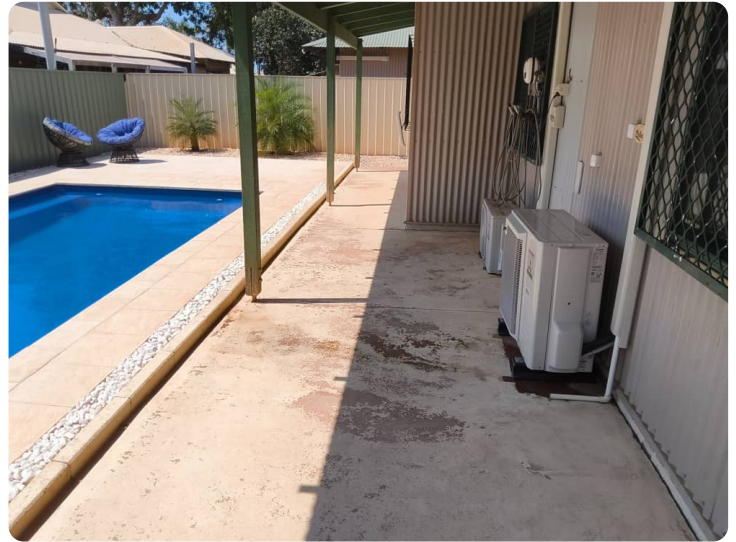
### 23. Veranda (Secondary)

The secondary veranda is constructed of same materials as the primary structure. The condition of the veranda is satisfactory in relation to its age and will require normal ongoing maintenance.

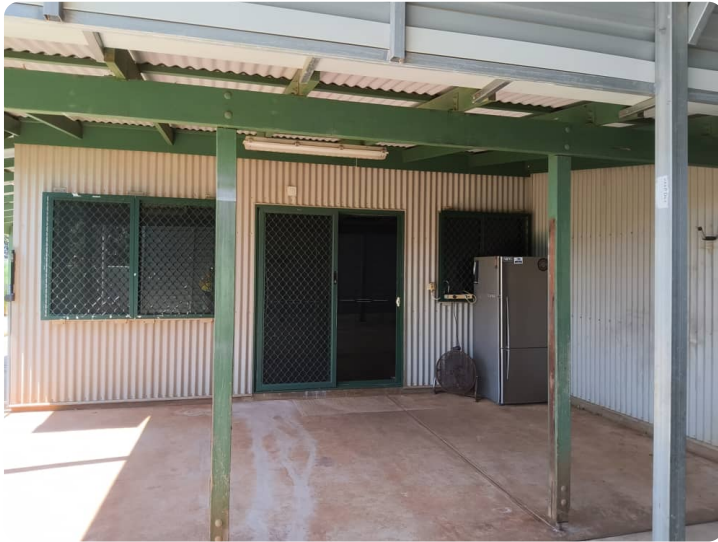
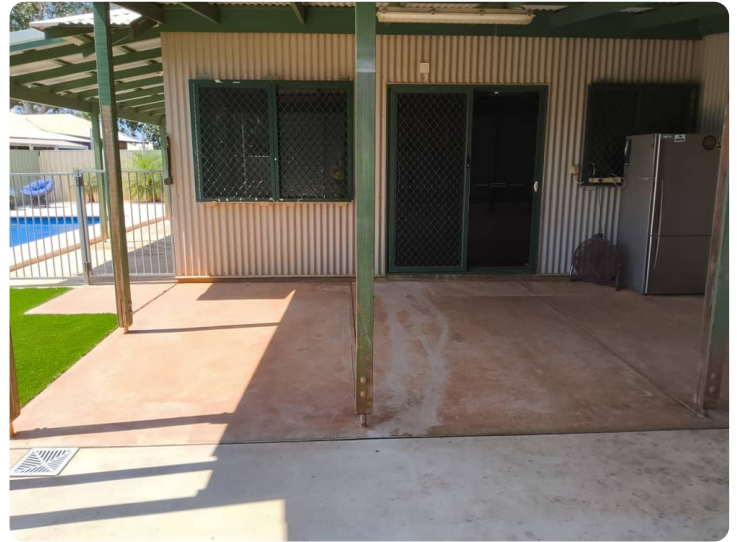
#### 24. Alfresco (under main roof)

The alfresco under the main roof is constructed of same materials as the building. The condition of the alfresco is satisfactory in relation to its age and will require normal ongoing maintenance.

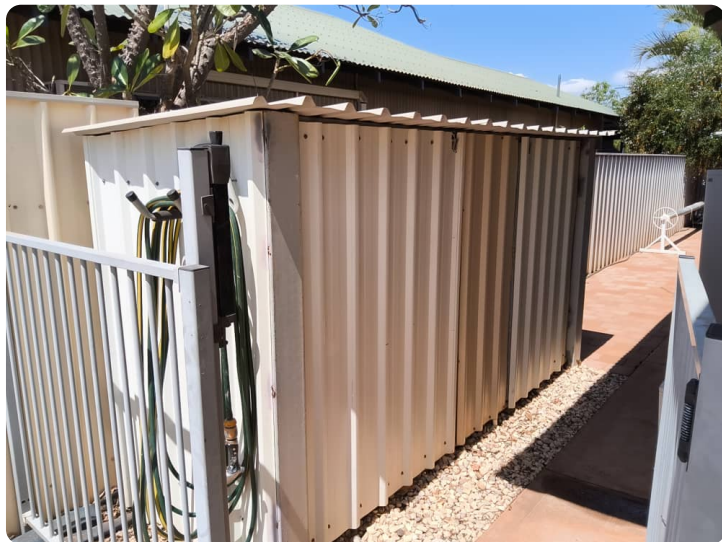
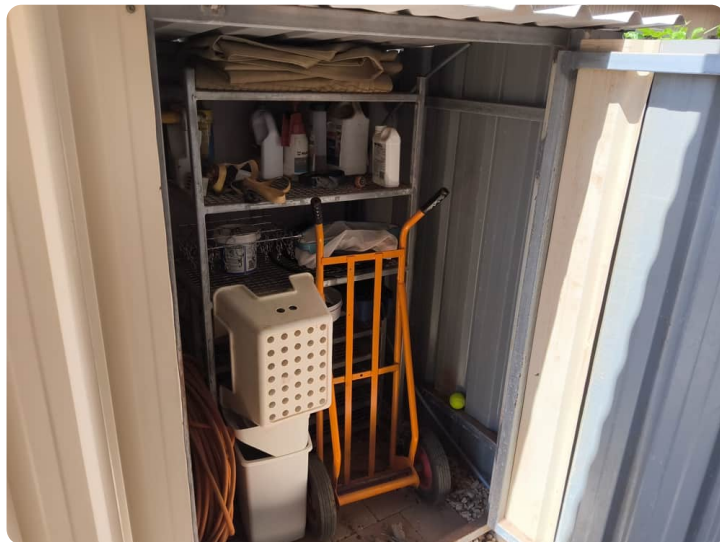
## 25. Garden shed primary

The primary garden shed is constructed of metal. The condition of the garden shed is satisfactory in relation to its age and will require normal ongoing maintenance. Access and visibility of the area was restricted by stored items.

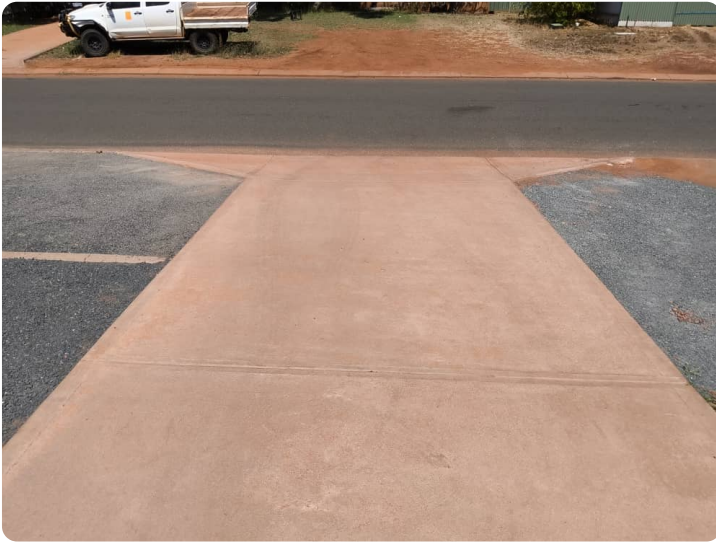
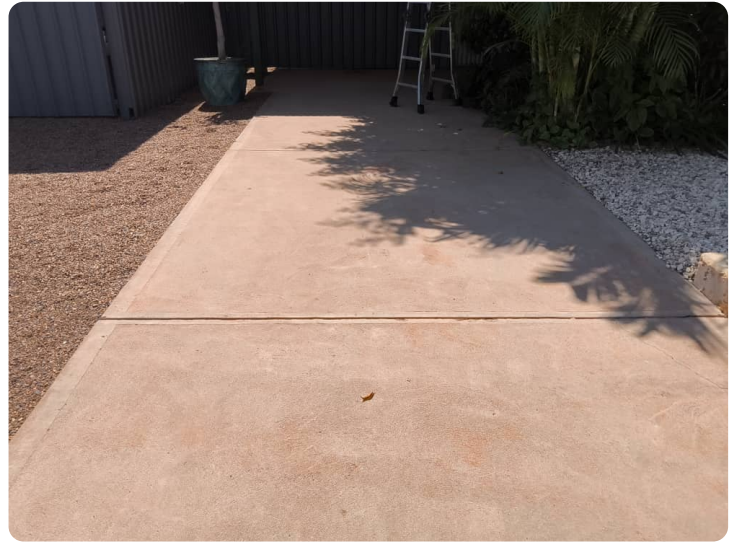
## 26. Driveway

The driveway and cross over is constructed of concrete. The condition of the driveway is satisfactory in relation to its age and will require normal ongoing maintenance.

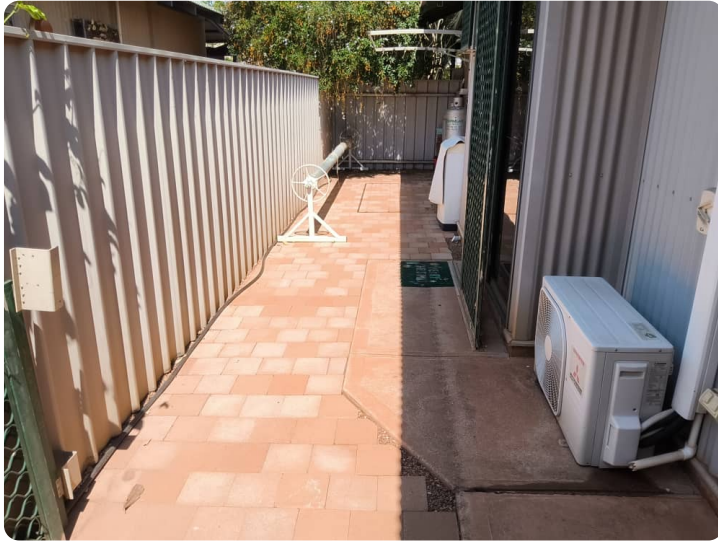
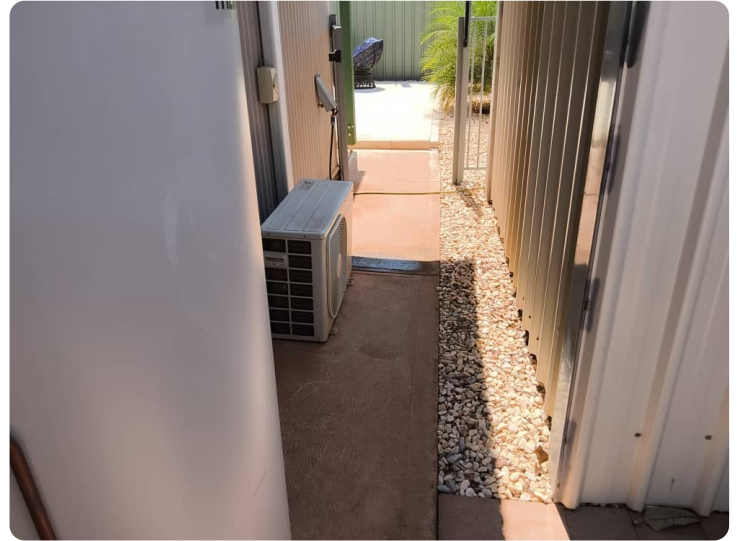
## 27. External walkways and paved areas

The external walkways and paved areas are constructed of a variety of materials. The condition of the external walkways and paved areas is satisfactory in relation to its age and will require normal ongoing maintenance.
