# **Houspect**

### **Pre purchase inspection**

**Job ID:** 92961

**Address:** 29 Stickney Way, Baynton WA 6714

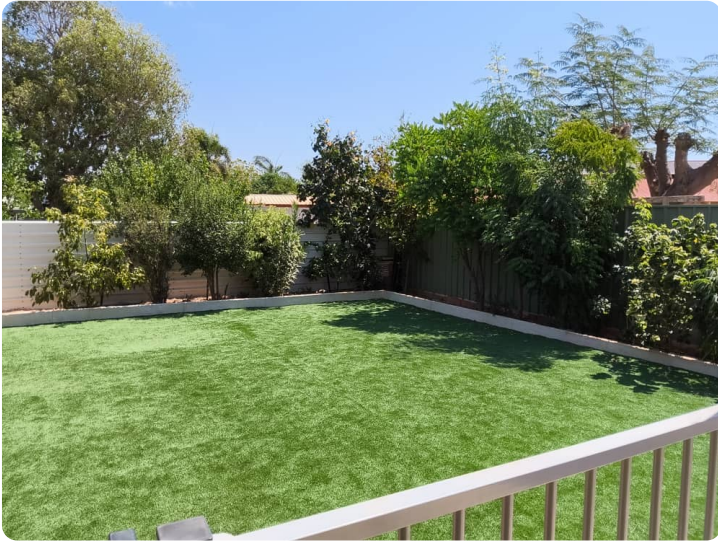
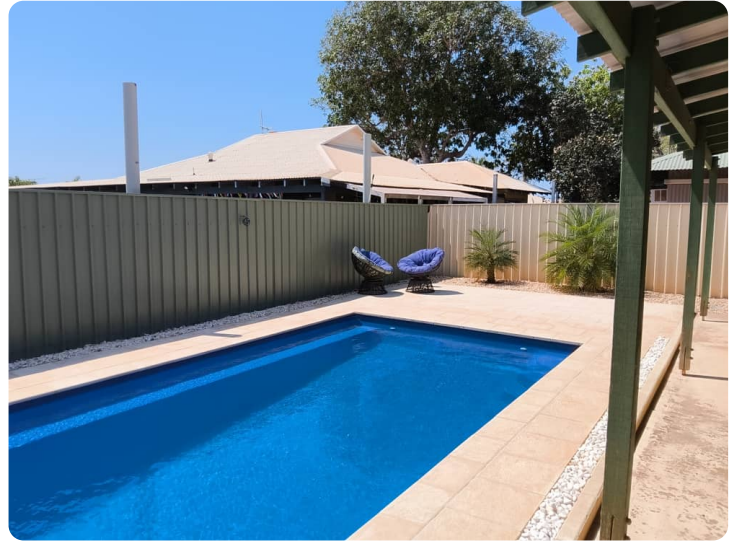
## 28. Fences - boundary

The boundary fences are constructed of metal. The condition of the boundary fence is satisfactory in relation to its age and will require normal ongoing maintenance. Some of the fences could not be viewed due to vegetation, stored items or secondary structures.

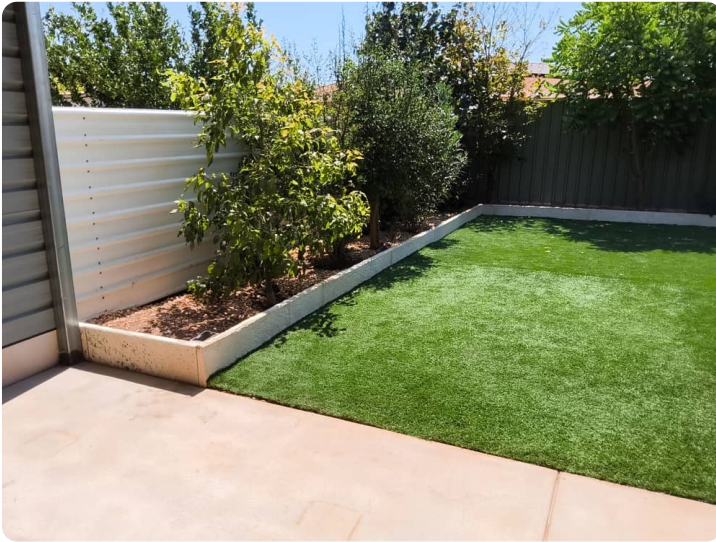
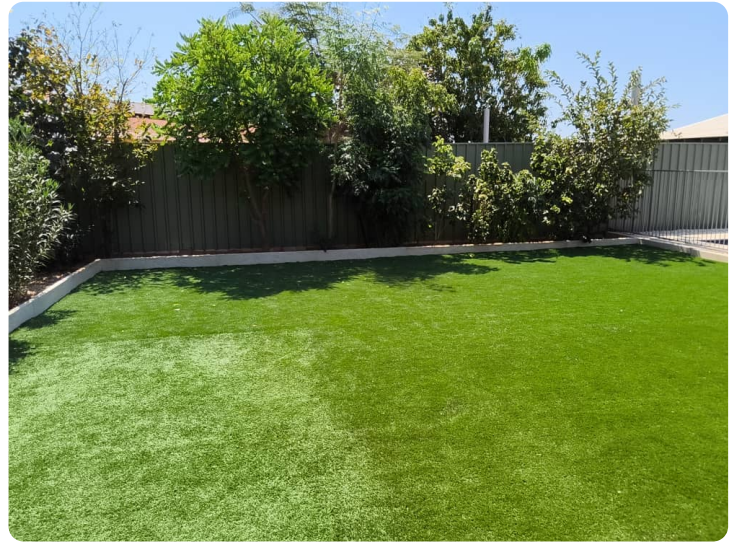
## 29. Retaining walls

The retaining walls are constructed of limestone or concrete blocks. The condition of the retaining wall is satisfactory in relation to its age and will require normal ongoing maintenance.

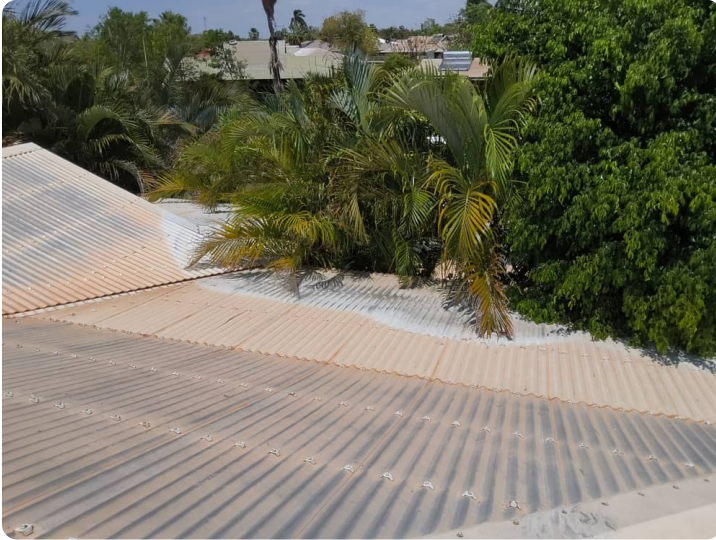
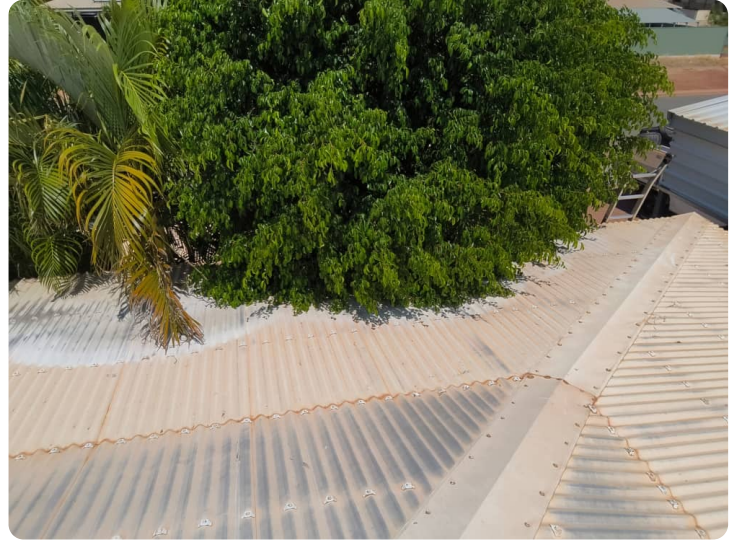
### 30. Trees

There are trees and/or vegetation which are or may be adversely impacting the building or other structures on the property.

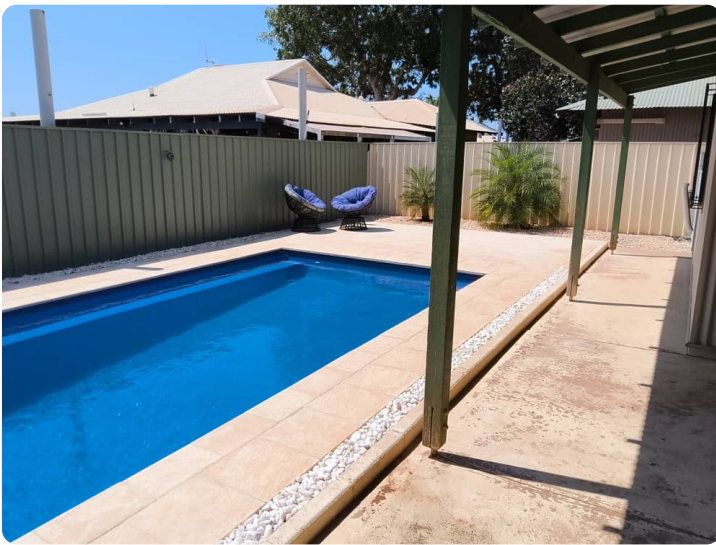
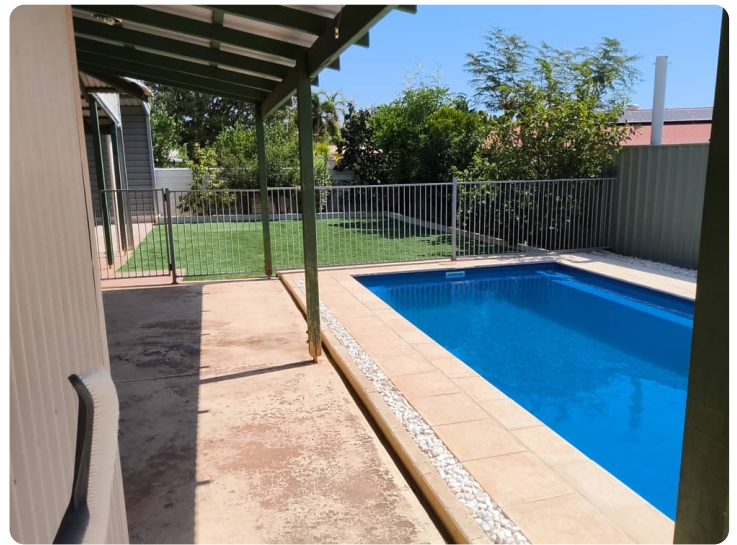
### 31. Pool (Building forms a portion of the pool fence barrier)

The pool is situated below ground. The external pool on the property is constructed of fibreglass. In relation to subsidence to the ground immediately adjacent to the pool, no significant subsidence was noted. The building and or boundary fences form part of barrier fencing for the pool and appear to be consistent with current pool fencing requirements. It is recommended that a copy of the previous Council Pool Safety Compliance Certificate is obtained. It is recommended that a pool maintenance contractor review and confirm the operation of all pool equipment.

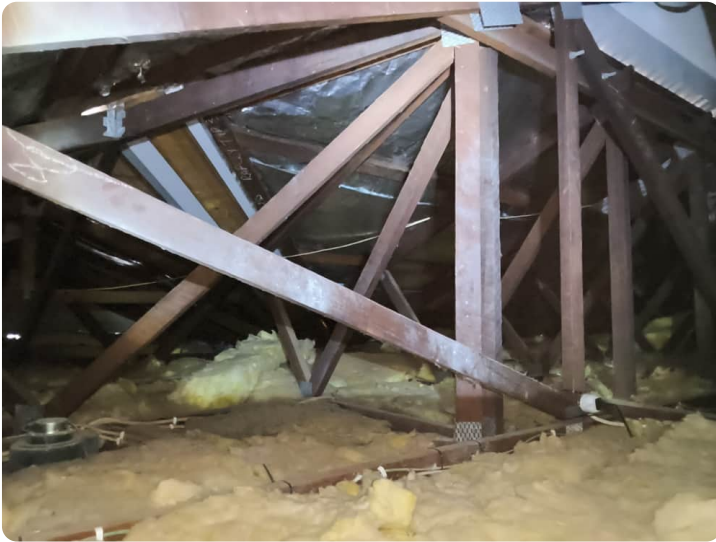
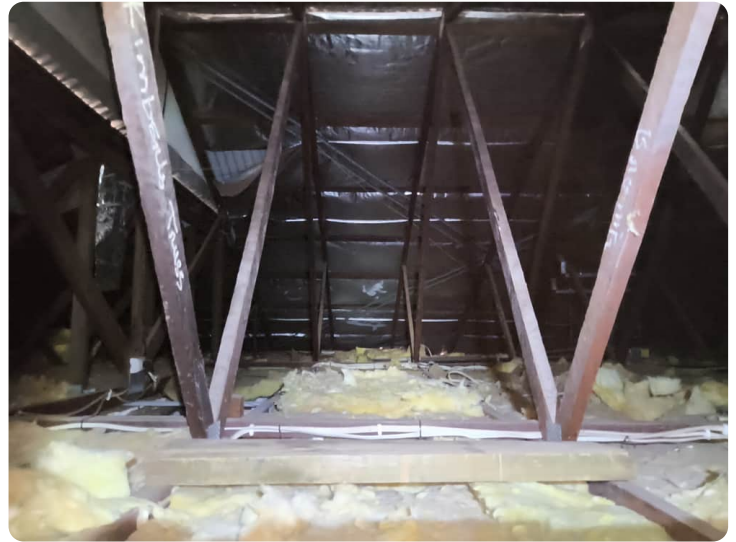
### 32. Under side of roof cover

The condition of the underside of the roof cover could not be determined as sarking had been installed.

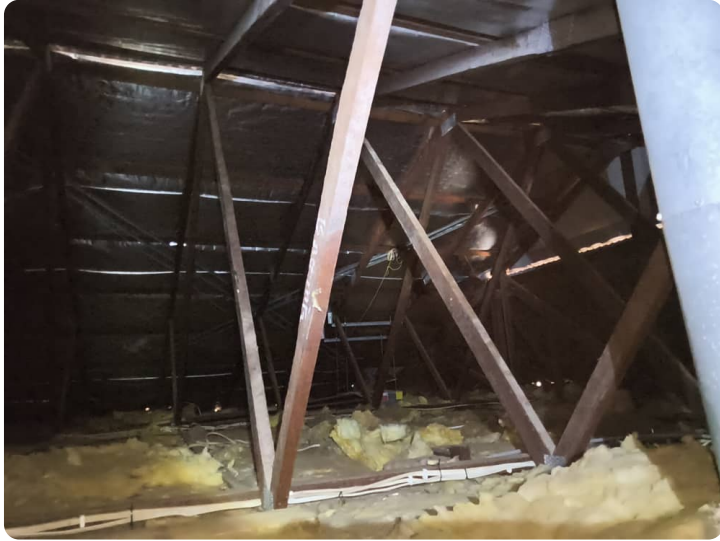
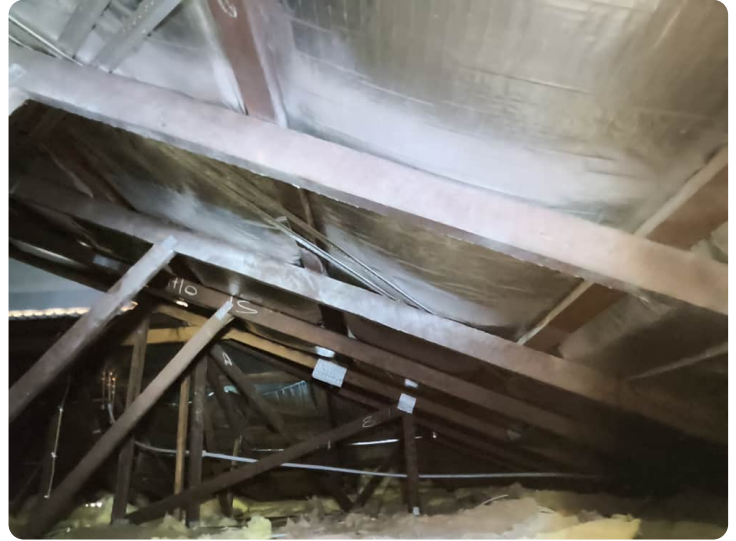
### 33. Sarking

Sarking to the underside of the roof was installed and was considered effective.

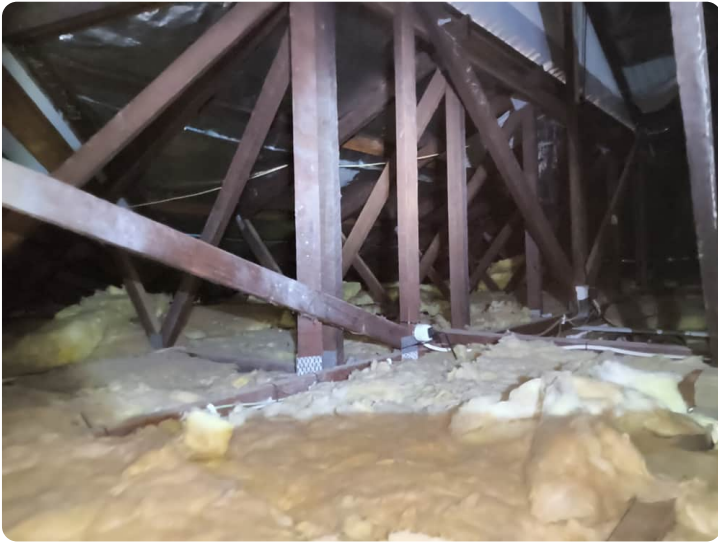
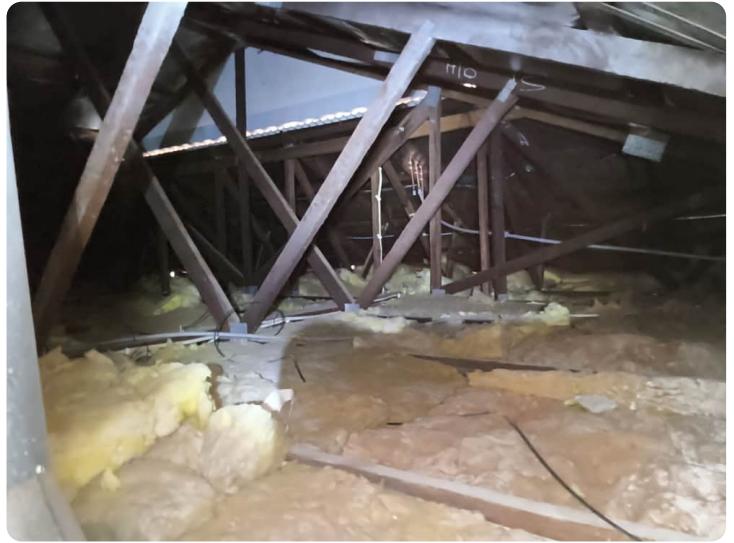
### 34. Roof frame

The roof frame type is a timber truss. The condition of the roof frame is satisfactory in relation to its age and will require normal ongoing maintenance. Access to the roof space was restricted by the pitch of the roof, insulation, ducting or other items. The inspector estimates that visibility was available to more than 75% of the area.

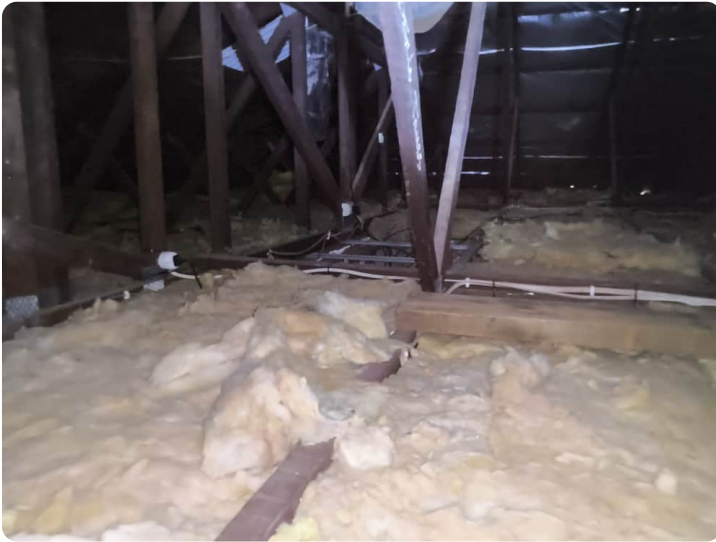
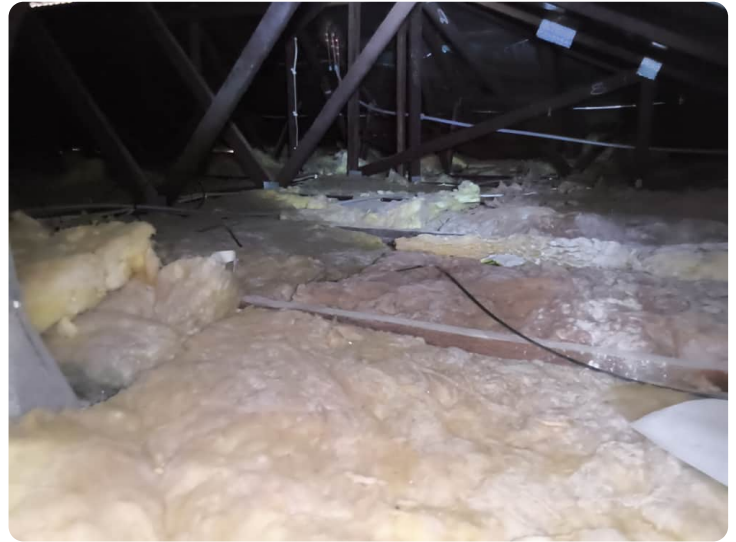
### 35. Insulation

Insulation was installed. Where insulation was installed it was considered effective. The insulation type was predominately batt or rolled type insulation.

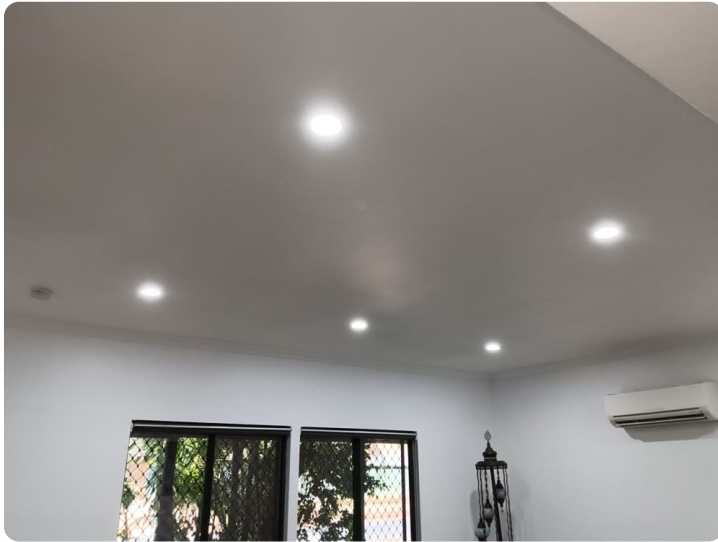
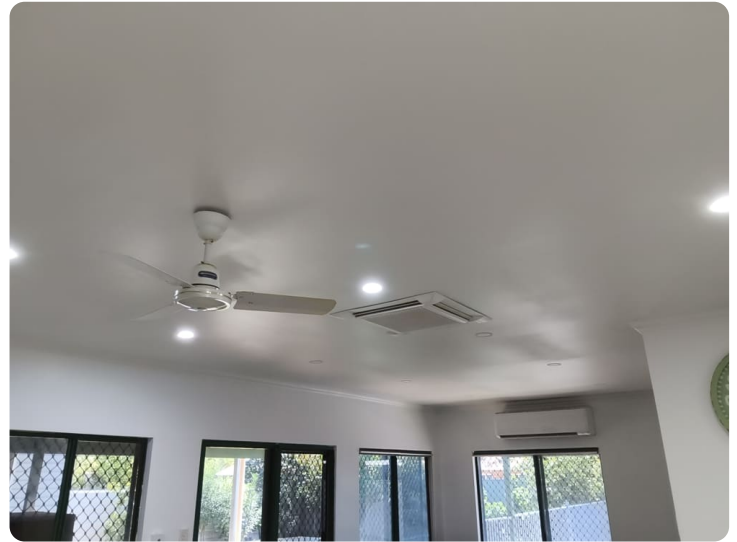
### 36. Ceilings

The ceilings are constructed of plasterboard with cornices constructed of plasterboard. The condition of the ceilings is satisfactory in relation to its age and will require normal ongoing maintenance.

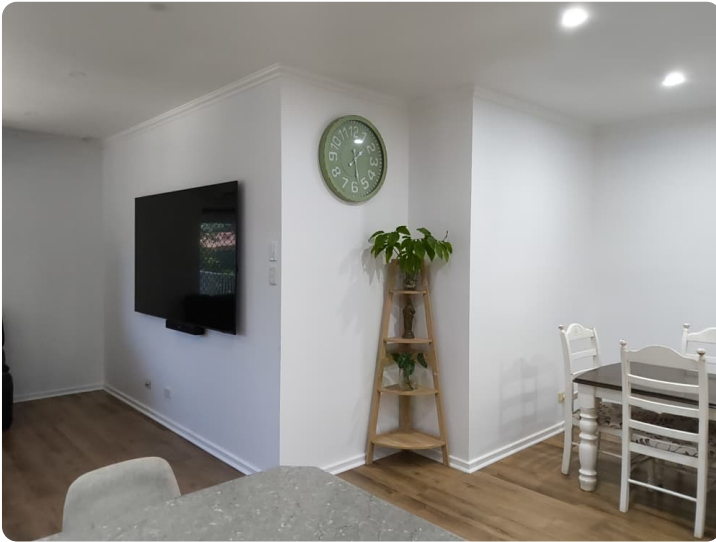
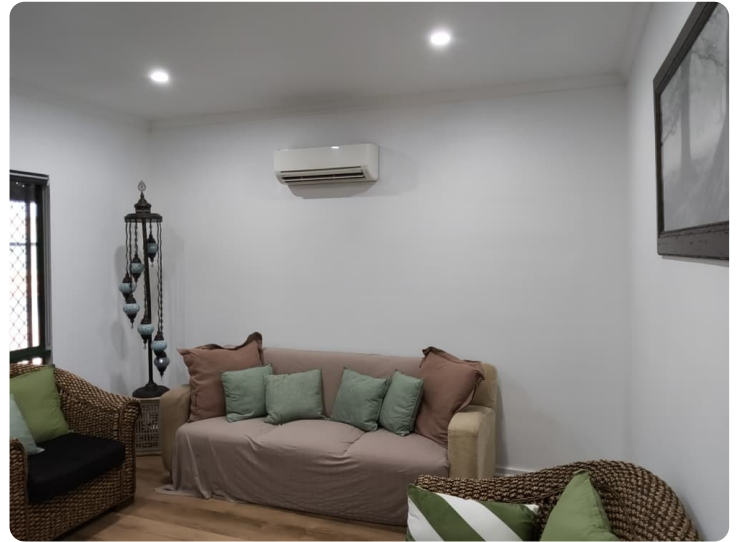
### 37. Internal walls

The internal walls are constructed of a frame with plaster board cladding. The condition of the internal walls is satisfactory in relation to its age and will require normal ongoing maintenance.

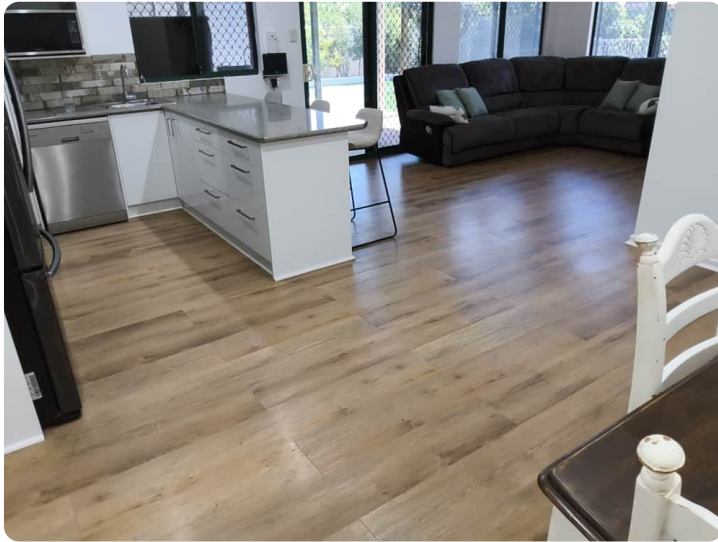
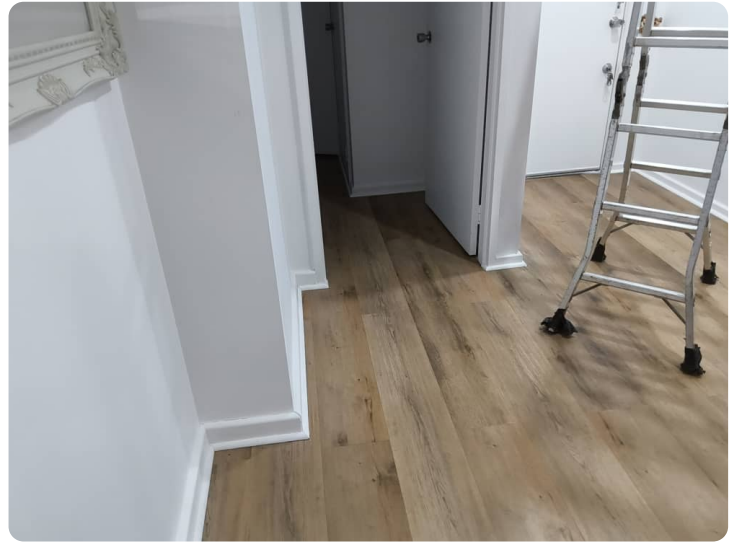
### 38. Internal floors

The internal floors are constructed of concrete and are covered in vinyl planks. The condition of the internal floors is unable to be determined as they could not be seen due to coverings.

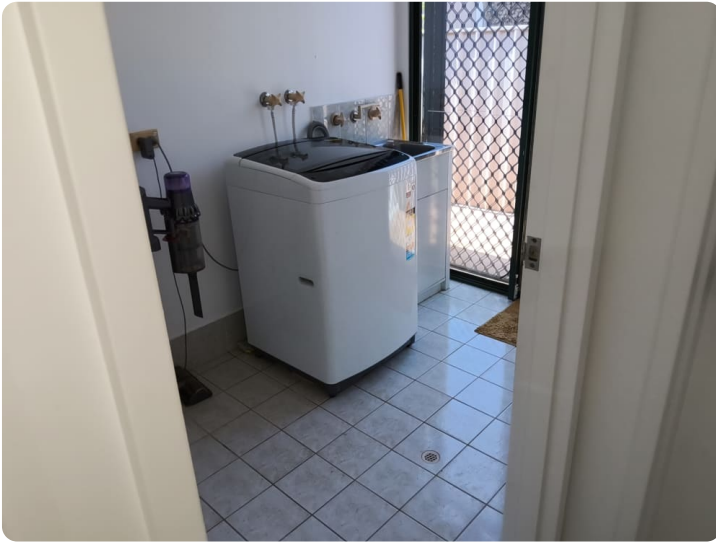
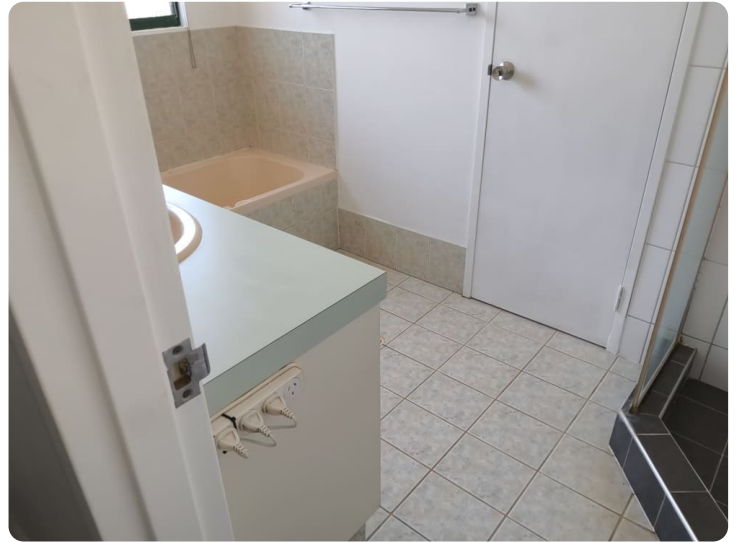
### 39. Tiled floors and walls

There are areas of internal floors and walls which are covered with a tile covering. The condition of the tiles is satisfactory in relation to its age and will require normal ongoing maintenance.

As per the images provided there is significant damage to the wall or floor tiles requiring repairs or replacement.

As per the images provided there is damage to the wall or floor tiles requiring repairs or replacement.

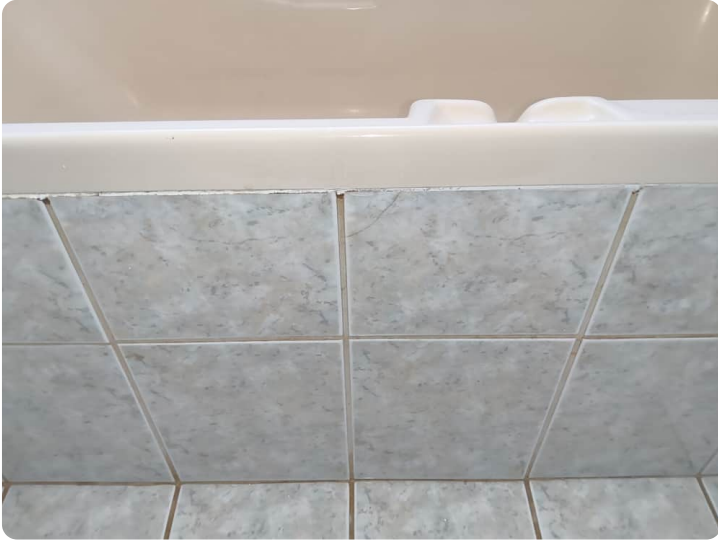
### 39.2 Tile damage - minor

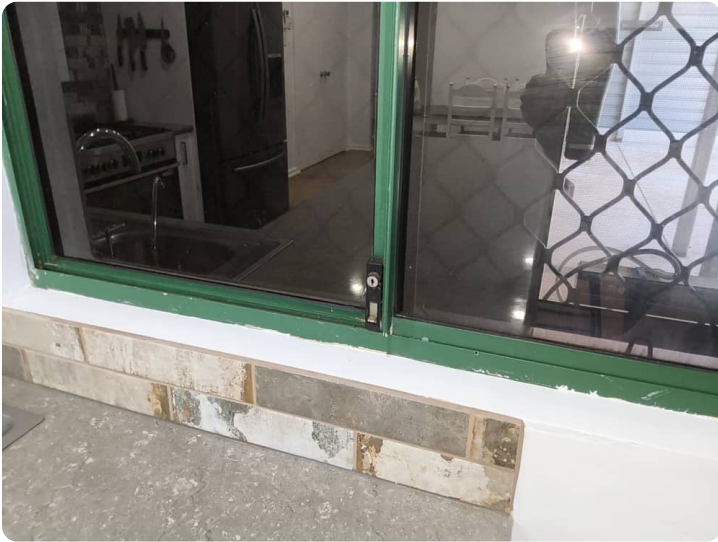
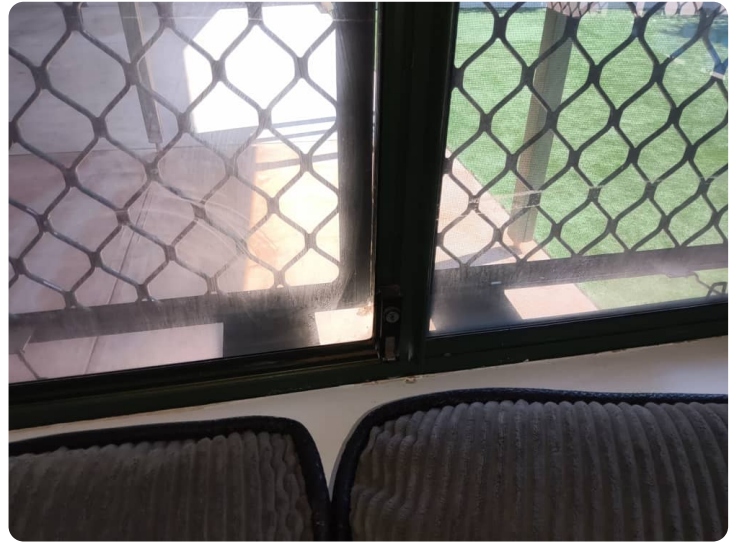
#### 40. Windows (internal)

The condition of the windows, as viewed from within the property, is satisfactory in relation to its age and will require normal ongoing maintenance. Window locks have been installed to all of the windows.

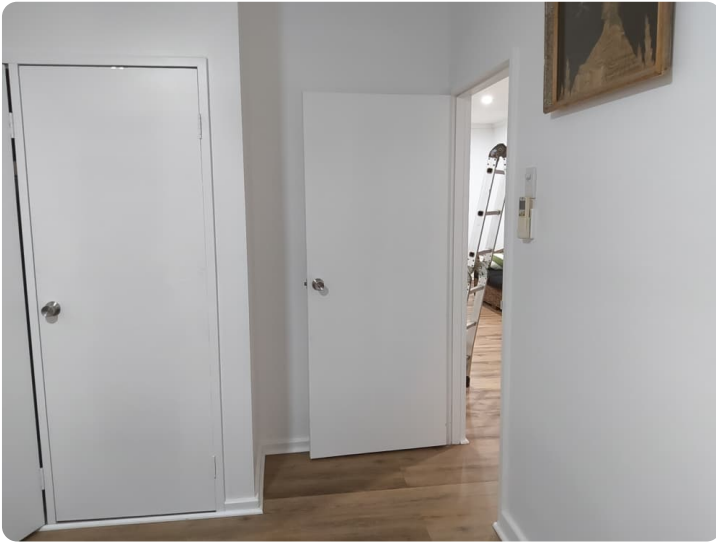
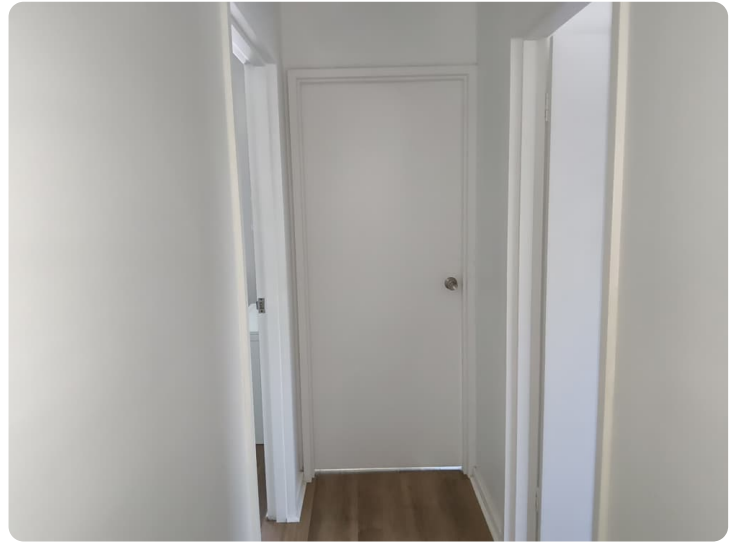
#### 41. Internal doors

The internal doors were mainly constructed of timber hollow core. The condition of the internal doors is satisfactory in relation to its age and will require normal ongoing maintenance.

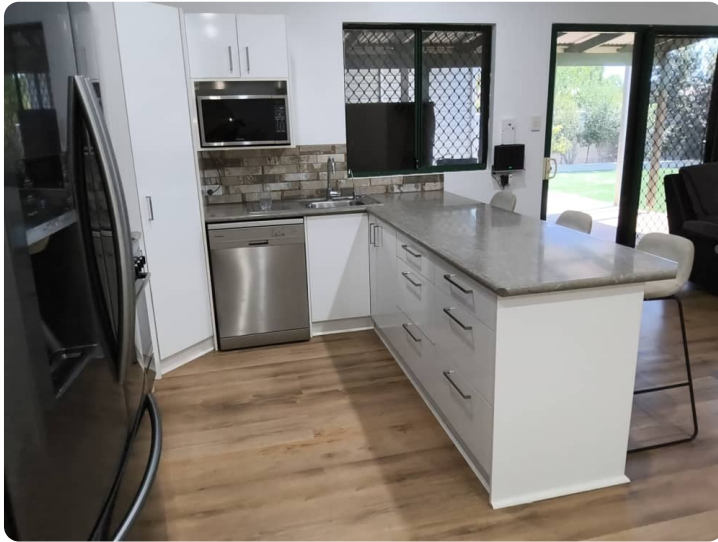
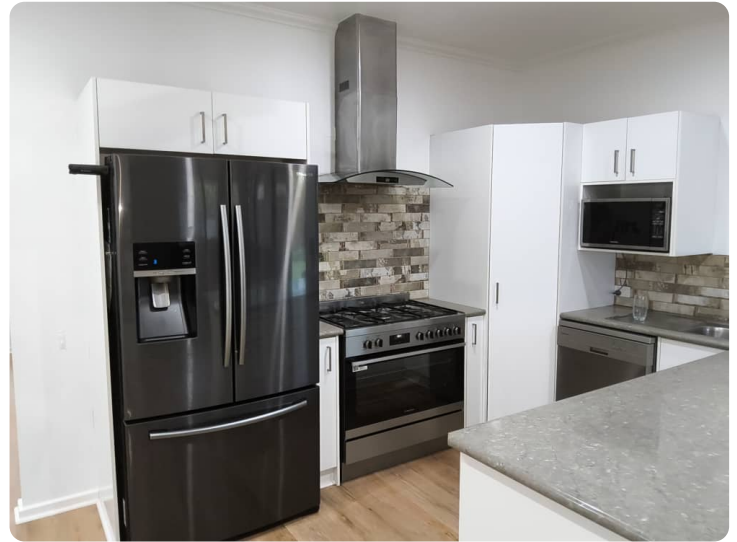
## 42. Kitchen cabinets

The condition of the kitchen cabinets in general is satisfactory in relation to their age and require normal maintenance.

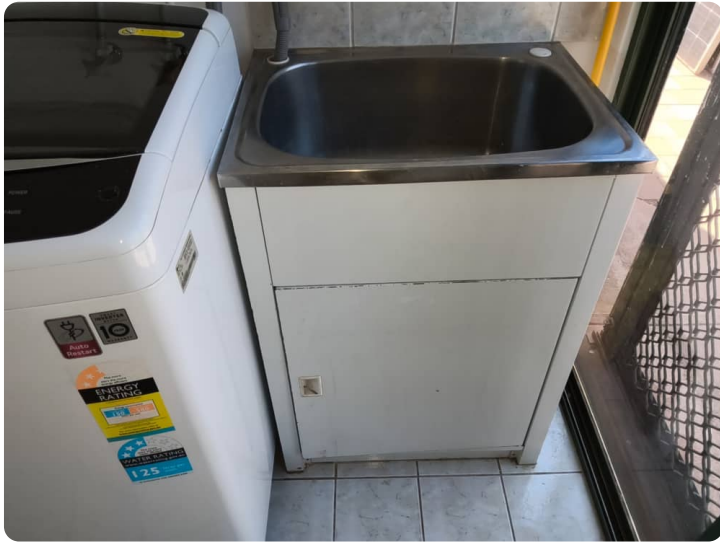
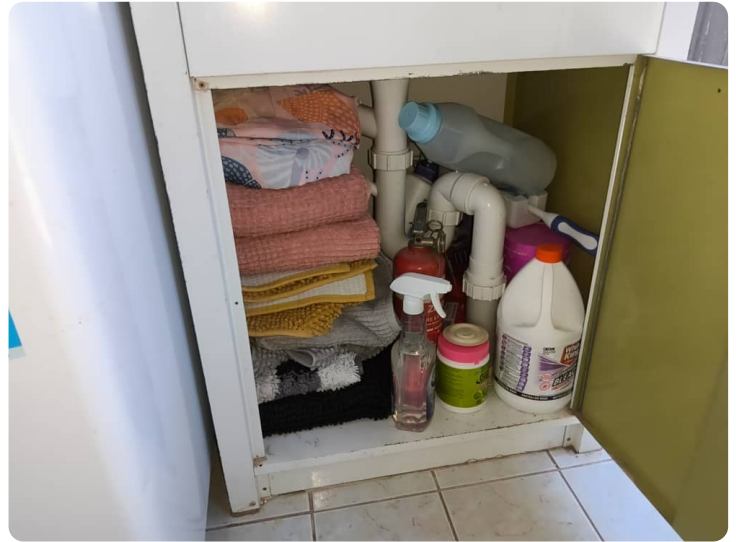
### 43. Laundry cabinets

The condition of the laundry cabinets is satisfactory in relation to their age and require normal maintenance.

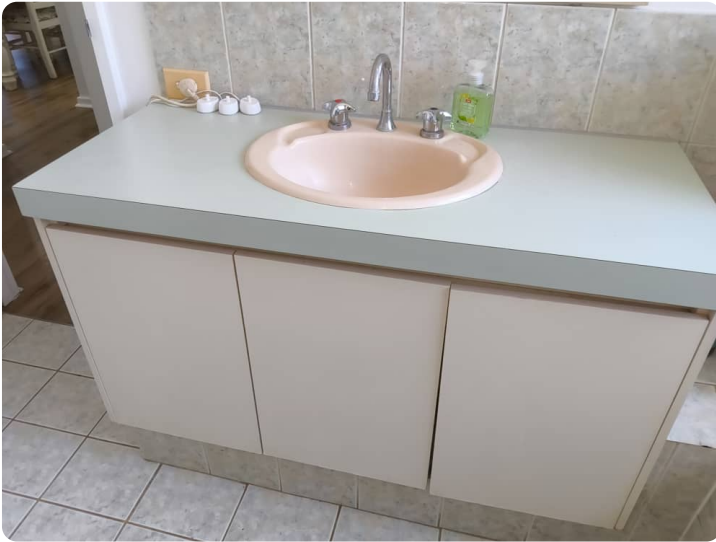
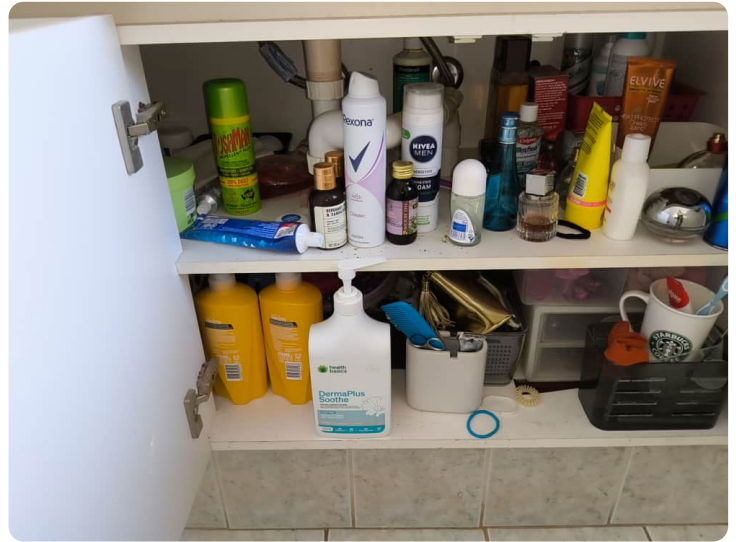
#### 44. Bathroom cabinets

The condition of the bathroom cabinets is satisfactory in relation to their age and require normal maintenance.

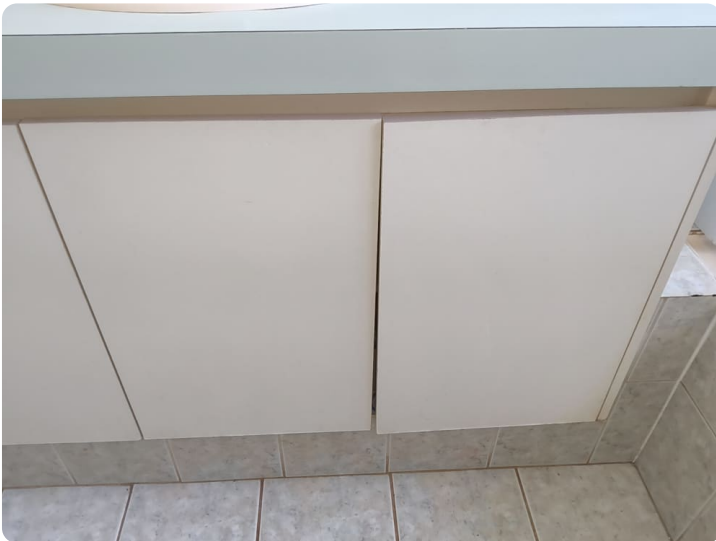
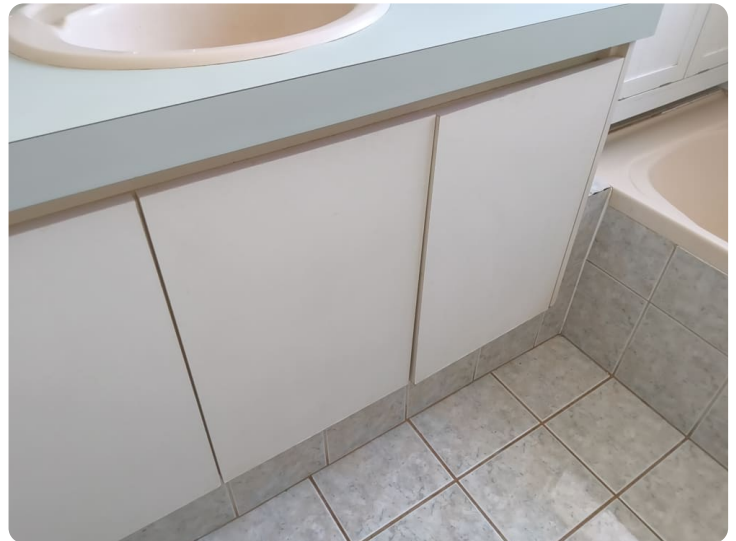
##### 44.1 Cabinet door drawer adjustment

As per the images some cupboard doors or drawers require adjusting to close correctly.

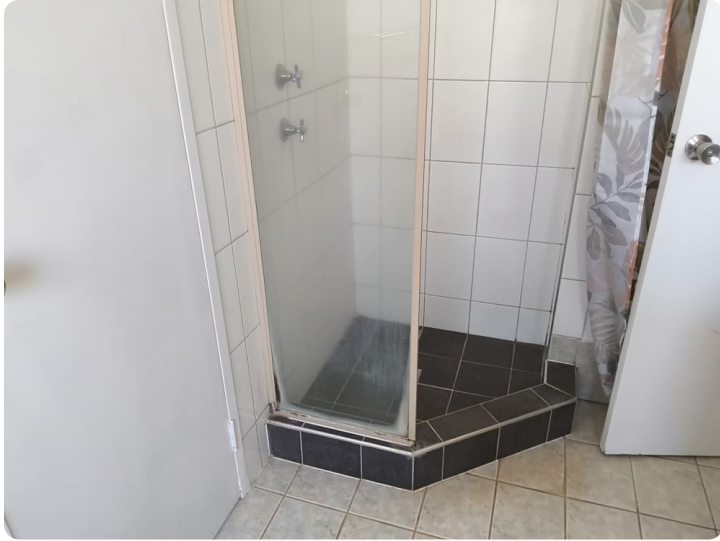
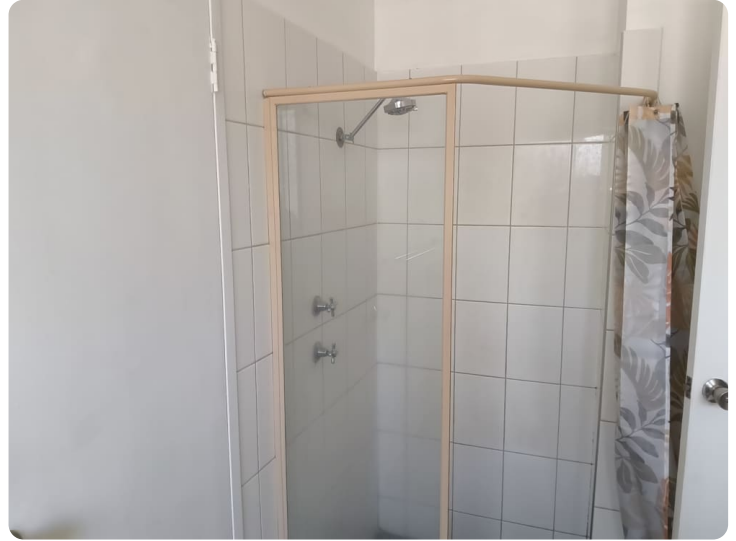
#### 45. Shower screens

The condition of the shower screens is fair in relation to its age and will require ongoing maintenance.

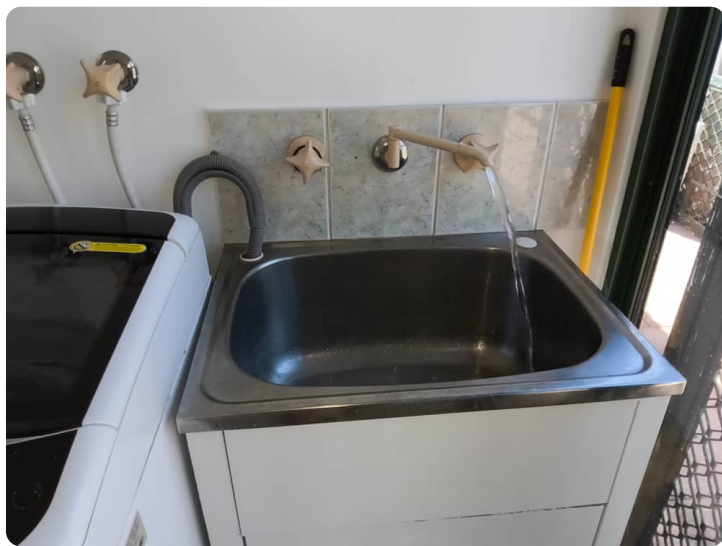
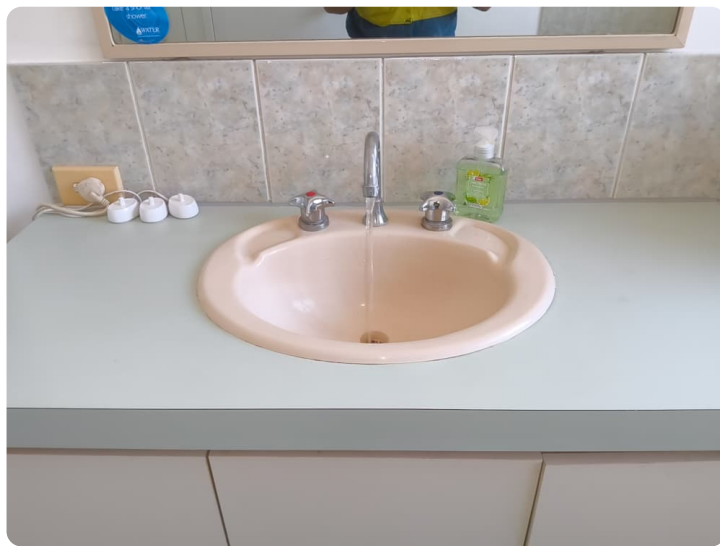
## 46. Plumbing

The taps to multiple areas were turned on and the water flow appeared to be reasonable. Water draining to several sinks and toilets appeared to be reasonable. The Building Inspector is not a Plumbing Contractor and is not permitted to test Plumbing items under WA Law. Where appropriate a Plumbing Contractor should be engaged to test the plumbing in the property.

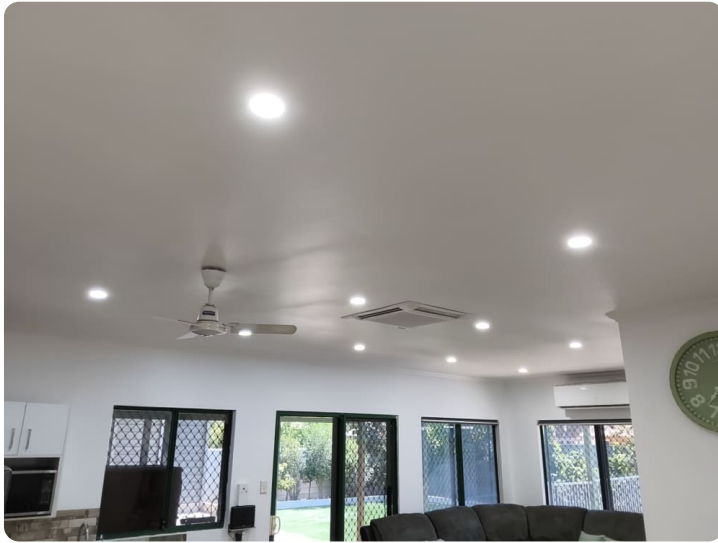
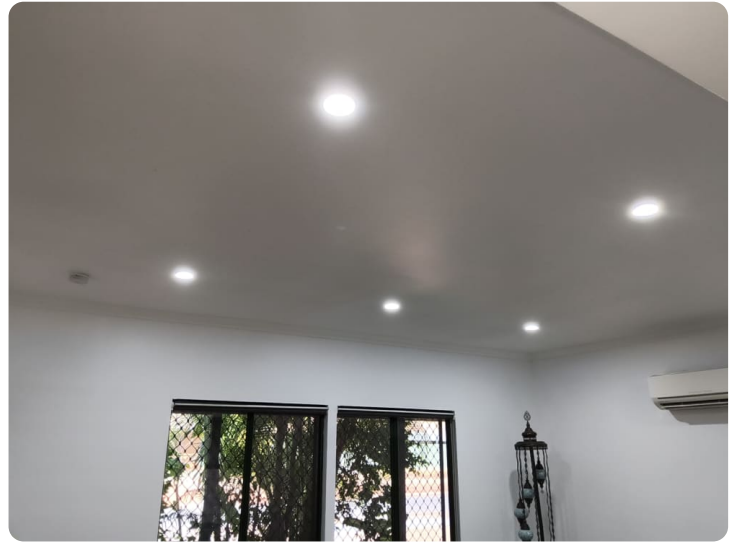
#### 47. Lights and power points

Several lights were turned on during the inspection and the lights appeared to be operational. The Building Inspector is not an Electrical Contractor and is not permitted to test Electrical items under WA Law. Where appropriate an Electrical Contractor should be engaged to test the electrical items in the property.

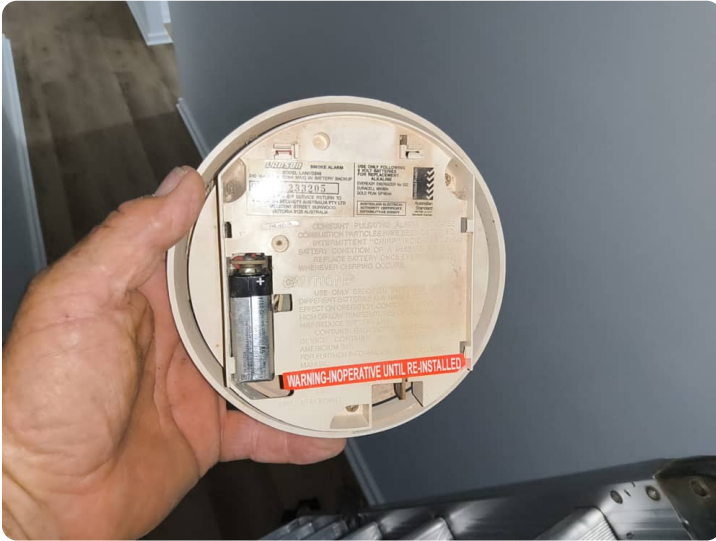
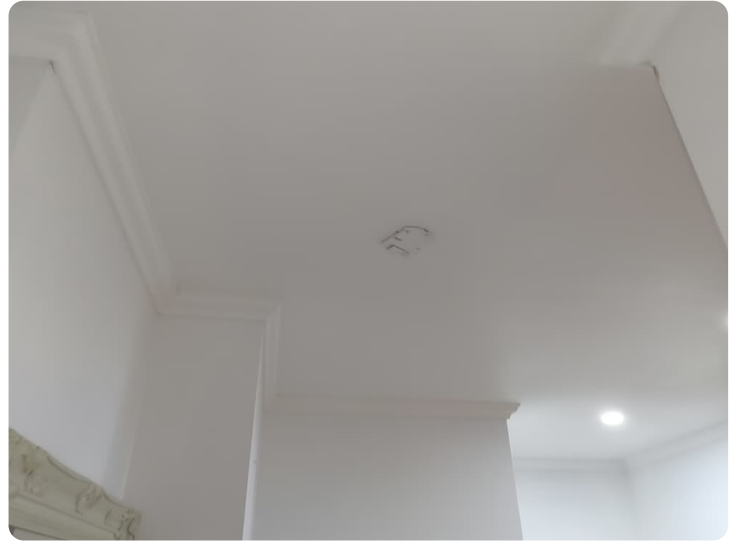
## 48. Smoke Alarms

There was one hardwired smoke alarms on site. There were no battery smoke alarms on site. The location, number and type of smoke alarms appeared to be inconsistent with Legislative requirements. It is suggested that an Electrical Compliance Certificate be obtained in relation to the smoke alarms.

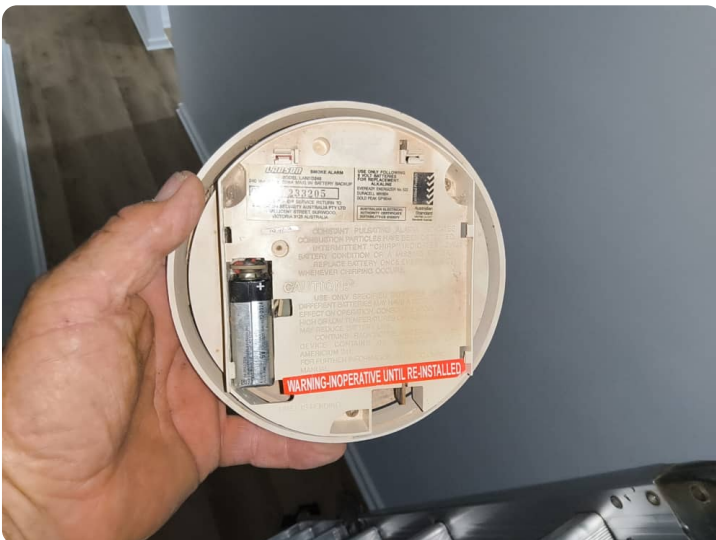
### 48.1 Smoke alarms older than 10 years - confirmed

#### Issue flag: Regulatory Safety Item

While on site the inspector checked the age of the smoke alarm via a date stamp on the rear of the alarm. The date indicated that the alarm was older than 10 years. Under WA laws smoke alarms must be less than 10 years old. It is recommended that an Electrical Contractor be engaged to review and provide an Electrical Compliance Certificate.

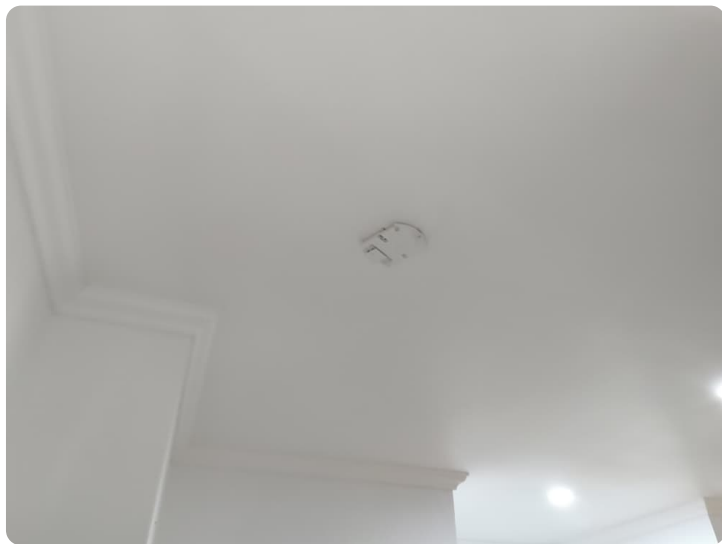
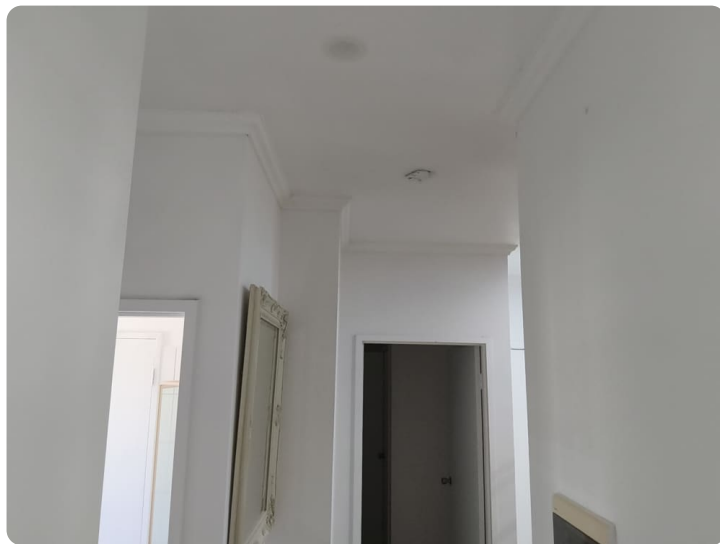
### Issue flag: Regulatory Safety Item

The smoke alarm in the images appears to be either dismantled, disconnected to otherwise not working and hence there appears to be insufficient Smoke Alarms located in the correct locations in the property. All single and multi-storey dwellings, duplexes, town houses, terrace houses, apartments and residential units in a building of another class e.g. a caretaker residence require smoke alarms to be installed on or near the ceiling in a. any storey containing bedrooms, b. between the bedrooms and the remainder of the dwelling c. where bedrooms are served by a hallway, in that hallway; and d. any other storey not containing bedrooms, in the area of the stairway (exit path) between each level. It is recommended that an Electrical Contractor be engaged to review and provide an Electrical Compliance Certificate.
