**PILBARA
PEST CO**

Pre-Purchase Timber Pest Inspection Report

8B Comrie Court, Baynton WA, Australia

Pre-Purchase Timber Pest Inspection (AS4349.3-2010)

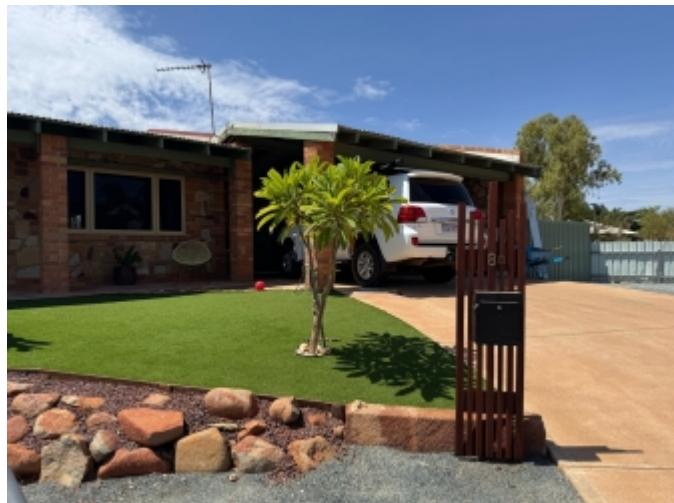
4. ABOUT THE PROPERTY INSPECTED

The front facade of the dwelling faces:	Approximately South
Type of Structure:	Unit
Height of Structure:	Single Storey
Wall Construction:	Brick Veneer
Floor Type:	Concrete Slab
Please note that If the building, or any part thereof, includes a concrete slab, there is the possibility of a concealed termite entry and therefore a higher probability of termite attack.	
Roof Type:	Conventional Cut Roof
	Trusses
	Steel Sheeting
Additional Comments:	Completed a visual non invasive pre purchase timber pest inspection to all accessible areas of the building, including the site within 30m of the main dwelling in accordance with AS4349.3 it should be noted that all inspections to Australian standards have some level of obstructions that could conceal termite activity.
Property Furnishing Status:	At the time of the inspection the property was unfurnished
Property Occupancy Status:	At the time of inspection the property was occupied
