# 10-YEAR PLAN

& CONDITION REPORT

21 Northwood Street,  
West Leederville WA 6007

Strata Plan No: S068009

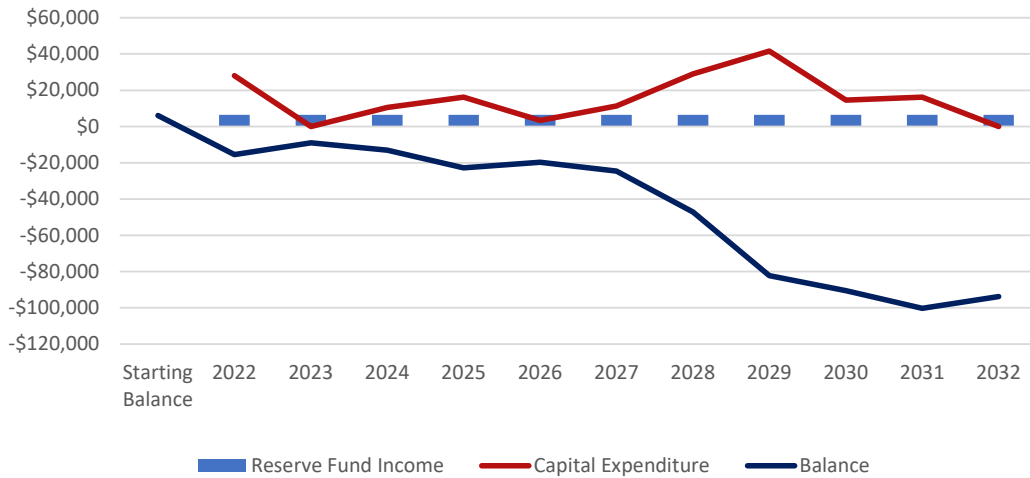
Chart A. Current Funding Levels

Year	Reserve Fund Income	Capital Expenditure	Balance
Starting Balance	\$0		\$6,064
2022	\$6,440	\$28,000	-\$15,496
2023	\$6,440	\$0	-\$9,056
2024	\$6,440	\$10,506	-\$13,122
2025	\$6,440	\$16,153	-\$22,835
2026	\$6,440	\$3,311	-\$19,707
2027	\$6,440	\$11,314	-\$24,581
2028	\$6,440	\$28,992	-\$47,133
2029	\$6,440	\$41,604	-\$82,297
2030	\$6,440	\$14,621	-\$90,478
2031	\$6,440	\$16,235	-\$100,273
2032	\$6,440	\$0	-\$93,833
